# NATIONAL TRANSPORTATION SAFETY BOARD

## MATERIALS LABORATORY FACTUAL REPORT

Report No. 16-087

Place : West Chester, Pennsylvania  
Date : March 29, 2015  
Vehicle : Piper PA-28-140  
NTSB No. : ERA15FA171  
Investigator : Timothy Monville AS-ERA

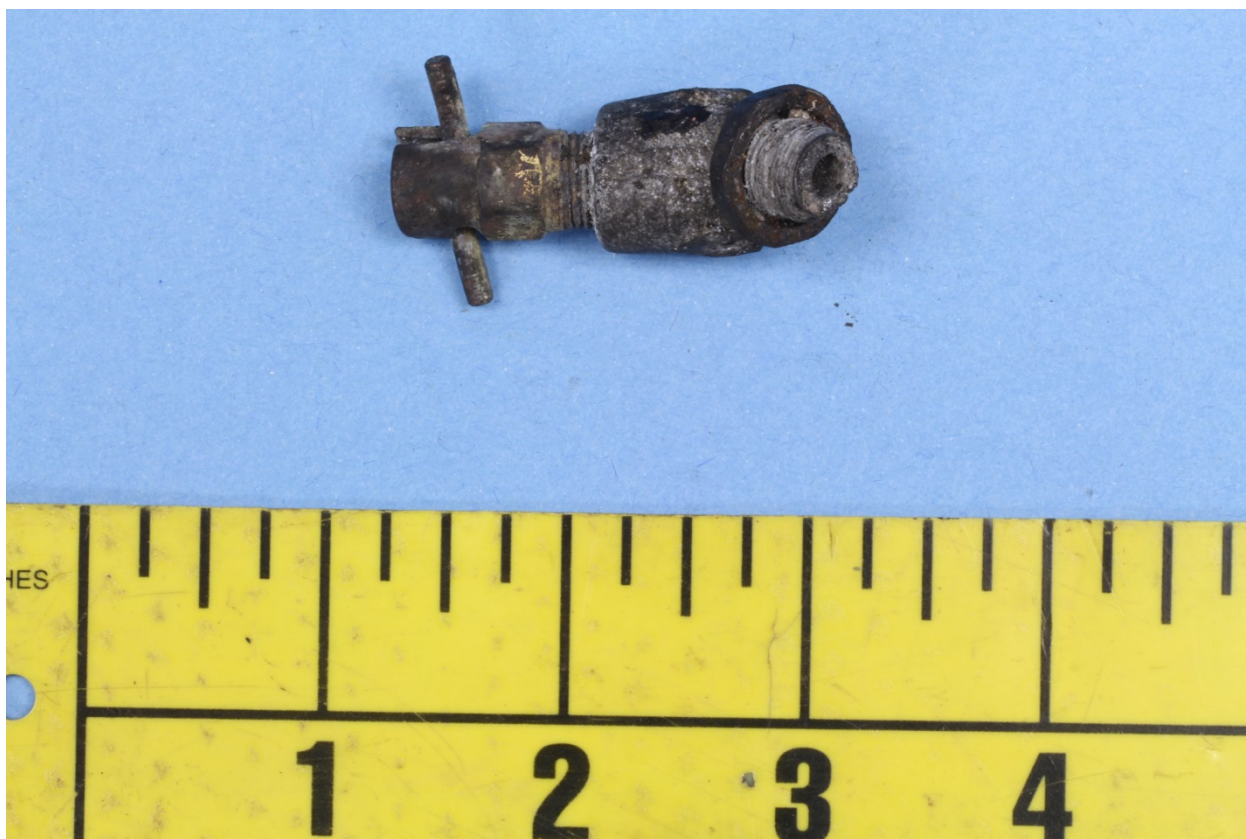
The gascolator from the accident aircraft was submitted for to the Materials Laboratory, as shown in Figure 1, to determine the valve stem position. The outer surface of the gascolator was sooted and covered in a white oxide layer consistent with exposure to fire.

The gascolator was examined using a 50X to 200X digital microscope. The valve stem had impact damage and the locks were bent. There are some scrapes and divots on the lock but nothing consistent with the T-pin. The securing T-pin was found partially in the "Locked" position. It could not be determined conclusively if this was the position of the locking pin and valve prior to impact. The fire damage is obscuring or obliterated any witness marks.

**Figure 1. Overall photograph of accident aircraft gascolator.**

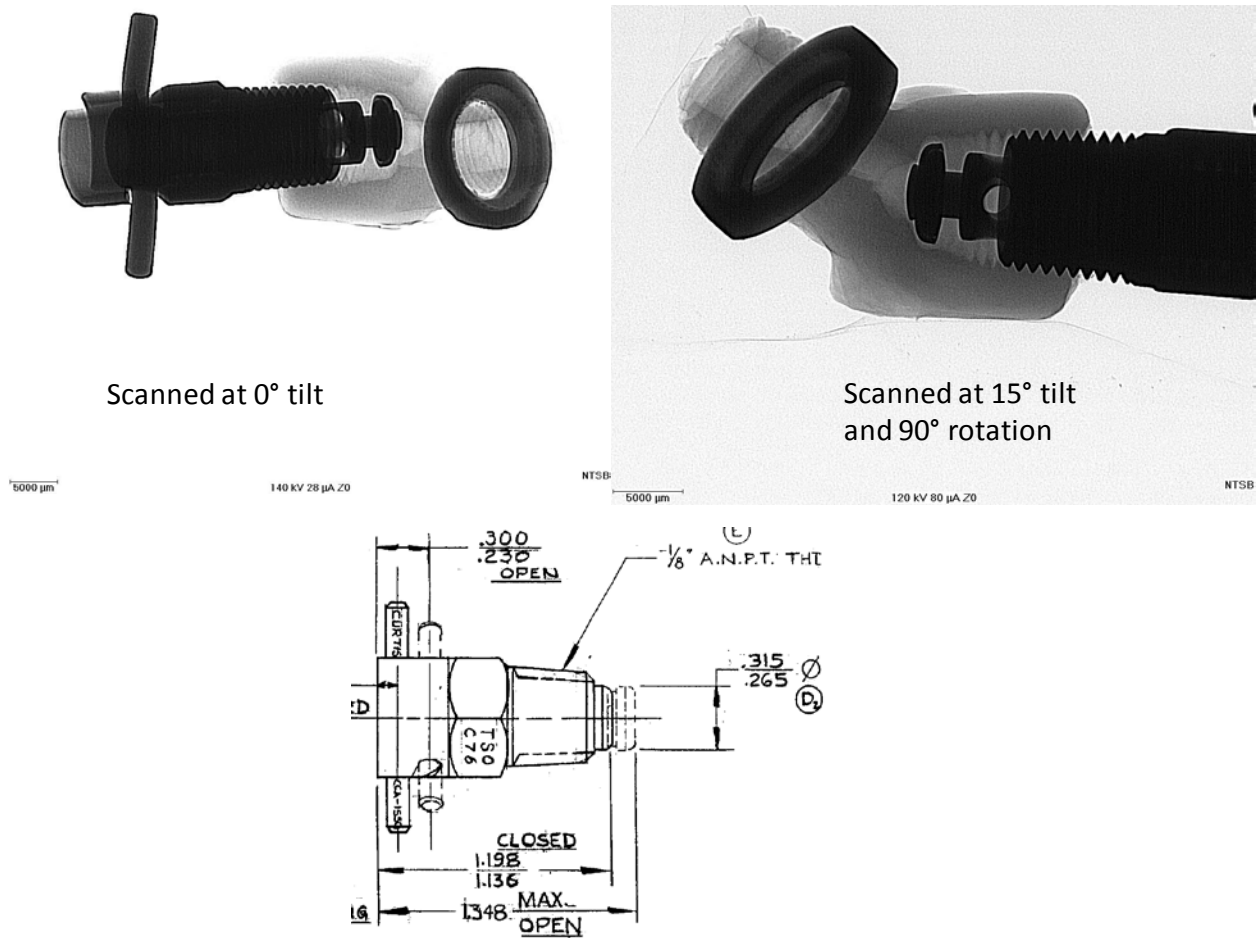
To determine internal position of the valve stem, the gascolator was x-rayed. The radiograph, shown in Figure 2, shows that the internal stem is in the "Open" position.

Figure 2. Radiographs of gascolator compared to part drawing.
