# NATIONAL TRANSPORTATION SAFETY BOARD

MATERIALS LABORATORY FACTUAL REPORT

Report No. 16-006

Place : Lakeland, Florida  
Date : April 20, 2015  
Vehicle : Mooney M20TN  
NTSB No. : ERA15FA191  
Investigator : Shawn Etcher, AS-ERA

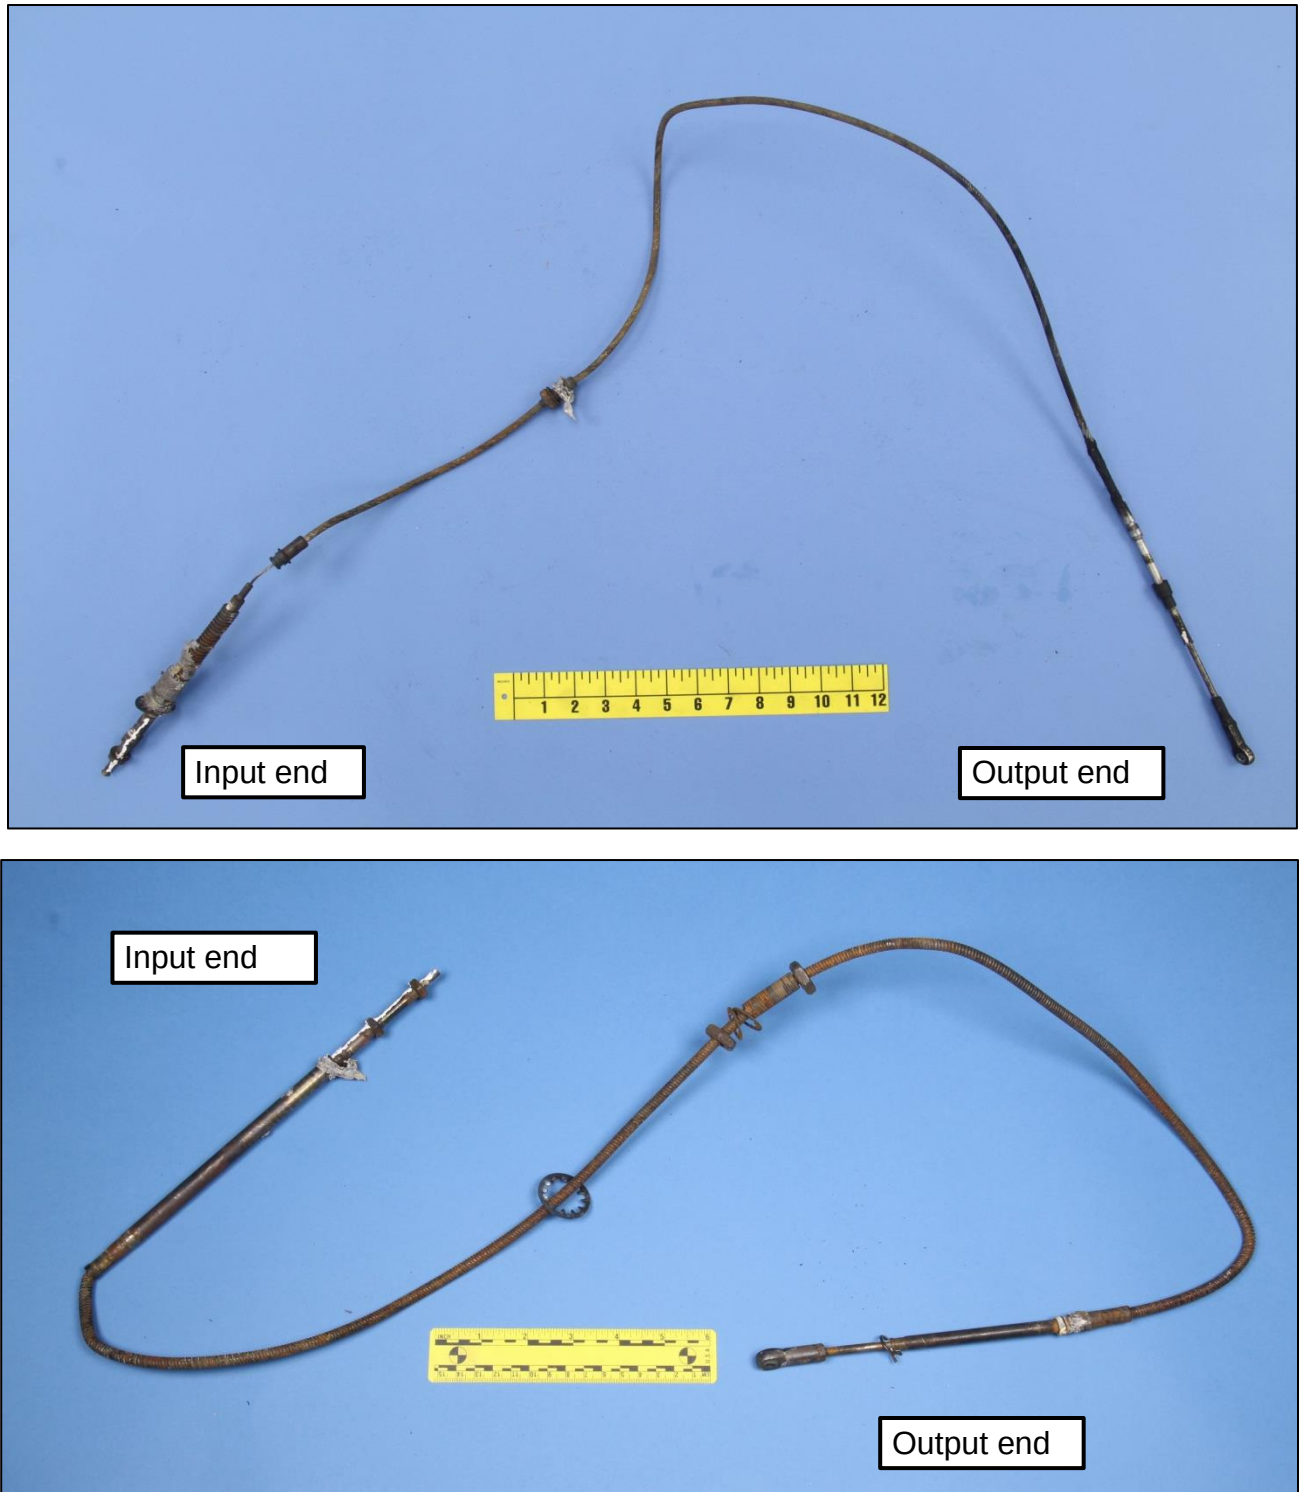
Overall views of the throttle and mixture control assemblies are shown in figure 1. Both assemblies were discolored and oxidized consistent with exposure to high heat. Remnants of aluminum alloy components on the assemblies were distorted, oxidized, flowed, and missing consistent with having been molten due to exposure to the heat.

Figure 1. Overall views of the throttle control assembly (upper image) and the mixture control assembly (lower image).

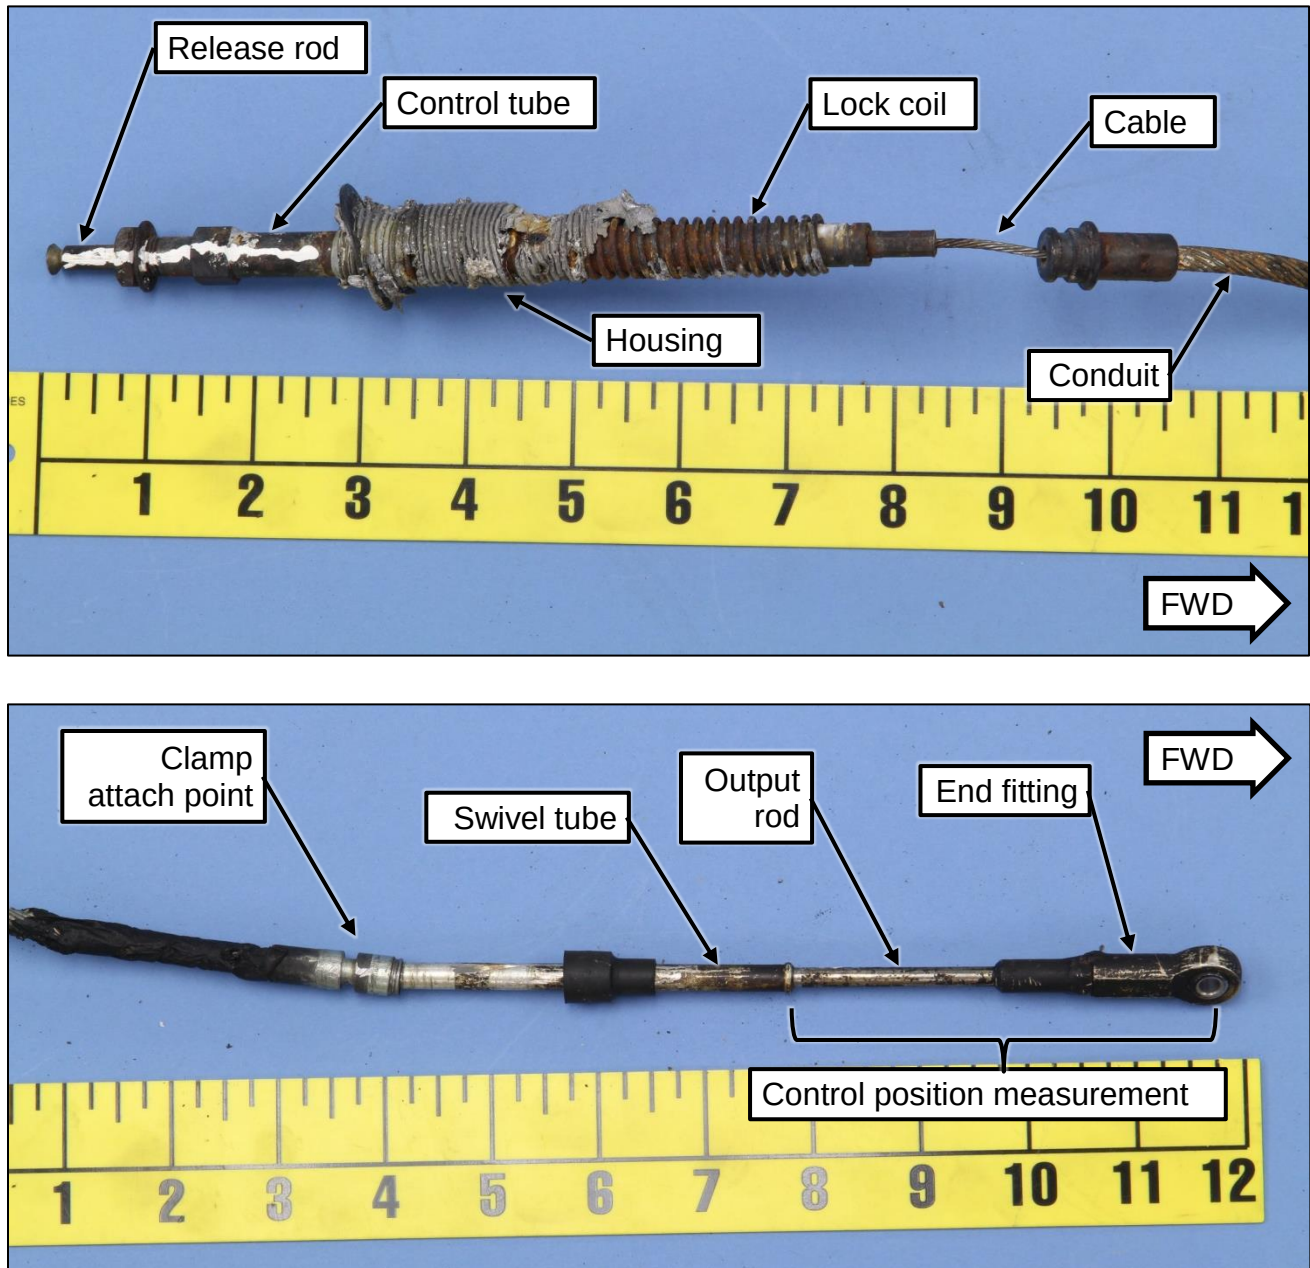
Closer views of the input and output ends of the throttle control assembly are shown in figure 2. The position of the input control had been documented on-scene with a line of white paint visible on the release rod and control tube in the upper image

in figure 2 and on the swivel tube and output rod at the output end. The forward portion of the aluminum alloy housing was missing from the input control, exposing the lock coil and cable. The exposed segment of cable had tight wound strands and showed no evidence of “birdcage” deformation<sup>1</sup> that would indicate compression buckling of the cable.

The position of the control was measured at the output end of the assembly and compared to full throttle and idle position descriptions provided by a Mooney representative. As installed on the airplane and measured from the end of the swivel tube to the center of the end fitting attachment hole (see the labeled bracket in figure 2), the full open throttle position measures 4.620 inches, and the full closed throttle position measures 1.3 inches. On the accident control, the throttle position measurement was 3.75 inches, corresponding to a throttle position of 74% of full open.

Figure 2. Closer view of the throttle control assembly at the input end (upper image) and output end (lower image).

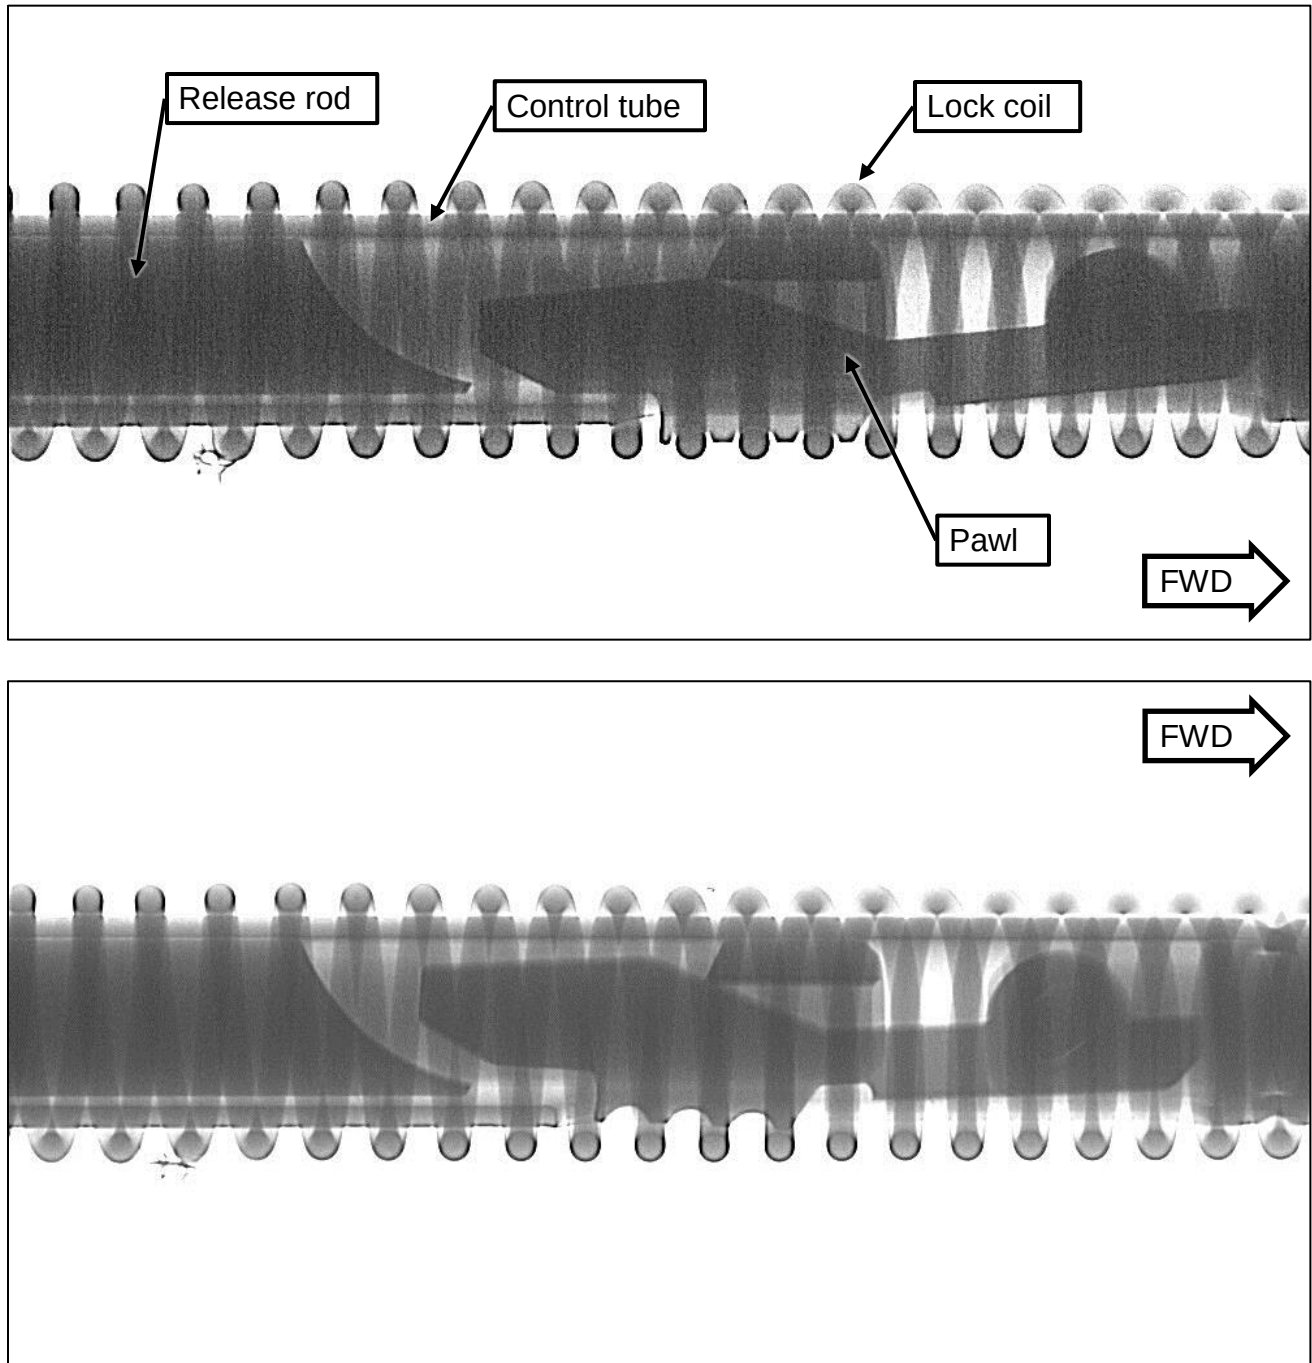
Additional x-ray radiographs were taken documenting the input control lock mechanism of the throttle control assembly with the release rod in varying positions as shown in figures 3 and 4. With the release button fully extended, the pawl engaged with the lock coil as shown in the upper image in figure 3. As the release rod was pressed in, the pawl disengaged from the lock coil, and the control was able to move relative to the coil as shown in the lower image in figure 3. The radiograph in figure 4 shows the position of the pawl with the release rod pressed in to its forward limit, and the pawl is retracted further into the control tube as compared to the position shown in the lower image in figure 3.

The range of operation of the release rod was measured from the lock position to the full release position. In the lock position (upper image in figure 3), the release rod extended 0.733 inch aft of the aft face of the nut on the aft end of the control tube. With the pawl just disengaged (lower image in figure 3), the release rod extended 0.605 inch from the nut. When the release rod was fully depressed (figure 4 position), the rod extended 0.425 inch from the nut.

Figure 3. Radiographs of the input control lock mechanism in the throttle control assembly in the locked position (upper image) and in the just unlocked position (lower image).

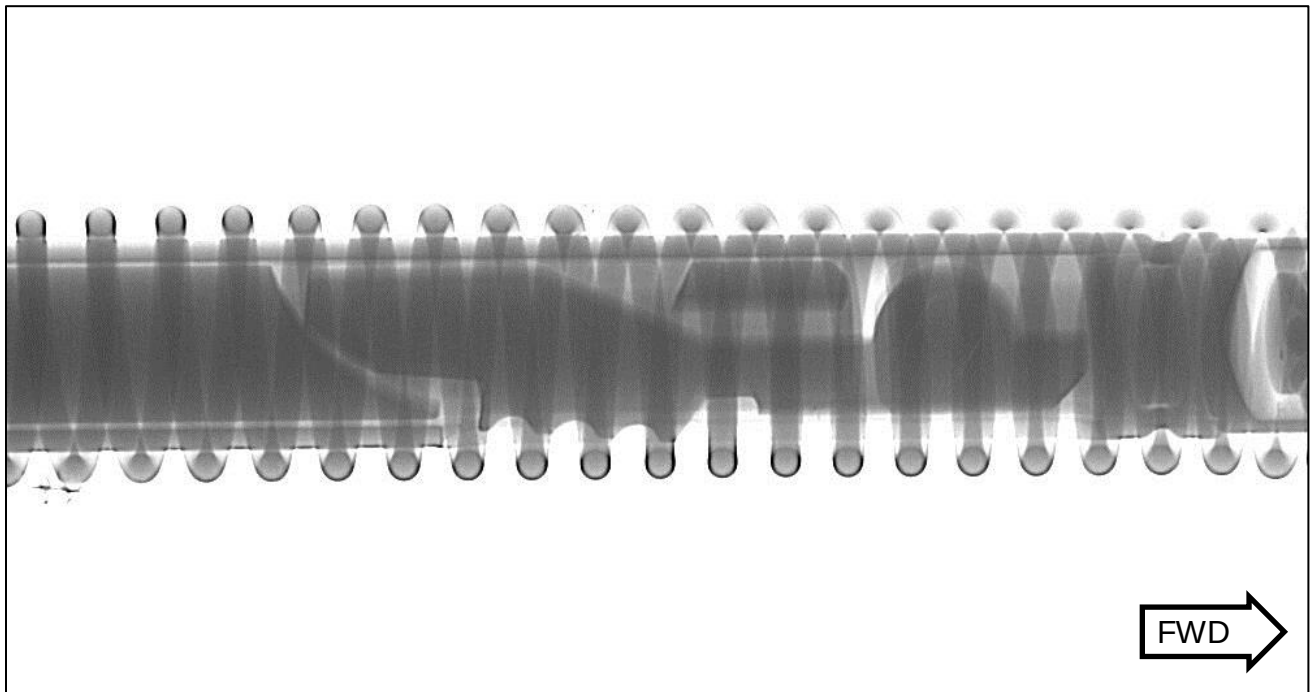
Figure 4. Radiograph of the input control lock mechanism in the throttle control assembly with the lock mechanism fully retracted.

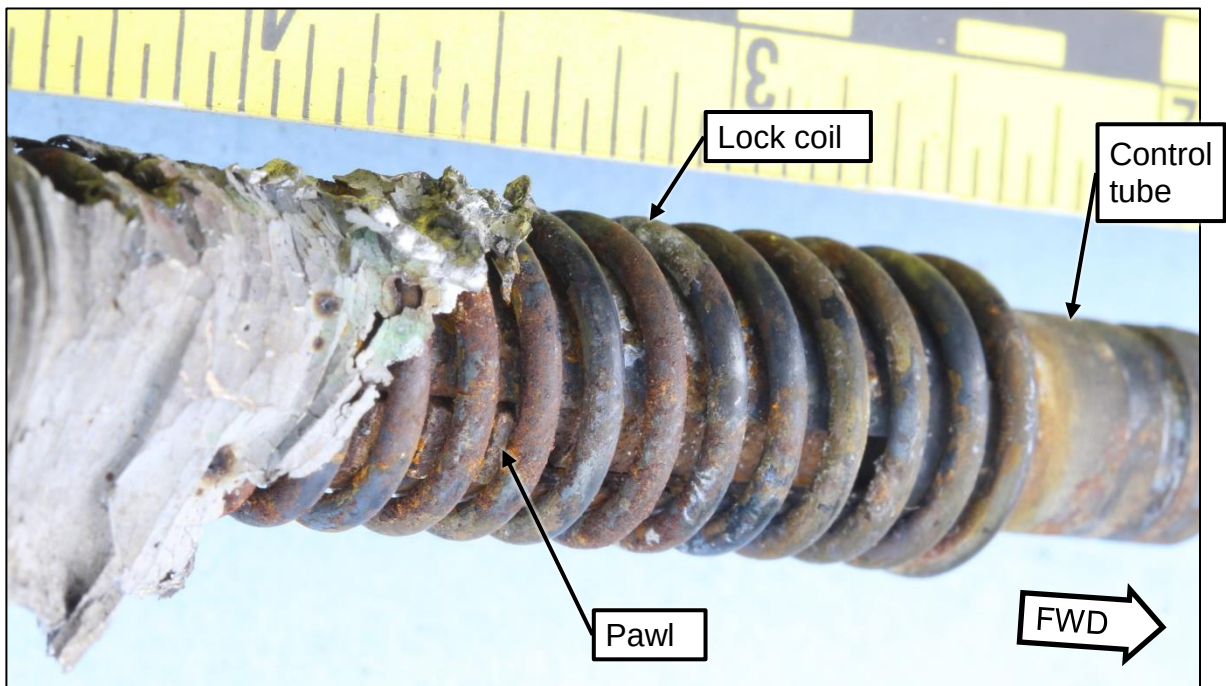
Photographs of the lock mechanism in positions comparable to those of figure 3 are shown in figures 5 and 6. In figure 5, the pawl is shown engaged with the lock coil with the release rod fully extended. In figure 6, the pawl is shown disengaged from the lock coil after the release rod was pressed in sufficiently to disengage the lock.

Figure 5. View of the input control lock mechanism for the throttle control assembly with the pawl engaged with the lock coil.

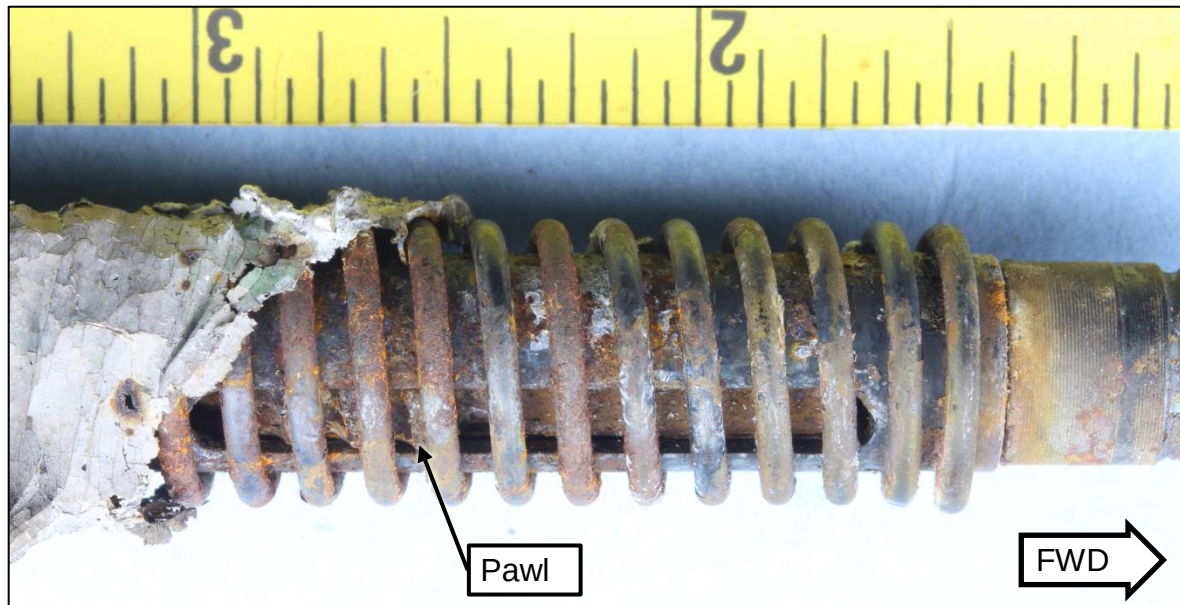
Figure 6. View of the input control lock mechanism for the throttle control assembly with the pawl disengaged from the lock coil.

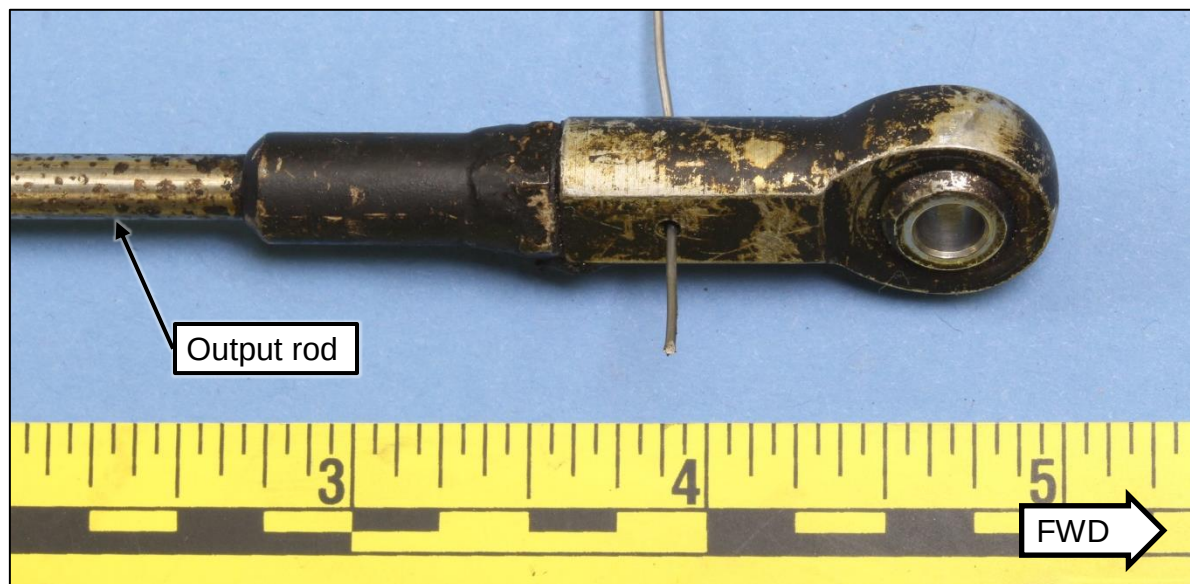
At the output end of the throttle control assembly, the inspection hole in the end fitting was open across the fitting. In figure 7, a wire is shown inserted through the fitting in the inspection hole, demonstrating the inspection hole was open through the

thickness of the end fitting. Based on an x-ray inspection, the end fitting was threaded onto the end of the output rod such that the end of the rod was just aft of the inspection hole. Upon further inspection, the end of the rod was visible by looking through the inspection hole with an optical microscope.

Figure 7. View of the end fitting at the output end of the throttle control assembly with a wire inserted through the inspection hole.

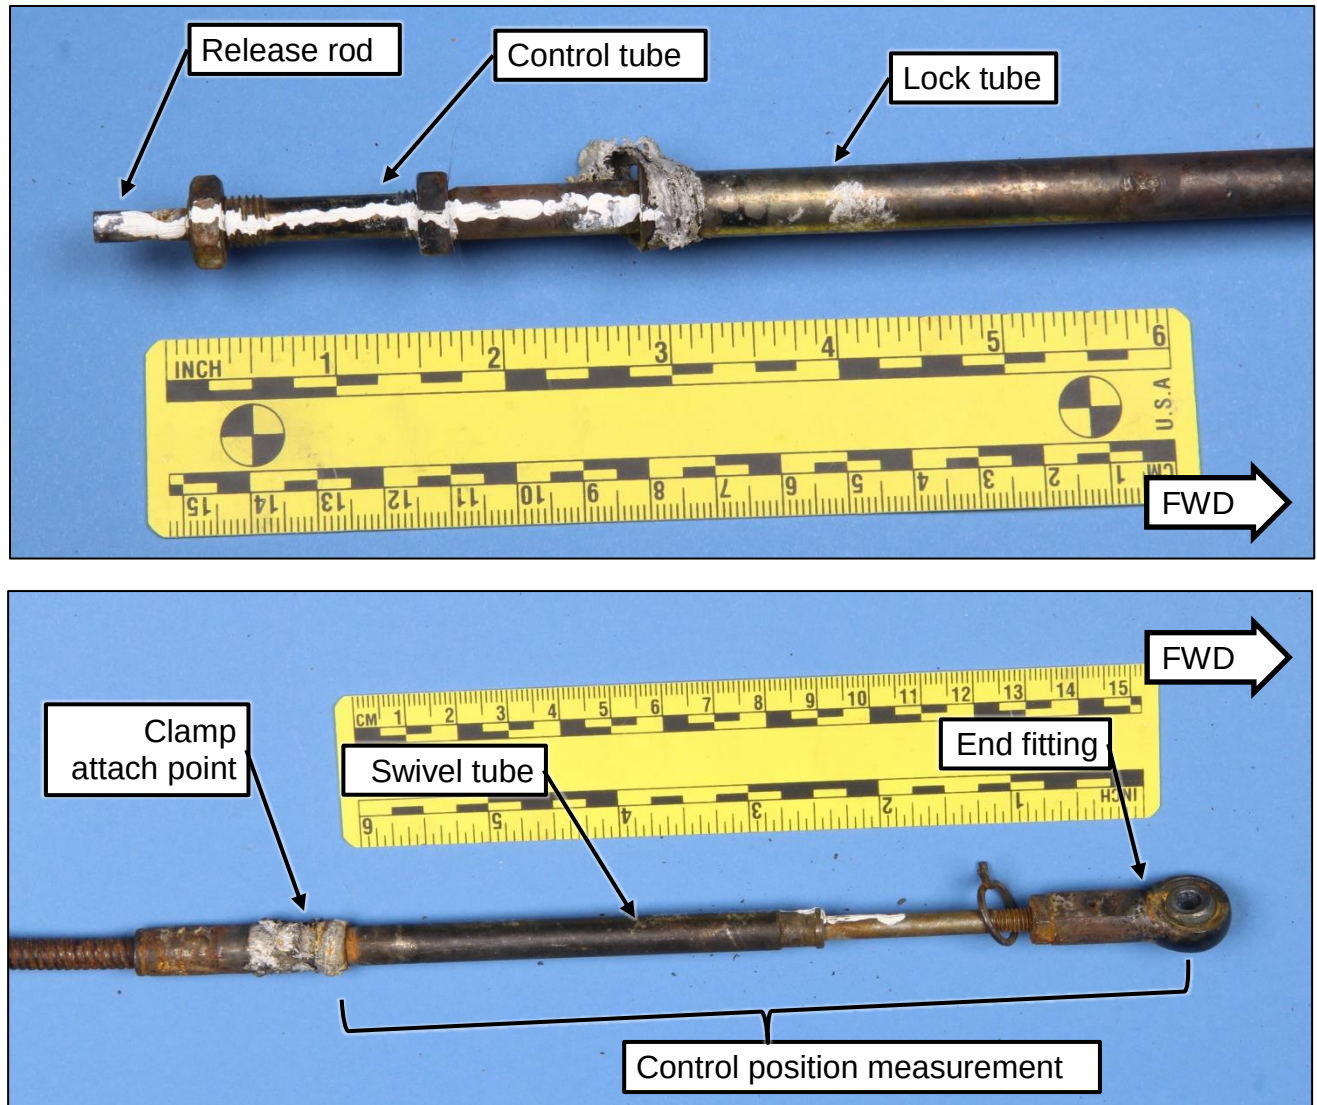
Closer views of the input and output ends of the mixture control assembly are shown in figure 8. As with the throttle control assembly, the positions of the mixture control assembly had been documented on-scene with a line of white paint on the release rod, control tube, and lock tube on the input end visible in the upper image in figure 8 and on the swivel tube and output rod on the output end visible in the lower image in figure 8. Remnants of an aluminum alloy housing was present at the aft end of the lock tube.

The mixture control position was measured at the output end of the assembly and compared to full rich and idle cut-off position descriptions provided by a Mooney representative. As installed on the airplane and measured from the clamp attach point to the center of the end fitting attachment hole (see the labeled bracket in figure 8), the full rich mixture position measures 7.70 inches, and the idle cut-off position measures

5.35 inches. On the accident control, the mixture position measurement was 6.70 inches, corresponding to a mixture position of 57% of full rich.

Figure 8. Close views of the input end (upper image) and output end (lower image) of the mixture control assembly.

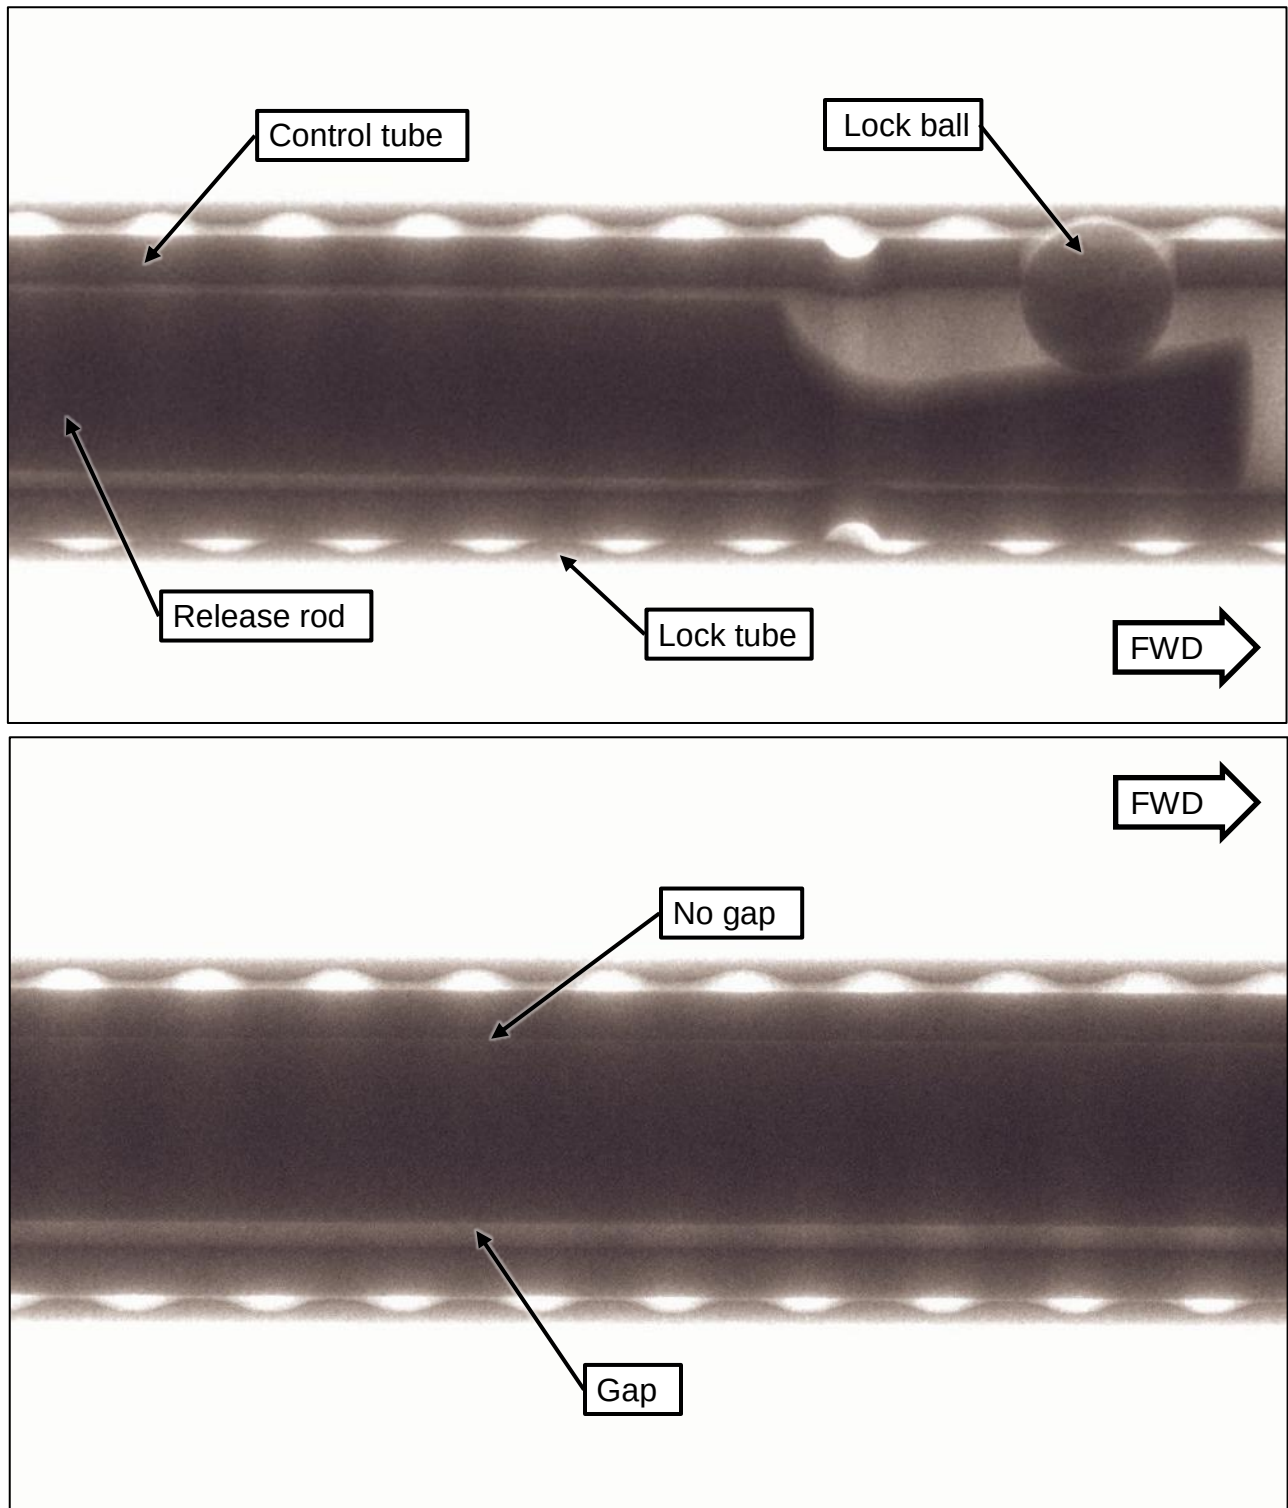
The mixture control assembly was initially examined visually, and the position of the internal mechanism in the input control was documented using x-ray radiography as shown in figures 9 and 10. The lock ball was engaged with an internal groove in the lock tube as shown in the upper image in figure 9. Near the middle of the tube, shown in the lower image in figure 9, the release rod was positioned closer to one wall of the control tube leaving a gap on one side and no gap on the other side. At the input end shown in figure 10, the gap between the release rod and the control tube was similar on both sides. Once the initial documentation was complete, attempts were made to operate the input control by pressing the release rod, and the release rod did not move.

Figure 9. Radiographs of the lock mechanism (upper image) and the middle portion (lower image) of the mixture input control.

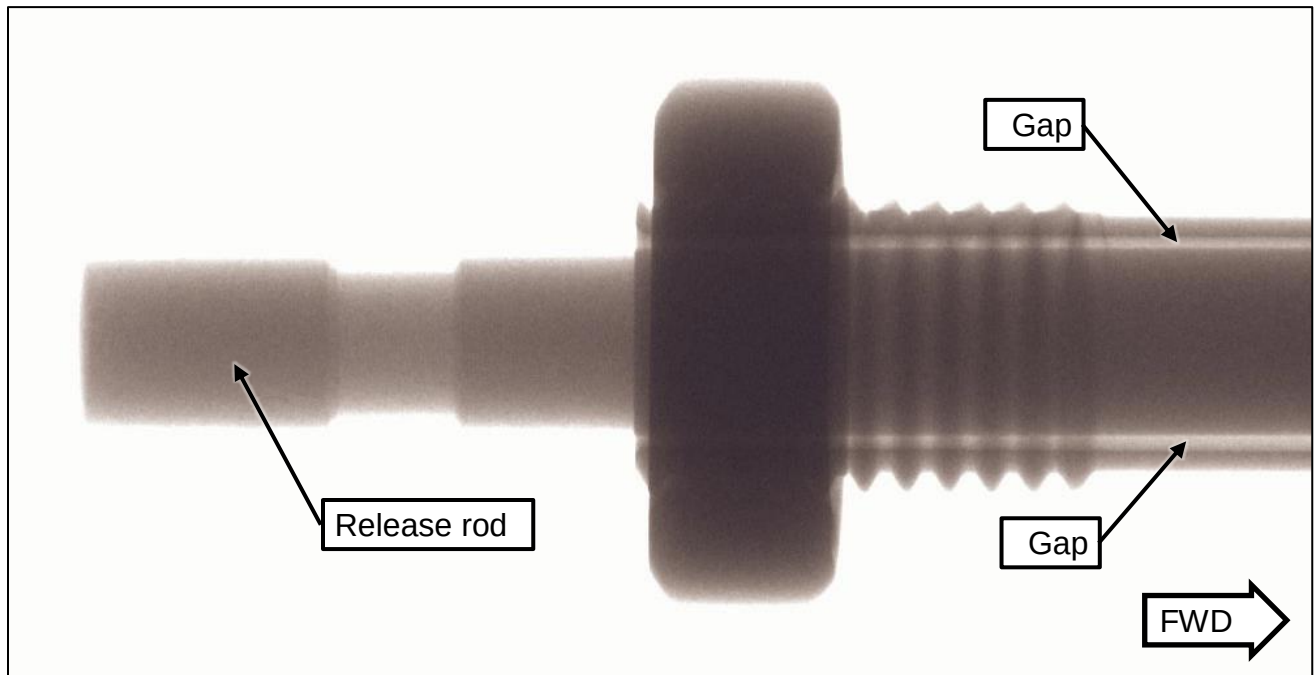
Figure 10. Radiograph of the input end of the mixture control assembly.

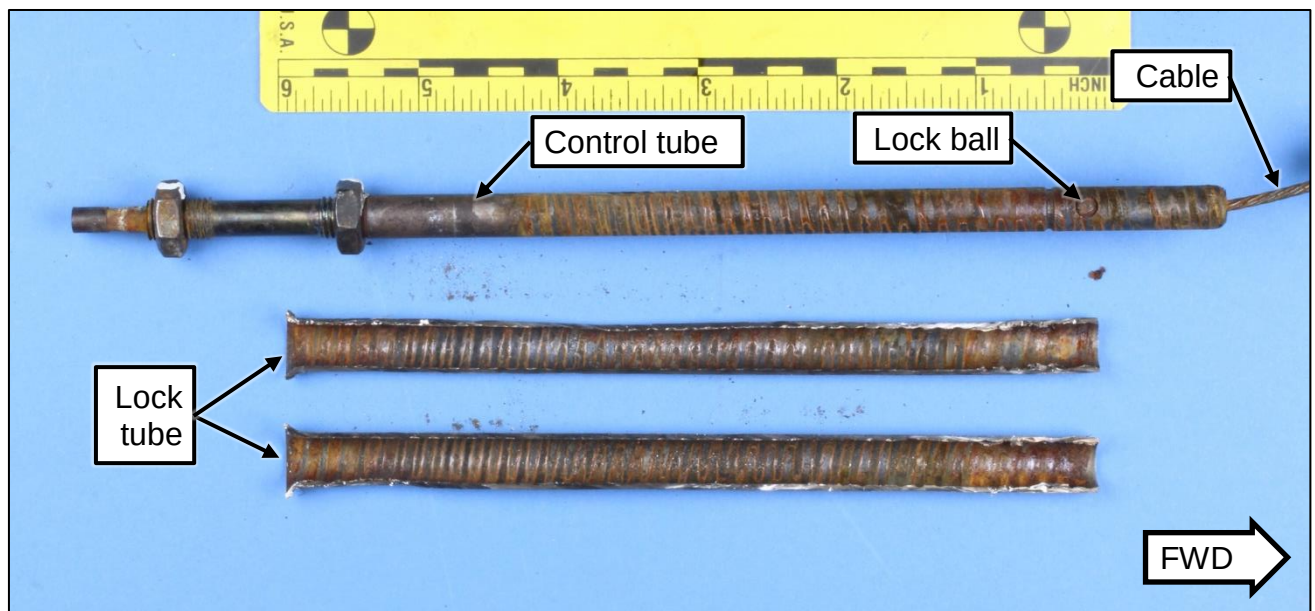
A view of the input assembly after sectioning the lock tube is shown in figure 11. The cable segment between control tube and the conduit was tightly wound and showed no evidence of birdcage deformation.

Figure 11. View of the input end of the mixture control assembly after sectioning the lock tube.

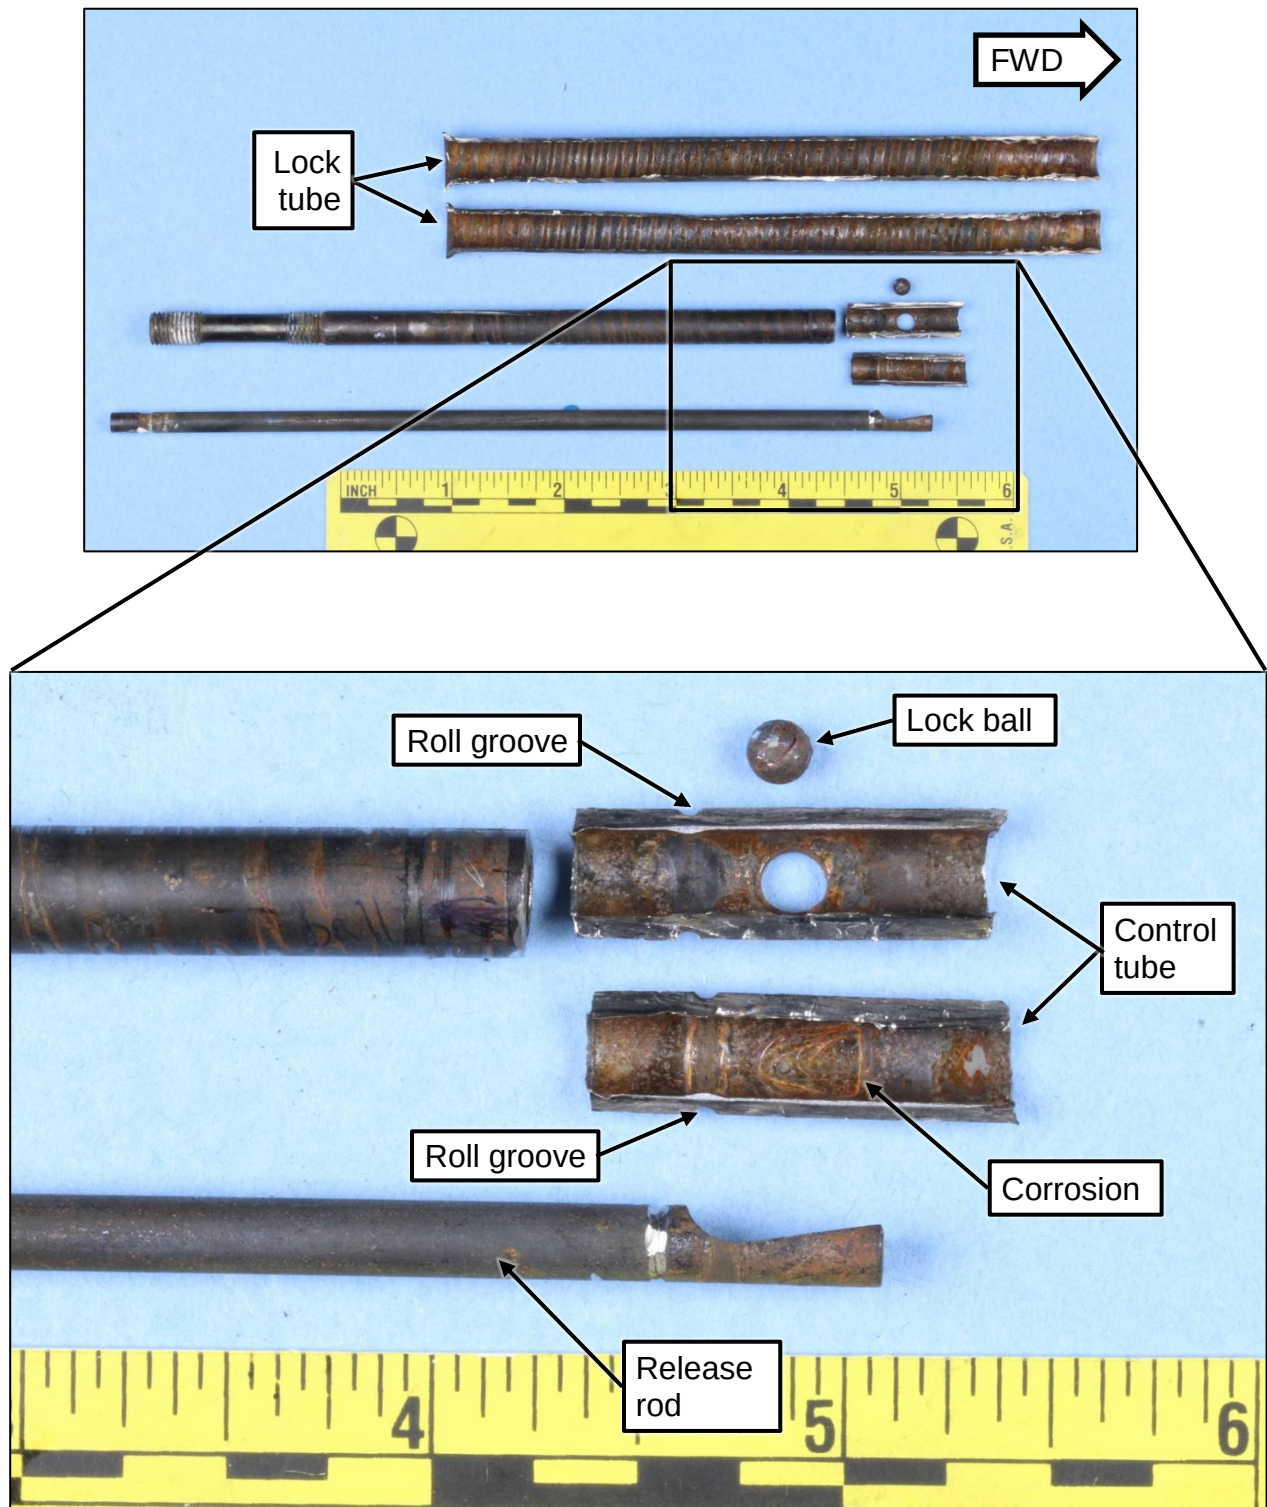
To facilitate separation of the release rod and examination of the control rod interior, the forward end of the control tube was sectioned longitudinally along sides 90 degrees from the lock ball hole and circumferentially just forward of the roll groove (see figure 12). After the cuts were complete, the release rod was pulled out the aft end of the input control.

The release rod was slightly bent consistent with observations from the radiographs. In the view shown in figure 12, the middle portion of the release rod was 0.015 inch higher than the ends.

A close view of the interior of the control tube in the area of the lock mechanism is shown in the lower image in figure 12. On the side opposite from the lock ball hole, corrosion was observed as indicated, and the pattern of the corrosion was consistent with an area of contact between the forward end of the release rod and the control tube interior.

The inside diameter of the control tube adjacent to the circumferential cut was 0.210 inch. The inside diameter of the control tube was reduced in the area of the roll groove (see labeled groove in figure 12). Based on the profile of the roll groove at the edges of the cut, the roll groove deformation penetrated approximately 0.008 inches from the rest of the wall, resulting in an estimated inside diameter of 0.194 inch at the roll groove. The outside diameter of the release rod measured 0.187 inch.

Figure 12. Views of the mixture input control lock mechanism after sectioning the control tube and removing the release rod from the control tube.
