Aircraft Accident/Incident Report No: \_150420

**NTSB File No.:** ERA15FA191

**Aircraft:** Mooney, 20TN

**Propeller Teardown Report****Date of Investigation:** April 22, 2015**Location:** Air Salvage, Groveland, FL**Propeller Model:** PHC-J3YF-1RF with 7498 blades

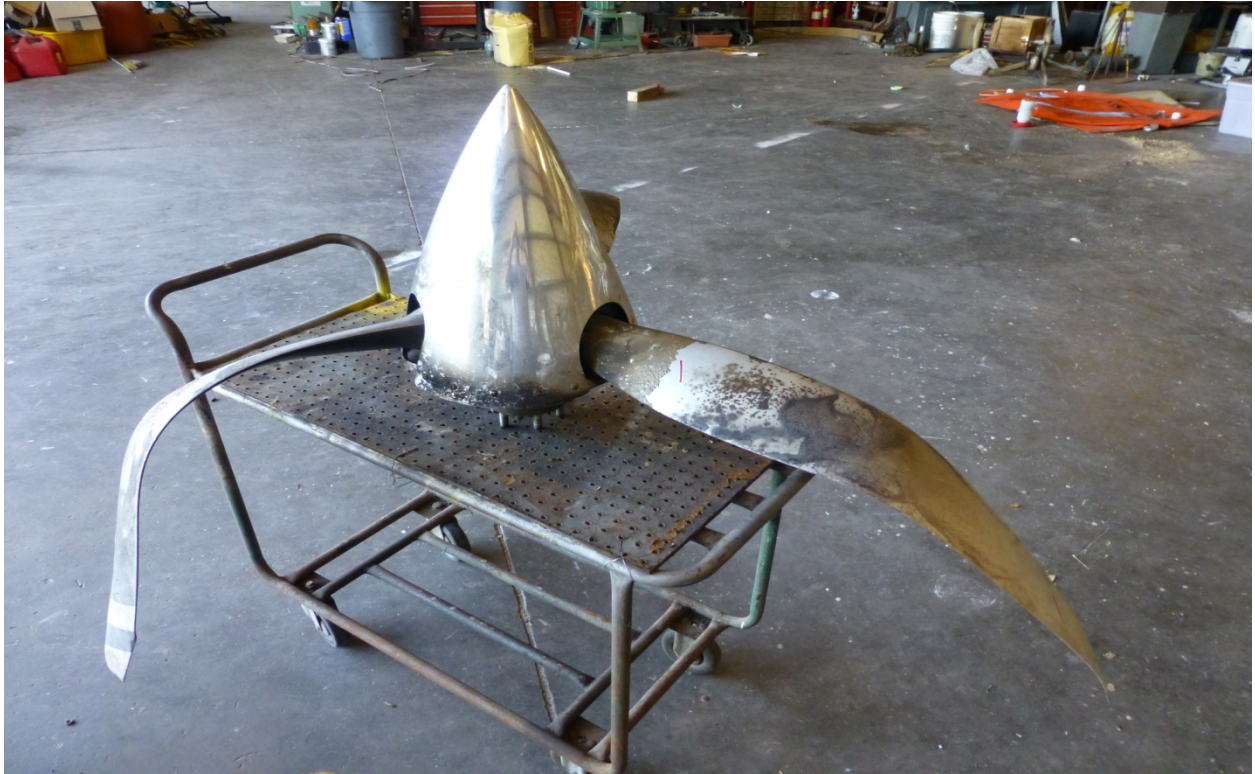
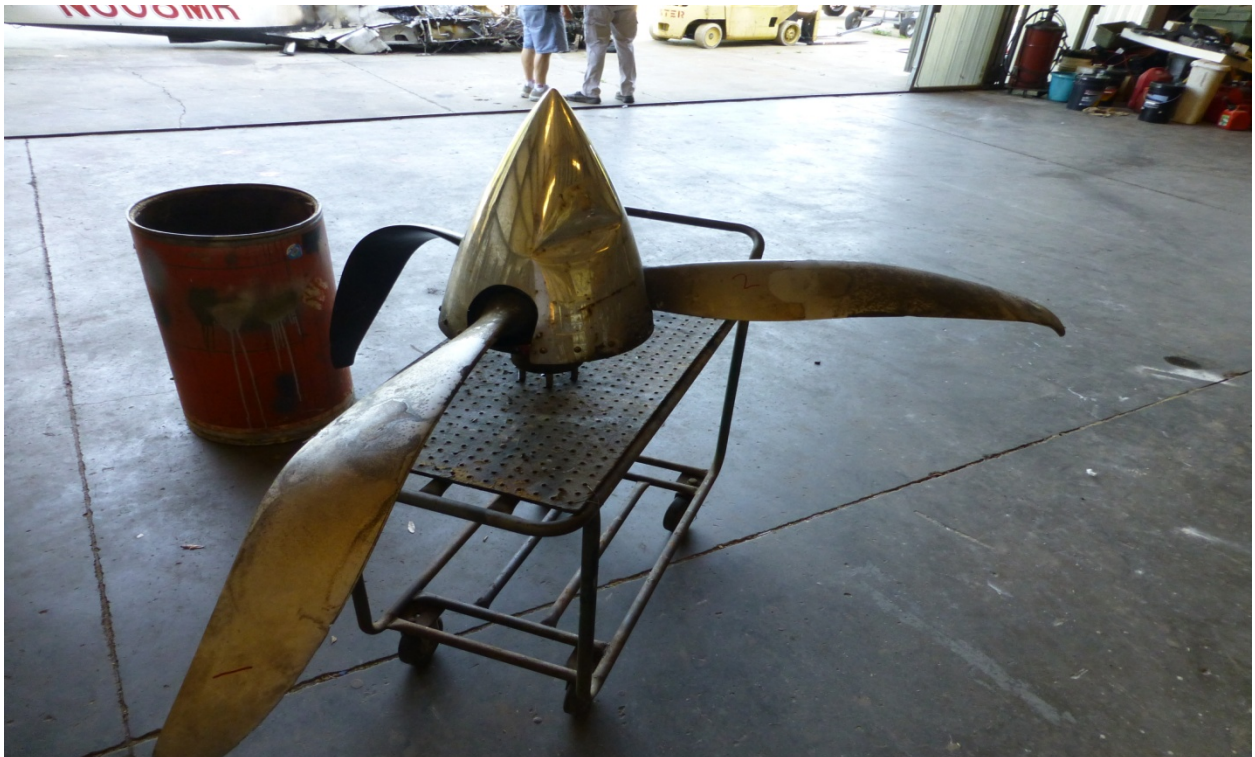
The propeller was thermally damaged. The propeller was still attached to the engine. All bolts were torqued. The #1 and #3 blades were bent aft at midblade. There were no signs of power on any of the blades.

The spinner dome was thermally damaged and bent on the bottom.

The bulkhead was thermally damaged and bent around the edges.

The propeller cycling was not possible due to thermal damage.

Photo #1, propeller as received.

Photo #2, propeller as received.

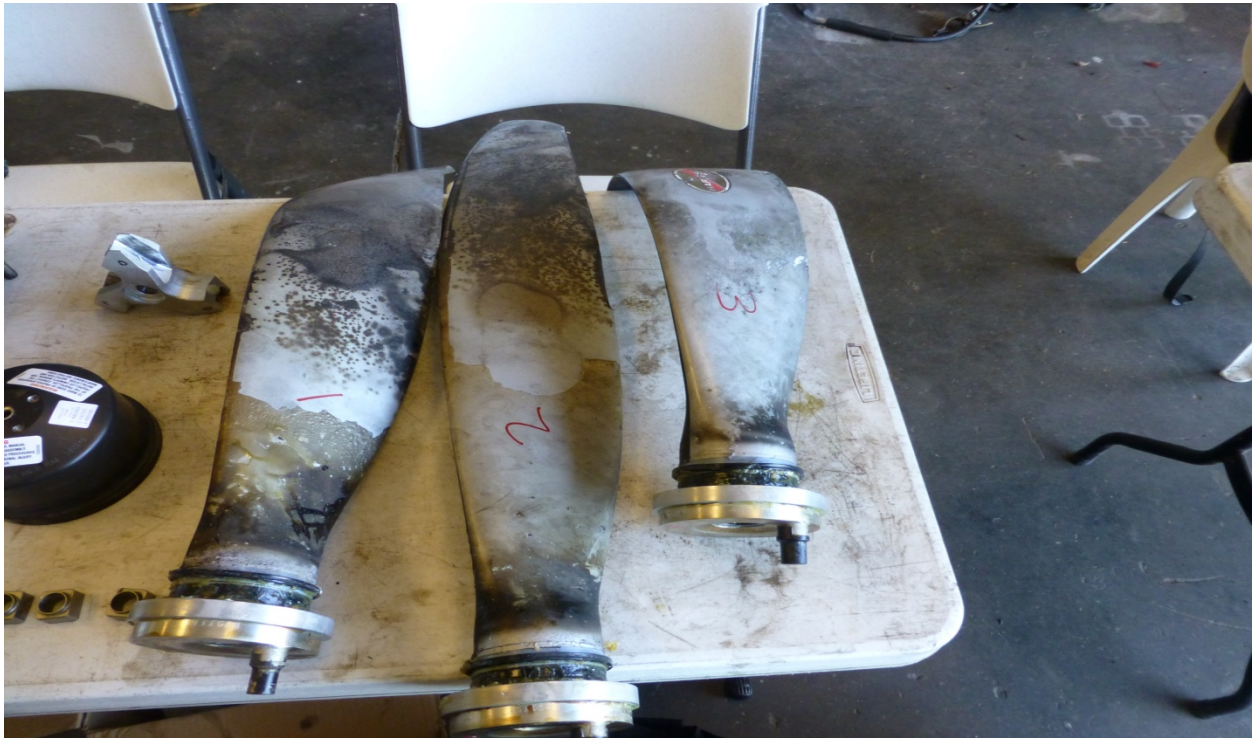
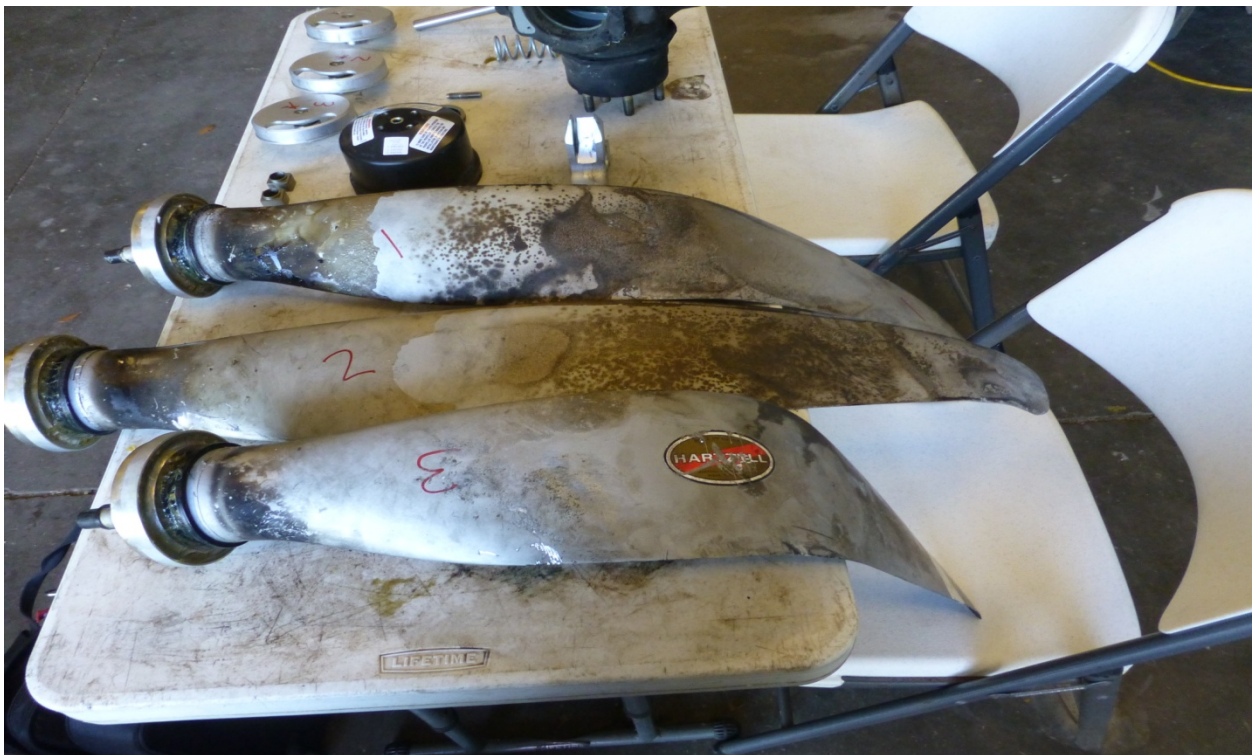
paint, camber side - thermally damaged.  
paint, flat side - thermally damaged.  
bend - aft midblade.  
twist - forward.  
lead edge damage - nick and gouges at tip.  
trail edge damage - none.  
knob condition - intact.

paint, camber side - thermally damaged.  
paint, flat side - thermally damaged.  
bend - none.  
twist - none.  
lead edge damage - none.  
trail edge damage - bent at tip.  
knob condition - intact.

paint, camber side - thermally damaged.  
paint, flat side - thermally damaged.  
bend - aft midblade.  
twist - forward.  
lead edge damage - nicks.  
trail edge damage - nicks.  
knob condition - intact.

Photo #3, propeller blades

Photo #4, propeller blades
