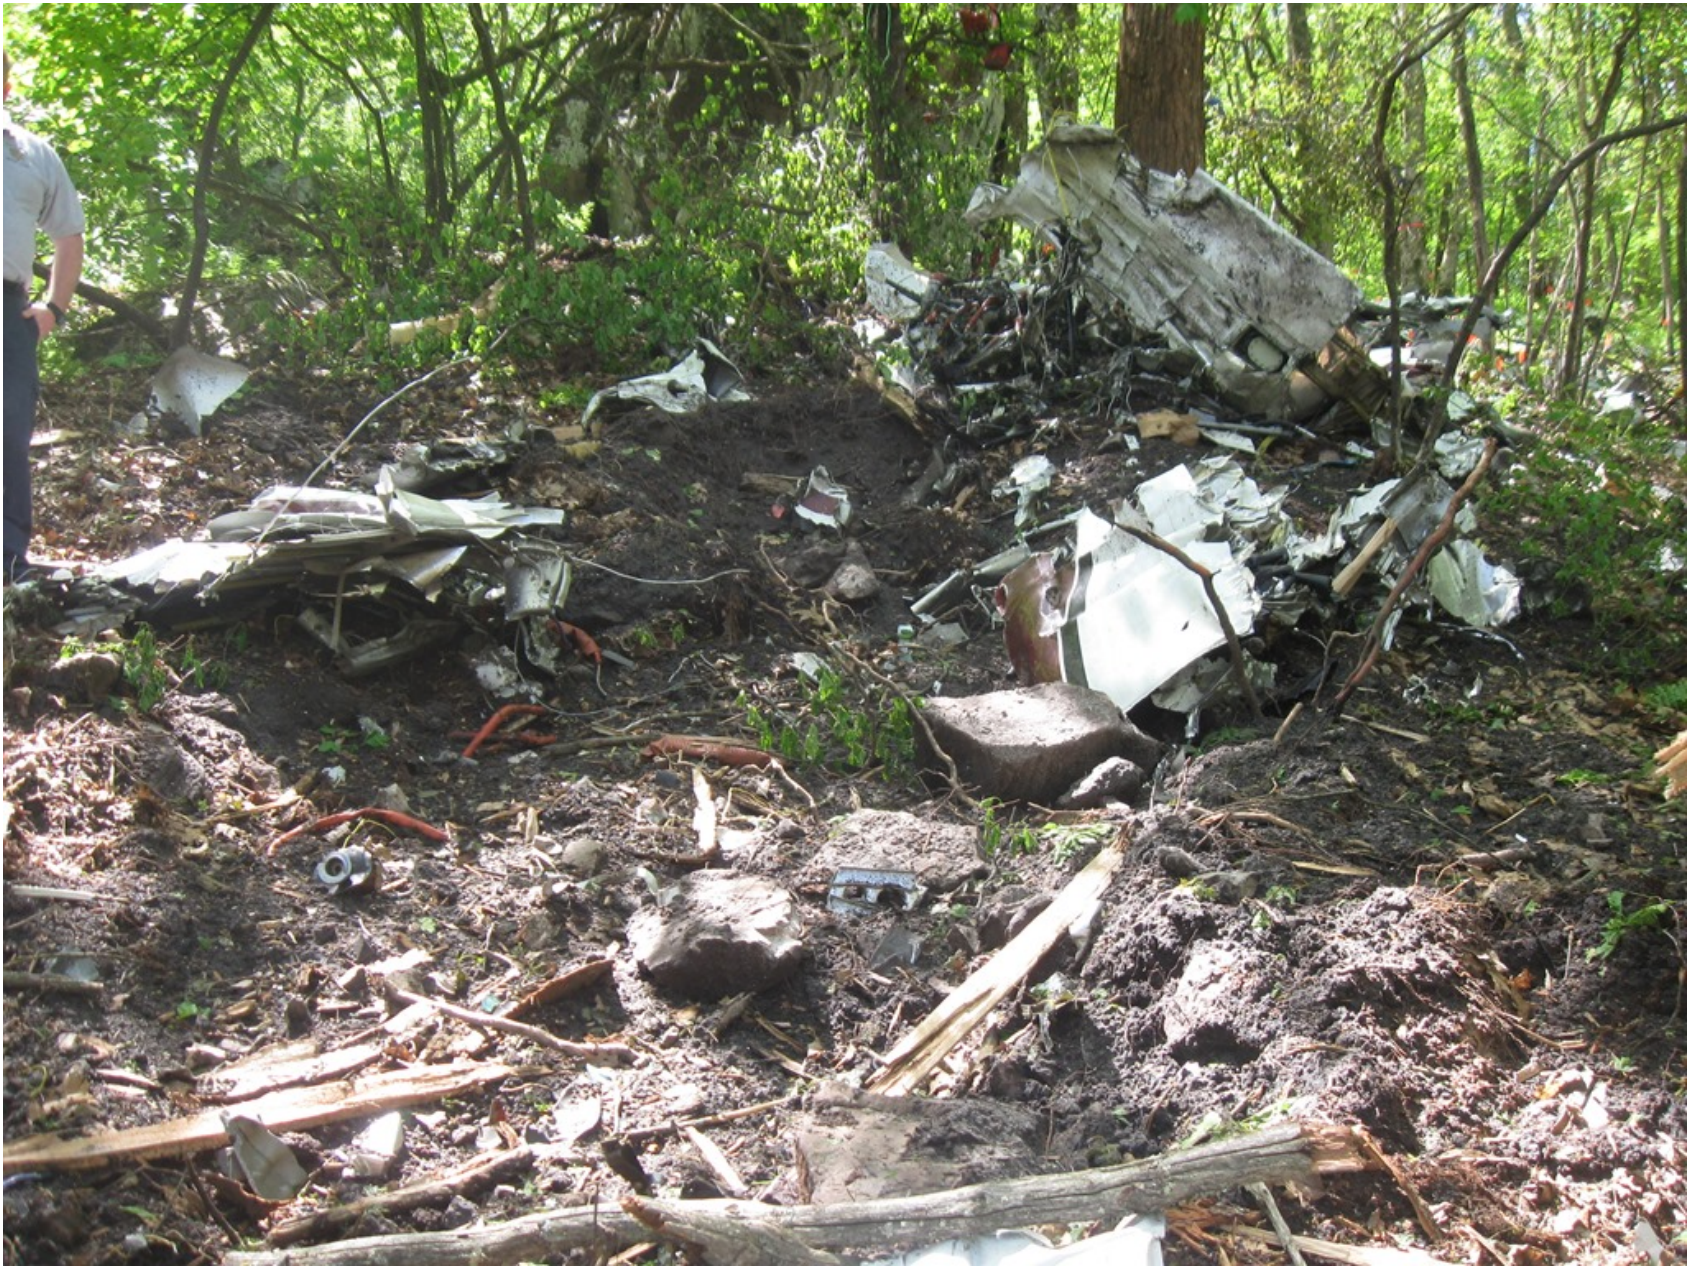
**Photo 1 – View of Initial Impact Crater**

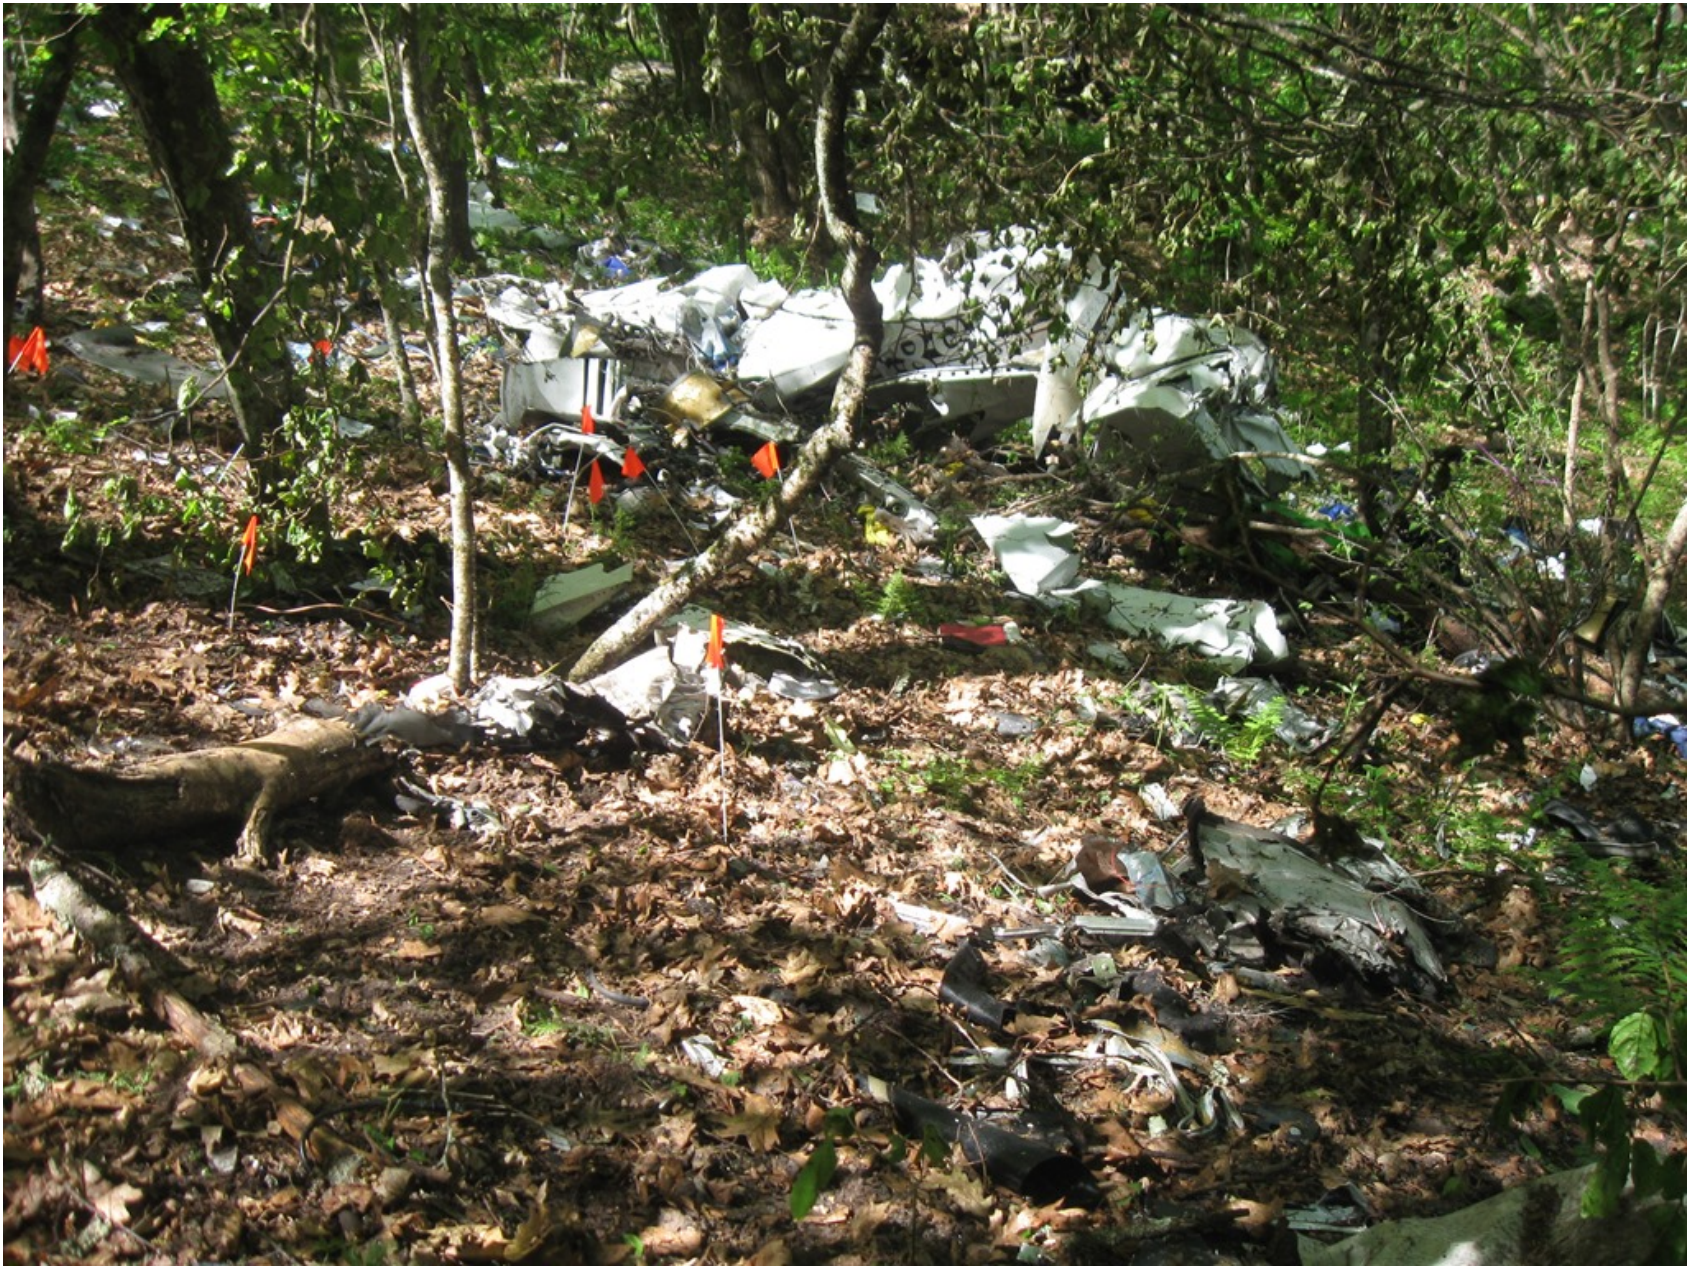
**Photo 2 – View of Debris Path and Aft Fuselage**

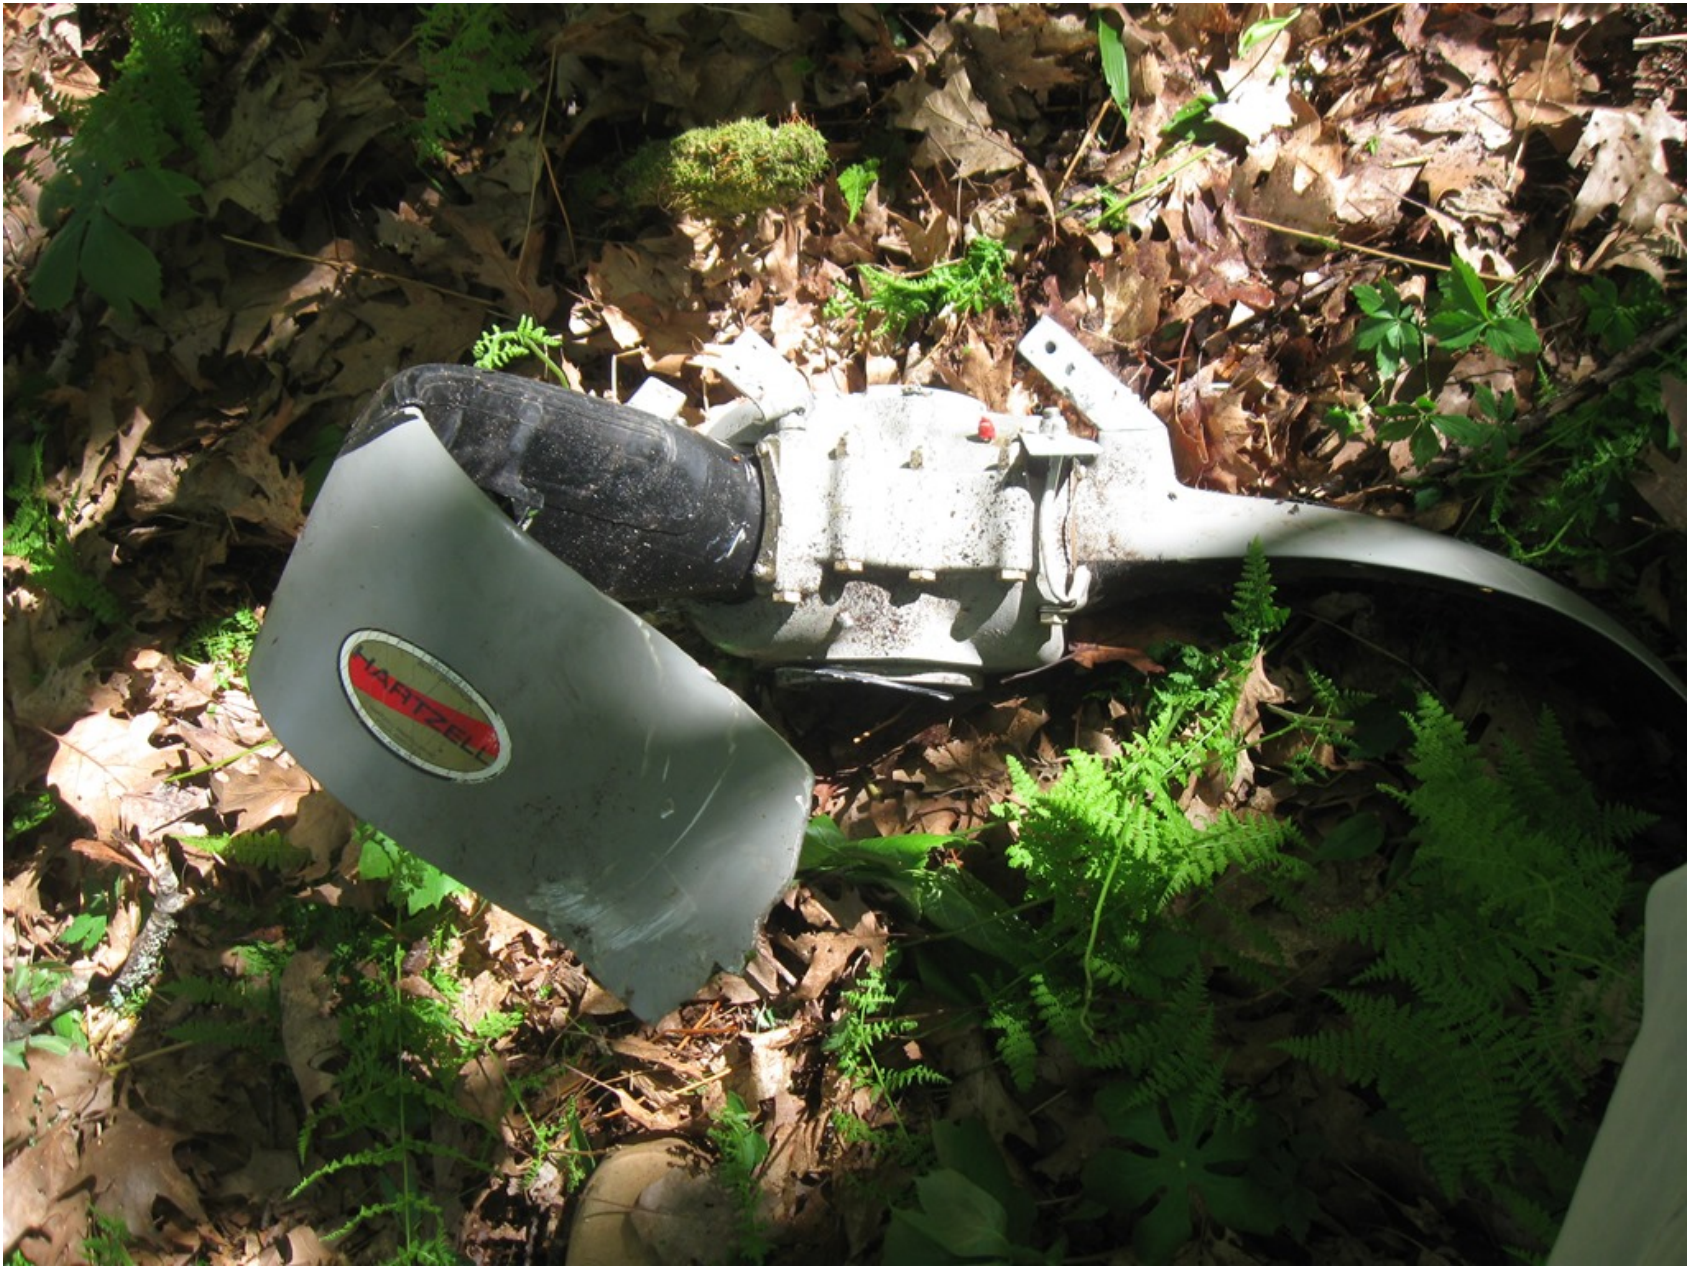
**Photo 3 – View of Propeller System**

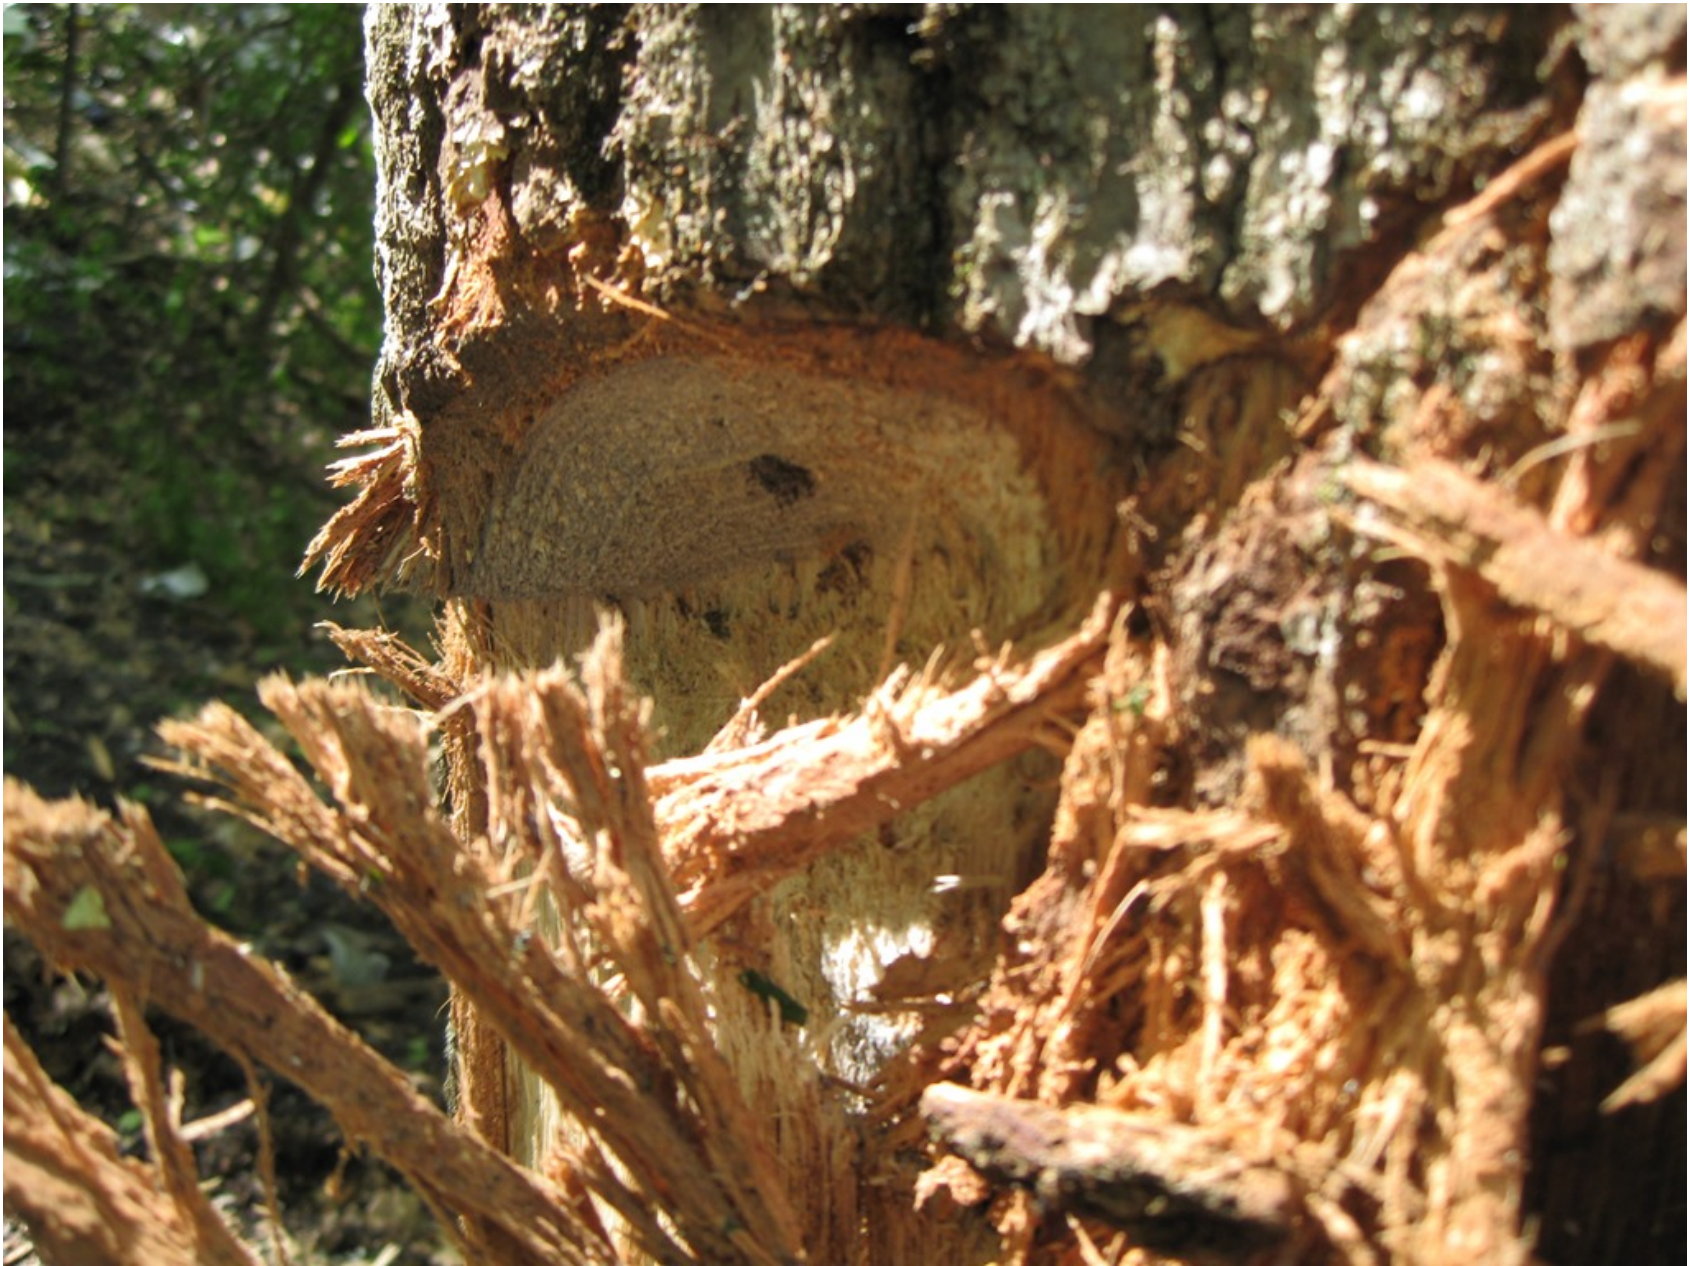
**Photo 4 – View of Slashed Tree Trunk with Paint Transfer (FAA)**

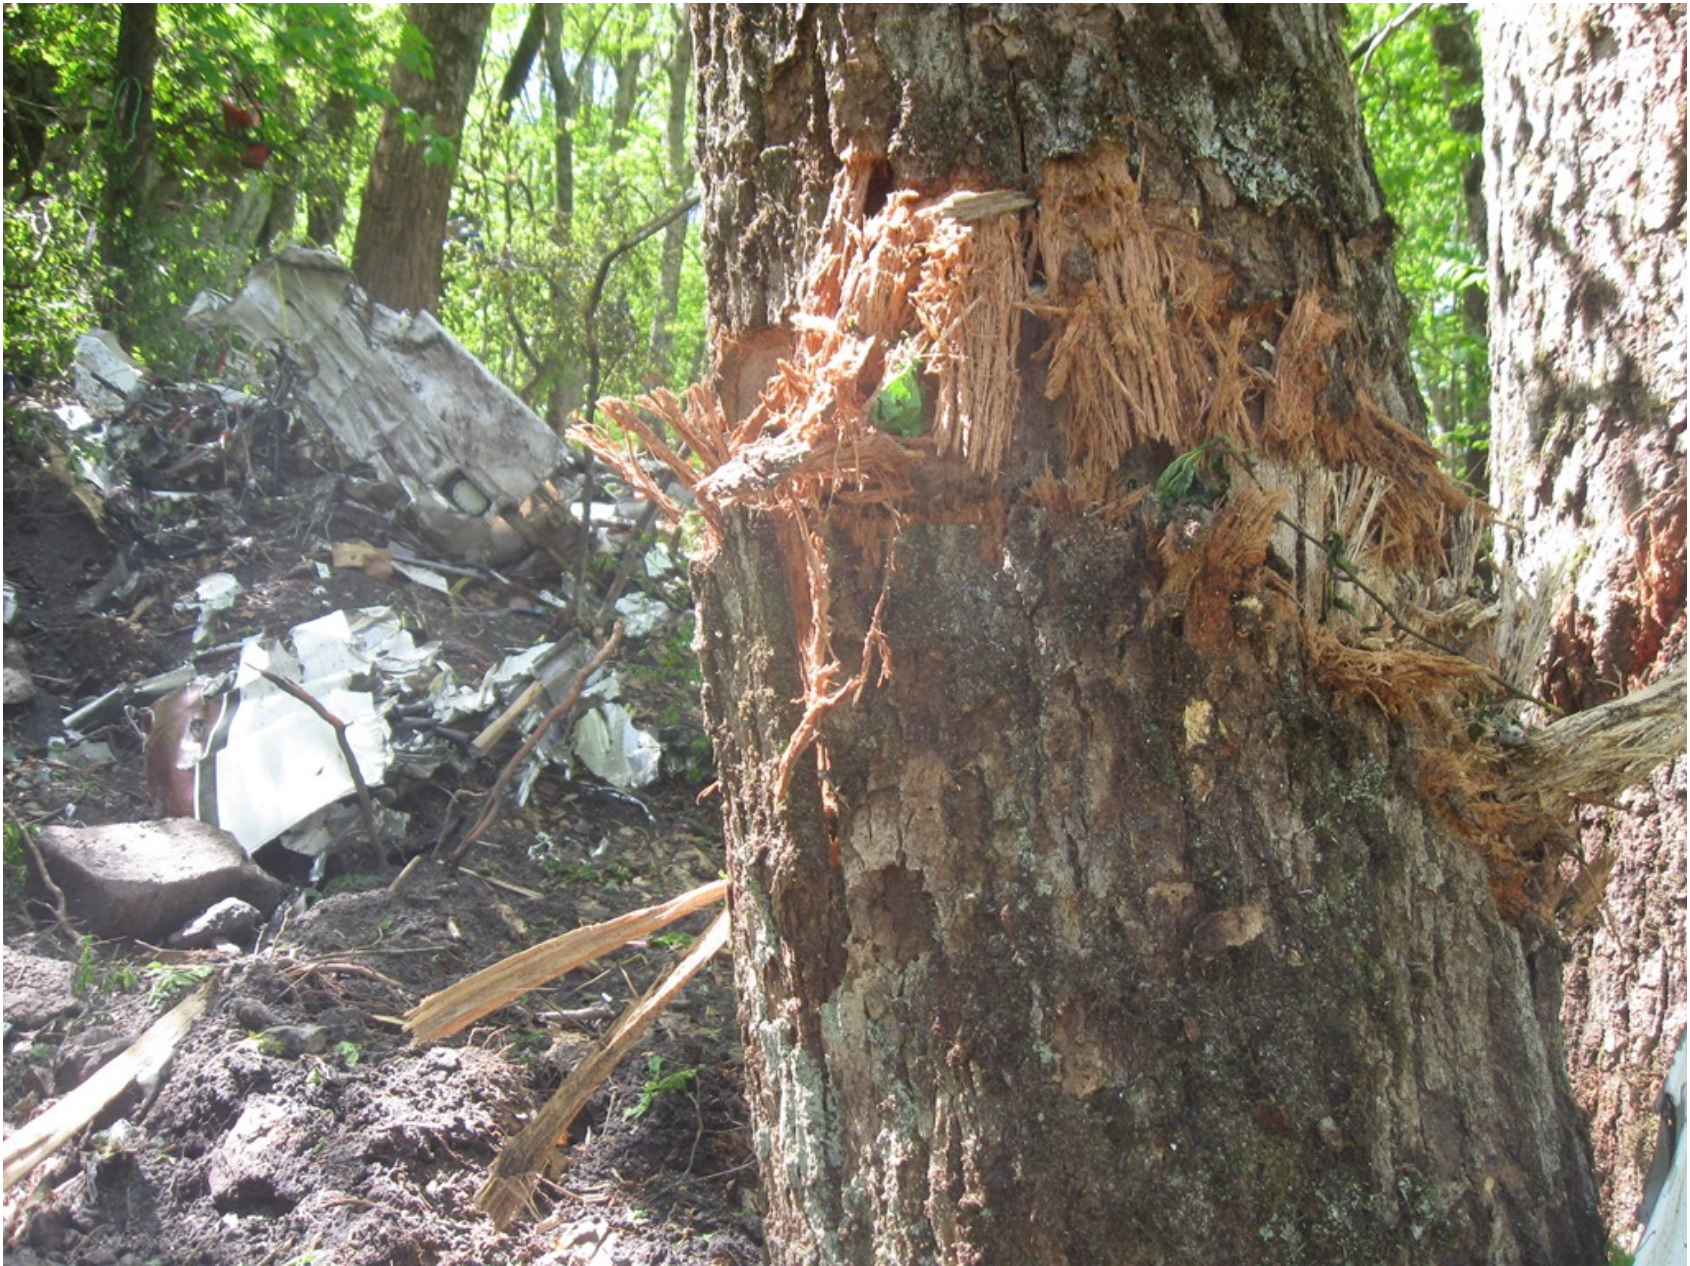
**Photo 5 – View of Slashed Tree Trunk**
