Aircraft Accident/Incident Report No.: 150807

**NTSB File No.:** ERA15FA297

**Aircraft:** Piper PA-46-500TP

**Written by:** Les Doud  
Air Safety Investigator, Hartzell Propeller Inc.

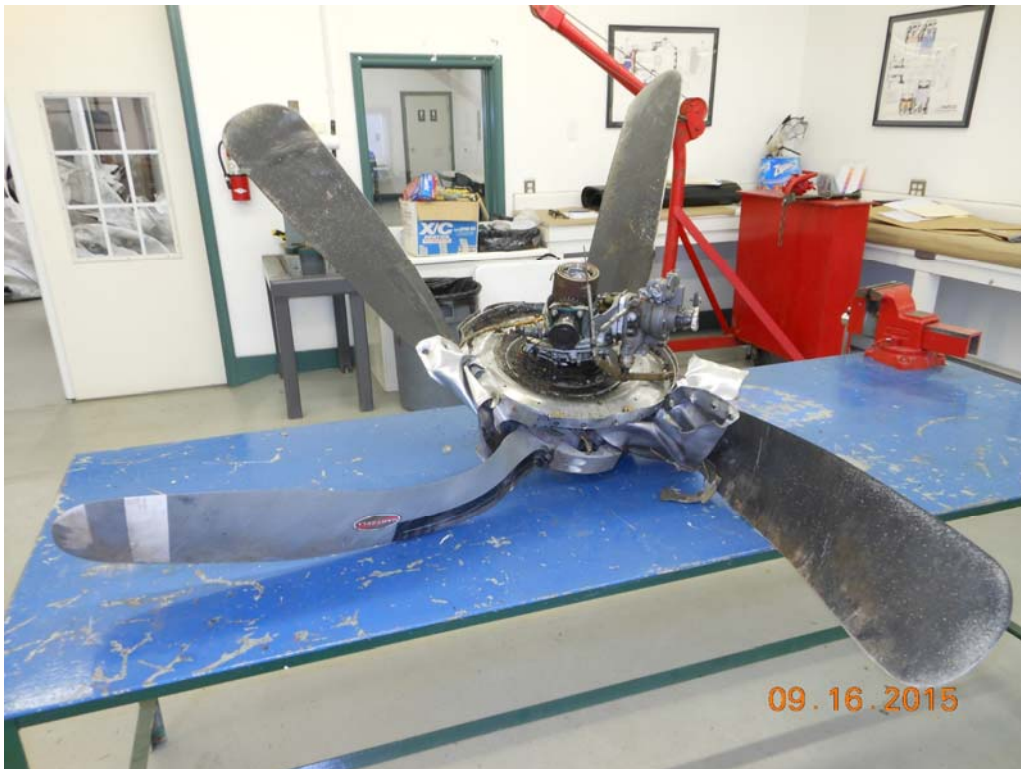
**Photo #1 – As received – Aft View of Assembly**

**As Received:** See Photos #1-#4. The propeller had separated from the engine with the propeller shaft and a portion of the propeller gearbox, including the propeller governor and tach generator still attached. The propeller could not be separated from the propeller mounting flange due to lack of access to the mounting bolts from impact damage. The hydraulic section (cylinder, piston, and feathering spring) of the propeller had fractured and was found in the crash debris; the piston and spring were retained in the cylinder by crimping damage to the lower/aft cylinder wall. The spinner dome was crushed, torn and deformed around the propeller hub and counterweights. Two of the four counterweights fractured from their mounting bosses. Blade #3 was loose in its retaining pocket and could be rotated by hand approximately 20 degrees from feather. All other blades could not be rotated by hand. The beta rod between blades #1 and #4 was bent and therefore cut flush with the forward hub half to facilitate propeller disassembly.

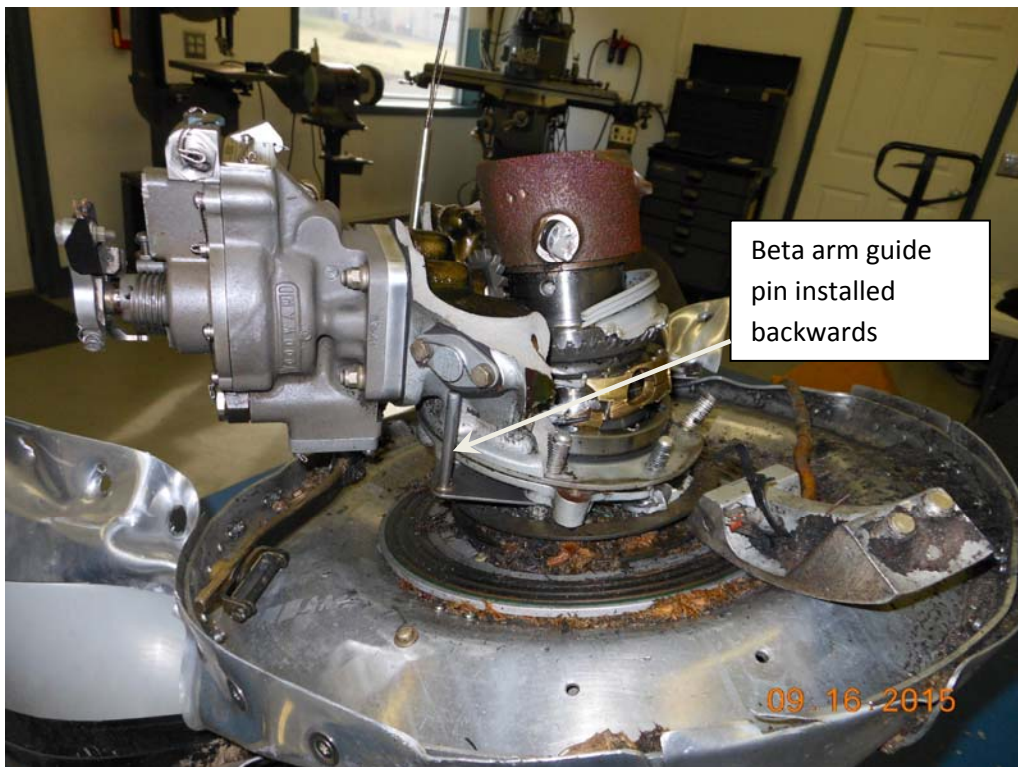
**Photo #2 – As received – Propeller Shaft**

It was found during the initial visual inspection the beta arm retaining pin had been installed backwards (see Photo #2); without this retaining pin installed correctly the beta arm/block could come out of the beta ring resulting in the prop feathering. However, detailed examination of the propeller components indicated the carbon block was in place and the propeller was not in feather at time of impact.

**Engine/Propeller Mounting:** The propeller was mounted to the propeller shaft and could not be removed due to impact damage. The engine propeller shaft and associated bearings fractured from the engine gearbox. The aft hub half remained attached to the engine flange after propeller disassembly.

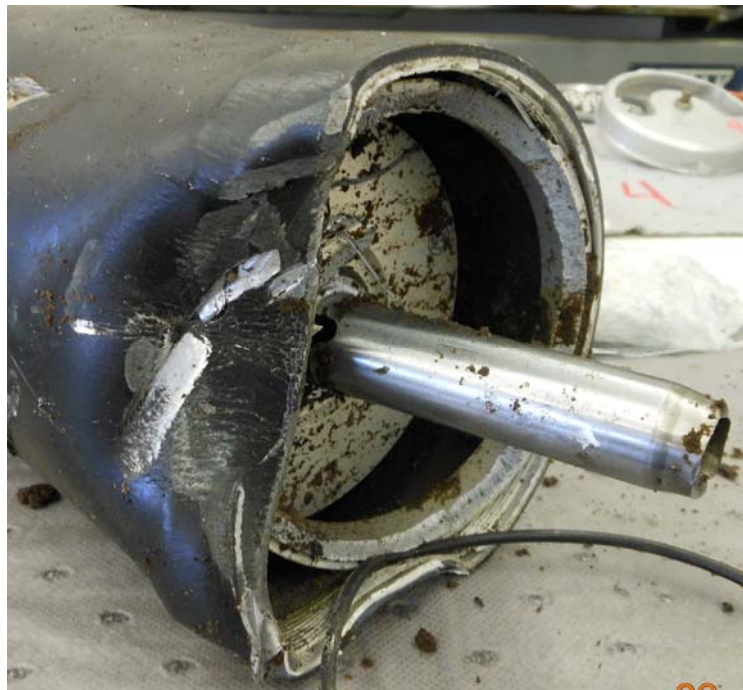
**Photo #5 –Retained Piston/Feathering Spring**

**Cylinder:** P/N D-488 Rev. N, S/N 4537 The cylinder fractured from the hub mounting threads during the impact sequence. The hub mounting thread material was retained in the cylinder along with the piston and spring by impact deformation and crimping damage of the lower/aft cylinder wall (see Photo #5).

**Piston:** The piston was trapped in the cylinder due to impact deformation and crimping damage to the lower cylinder wall. No attempt was made to remove the piston and feathering spring.

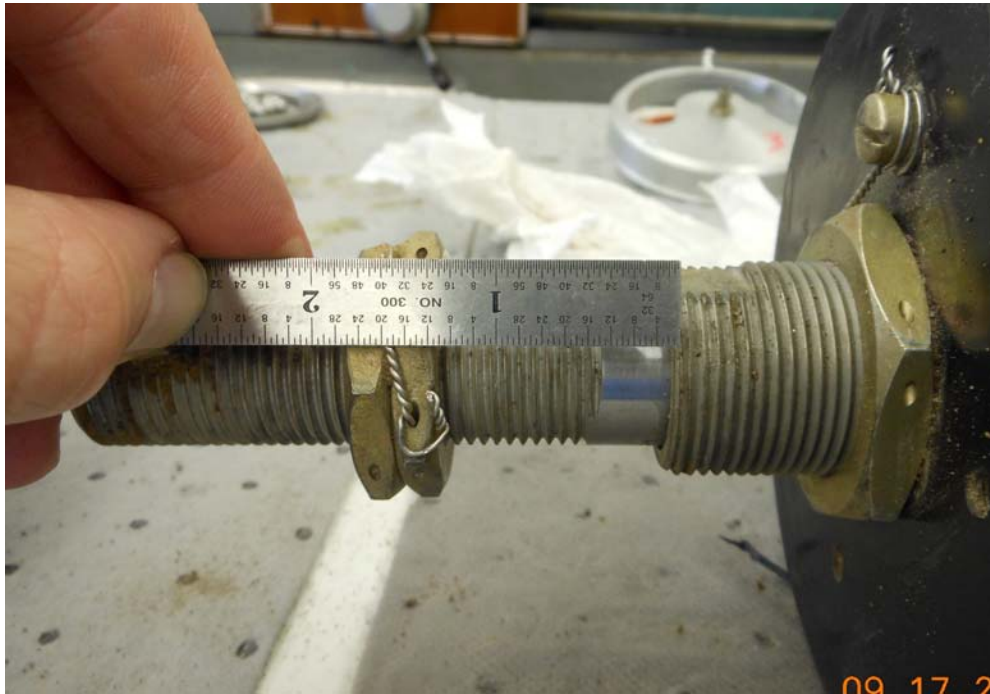
**Photo #6 – Pitch Change Rod Extension**

There were several indications the propeller was in the normal operating blade angle range at time of impact; the fork bumper mark on preload plate #3, the pitch change rod extension length, and blades #3 and #4 showed evidence of object impact at both positive and negative angles of attack. The preload plate mark and rod extension length equate a blade angle range of approximately 27-29°.

**Pitch Change Rod:** The pitch change rod is fractured in three parts; the portion forward of the fork connecting the piston, the small threaded segment in the fork, and a short segment aft of the fork that remained in the propeller before disassembly. The pitch change rod was extended approximately 1.34" beyond the feather stop (see Photo #6).

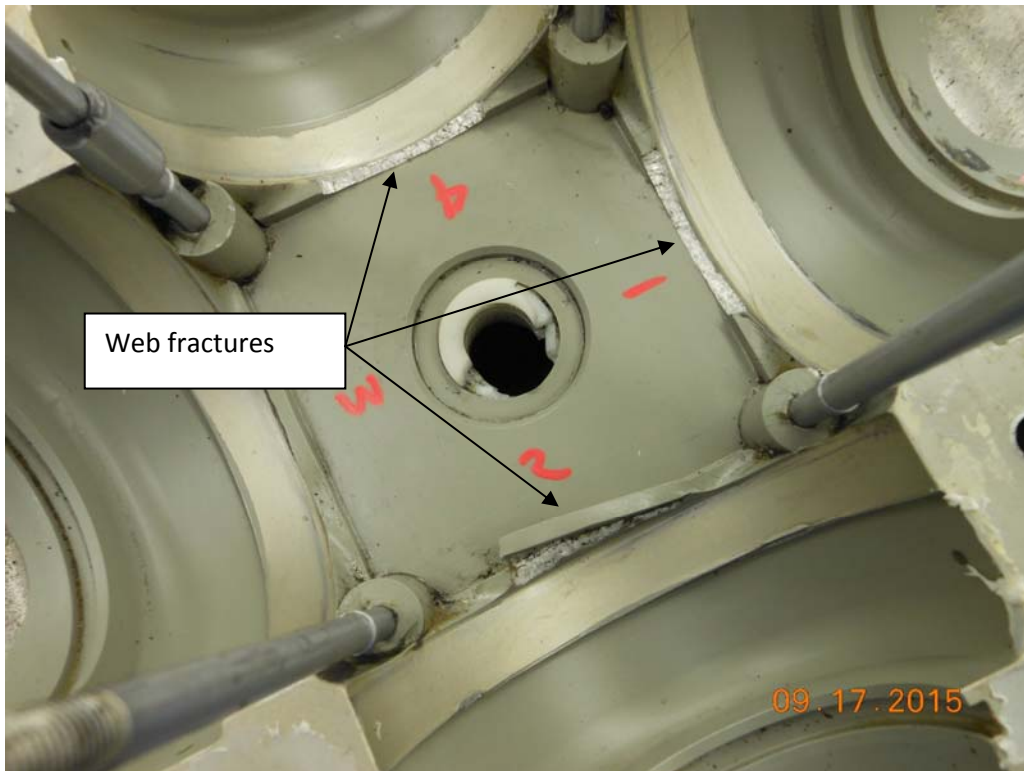
**Photo #7 – Aft Hub Internal**

**Hub Assembly:** The two hub halves remained bolted together and except for the fractured cylinder mounting threads, showed no visual external fractures or cracks. The aft/inboard internal webs of blade sockets #1, #2 and #4 were fractured in the inboard direction. (see Photo #7). Blade socket #3 showed a blade shank impact mark on the aft/trailing edge side of the blade aperture.

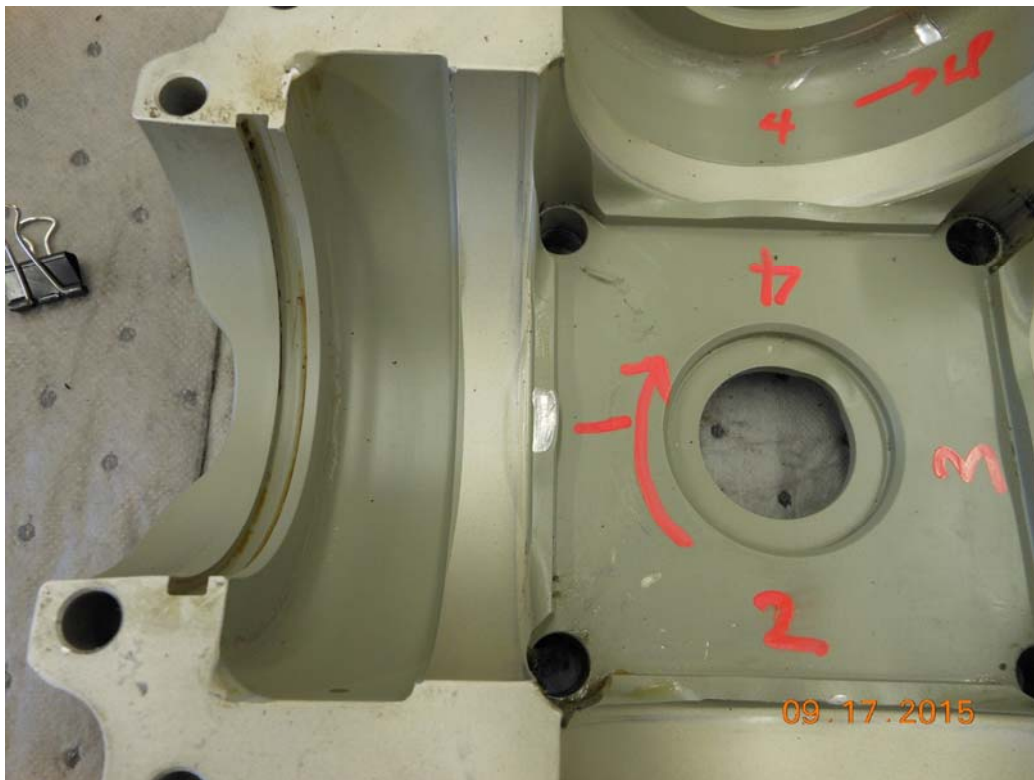
**Photo #8 – Forward Hub Internal**

The forward hub half socket #4 had some internal scoring/gouging in the bearing radius. There was an impact mark on the inboard web adjacent to preload plate #1 corresponding to the pitch change knob bracket location (see Photo #8).

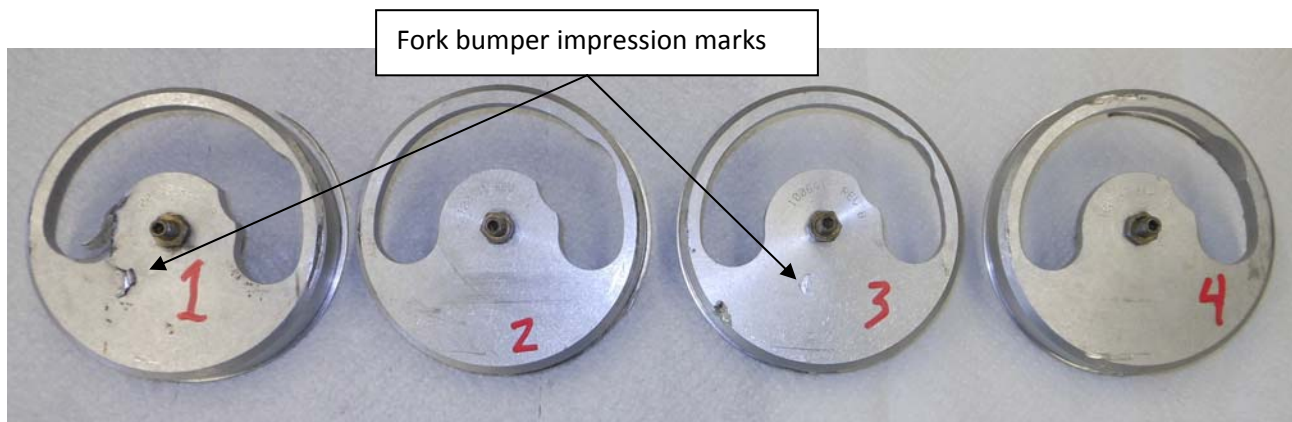
**Photo #9 – Preload plates**

**Preload Plates:** The #1 and #3 preload plates had distinct fork bumper impact marks (See Photo #9).

# 1 The #1 preload plate had hub contact marks on forward and aft chamfers with lip deformation along the trail/aft quadrant. The preload plate had a fork bumper impact mark at 37° forward of the hub split line. There was impact damage from the pitch change knob bracket in the slot on the forward/low pitch end.

# 2 The #2 preload plate lip had some deformation along the aft (face side) edge. There were hub contact marks on forward and aft chamfers. There was no evident impression mark made by the fork bumper.

# 3 The #3 preload plate had hub contact marks on the forward chamfer. The preload plate had a fork bumper impact mark at 10° forward of the hub split line. There was also impact damage from the beta rod/guide fork on the forward chamfer.

# 4 The #4 preload plate lip was deformed and sheared along the aft (face side) edge. There was no fork bumper impression mark. There are hub contact marks on forward and aft chamfers and some scrape marks on the chamfers near the hub split line.

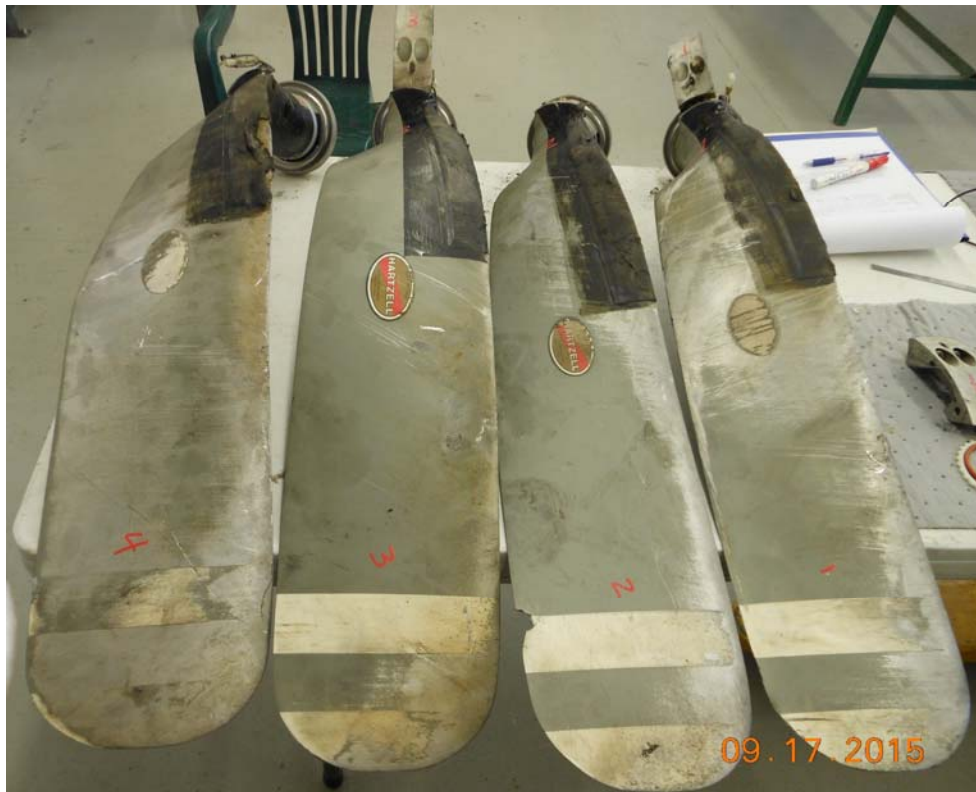
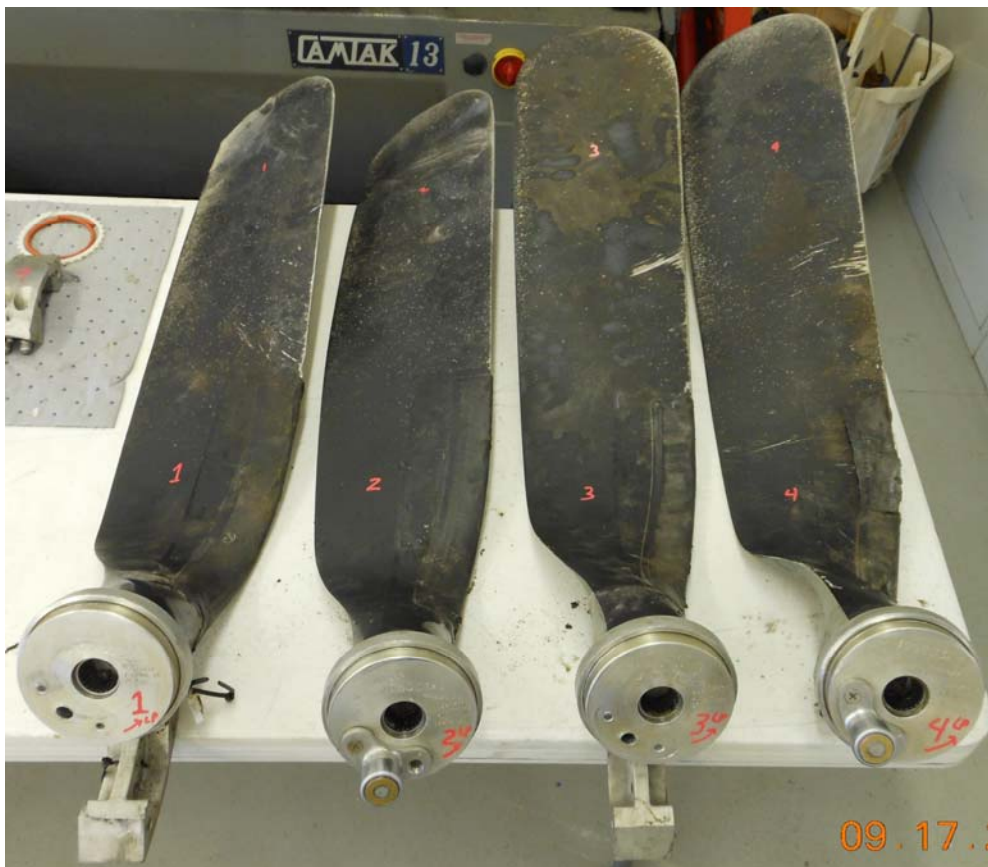
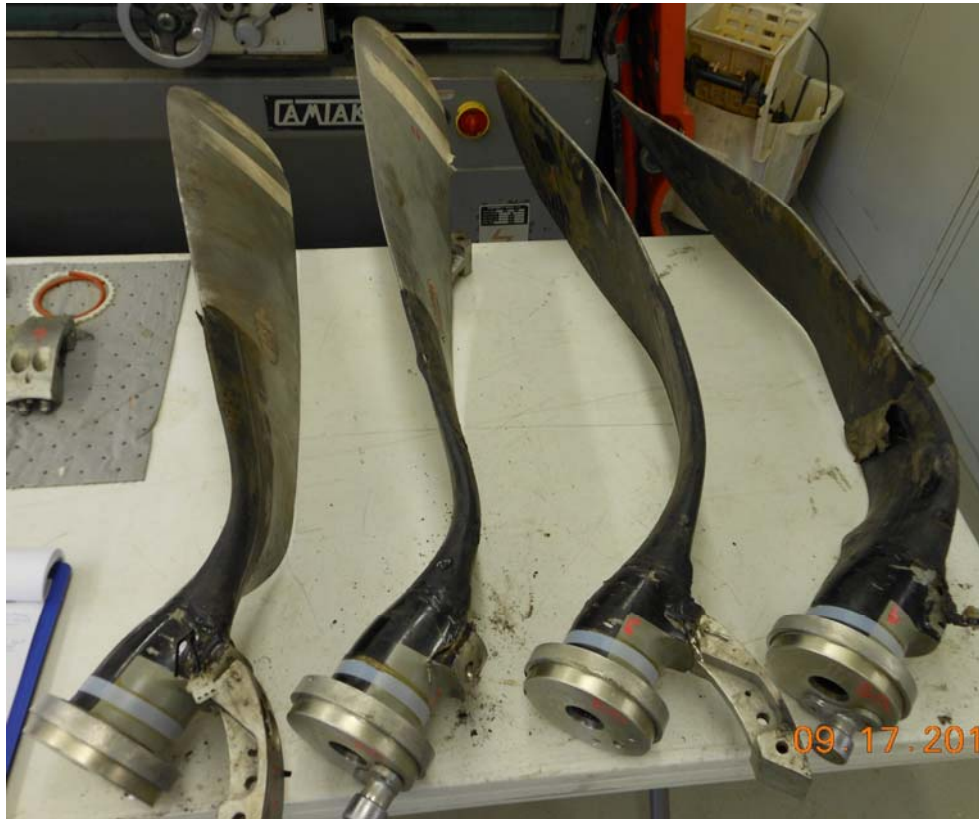
**Propeller Blades:** (See Photos #10 through #12)

paint, camber side - Chordwise scoring.  
 paint, flat side - Chordwise scoring outboard (OB) of boot.  
 bend - Bent aft starting from approximately 9-10" outboard of butt.  
 twist - Leading Edge (LE) down, toward low pitch.  
 lead edge damage - Gouge OB of boot, boot OB LE split.  
 trail edge damage - None.  
 knob condition - Fractured (bracket screw heads pulled off). Dowel hole deformation indicated twisting load towards low pitch. The knob bracket is bent towards Trailing Edge (TE).  
 counterweight - Retained by mounting bolts but loose, mounting boss fractured near one mounting bolt hole indicating load inboard toward hub.

paint, camber side - Chordwise scoring.  
 paint, flat side - Chordwise scoring 6" from tip.  
 bend - Bent aft starting from approximately 9-10" from butt.  
 twist - Twisting (LE down) towards low pitch.  
 lead edge damage - Boot LE split.  
 trail edge damage - 1" gouge/tear 6" from tip.  
 knob condition - In place but forward screw head fractured, bracket bent towards TE. Roller bearing cracked but could be rotated with noticeable ratcheting/resistance.  
 counterweight - Fractured from mount but retained near hub by de-ice wires and portions of spinner dome/bulkhead. Mounting holes showed deformation opposite rotation and inboard

paint, camber side - Chordwise scoring.  
 paint, flat side - Chordwise scoring 13" from tip.  
 bend - Bent aft starting 9-10" from butt.  
 twist - Favors LE up but not remarkable.  
 lead edge damage - No remarkable LE damage, localized bending LE up 13" from tip.  
 trail edge damage - No remarkable TE damage.  
 knob condition - Knob bracket fractured (mounting screw heads popped), dowel pin hole deformation in both directions, knob bracket feet bent in both directions.  
 counterweight - Intact.

paint, camber side - Chordwise scoring, OB de-ice boot abraded, peeled back.  
 paint, flat side - Chordwise scoring 13" and 22-24" from tip, OB de-ice boot peeled off.  
 bend - Bent aft 9-10" from butt, bend edgewise LE-to-TE.  
 twist - Twisting (LE down).  
 lead edge damage - No remarkable dents or gouges, localized bending LE down 4" from tip. Localized bending up 13" from tip.  
 trail edge damage - No remarkable damage.  
 knob condition - Knob bracket intact, bearing freely rotates.  
 counterweight - Fractured but recovered near propeller, hole deformation opposite rotation/direction of flight and OB.
