**Accident / Incident Report**

**Report No.: 15-085**

**Majestic Air LLC  
Piper PA46-500TP, Aircraft Reg. No. N819TB  
Saranac Lake, New York  
August 7, 2015  
PT6A-42A  
S/N RM0122**

**Written By: Jeff Davis  
Service Investigation Department**

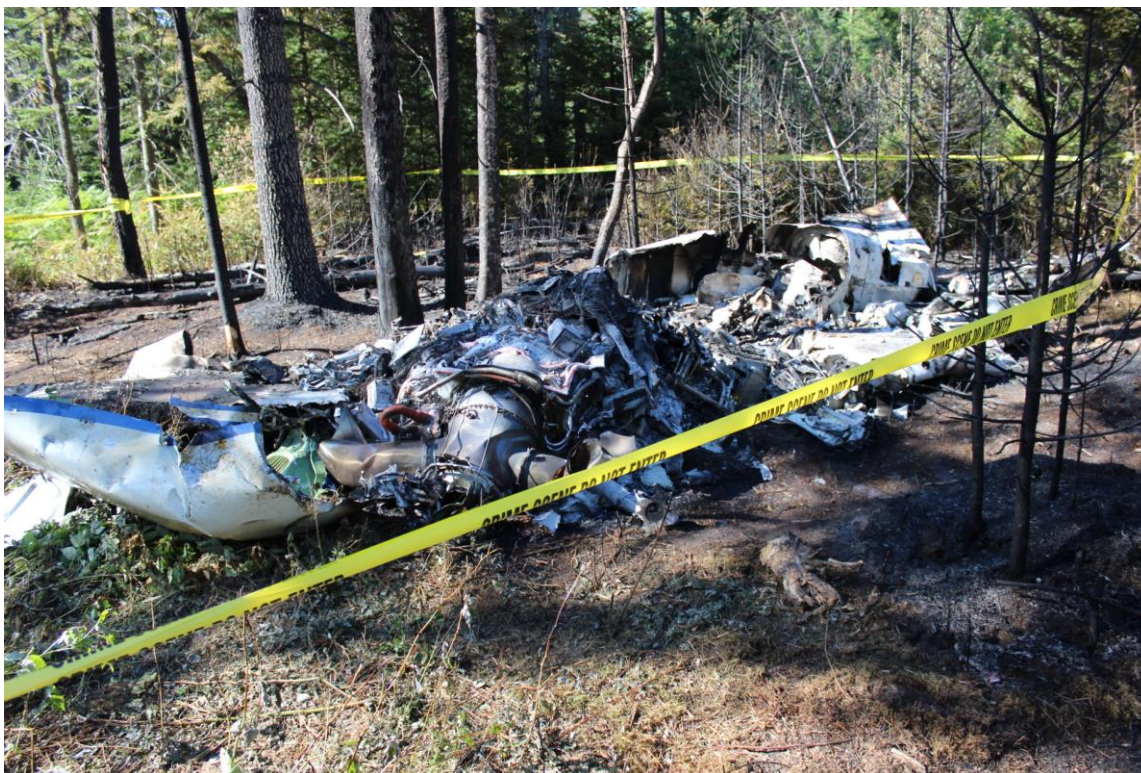
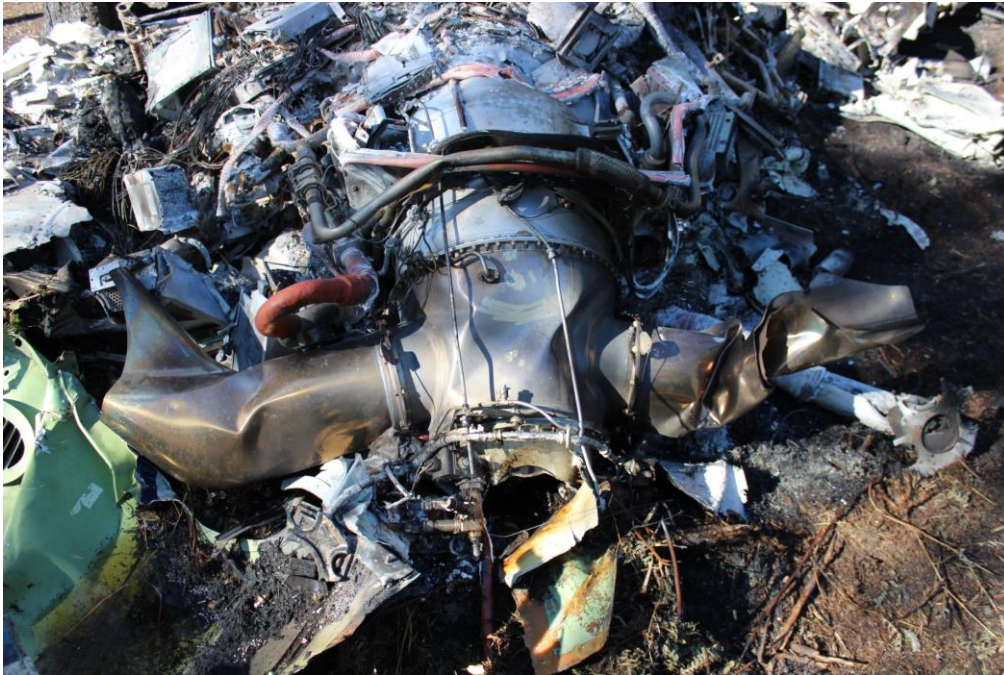
Photo No. 1, View of the engine attached to the aircraft

Photo No. 2, View of the engine

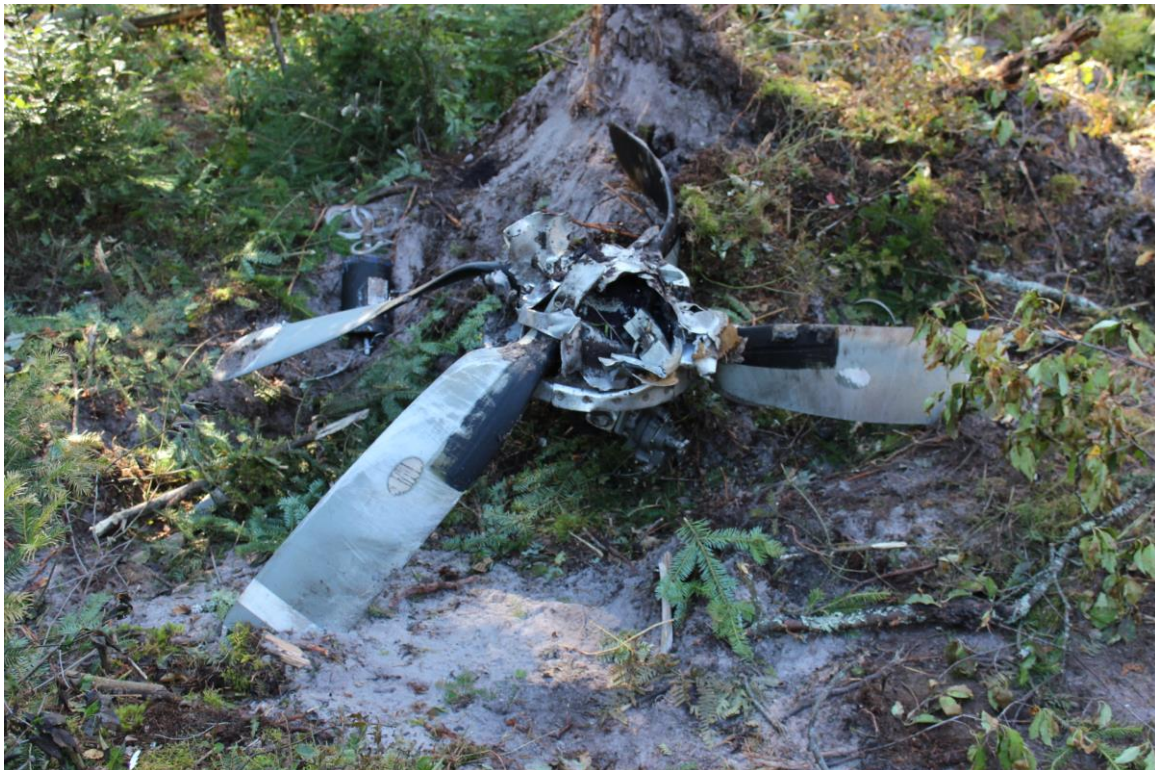
Photo No. 3, View of the propeller and a section of the front reduction gearbox

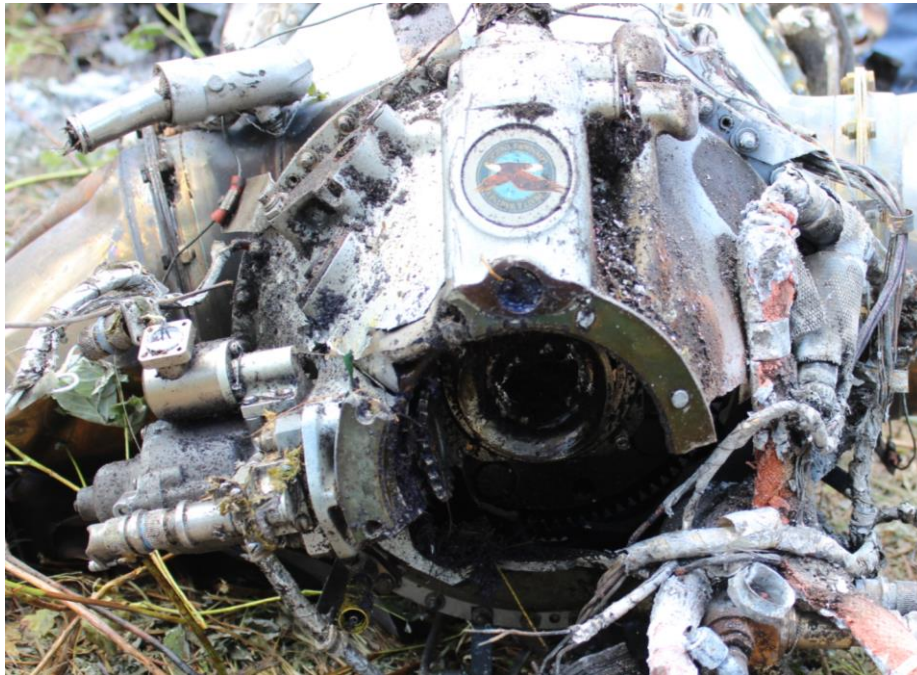
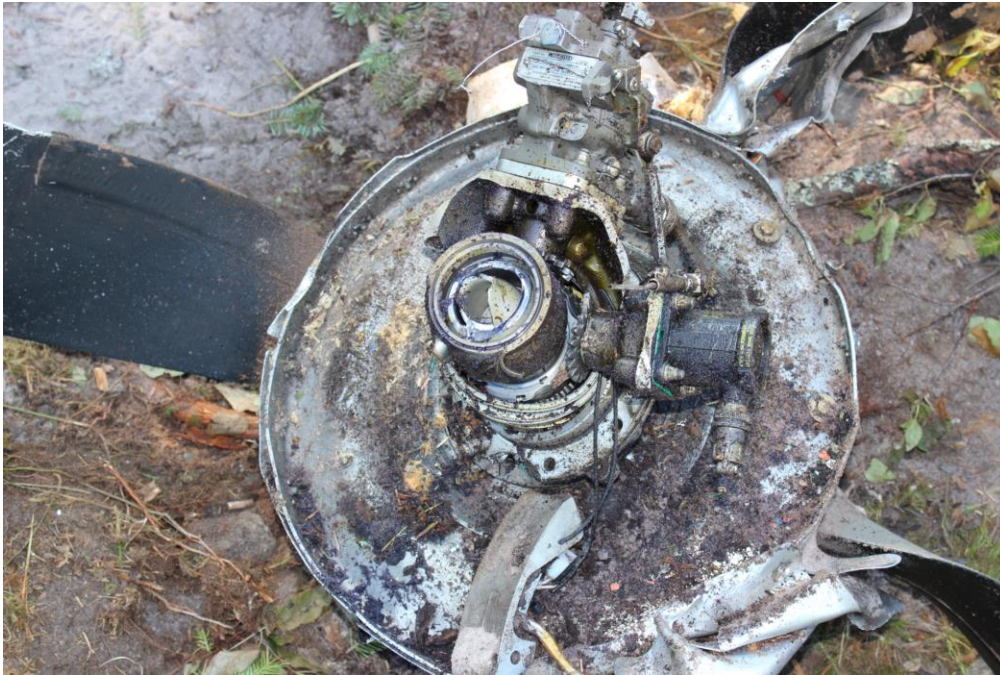
Photo No. 10

**Reduction Gearbox:** The gearbox housing was fractured at an angle from the propeller thrust bearing cover flange rearward to the mounting pads for the propeller governor and the tachometer generator (Ref. Photos No. 10 & 11). The bevel gearshafts for the propeller governor and tachometer generator drives were bent (Ref. Photos No. 12 & 13). A partial serial number “0122” was legible, painted on the gearbox housing (Ref. Photo No. 14).

**Forward Housing:** The housing was fractured at an angle from the propeller thrust bearing cover flange rearward to the pads for the propeller governor and the tacho generator (Ref. Photos No. 10 & 11).

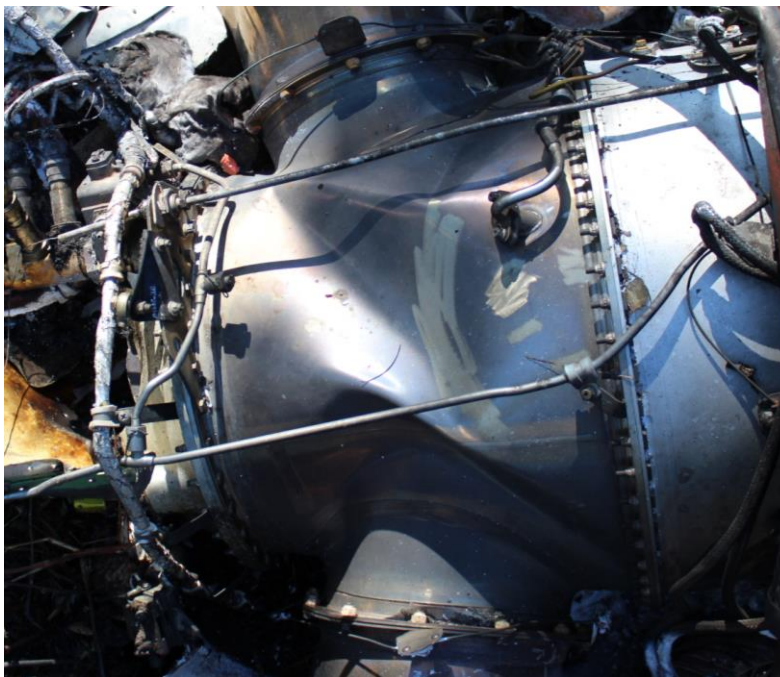
Photo No. 15

The fractured propeller shaft and the torsional bending of the exhaust duct indicate the engine was producing power at impact.

**Exhaust Duct:** The duct displayed torsional and compression bending (Ref. Photo No. 15).

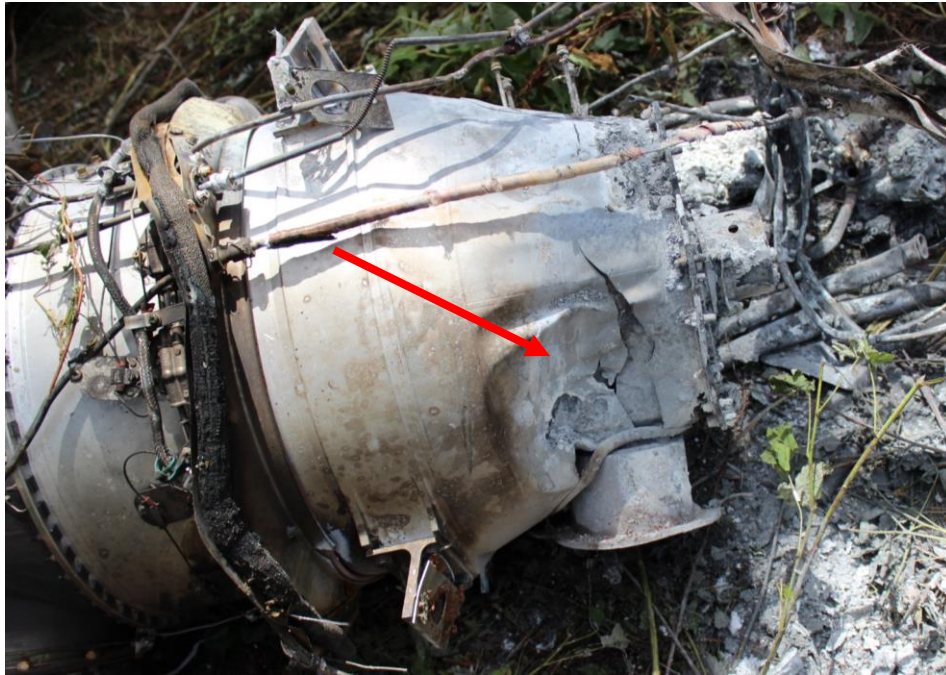
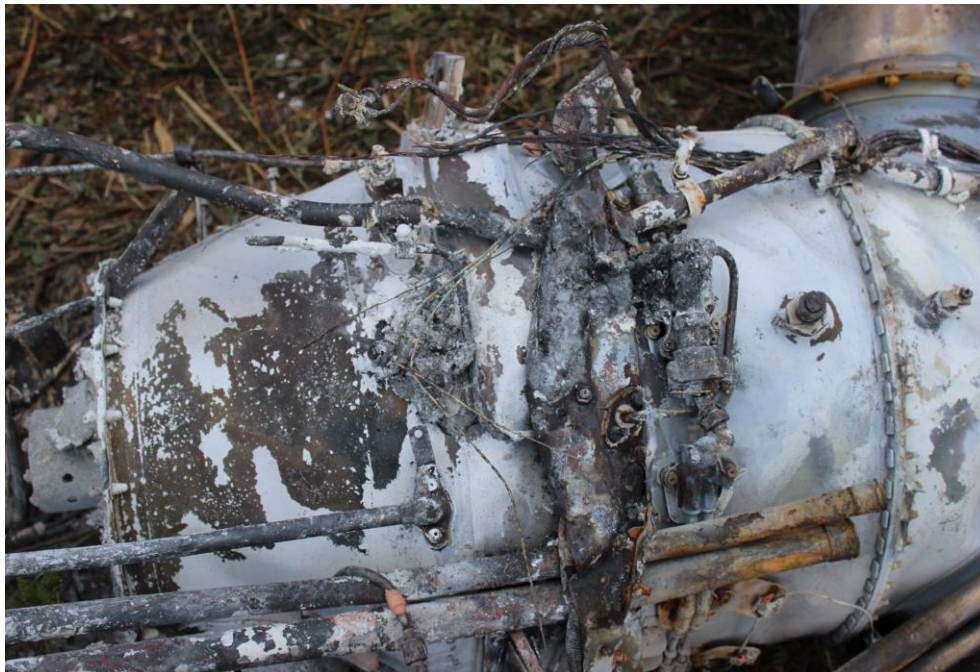
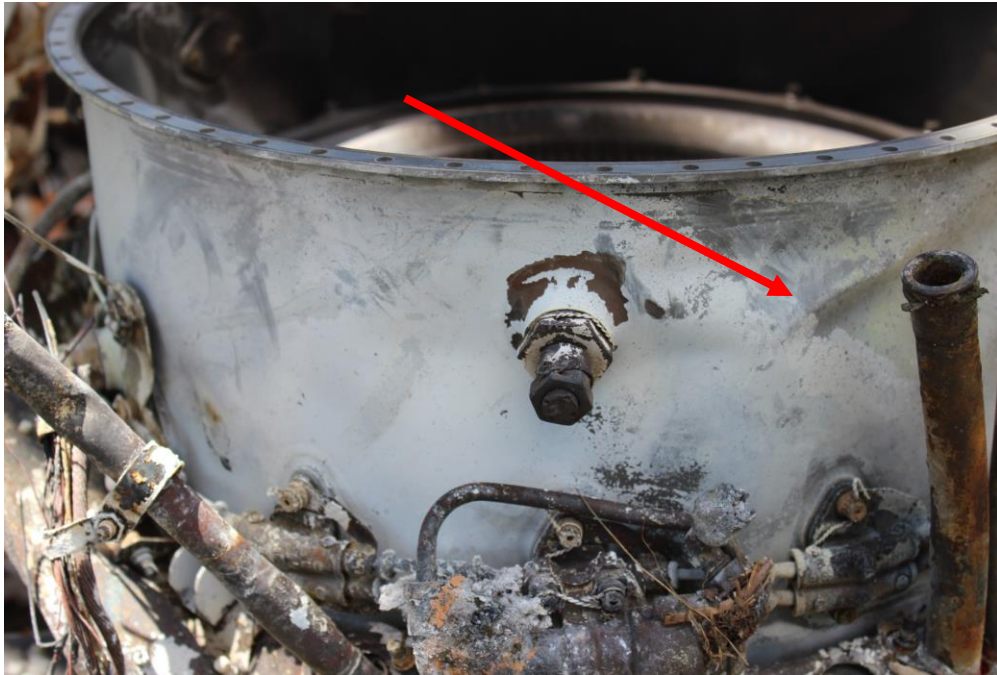
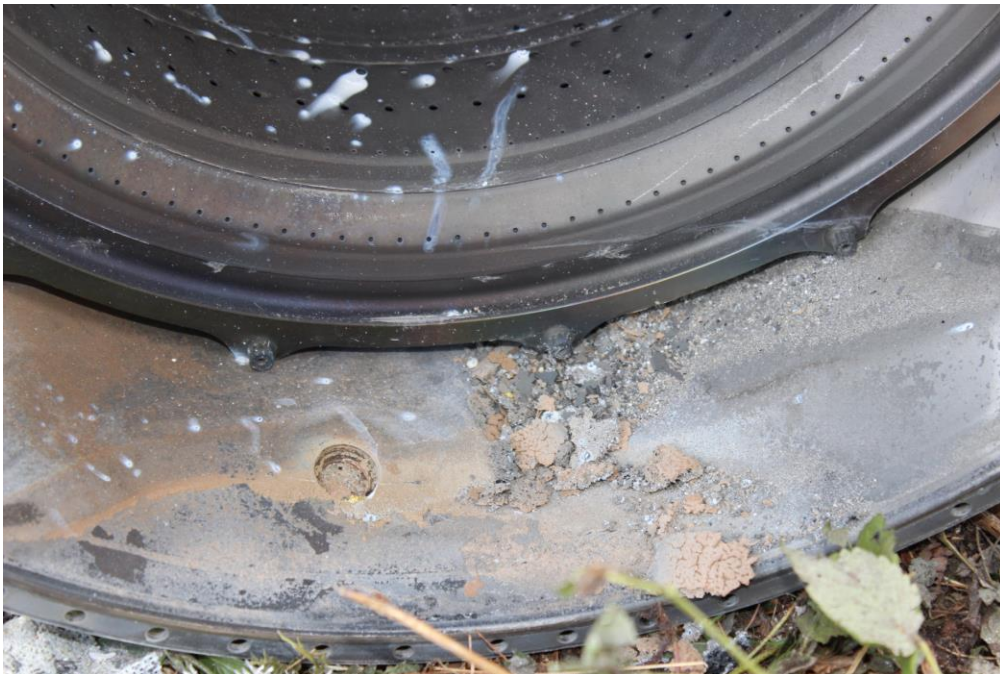
**Gas Generator Case:** The case was bent and torn adjacent to left hand bleed valve port from external impact damage (Ref. Photo No. 16, red arrow). The exterior of the case was burnt, which was more pronounced at the bottom of the case (Ref. Photo No. 17). Some bent areas were also evident adjacent to the front drain valve (Ref. Photo No. 18, red arrow). Organic debris was evident in the bottom of the case after it was separated from the exhaust duct (Ref. Photo No. 19). The debris was ingested during impact with the terrain. The inside diameter was also discoloured from the 5-7 o'clock position from heat transfer as a result of the external post flight fire (Ref. Photo No. 19).

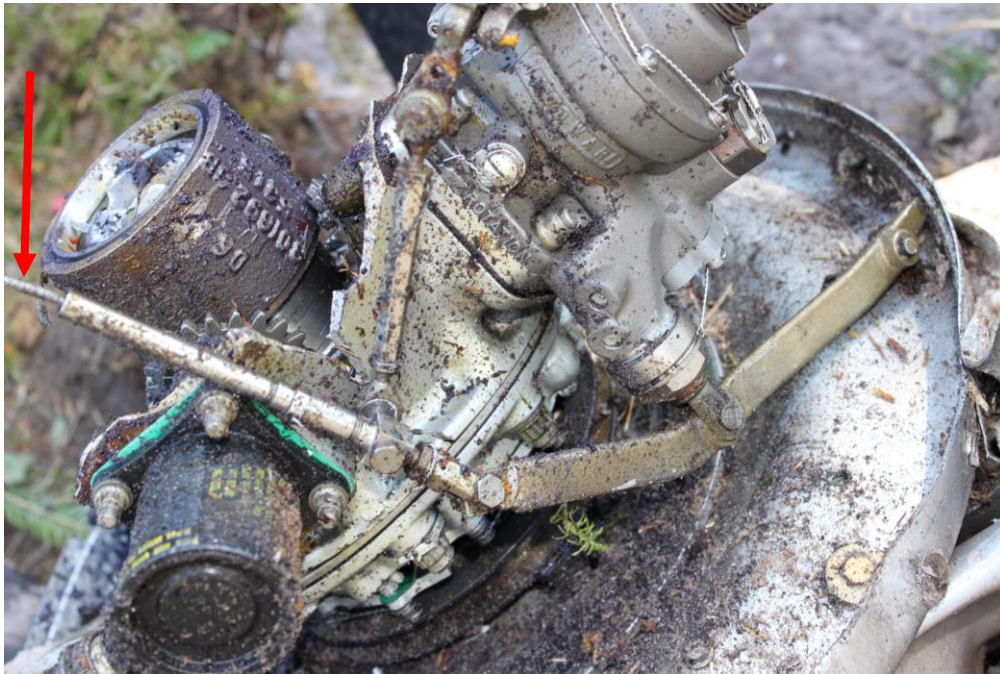
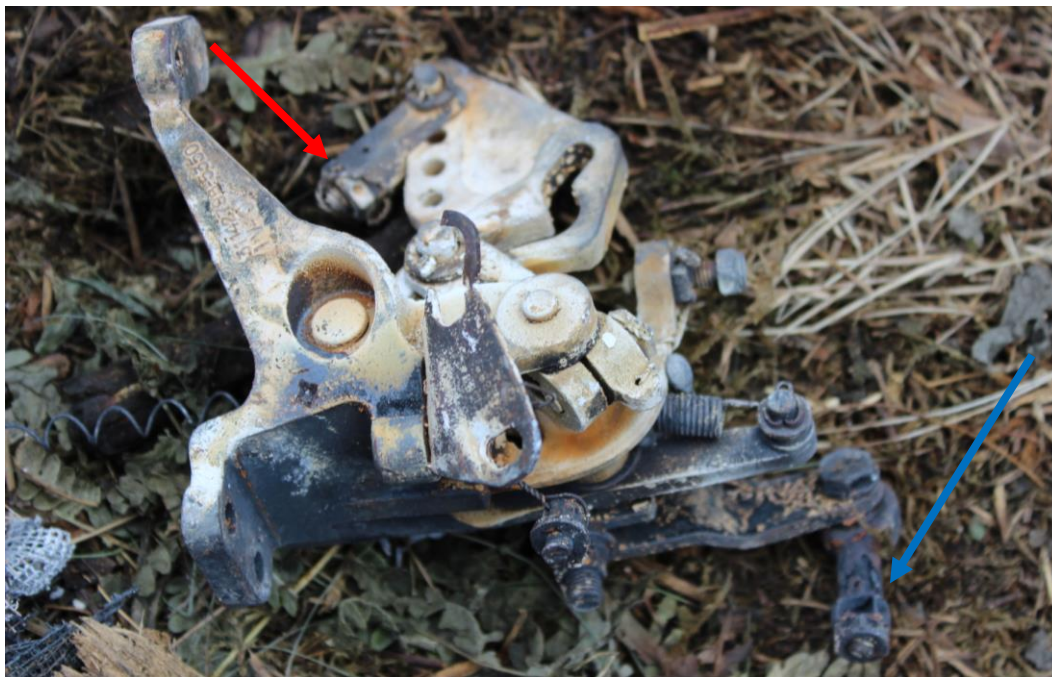
**3.1.2 Power Control and Reversing Linkage:** The front linkage was in place and secure (Ref. Photo No. 20). The wire rope was fractured during the separation of the propeller and front section of the gearbox separating from the engine (Ref. Photo No. 20, red arrow). The reversing lever guide pin bracket was installed inverted (Ref. Photo No. 21, arrow) and the carbon block was missing (Ref. Photo No. 21, yellow arrow). The reversing lever guide pin bracket (Ref. Figure 1, red arrow) retains the end propeller reversing lever (Ref. Figure 1, blue arrow) in position which keeps the carbon block engaged in the Beta ring. If the carbon block disengaged from the Beta ring, the propeller would have went into feather. The wire rope casing was fractured (Ref. Photo No. 22, red arrow) and the control terminal was fractured adjacent to the rear clevis (Ref. Photos No. 22, red oval & 23 blue arrow). The CAM box was recovered from the debris. The fuel control connecting rod was fractured (Ref. Photo No. 23, blue arrow) and the connection to the wire rope was fractured (Ref. Photo No. 23, red arrow).

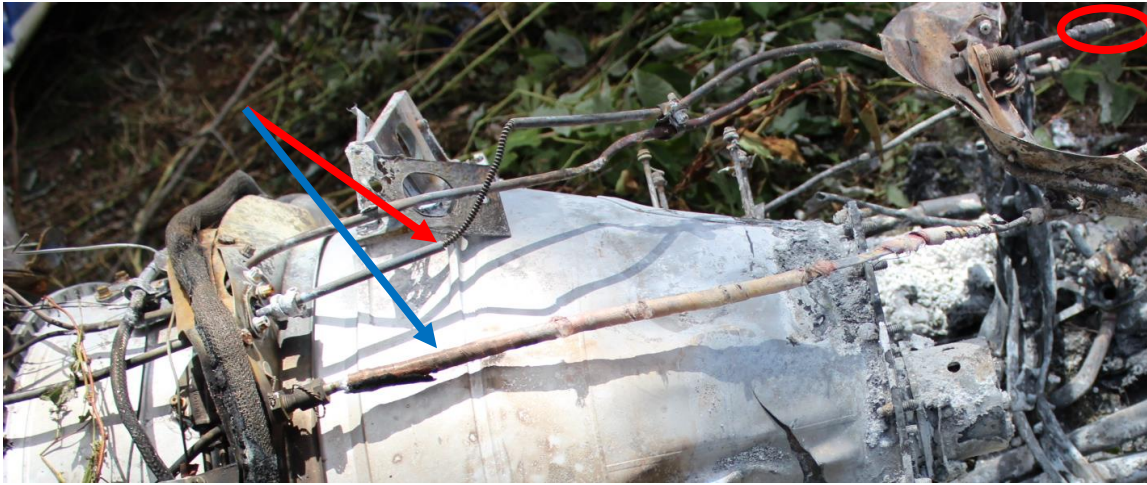
Photo No. 22

**Power Turbine Control (Py):** The line/fitting was fractured at the fitting for the propeller governor. The line attached to the torque limiter was complete to the centre fire seal. The line from the centre fire seal to the fuel control was in place with the fitting attached from the burnt fuel control (Ref. Photo No. 22, blue arrow).

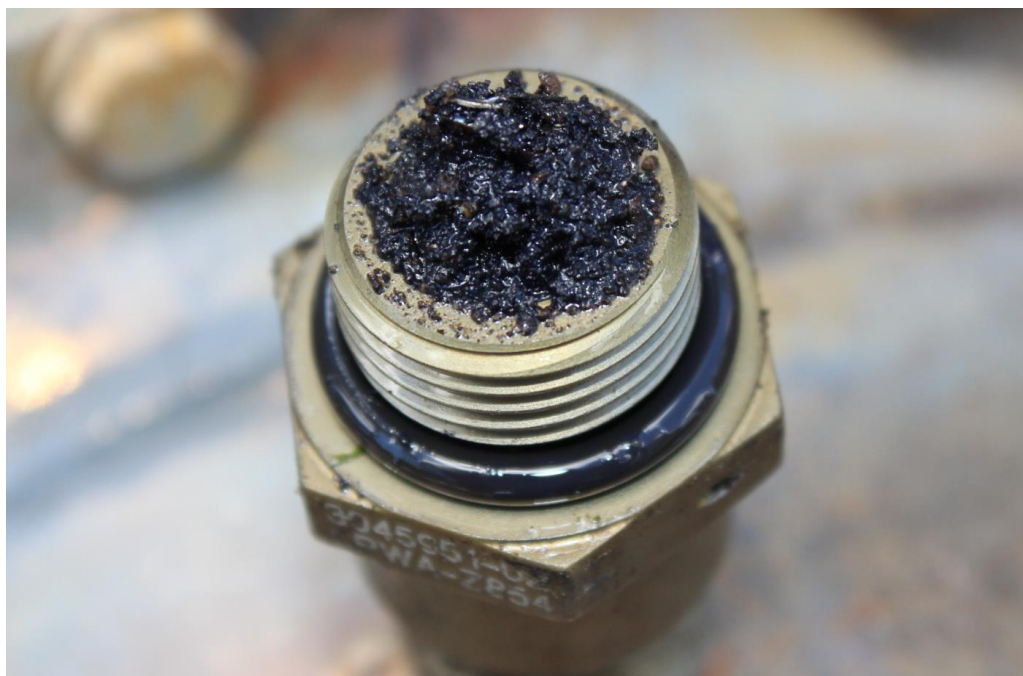
Photo No. 24

**Reduction Gearbox Chip Detector:** The magnetic poles were covered with organic debris and some magnetic particles (Ref. Photo No. 24).

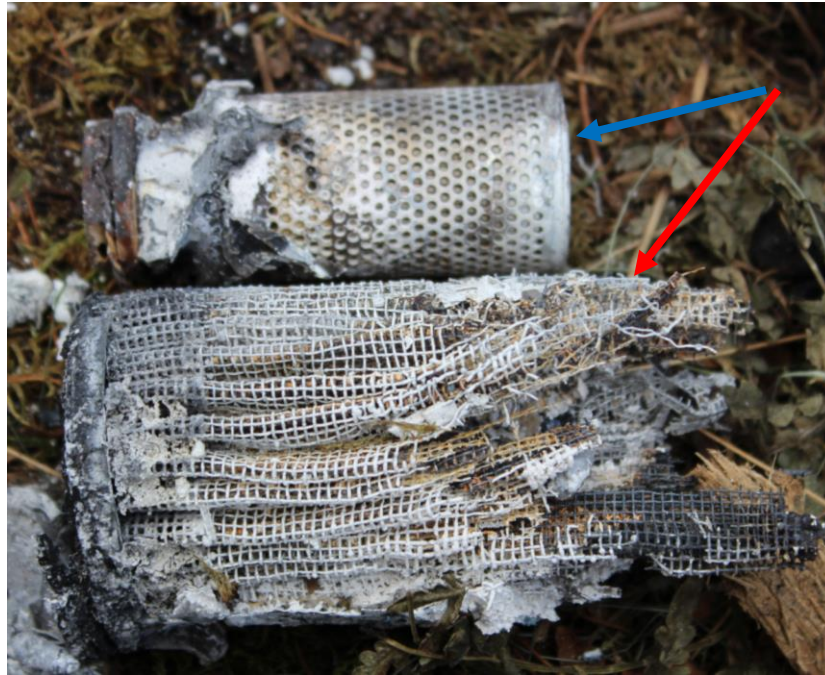
Photo No. 25

**Compressor Discharge Air (P3):** A section of the line was attached to the gas generator case. The burnt P3 air filter was recovered from the debris (Ref. Photo No. 25, blue arrow).

**Oil Filter:** Remnants of the oil filter and the burned P-3 air filter were recovered from the debris (Ref. Photo No. 25, red arrow).

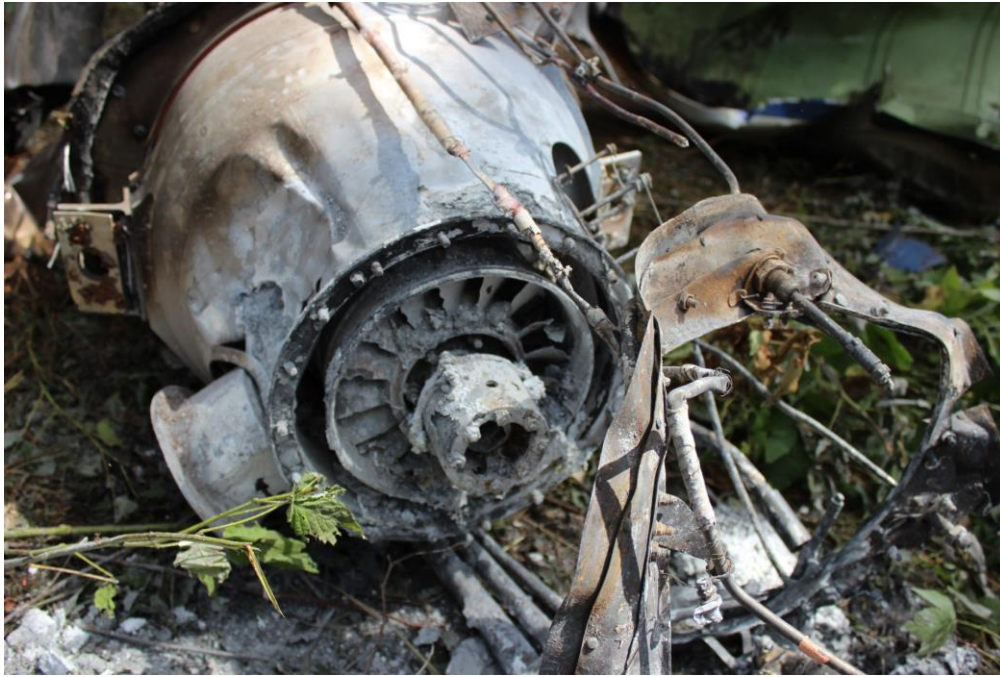
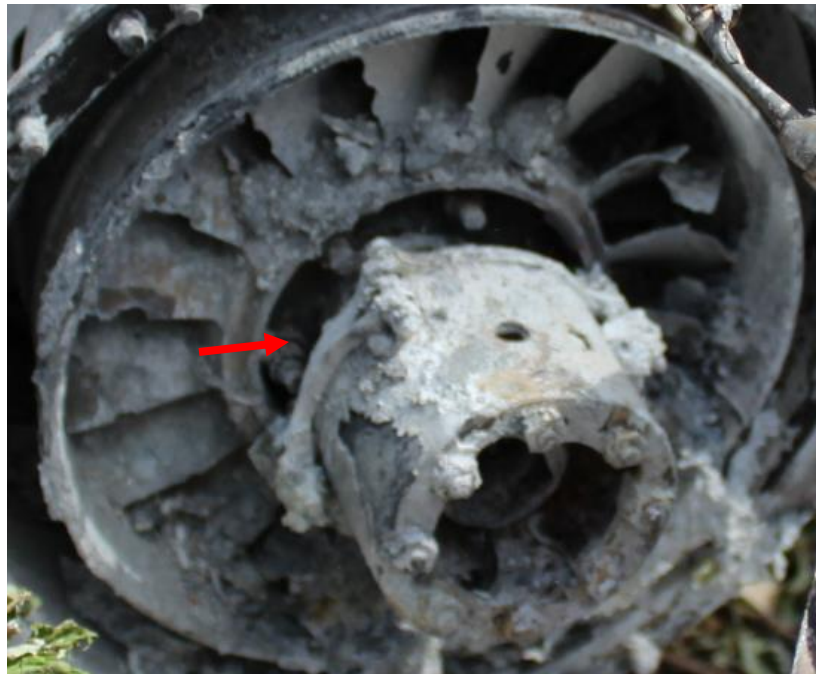
The bent 1<sup>st</sup> stage compressor rotor blades indicate the compressor was rotating under power during impact with the terrain. The ingested debris in the gas generator case also indicates engine operation during impact with the terrain.

**Compressor 1<sup>st</sup>, 2<sup>nd</sup>, and 3<sup>rd</sup> Stage Discs and Blades:** The 1<sup>st</sup> stage blades were burnt and coated with burnt material (Ref. Photo No. 26). The blades exhibited impact damage, tearing and were bent opposite the direction of rotation (Ref. Photo No. 27). The 2<sup>nd</sup> stage blades, 3<sup>rd</sup> stage blades, and three discs were not accessed for the purposes of this investigation.

**No. 1 Bearing and Airseals:** The stator air seal was consumed by the post flight fire (Ref. Photo No. 27, red arrow). The bearing and rotor air seal were in place but were not removed for the purposes of this investigation.

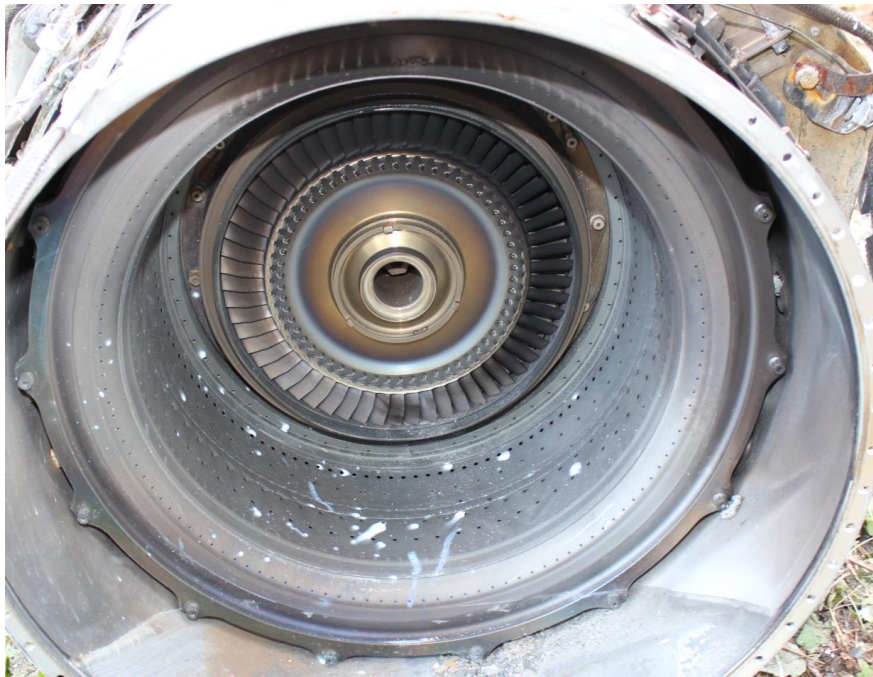
Photo No. 28

**Combustion Chamber Liner:** The visible portion of the liner was unremarkable except for some discoloration between the 5-7 o'clock position (Ref. Photo No. 28).

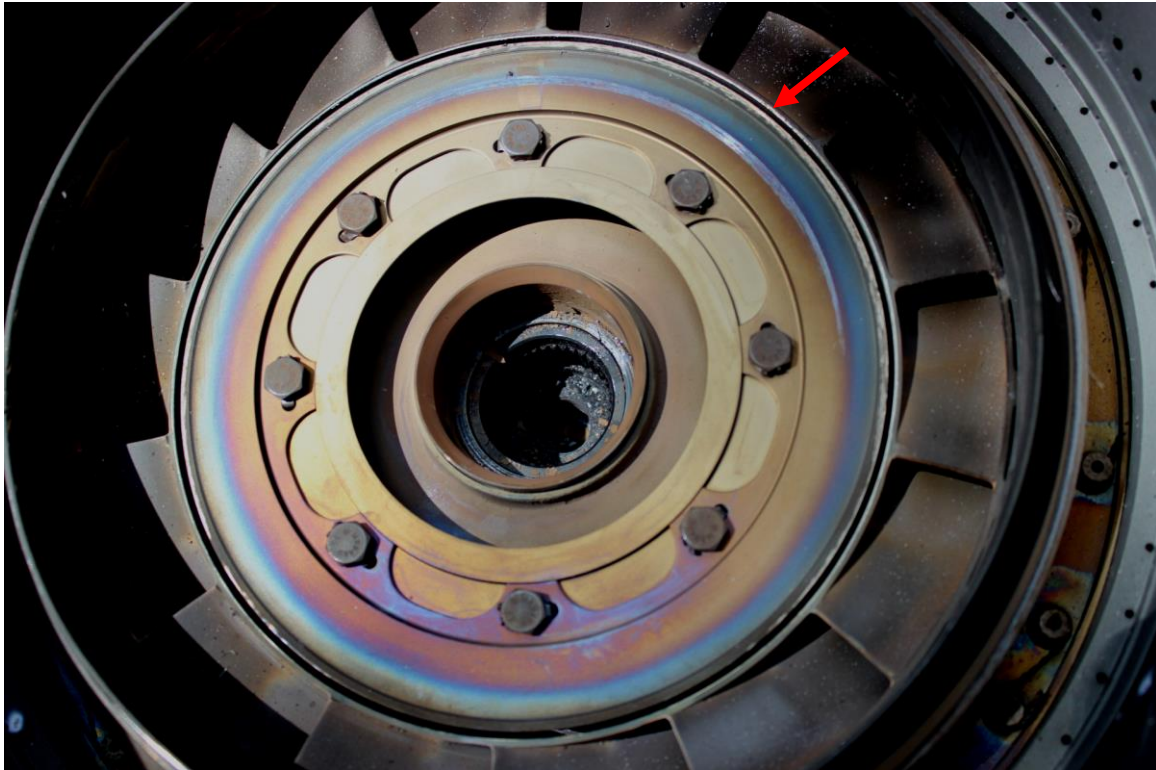
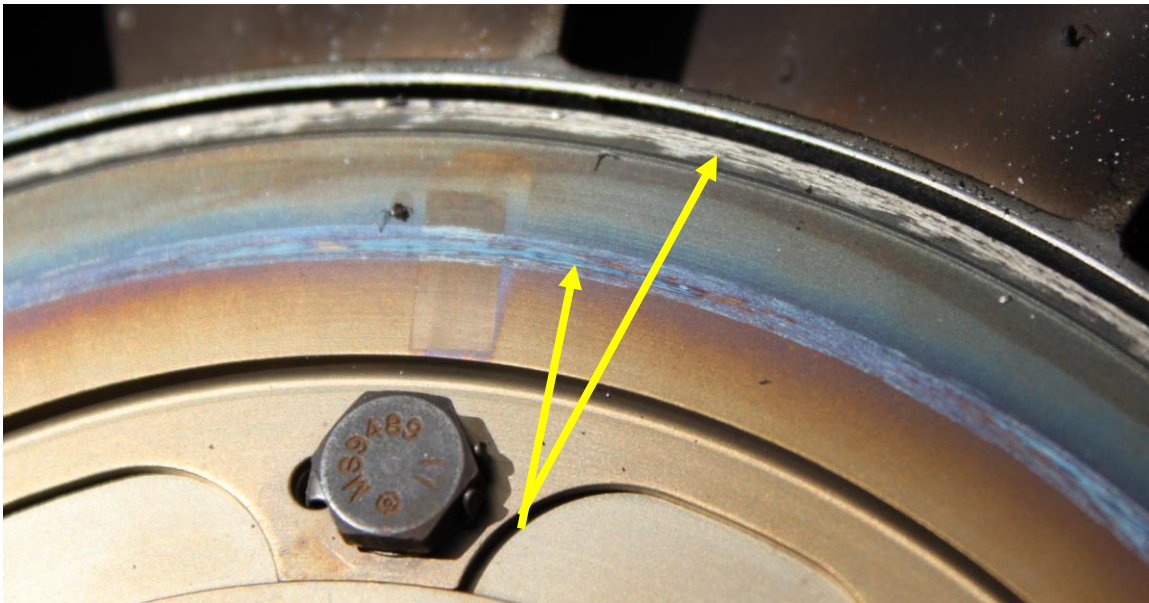
**Compressor Turbine Guide Vane Ring:** The visible area of the vane airfoils were unremarkable, a rub was evident on the inner rim from 7 to 2 o'clock position from contact with the upstream side of the compressor turbine disk blades (Ref. Photo No. 29, red arrow). Compressor turbine air baffle exhibited two rubbed regions from the 9 to 3 o'clock position from contact with the upstream side of the compressor turbine disc and blades (Ref. Photo No. 30, yellow arrows).

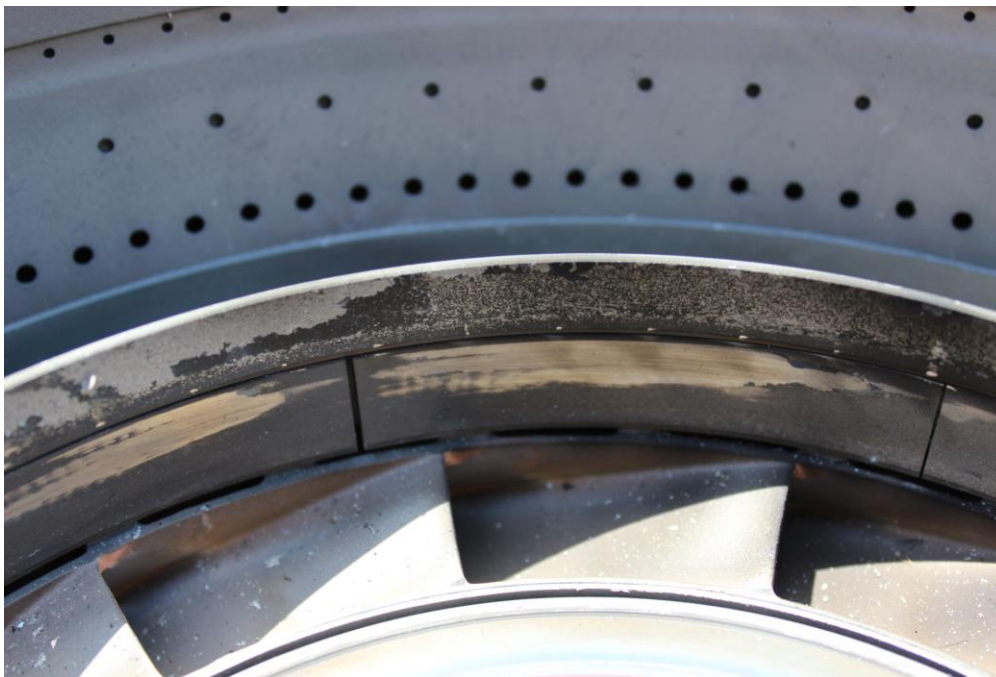
Photo No. 31

**Compressor Turbine Shroud:** The shroud exhibited a rub from the 9 to 10 o'clock position (Ref. Photo No. 31).

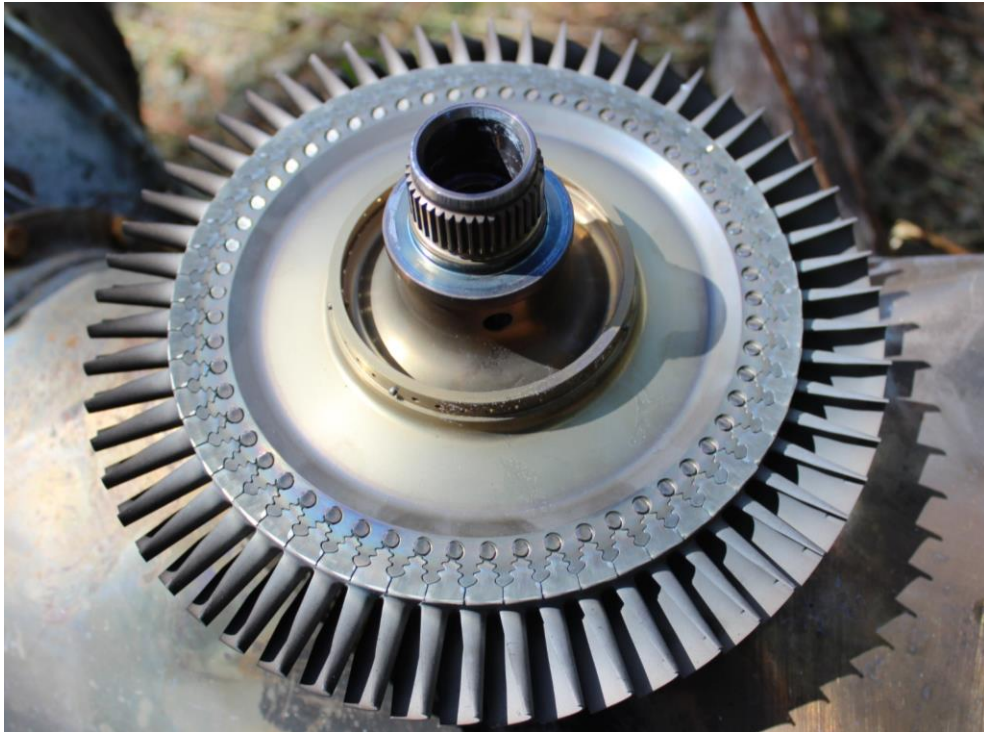
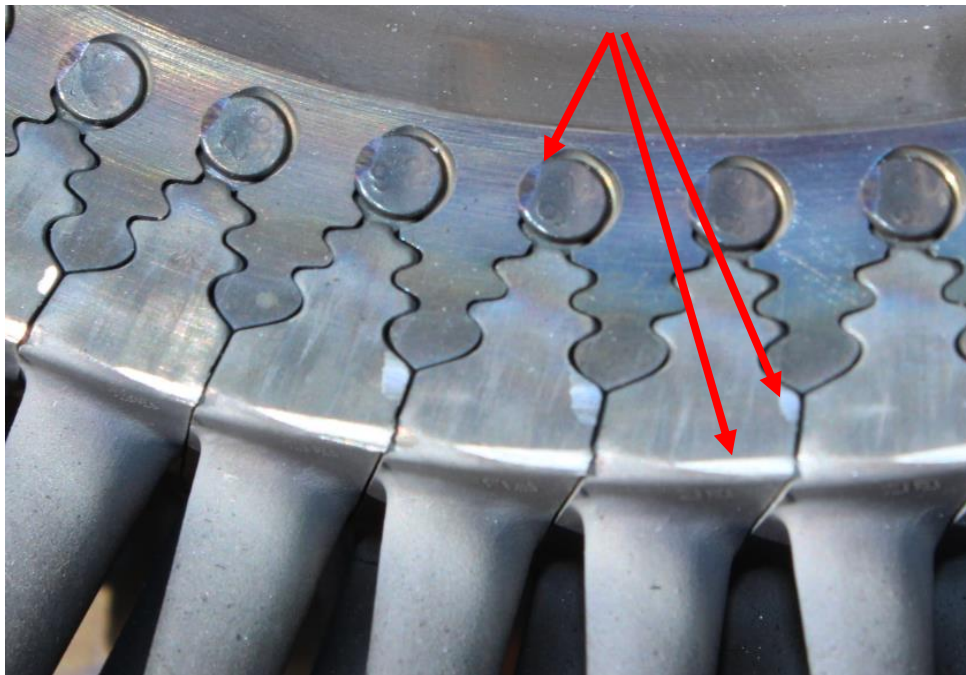
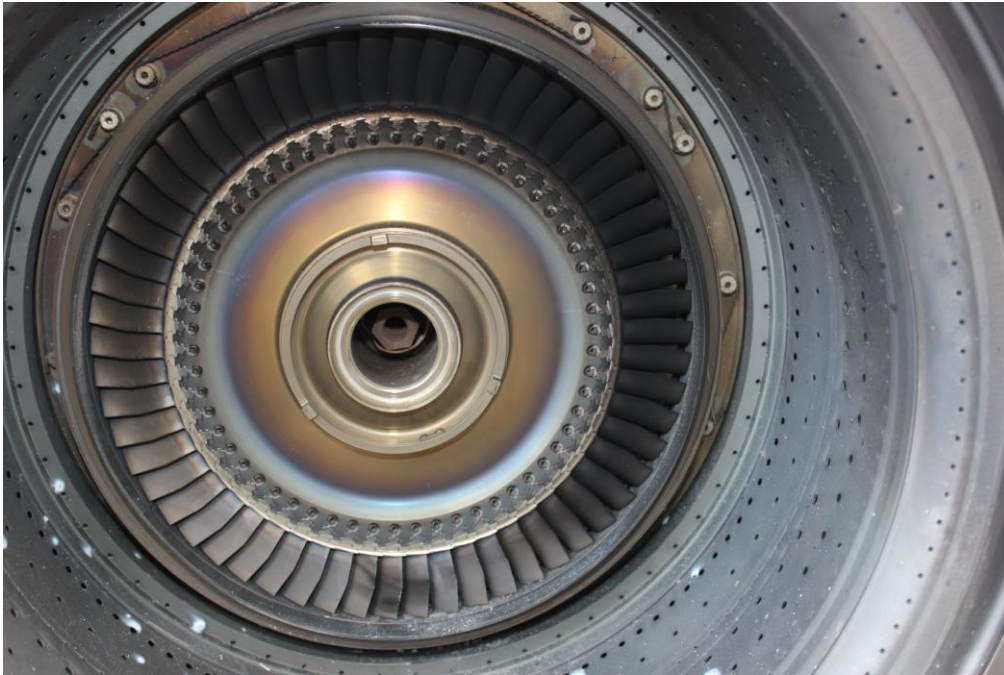
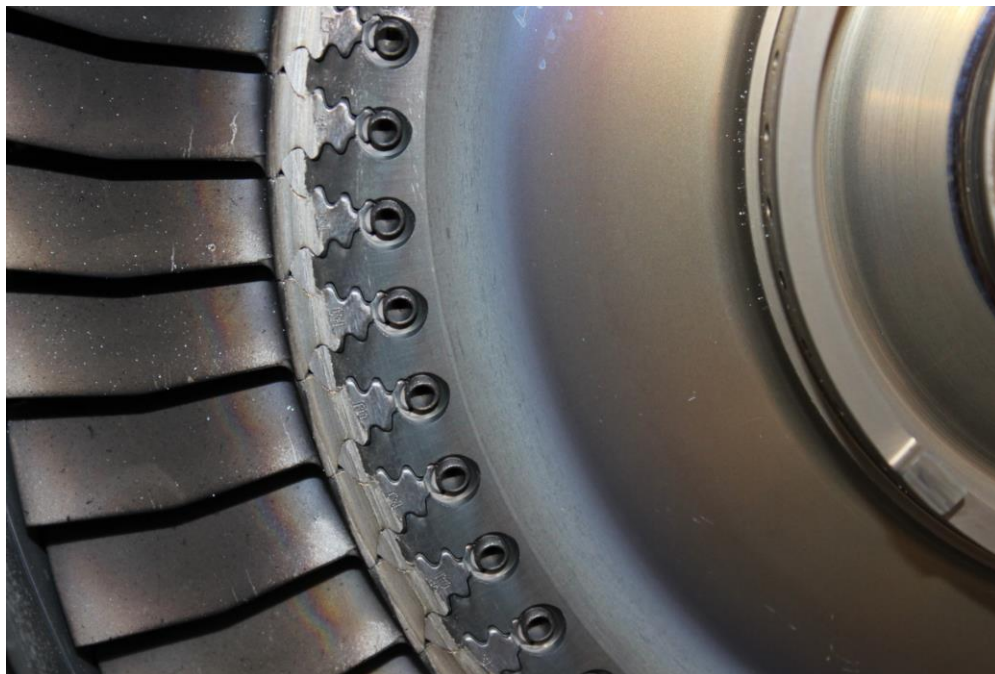
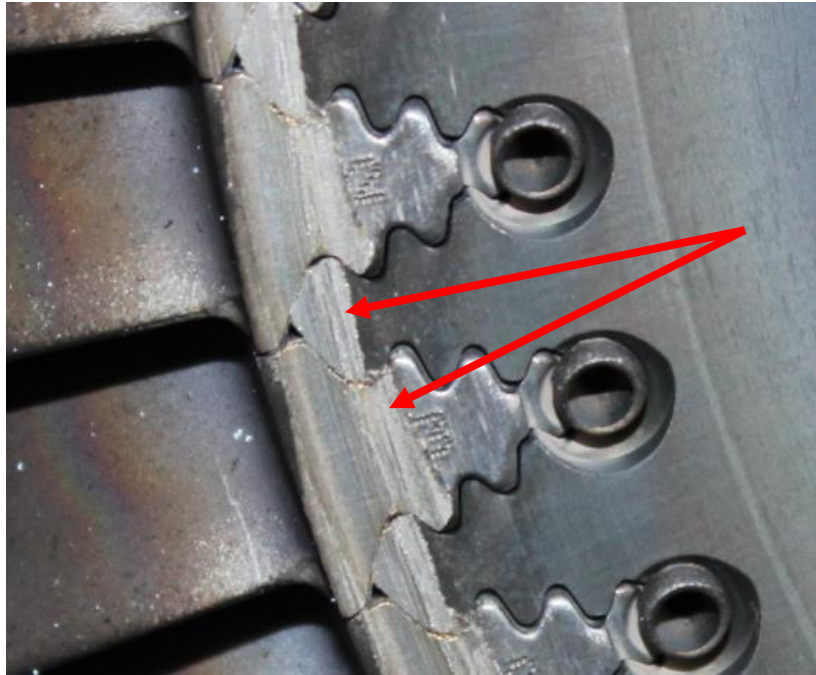
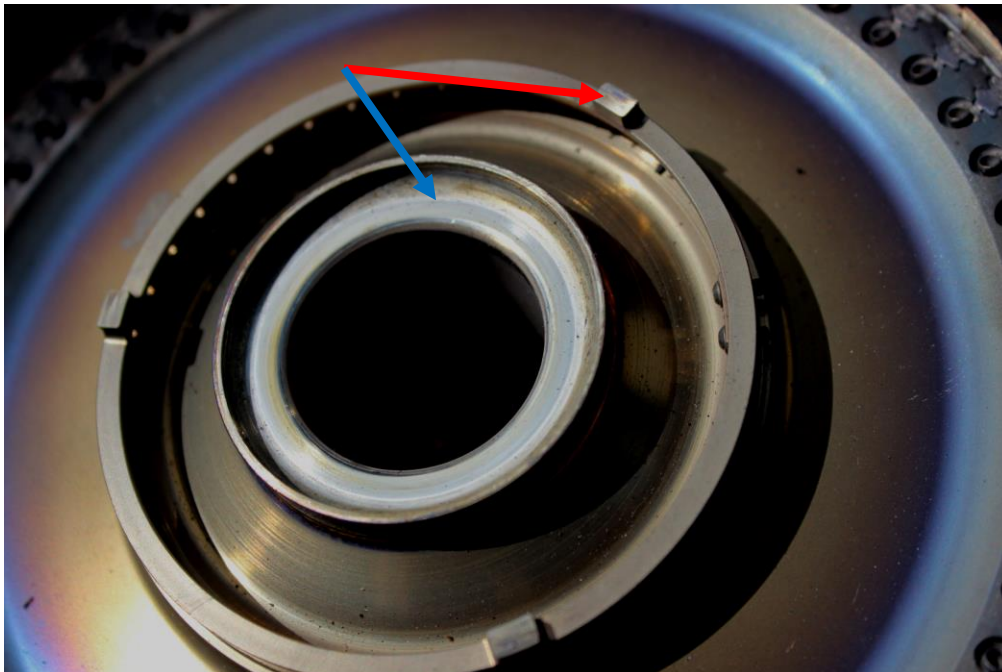
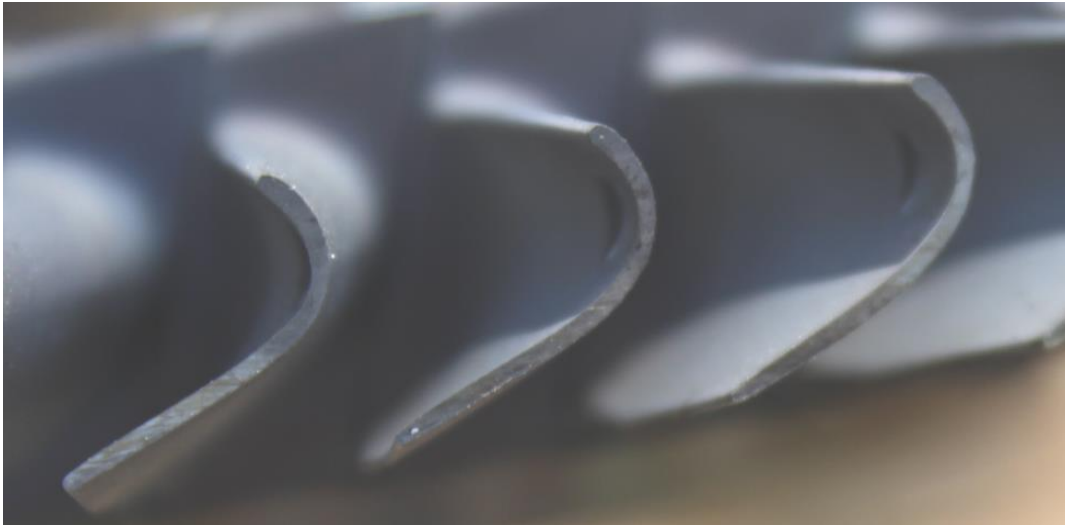
The rotational signatures that were found on the compressor turbine vane, compressor turbine baffle, compressor turbine, 1<sup>st</sup> stage power turbine vane, and the 1<sup>st</sup> stage power turbine indicate they were rotating under power at impact with the terrain.

**Compressor Turbine:** The upstream side of the blades and retention rivets exhibited rubs from contact with the compressor turbine vane and air baffle (Ref. Photos No. 32 & 33, red arrows). The downstream side of the disc and blades exhibited a rub from contact with the upstream side of the power turbine vane and baffle (Ref. Photos No. 34 to 36, red arrows). The tooling anti-rotation lugs exhibit rubs from contact with power turbine baffle (Ref. Photo No. 37, red arrow). The region adjacent to disk retention bolt had rubbed with the centre of the power turbine vane baffle (Ref. Photo No. 37, blue arrow). The blade tips had rubbed with their respective shroud (Ref. Photo No. 38).

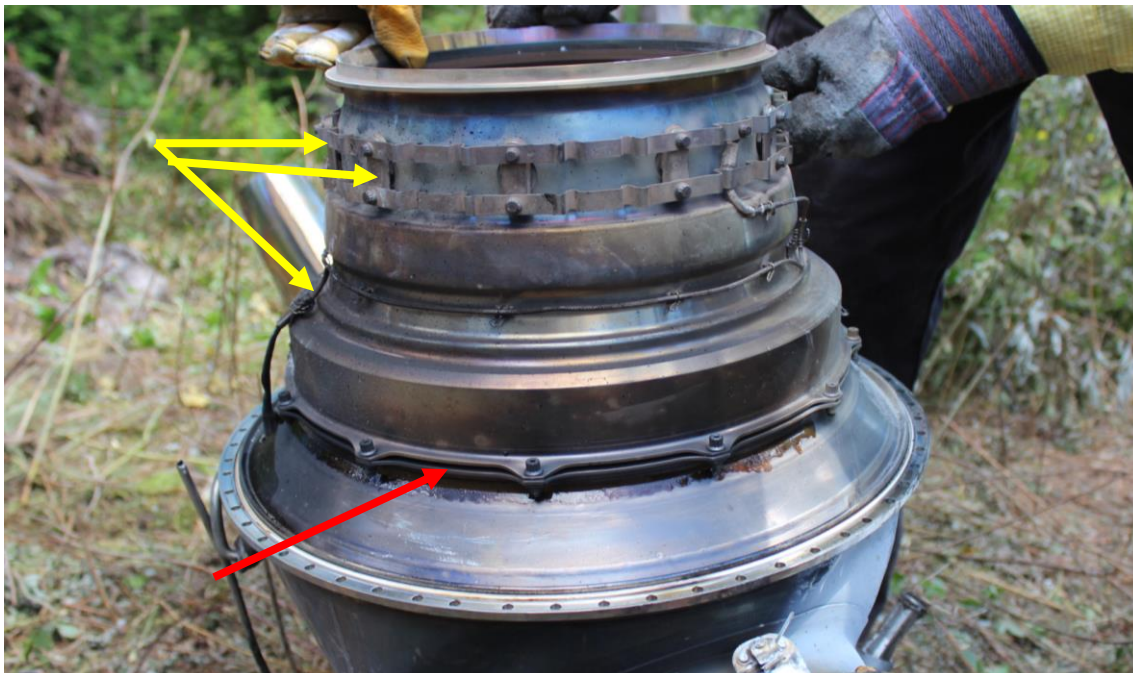
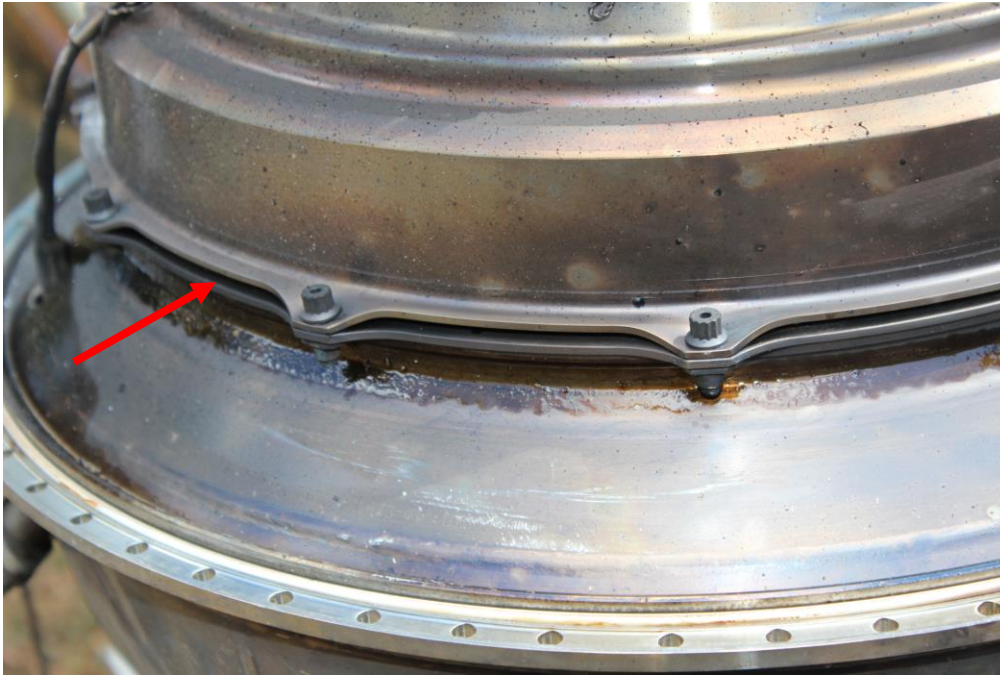
**ITT Probes, Busbar, and Harness:** The probes, busbar, and harness were all in place and secure (Photo No. 39, yellow arrows).

**Power Turbine Housing:** The housing was displaced rearward away from its mating flange with the exhaust duct (Ref. Photos No. 39 & 40, red arrows).
