**Accident / Incident Report**

**Report No.: 15-085**

**Majestic Air LLC  
Piper PA46-500TP, Aircraft Reg. No. N819TB  
Saranac Lake, New York  
August 7, 2015  
PT6A-42A  
S/N RM0122**

**Written By: Jeff Davis  
Service Investigation Department**

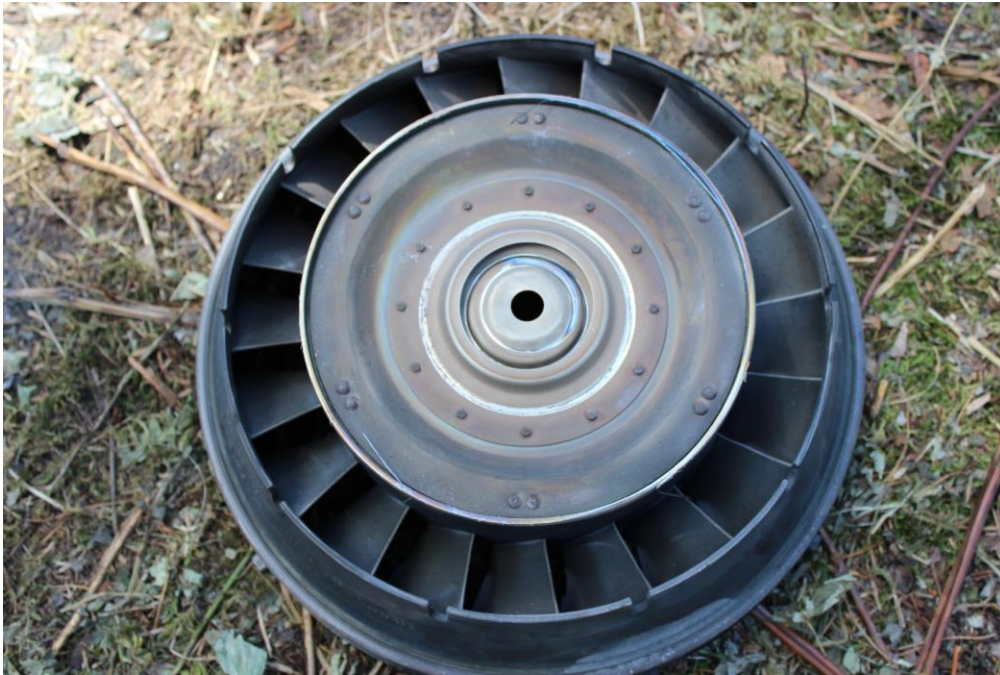
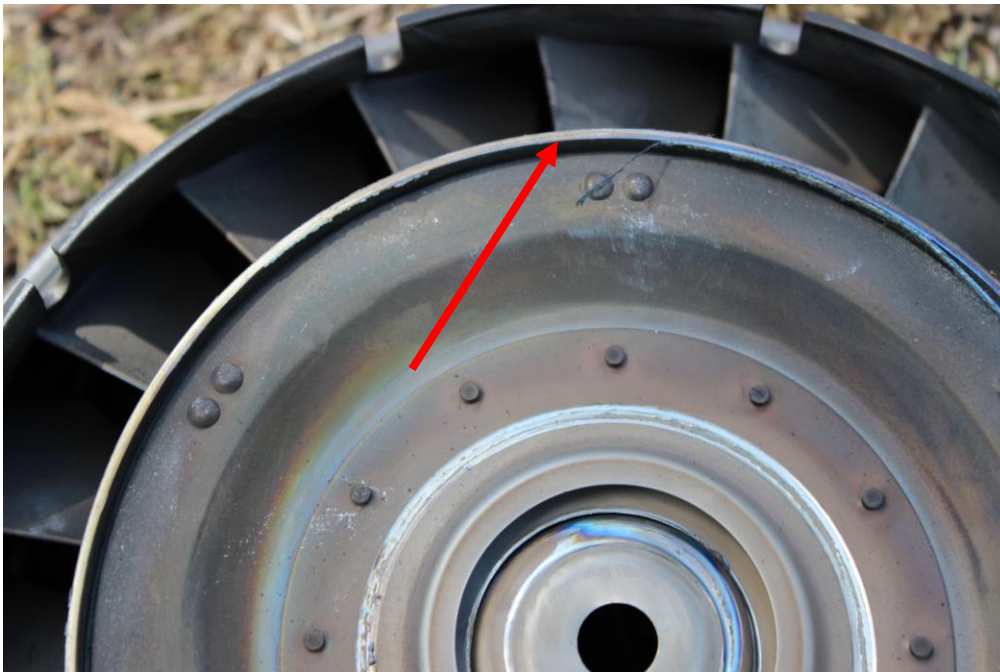
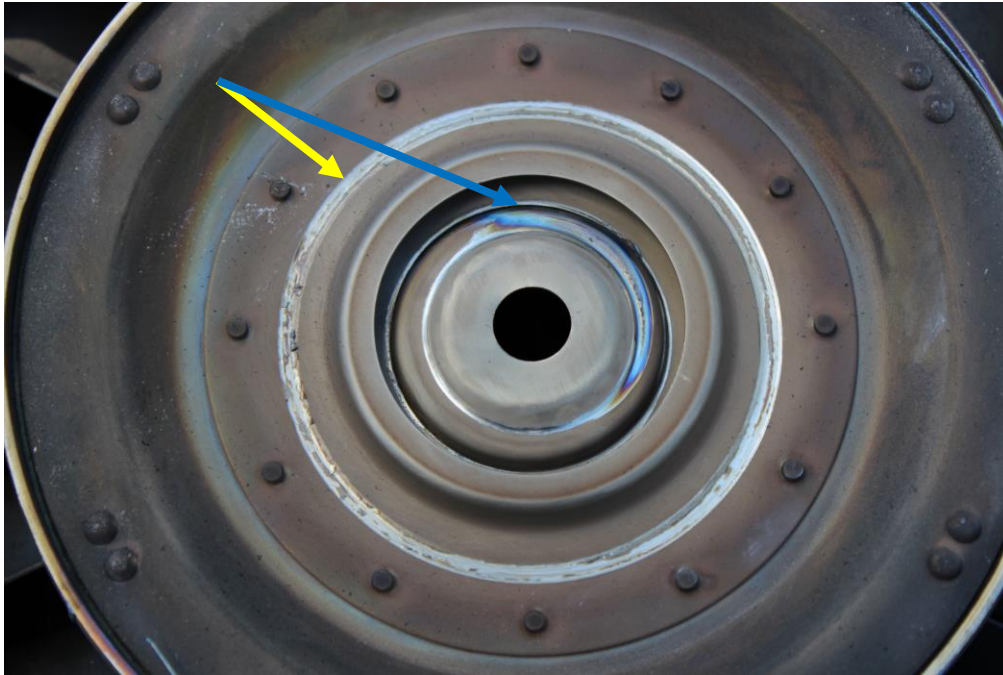
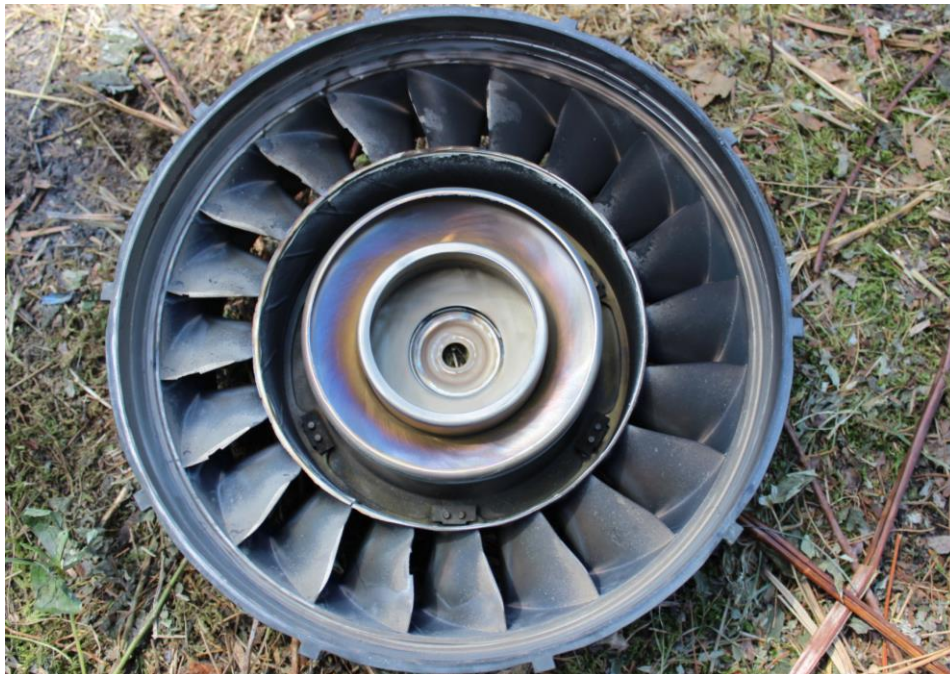
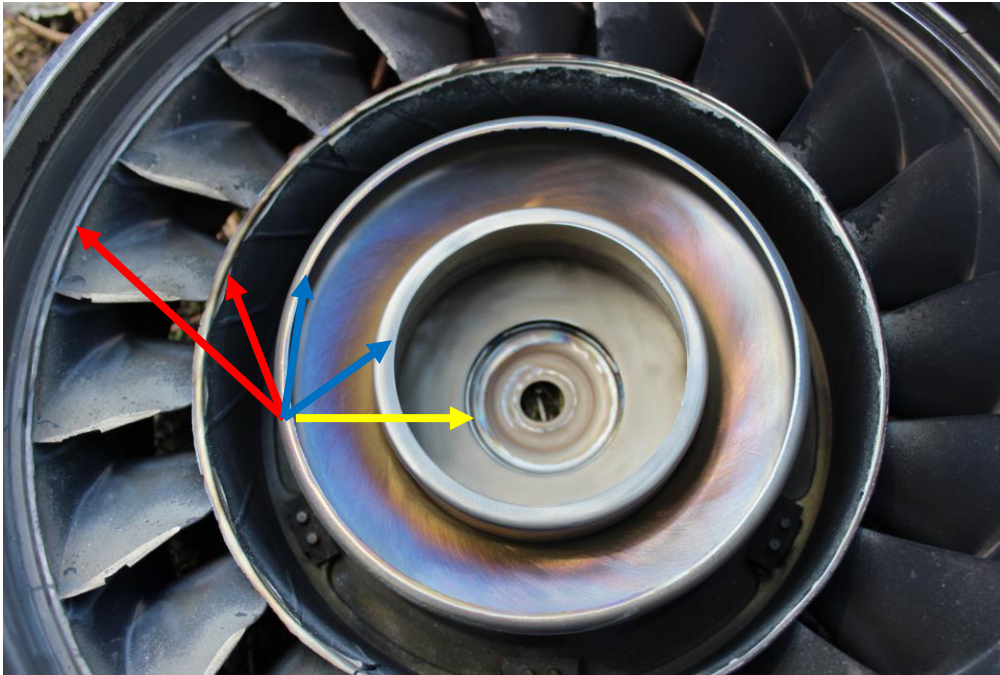
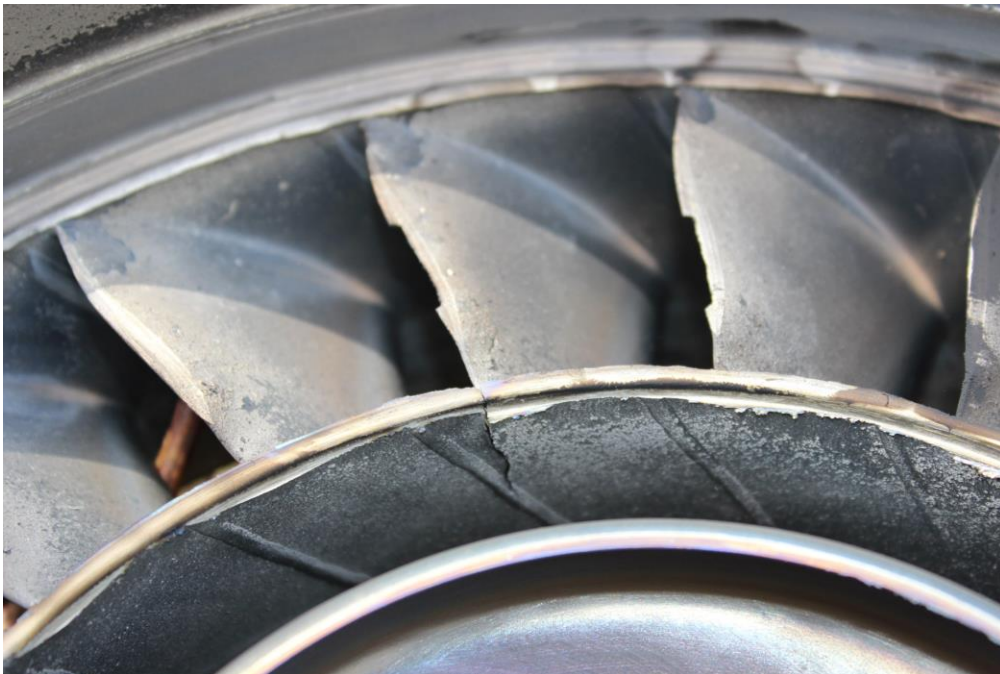
**1<sup>st</sup> Stage Power Turbine Guide Vane Ring and Interstage Baffle:** The inner rim of the upstream side of the vane was rubbed from contact with the compressor turbine blades and disc (Ref. Photos No. 41 & 42, red arrow). The region adjacent to the centre of the baffle exhibited a rub from contact with compressor turbine disc tooling lugs (Ref. Photo No. 43, yellow arrow). The centre of the baffle exhibited a rub from contact with the area of the compressor turbine disc adjacent to the retention bolt bore (Ref. Photo No. 43, blue arrow). The downstream side of the vane exhibited rubs on the outer rim and inner rim (Ref. Photos No. 44 & 45, red arrows). The inner rim was cracked at two locations and the trailing edge of several airfoils were missing (Ref. Photo 46). The outer diameter and inner diameter exhibited rubs from contact with the 1<sup>st</sup> stage power turbine disc (Ref. Photo No. 45, blue arrows). The centre of the baffle exhibited a rub from contact with the power turbine retention nut (Ref. Photo No. 45, yellow arrow).

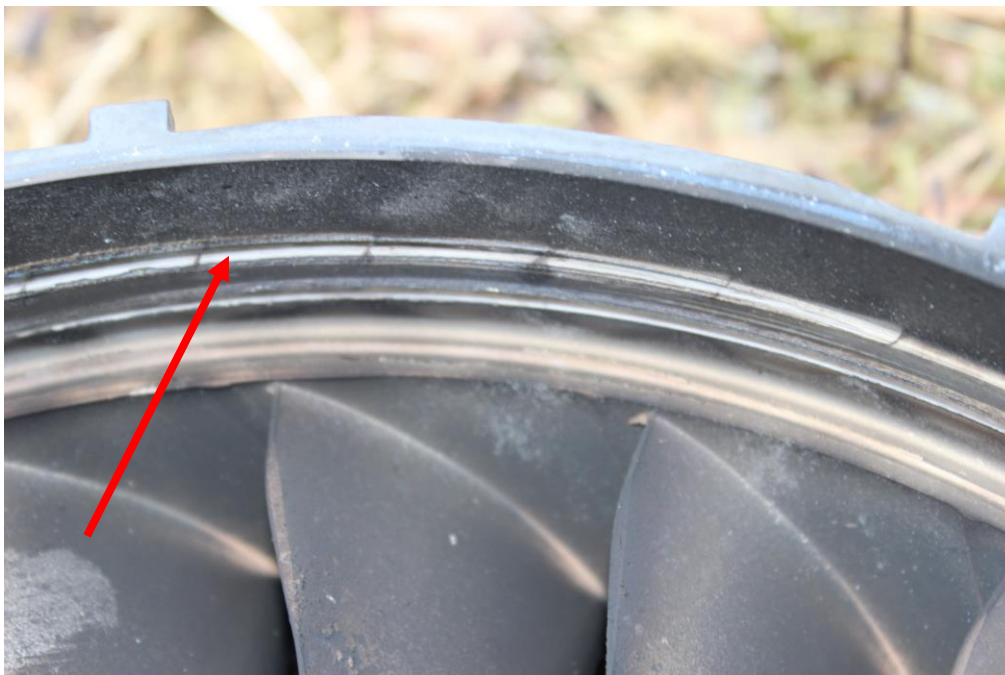
Photo No. 47

**1<sup>st</sup> Stage Power Turbine Shroud:** The shroud exhibited a rub from the 11 to 2 o'clock position from contact with its respective blades (Ref. Photo No. 47, red arrow).

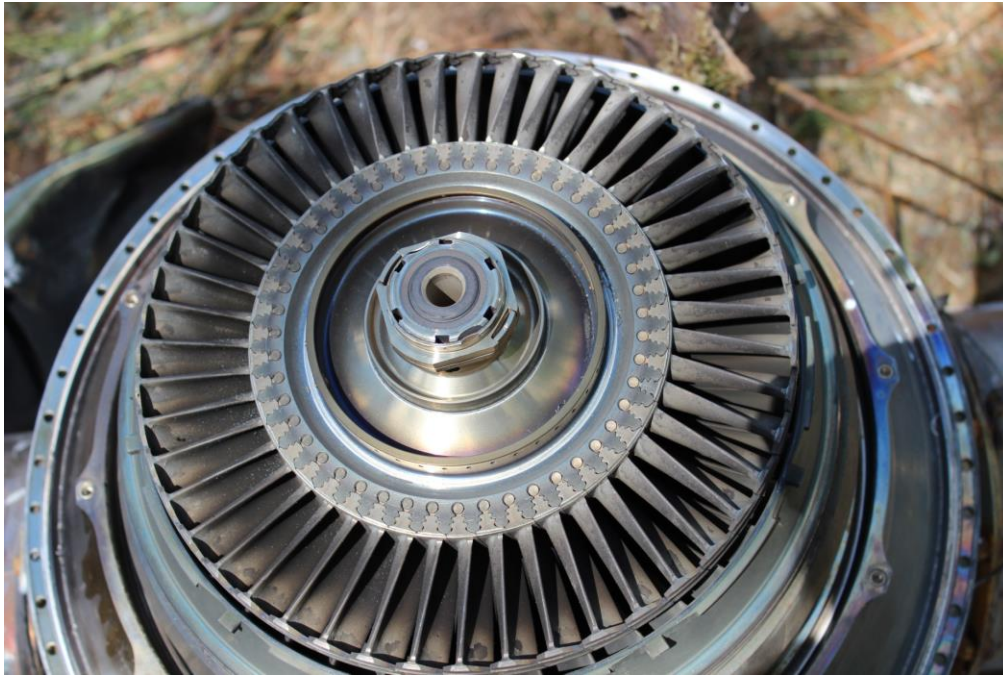
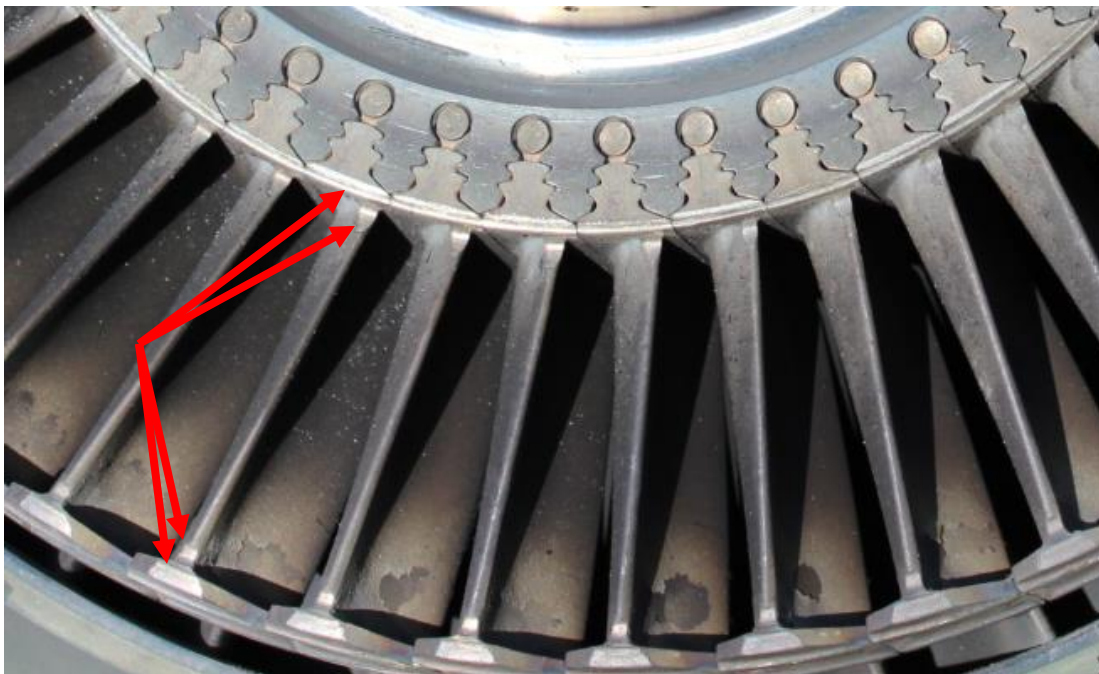
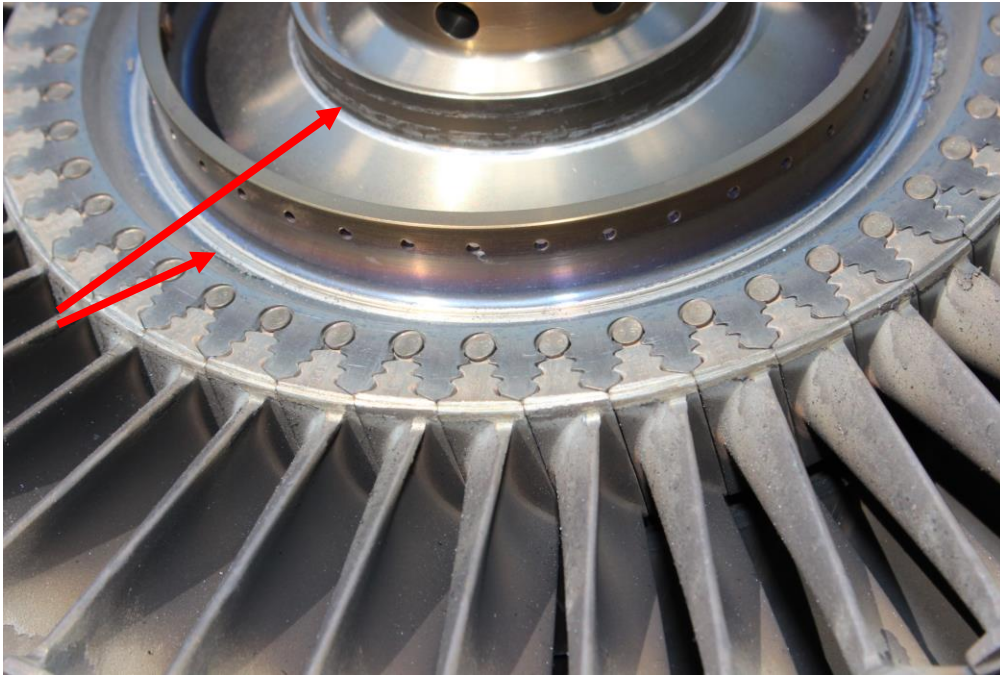
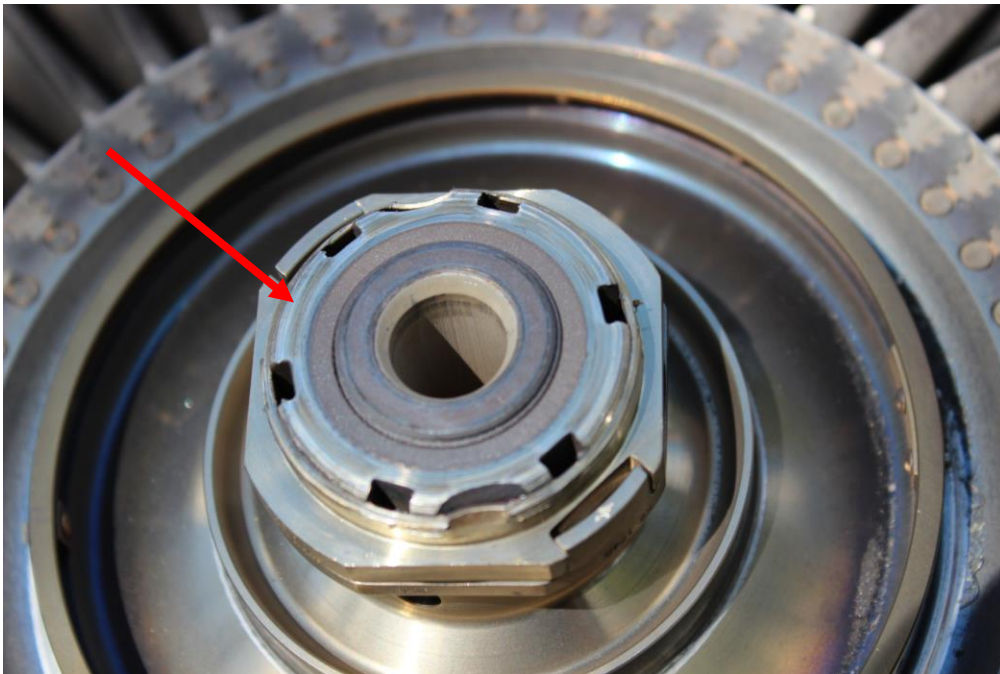
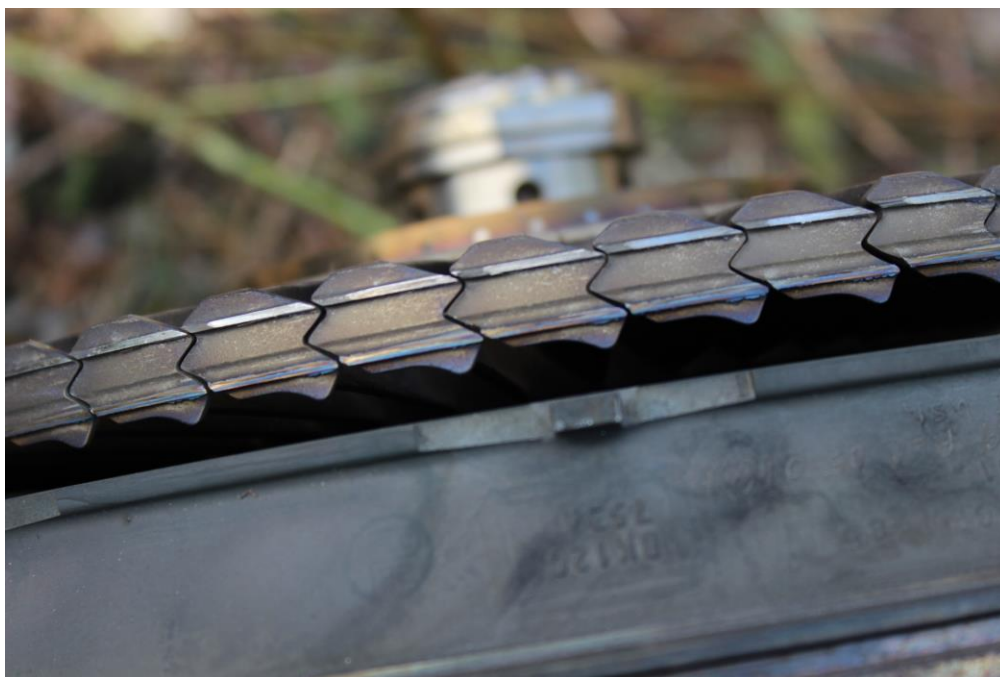
**1<sup>st</sup> Stage Power Turbine:** The leading edge of the turbine blades exhibited rubs at the tip, at the root and on the platform from contact with the downstream side of the power turbine vane (Ref. Photos No. 48 & 49, red arrows). The disc displayed two rubbed regions, adjacent to the balancing rim and the rim adjacent to the cooling orifices from contact with the baffle (Ref. Photo No. 50, red arrows). The turbine retention nut exhibited a rub from contact with the centre of the baffle (Ref. Photo No. 51, red arrow). The blade tips had rubbed with the power turbine shroud (Ref. Photo No. 52).

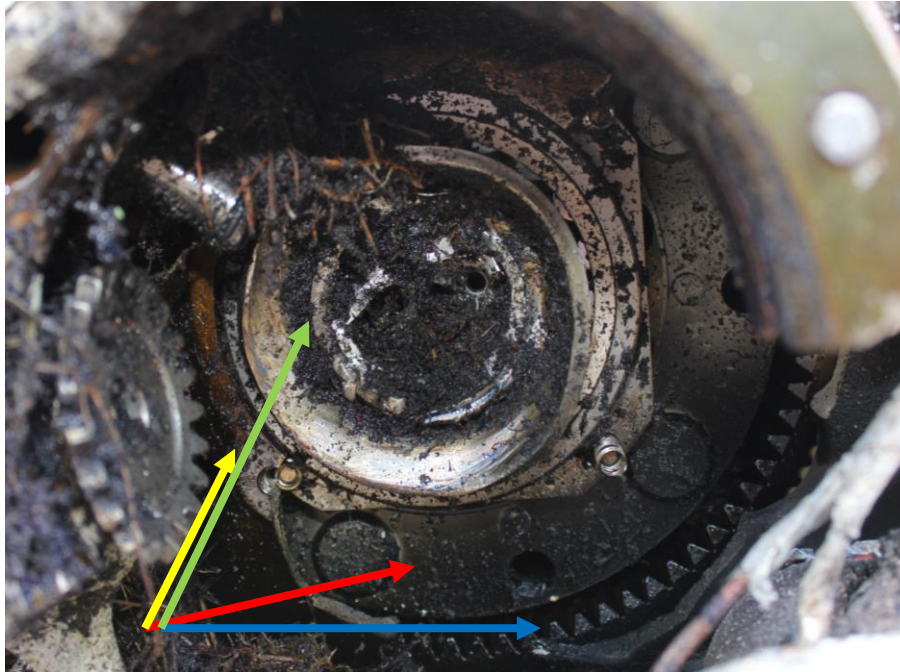
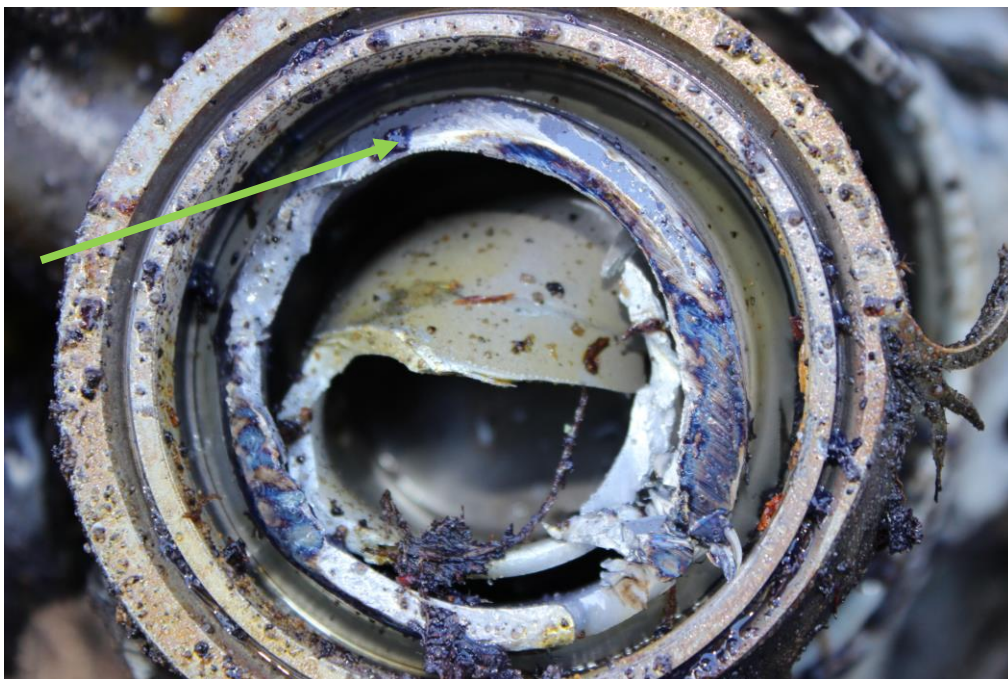
**2<sup>nd</sup> Stage Planet Gear Carrier:** The carrier was not accessed for the purposes of this investigation but a portion of the carrier was visible due to the fractured front reduction gearbox housing (Ref. Photo No. 53, red arrow). The carrier was attached to the fractured propeller shaft.

**2<sup>nd</sup> Stage Ring Gear:** The gear was not accessed for the purposes of this investigation but a portion of the gear was visible due to the fractured front RGB housing (Ref. Photo No. 53, blue arrow). The visible portion of the gear was in its respective position in the gearbox housing.

**No. 5 Bearing:** The bearing was not accessed for the purposes of this investigation but a portion of the bearing was visible due to the fractured front RGB housing (Ref. Photo No. 53, yellow arrow). The roller elements were in place.

**Propeller Shaft:** The shaft was fractured between the propeller sleeve and the 2<sup>nd</sup> stage carrier (Ref. Photo No. 53, green arrow and Photo No. 54, green arrow). The fracture surface displayed features consistent with a torsional overload fracture.

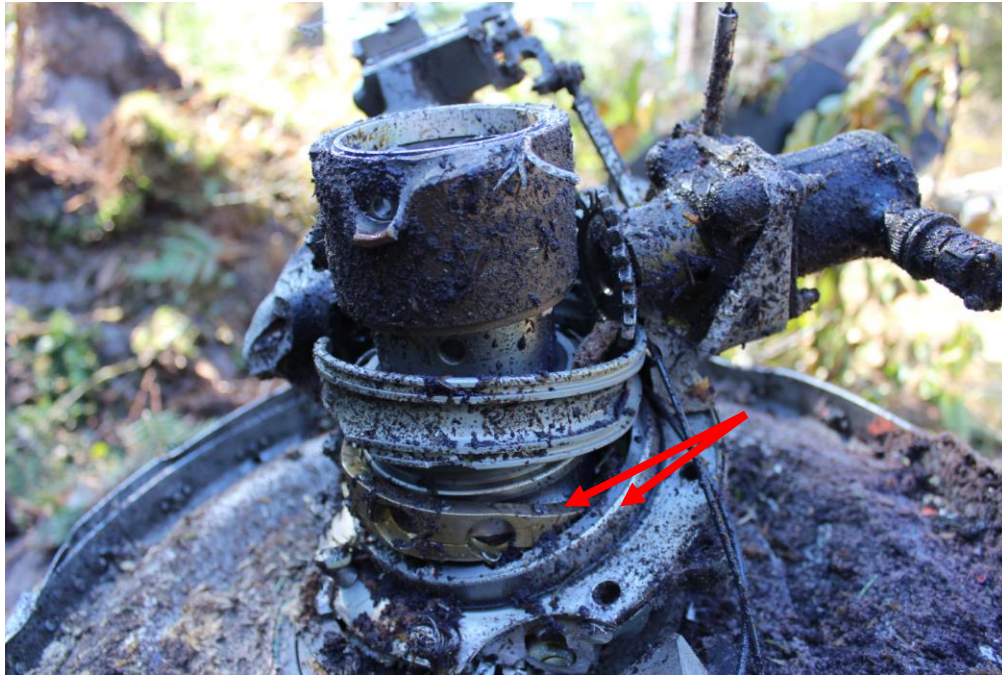
Photo No. 55

**No. 6 Bearing:** The bearing cage was bent and several of the ball elements were missing (Ref. Photo No. 55, red arrows).

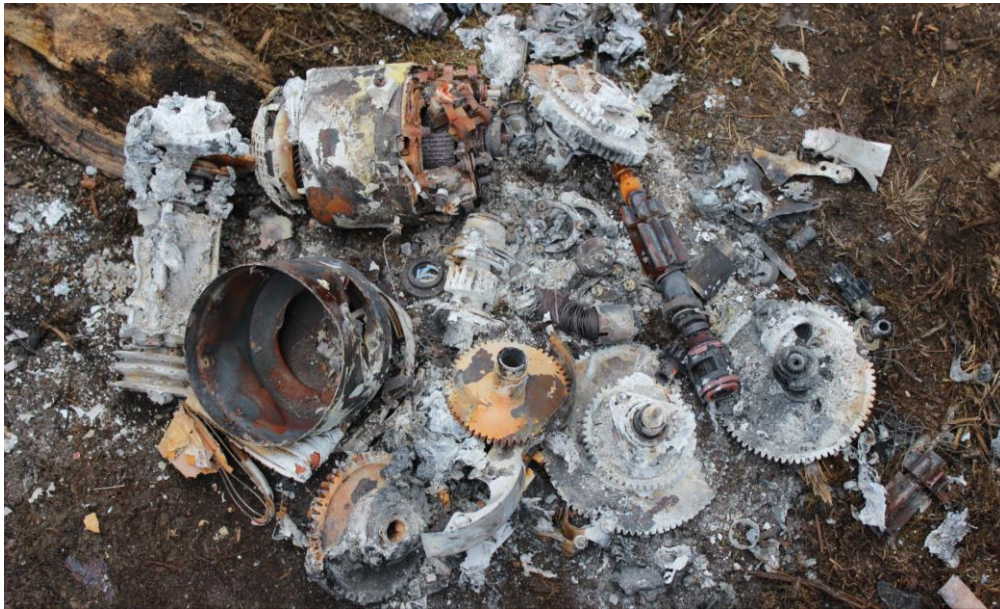
Photo No. 56

3.2.5 **Accessory Gearbox:** The gears shafts and some of the gear shaft bearings were recovered from the debris from the burnt gearbox and inlet case (Ref. Photo No. 56). No examination of the shafts and bearings was conducted due to their burnt condition.

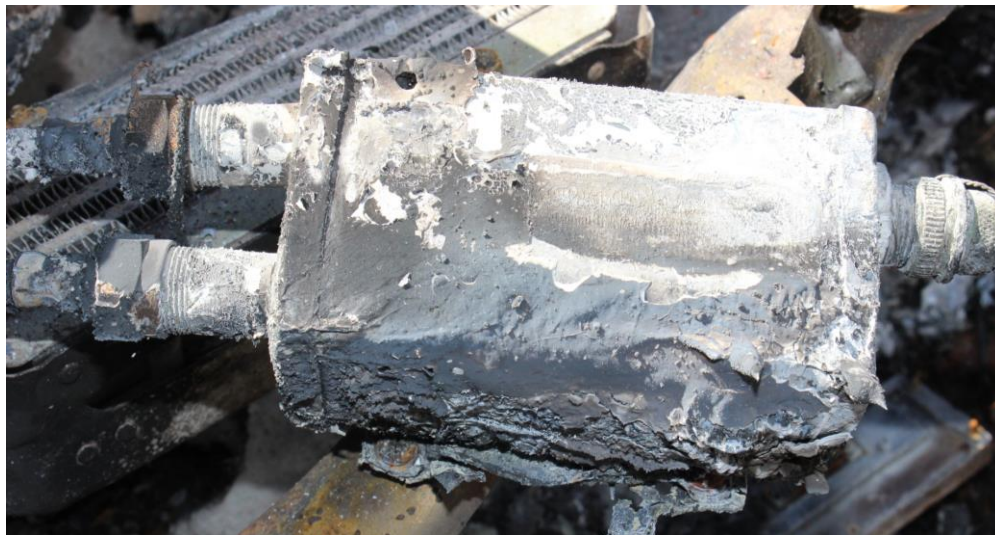
Photo No. 57

**Exciter Box:** The exciter box was in place and secure. The exterior of the housing exhibited thermal distress from exposure to the post flight fire (Ref. Photo No. 57).

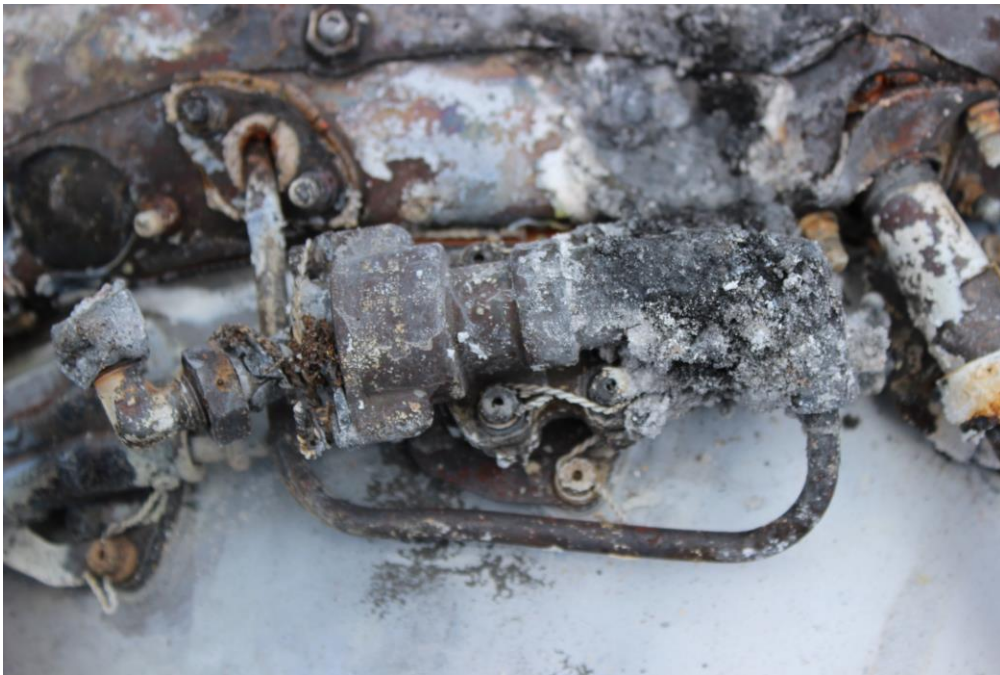
Photo No. 58

**Flow Divider:** The divider was in place and secure. The exterior was thermally damaged from the post flight fire (Ref. Photo No. 58).

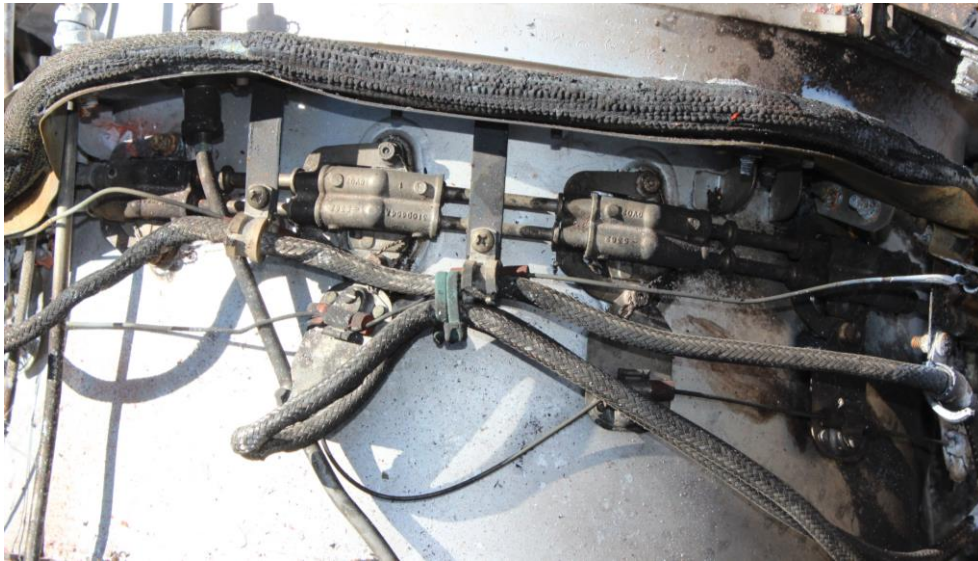
Photo No. 59

**Fuel Nozzles:** The nozzles were in place and secure (Ref. Photo No. 59). Several of the fuel transfer tubes were bent and/or thermally damaged.

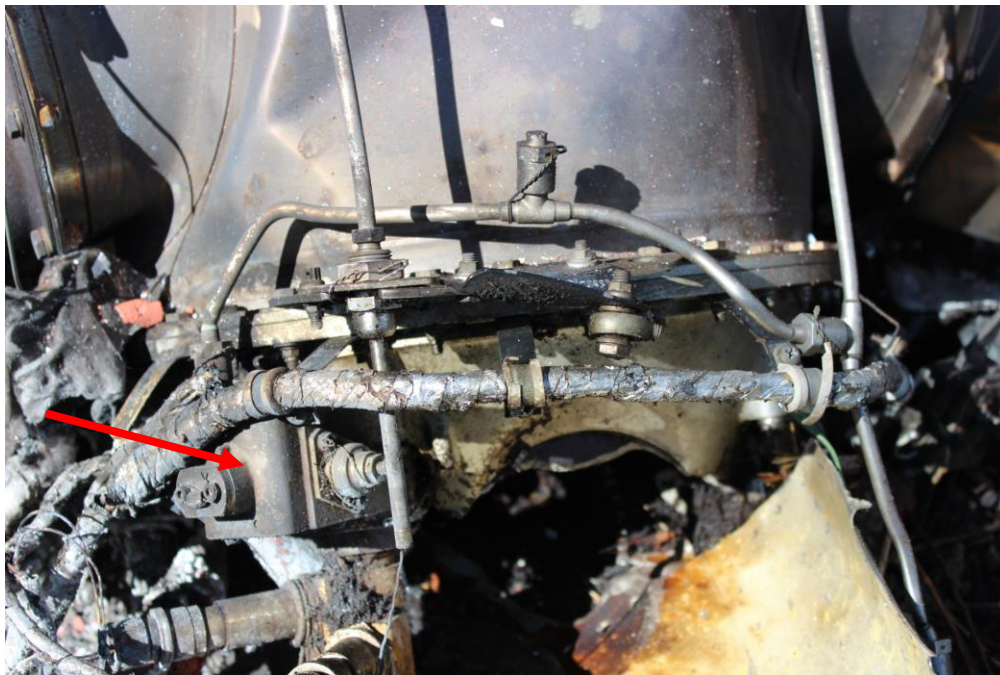
Photo No. 60

**Torque Limiter:** The limiter was in place and secured (Ref. Photo No. 60, red arrow). The PY line was in place and secured to the limiter.

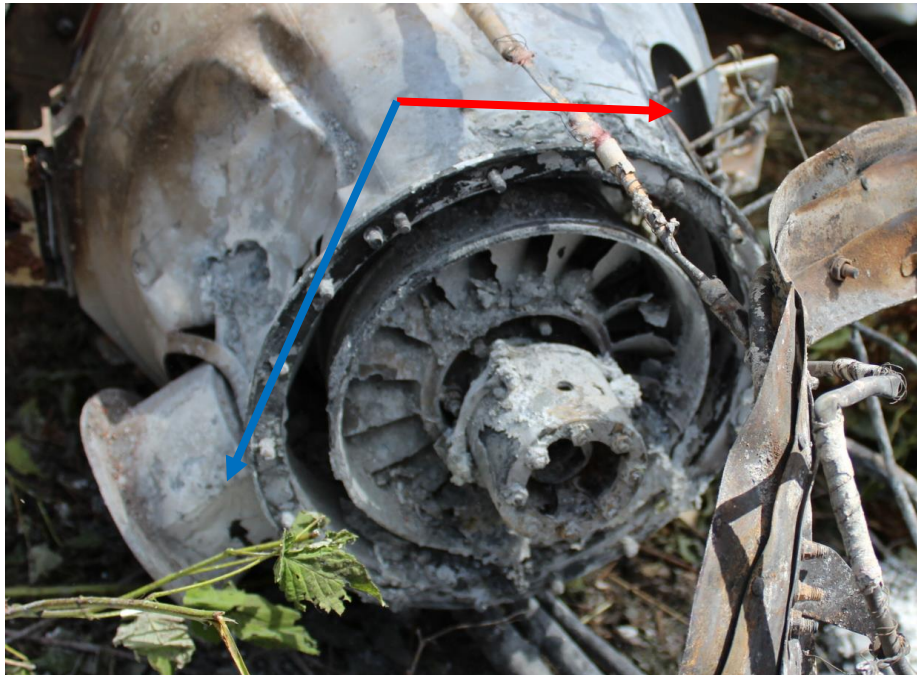
Photo No. 61

**Compressor Bleed Valves:** The right hand bleed valve was consumed in the post flight fire (Ref. Photo No. 61, red arrow). The left hand bleed valve was in place and thermally distressed from the post flight fire (Ref. Photo No. 61, blue arrow).

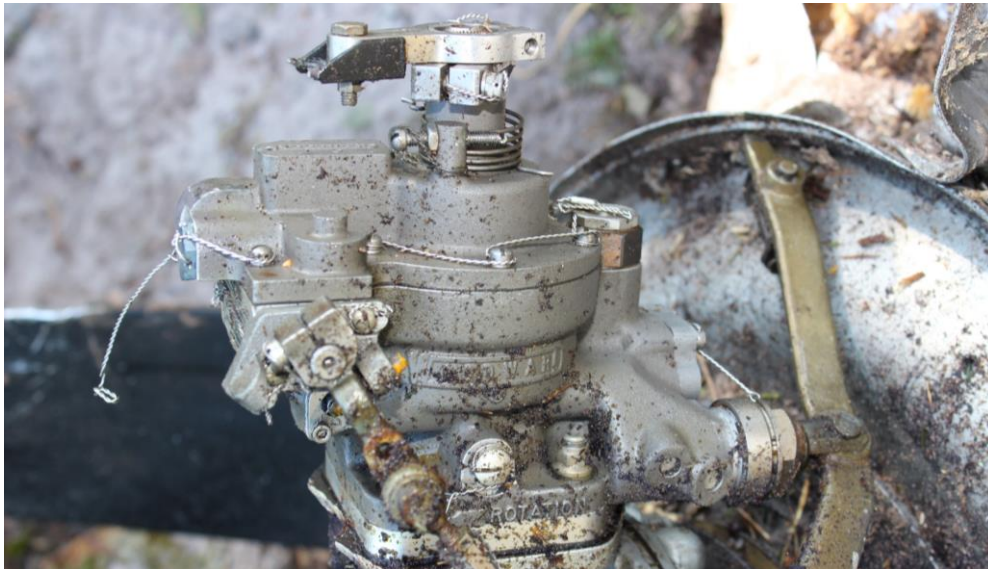
Photo No. 62

**Propeller Governor:** The governor was in place and secure on the front reduction gearbox housing (Ref. Photo No. 62). The exterior was partially coated with organic debris and some external impact damage was evident.

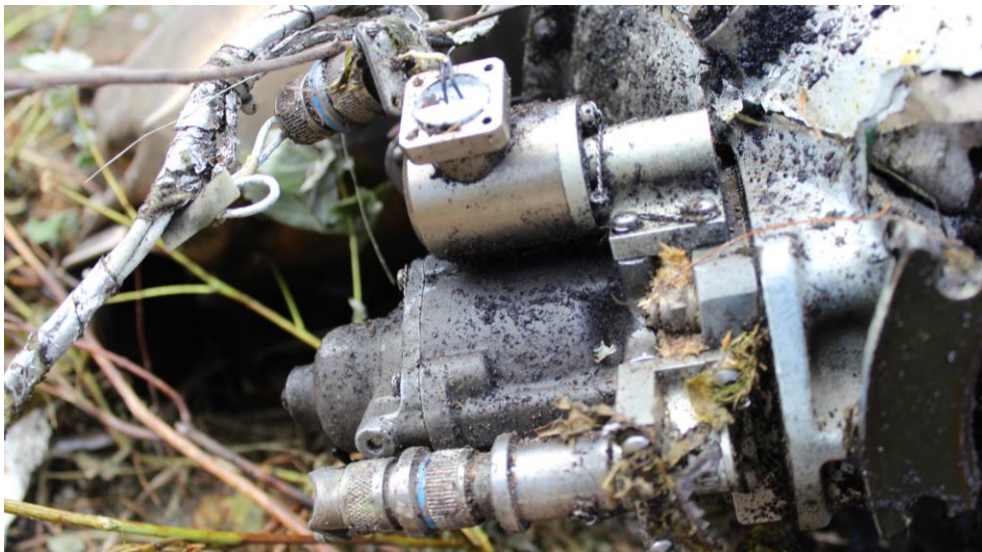
Photo No. 63

**Overspeed Governor:** The governor was in place and secure on the front reduction gearbox housing (Ref. Photo No. 63). The exterior was partially coated with organic debris and some external impact damage was evident.
