# NATIONAL TRANSPORTATION SAFETY BOARD

## MATERIALS LABORATORY FACTUAL REPORT

Report No. 16-091

Place : West Caldwell, New Jersey  
Date : August 15, 2015  
Vehicle : Cessna T206H; N63TV  
NTSB No. : ERA15FA312  
Investigator : Todd Gunther, AS-ERA

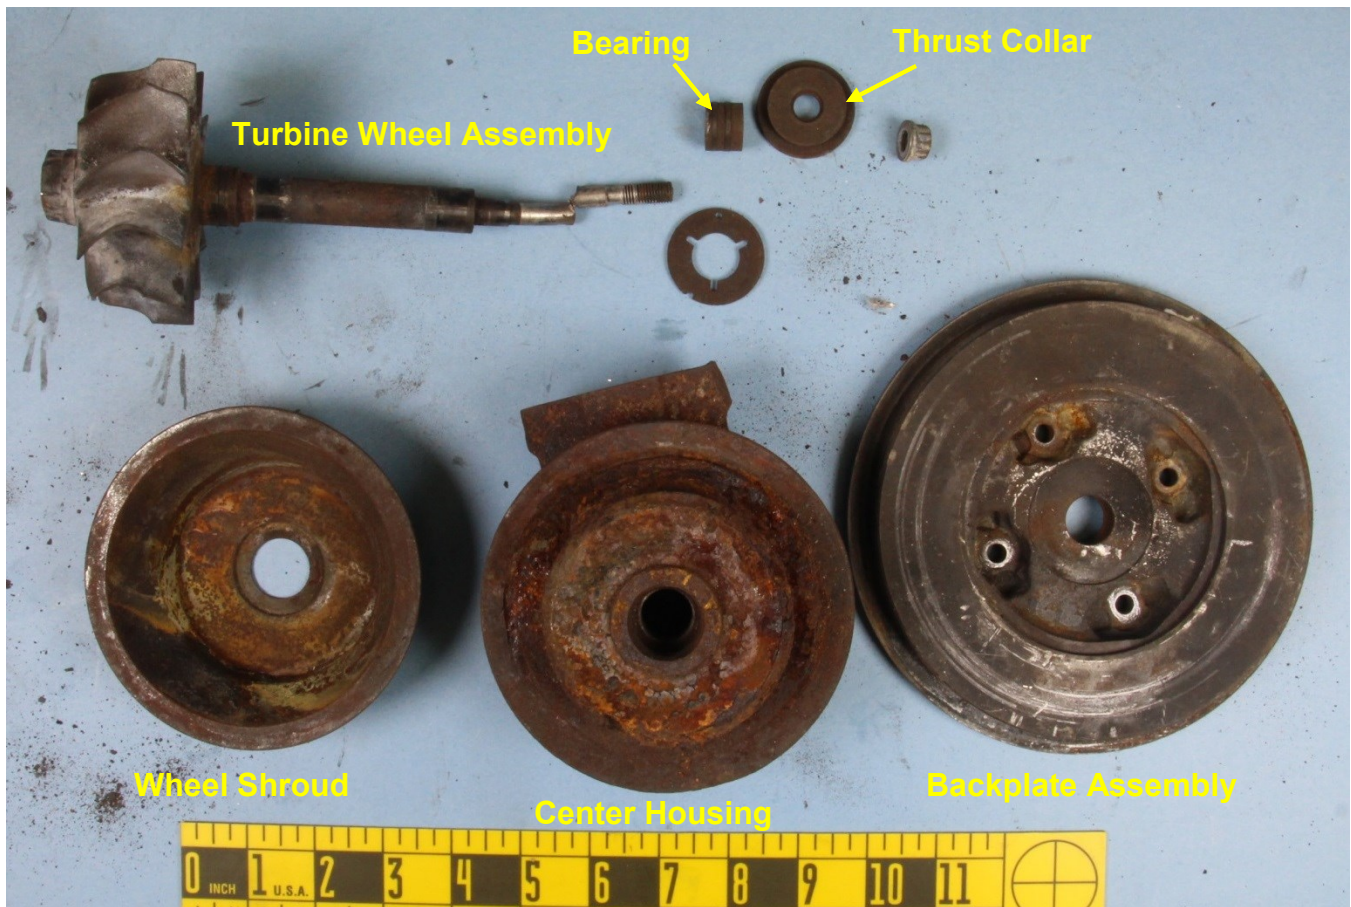
turbocharger components exhibited surface oxidation (rusting) and evidence of coking with soot residue. These conditions were consistent with exposure to fire, as well as exposure to water. The center housing label plate, shown in Figure 2, stated the following: "FAA-PMA, Part No. 466881-0001, Serial No. H-PHL00, Hartzell Engine Technologies."

Figure 1 – Some of the components submitted from the Hartzell turbocharger.

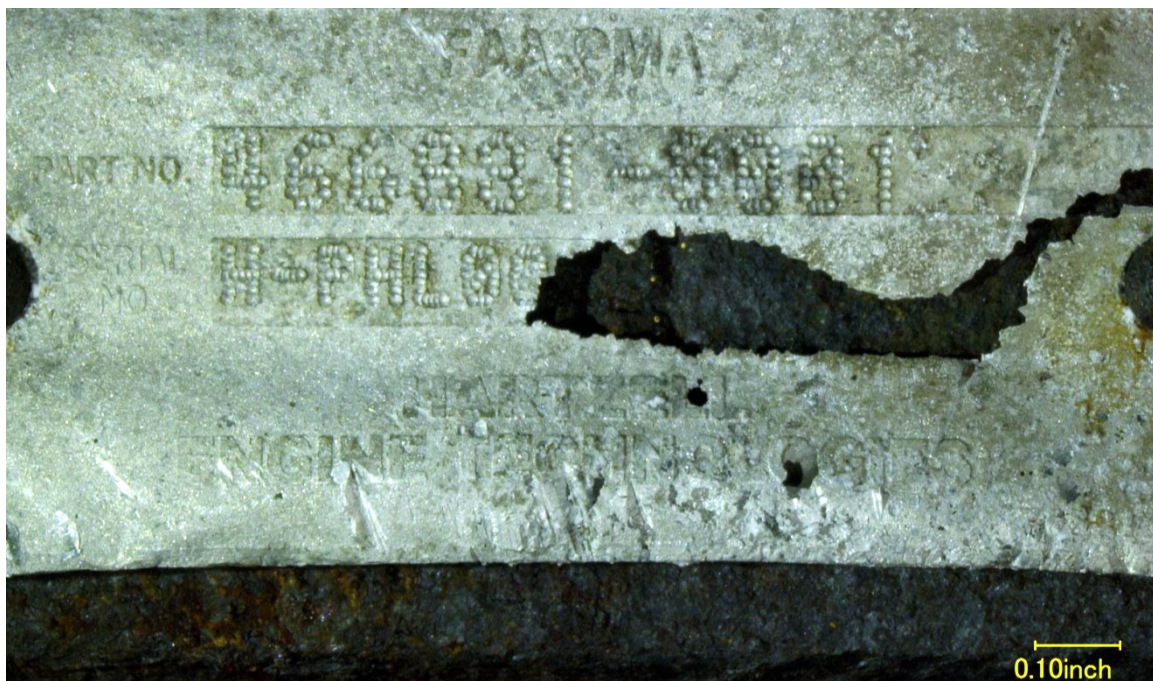
Figure 2 – The label plate on the upper side of the center turbocharger housing.

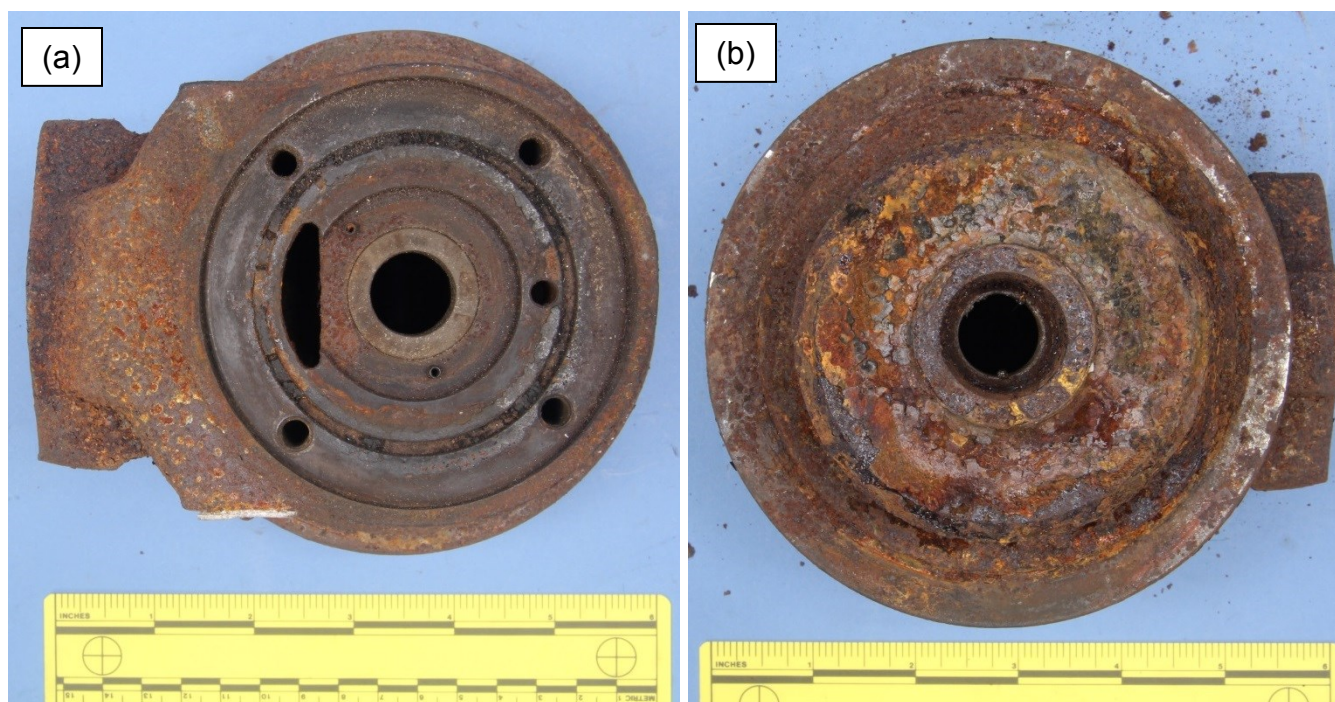
The center housing of the turbocharger is depicted from both the compressor and turbine sides in Figure 3. As previously stated, the part had rusted to a degree that the iron oxide was starting to spall. No other visible damage, such as distortion, wear, or cracking was present on the component exterior. The center housing was radiographed and inspected using computed tomography (CT) scanning. There were no discernable features noted on the center housing using these techniques.

Figure 3 – The center housing of the turbocharger, viewed from (a) the compressor side and (b) the turbine side.

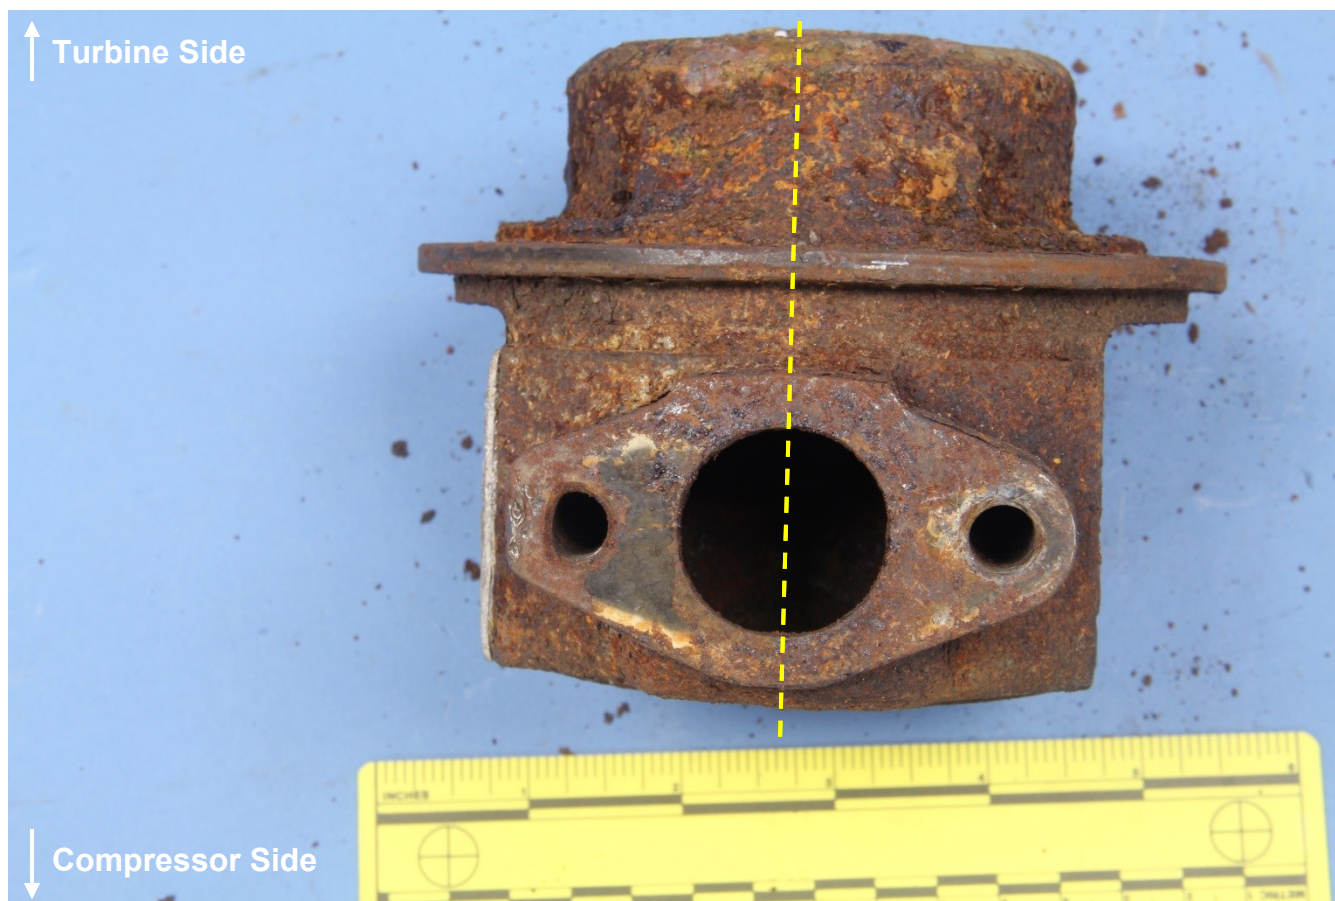
The center housing was sectioned using a band saw with a water-based emulsion-coolant. The location of the sectioning was along the position of the turbine wheel, as illustrated in Figure 4. Figure 5 shows one of the sectioned halves of the center housing interior. Figure 6 shows the same section with the turbine wheel assembly, as it was present during the accident.

Figure 4 – The center housing of the turbocharger, viewed from the upper side. The yellow line shows the location of the sectioning.

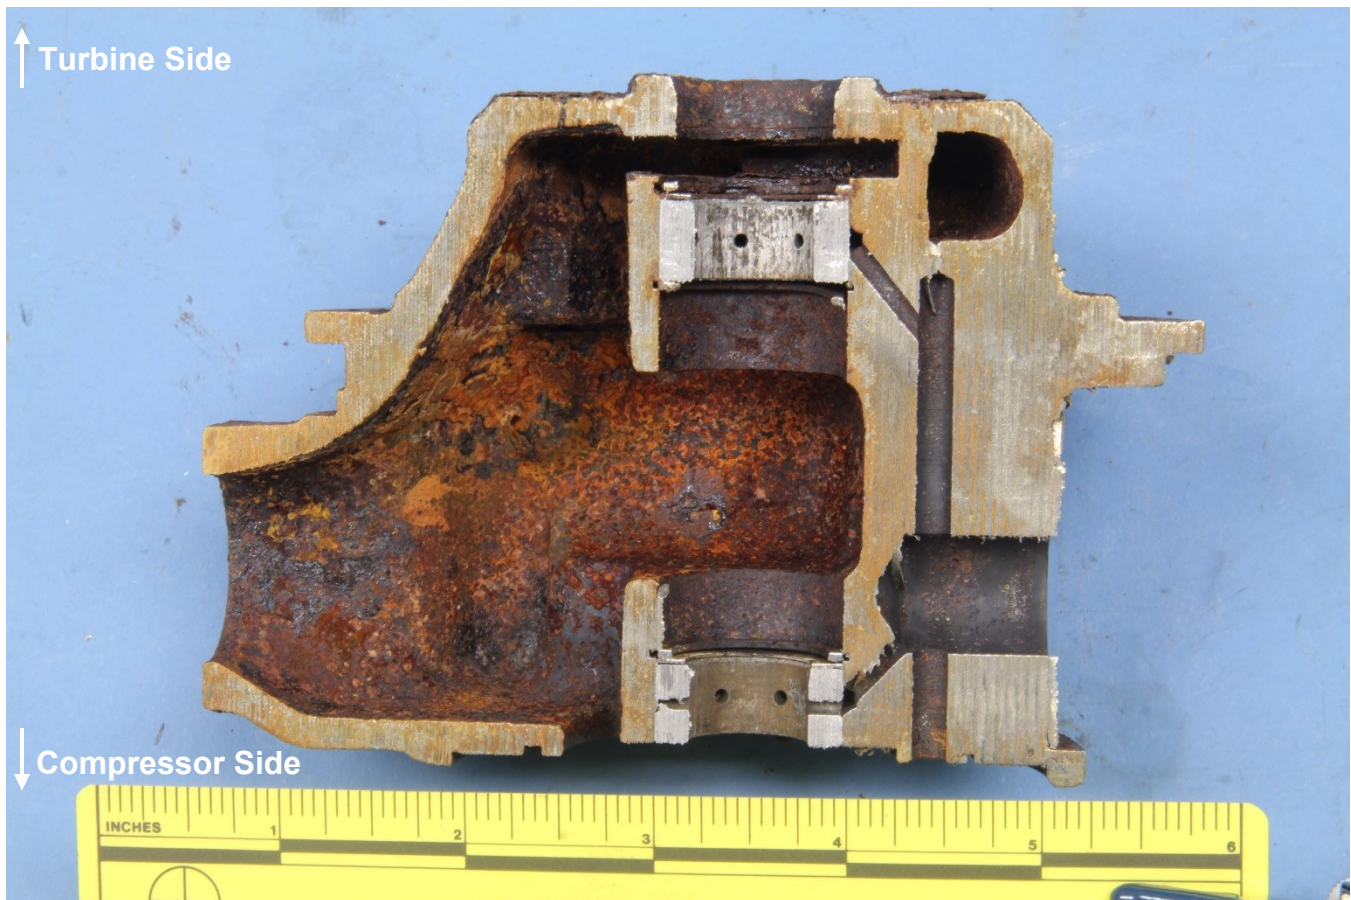
Figure 5 – The center housing, after sectioning along the center axis identified in Figure 4.

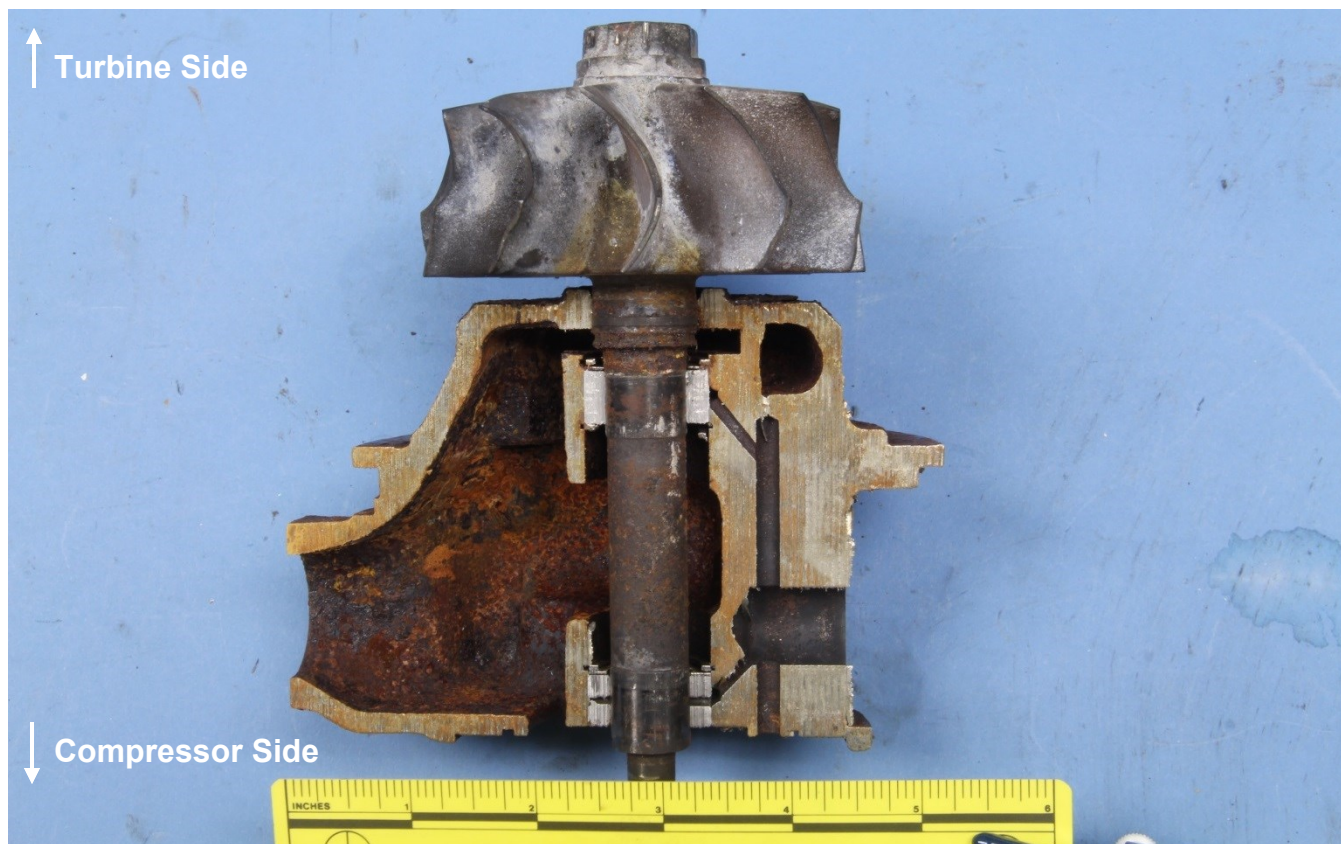
Figure 6 – The sectioned center housing of the turbocharger, showing the location of the turbine wheel along the internal bearings.

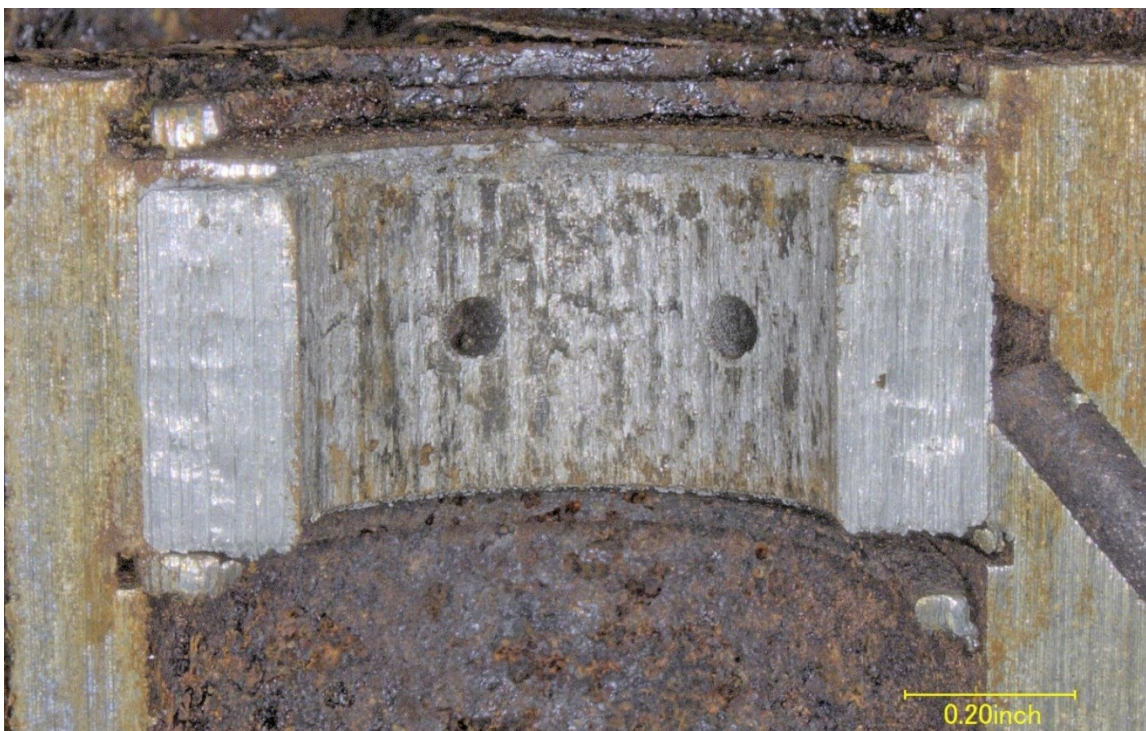
The housing bearing on the turbine side exhibited longitudinal and circumferential wear, with relatively less rust and other surface contamination compared to the bearing on the compressor side (see Figure 7). Some gouging was also present on the interior surface of the turbine side bearing (Figure 8). There was no evidence of damage to, or blockage of, the oil holes.

Figure 7 – A closer view of the sectioned turbine side bearing inside the center turbo housing.

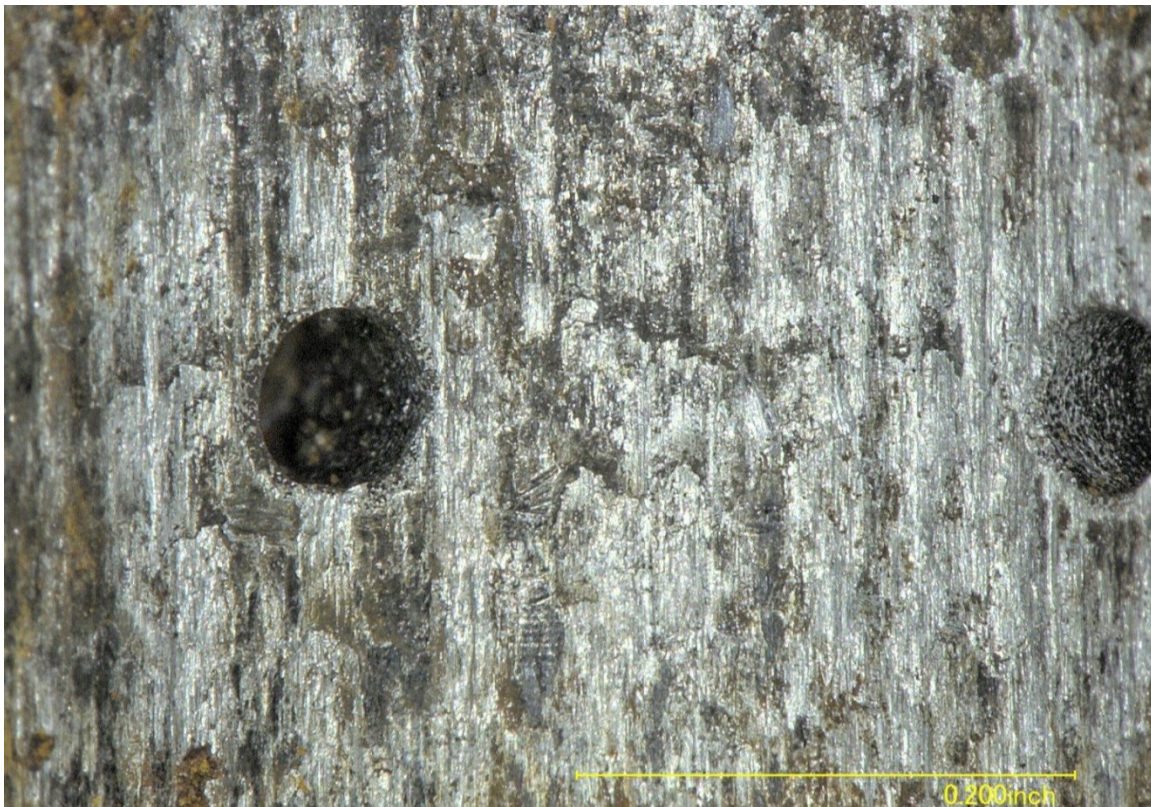
Figure 8 – A closer view of the sectioned turbine side bearing inside the center turbo housing.

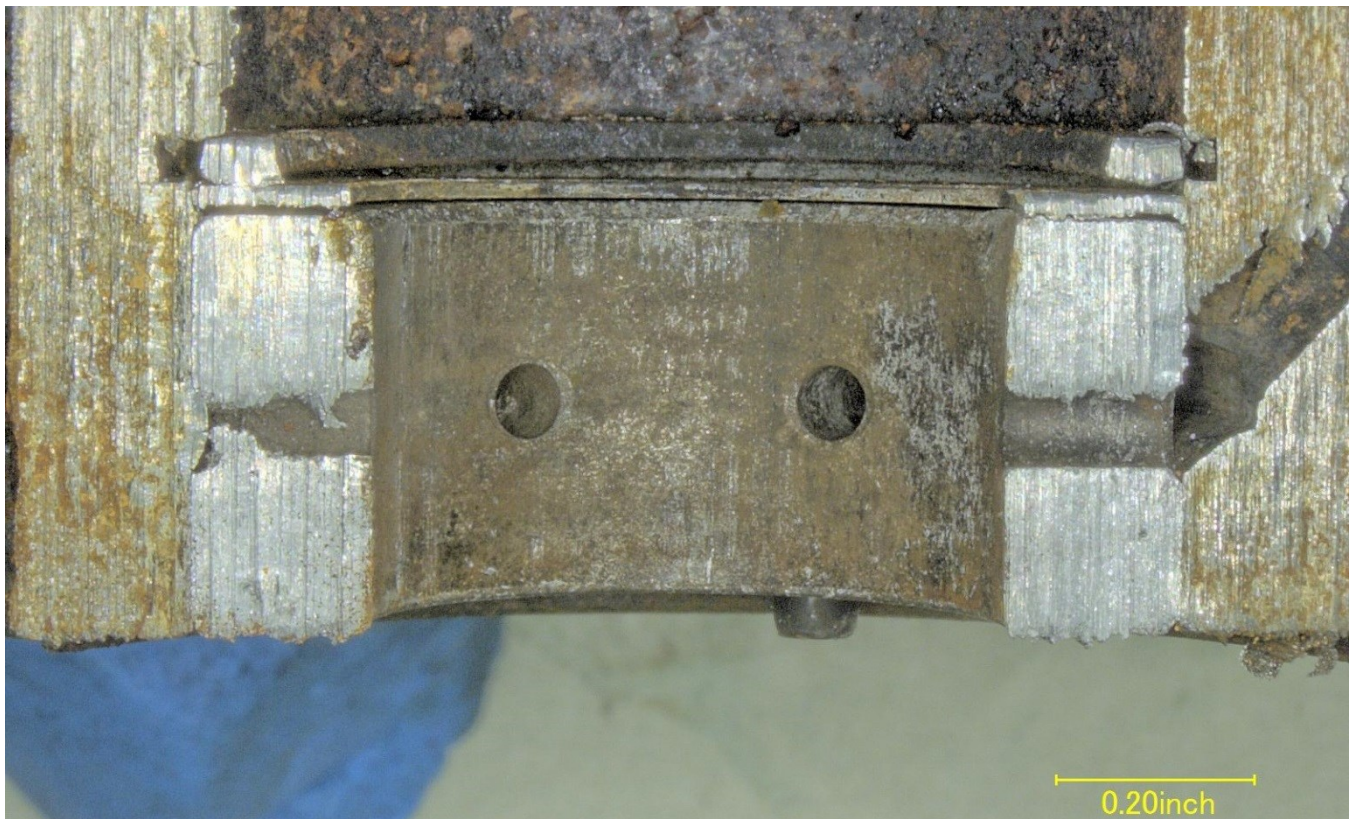
In contrast, the center housing bearing on the compressor side exhibited primarily circumferential wear (Figure 9). The longitudinal marks were consistent with machine marks or sliding wear. There was internal surface rusting on this bearing. There was no evidence of blockage or damage to the oil holes or channels in this section of the housing. No other indications of internal mechanical malfunctions were found inside the center housing.

Figure 9 – A closer view of the sectioned compressor side bearing inside the center turbo housing.

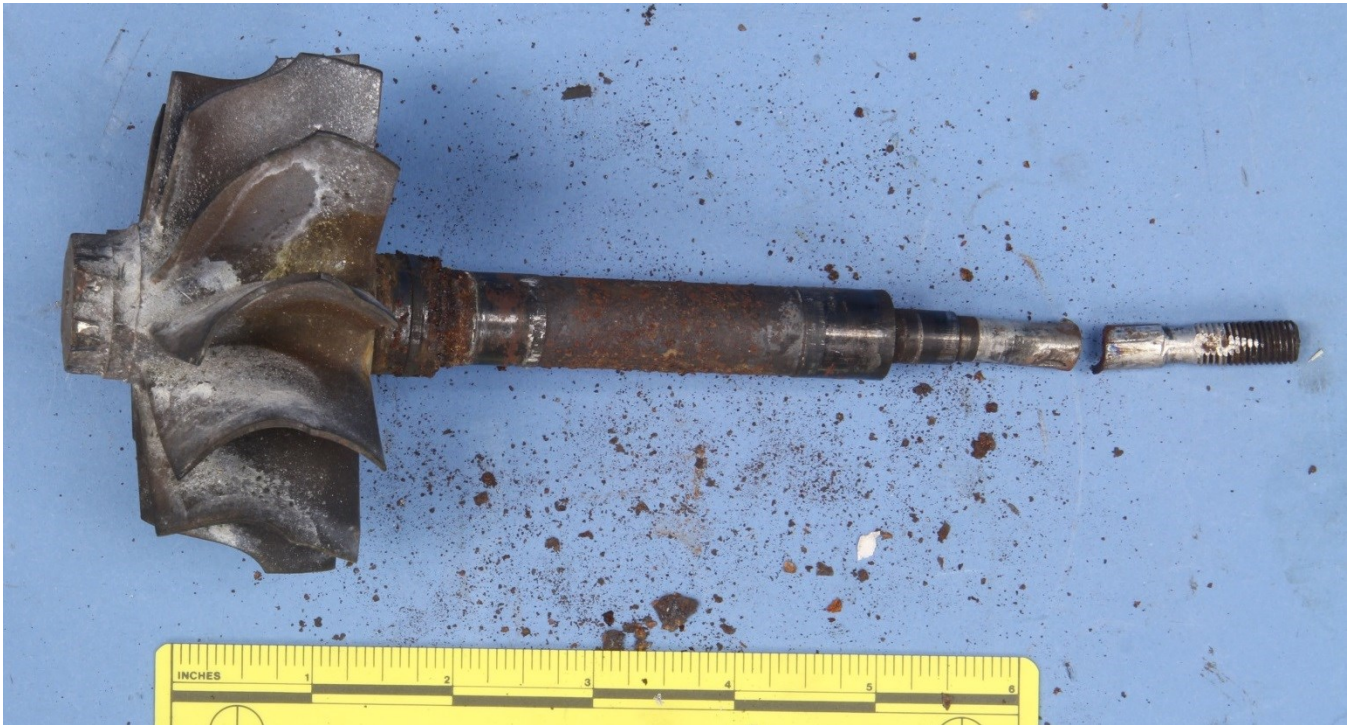
The turbine wheel assembly is illustrated in Figure 10, as received. The turbine wheel blade fins did not exhibit any mechanical damage consistent with foreign object impacts, overheating, or distortion. There was no chipping or cracking observed.

The tapered stub shaft of the compressor side had fractured away from the threaded portions of the shaft. The features on the fracture surface had been entirely obliterated by smearing, consistent with post-fracture damage. However, the area adjacent to fracture exhibited a jog on one side, with a general flat surface. This pattern was consistent with overstress failure in shear of a ductile material.

Figure 10 – The turbine wheel assembly, showing both fractured portions of the shaft segment from the compressor side.

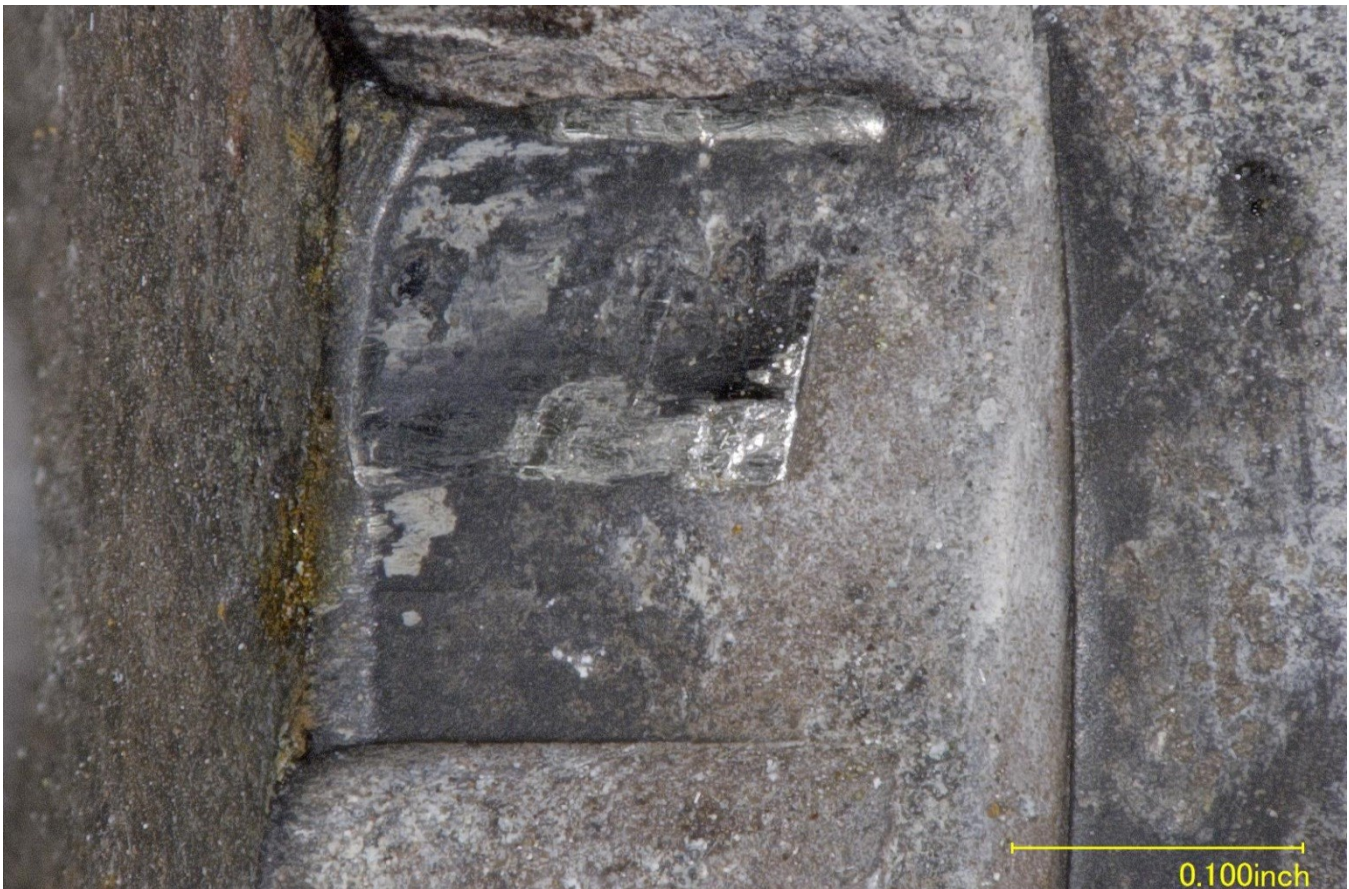
Gouge marks were present on the hexagonal cap on the turbine side of the wheel (Figure 11). These marks were consistent with a sudden impact with an adjacent component or tool, in a clockwise rotation. The turbine side bearing surface of the turbine wheel is illustrated in Figure 12. The surface exhibited longitudinal gouging marks, in addition to the circumferential wear marks. These gouge marks matched those of the

Figure 11 – Witness marks on the turbine side of the wheel.

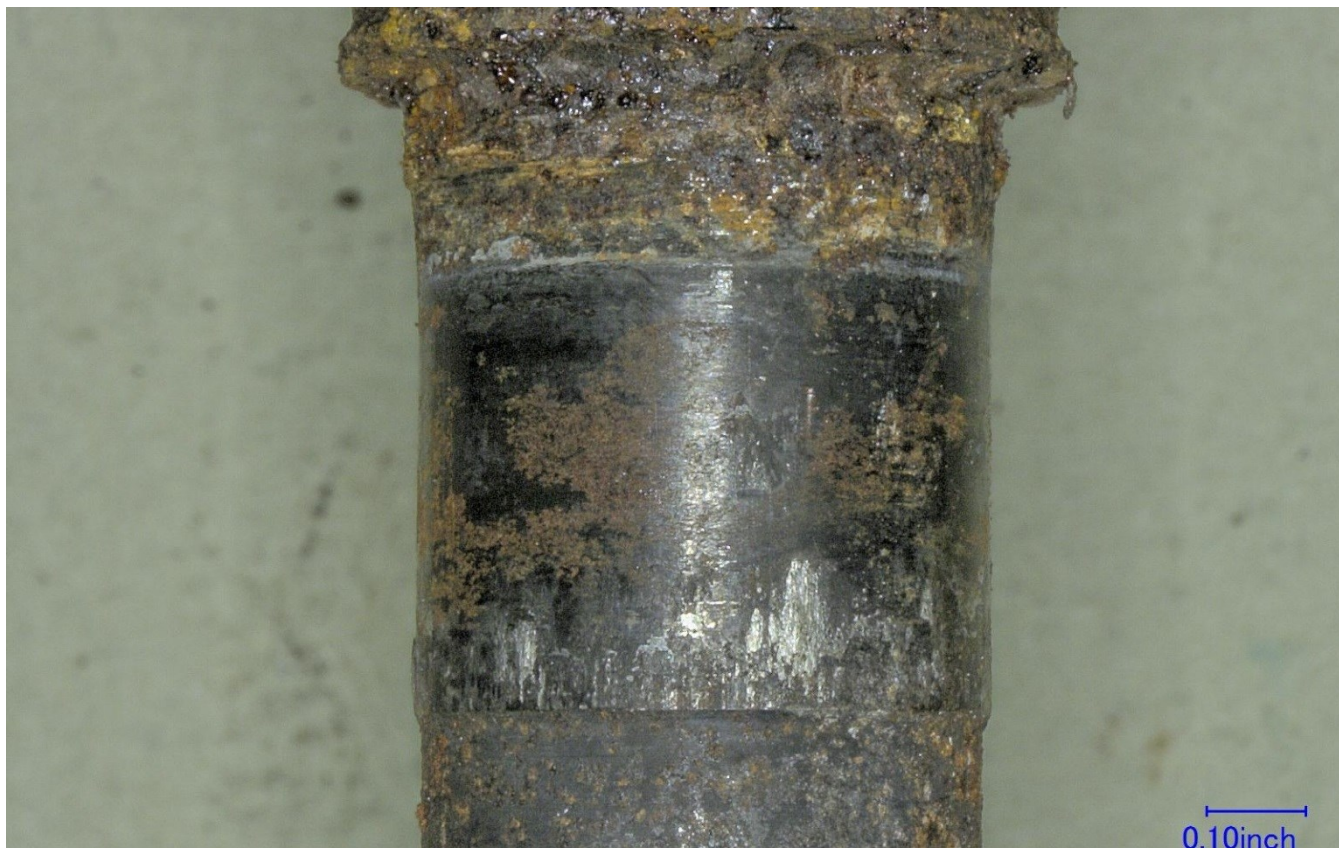
bearing surface of the sectioned center housing. These marks were consistent with the wheel assembly shifting forward while positioned in the housing.

Figure 12 – The turbine side of the turbine wheel shaft, which mated against the turbine side bearing in the center turbine housing. The shaft shows rotational and longitudinal wear marks.

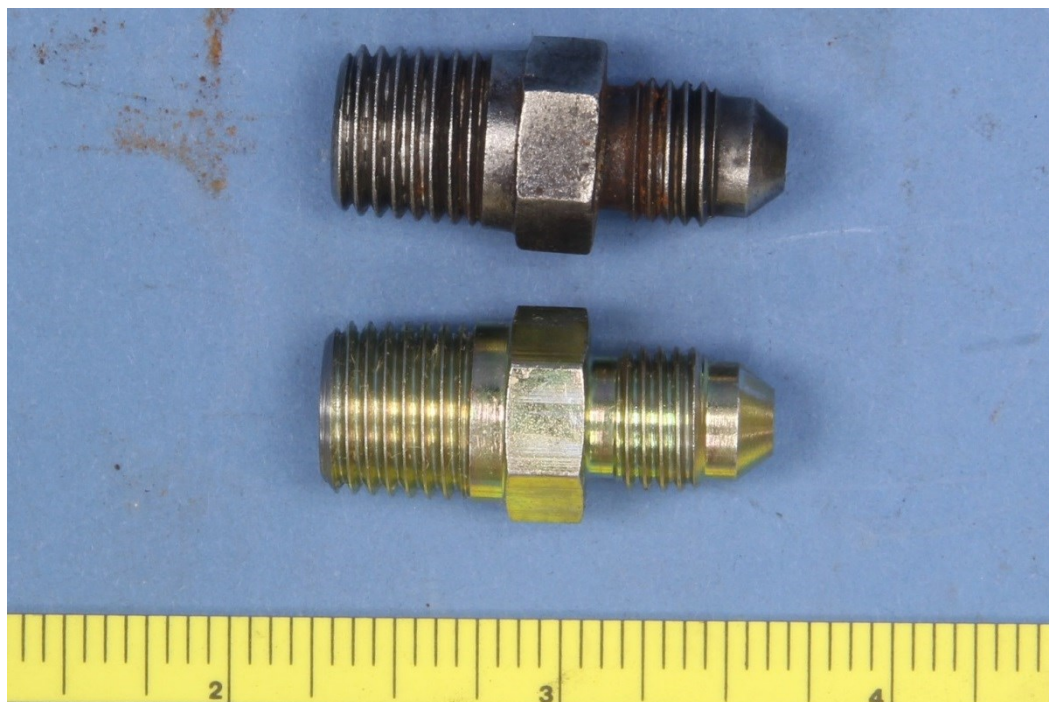
The check valve submitted is shown in Figure 13, along with an exemplar check valve. This check valve had been positioned in the oil pressure supply line. The accident check valve and an exemplar check valve were inspected by radiography and CT scanning. As shown in Figure 14, the accident check valve exhibited a small gap (yellow dashed circle in Figure 14) between the ball and the internal channel along the neck. The spring that held the ball was angled. In contrast, neither the ball nor the spring in the exemplar check valve exhibited these features noted in the accident valve.

Figure 13 – The accident oil check valve (above) and an exemplar (below).

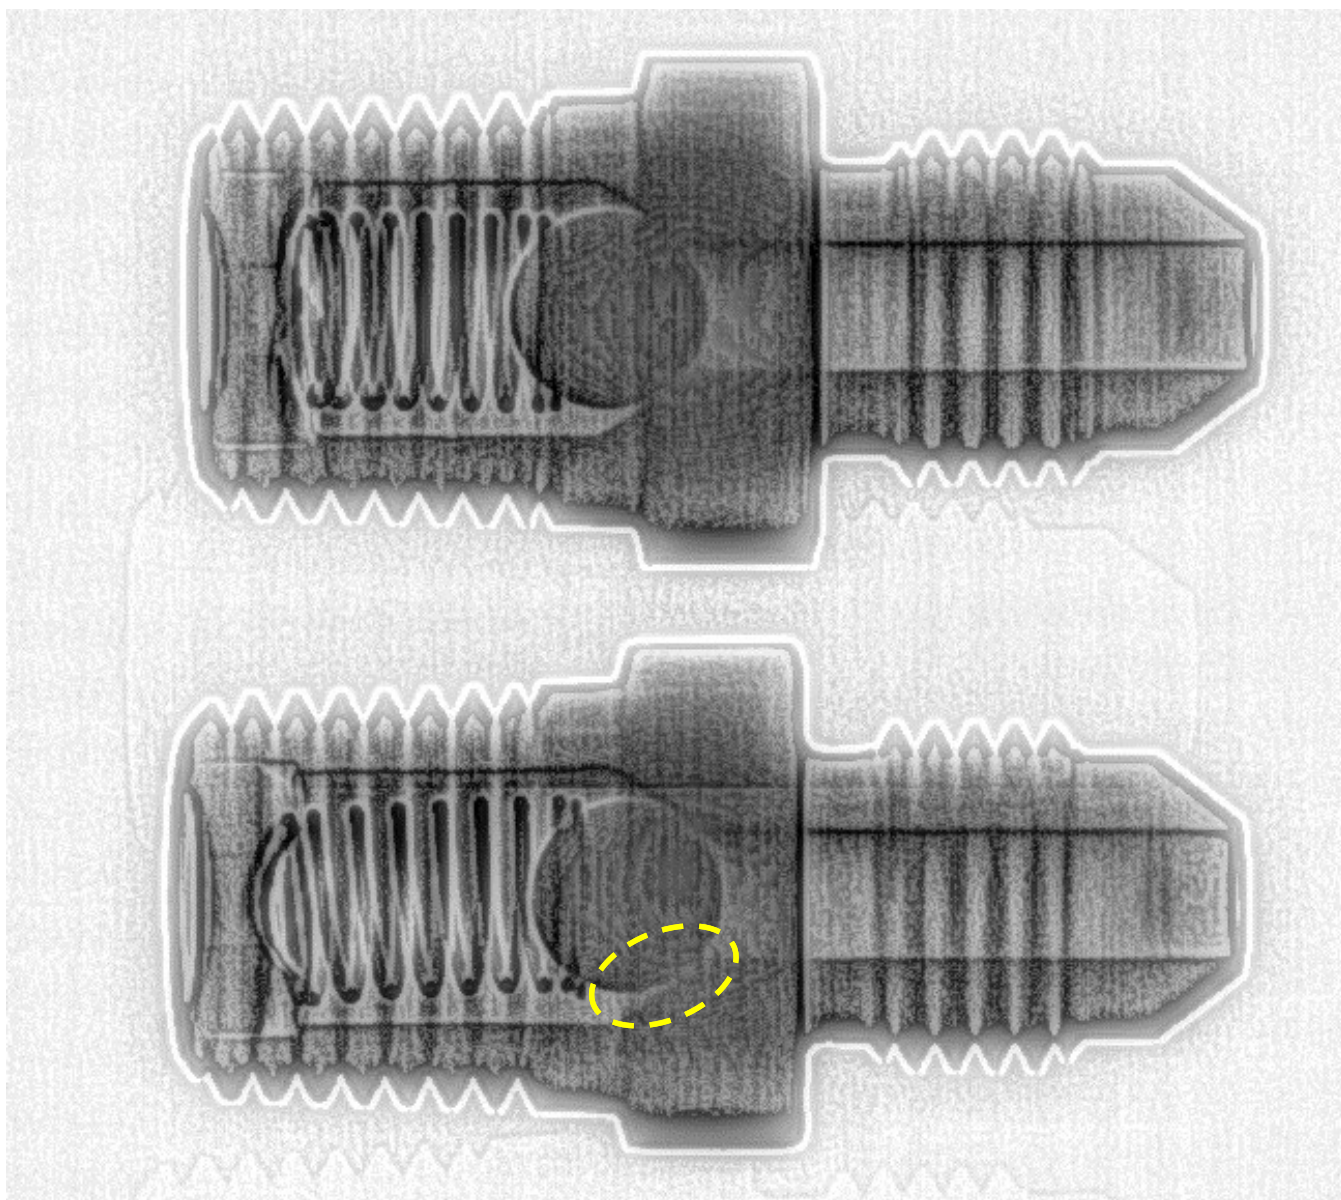
Figure 14 – Radiograph of the exemplar (top) and accident (bottom) check valves. The circled area shows a gap between the ball valve and the shoulder wall. Radiograph was taken at 140 kV and 210  $\mu$ A.

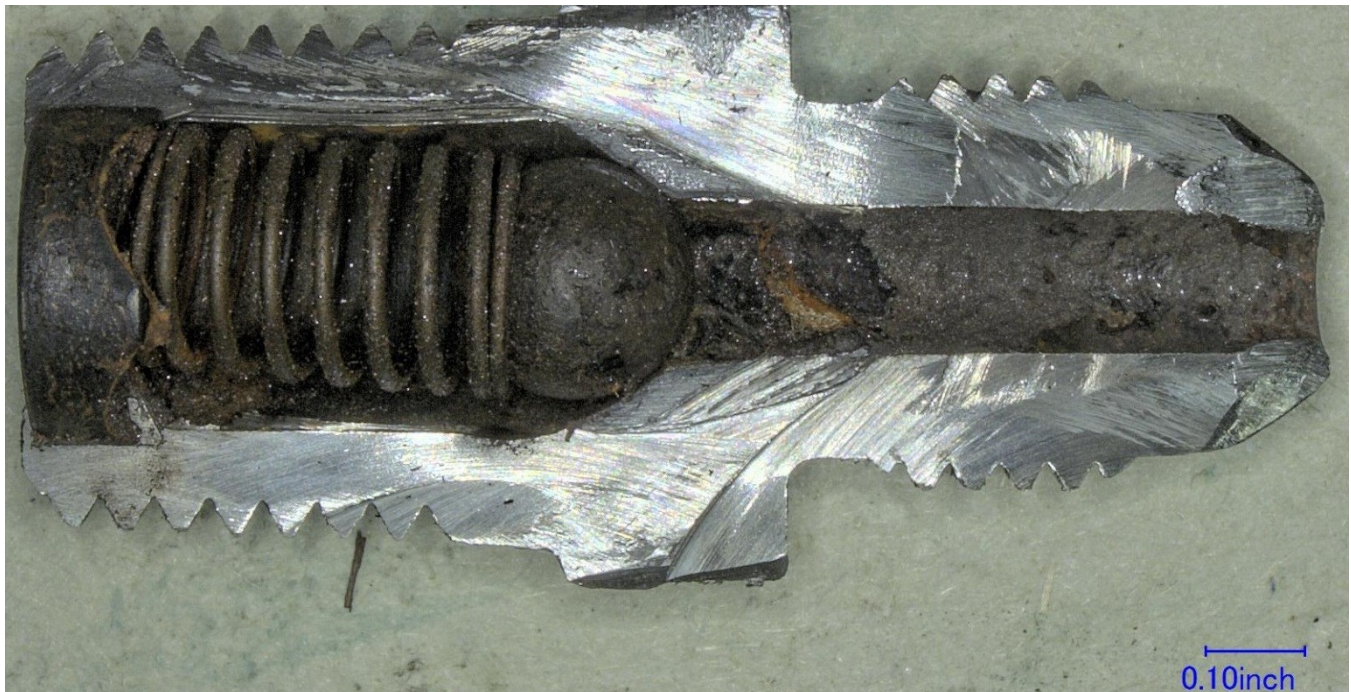
Both the accident and the exemplar check valves were sectioned along the channel direction. One of the sections of the accident check valve is shown in Figures 15 and 16. The internal components showed a darker color, consistent with long-term exposure to oil. However, the channel in front of the spring-loaded ball contained contamination and solid material. Inspection of this material with Fourier transform infrared spectroscopy (FTIR) found some of the constituents to be consistent with lubricating oil (Figure 17). This oil and debris residue was positioned between the ball and the channel wall. The mating side of the sectioned check valve (absent the ball and spring) is shown in Figure 18.

Figure 15 – The accident check valve, after sectioning the inner channel, with the spring and ball still present.

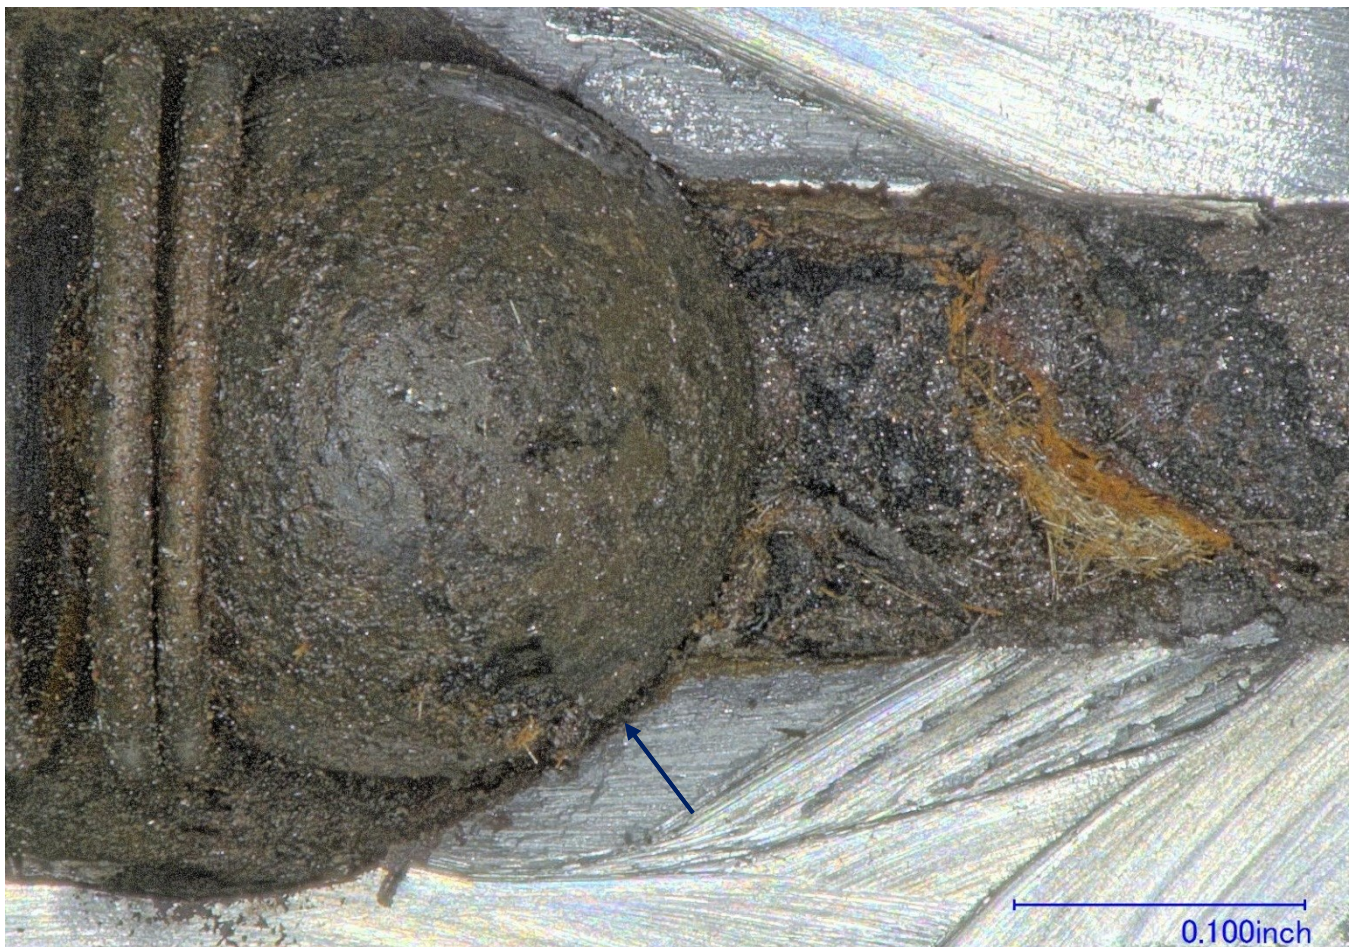
Figure 16 – Closer view of the ball valve of the accident check valve, showing a gap (arrow) with foreign material.

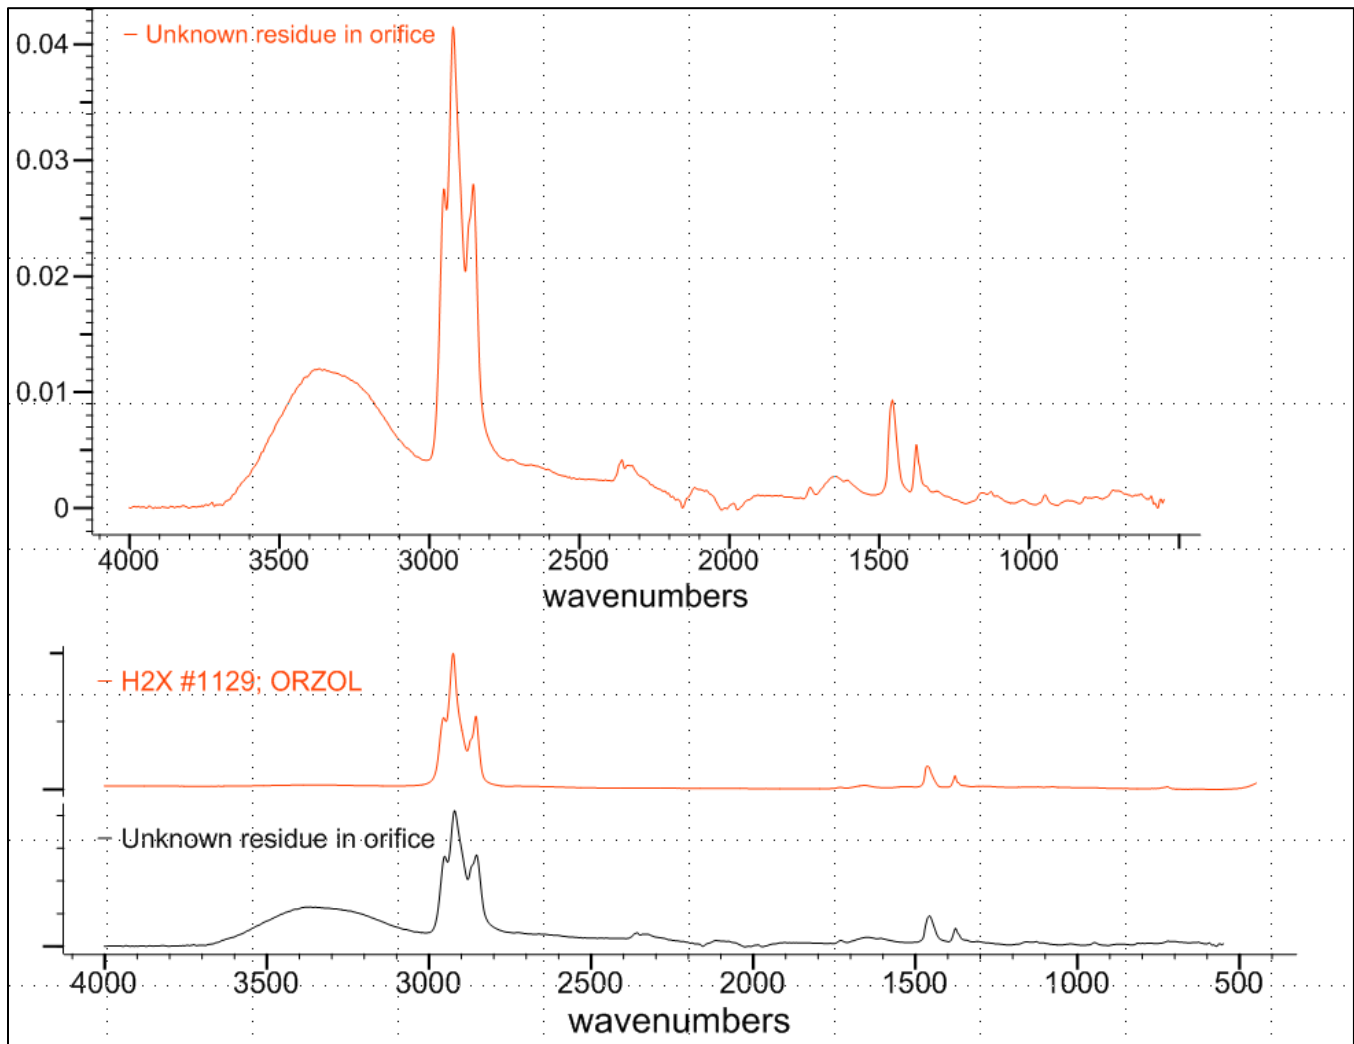
Figure 17 – FTIR spectra of the debris found in the accident oil pressure supply line check valve, compared to lubricating oil.

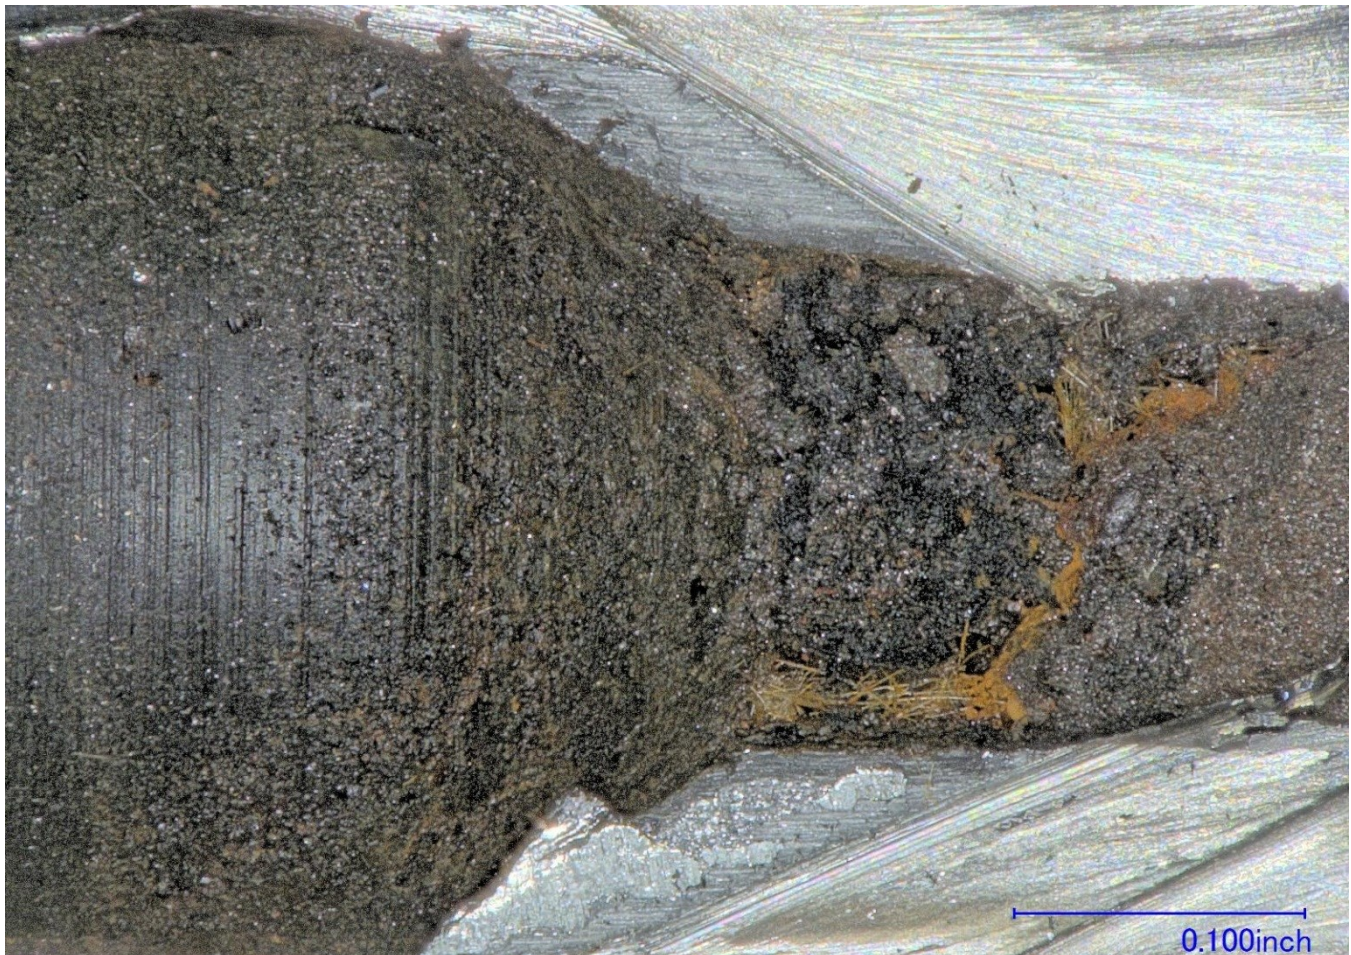
Figure 18 – The mating side of the sectioned accident check valve, showing contamination in the channel.

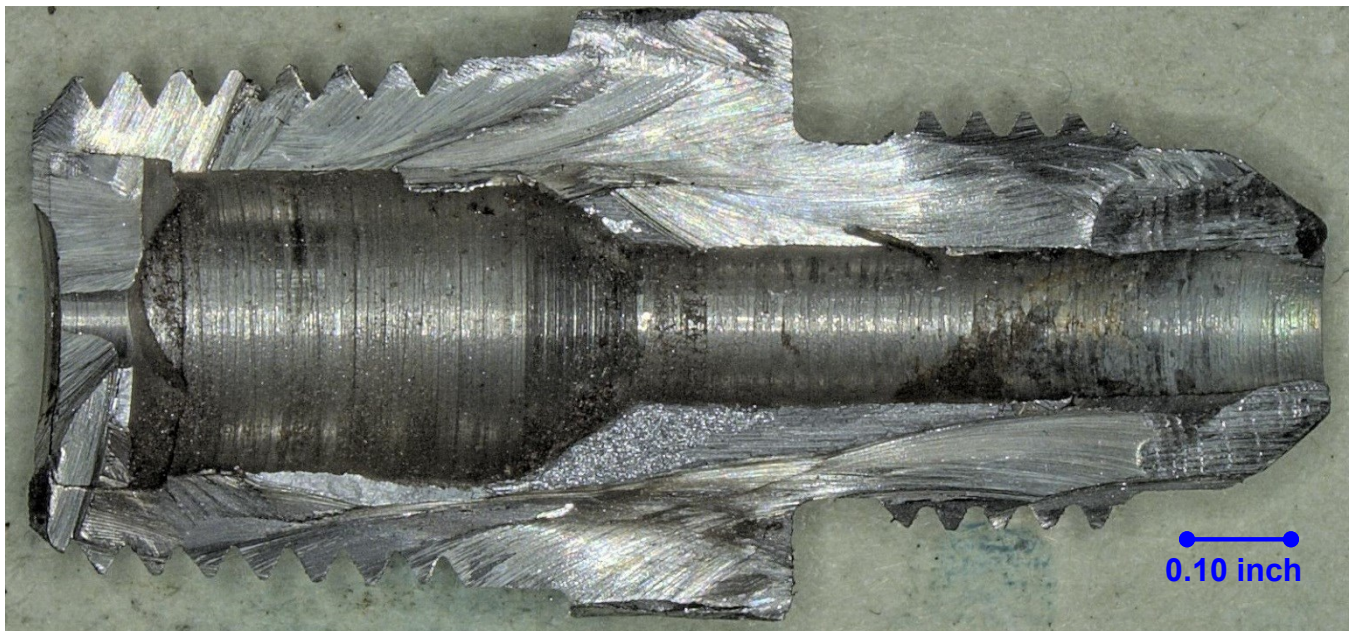
The sectioned exemplar check valve is shown in Figures 19 through 21. The exemplar did not contain any loose or foreign material in the channel. The channel exhibited circumferential marks, which were consistent with machine marks from manufacture. These marks were also visible in the sectioned accident valve (compare with Figure 18). The ball and spring in the exemplar valve were damaged during sectioning. However, the ball was still in contact with the channel walls after sectioning.

Figure 19 – One of the exemplar check valves, after sectioning.
