# NATIONAL TRANSPORTATION SAFETY BOARD

## MATERIALS LABORATORY FACTUAL REPORT

Report No. 16-091

Place : West Caldwell, New Jersey  
Date : August 15, 2015  
Vehicle : Cessna T206H; N63TV  
NTSB No. : ERA15FA312  
Investigator : Todd Gunther, AS-ERA

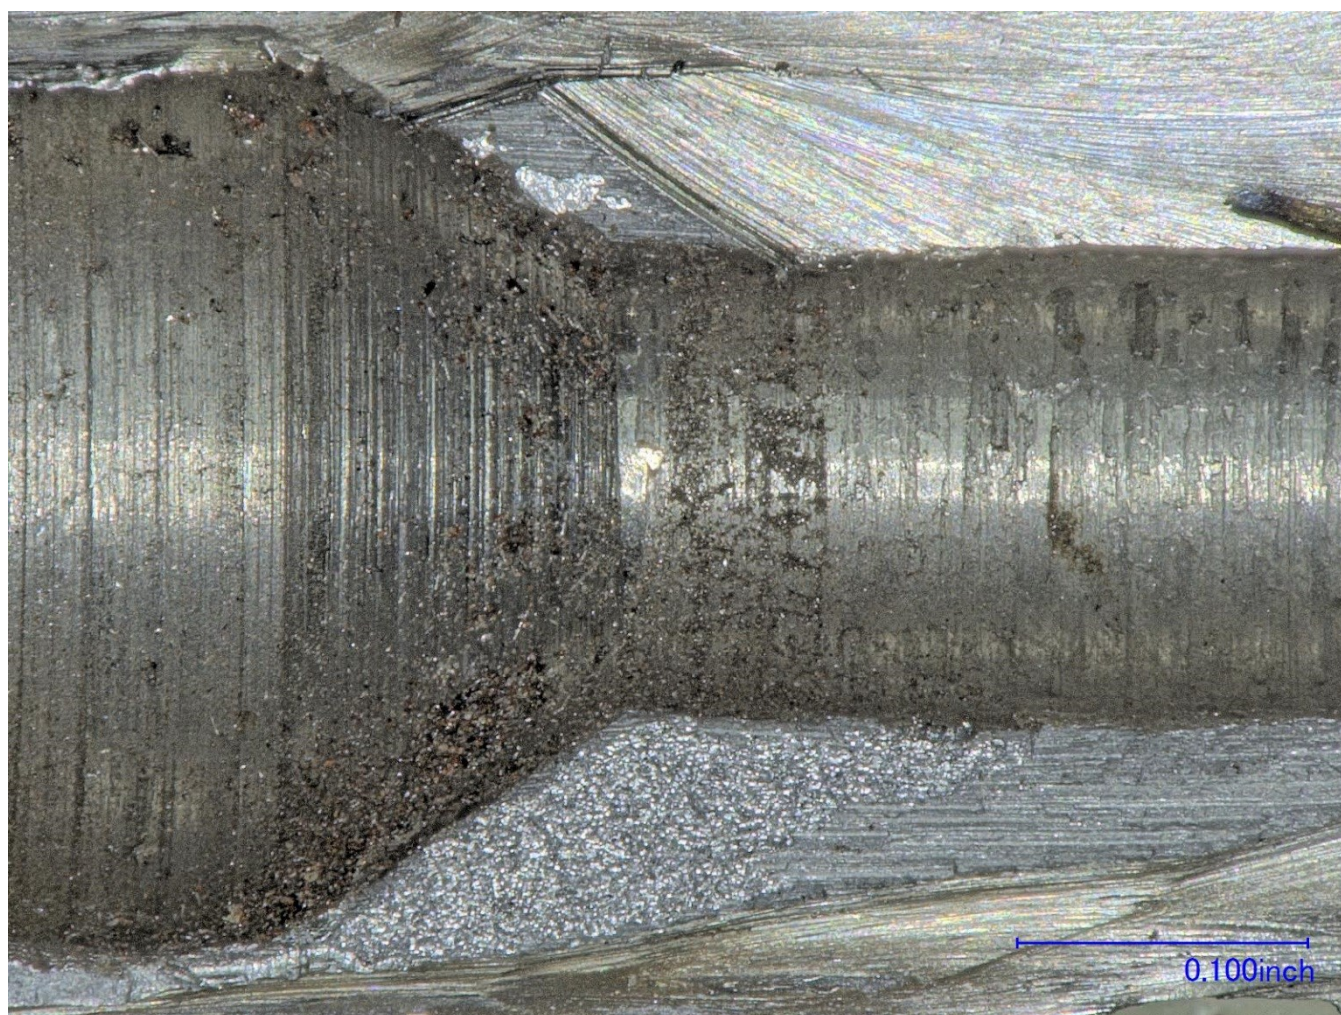
The sectioned exemplar check valve is shown in Figures 19 through 21. The exemplar did not contain any loose or foreign material in the channel. The channel exhibited circumferential marks, which were consistent with machine marks from manufacture. These marks were also visible in the sectioned accident valve (compare with Figure 18). The ball and spring in the exemplar valve were damaged during sectioning. However, the ball was still in contact with the channel walls after sectioning.

Figure 20 – Closer view of the channel in the exemplar check valve, after sectioning.

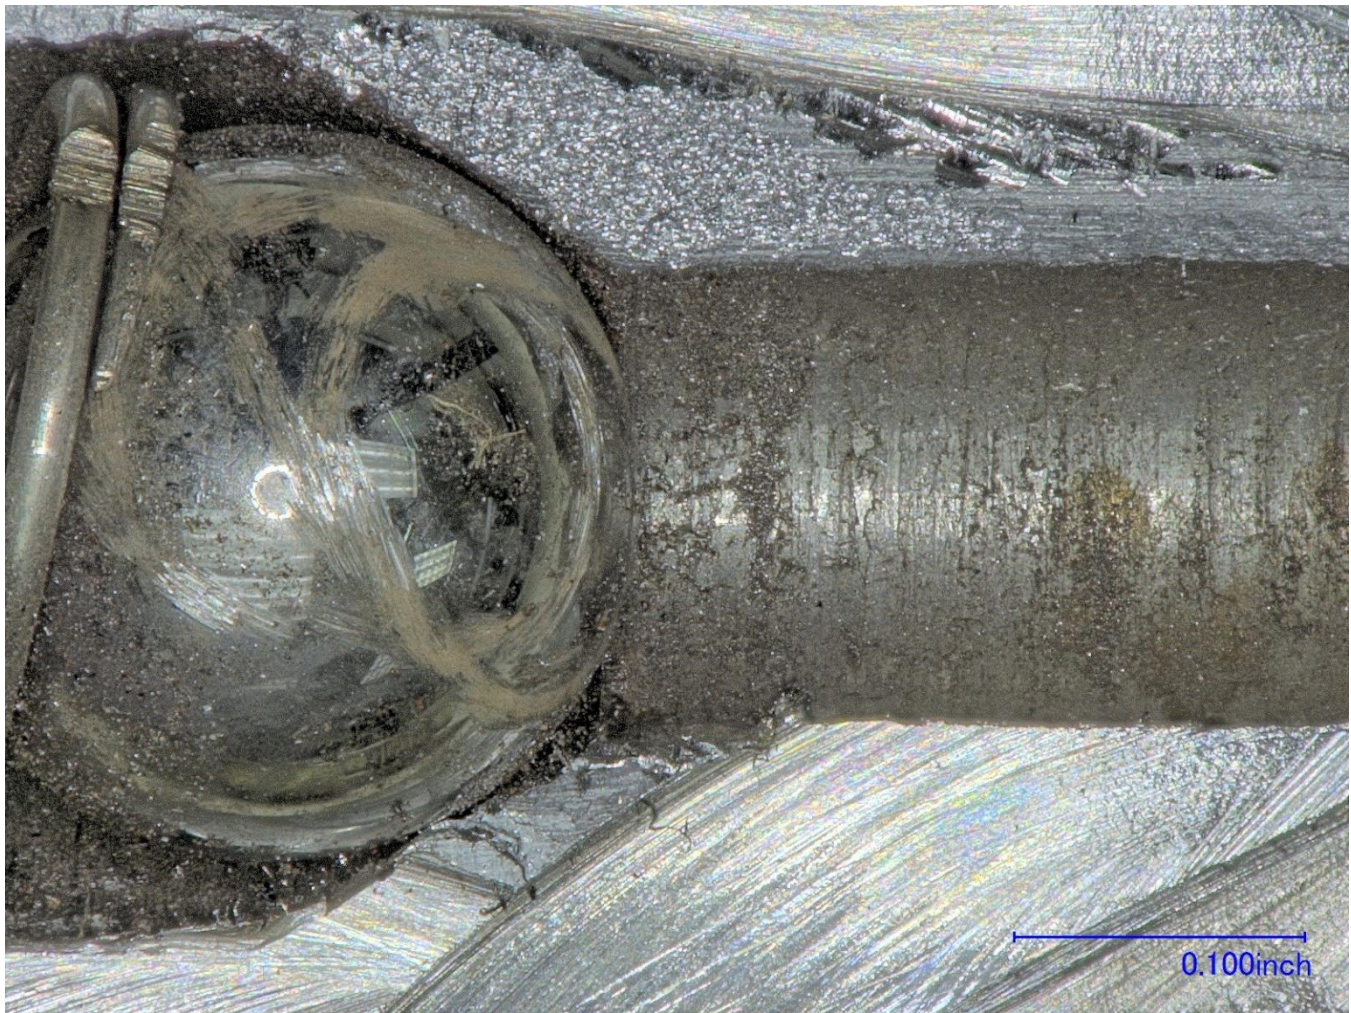
Figure 21 – The mating side of the sectioned check valve from Figure 19, showing the position of the ball and spring.
