## NATIONAL TRANSPORTATION SAFETY BOARD

### Group Chairman's Factual Report

## AIR TRAFFIC CONTROL

ERA15FA313

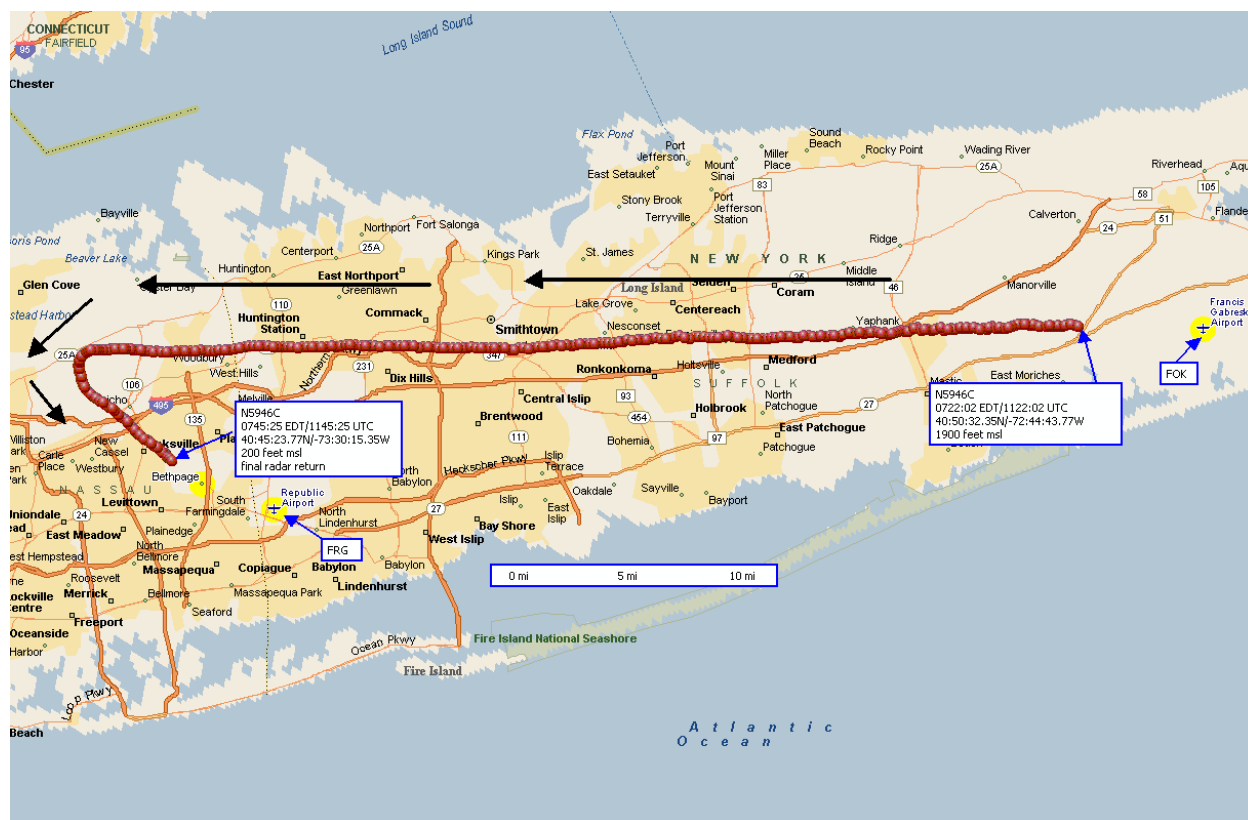
Figure 1 – The radar flight track of N5946C is indicated by red dots. Aircraft direction of travel is indicated by the black arrows. FOK, FRG, and Bethpage are highlighted in bright yellow.

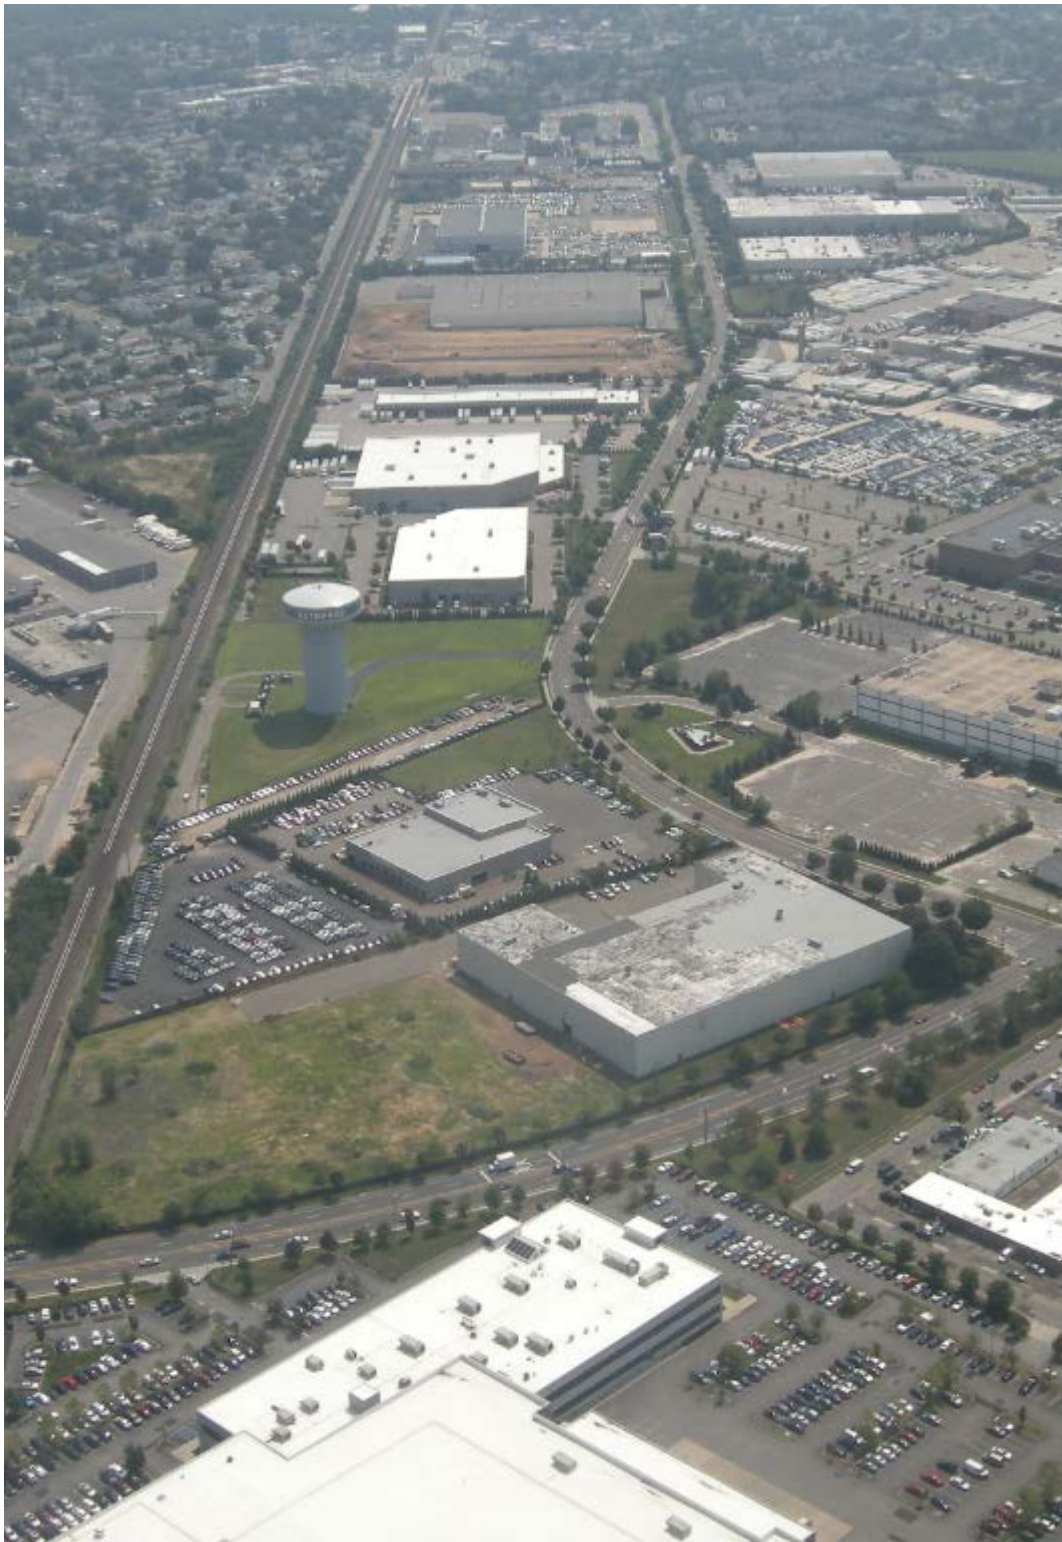
An examination of the former Bethpage Airport facility revealed that industrial buildings occupied the former runway surface area and the physical runway was no longer in existence. The accident site was about 0.25 nm northwest of the where the runway approach end used to exist.

Figure 4 – A present day southeast view of where the runway used to exist. This photograph was taken in August 2015. The accident site of N5946C was near the lower left corner of this photograph.

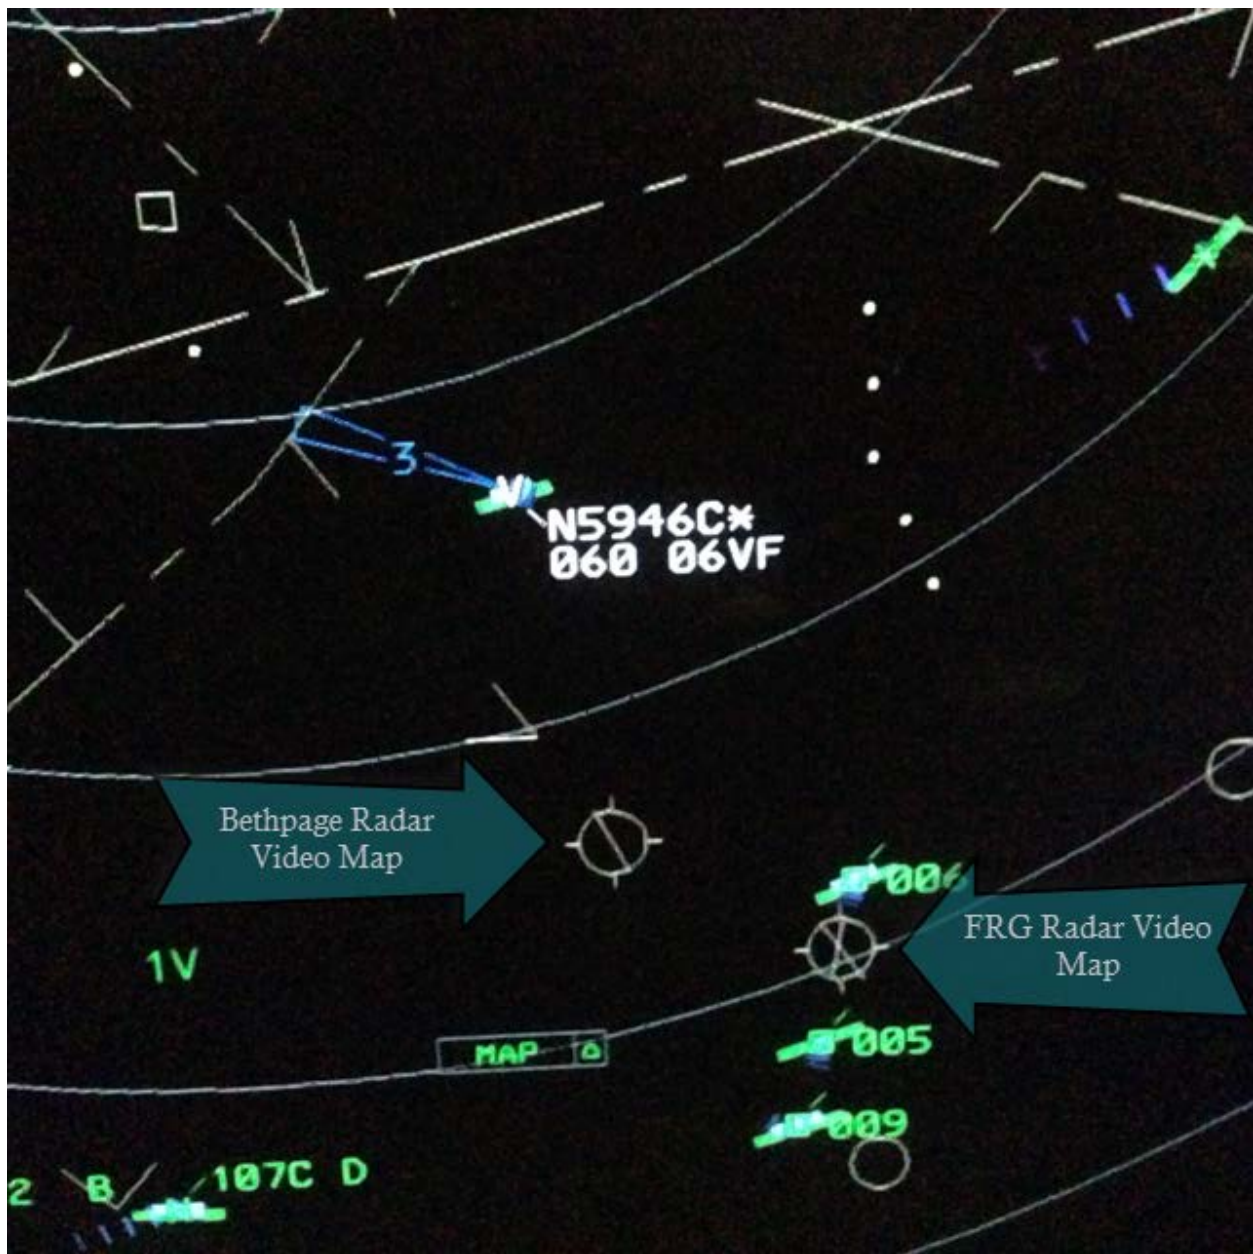
Figure 5 – Radar presentation of N5946C as seen by the N90 LGA area controller. The RVM for Bethpage and FRG are indicated by green arrows.

Although there was geographic overlap between the radar maps used by the LGA, Kennedy, and Islip areas, the information on each area's maps was inconsistent. Bethpage was depicted on the LGA RVM, but not on the Islip RVM. FRG was depicted on the Islip, Kennedy, and LaGuardia RVMs, but the symbology used was different. The N90 ATC standard operating procedure (SOP) manual depicted the RVMs for the Islip, Kennedy and LaGuardia areas individually. The LGA section of the SOP showed Bethpage as an airport, but the Islip and Kennedy sections did

not. The data provided in the SOP did not correlate with the actual radar presentation the controllers were using. At the time of the accident, the LGA controller was using radar map number N90-3100C, which was included in N90 system adaptation on December 20, 2013.

Immediate steps were taken locally and nationally to address the RVM periodic review issue. Locally, N90 management issued a memorandum informing the air traffic controller workforce that there was no airport associated with Bethpage. Corrected RVMs, removing the Bethpage airport symbol, were installed at N90 on the evening of September 3, 2015.

Nationally, the FAA Vice President of Air Traffic Services issued a memorandum dated September 1, 2015, requiring all terminal air traffic facilities to immediately review all RVMs and EOVMs to ensure only operational airports were depicted, and to check all RVM files for airport information accuracy and existence. This review was to be completed by October 15, 2015. The memorandum did not indicate a pending amendment to FAAO 7210.3 regarding RVM review periodicity.

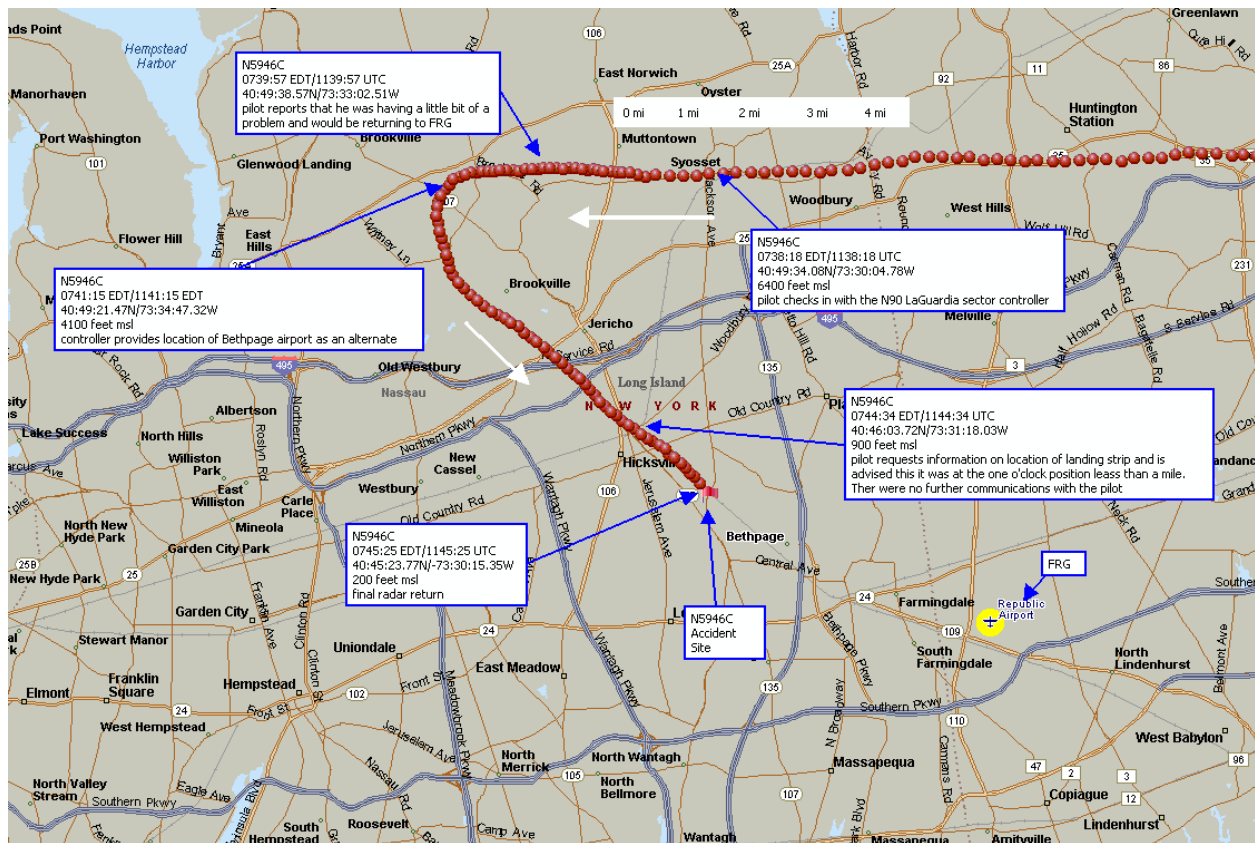
Figure 6 – The radar flight track of N5946C is indicated by red dots. The direction of flight is indicated by white arrows. The accident site is indicated by a red flag. The Republic airport (FRG) is highlighted with a bright yellow circle.
