## **NATIONAL TRANSPORTATION SAFETY BOARD**

### **ATC Factual Report**

**ERA15FA326**

Location: Houlton International Airport (KHUL), Houlton, Maine  
Date: August 27, 2015  
Time: 0155 eastern standard time (EST)<sup>1</sup> / 0555 universal coordinated time (UTC)<sup>2</sup>  
Airplane: N553MD, PA-44-180

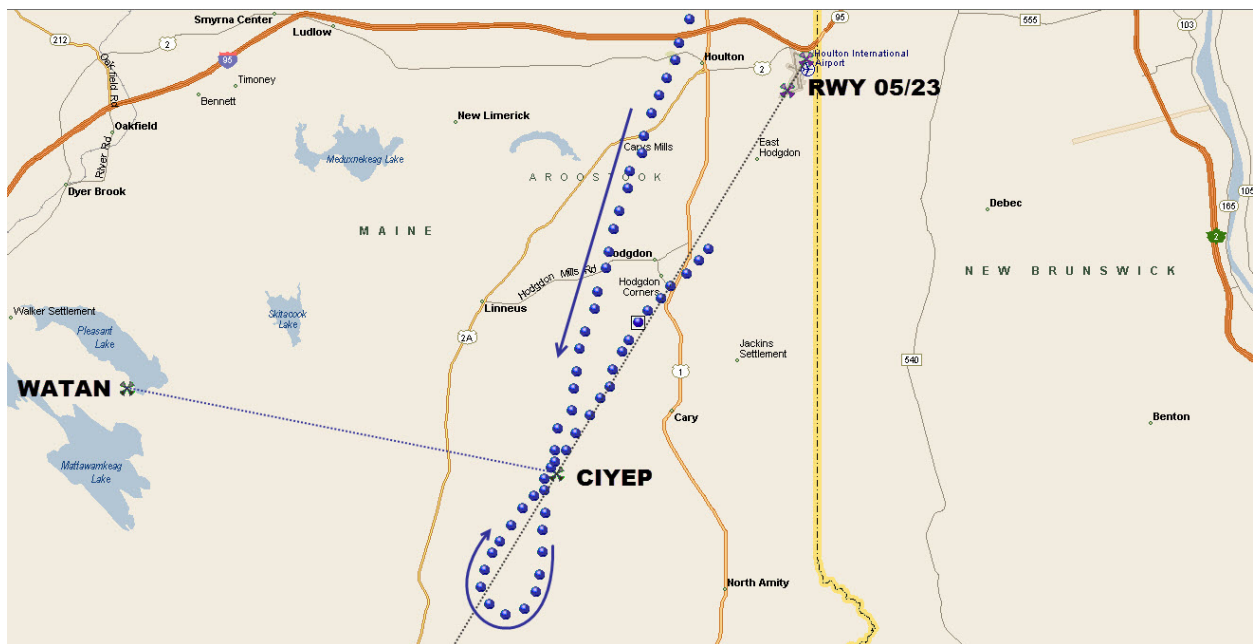
Radar and communications data for this report were obtained from ZBW and were of good quality. Radar mode C altitude data indicated the pilot flew over the initial approach fix (IAF) CIYEP outbound at 3,100', 400' lower than cleared. Radar data indicated the pilot flew a right turn back towards CIYEP. On the inbound leg to the airport, the pilot crossed CIYEP at 2,300', 700' lower than the instrument approach procedure authorized. The last radar target was near the final approach fix (FAF) AHOLA at an altitude of 1,500', 300' lower than the instrument approach procedure authorized.

Figure 1 – Radar plot of the aircraft as it maneuvered for landing at KHUL. The “x’s” depict the latitude and longitude of the fixes for the instrument procedure, and of the runway ends.

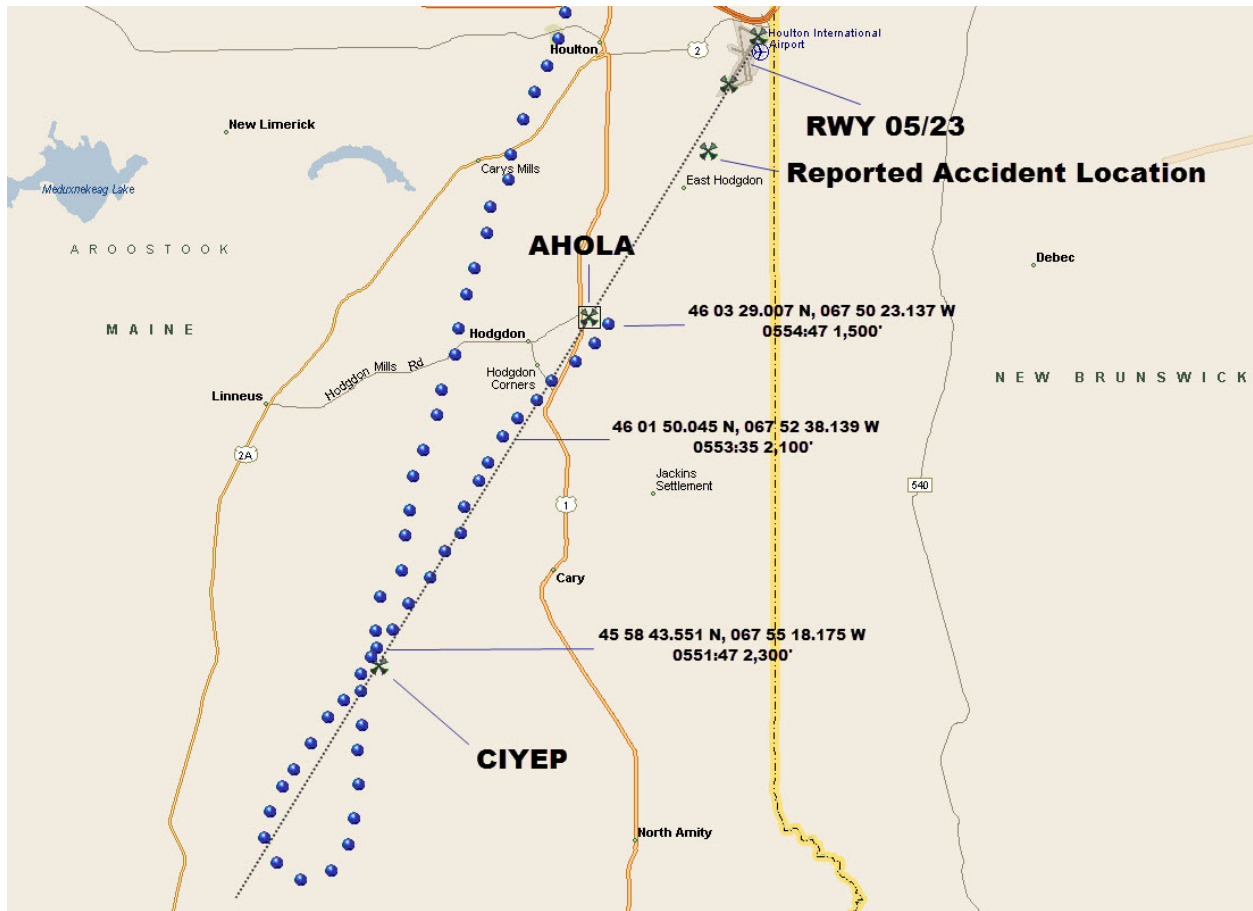
The last radar target was at 0154:47 at latitude and longitude 46 03 29.007° N, 067 50 23.137° W. The reported accident location was 46.10083° N 67.80444° W; about 2.11 nautical miles from the last radar target.

Figure 2 - The final radar plots of N553MD.
