# AIR SAFETY INVESTIGATION RECIPROCATING MULTI-ENGINE ACCIDENT REPORT

| 15082701 | C-MIKE |
| ERA15FA326 | |

| 1980 PA-44-180 | 44-8095021 | N553MD | | Destroyed | No |

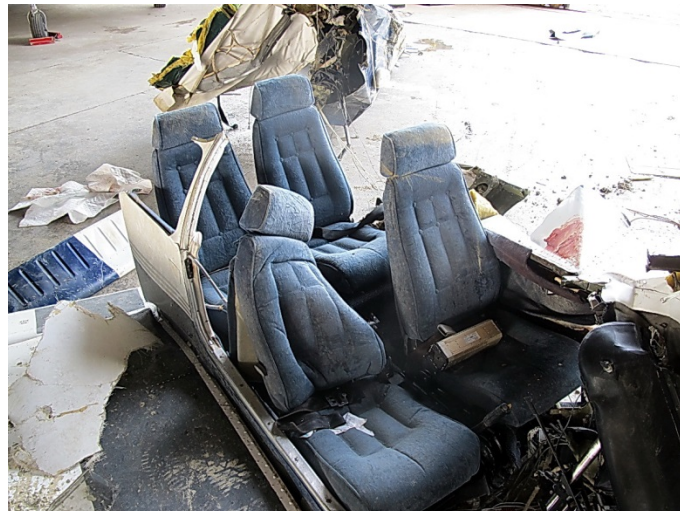
Seats

| | Seat Occupied | Lap Belt Used | Shoulder Belt Used | Seats and Restraints, Condition / Description | Code(s) |
|---|---|---|---|---|---|
| 2. | No | N/A | N/A | Secure on tracks, left top corner of seat back bent aft, head rest in place, good condition | I, W |

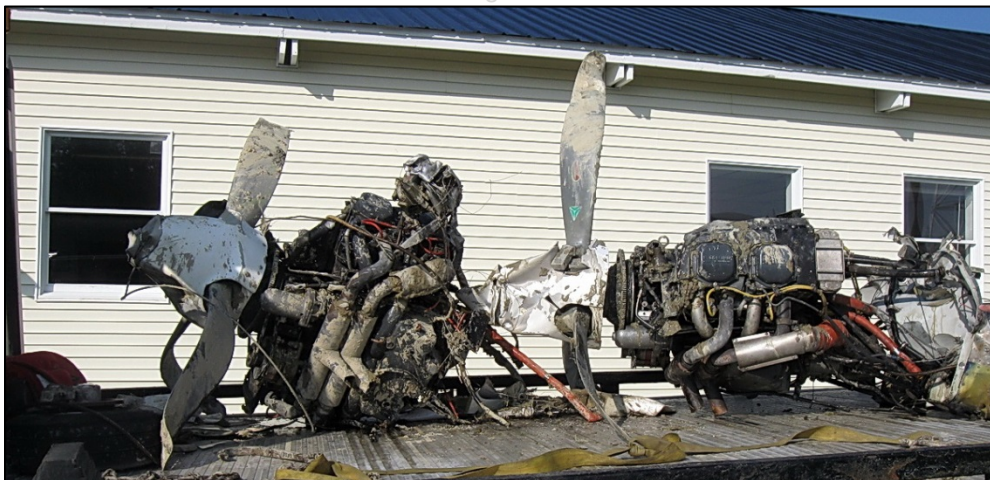
### Engines

Left engine on right, right engine on left

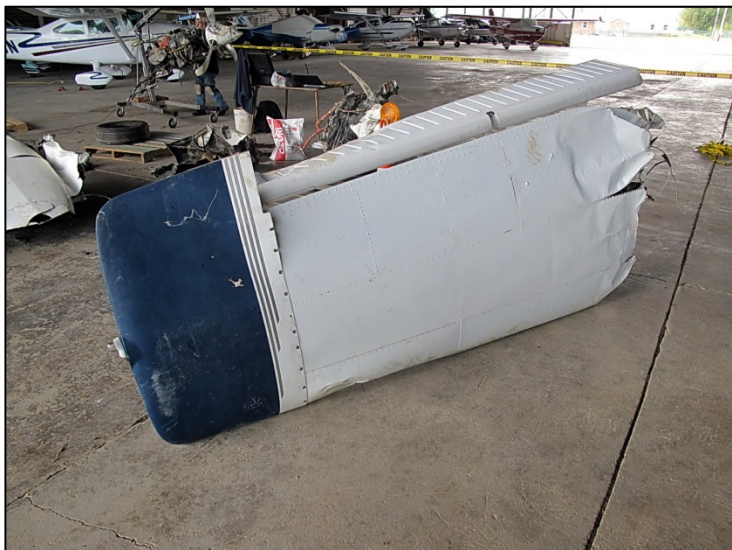
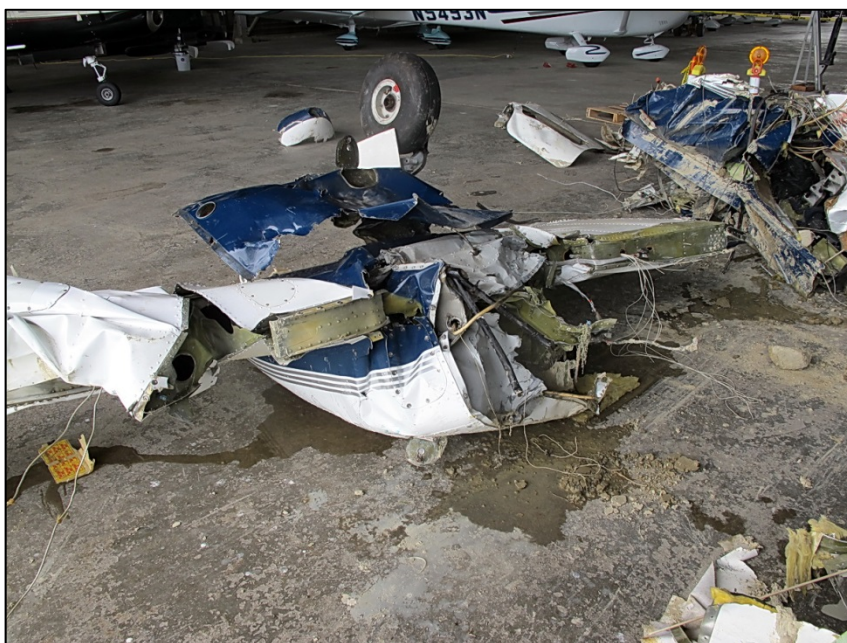
### **Left Wing**

The left wing was separated from the fuselage at the wing root and was broken about 7 feet outboard of the root. The outboard section was fragmented and displayed compression impact damage. The engine and propeller were separated. There was a circular depression starting from the leading edge which penetrated aft which was near vertical and had fibrous material imbedded in the cracked areas of the skin consistent with tree impact. The impact damage penetrated through the wing also separating the flap and fragmenting the aileron. The flap was not recovered but the attach points remained secure to the wing and displayed separations consistent with overload.

The landing gear actuator and gear was extended but not locked. The pitot tube was in place and showed no blockage.

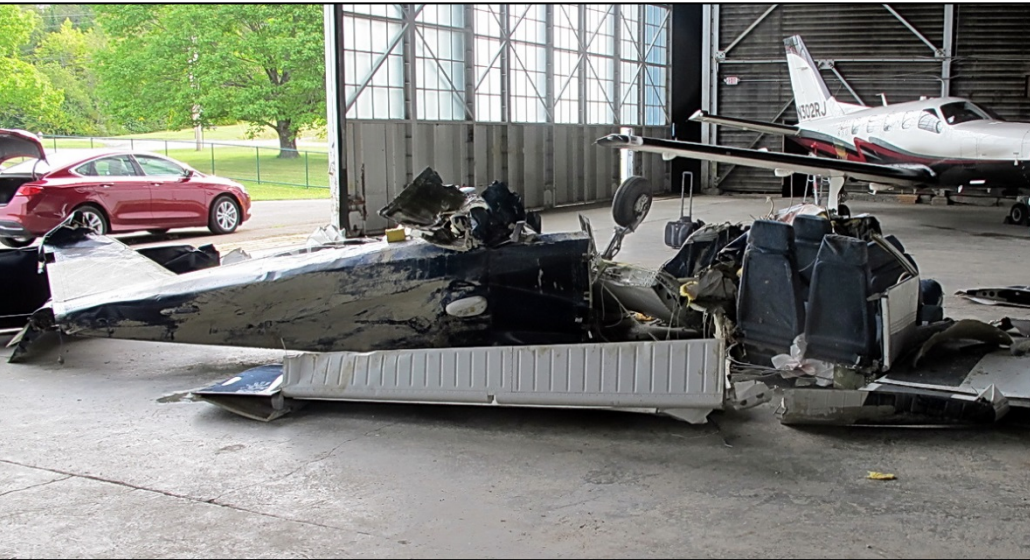
## **Fuselage**

The fuselage displayed substantial impact damage to the front, right rear and was fragmented. The top had been pulled back exposing the entire cabin area. The fuselage had been cut aft of the rear seats to facilitate transport. All four seats were in place and secure to the seat tracks. All seats had available seat lap and shoulder belts. The left front seat belt displayed stretching and puckering of the lap belt web. The shoulder belt was not fastened to the lap belt. The right front seat back was twisted left side toward the rear of the aircraft.
