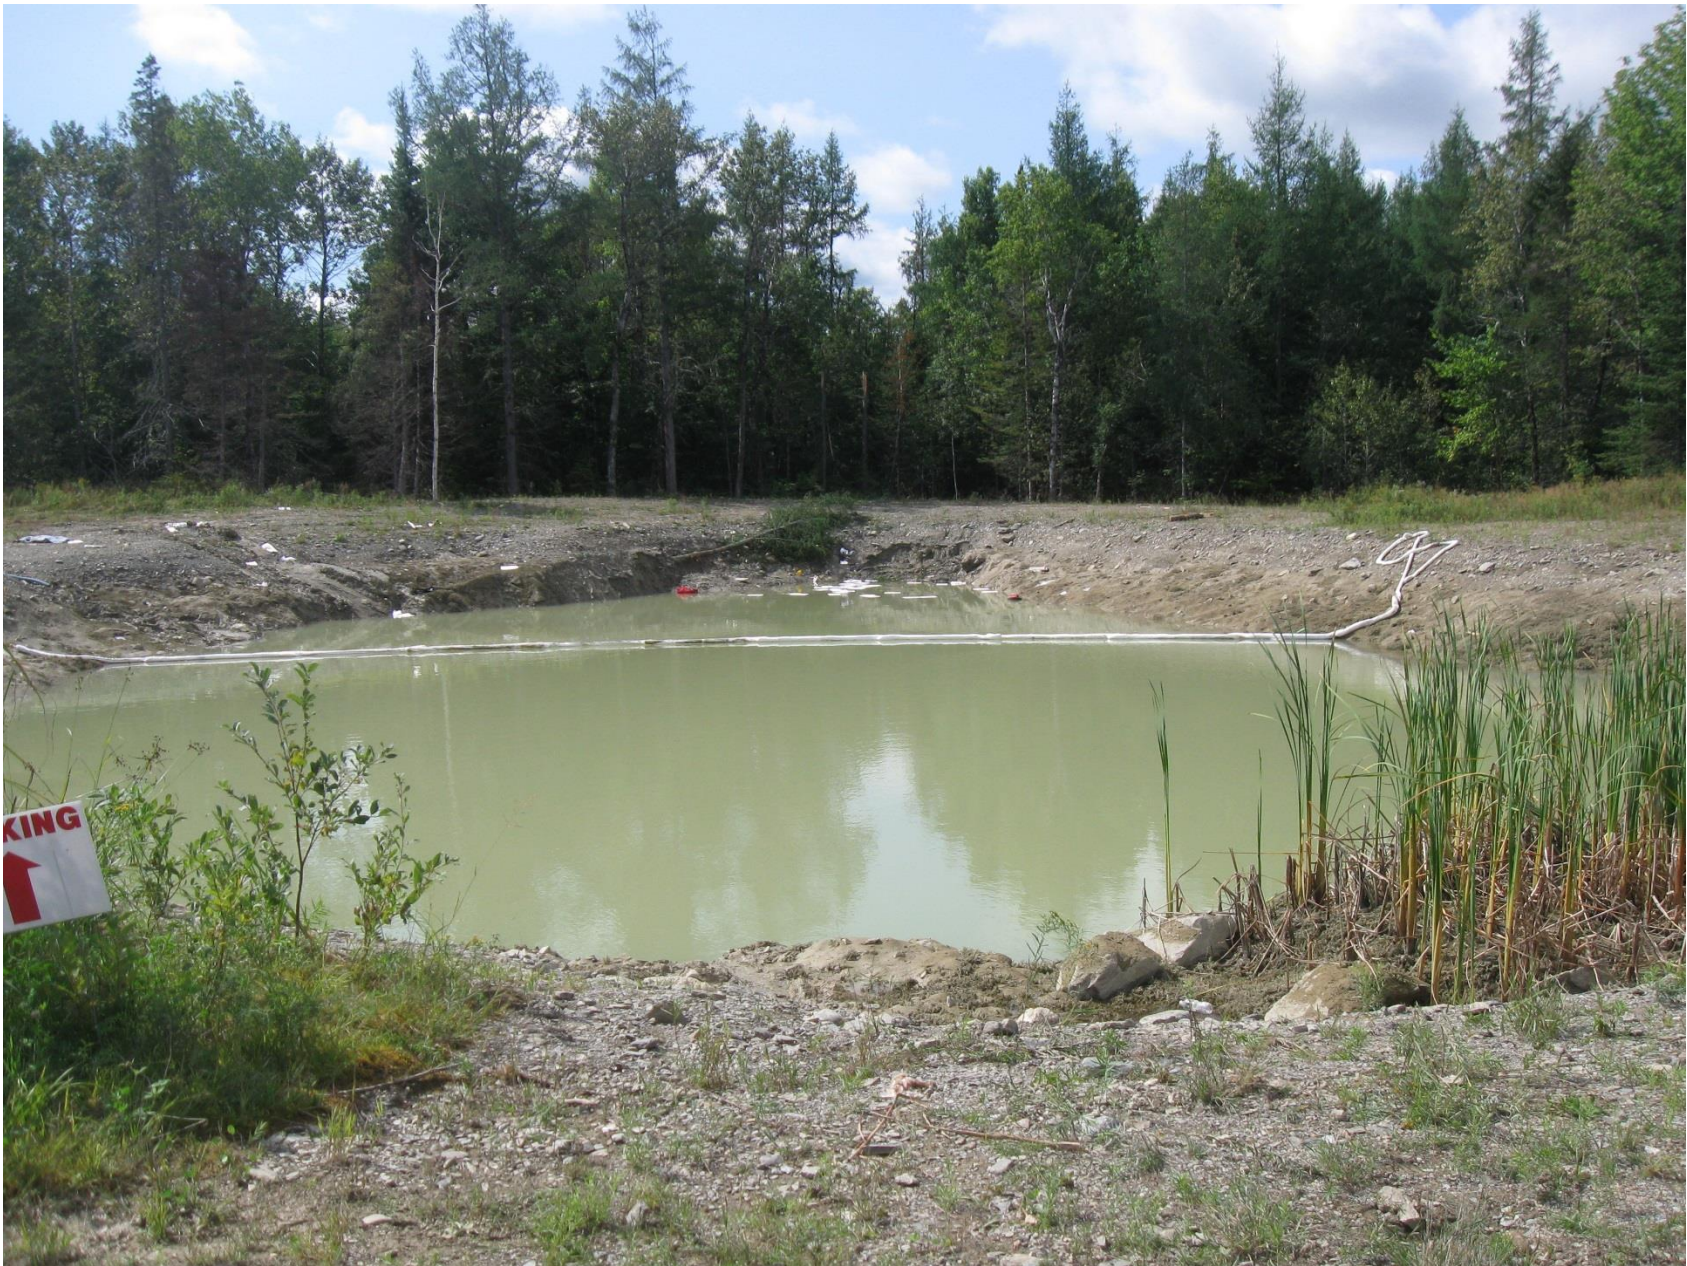
**Photo 1 – View of Accident Site Facing Opposite Direction of Travel**

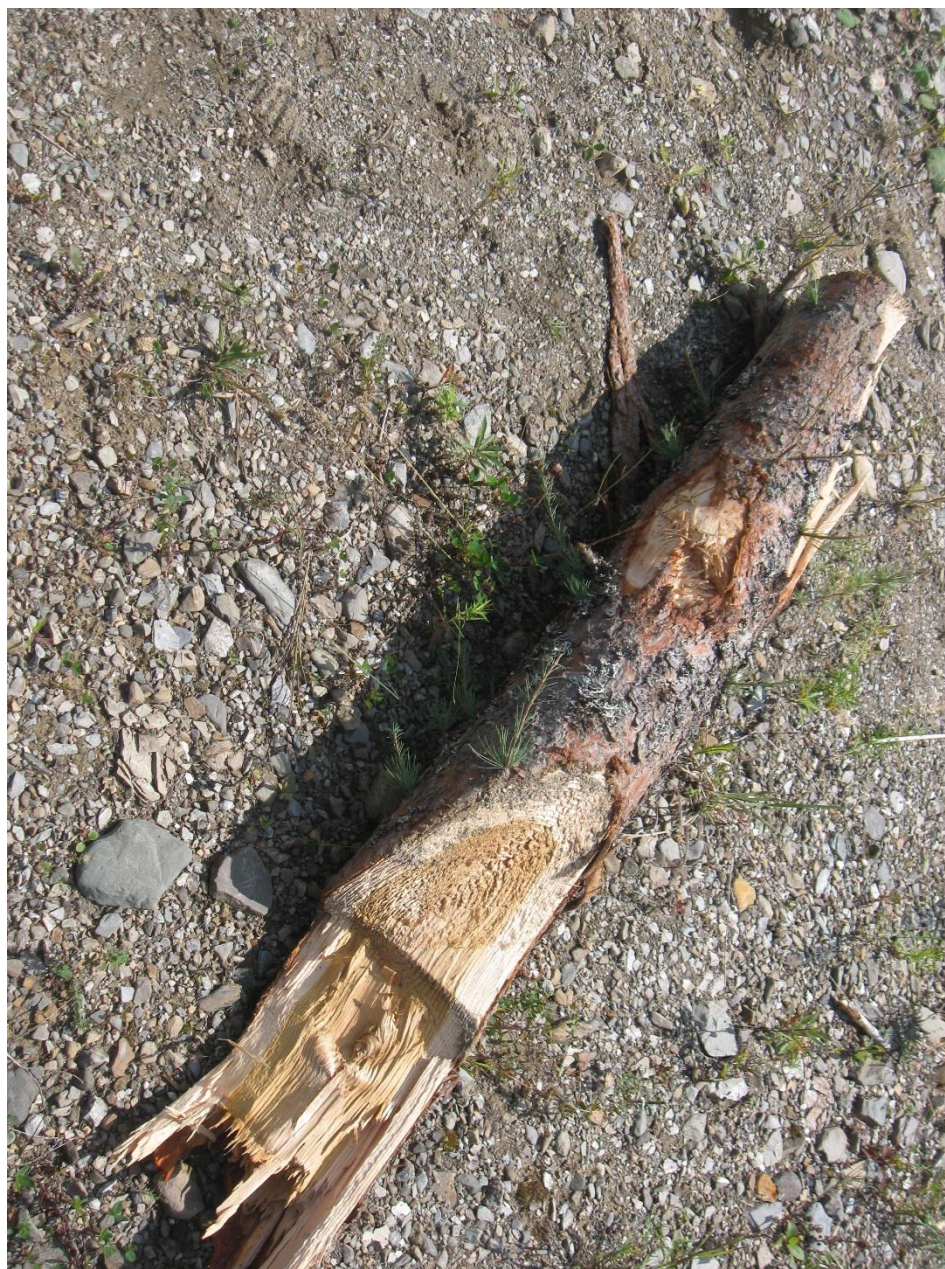
**Photo 2 – View of Broken Branch along Wreckage Path with Angular Cuts Displayed**

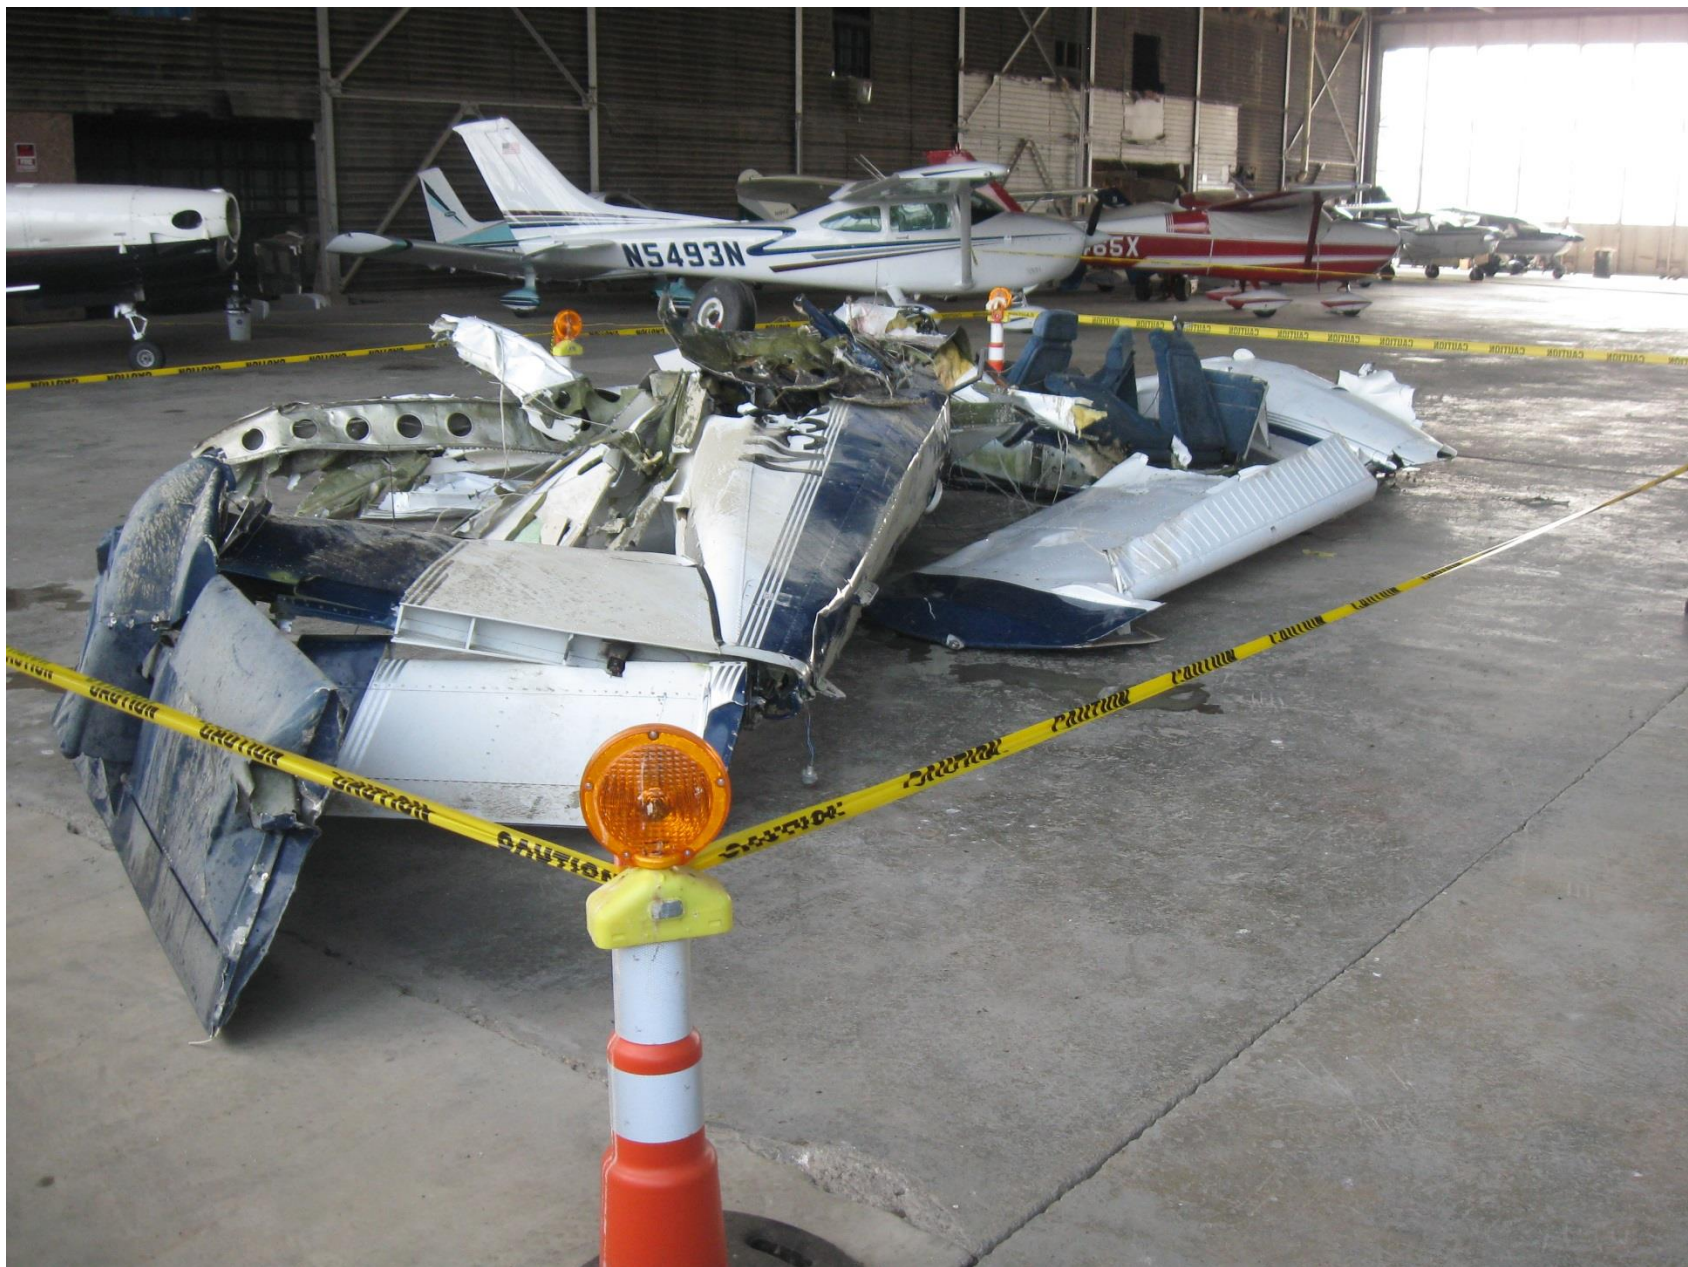
**Photo 3 – View of Main Wreckage after Recovery**

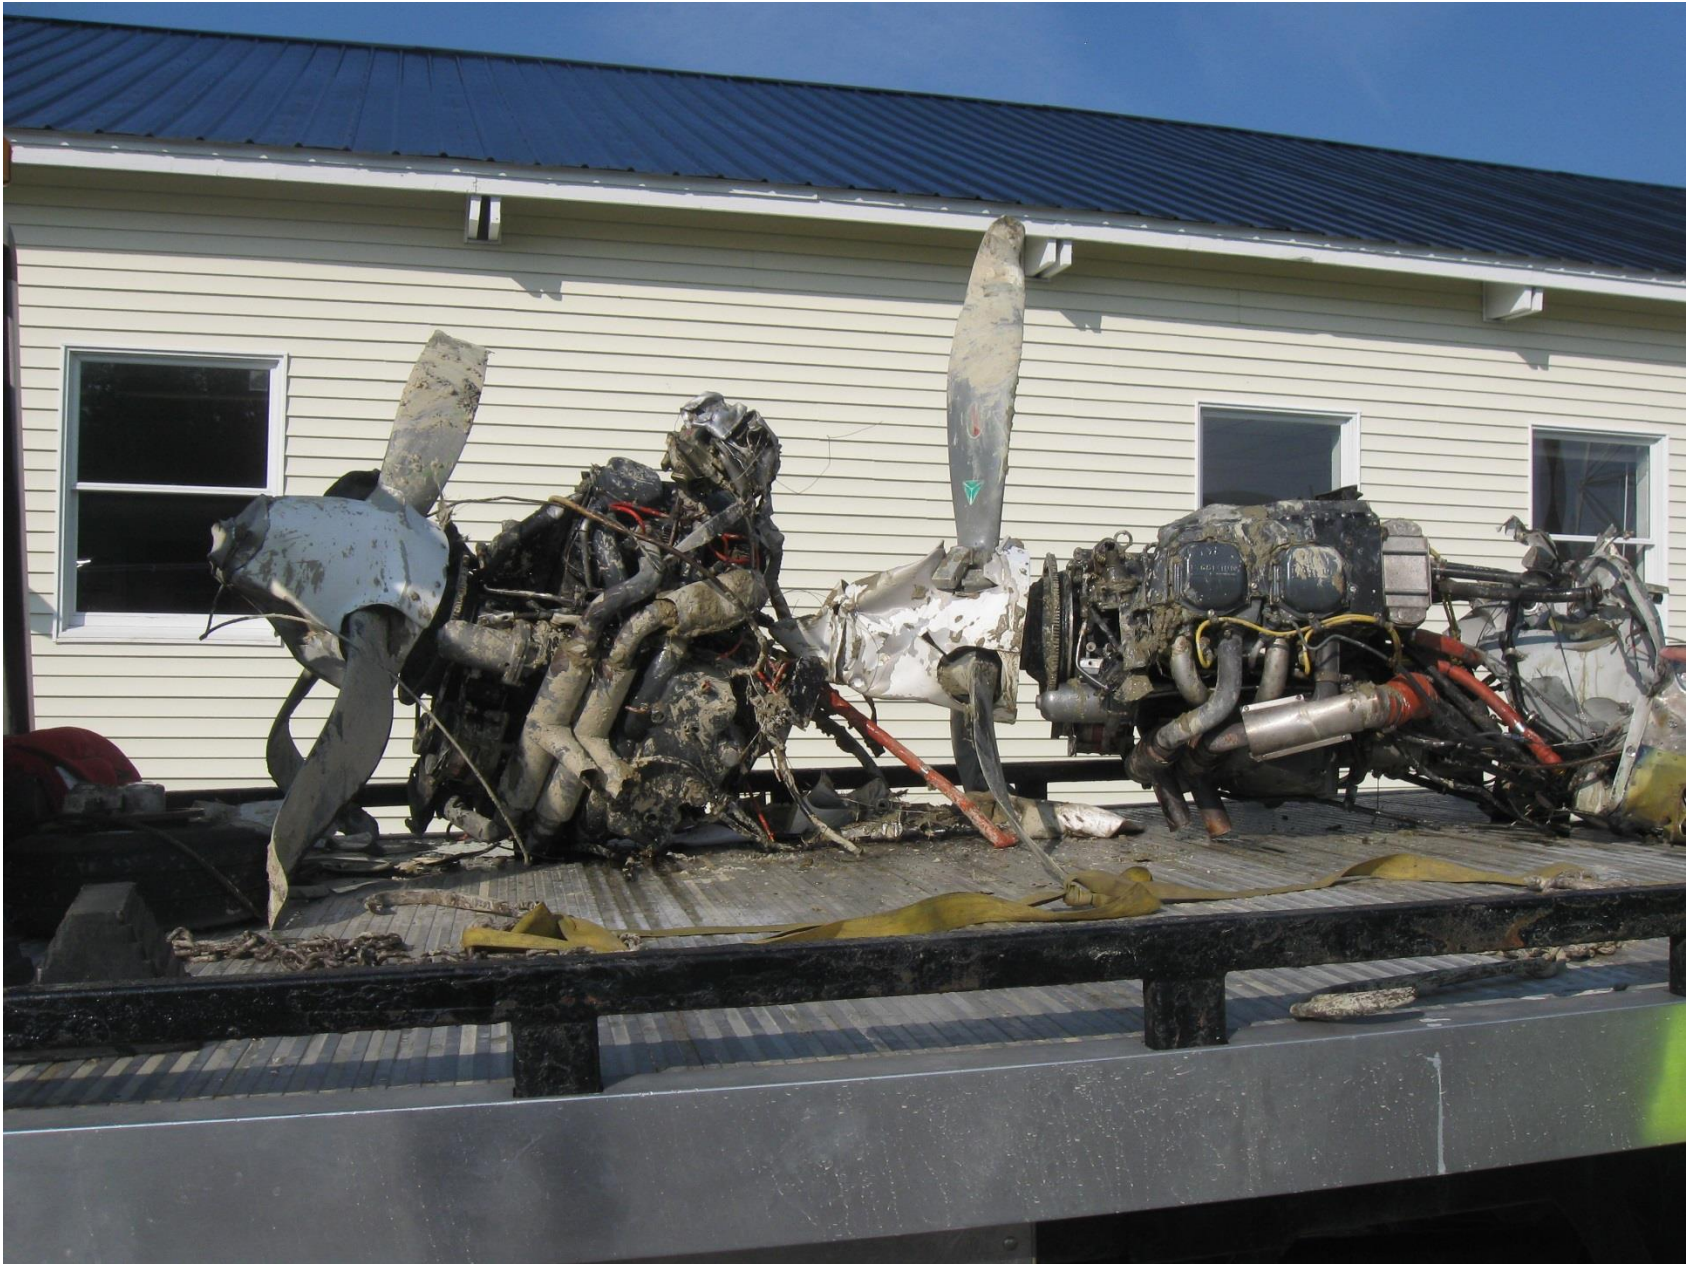
**Photo 4 – View of Engines and Propeller Systems after Recovery**
