## ENGINE EXAMINATION REPORT

| ENGINE MODEL | IO-550-N |
| AIRCRAFT MAKE & MODEL | Cirrus SR22 |

NTSB ACCIDENT # ERA15FA330

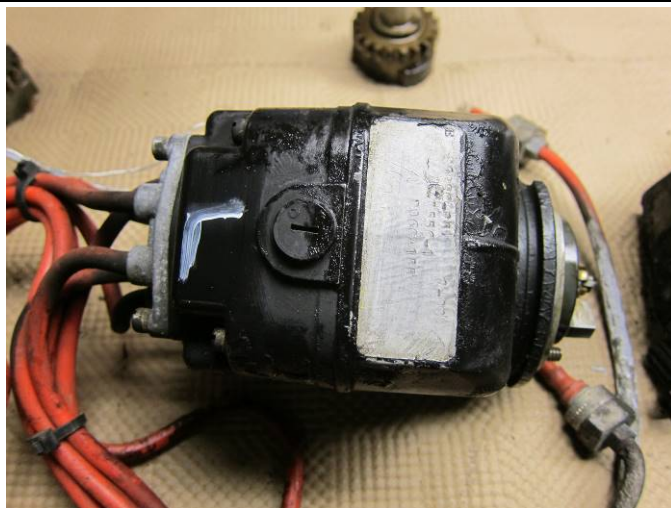
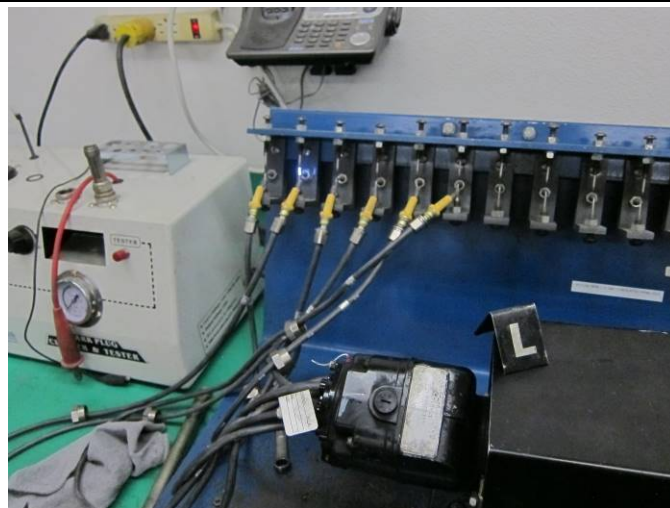
### LEFT MAGNETO

**Condition:** The magneto remained attached to its installation point and displayed thermal damage signatures. The magneto was removed from the engine and it was noted that the drive shaft was capable of normal rotation. The magneto was placed on a test bench and was tested throughout its operating speeds; the magneto was capable of producing a spark on all six posts in the correct order.

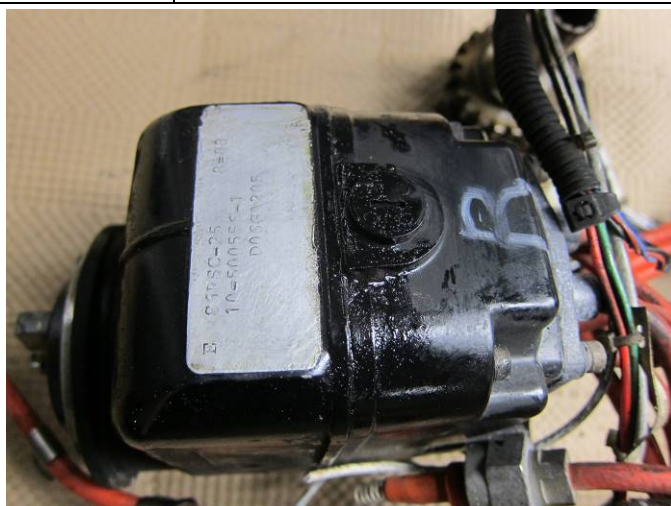
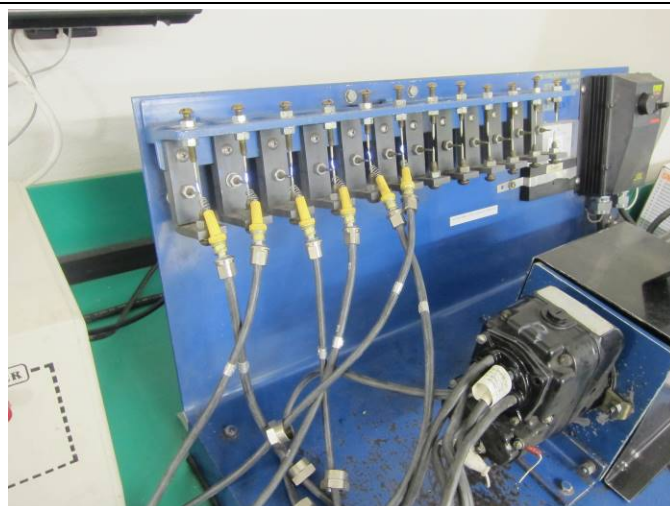
### RIGHT MAGNETO

**Condition:** The magneto remained attached to its installation point and displayed thermal damage signatures. The magneto was removed from the engine and it was noted that the drive shaft was capable of normal rotation. The magneto was placed on a test bench and was tested throughout its operating speeds; the magneto was capable of producing a spark on all six posts in the correct order.

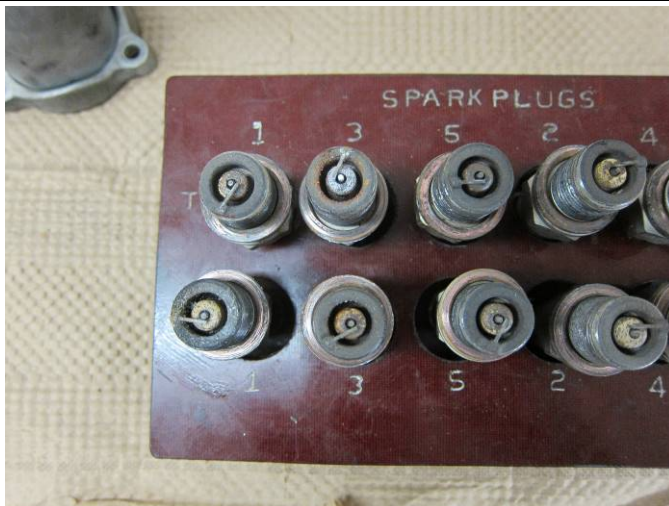
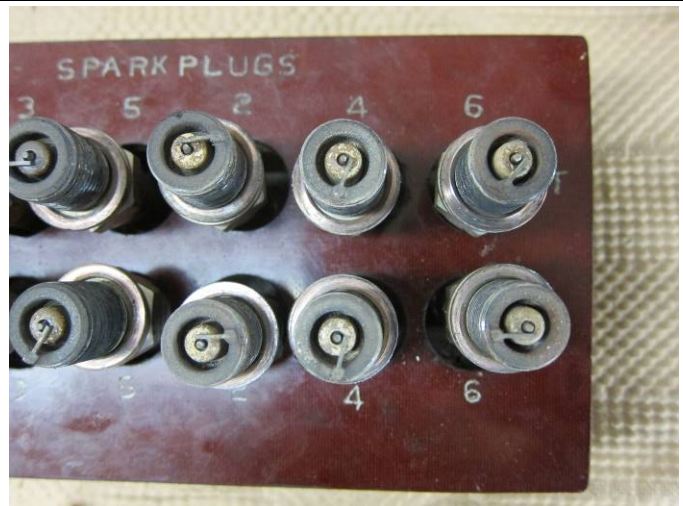
## SPARK PLUGS

All of the spark plugs remained installed in their cylinders and displayed varying degrees of thermal damage. The spark plugs were removed and the electrodes were visually inspected. The electrodes displayed normal operating and wear signatures.

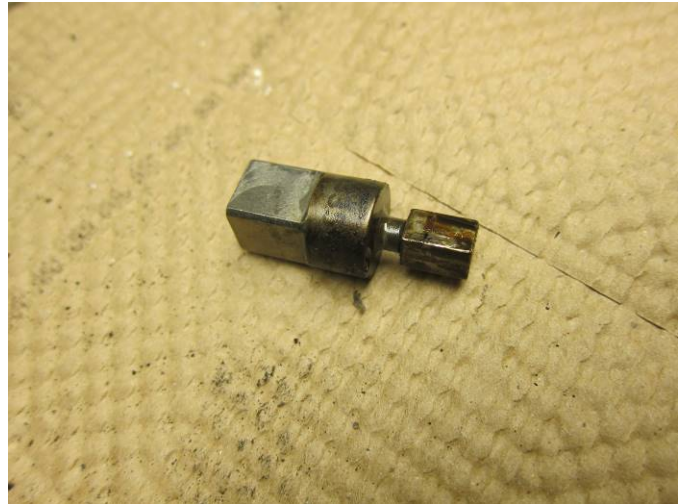
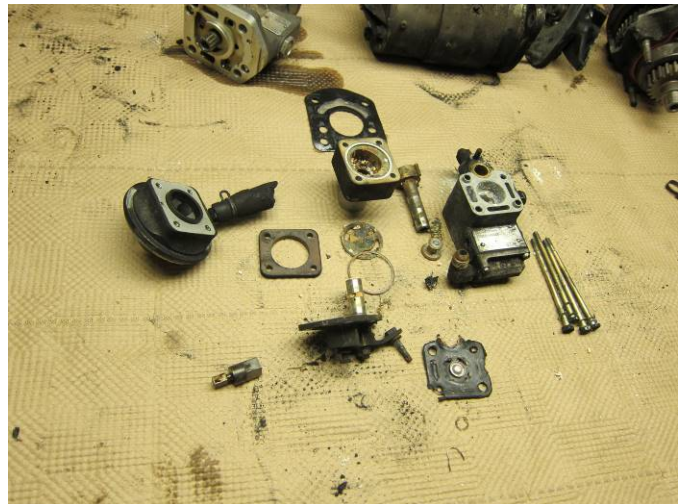
#### FUEL PUMP

The fuel pump remained attached to its installation point and displayed thermal and impact damage signatures. The fuel pump was removed and it was noted that the fuel pump drive coupling remained intact. It was noted that the fuel pump drive was not capable of rotation by hand. The fuel pump was disassembled and the internal components were visually inspected. All of the internal components displayed thermal damage signatures and normal operating signatures. There were no anomalies noted.

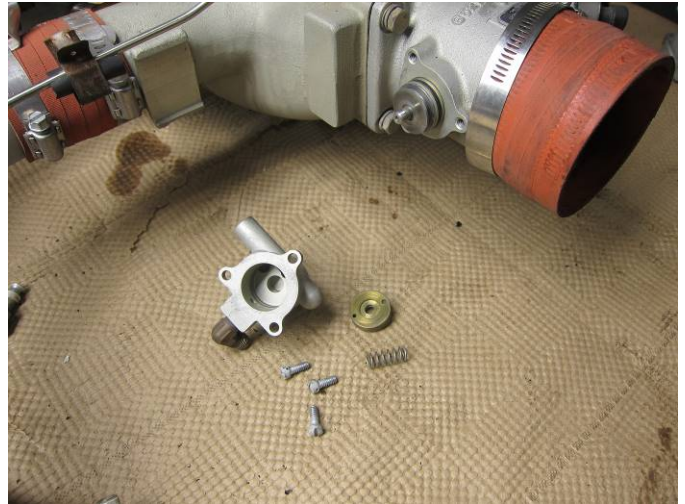
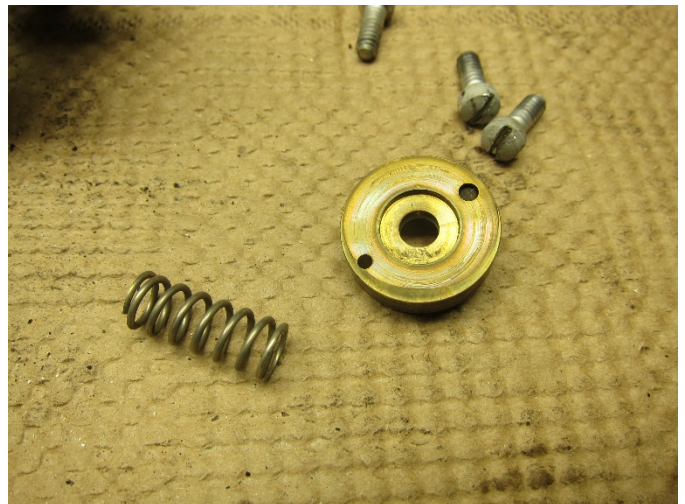
## THROTTLE BODY METERING UNIT

The throttle and fuel metering assembly remained attached to its installation point and was undamaged. The fuel metering portion of the assembly was disassembled and the internal components were visually inspected. There were no anomalies noted with the throttle and fuel metering assembly.

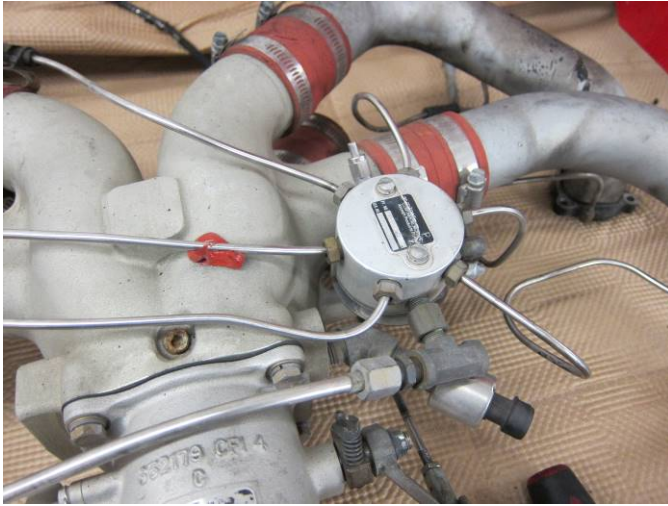
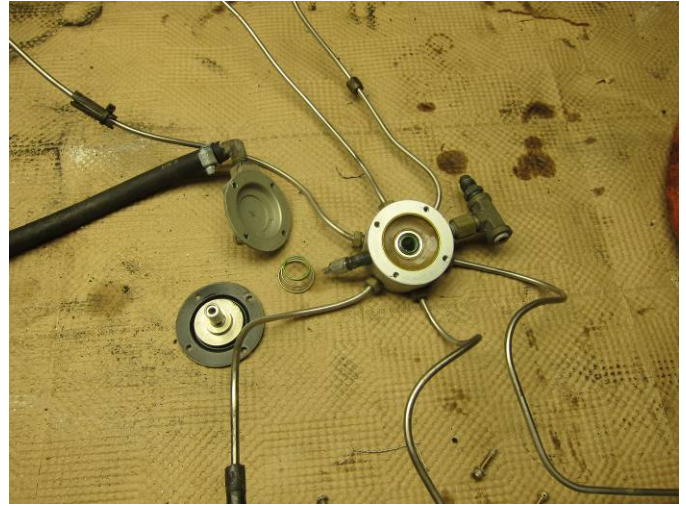
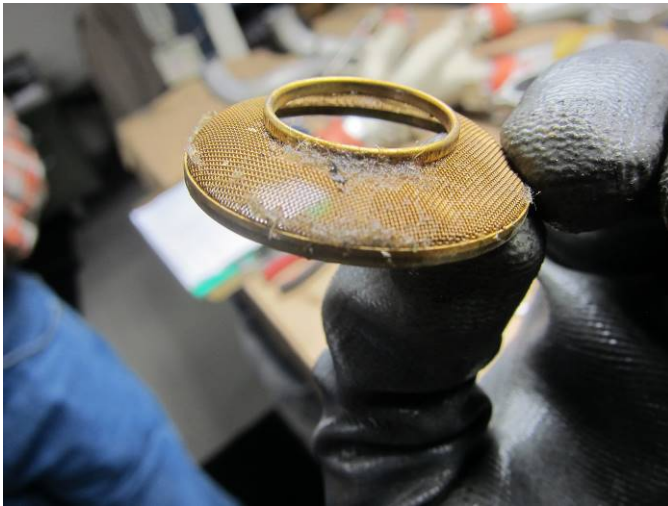
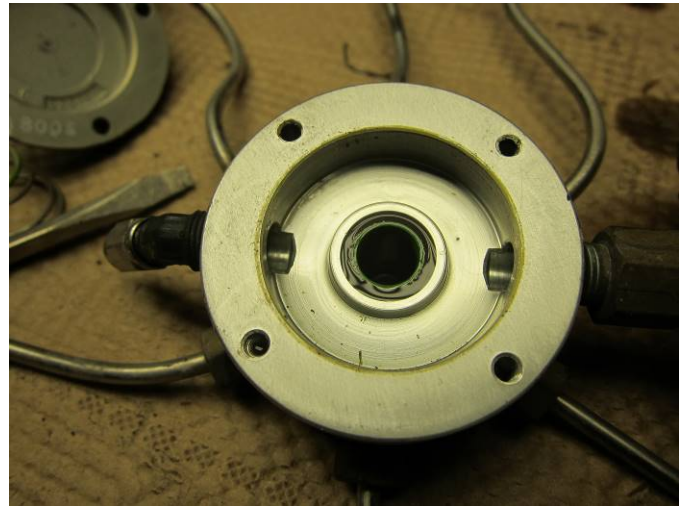
## FUEL MANIFOLD VALVE

The fuel manifold valve remained attached to its installation point and was undamaged. There were no signs of fuel leaks noted around the manifold valve. The manifold valve was disassembled and the internal components were visually inspected. The fuel screen was noted to have fibrous material in the screen; however, the screen was not blocked and there were no signs of the fibrous material on the filtered side of the manifold valve. The remaining components displayed normal operating signatures.

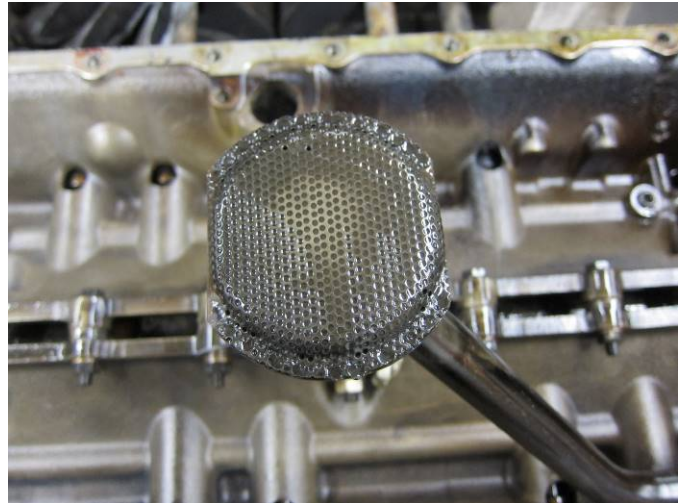
#### OIL PICK-UP TUBE & SCREEN

Condition: The oil pick-up tube and screen were intact and undamaged. The oil pick-up screen was clear of any contaminants. There were no anomalies noted.

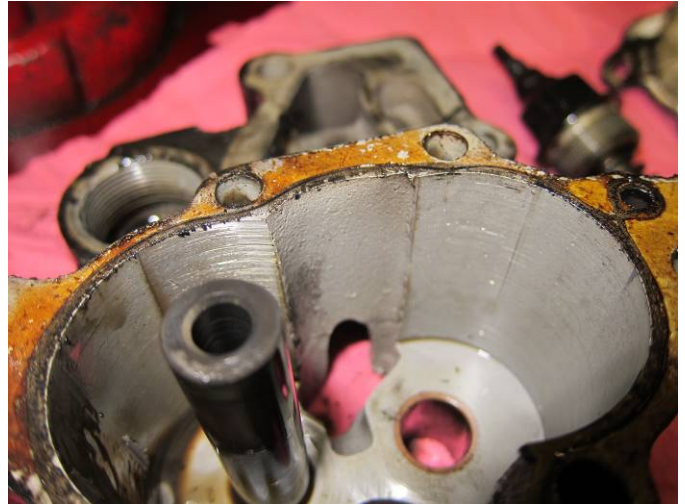
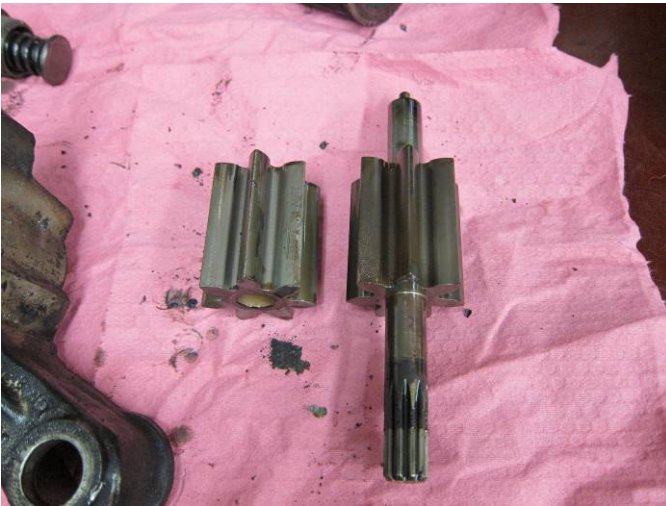
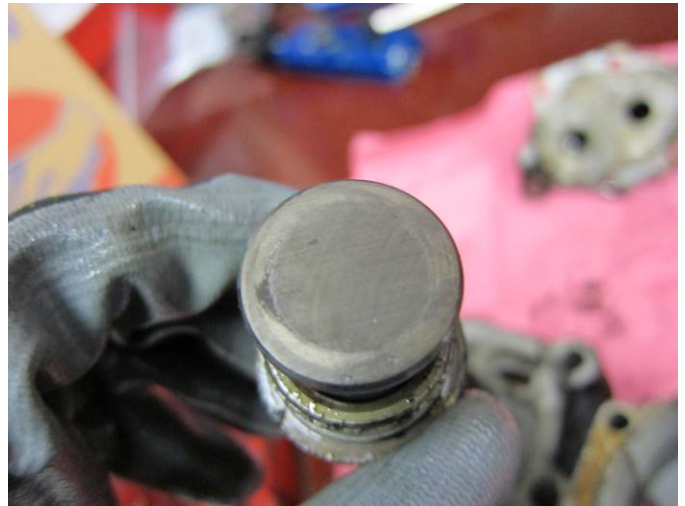
## OIL PUMP

**Condition:** The oil pump displayed thermal damage signatures and remained intact. The oil pump was disassembled and the internal components were visually inspected. The oil pump housing displayed scoring consistent with hard particle passage. The oil pump gears and pressure relief valve displayed normal operating signatures.

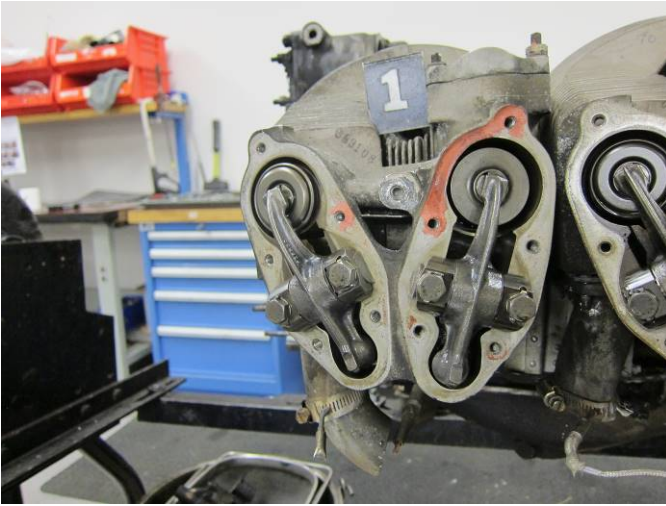
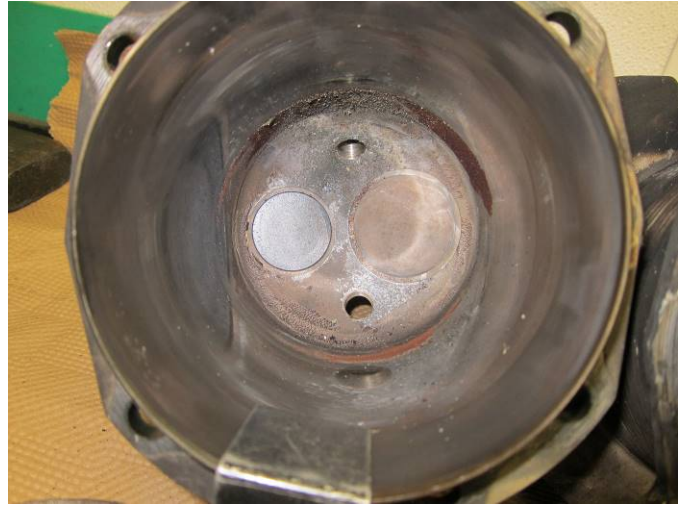
### CYLINDER #1

**Condition:** The cylinder remained attached to its cylinder bay and displayed some impact and thermal damage signatures. The cylinder was removed from the engine and visually inspected. The cylinder bore displayed normal operating signatures. The valve heads displayed normal operating and combustion signatures. The overhead components (valves, springs, and rocker arms) displayed normal operating and lubrication signatures.

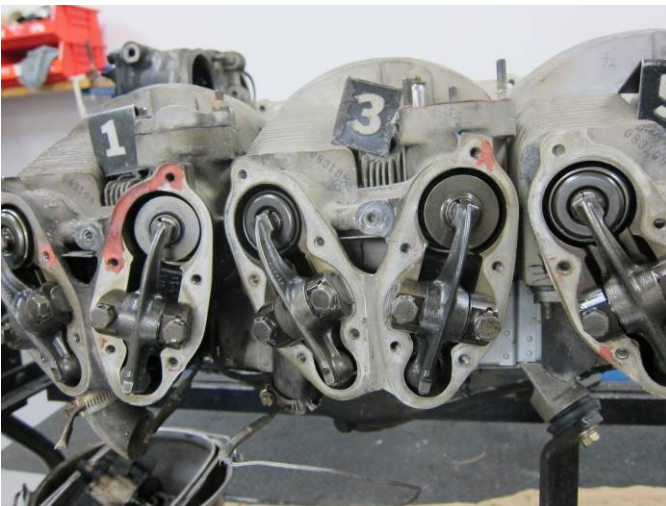
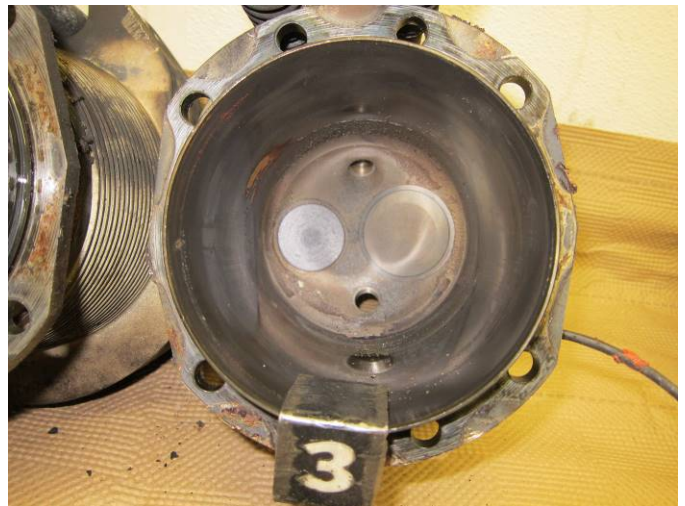
### CYLINDER #3

**Condition:** The cylinder remained attached to its cylinder bay and displayed some impact and thermal damage signatures. The cylinder was removed from the engine and visually inspected. The cylinder bore displayed normal operating signatures. The valve heads displayed normal operating and combustion signatures. The overhead components (valves, springs, and rocker arms) displayed normal operating and lubrication signatures.

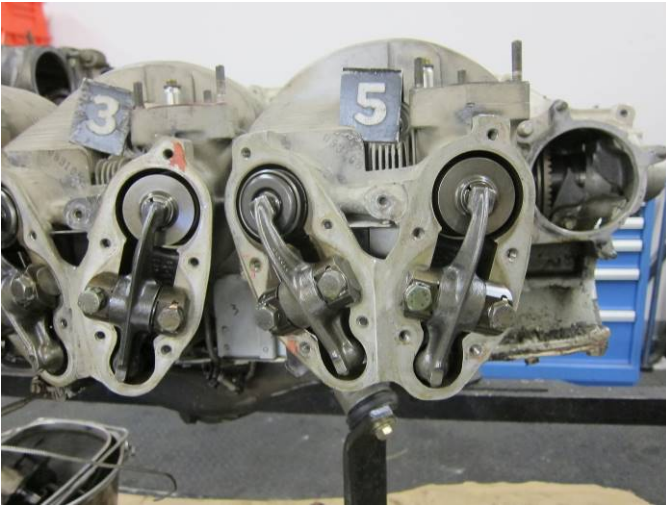
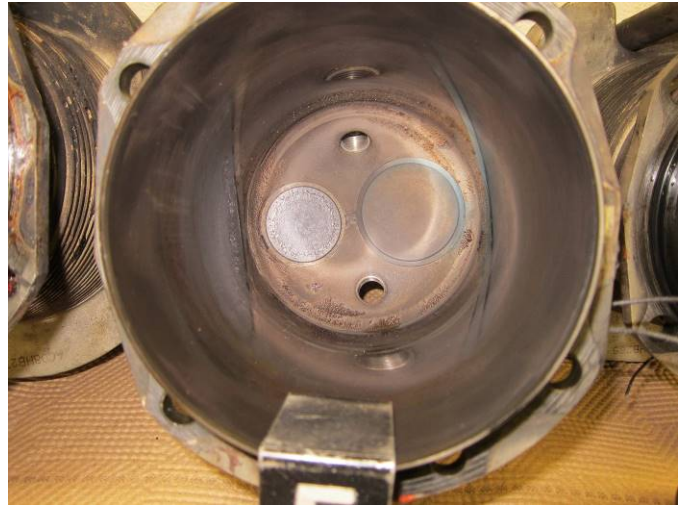
## CYLINDER #5

Condition: The cylinder remained attached to its cylinder bay and displayed some impact and thermal damage signatures. The cylinder was removed from the engine and visually inspected. The cylinder bore displayed normal operating signatures. The valve heads displayed normal operating and combustion signatures. The overhead components (valves, springs, and rocker arms) displayed normal operating and lubrication signatures.

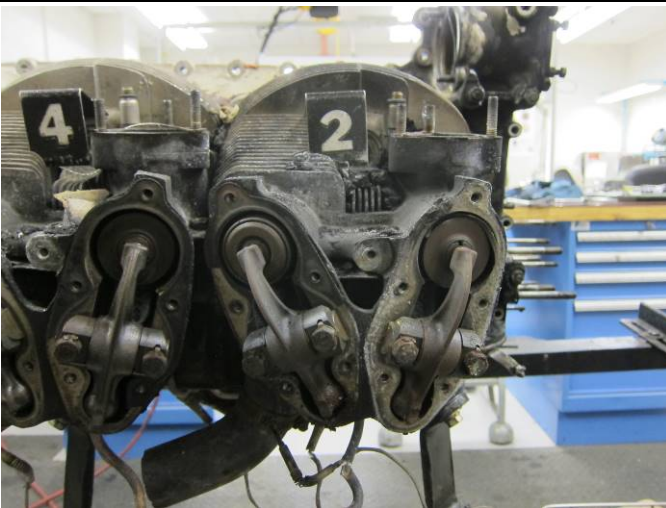
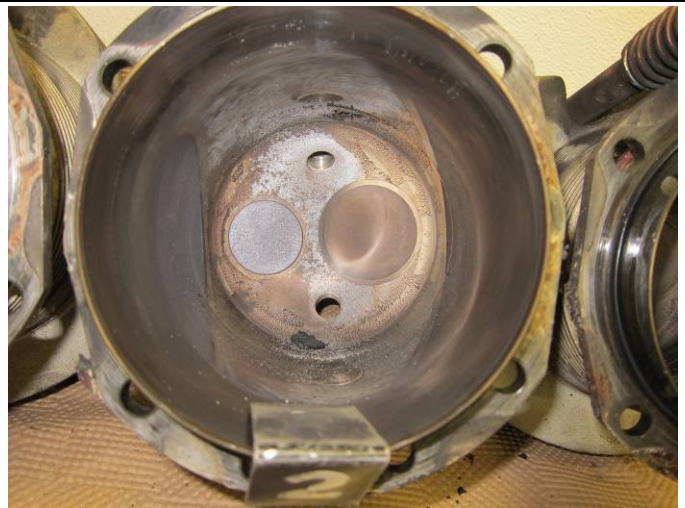
## CYLINDER #2

Condition: The cylinder remained attached to its cylinder bay and displayed some impact and thermal damage signatures. The cylinder was removed from the engine and visually inspected. The cylinder bore displayed normal operating signatures. The valve heads displayed normal operating and combustion signatures. The overhead components (valves, springs, and rocker arms) displayed normal operating and lubrication signatures.

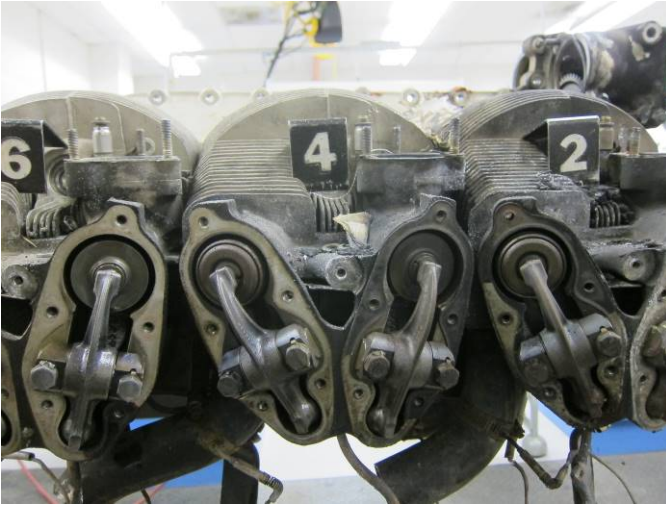
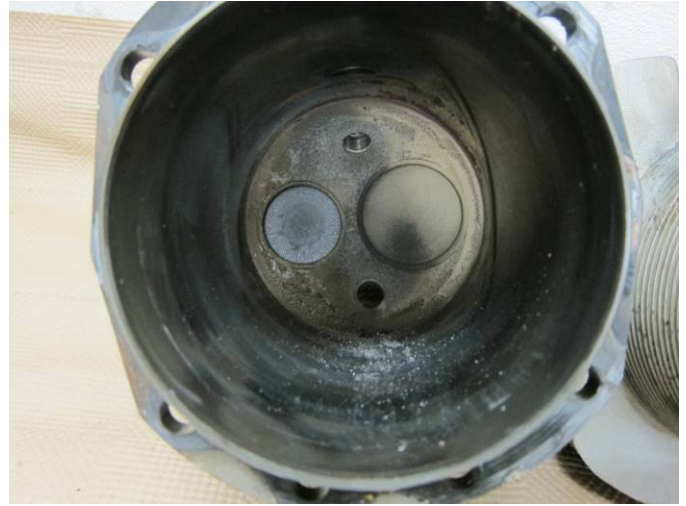
## CYLINDER #4

Condition: The cylinder remained attached to its cylinder bay and displayed some impact and thermal damage signatures. The cylinder was removed from the engine and visually inspected. The cylinder bore displayed normal operating signatures. The valve heads displayed normal operating and combustion signatures. The overhead components (valves, springs, and rocker arms) displayed normal operating and lubrication signatures.

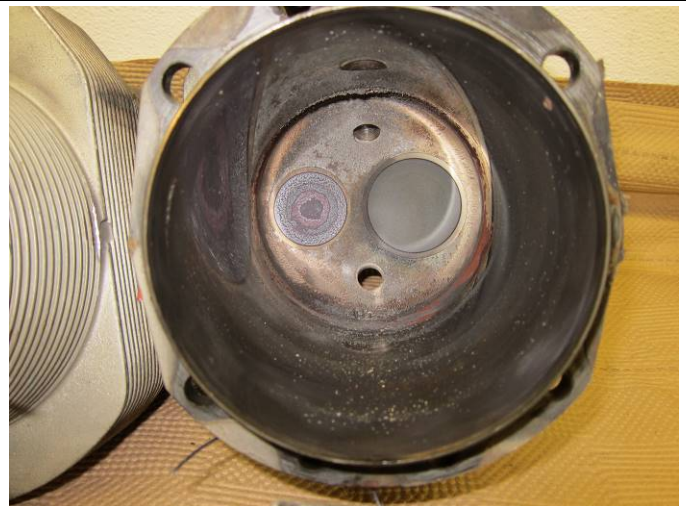
## CYLINDER #6

Condition: The cylinder remained attached to its cylinder bay and displayed some impact and thermal damage signatures. The cylinder was removed from the engine and visually inspected. The cylinder bore displayed normal operating signatures. The valve heads displayed normal operating and combustion signatures. The overhead components (valves, springs, and rocker arms) displayed normal operating and lubrication signatures.

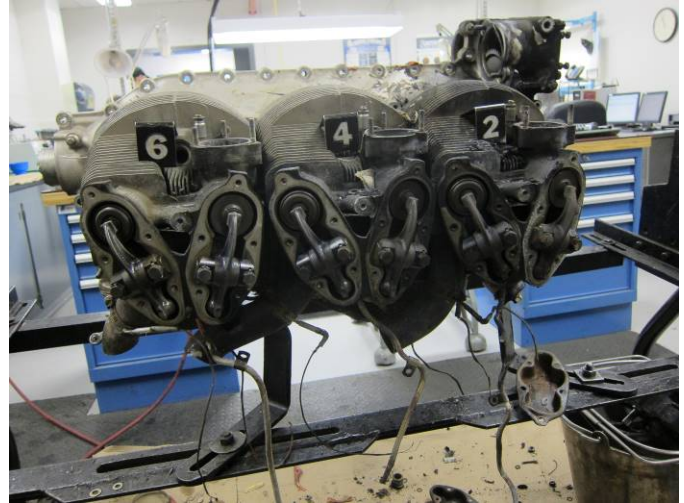
### ROCKER ARMS AND SHAFTS

Condition: All of the rocker arms displayed normal operating and lubrication signatures. There were no anomalies noted with the rocker arms.

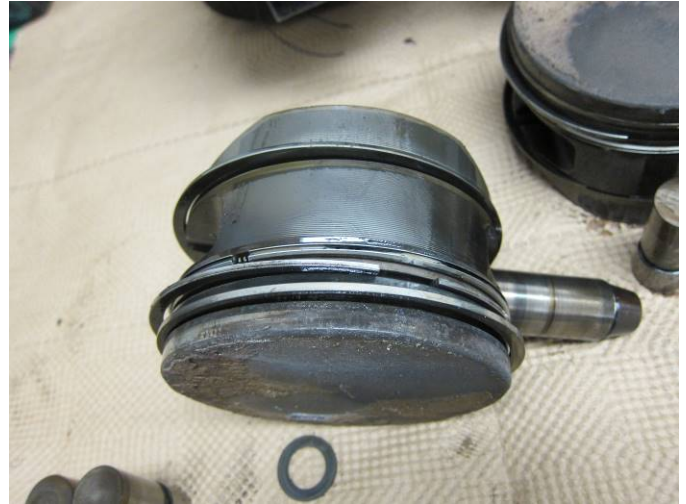
## PISTONS

Condition: The pistons remained intact and were undamaged. The piston faces displayed normal operating and combustion signatures. The piston rings were capable of normal movement in their grooves. There were no anomalies noted with the pistons.

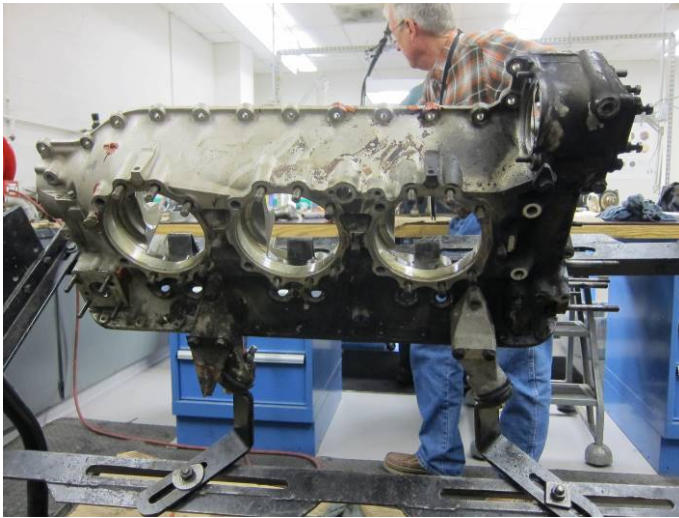
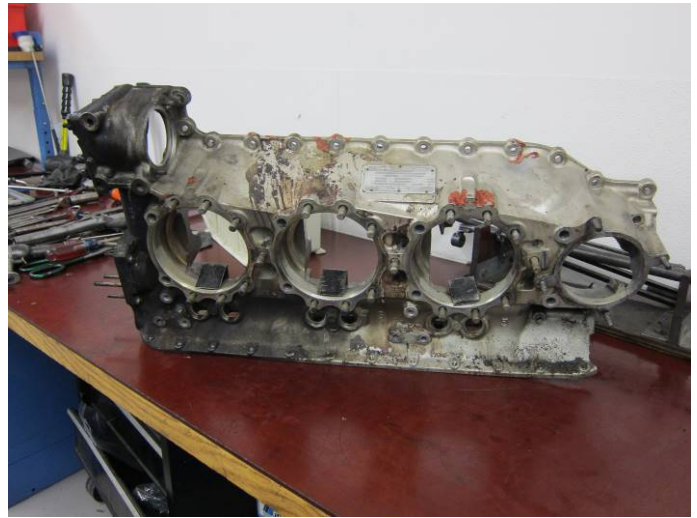
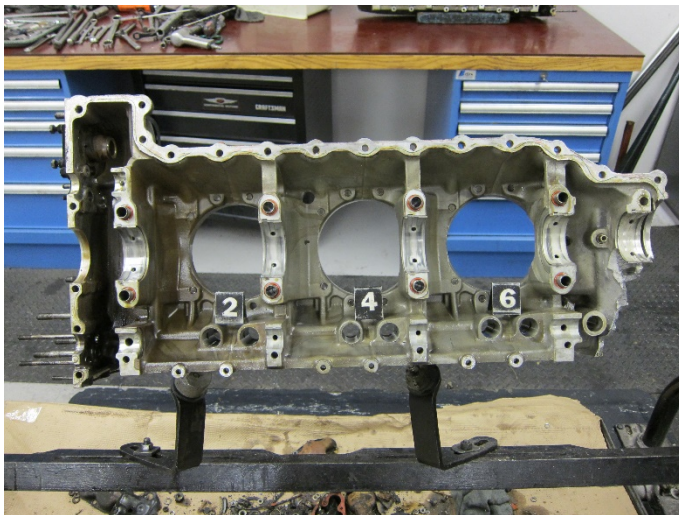
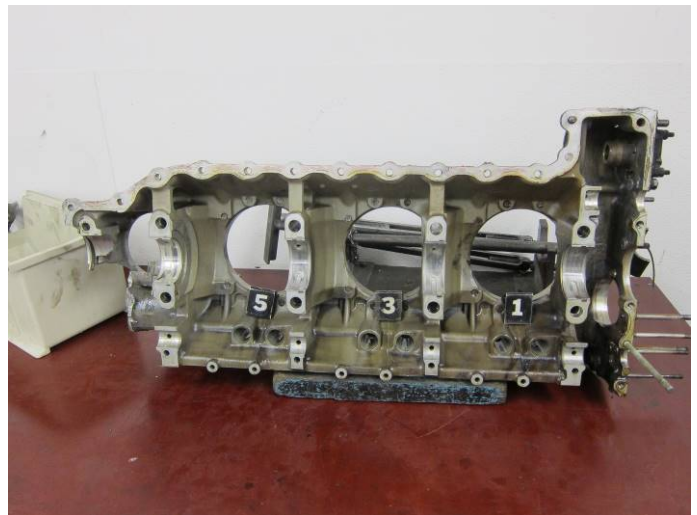
#### CRANKCASE

The crankcase displayed a significant amount of impact damage to the bottom forward portion of the crankcase. The crankcase halves were split and the crankcase was visually inspected. There were no signs of lock tab elongation or fretting on the crankcase halves. There were no anomalies noted with the crankcase.

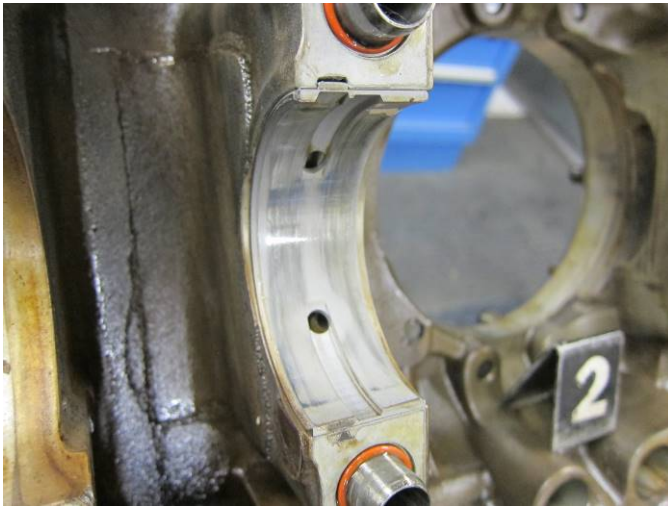
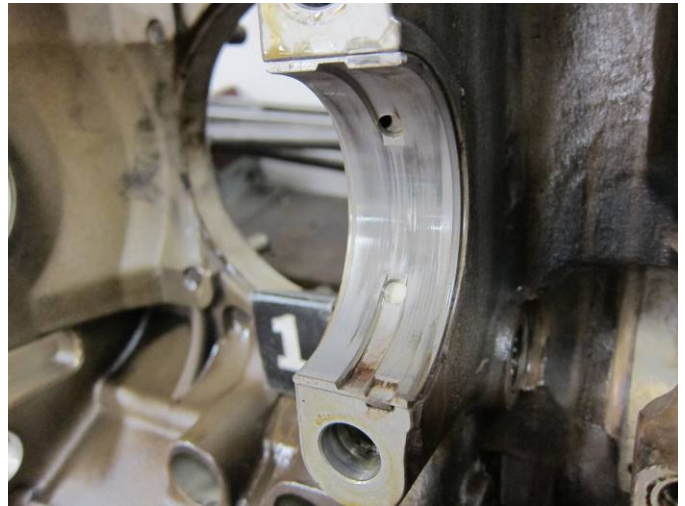
## #1 MAIN BEARINGS

The bearings remained in place and were undamaged. The bearings displayed normal operating and lubrication signatures. There were no signs of bearing shift or lubrication distress. There were no anomalies noted.

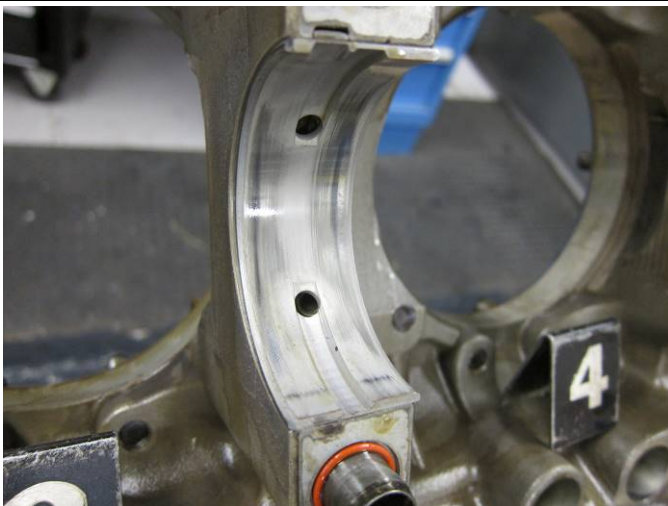
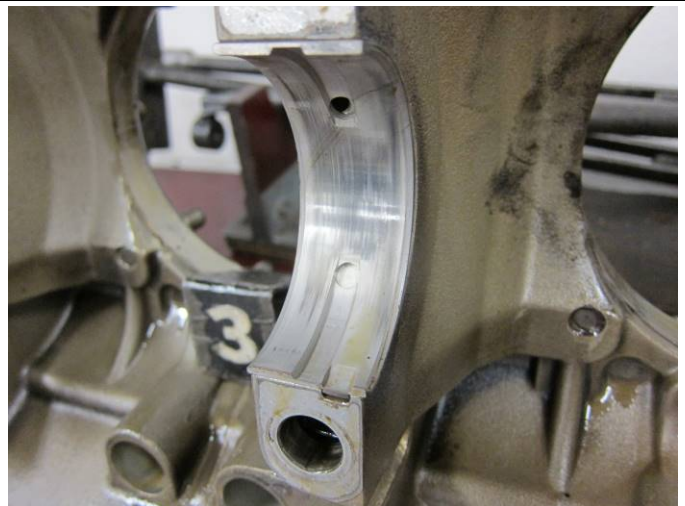
## #2 MAIN BEARINGS

The bearings remained in place and were undamaged. The bearings displayed normal operating and lubrication signatures. There were no signs of bearing shift or lubrication distress. There were no anomalies noted.

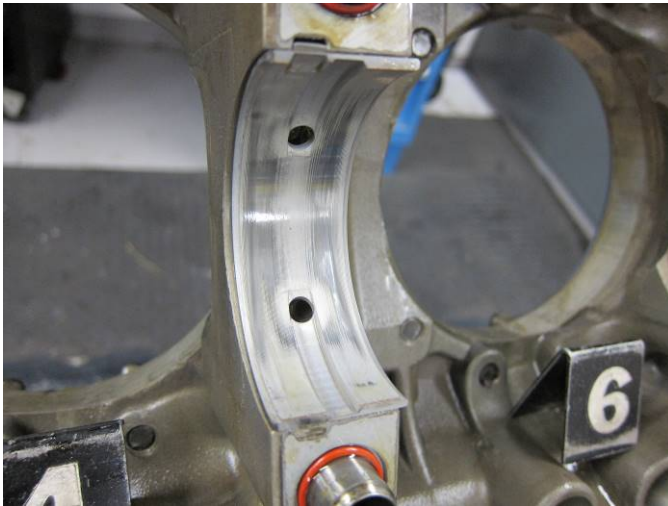
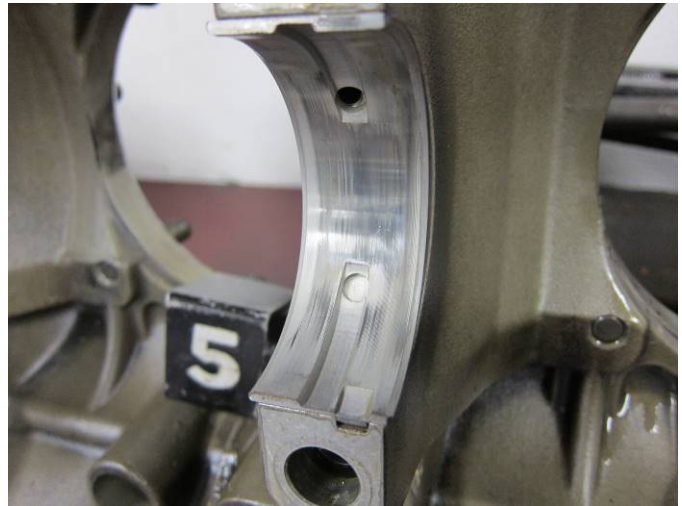
## #3 MAIN BEARINGS

The bearings remained in place and were undamaged. The bearings displayed normal operating and lubrication signatures. There were no signs of bearing shift or lubrication distress. There were no anomalies noted.

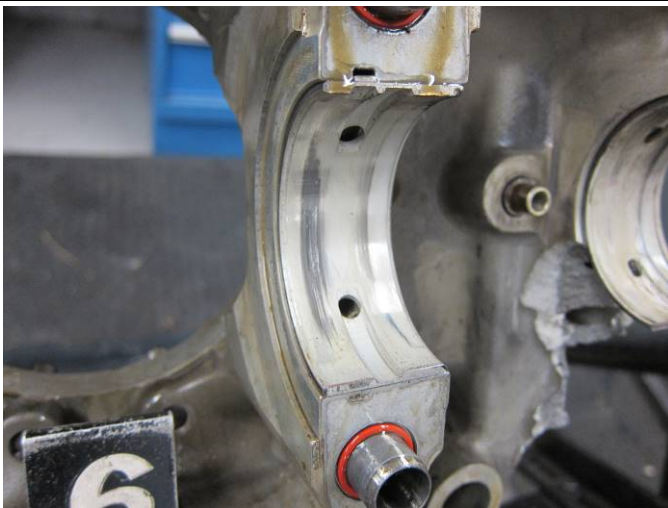
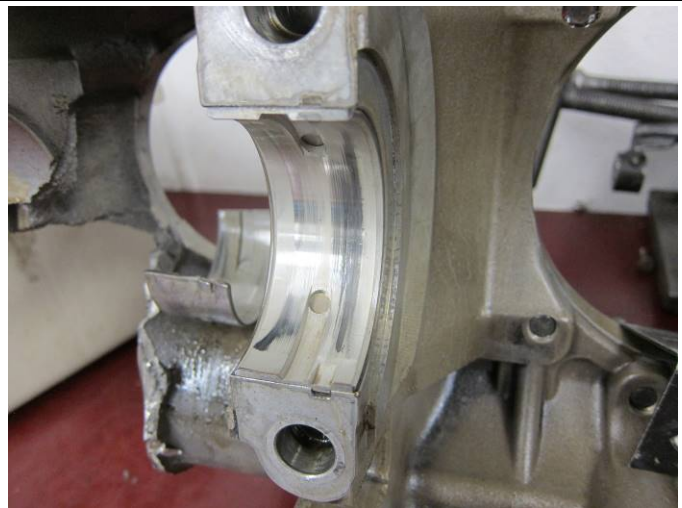
## #4 MAIN BEARINGS

The bearings remained in place and were undamaged. The bearings displayed normal operating and lubrication signatures. There were no signs of bearing shift or lubrication distress. There were no anomalies noted.

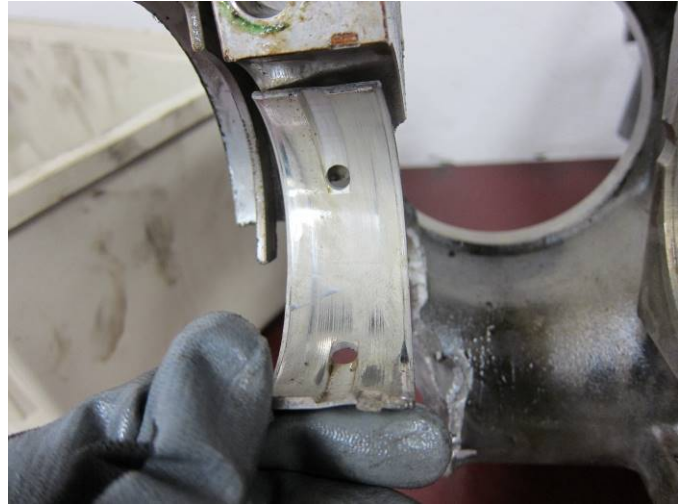
## #5 MAIN BEARINGS

Due to the impact damage to the forward portion of the crankcase both of the bearings were displaced. The bearings displayed normal operating and lubrication signatures. There were no signs of bearing shift or lubrication distress. There were no anomalies noted.

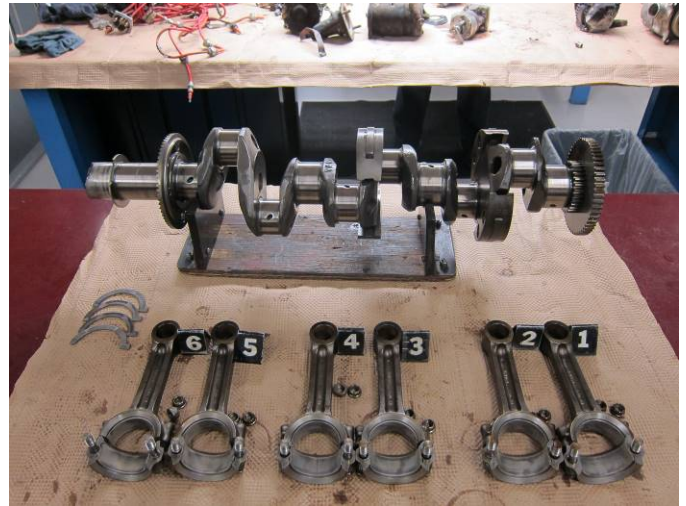
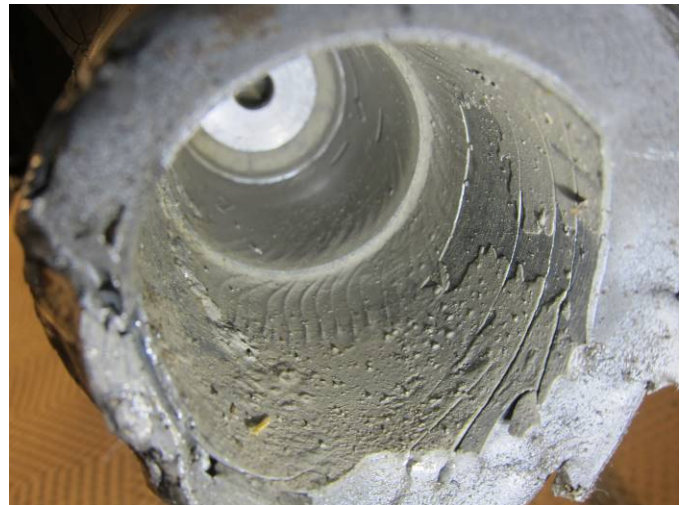
#### CRANKSHAFT

Condition: The propeller flange had broken free from the rest of the crankshaft and was not shipped with the rest of the engine. The fracture was consistent with impact damage and there were several cracks at a 45-degree angle noted near the fracture point. The rest of the crankshaft remained intact and the crankshaft gear remained secured to the crankshaft. All of the main bearing journals and connecting rod journals displayed normal operating and lubrication signatures.

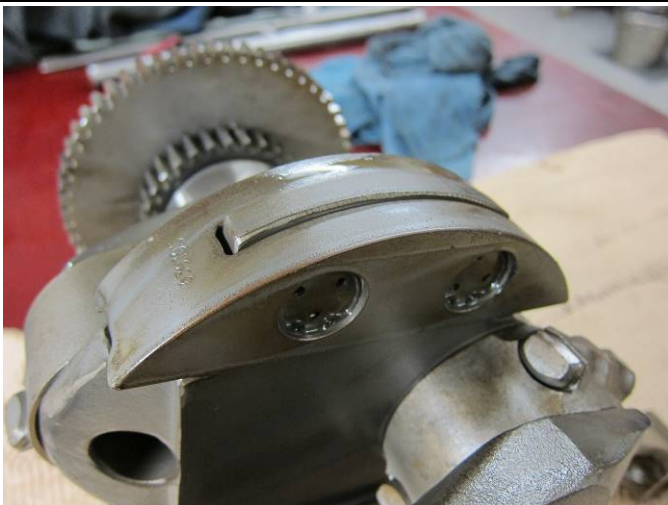
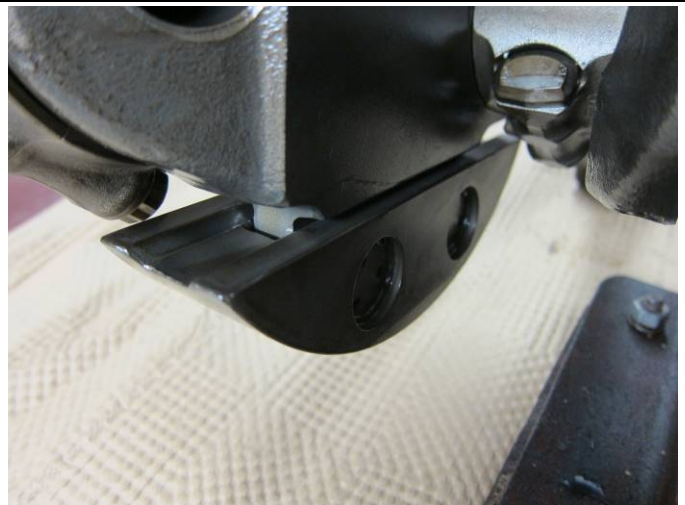
### COUNTER WEIGHTS

Condition: All of the counterweights remained attached to their hangers and were undamaged. The counterweights were capable of normal movement on their hangers. There were no anomalies noted.

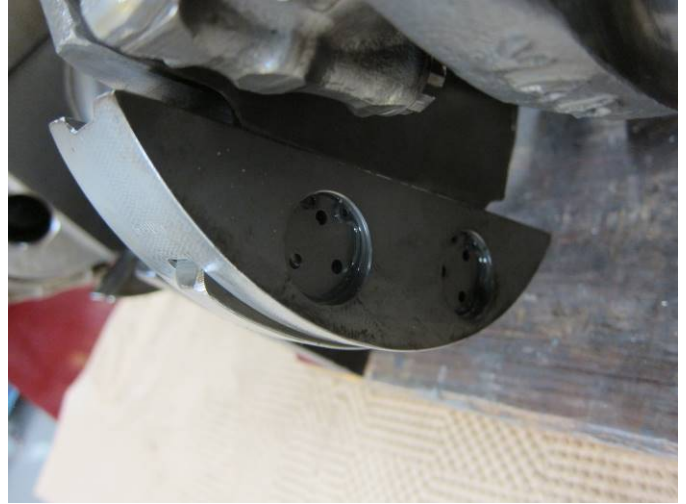
## INTERNAL TIMING

Condition: The internal timing was verified to be correct.

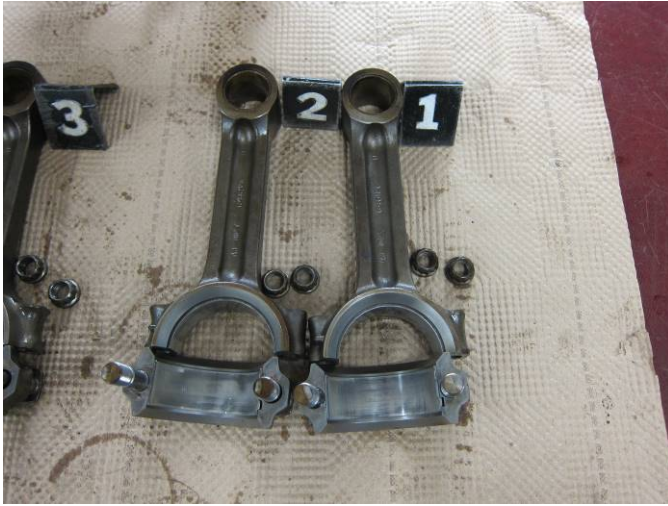
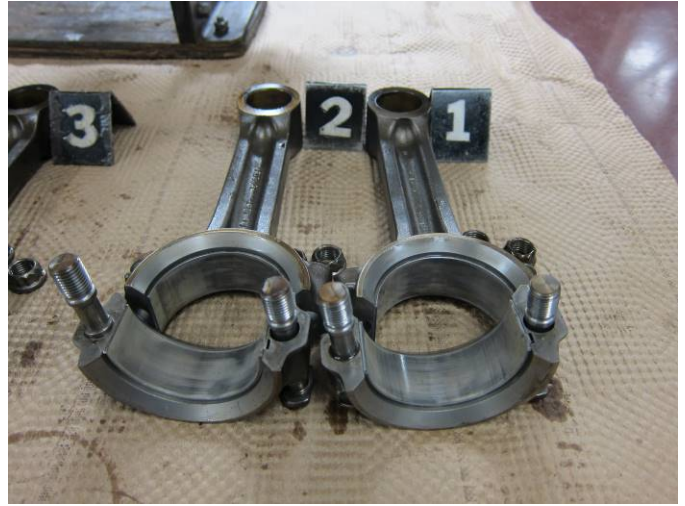
## #1 CONNECTING ROD

The connecting rod remained intact and undamaged. The connecting rod displayed normal operating signatures. There were no anomalies noted.

The connecting rod bearing displayed normal operating signatures and normal lubrication signatures. There were no signs of lubrication distress. There were no anomalies noted.

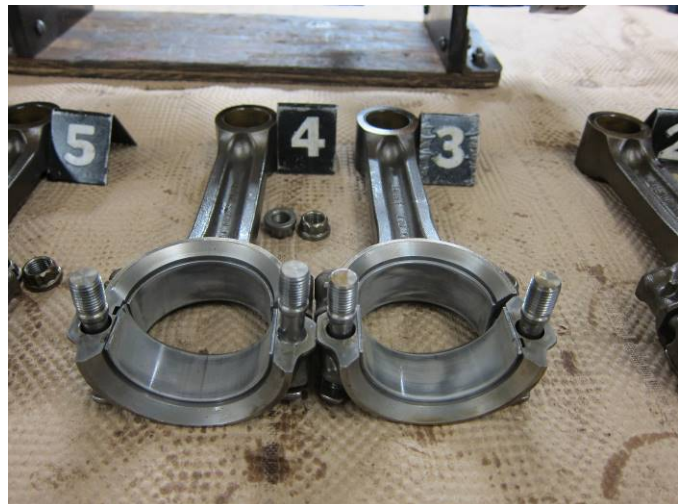
## #3 CONNECTING ROD

The connecting rod remained intact and undamaged. The connecting rod displayed normal operating signatures. There were no anomalies noted.

The connecting rod bearing displayed normal operating signatures and normal lubrication signatures. There were no signs of lubrication distress. There were no anomalies noted.

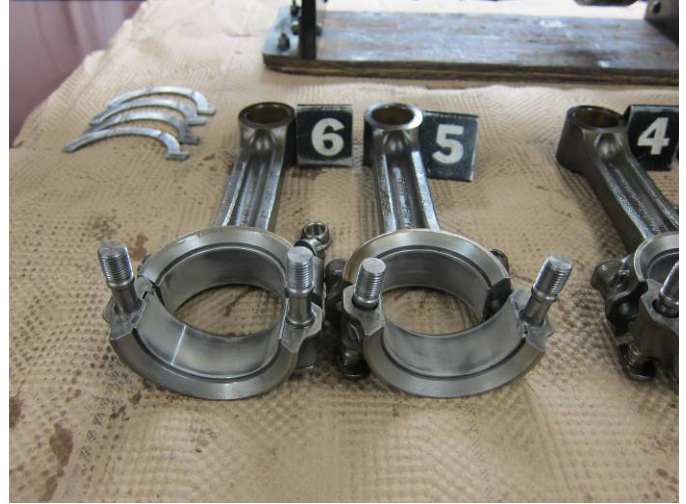
## #5 CONNECTING ROD

The connecting rod remained intact and undamaged. The connecting rod displayed normal operating signatures. There were no anomalies noted.

The connecting rod bearing displayed normal operating signatures and normal lubrication signatures. There were no signs of lubrication distress. There were no anomalies noted.

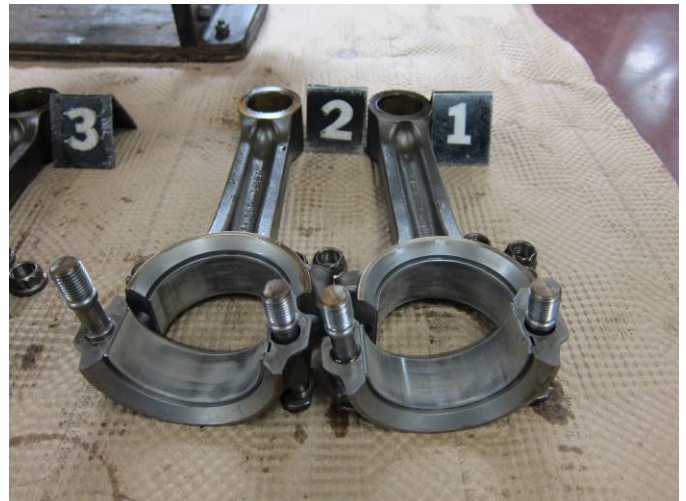
## #2 CONNECTING ROD

The connecting rod remained intact and undamaged. The connecting rod displayed normal operating signatures. There were no anomalies noted.

The connecting rod bearing displayed normal operating signatures and normal lubrication signatures. There were no signs of lubrication distress. There were no anomalies noted.

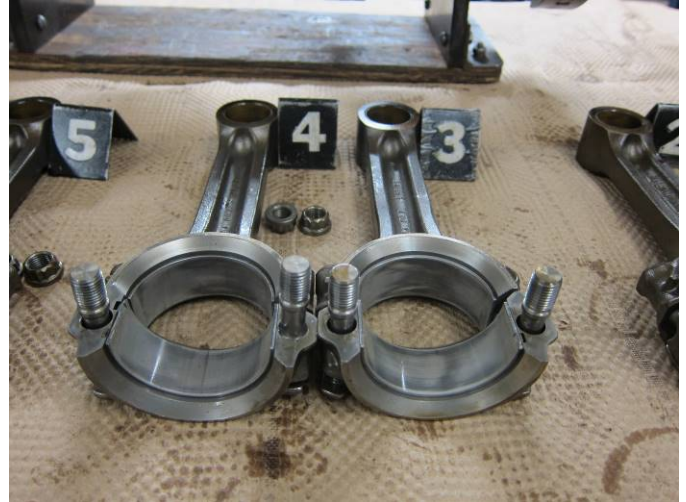
## #4 CONNECTING ROD

The connecting rod remained intact and undamaged. The connecting rod displayed normal operating signatures. There were no anomalies noted.

The connecting rod bearing displayed normal operating signatures and normal lubrication signatures. There were no signs of lubrication distress. There were no anomalies noted.

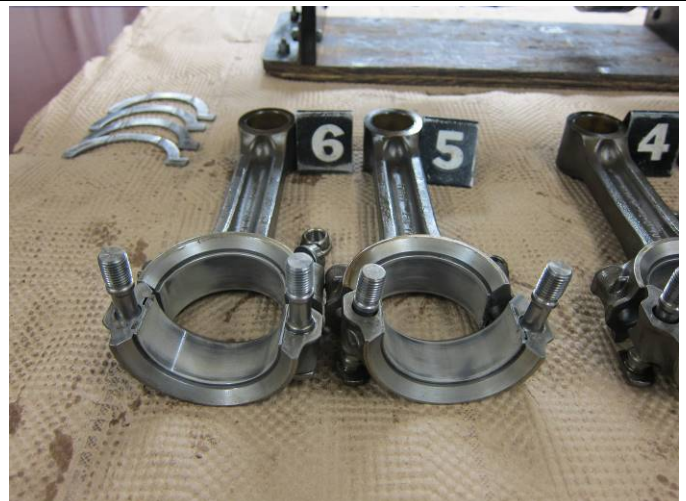
## #6 CONNECTING ROD

The connecting rod remained intact and undamaged. The connecting rod displayed normal operating signatures. There were no anomalies noted.

The connecting rod bearing displayed normal operating signatures and normal lubrication signatures. There were no signs of lubrication distress. There were no anomalies noted.
