## ENGINE EXAMINATION REPORT

| ENGINE MODEL | IO-550-N |
| AIRCRAFT MAKE & MODEL | Cirrus SR22 |

NTSB ACCIDENT # ERA15FA330

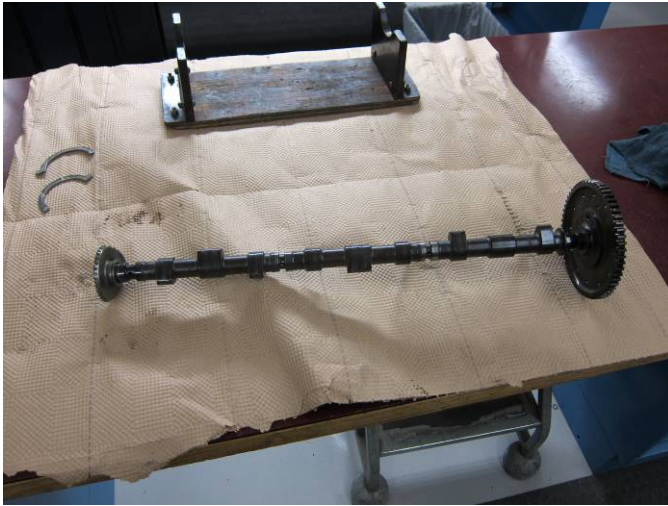
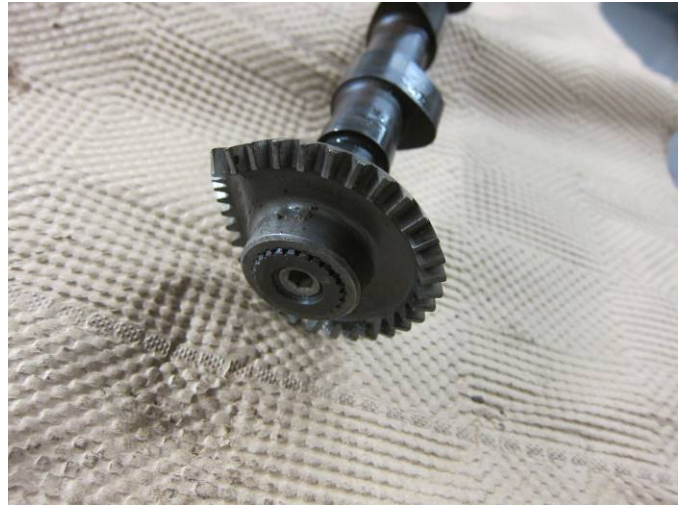
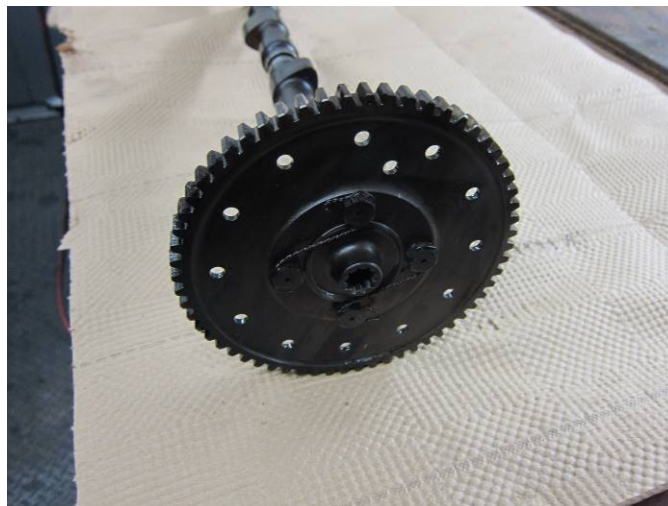
#### CAMSHAFT

Condition: The camshaft remained intact and displayed impact damage signatures to the forward camshaft gear. The camshaft lobes and journals displayed normal operating and lubrication signatures. The camshaft gear was undamaged and remained secured to the camshaft. There were no anomalies noted with the camshaft.

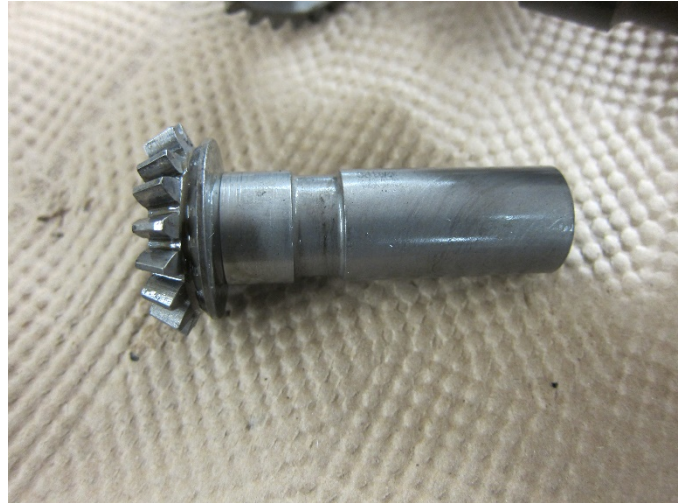
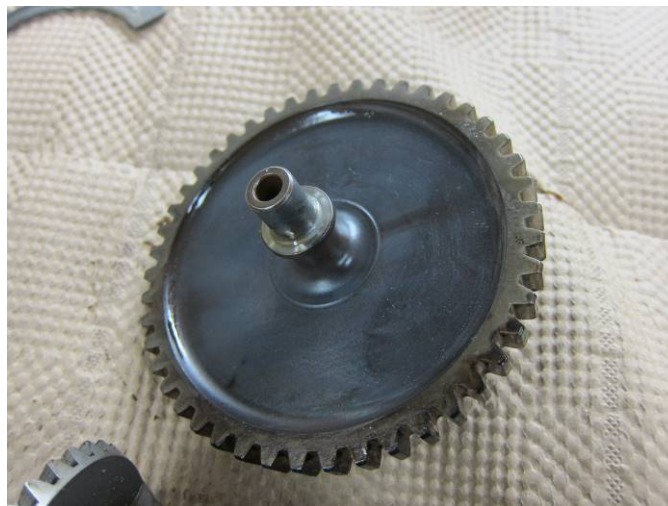
### ACCESSORY GEARS

Condition: The accessory gears were undamaged and displayed normal operating signatures. There were no anomalies noted.

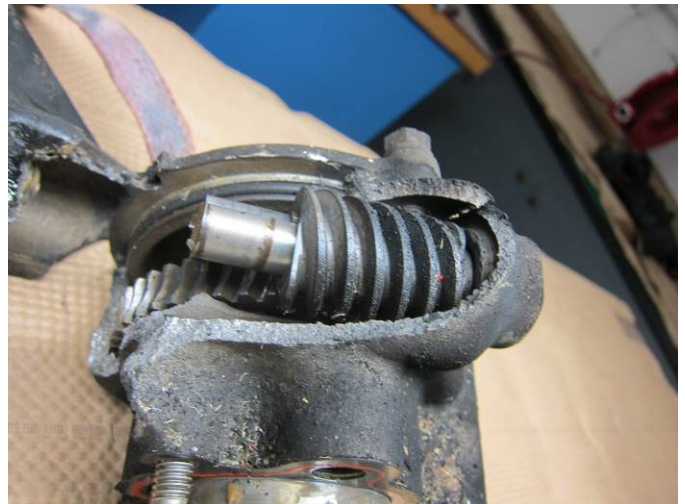
The starter adapter remained attached to its installation point and displayed impact and thermal damage signatures. A large portion of the starter adapter housing had broken free from the rest of the adapter and some of the internal components were visible. There were no pre-impact anomalies noted with the starter adapter.

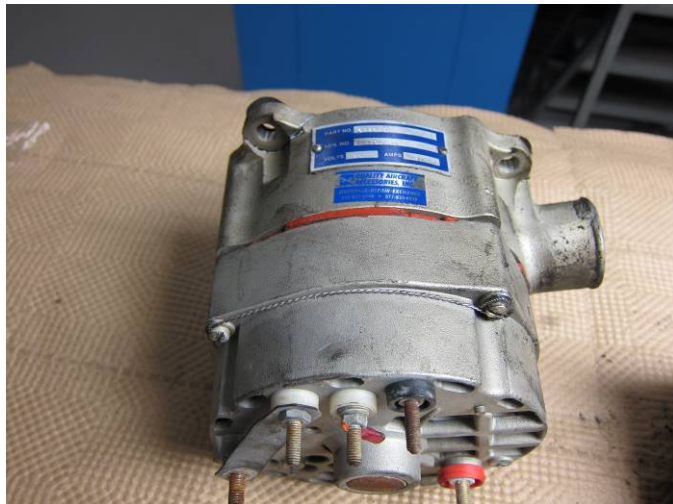
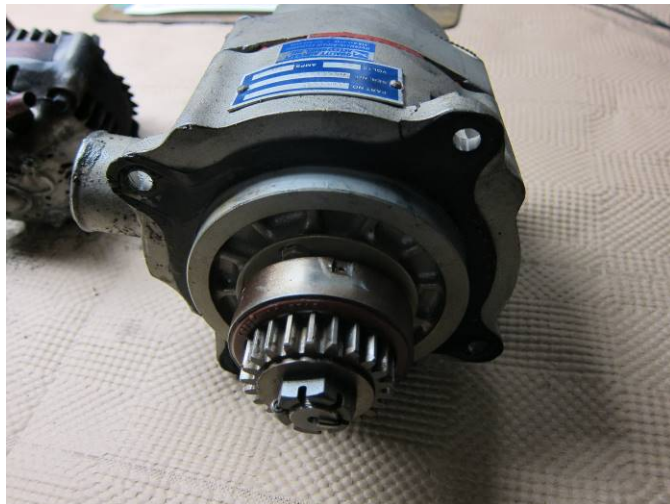
The alternator remained attached to its installation point and displayed minor impact damage signatures. There were no pre-impact anomalies noted with the alternator.

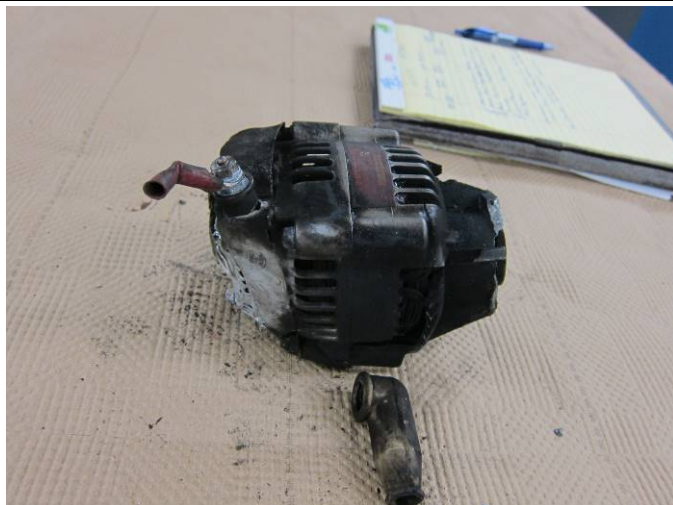
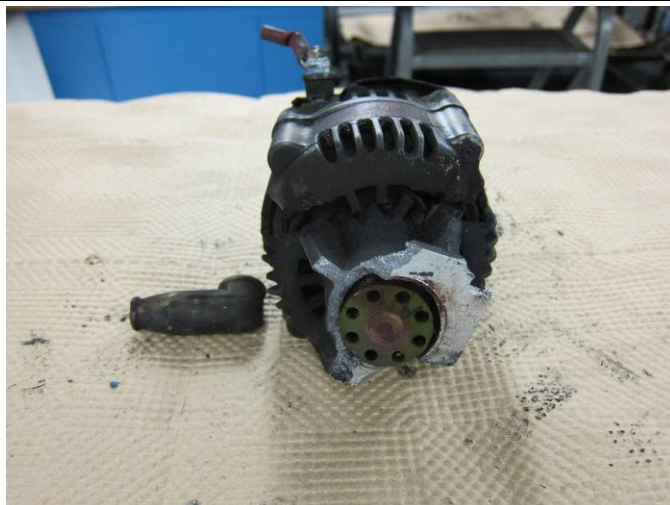
ALT/GEN #2

The alternator had broken free from its installation point and displayed impact and thermal damage signatures. There were no pre-impact anomalies noted with the alternator.

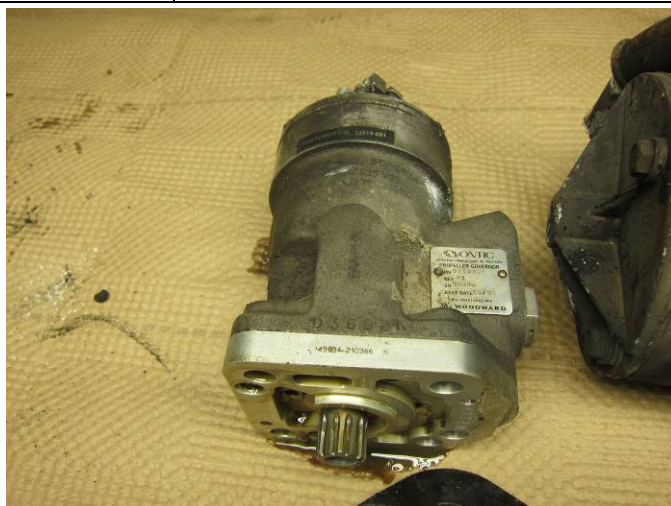
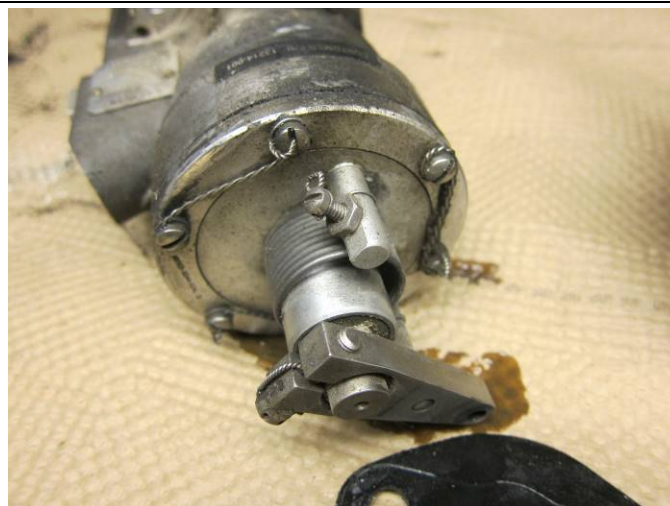
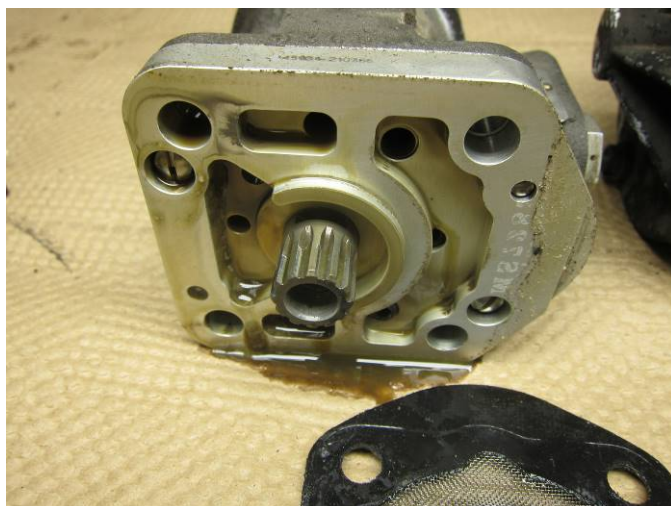
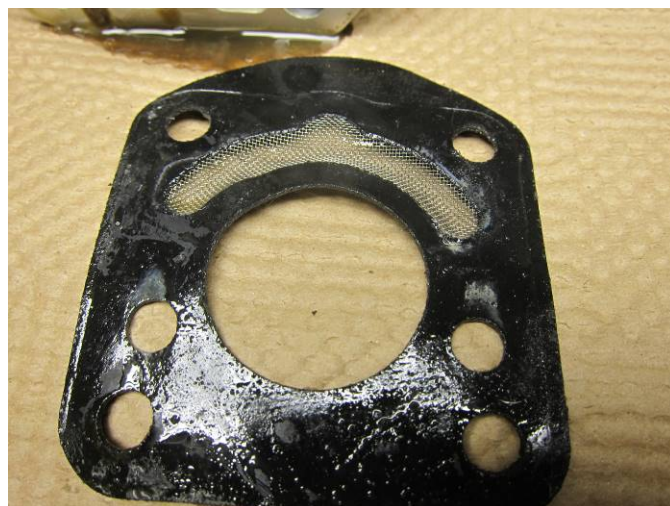
The propeller governor remained attached to its installation point and was undamaged. The governor was removed and it was noted that the gasket screen was clear of any contaminants. The propeller governor drive was capable of rotation and residual oil was pumped out of the governor. There were no anomalies noted with the governor.
