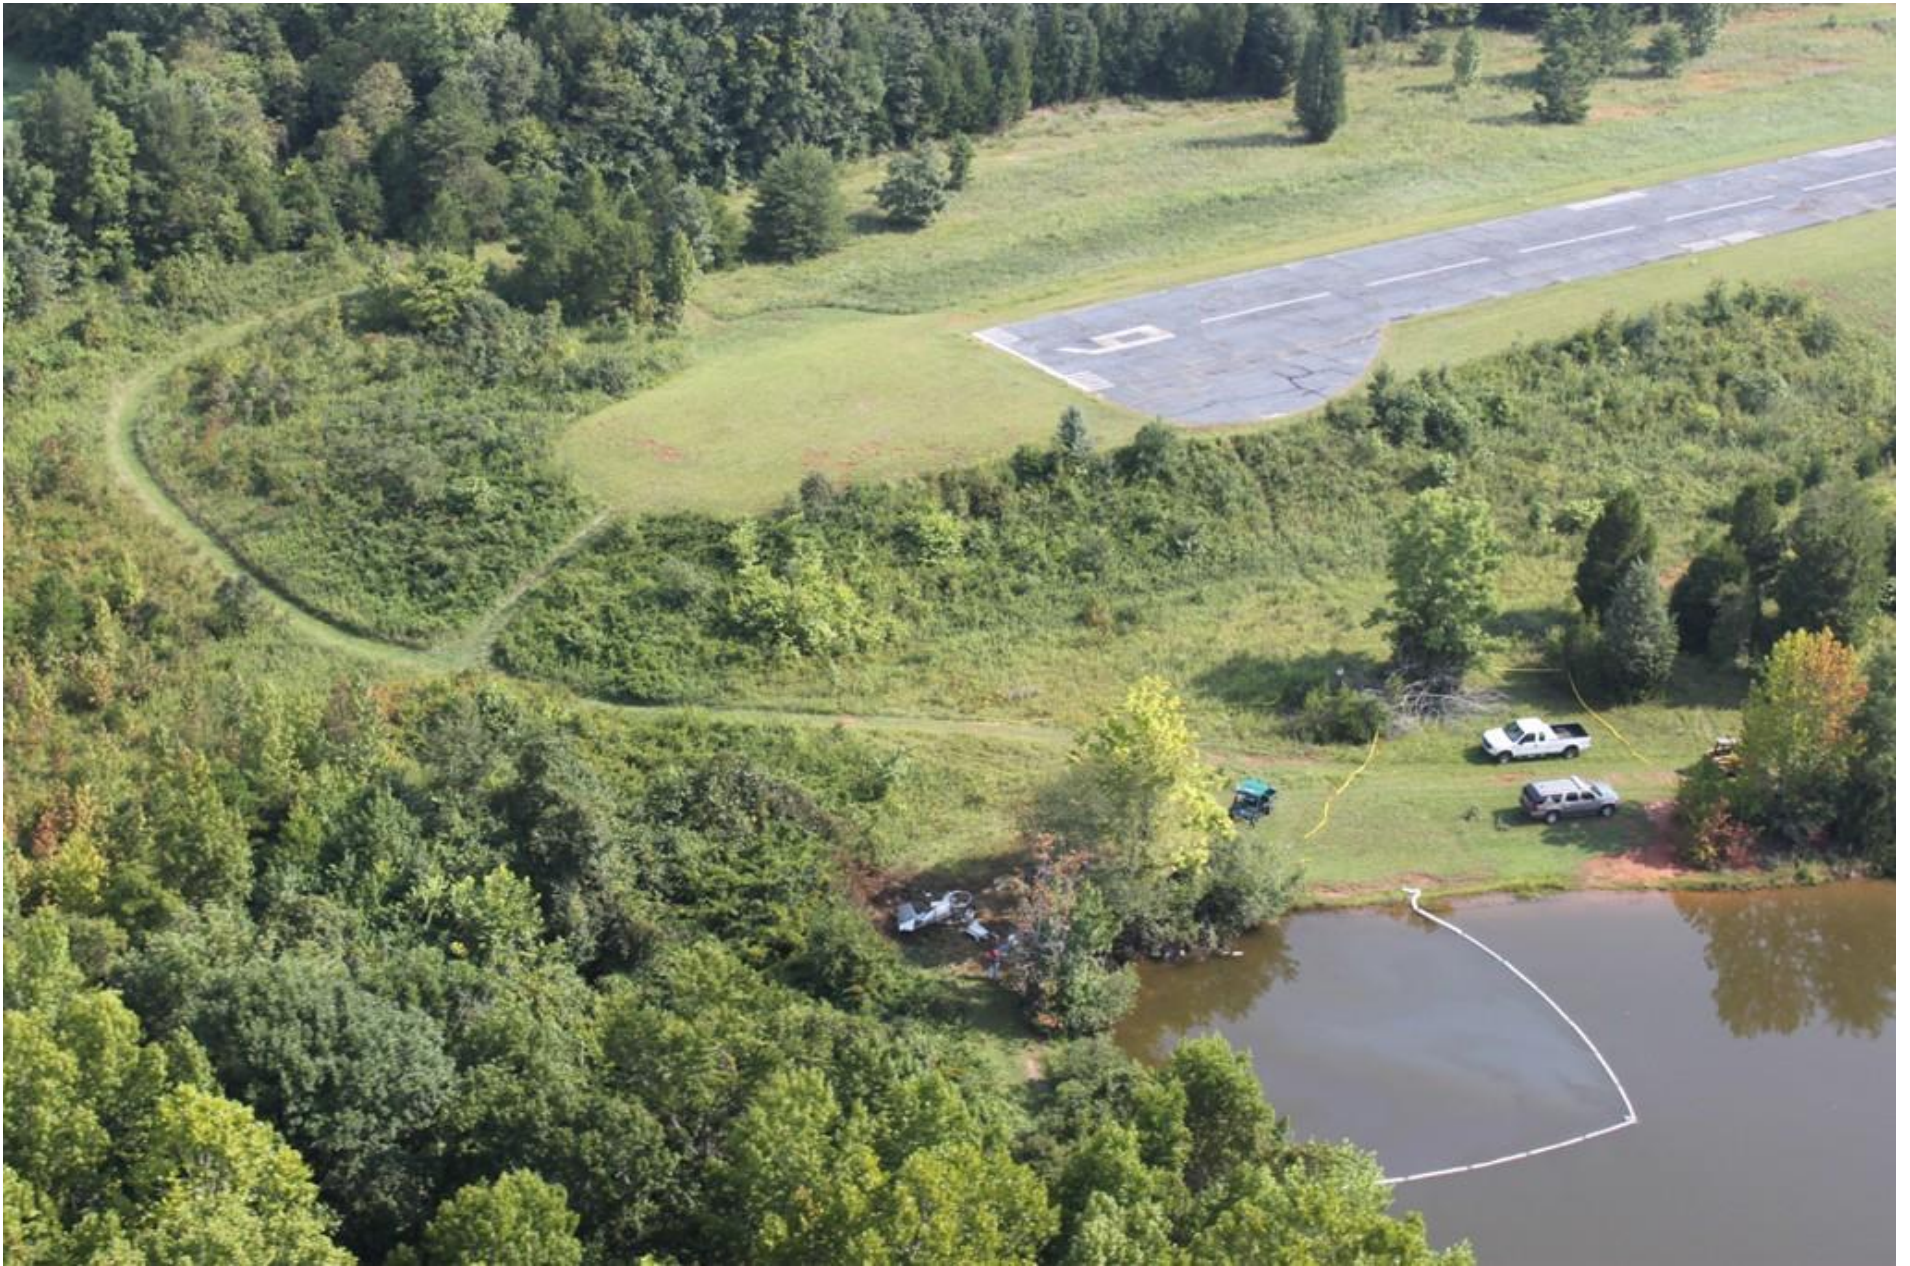
**Photo 1 – NTSB Digital Photograph. Aerial view Depicting the Accident Site Location Reference to the Runway.**

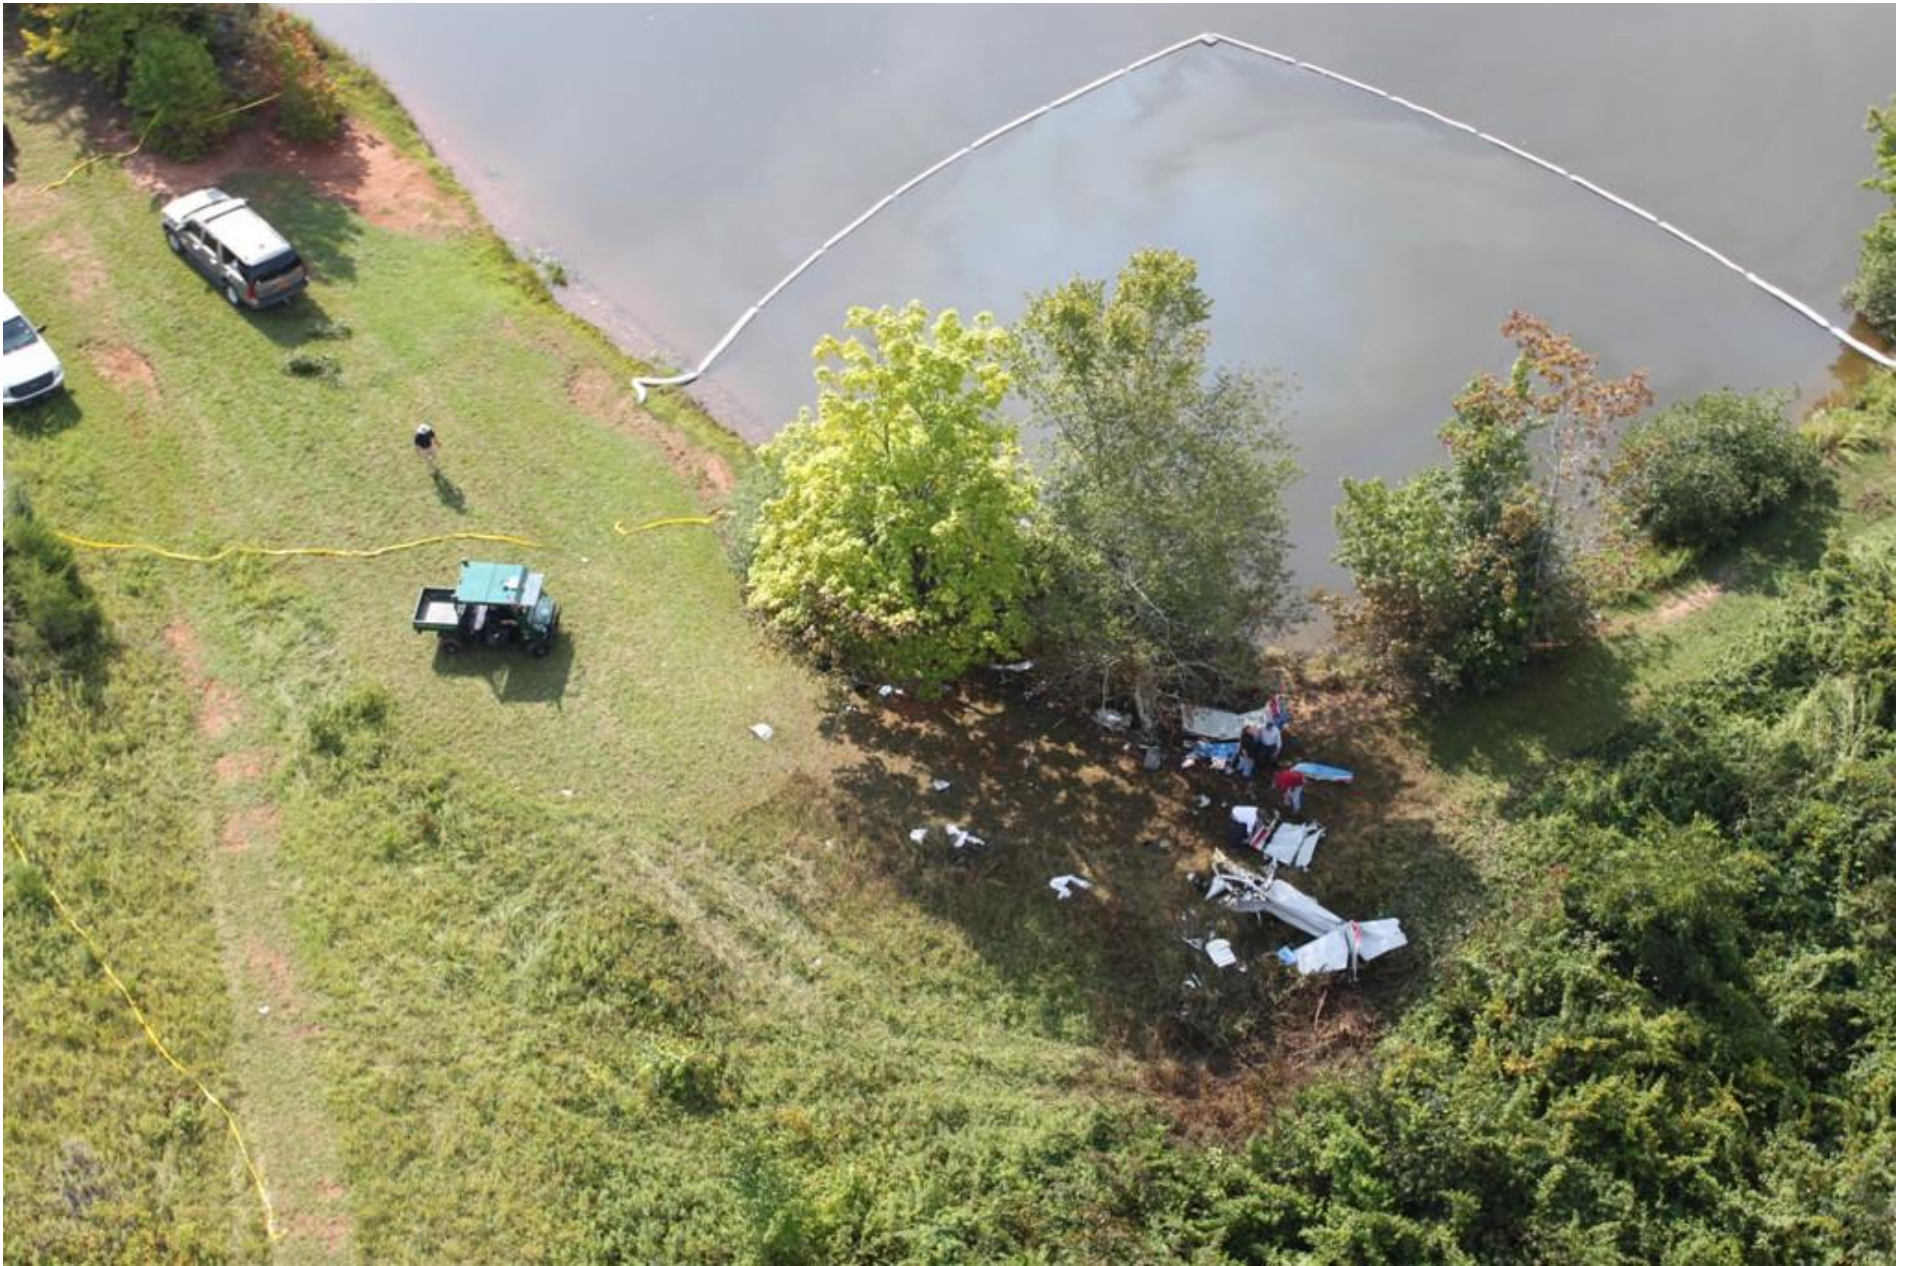
**Photo 2 - NTSB Digital Photograph. Close-Up Aerial View of the Accident Site. Note the fuel sheen on the water.**

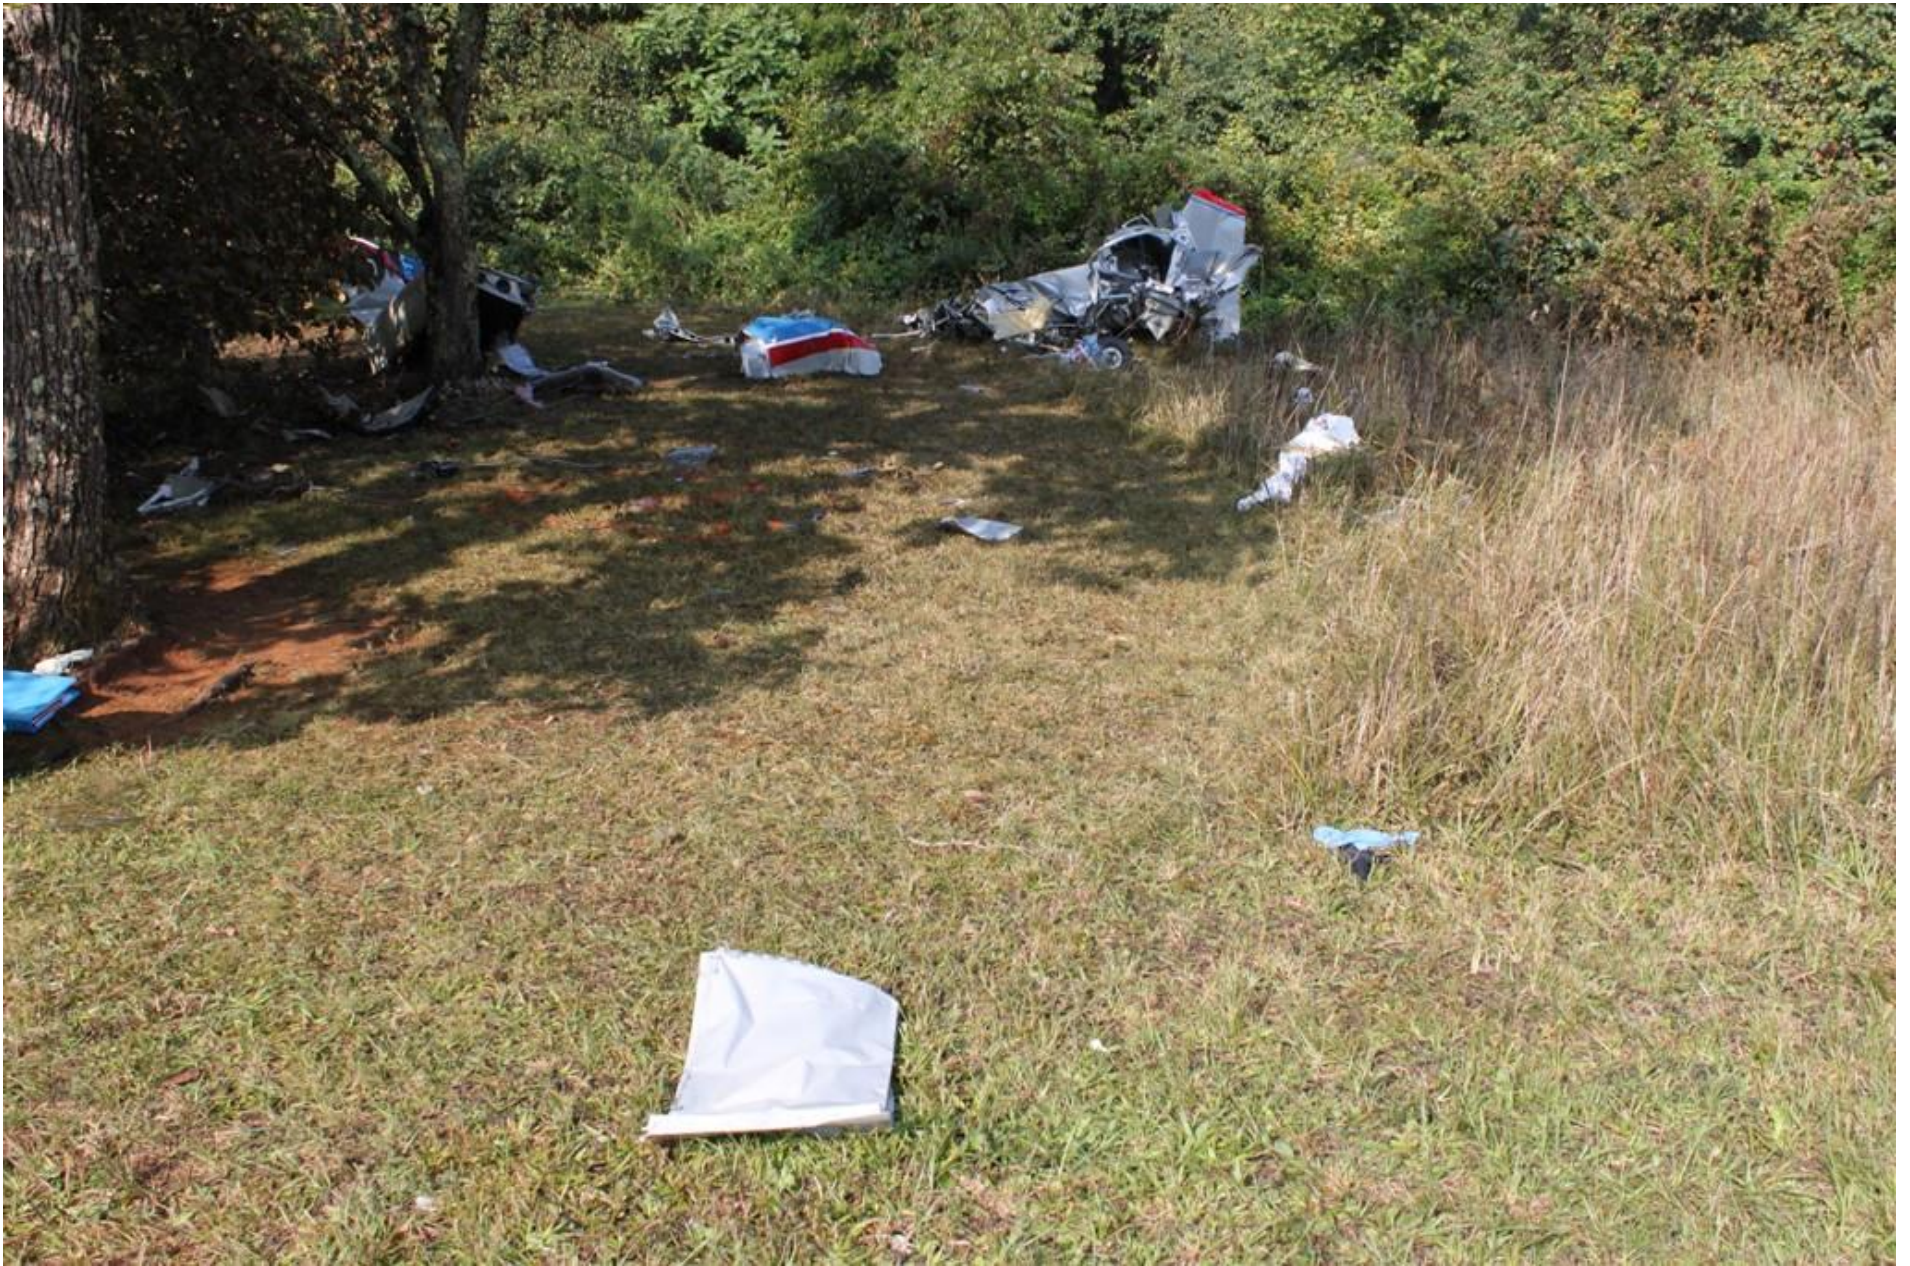
**Photo 3 - NTSB Digital Photograph. Ground View of the Main Wreckage at the Accident Site. Note the fragmentation.**

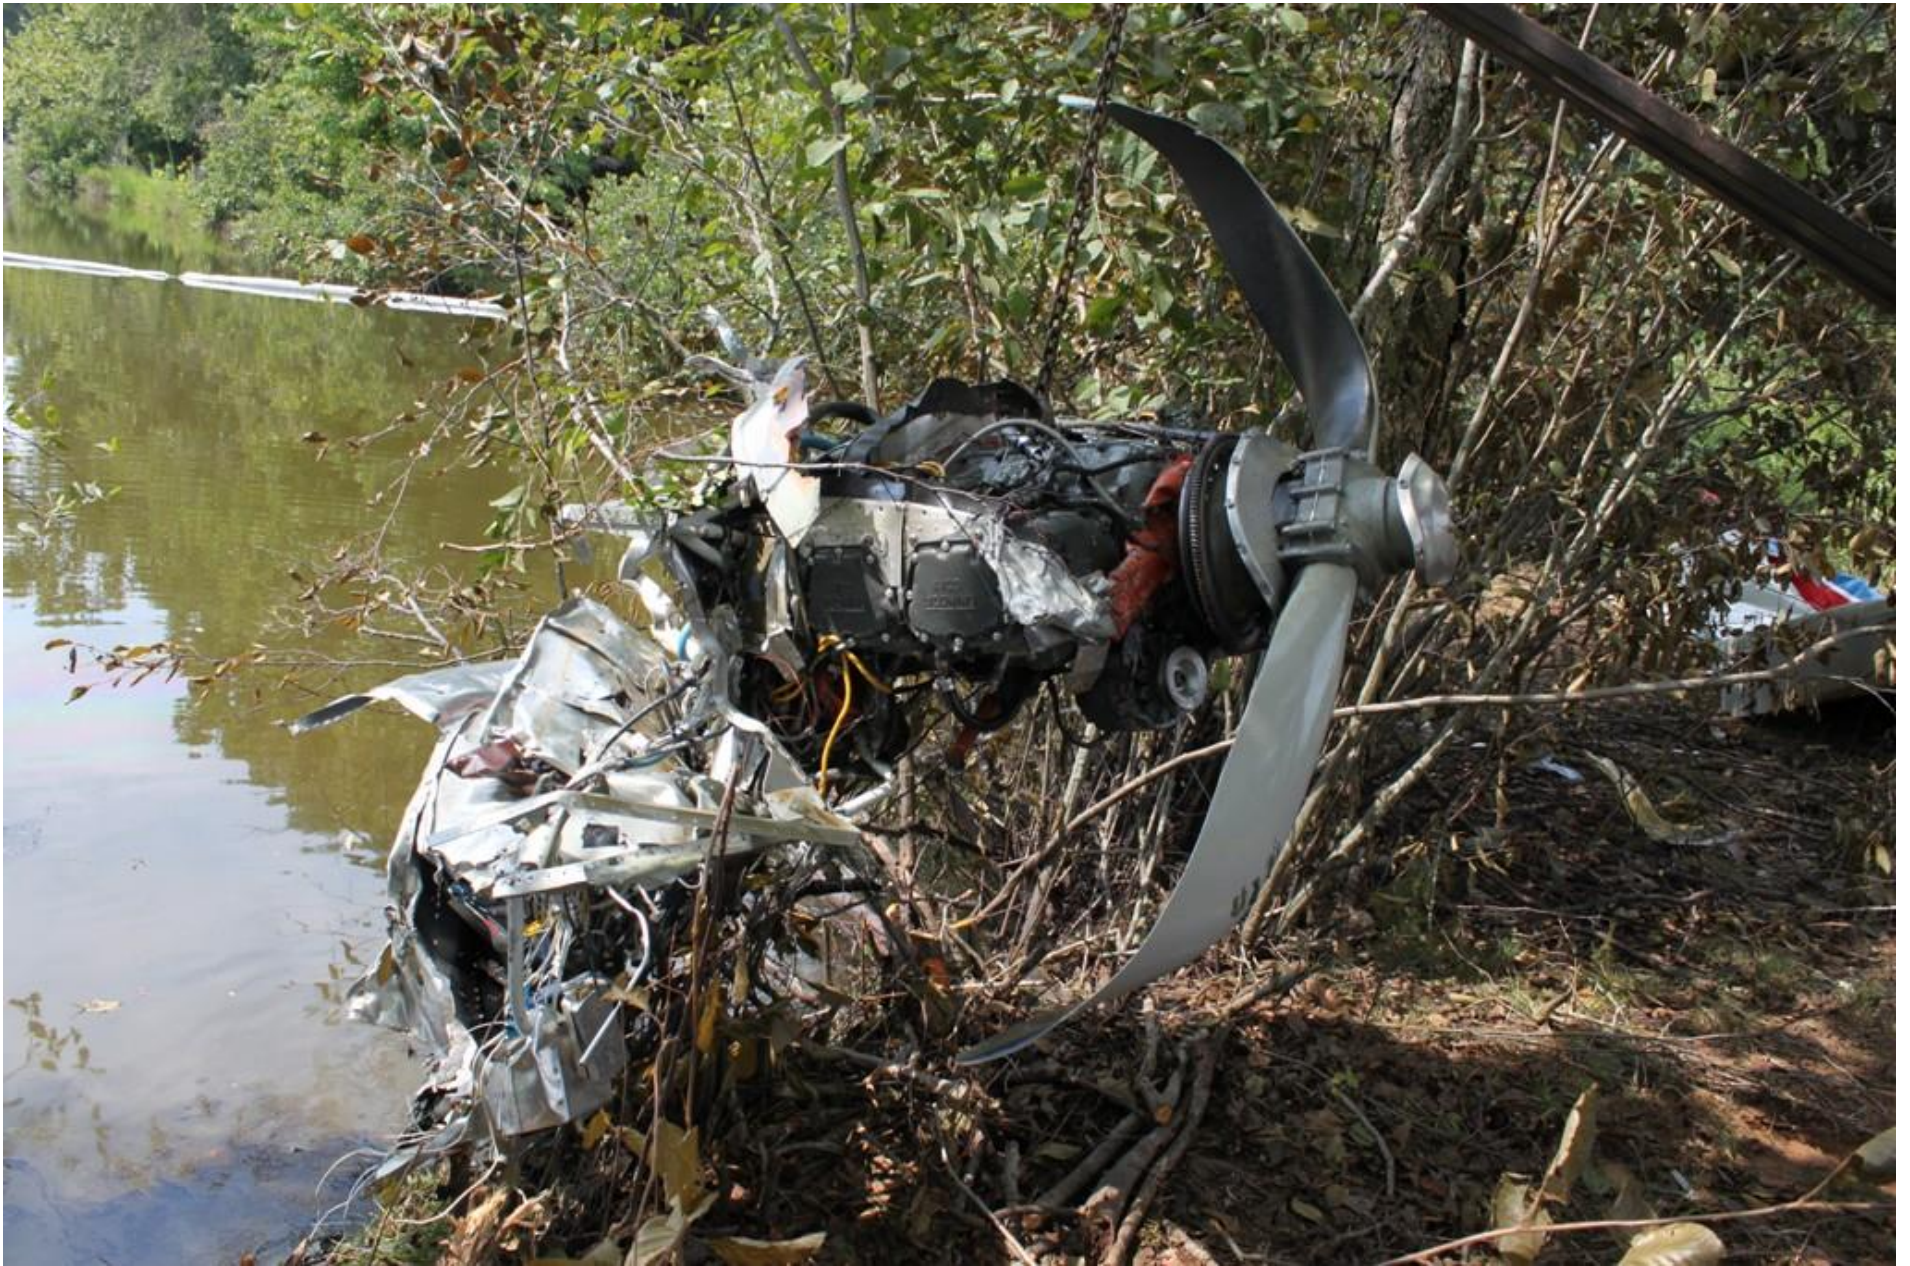
**Photo 4 - NTSB Digital Photograph. View Depicting the Engine Assembly with Attached Firewall Being Removed from the Water.**

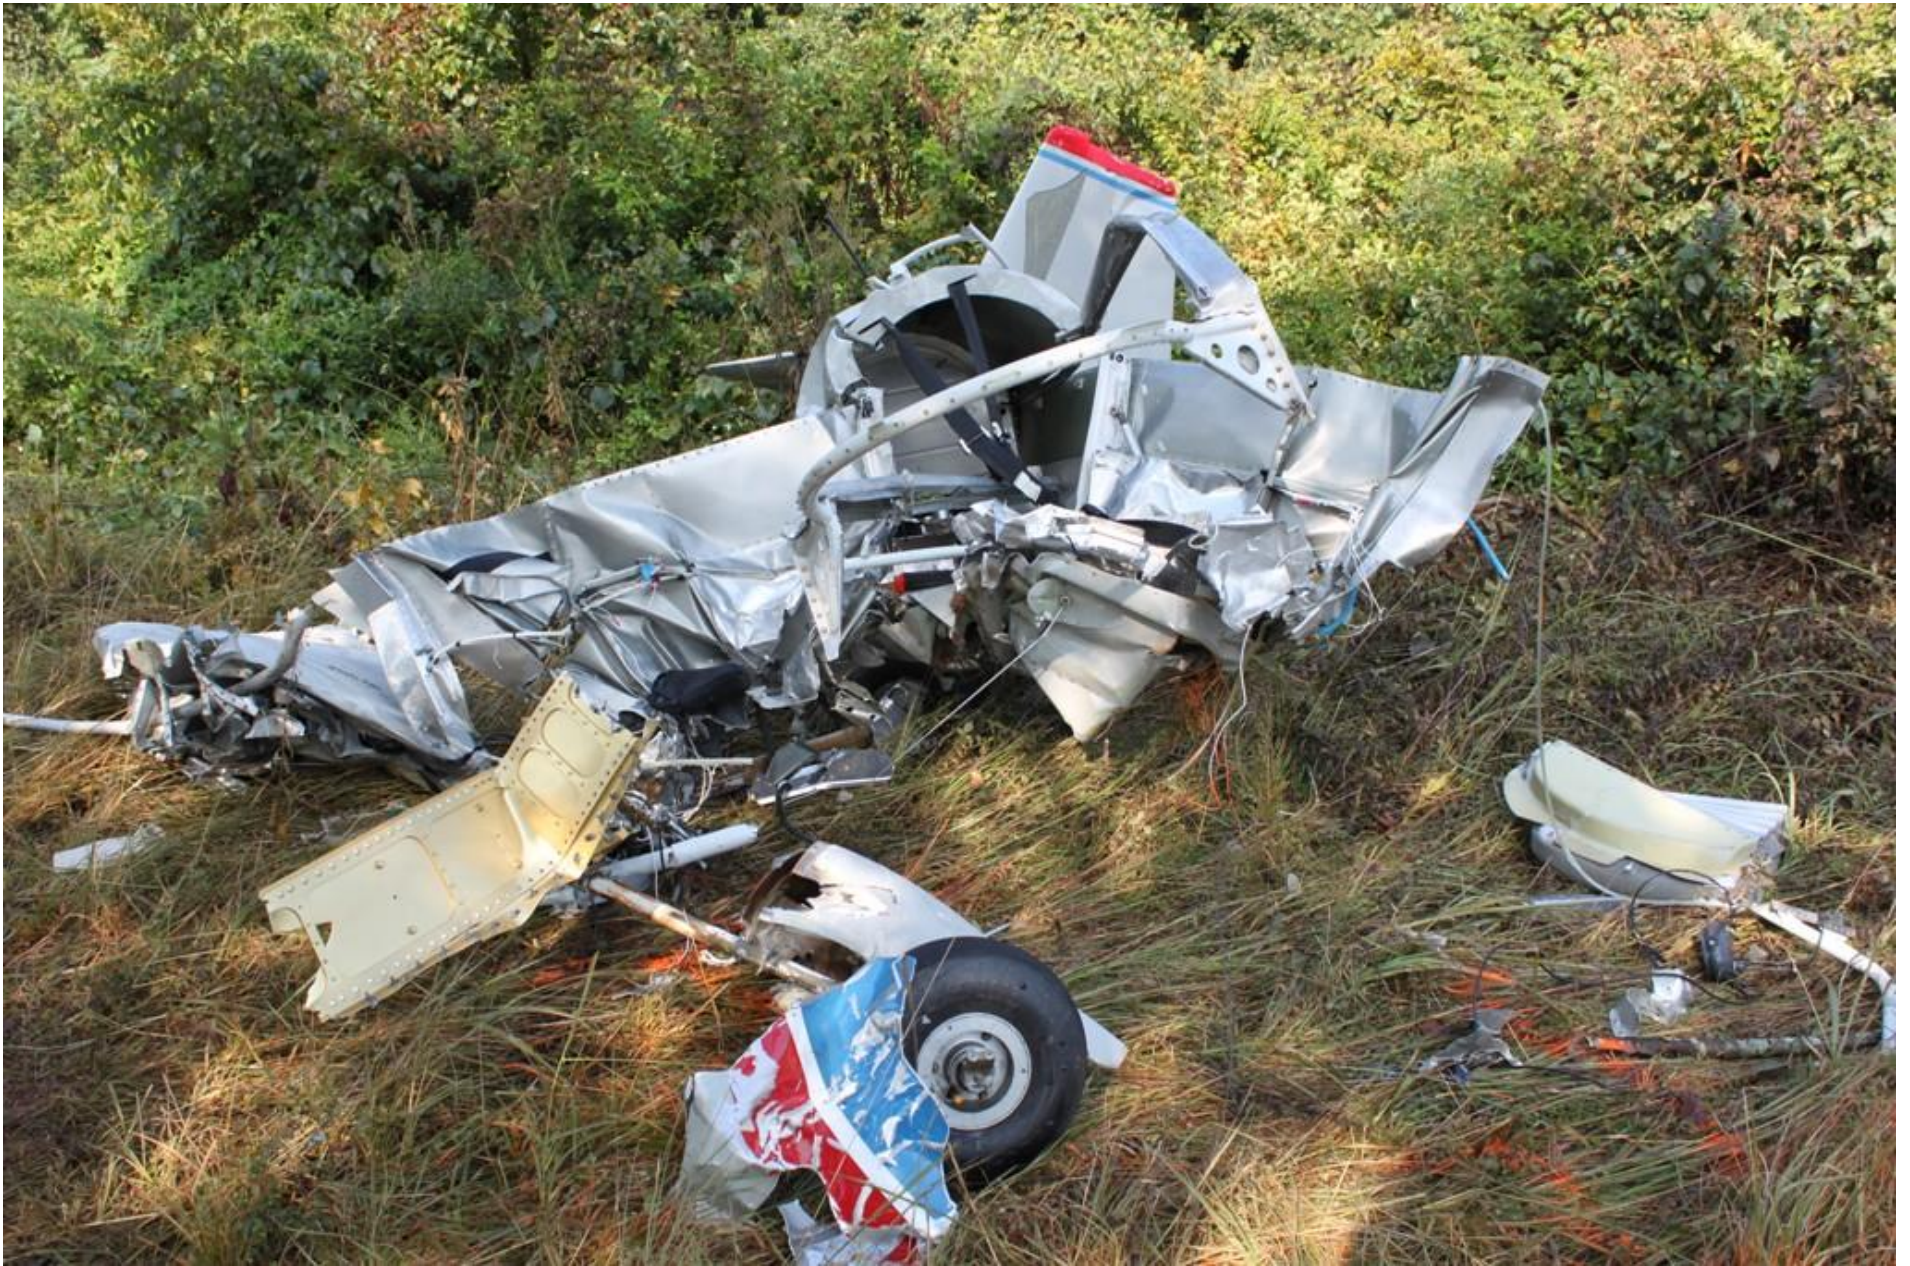
**Photo 5 - NTSB Digital Photograph. View Depicting the Cockpit and Empennage.**

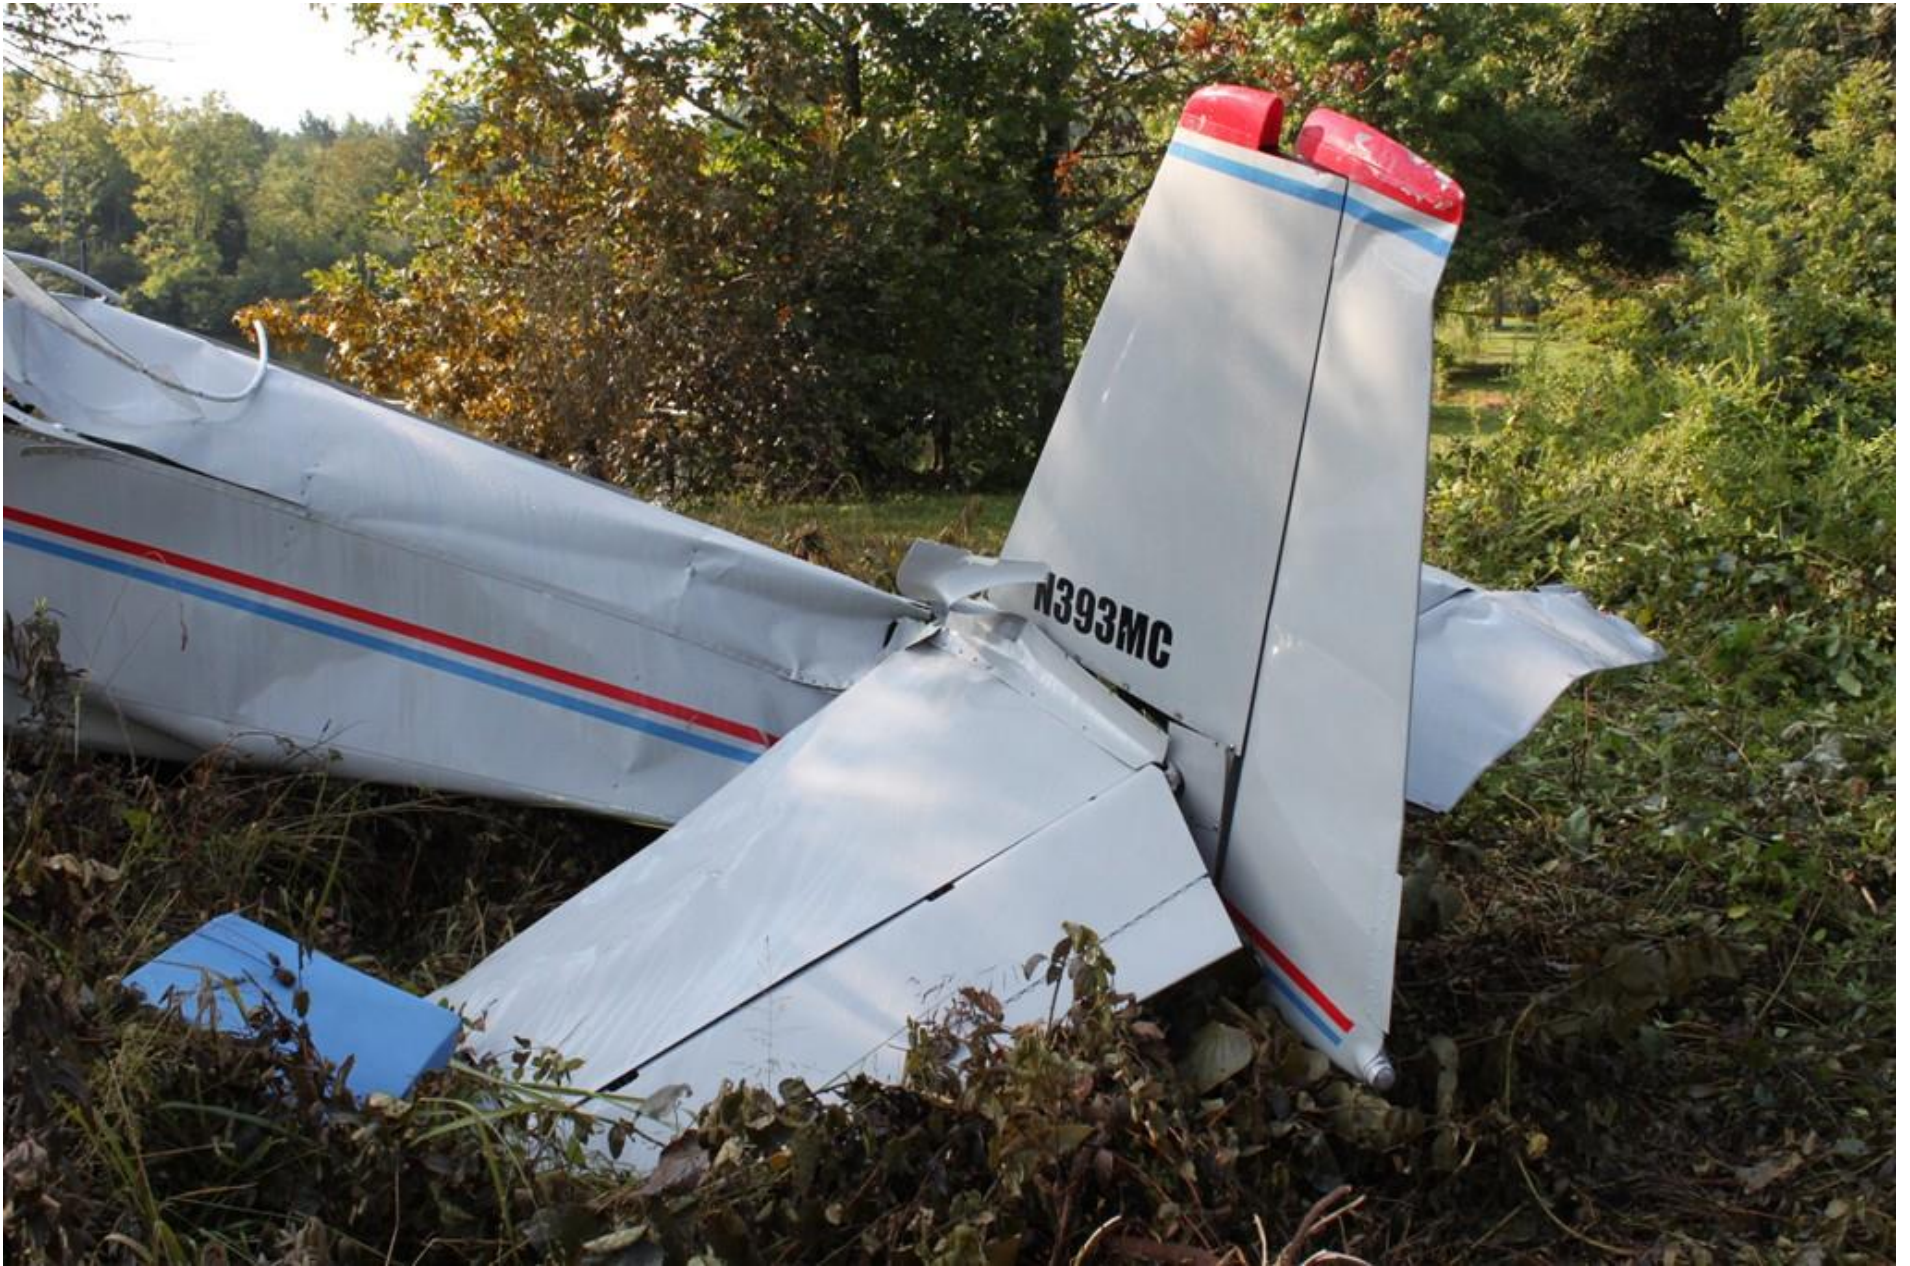
**Photo 6 - NTSB Digital Photograph. Left Side View of the Empennage.**

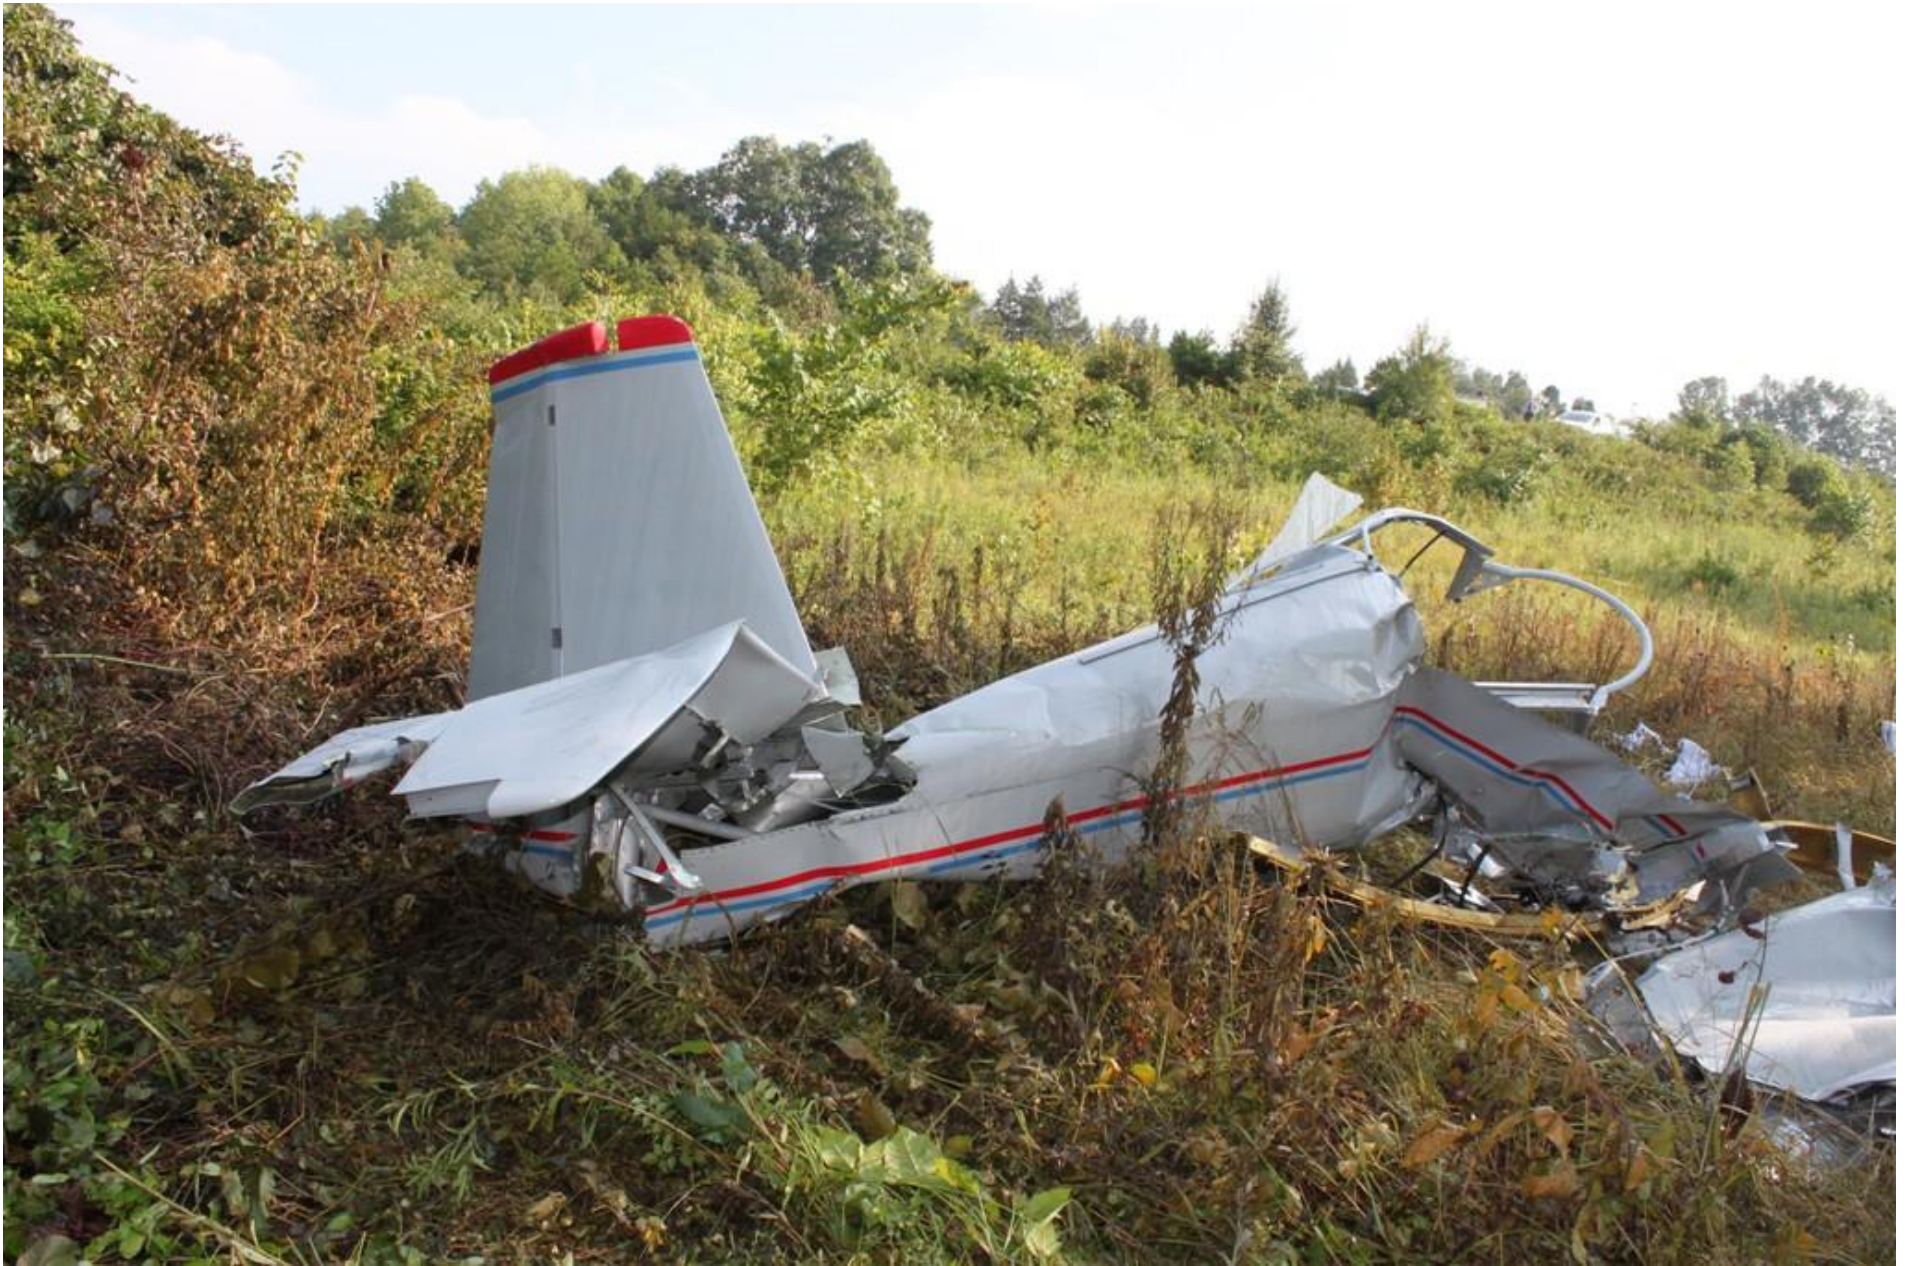
**Photo 7 - NTSB Digital Photograph. Right Side View of the Empennage. Note the damaged Right Horizontal Stabilizer.**

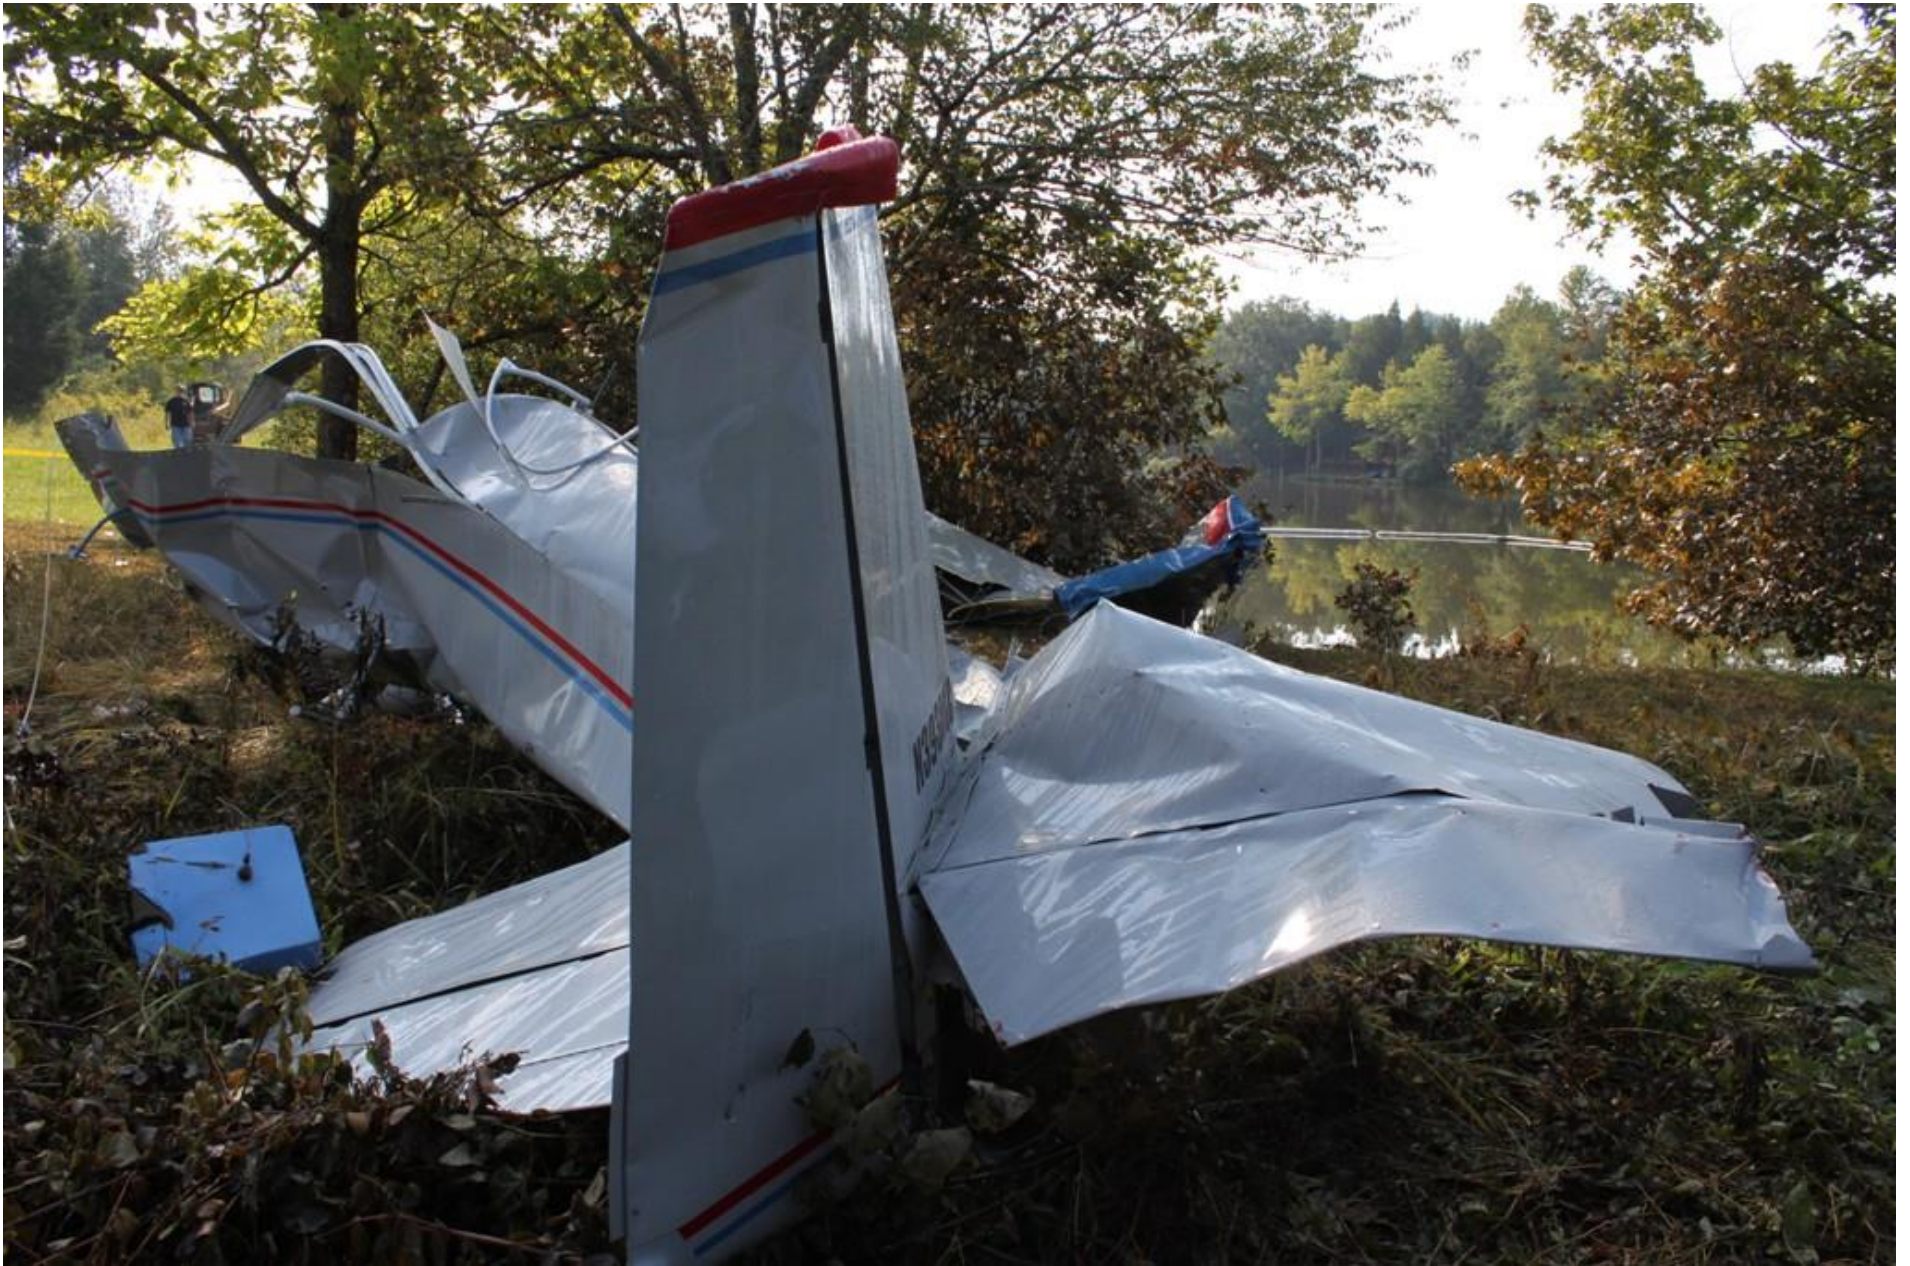
**Photo 8 - NTSB Digital Photograph. Rear View of the Empennage.**

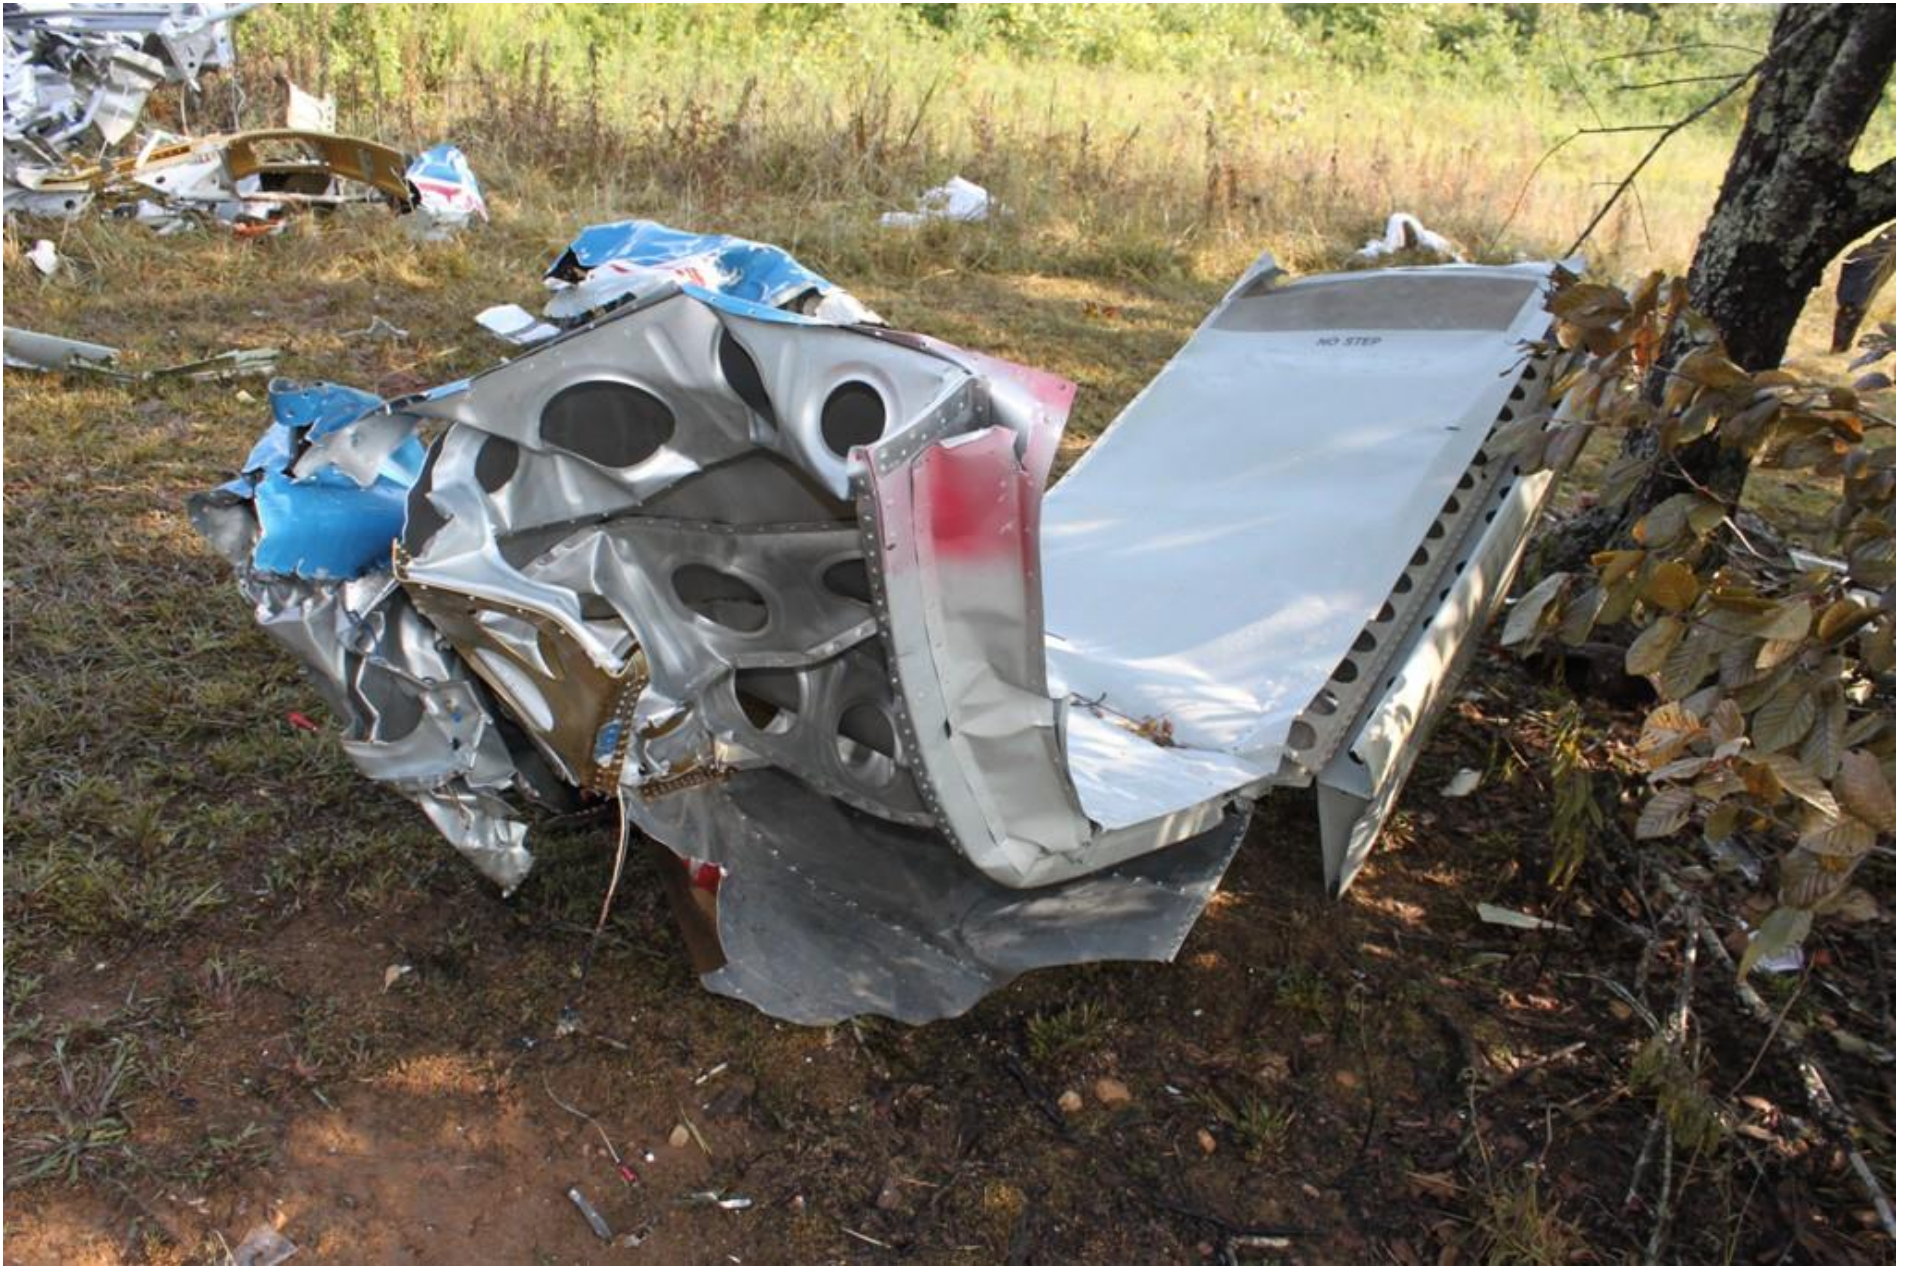
**Photo 9 - NTSB Digital Photograph. View Depicting the Left Wing.**
