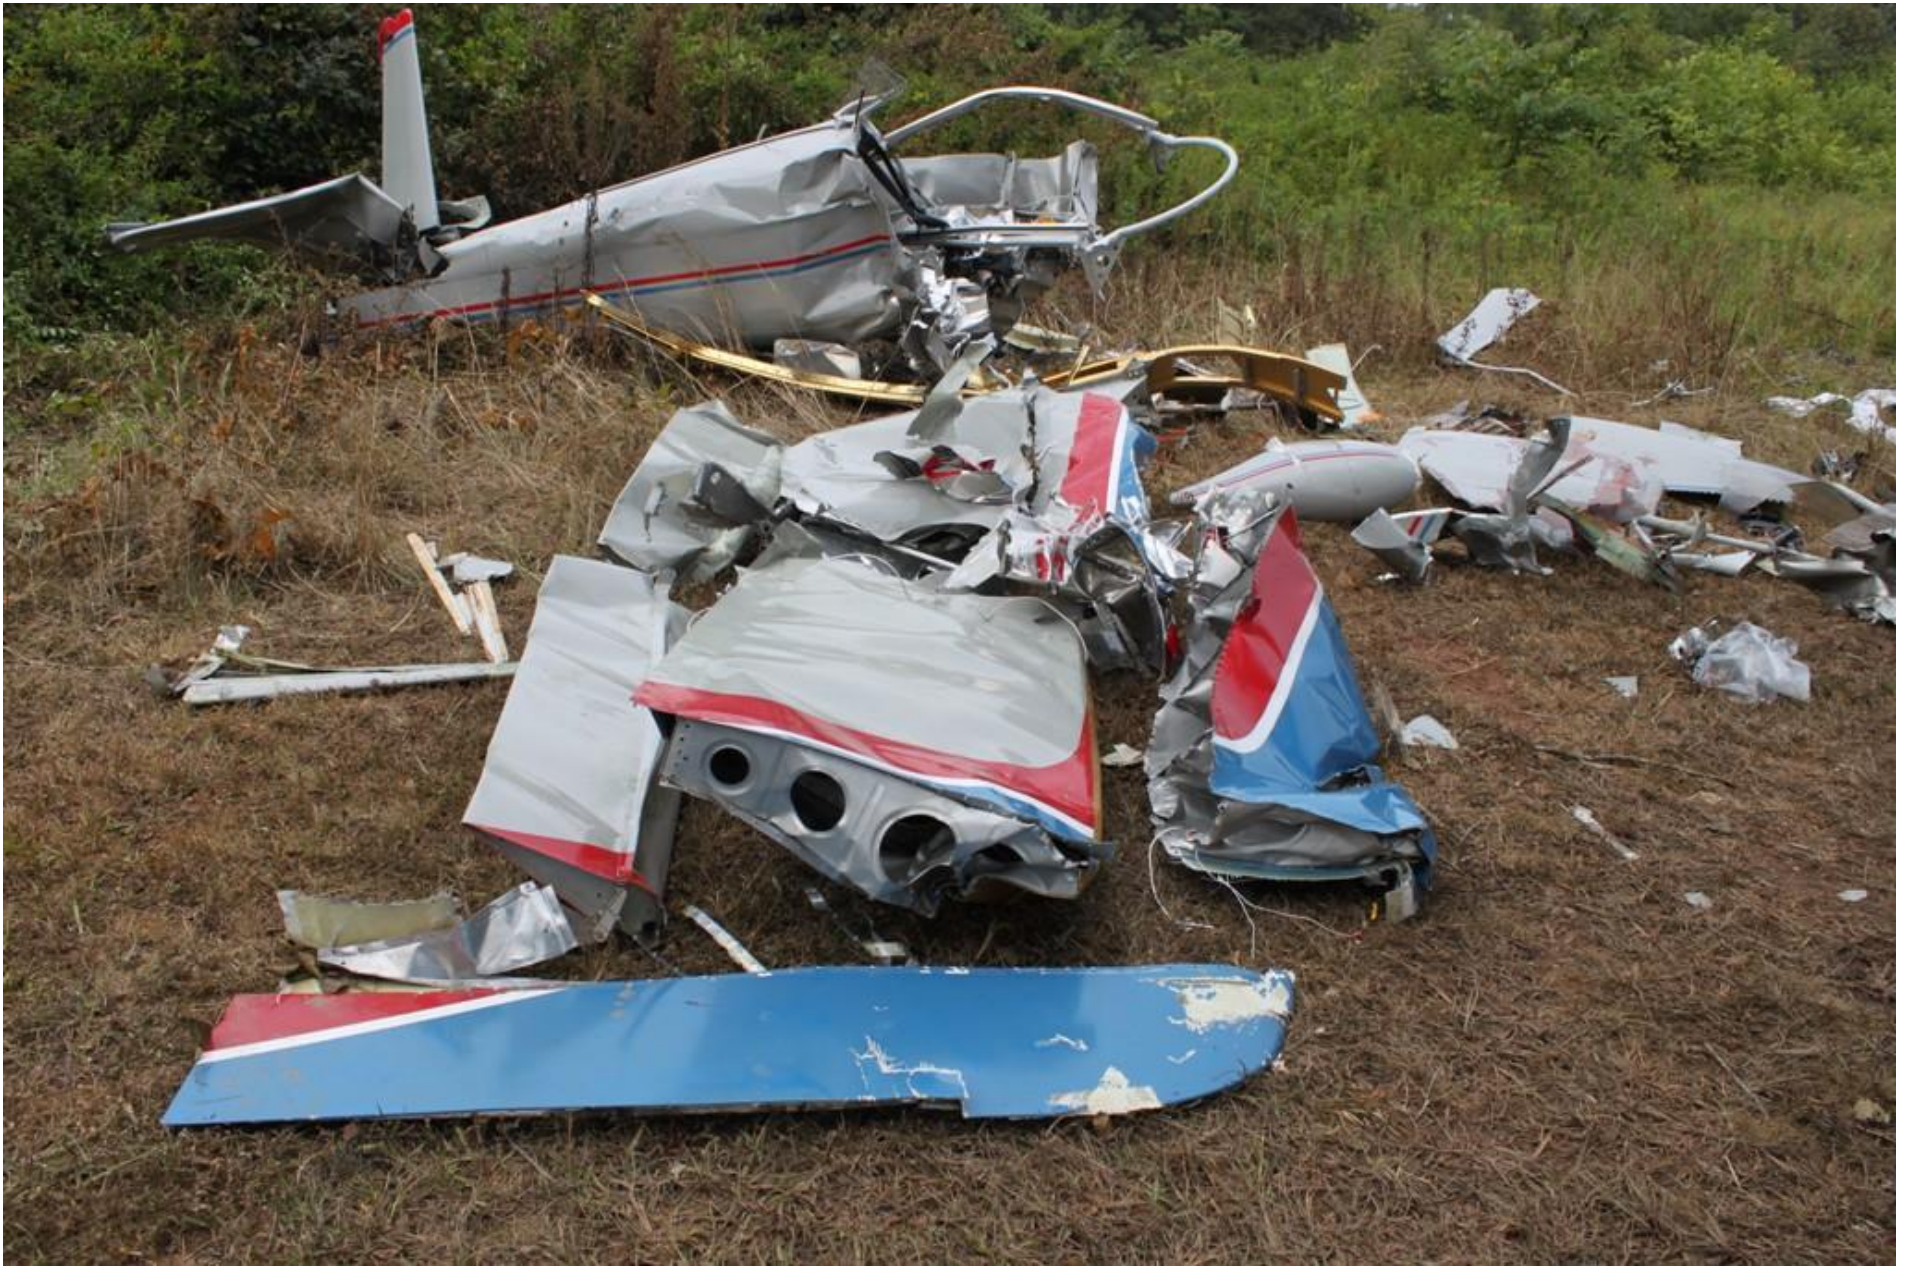
**Photo 10 - NTSB Digital Photograph. View of the Fragmented Right Wing.**

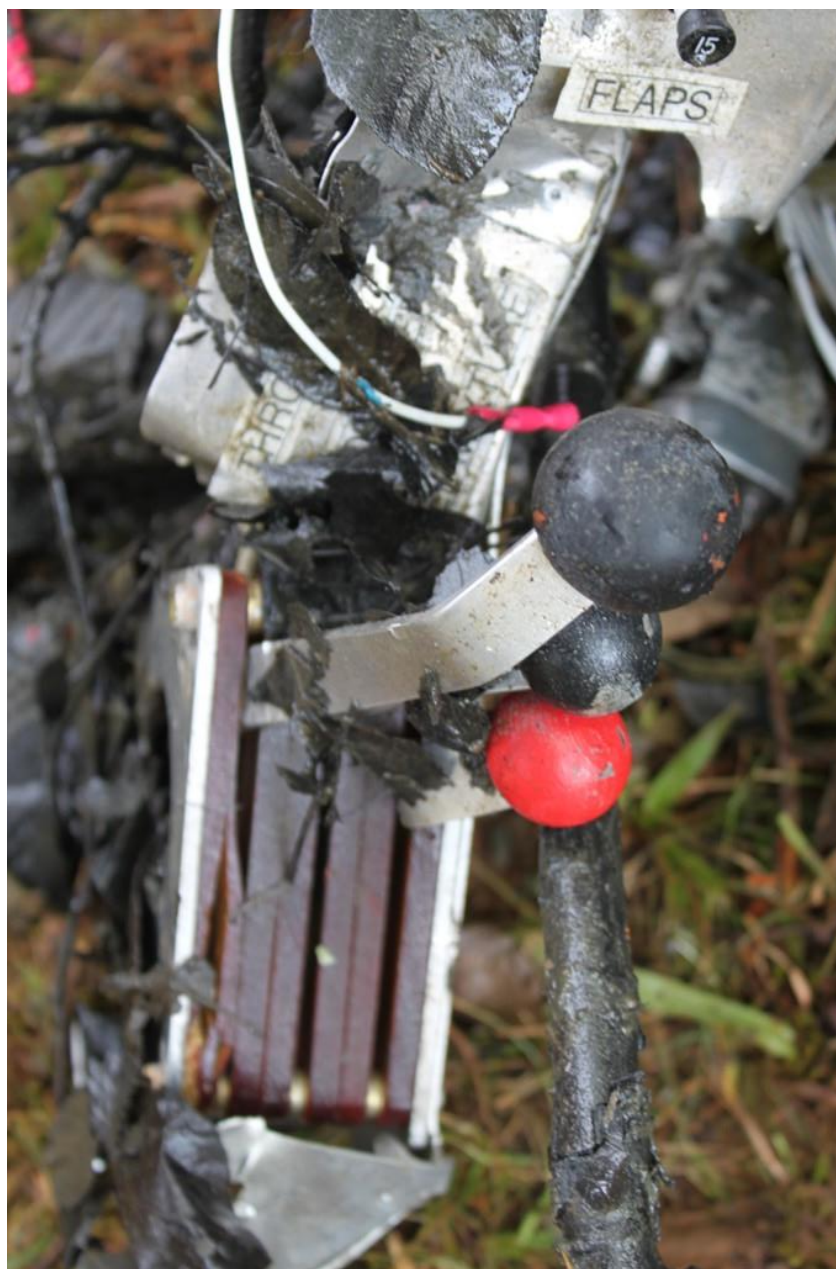
**Photo 11 - NTSB Digital Photograph. View of the Throttle Quadrant.**

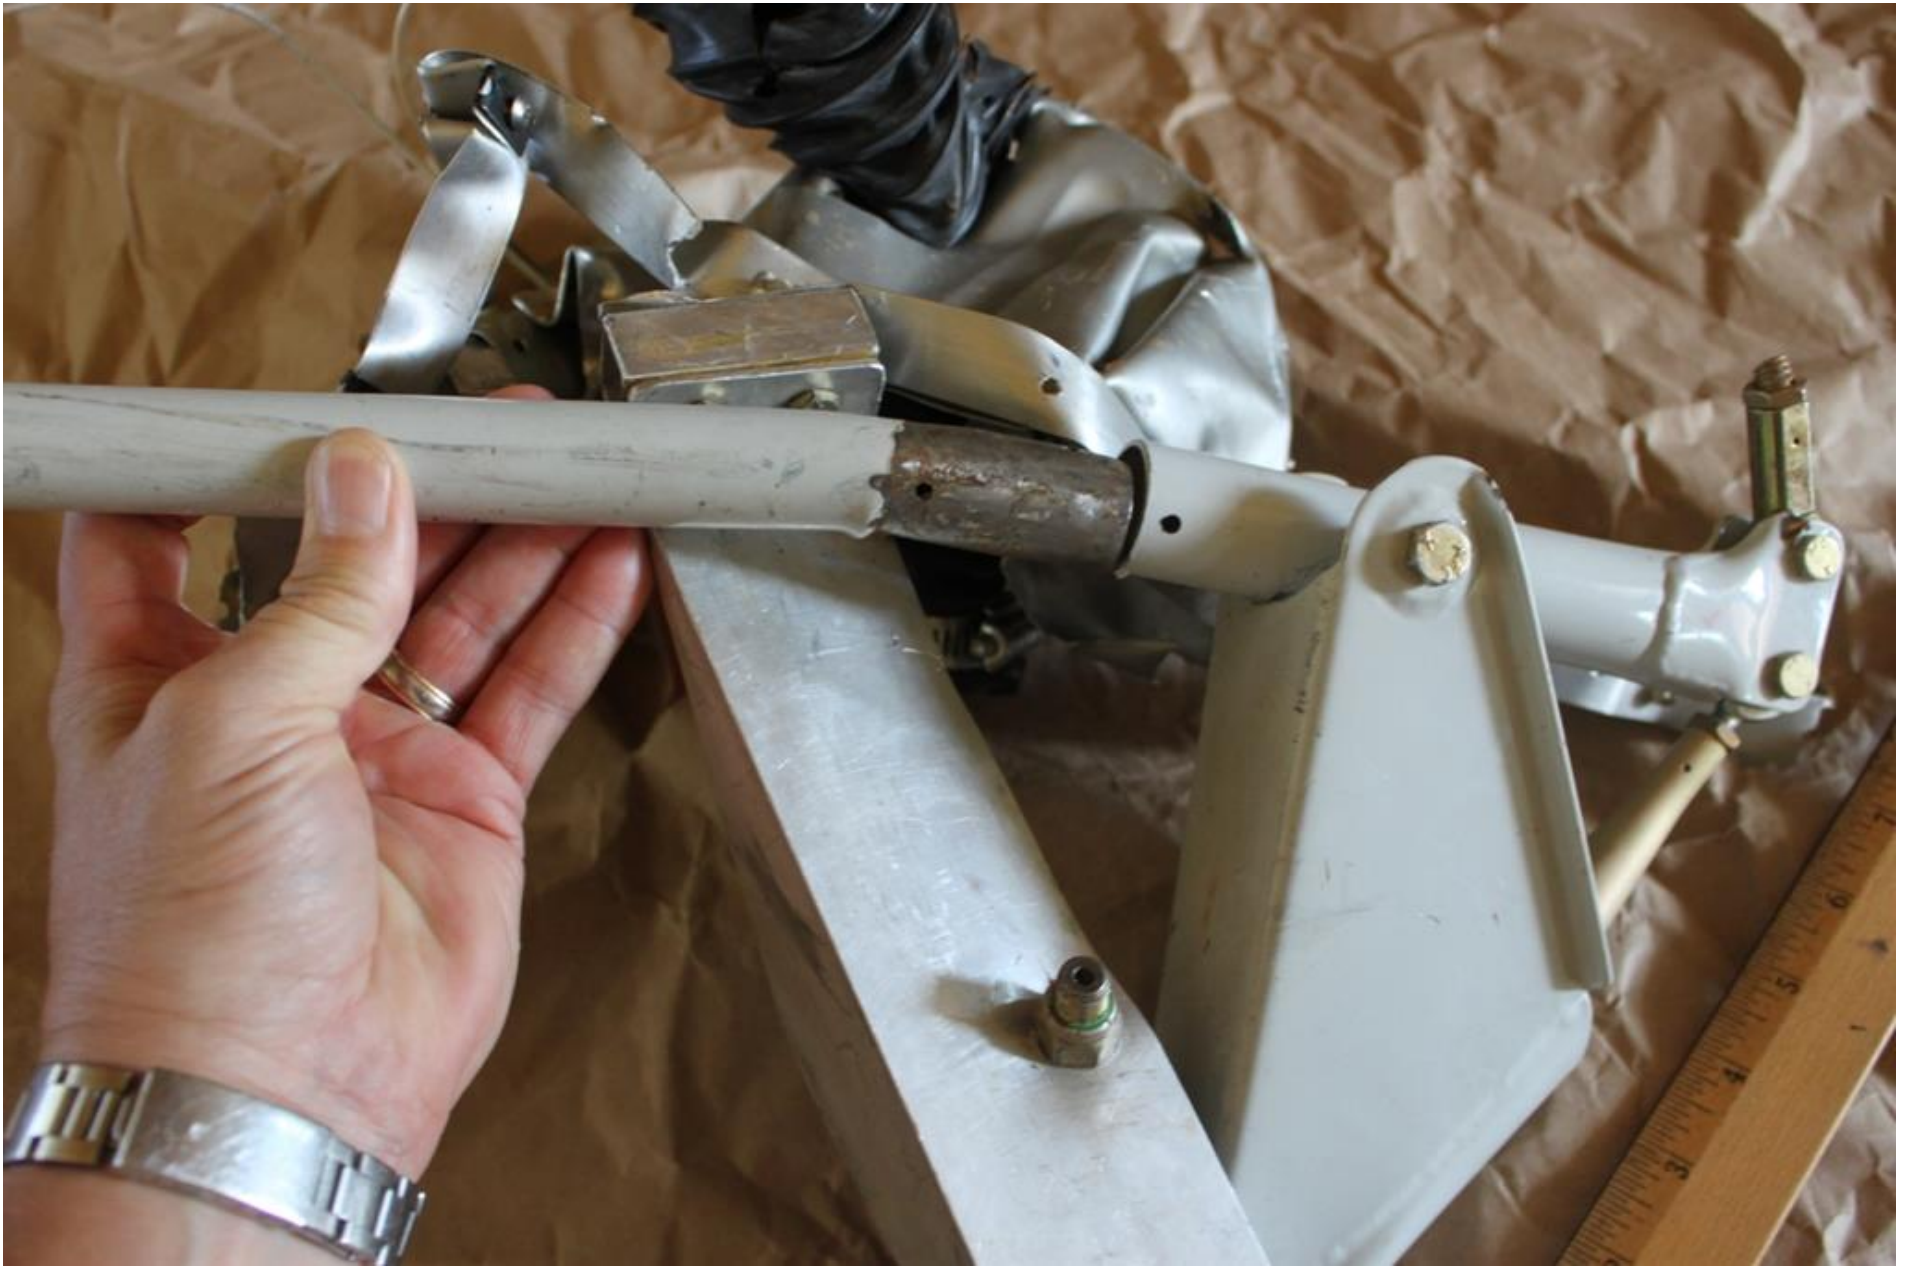
**Photo 12 - NTSB Digital Photograph. Left Side View of the Rear Seat Control Stick and Control Stick Base. Note the bulging on the Forward Portion of the Control Stick.**

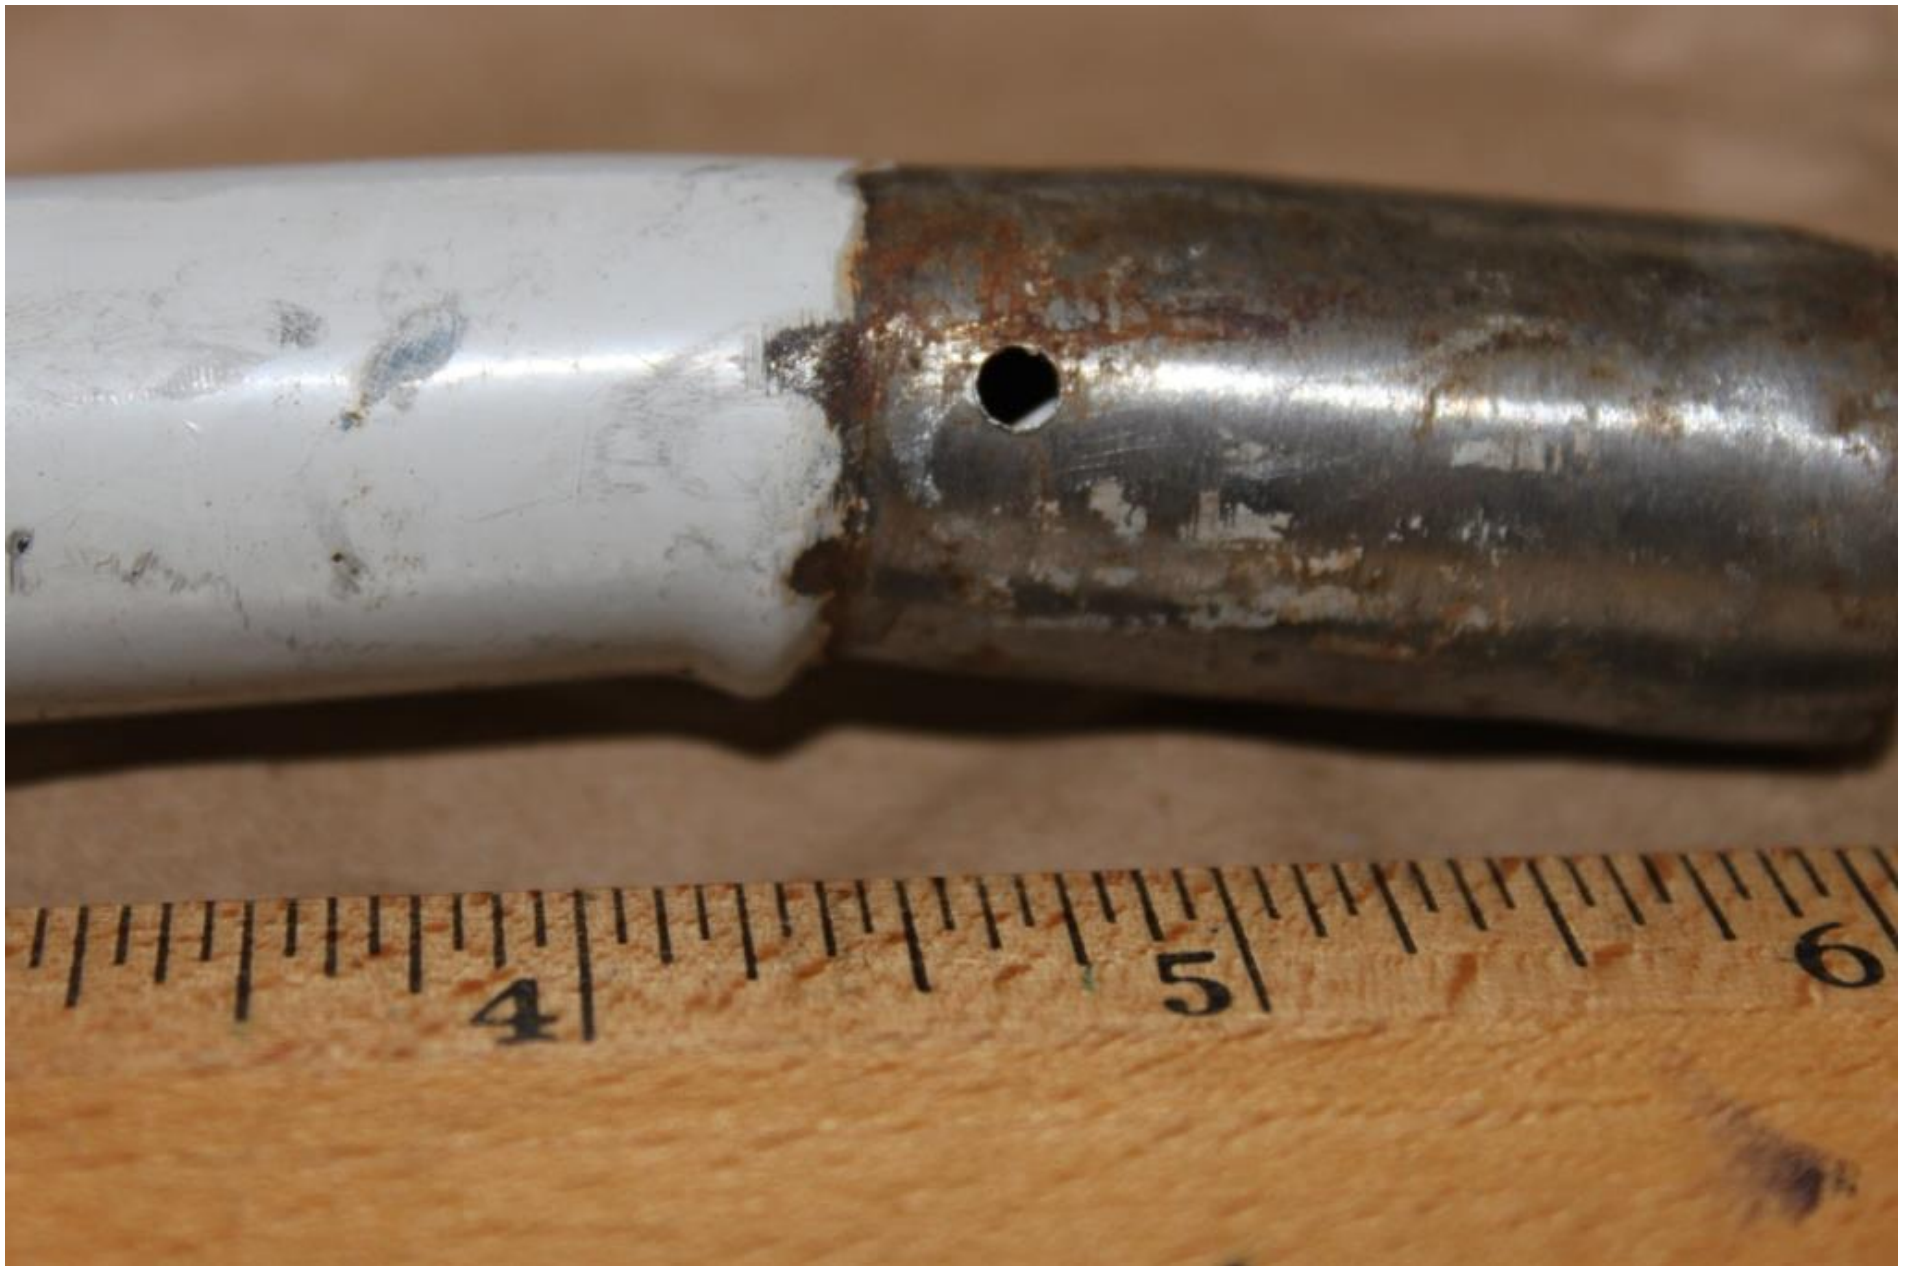
**Photo 13 - NTSB Digital Photograph. Close-Up view of the Left Side of the Rear Seat Control Stick. Note the Bulging on the Forward Portion of the Control Stick.**

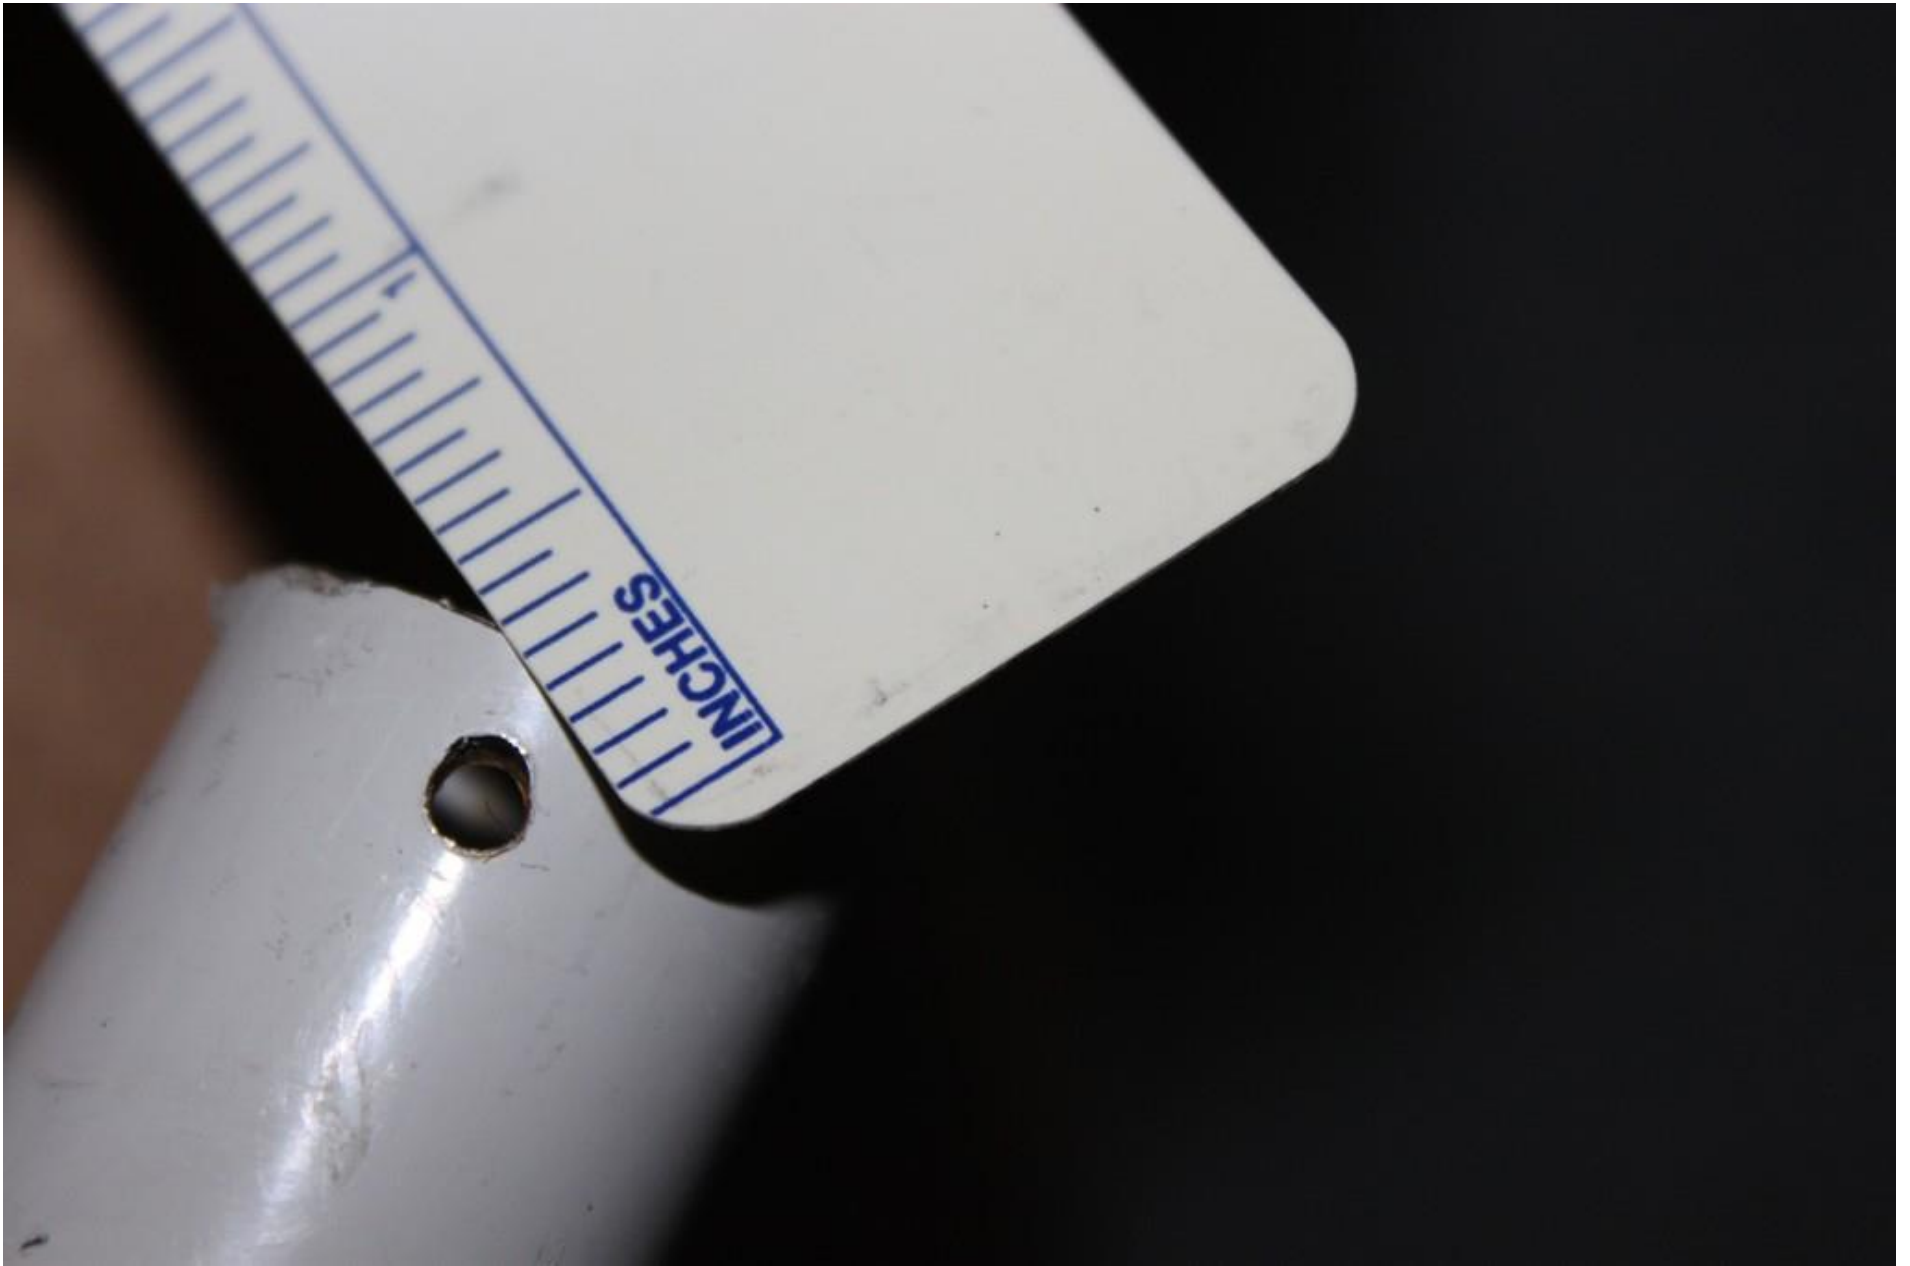
**Photo 14 - NTSB Digital Photograph. Close-Up view of the Left Side of the Rear Seat Control Stick Base. Note the Deformation of the Upper Portion of the Hole.**
