## **NATIONAL TRANSPORTATION SAFETY BOARD**

### **Group Chairman's Factual Report**

#### **AIR TRAFFIC CONTROL**

**ERA15FA340**

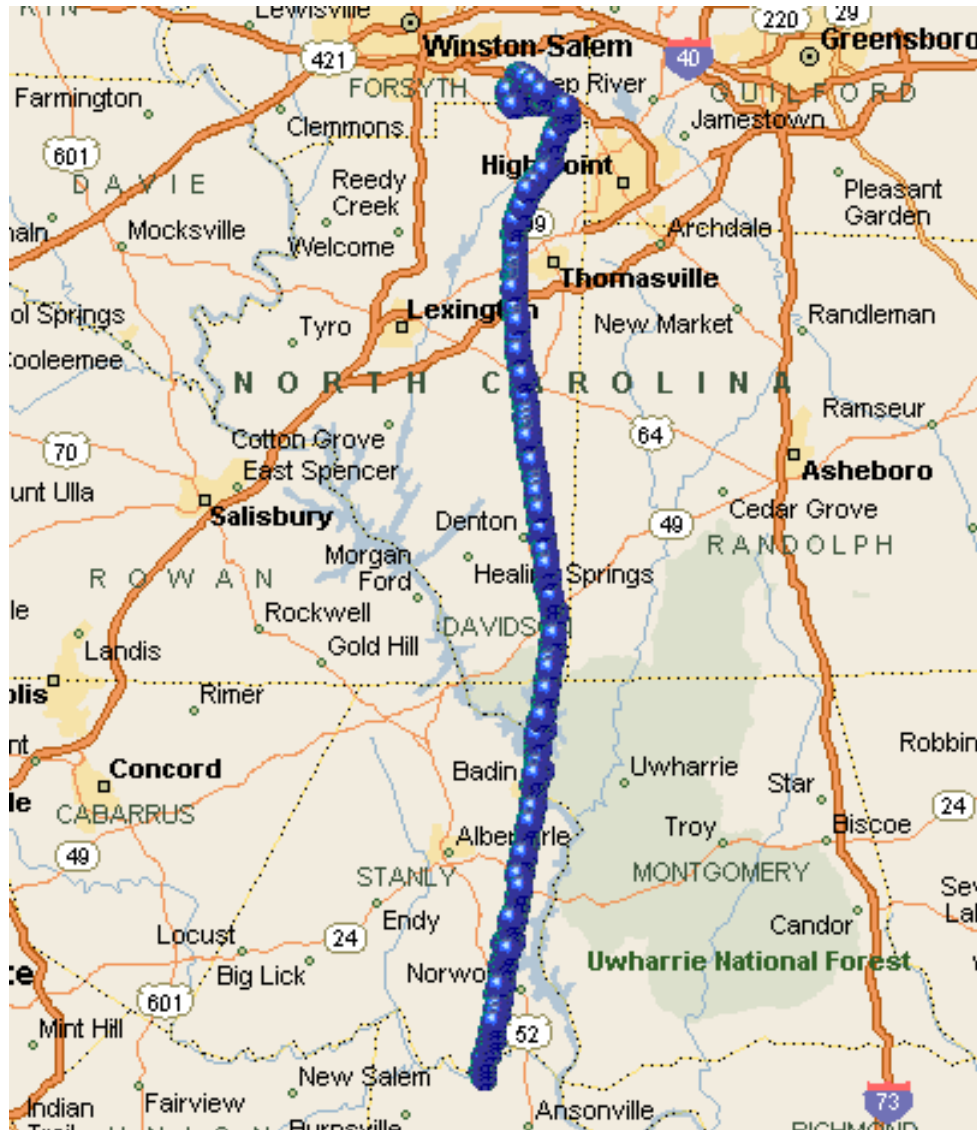
Figure 1 – N36HT flight track overview.

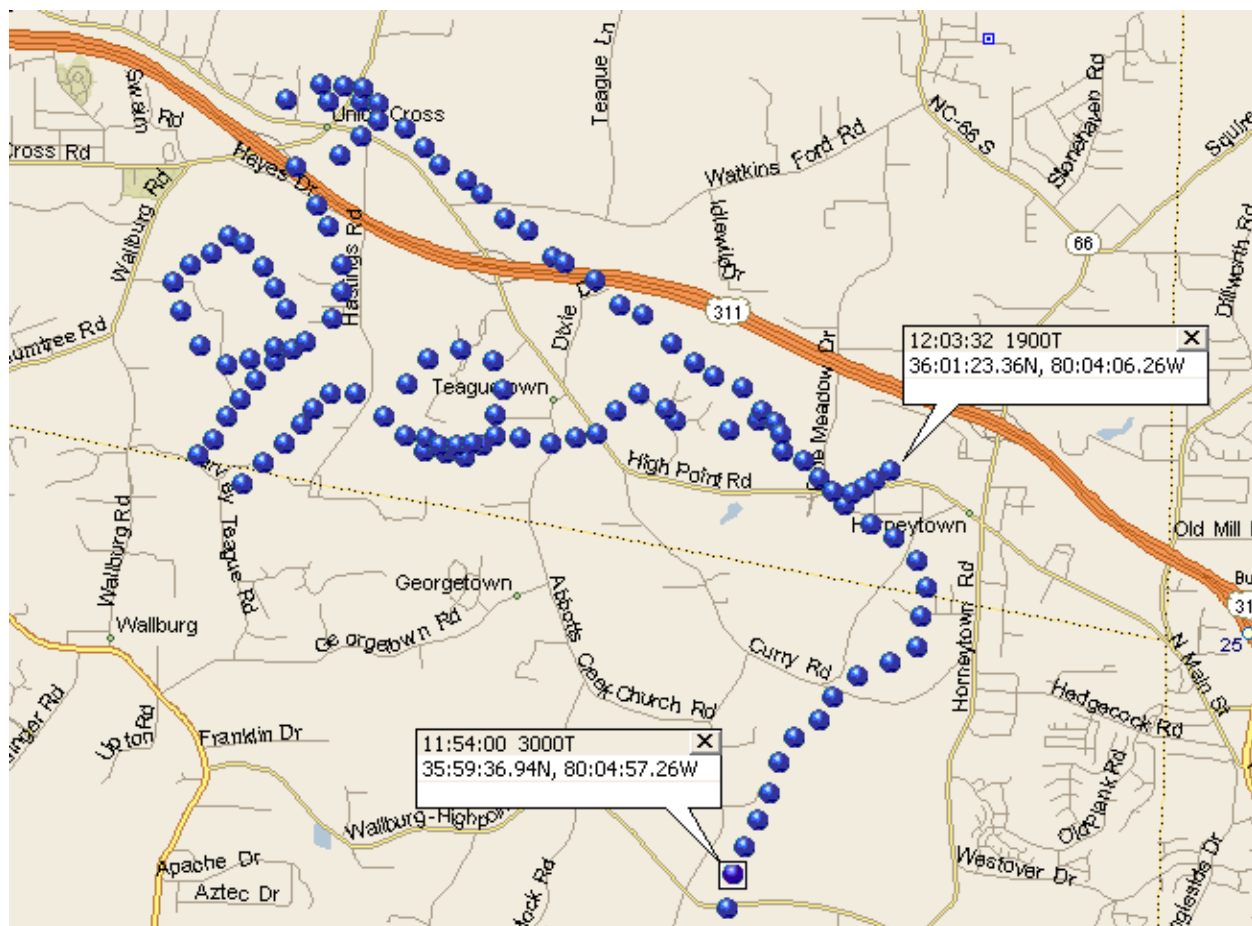
Figure 2 – Closeup view of the ground track just before the accident. Data tags show time (EDT), altitude corrected for local altimeter setting, latitude, and longitude.
