NATIONAL TRANSPORTATION SAFETY BOARD

**POWERPLANTS GROUP CHAIRMAN'S FACTUAL REPORT**

NTSB ID No.: ERA15FA353

Location: Oneida, Tennessee  
Date: September 12, 2015  
Time: 1625 eastern daylight time  
Aircraft: Aero Vodochody L-39C Albatross, N139RT

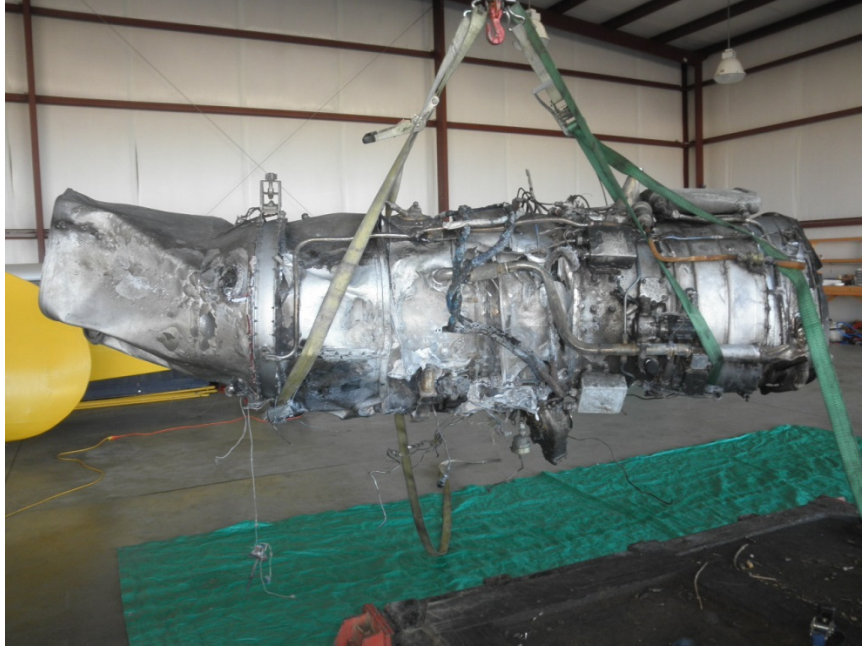
The engine was complete from the inlet case front flange and inlet dome to the exhaust duct. (Photos Nos. 1 and 2) The engine was crushed on the right side from the inlet case to the fan exhaust duct and rear mount that was twisted out of position.<sup>3</sup> The fan ducts and exhaust duct were blistered. The fan duct between the intermediate case and the rear fan duct between 10 and 2 o'clock was burned away. There was no evidence of an uncontainment, case rupture, or in-flight fire.

Photo No. 2: View of top of engine showing no uncontainments, case ruptures, or in-flight fire damage.

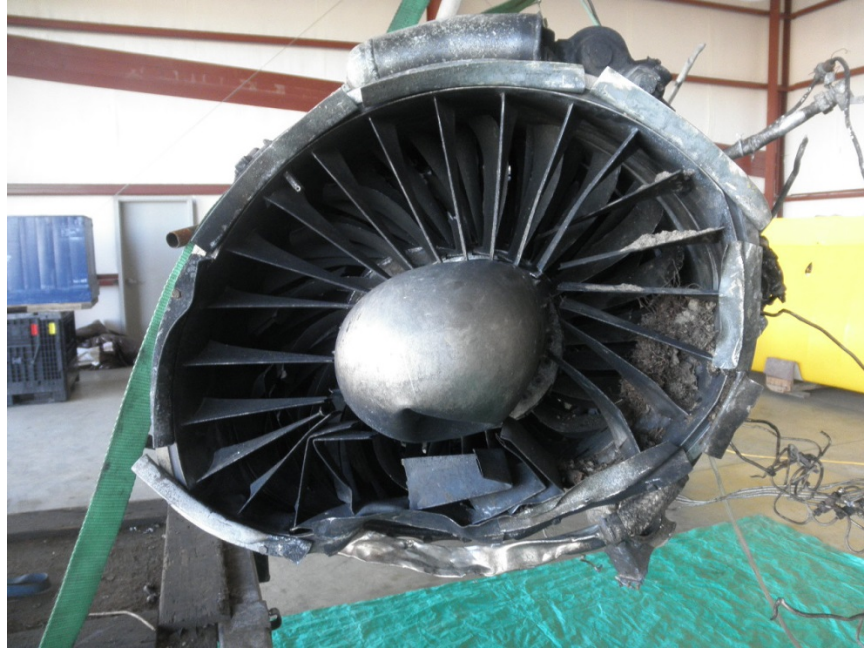
The inlet case was in place on the forward fan duct. The inlet case was partially crushed radially inward between 1 and 5 o'clock. All of the IGVs were present. All of the IGVs were separated from the inner shroud. The IGVs between 2 and 4 o'clock were buckled. (Photo No. 3) There were three IGVs that were separated completely from the inner and outer shrouds. The inlet case outer shroud inner diameter had an elliptical shaped rub mark, which was about 18.7-inches long and 1.1-inches wide at the widest point, directly in front of the fan stage 1 blade rub strip, which did not have any circumferential rub marks.

Photo No. 3: View of inlet case showing damage to the inlet guide vanes.

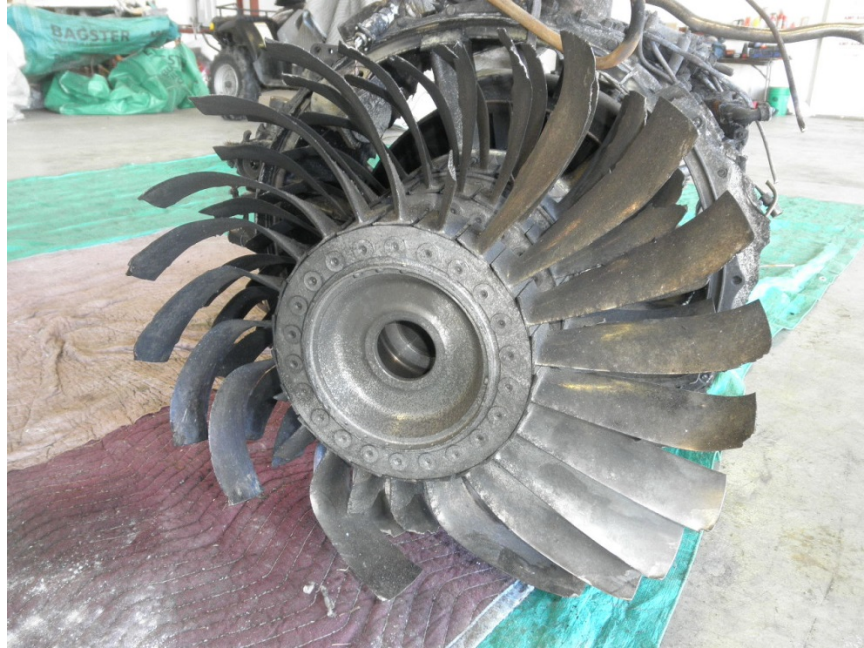
All of the 1st, 2nd, and 3rd stage fan blades were in place in their respective disks. There were five 1st stage fan blades that were fractured transversely across the airfoil between about 0.6-inches and 2-inches above the blade root platforms and there were five 2nd stage fan blades that were fractured across the airfoils up to 1-inch below the tips. The fracture surfaces on all of the fractured fan blades were coarse and grainy. All of the remaining 1st and 2nd stage fan blades and all of the 3rd stage fan blades were full length and were bent opposite the direction of rotation. (Photo No. 4) None of the 1st stage fan blades had any soft body<sup>5</sup> or hard body<sup>6</sup> impact damage. Many of the 1st and 2nd stage fan blades had a purple discoloration along the full length of the airfoil.

Photo No. 4: View of fan rotor showing fan blades bent opposite the direction of rotation.

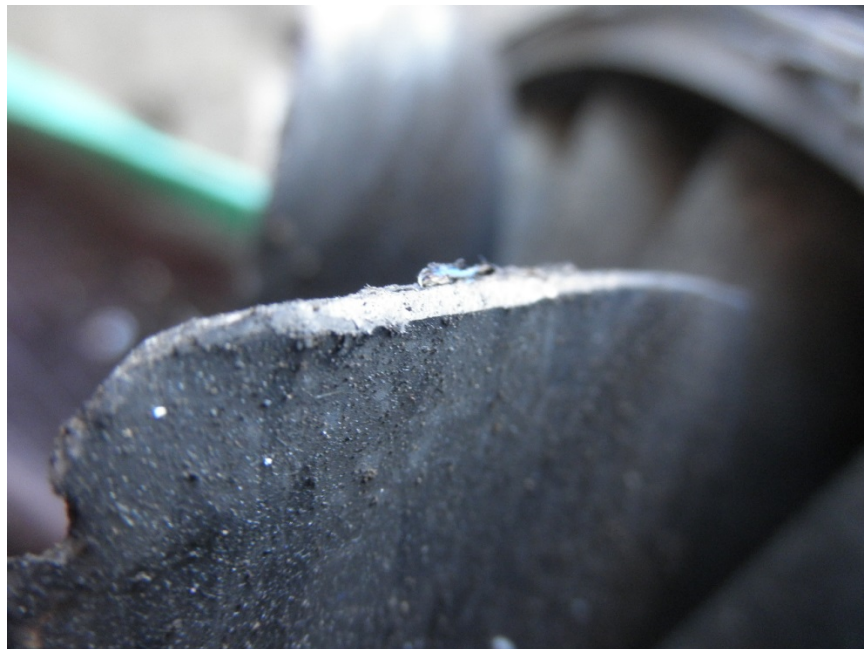
Many of the full length 1st stage fan blades had a flat spot at about a  $45^\circ$  angle to the airfoil on the convex side tip corner between about 0.4-inches and 1-inch aft of the leading edge. (Photo No. 5) There was an approximately  $30^\circ$  arc of blades that had an approximately 0.4-inch wide rub mark that had heat discoloration. (Photo 6)

Photo No. 5: Close up of 1st stage fan blade tip showing flat spot on concave corner.

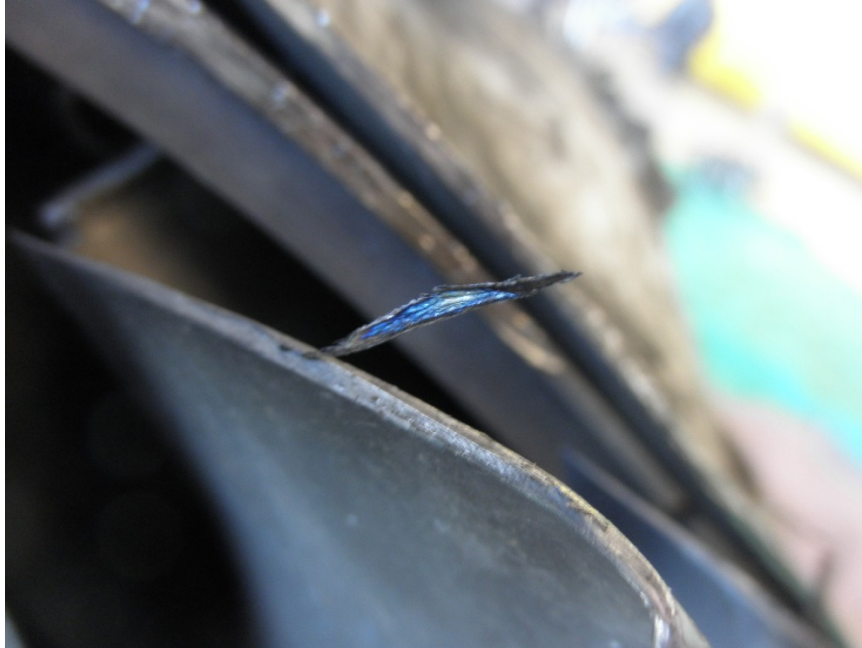
Photo No. 6: Close up of a 1st stage fan blade tip that had circumferential rub mark and tab of metal with heat discoloration.

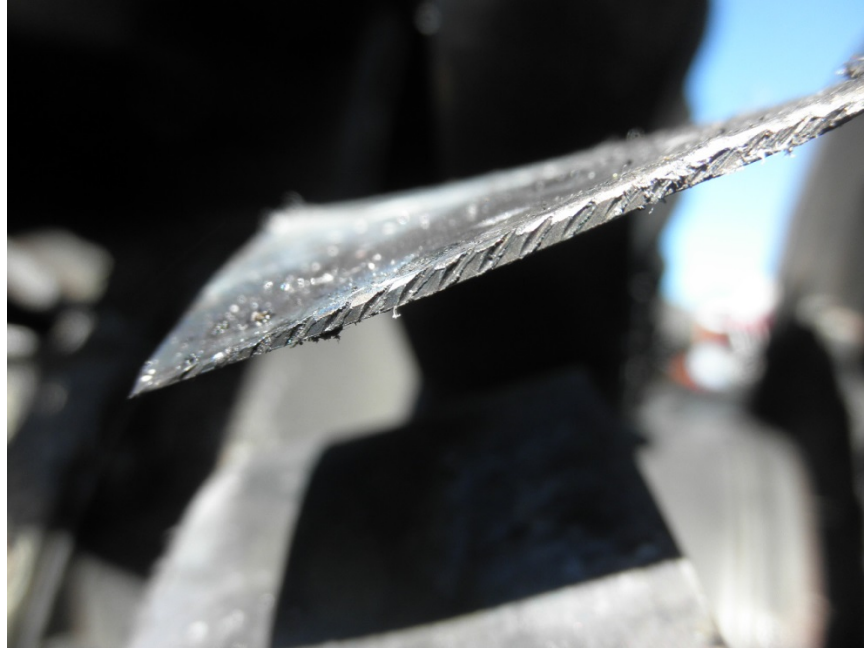
Many of the 2nd and 3rd stage fan blades had the leading tip corner bent towards the direction of rotation. There was a group of five 3rd stage blades that had an imprint of parallel cuts on the tips that corresponded to the spacing of the circumferential knife edges on the 3rd stage fan shroud. (Photo No. 7) The 3rd stage fan shroud had an approximately 10-inch long sector that was missing the coating and corresponded to the cuts on the 3rd stage fan blades tips. (Photo No. 8) There were three pairs of adjacent 3rd stage fan blades that had the blade root platforms shingled.<sup>7</sup>

Photo No. 7: Close up of 3rd stage fan blade tip showing marks from shroud rub strip.

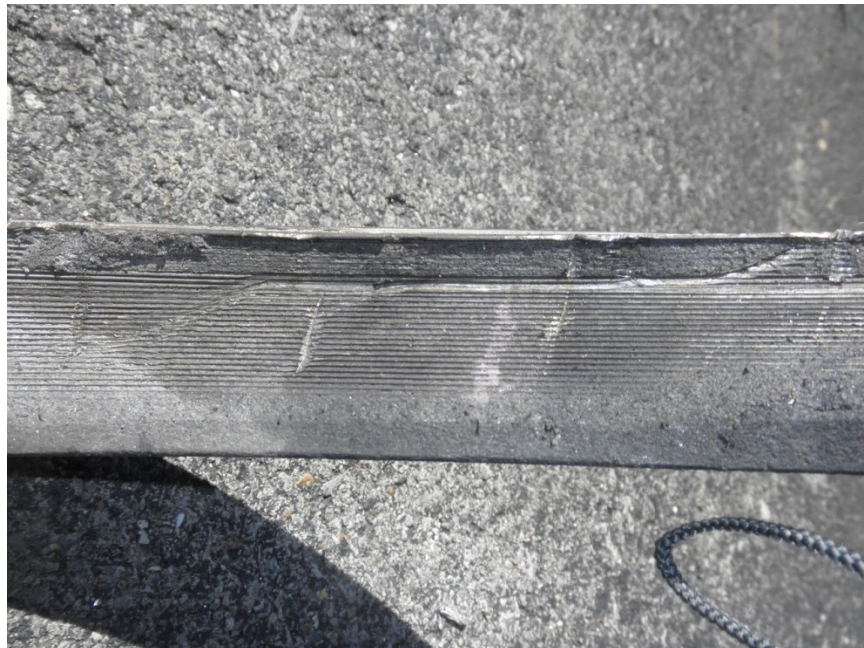
Photo No. 8: Close up of 3rd stage fan rub strip showing imprints of blade tips.

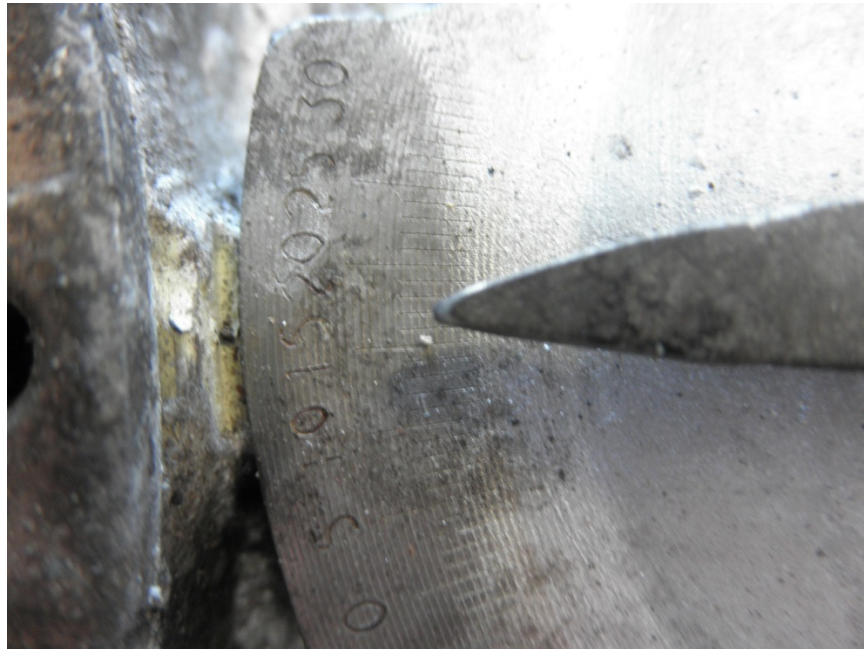
The HPC variable stator vane indicator was pointing to about 17.<sup>8</sup> (Photo No. 9)

Photo No. 9: Close up view of variable stator vane indicator needle pointing to 17.

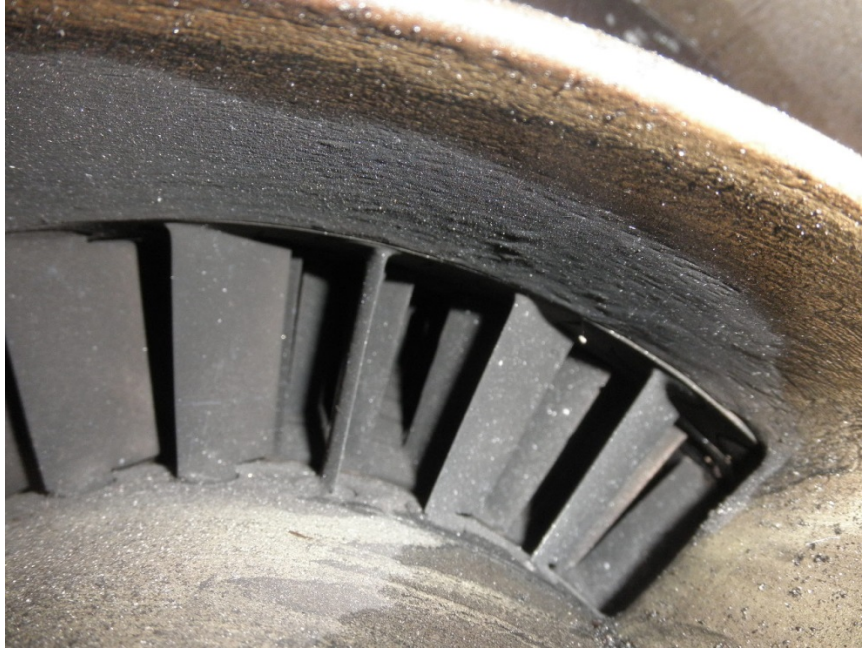
The HPC IGVs were all in place in what appeared to be a partially open position. There was no apparent damage to the HPC IGVs. (Photo No. 10)

Photo No. 10: Close up view of high pressure compressor inlet guide vanes and 1st stage blades.

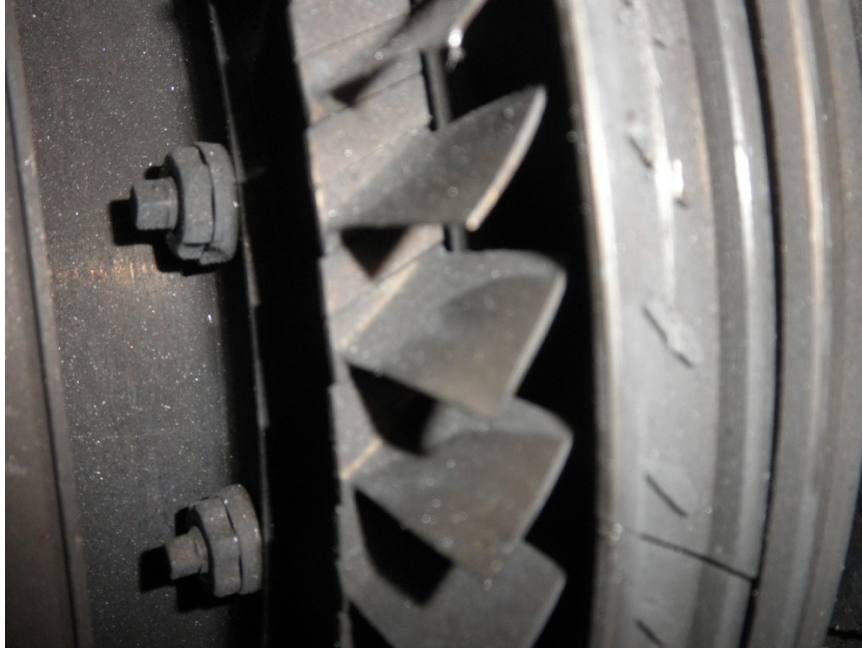
A small sector of the HPC 8th stage blades were visible through a hole that was cut in the aft end of the compressor case and forward end of the diffuser case. The HPC 8th stage blades that were visible did not have any apparent damage or metal spray on the airfoils. (Photo No. 11)

Photo No. 11: Close up of high pressure compressor 8th stage blades showing no damage.

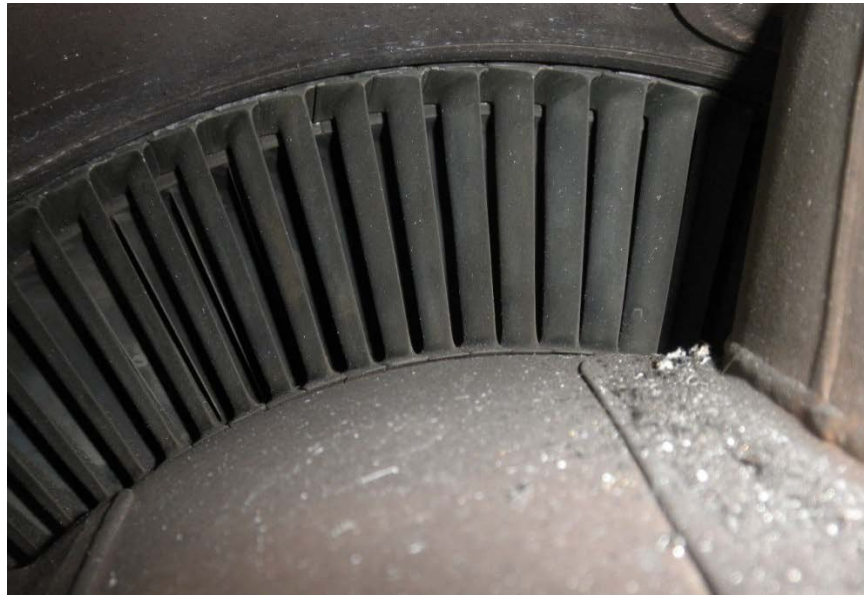
The LPT rotor could not be moved. The LPT 2nd stage blades were all in place. There was no apparent damage to the LPT 2nd stage blade airfoils nor was there any apparent metal spray on the airfoils. (Photo No. 12)

Photo No. 12: View of low pressure turbine 2nd stage blades showing no damage to the airfoils.

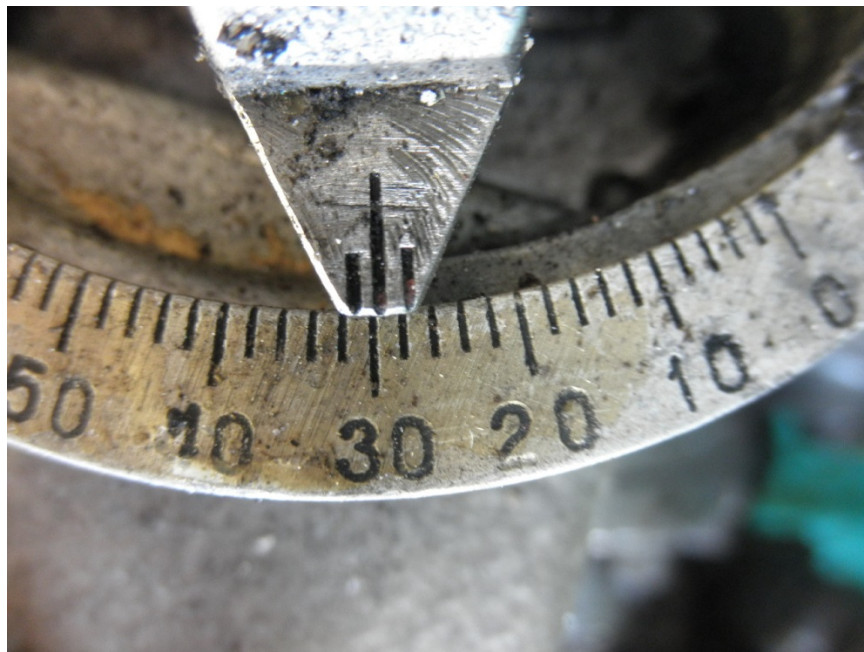
The fuel control unit (FCU) was in place on the bottom of the engine. The FCU was intact, but it appeared to have been exposed to heat. The throttle protractor indicating pointer was pointing to about 30.<sup>9</sup> (Photo No. 13) It was not possible to test the FCU. There are no facilities in the U.S. to test an AI-25TL engine's FCU. The manufacturer did not respond to several requests for information or assistance.

Photo No. 13: Close up view of fuel control throttle protractor indicator pointing to 30.
