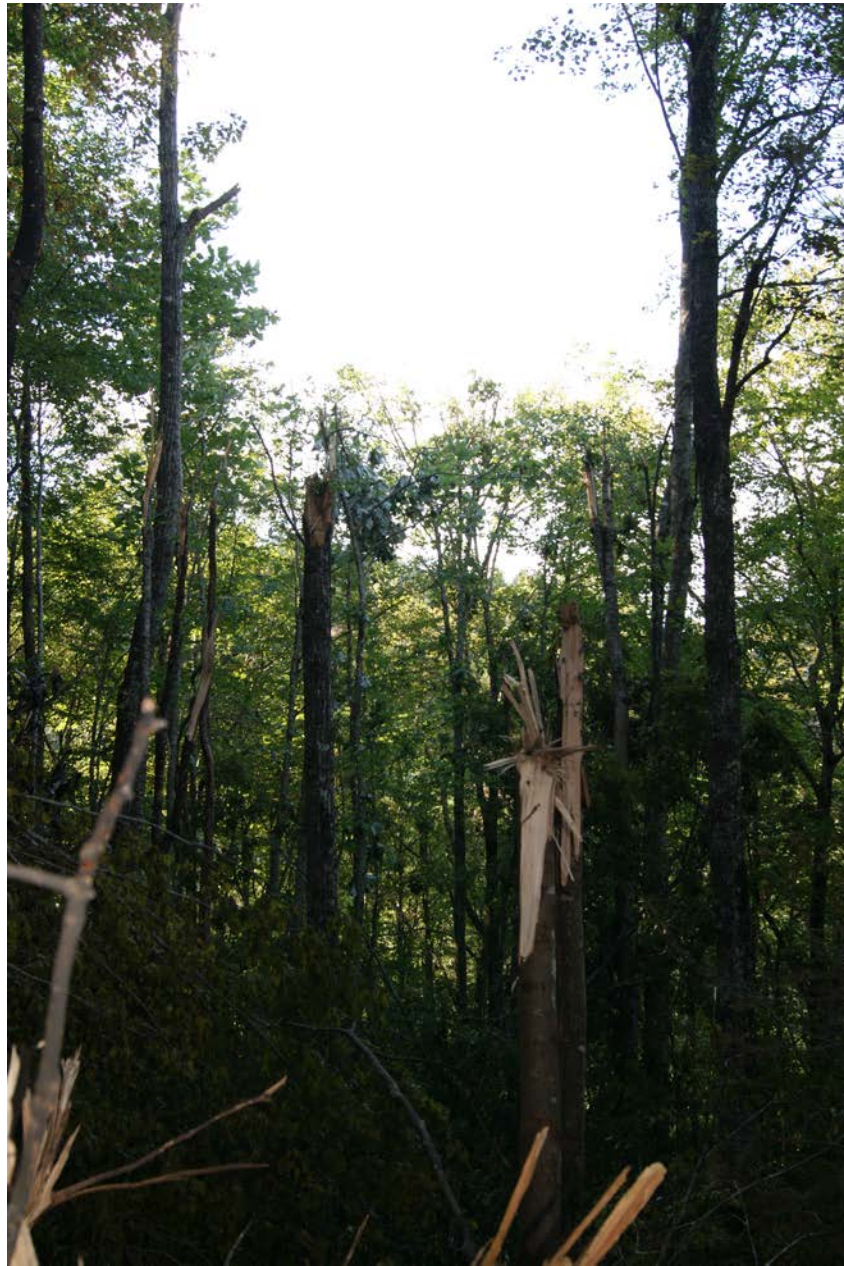
**Photo 1 – Initial tree strikes**

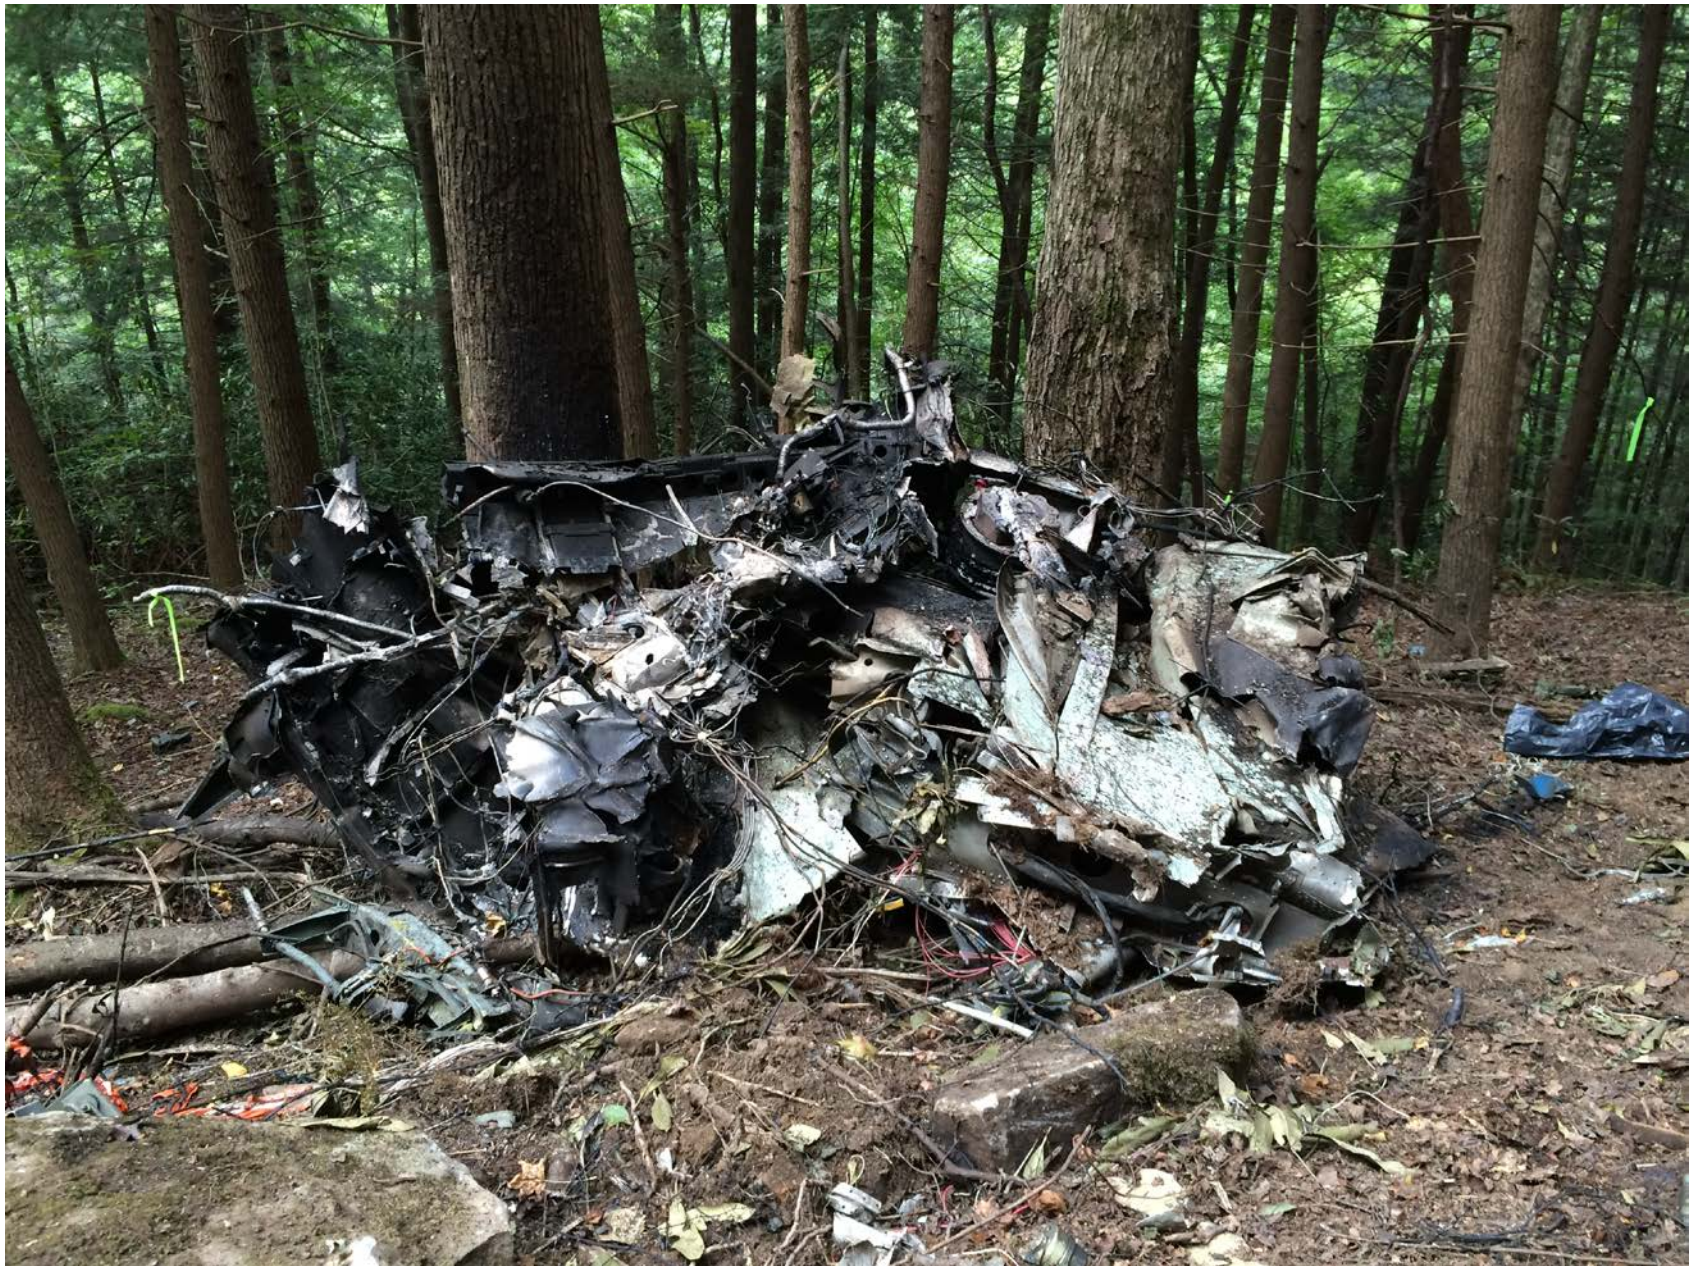
**Photo 2 – Main wreckage**

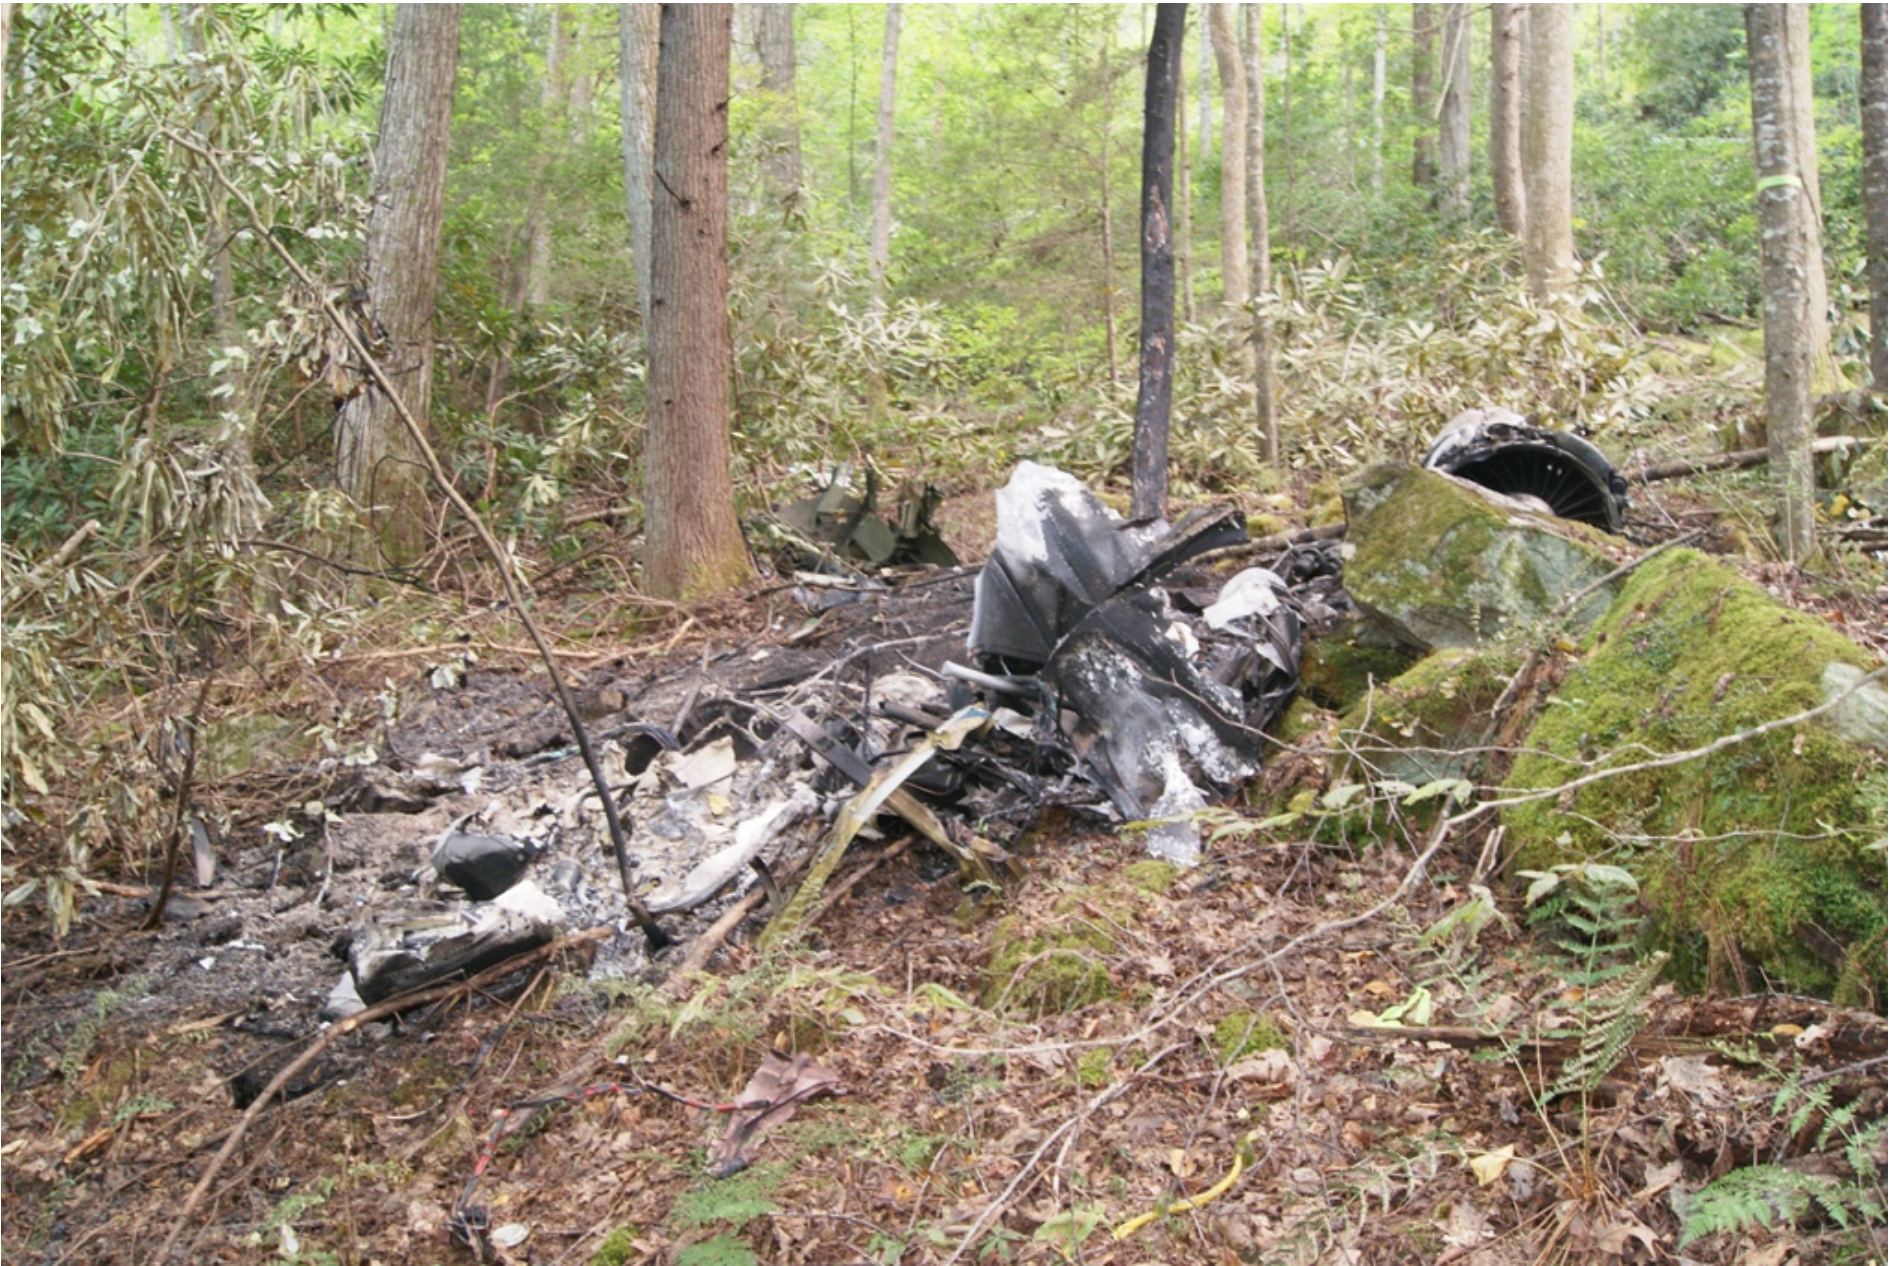
**Photo 3 – Engine and debris at accident site (view 1)**

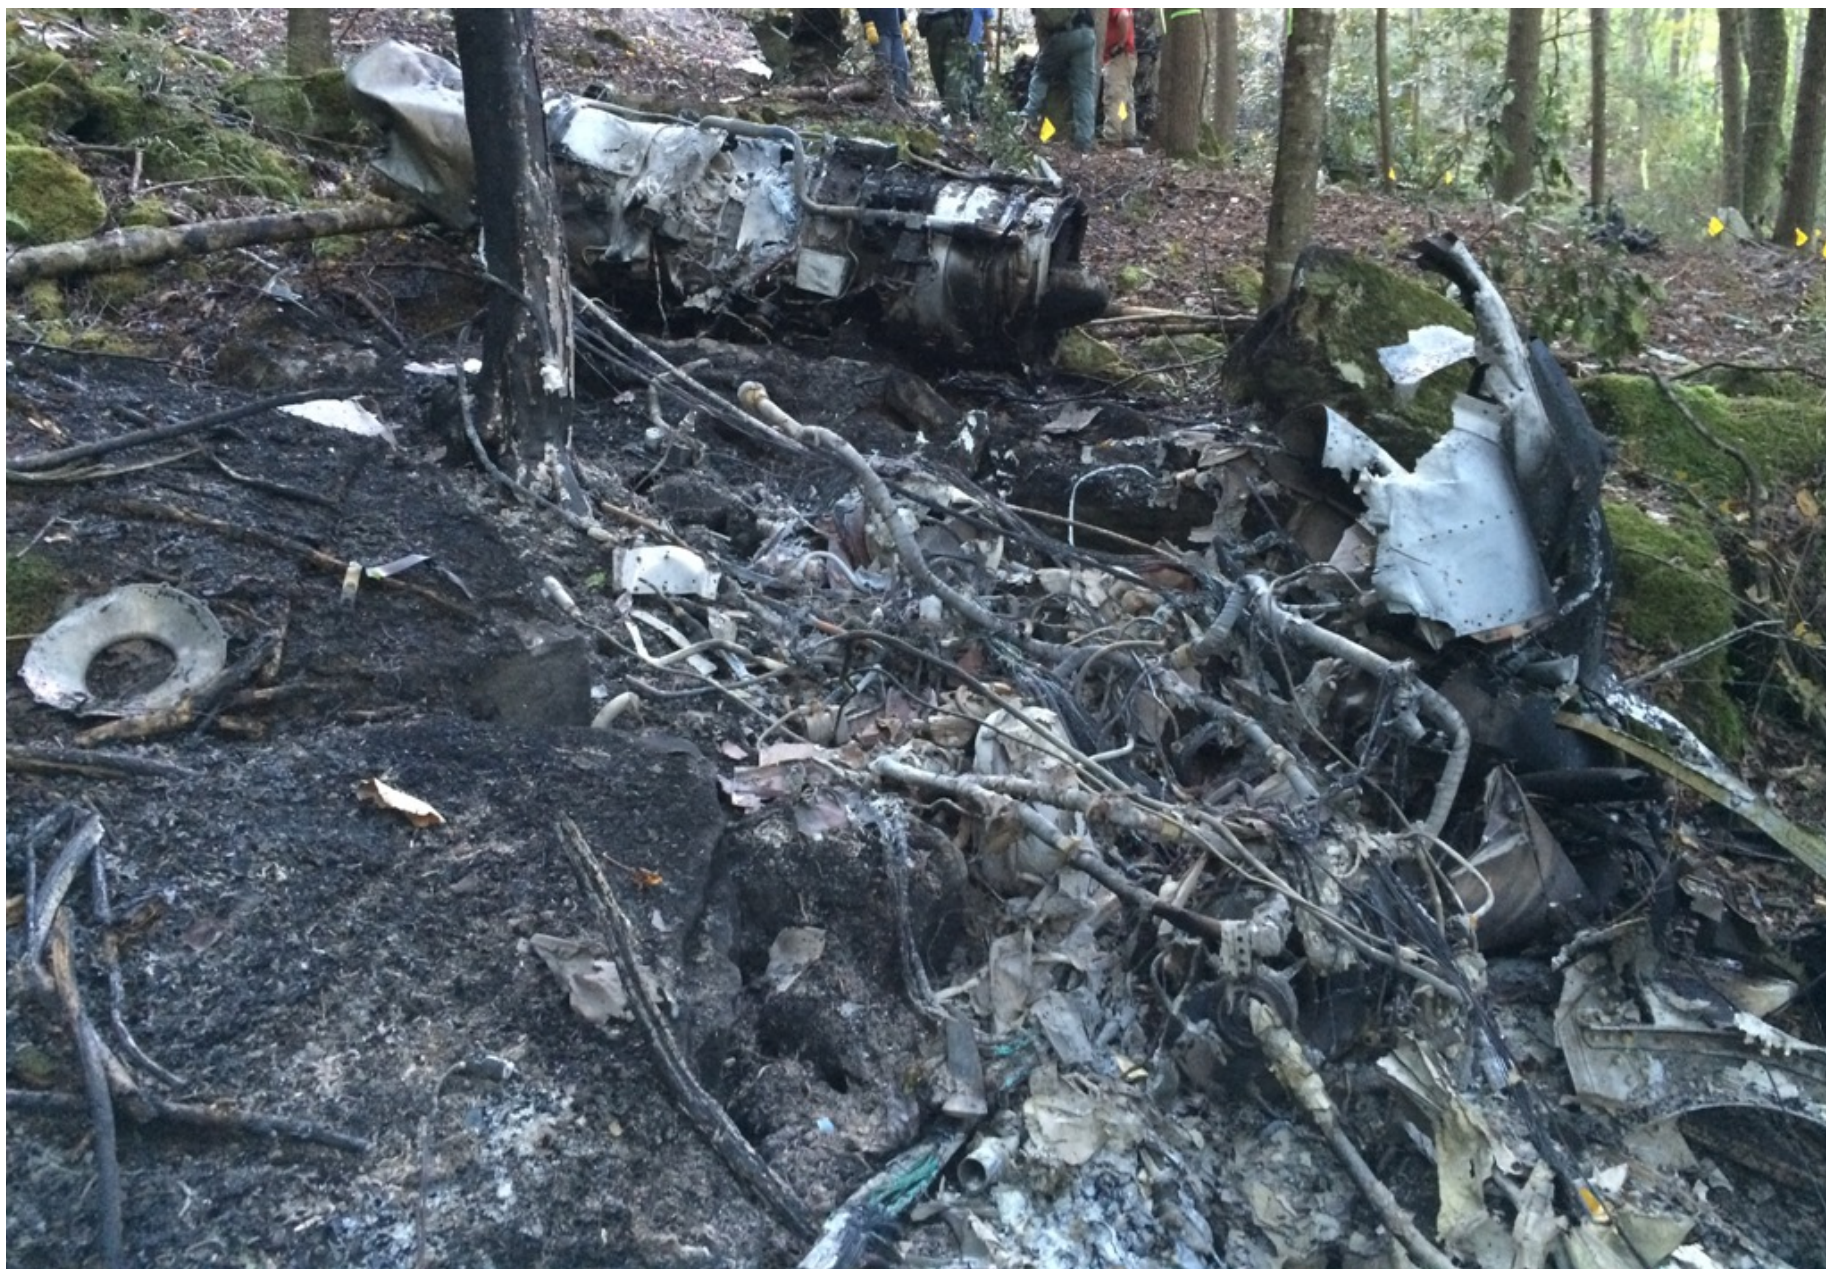
**Photo 4 – Engine and debris at accident site (view 2)**

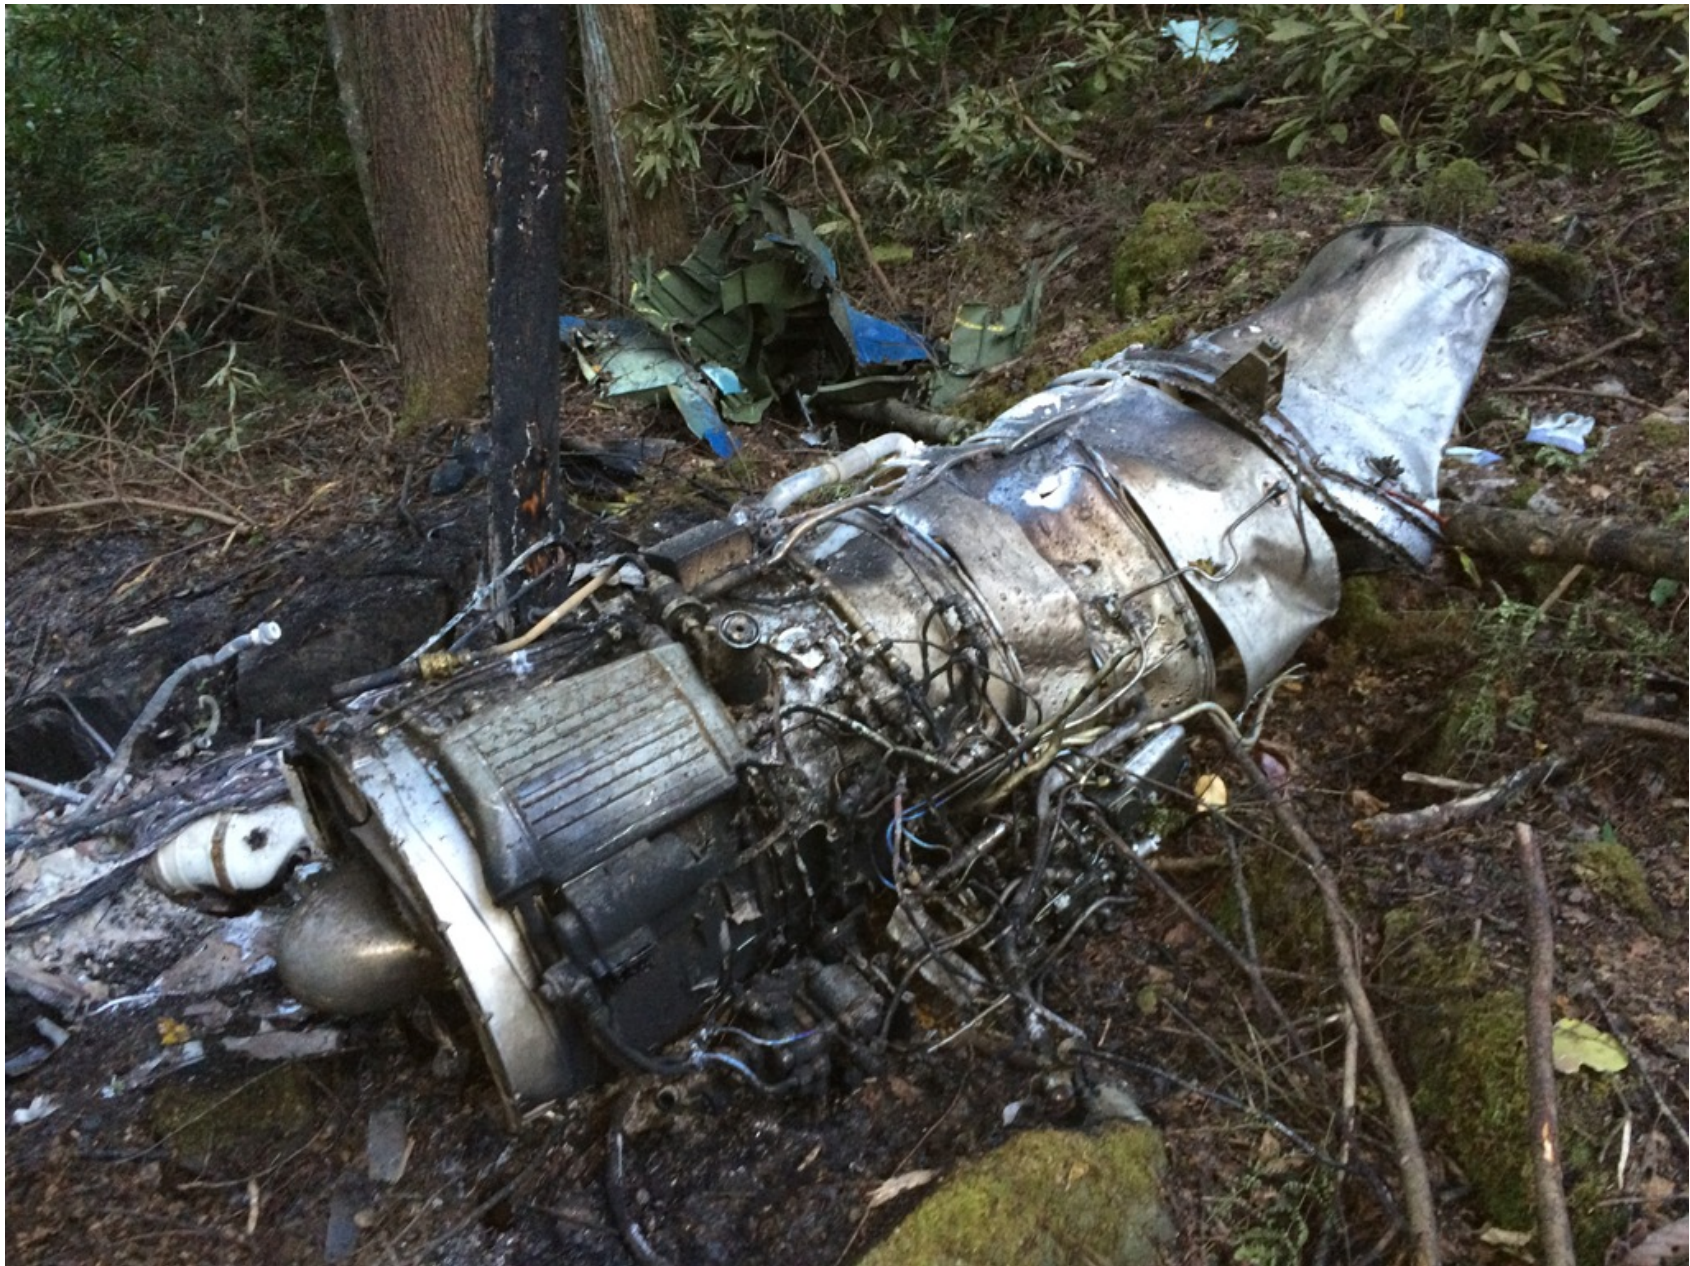
**Photo 5 – Engine at accident site**

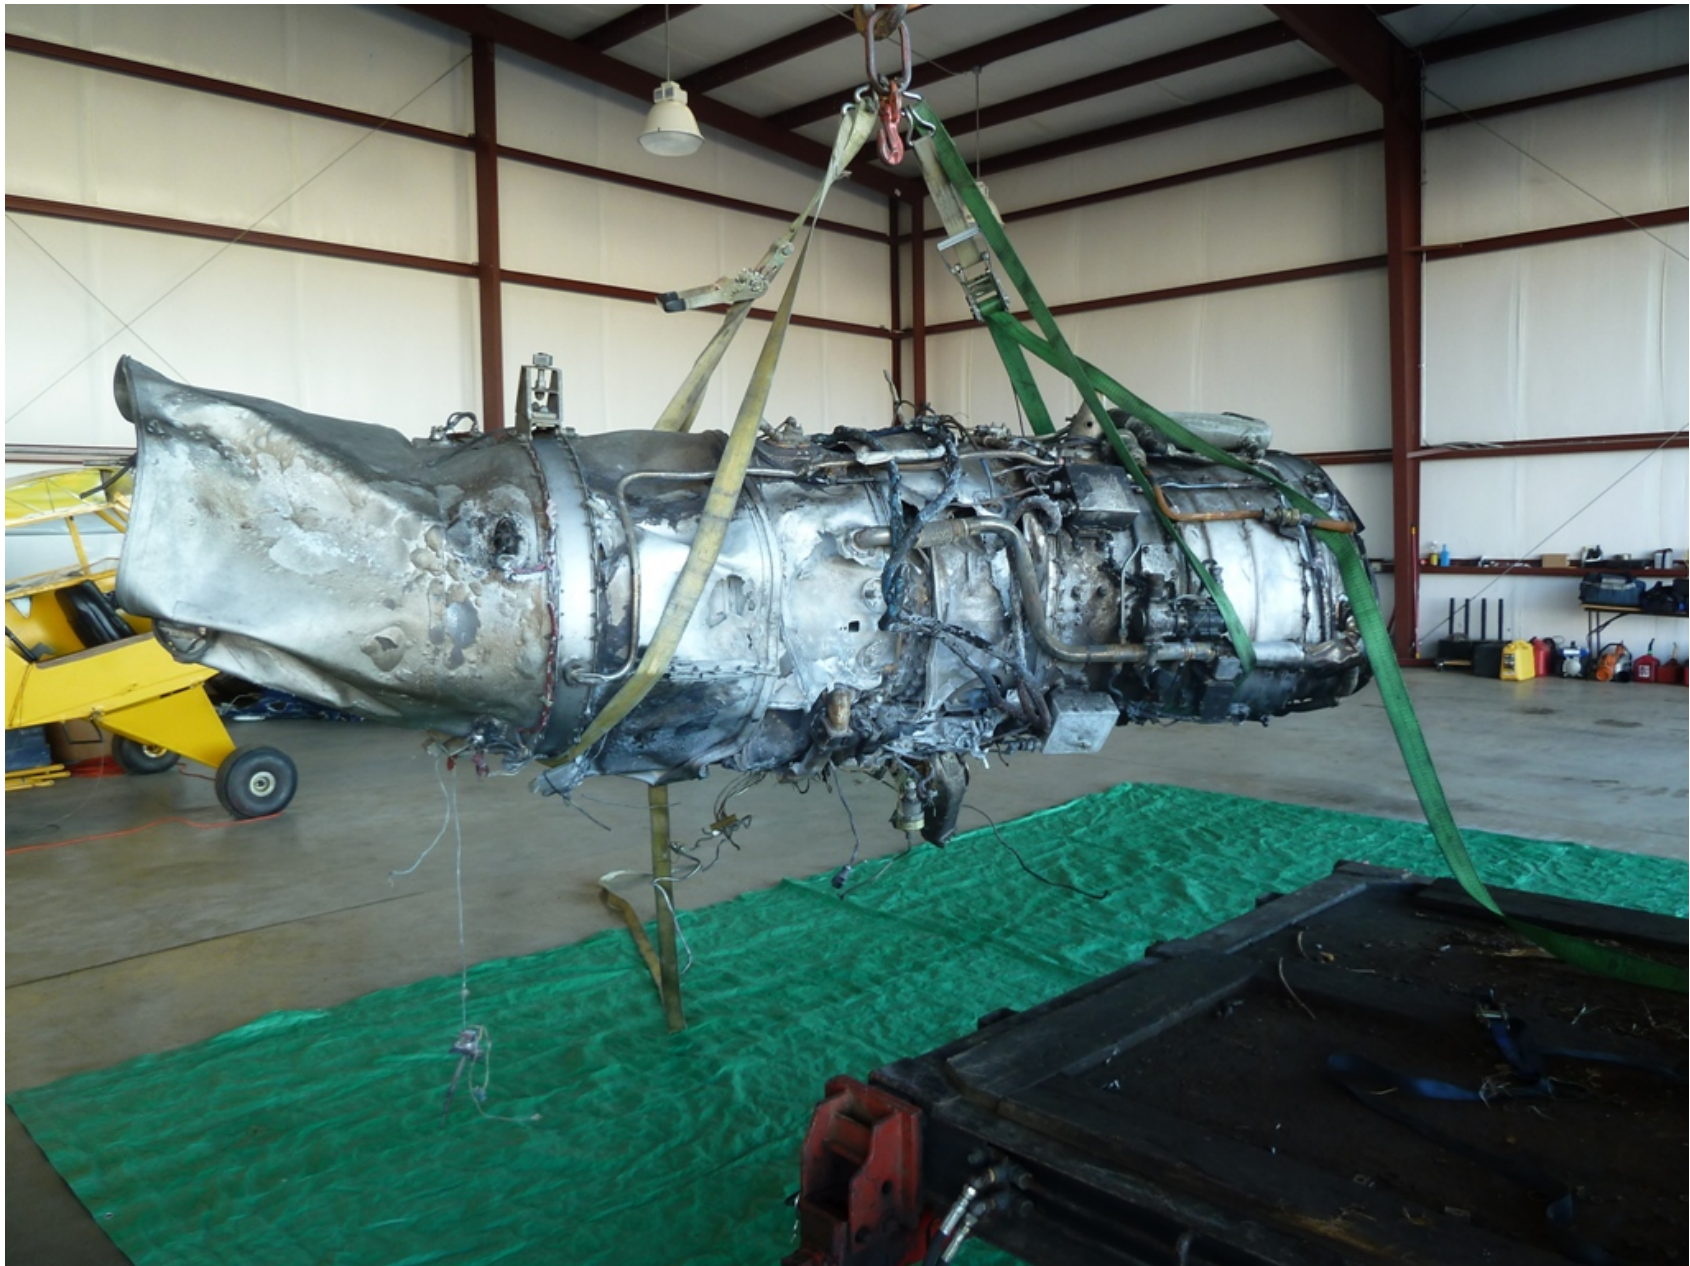
**Photo 6 – Engine at recovery facility**

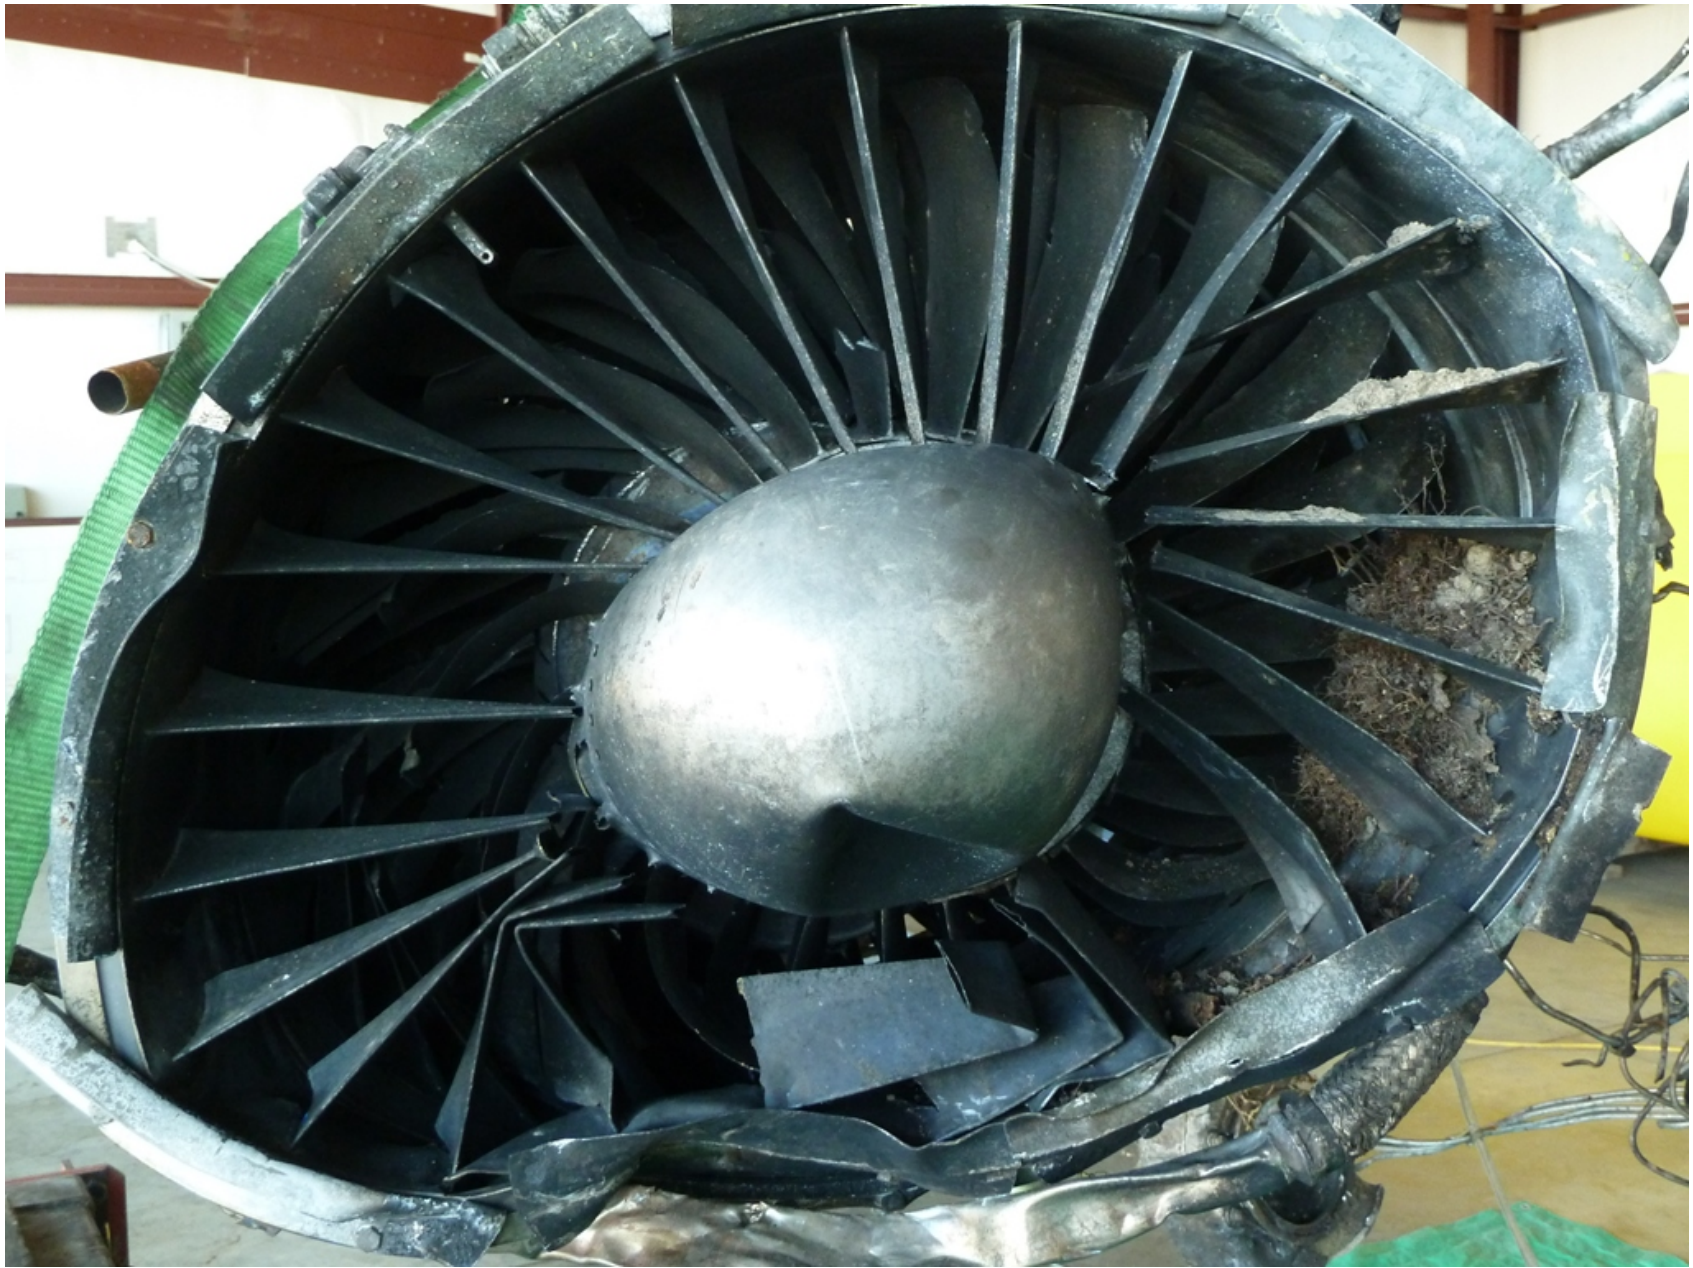
**Photo 7 – Engine inlet**

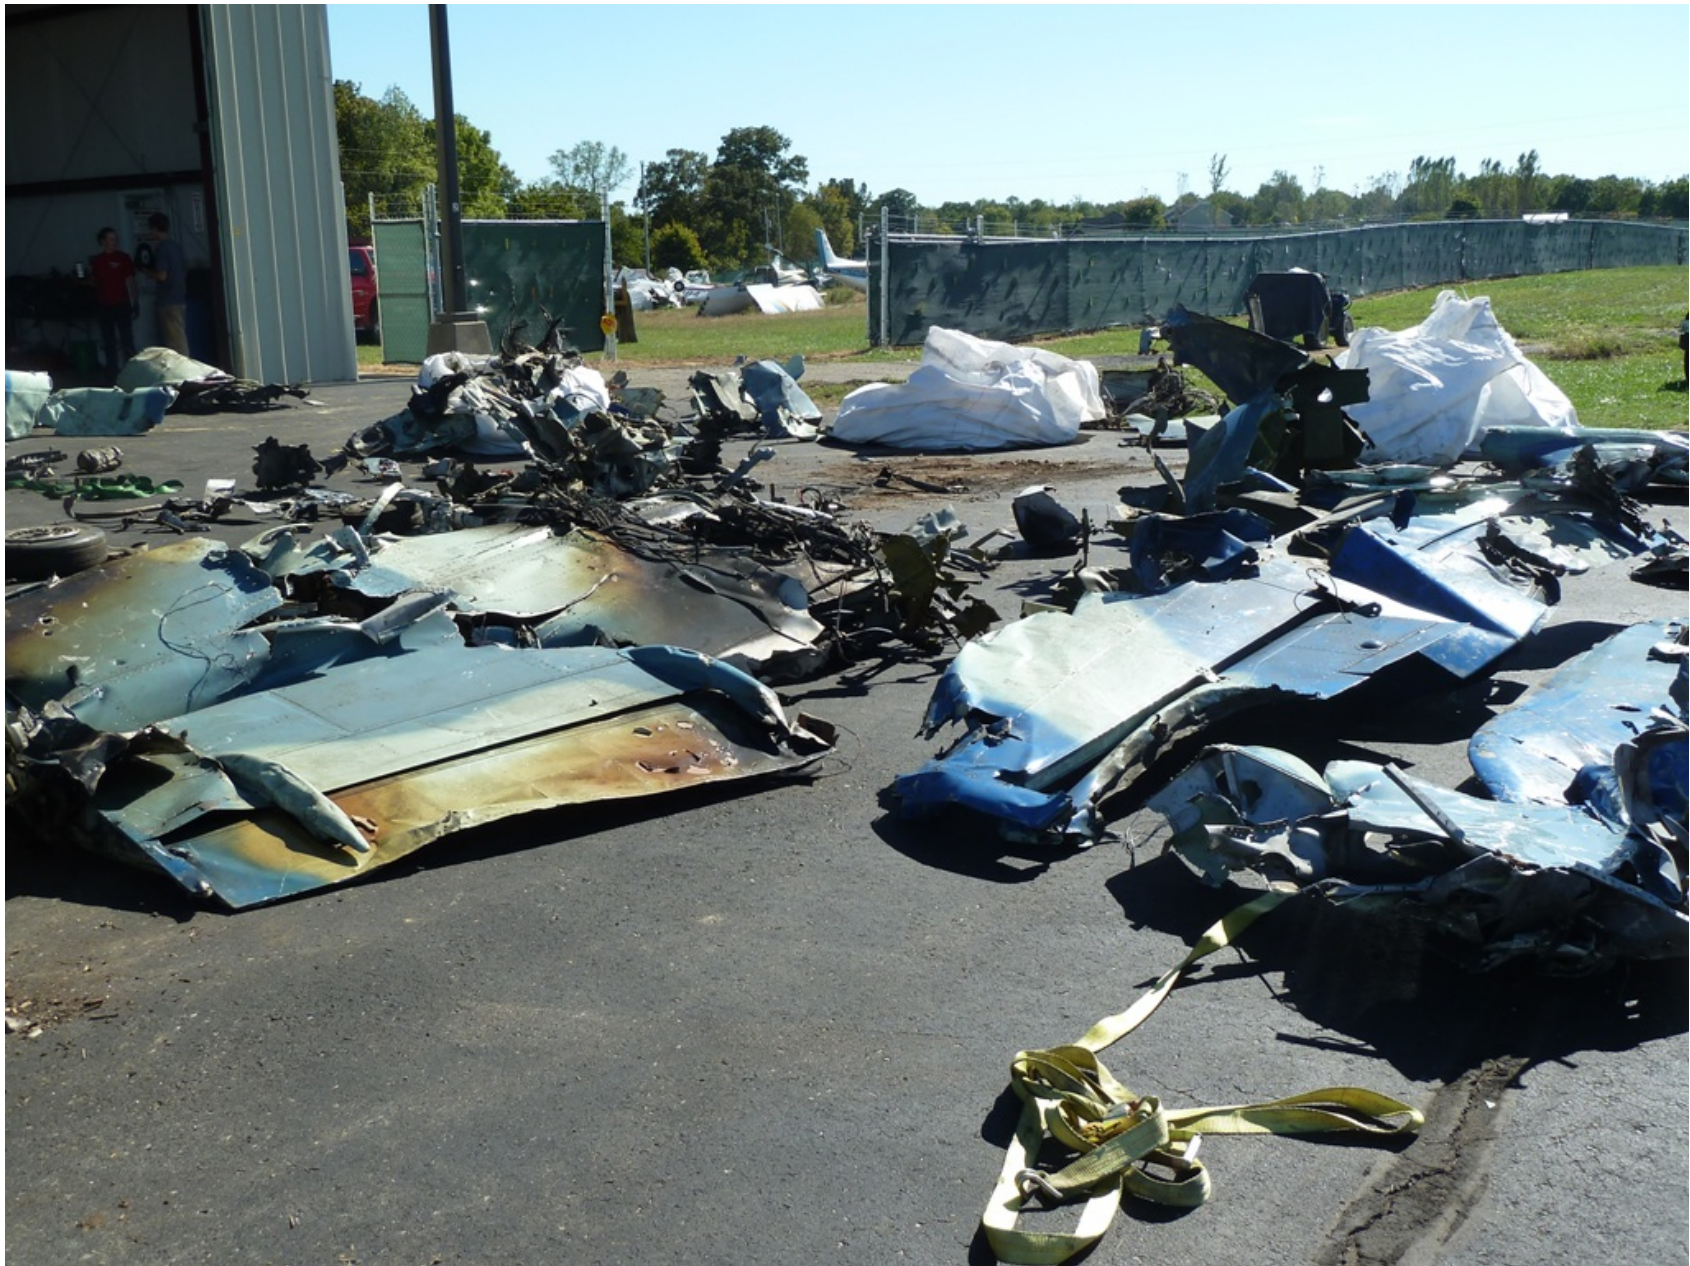
**Photo 8 – Wreckage layout at recovery facility**

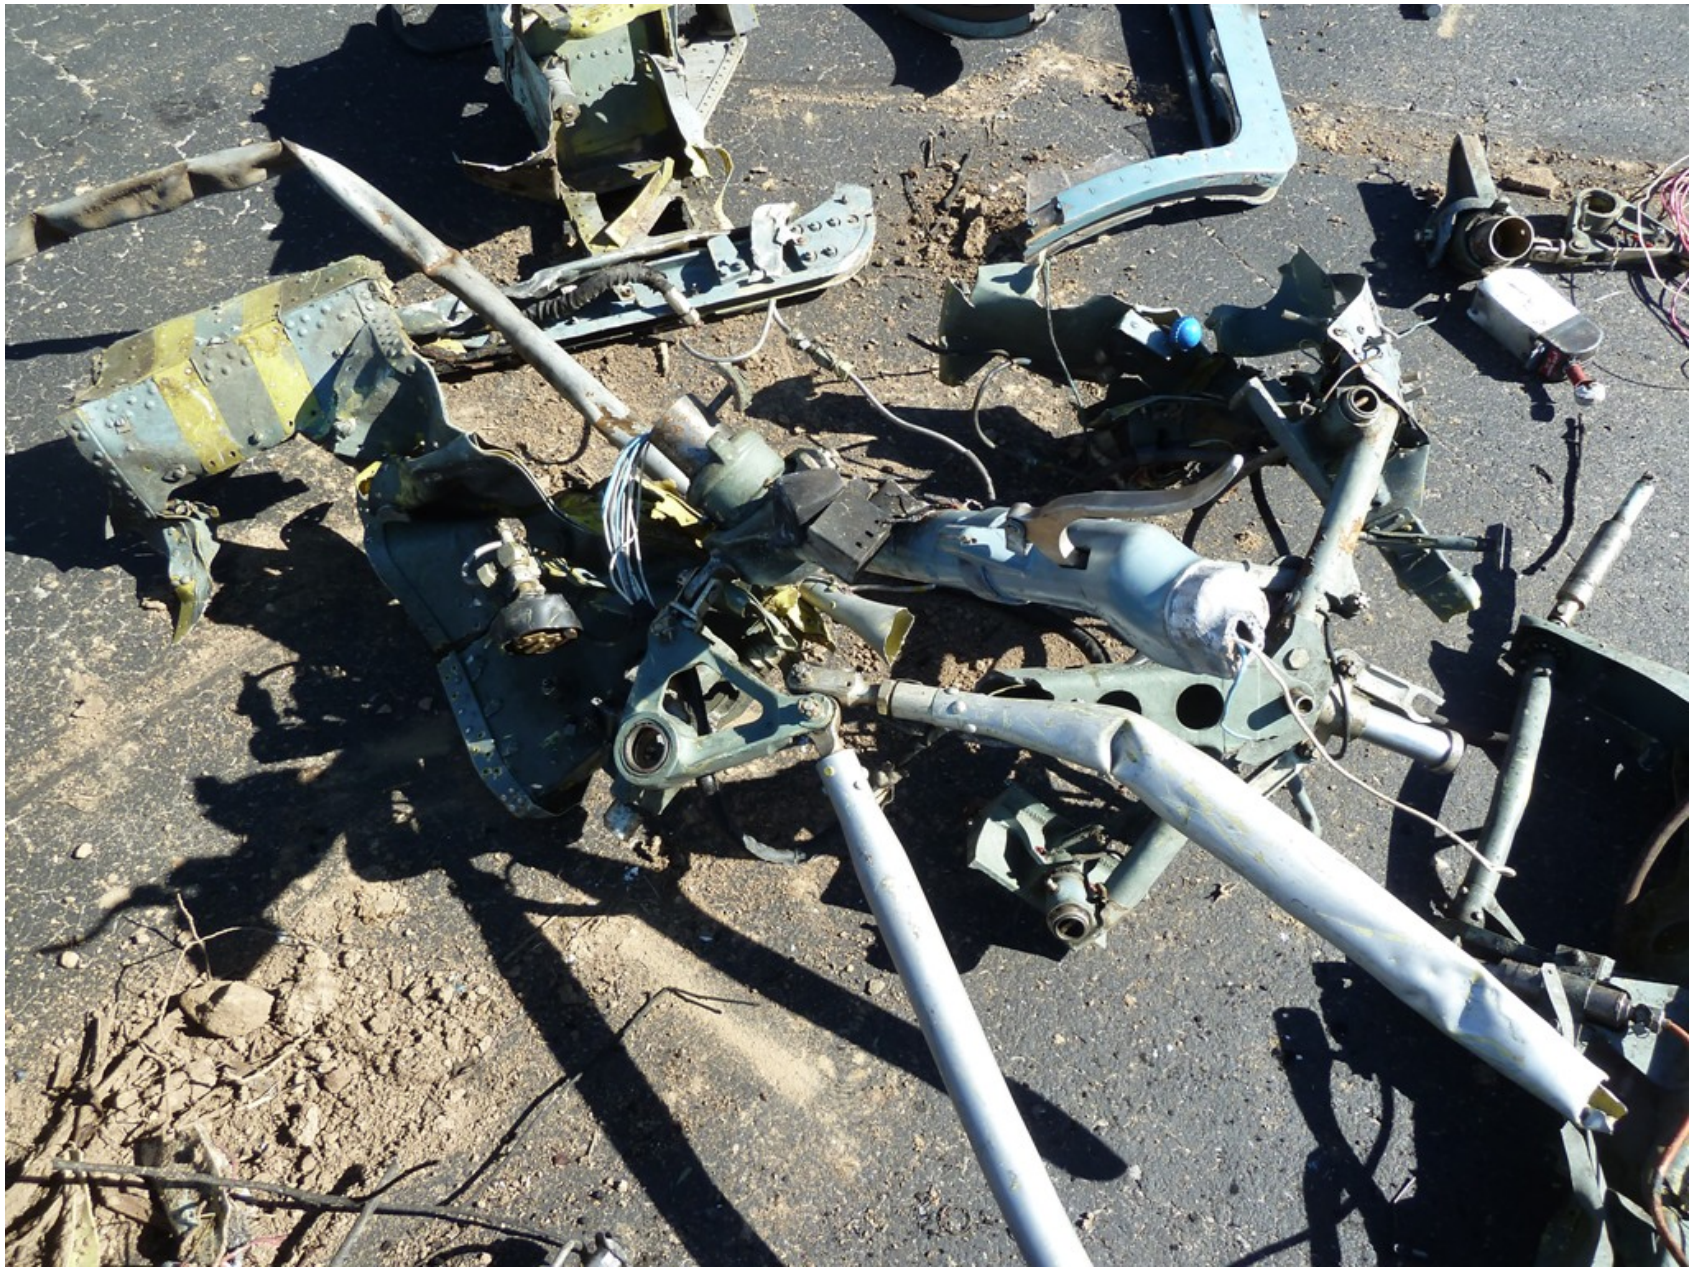
**Photo 9 – Cockpit push-pull control tubes**

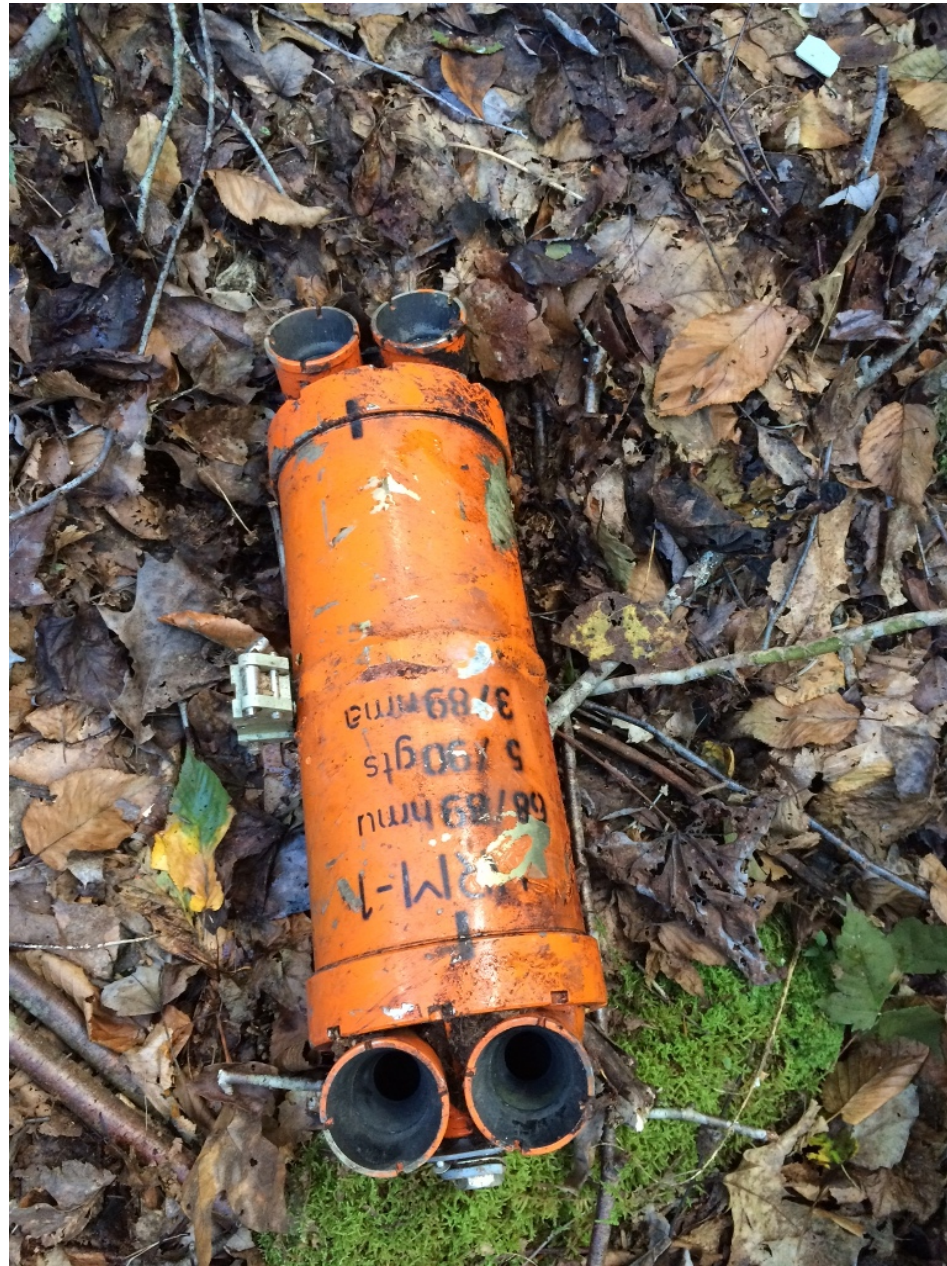
**Photo 10 – Discharged ejection seat rocket motor**

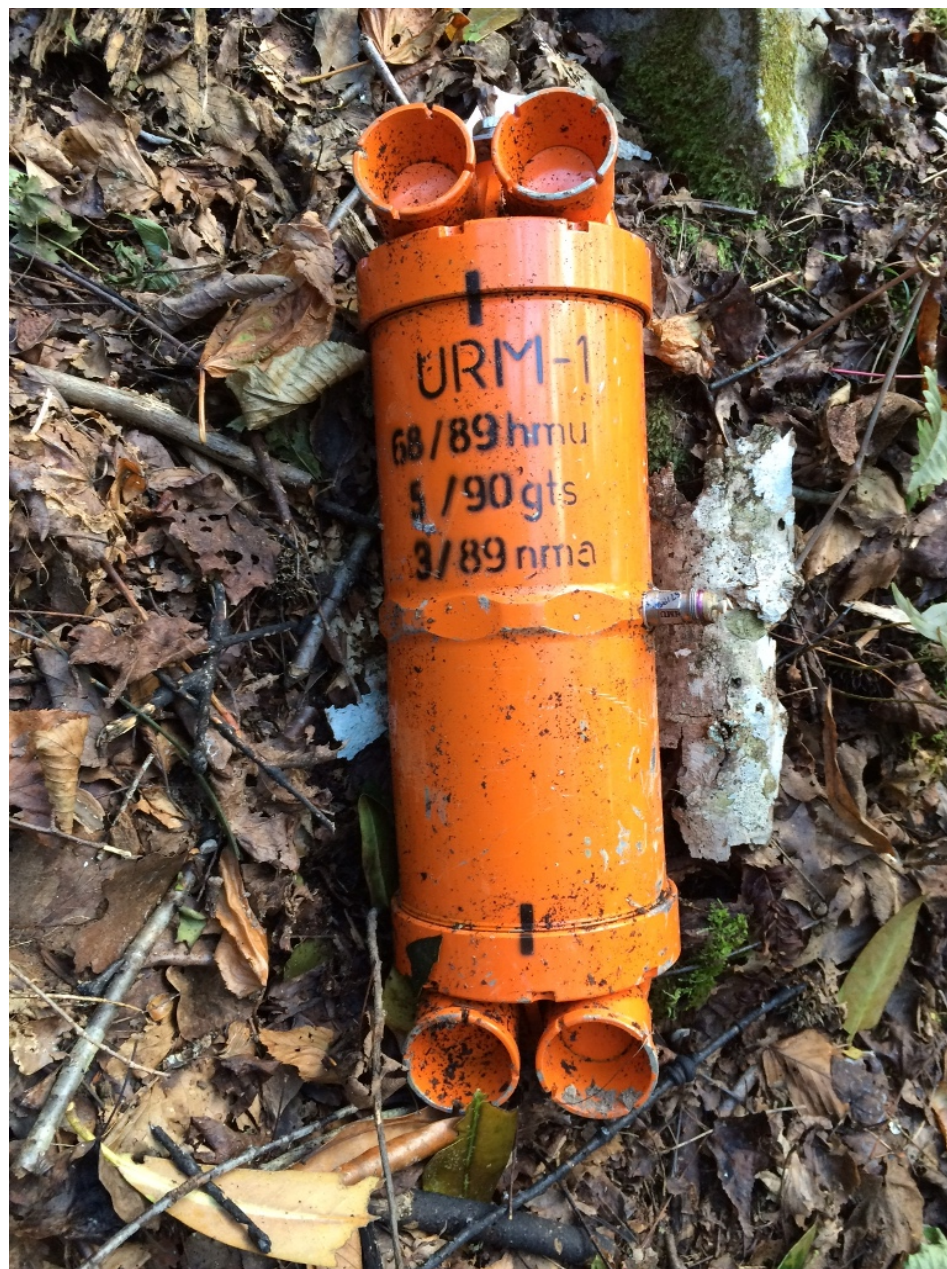
**Photo 11 – Undischarged ejection seat rocket motor**
