# NATIONAL TRANSPORTATION SAFETY BOARD

## MATERIALS LABORATORY FACTUAL REPORT

Report No. 15-052

Place : Teterboro, New Jersey  
Date : May 3, 2015  
Vehicle : Cessna 525B, N784JS  
NTSB No. : ERA15IA206  
Investigator : Timothy W. Monville, AS-ERA

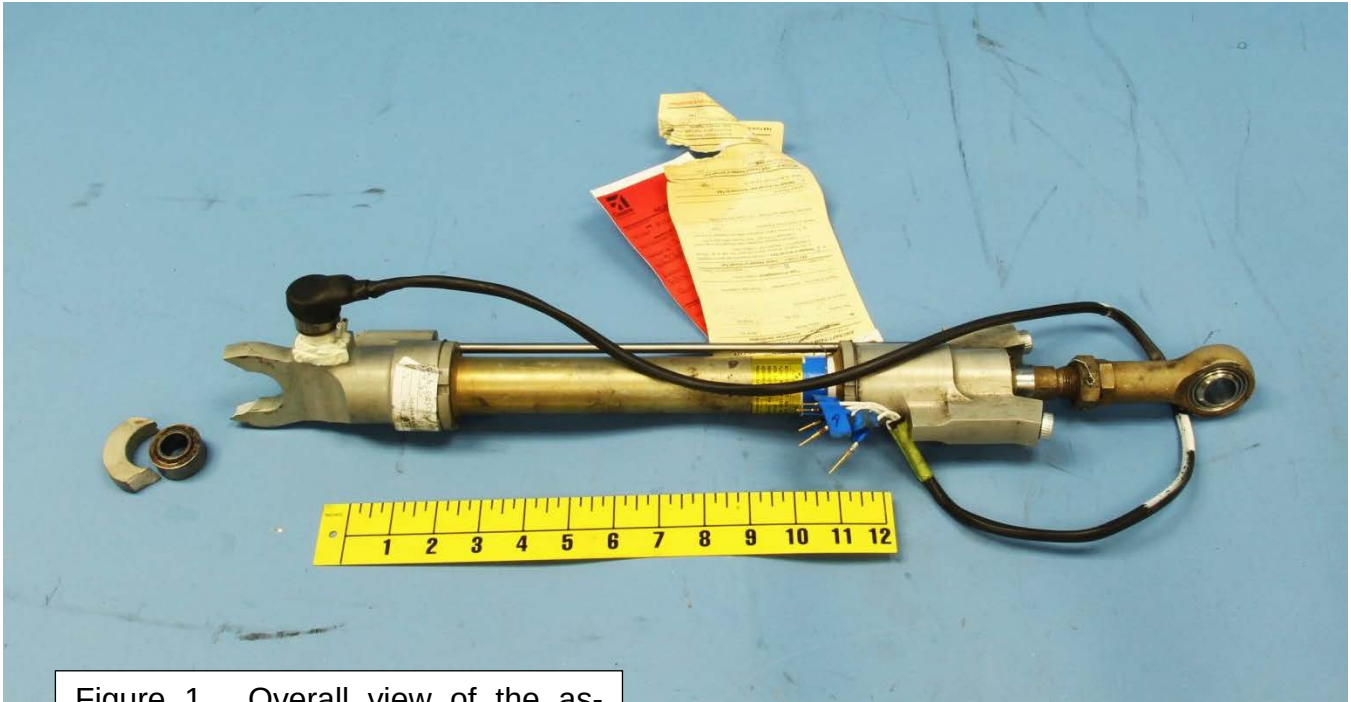
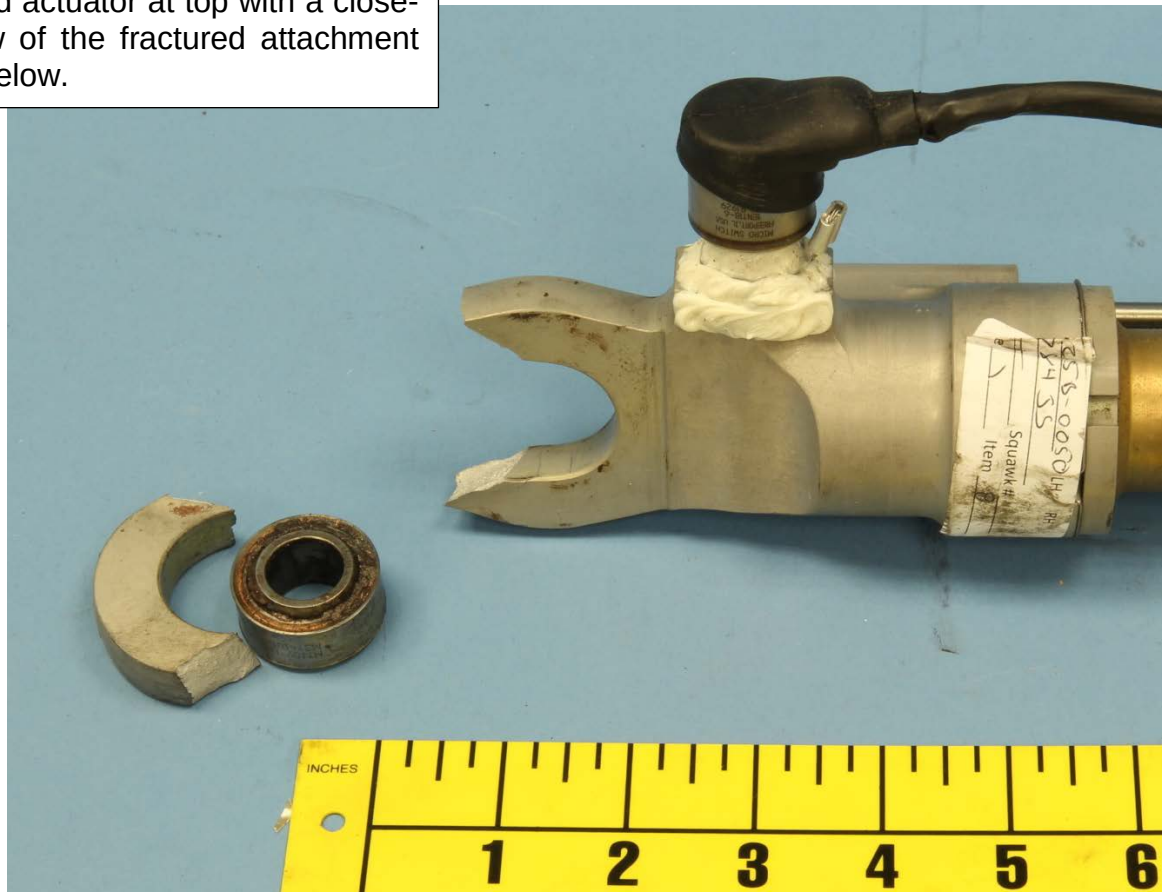
The as-received actuator is displayed in the two views of figure 1. The end attachment fitting on the actuator was fractured in locations on either side of the bearing as shown. Magnified visual examination on the fitting revealed fracture features and deformation patterns consistent with overstress separations at both locations. The fracture locations were consistent with tensile forces along the axis of the actuator. No indications of preexisting cracking or corrosion were noted.

X-ray Fluorescence spectroscopy of the fitting identified the material as 7075 aluminum alloy. Hardness (HRB 75.2 avg) and electrical conductivity (40.8% IACS) measurements were consistent with 7075 aluminum in the T73 temper condition.

Figure 1. Overall view of the as-received actuator at top with a close-up view of the fractured attachment fitting below.
