**ERA15LA091**

**Cessna 172M**

**N12182**

**NTSB AIRFRAME AND ENGINE EXAMINATION**

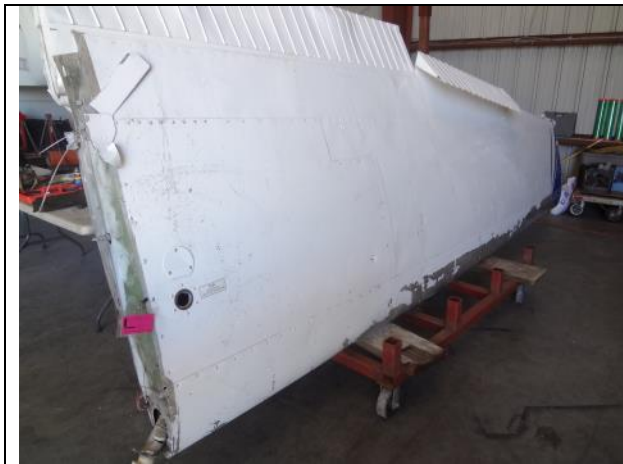
The airframe was examined and the above items were noted as absent. During the examination burn marks were noted on the left wing near an access panel and the wing light. Recovery personnel stated that when separating the wings smoke was observed exiting the wing areas. Removal of the fuel cap revealed a light blue color similar in smell to 100LL aviation fuel. They further reported that due to the smoke and risk of fire they concentrated on the extinguishing of the possible flames and not about the amount of fuel that exited. They further stated they could not speculate how much fuel was on board but that fuel was present and appeared free of debris.

Photo 7: Top side of Left Wing - Post Recovery

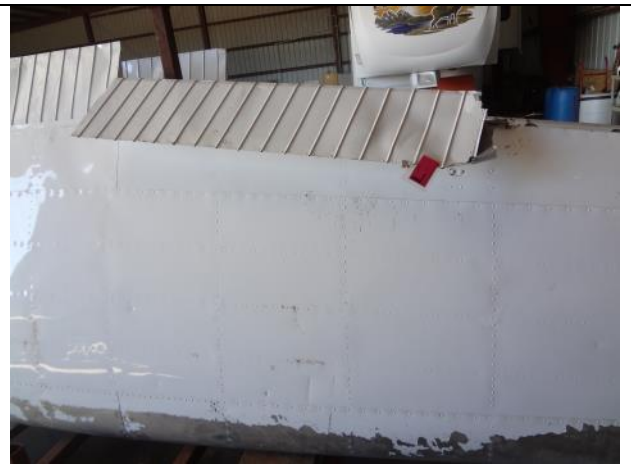
- The right and left wings were removed by the recovery company to facilitate transport
- The right wing aileron and approximately one-half of the left wing aileron were absent and unable to be located during recovery

Photo 8: Remaining Portion of Left Aileron - Post Recovery

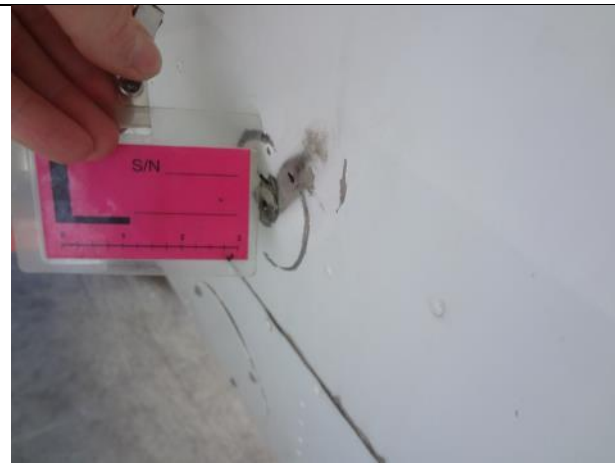
Photo 11: Burn Mark on Bottom Side of Left Wing – Post Recovery

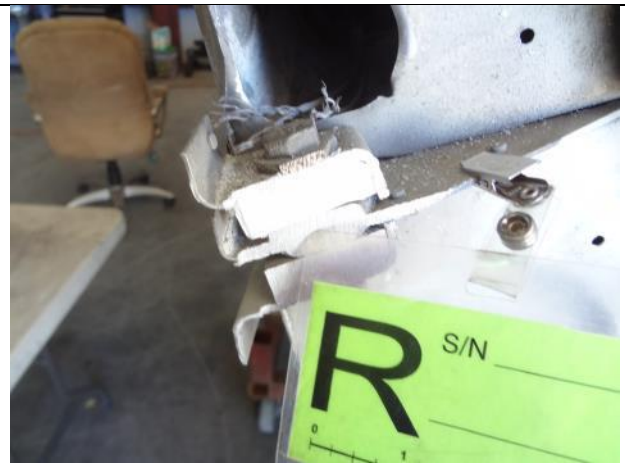
Photo 12: Right Wing Flight Control Cable with Recovery Cut Marks

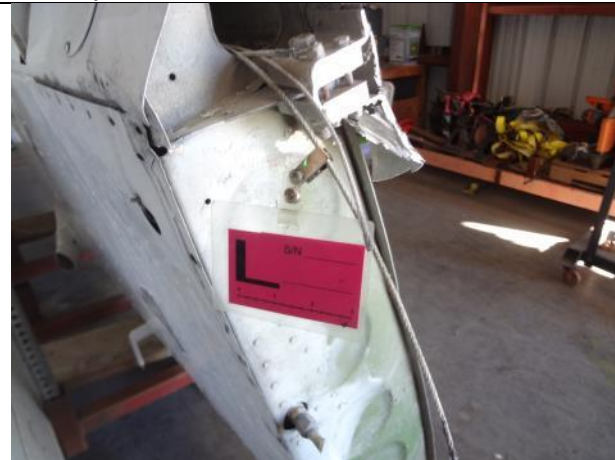
Photo 13: Left Wing Flight Control Cables with Recovery Cut Marks

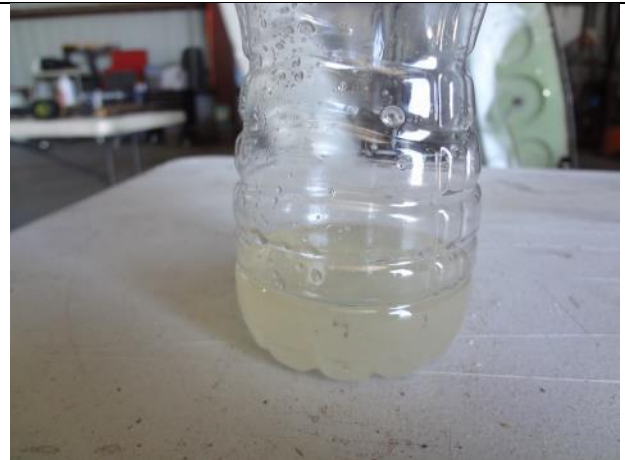
Photo 14: Fluid Extracted from Fuel Strainer

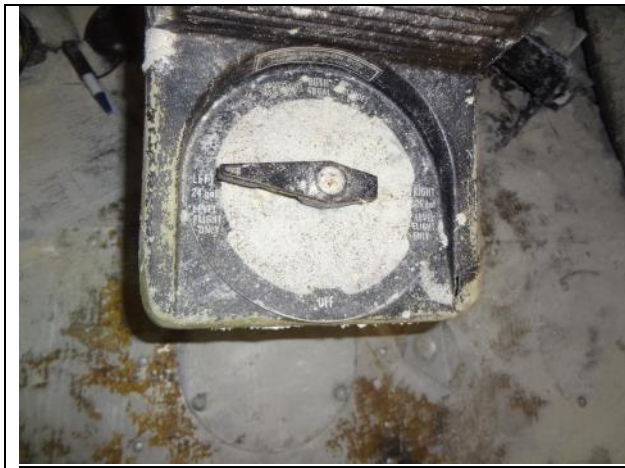
The cockpit was examined and the fuel selector was selected to the "Left" fuel tank. The mixture, throttle, and carburetor heat were in, which was associated with a full rich mixture, full power setting, and carburetor heat "OFF." The dual rocker master switch was in the "ON" position. The flaps setting could not be determined; however, the flap indication on the wing was in the full "UP" or flaps retracted setting. All of the light switches, except for the landing light switch, were in the "OFF" position. The magneto switch was in the "OFF" position. No circuit breakers were found tripped. Fuel Primer switch was in and secured. The ELT cockpit activation switch was in the "ON" position. The airspeed indicator exhibited water intrusion and indicated about 100 knots. Avionics By-Pass switch was in the "OFF" position. The transponder was set to "7600" and also set to "ALT;" however, no radio or frequency could be ascertained due to the salt water intrusion. The left front (pilot seat) seatbelt was unbuckled and exhibited minimal webstretching. The right front seat belt remained attached to the floor structure and had no web stretching noted.

Photo 15: Fuel Selector Valve - Left Tank Selected

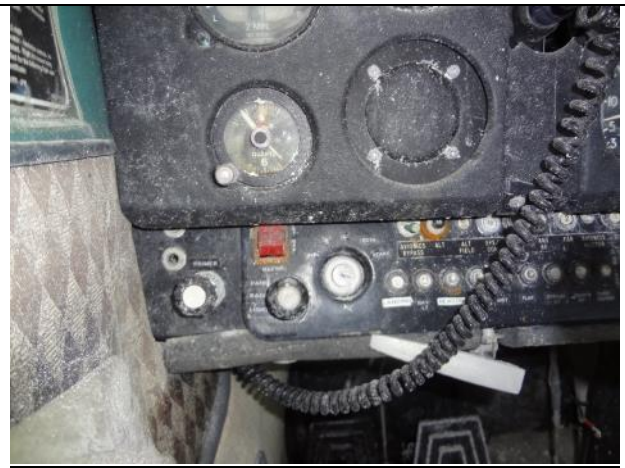
Photo 16: Magneto Switch in "OFF" Position

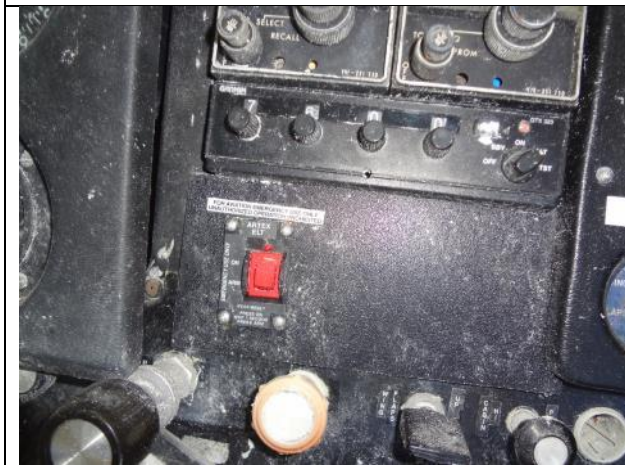
Photo 17: ELT Switch in "ON" Position as Found

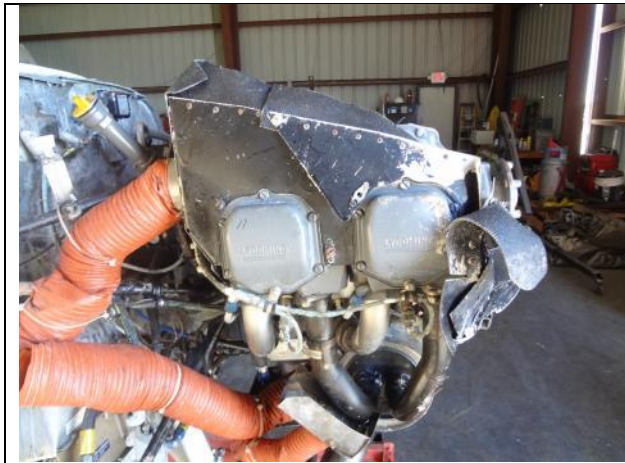
Photo 21: Cylinder No. 1 and 3 as Found - Post Recovery

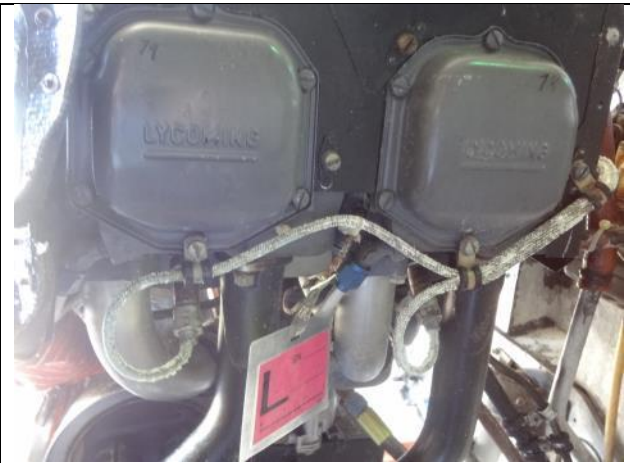
Photo 22: Cylinder No. 2 and 4 as Found - Post Recovery

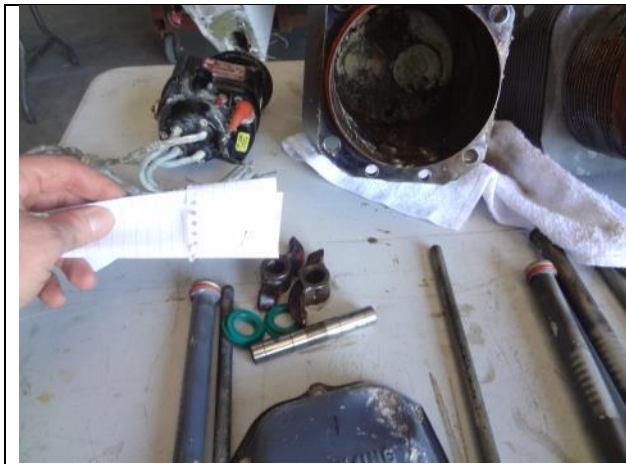
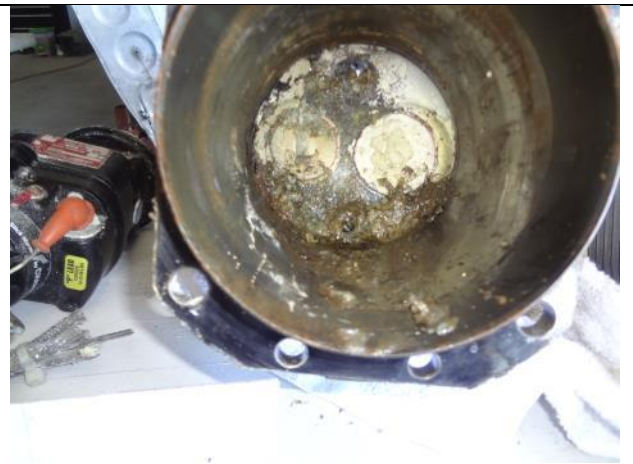
Cylinder No. 1 remained attached and exhibited corrosion on the forward side of the cooling fins, as well as sand, pebbles, and salt throughout the cooling fins. During removal, the cylinder head was partly adhered to the cylinder barrel wall due to corrosion. Following the separation of the cylinder from the engine case revealed no scoring on the cylinder wall. The inside of the cylinder barrel, the cylinder head, connecting rod, and attach point at the crankshaft revealed extensive salt water corrosion.

Photo 29: Cylinder No. 1 Components after Removal

Photo 30: Cylinder No. 1 Barrel after Removal

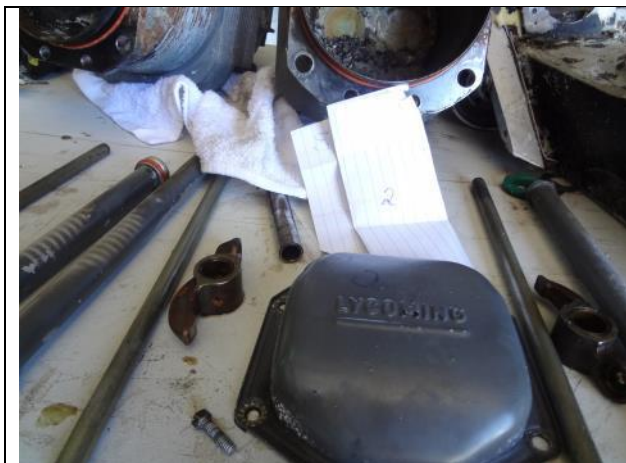
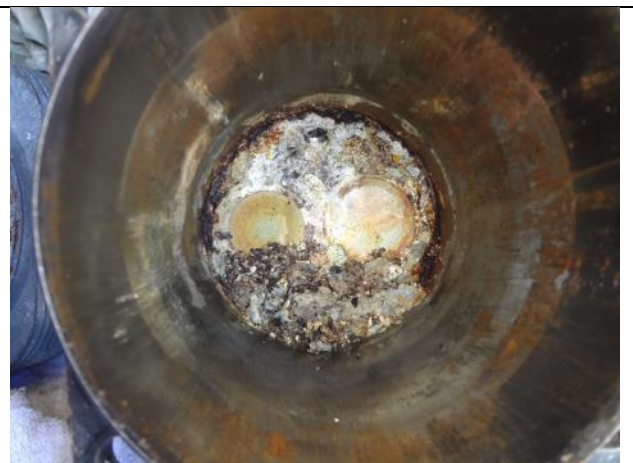
Cylinder No. 2 remained attached and exhibited corrosion at the cylinder base and carry through bolts. During removal, the cylinder head was partly adhered to the cylinder barrel wall due to corrosion. Following the separation of the cylinder from the engine case revealed no scoring on the cylinder wall. The inside of the cylinder barrel, the cylinder head, connecting rod, and attach point at the crankshaft revealed extensive salt water corrosion.

Photo 31: Cylinder No. 2 Components after Removal

Photo 32: Cylinder No. 2 Barrel after Removal

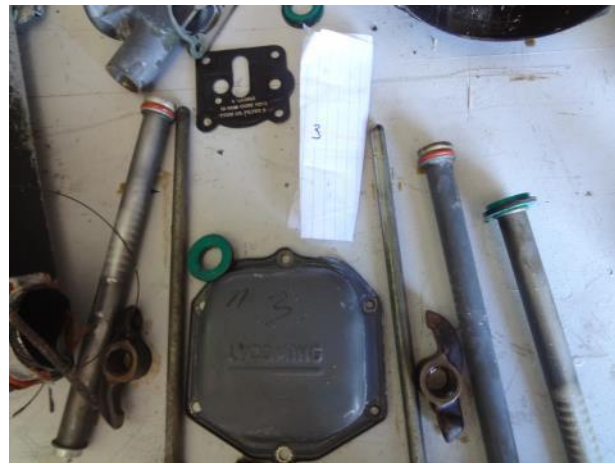
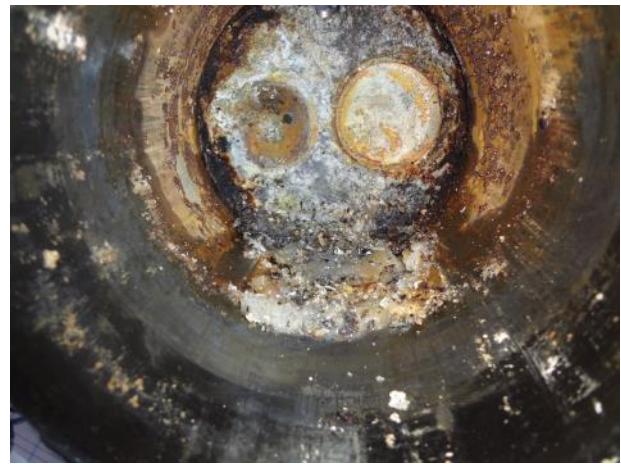
Cylinder No. 3 remained attached and exhibited corrosion at the cylinder base and carry through bolts. During removal, the cylinder head was partly adhered to the cylinder barrel wall due to corrosion. Following the separation of the cylinder from the engine case, revealed no scoring on the cylinder wall. The inside of the cylinder barrel, the cylinder head, connecting rod, and attach point at the crankshaft revealed extensive salt water corrosion.

Photo 33: Cylinder No. 3 Components after Removal

Photo 34: Cylinder No. 3 Barrel after Removal

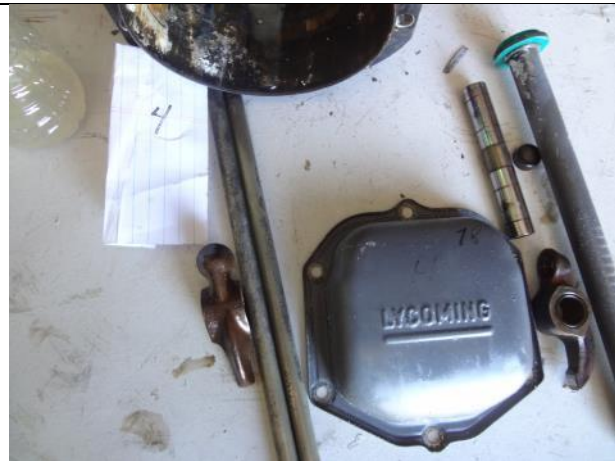
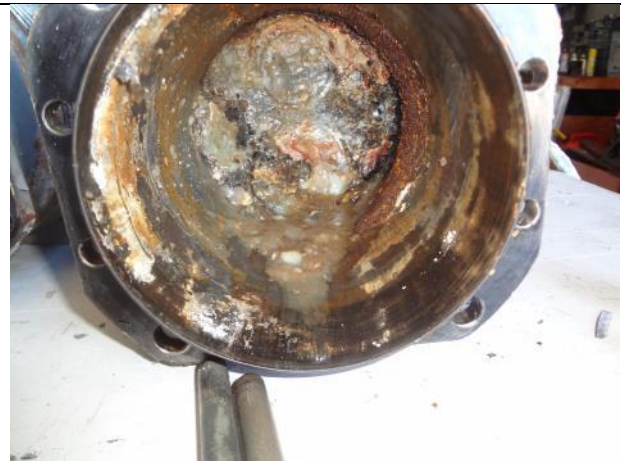
Cylinder No. 4 remained attached and exhibited corrosion at the cylinder base and carry through bolts. During removal, the cylinder head was partly adhered to the cylinder barrel wall, due to corrosion. Following the separation of the cylinder from the engine case revealed no scoring on the cylinder wall. The inside of the cylinder barrel, the cylinder head, connecting rod, and attach point at the crankshaft revealed extensive salt water corrosion.

Photo 35: Cylinder No. 4 Components after Removal

Photo 36: Cylinder No. 4 Barrel after Removal

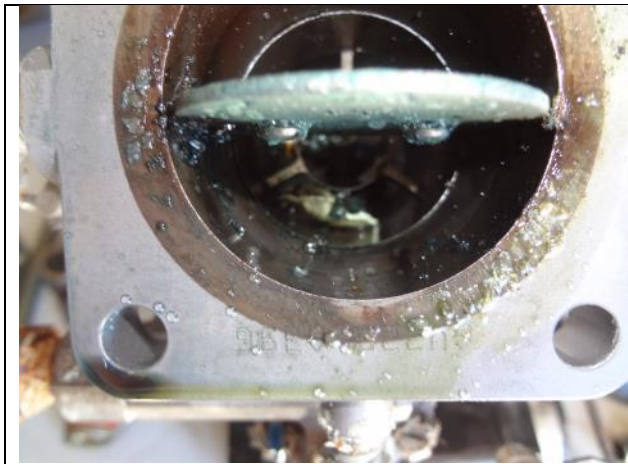
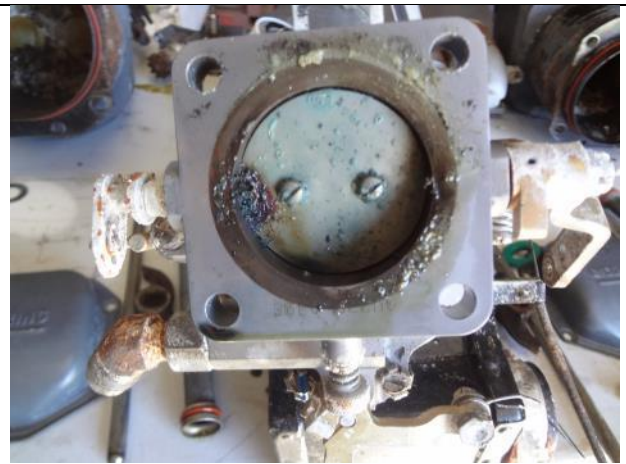
The carburetor remained attached to the engine; was removed and examined. There was no damage noted; however, corrosion was noted on the butterfly valve. The valve was operated by hand with no binding noted; water was noted excreting while the valve was manually manipulated.. The carburetor was disassembled and the floats appeared normal in appearance with no deformation noted. The carburetor was found with about one-half cup of water present and no fuel was noted, combined with the water.

Photo 37: Carburetor Valve as Found

Photo 38: Carburetor Butterfly Valve after being Manually Manipulated

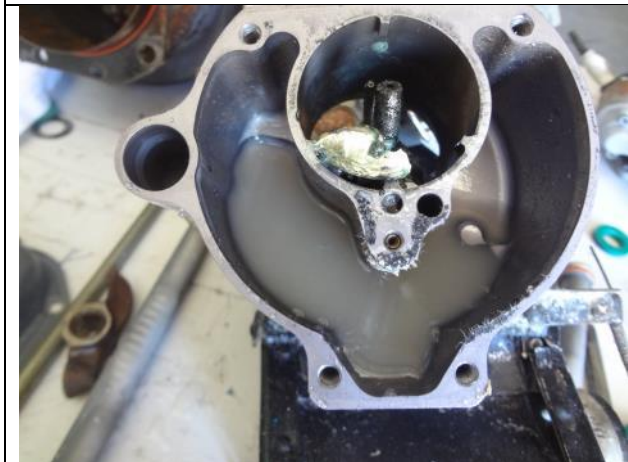
Photo 39: Fluid Found in Carburetor

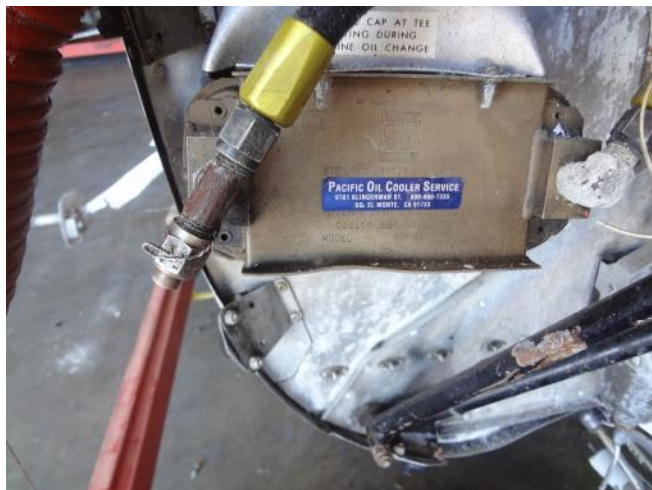
Photo 41: Oil Cooler as Found

The oil cooler remained attached to the firewall and baffling. The lines to the oil cooler remained secured. It had been manufactured by Pacific Aerospace Oil Cooler; however, no discernable part or serial numbers could be ascertained. The cooling fins were free of debris. The cooler exhibited saltwater corrosion damage but was otherwise unremarkable.

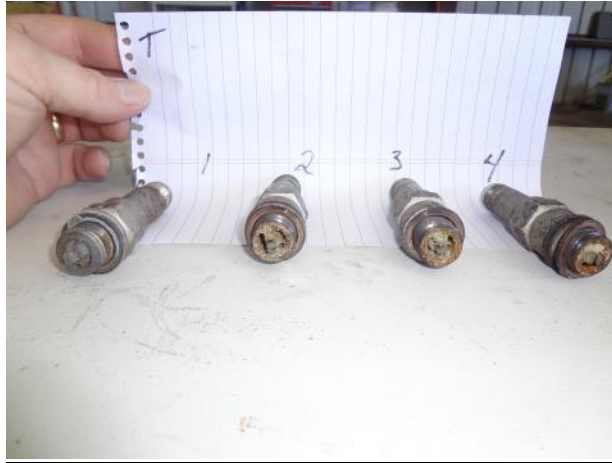
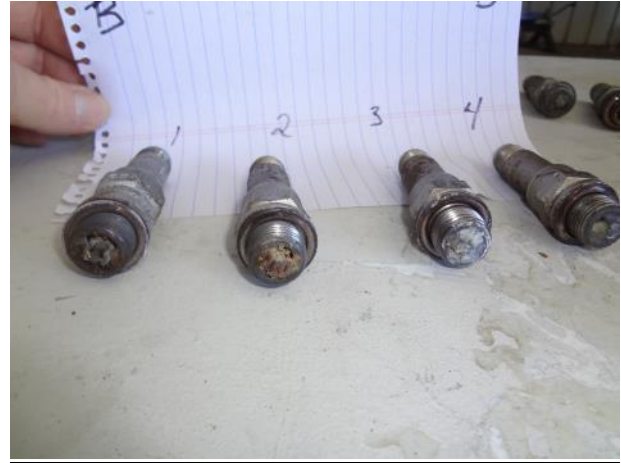
The top and bottom spark plugs were removed. They were Tempest UREM40E sparkplugs. The sparkplugs exhibited extensive saltwater corrosion but otherwise, the sparkplugs were unremarkable.

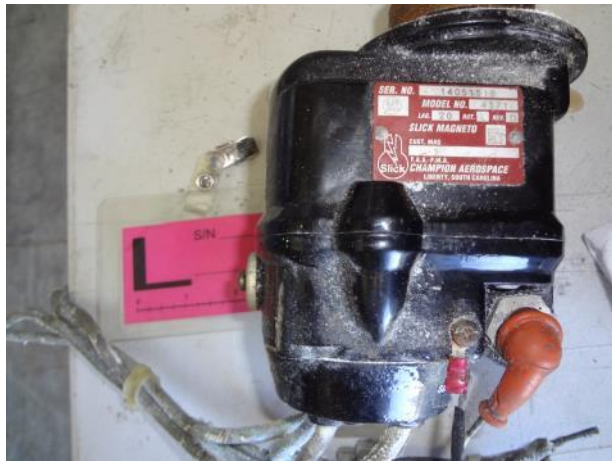
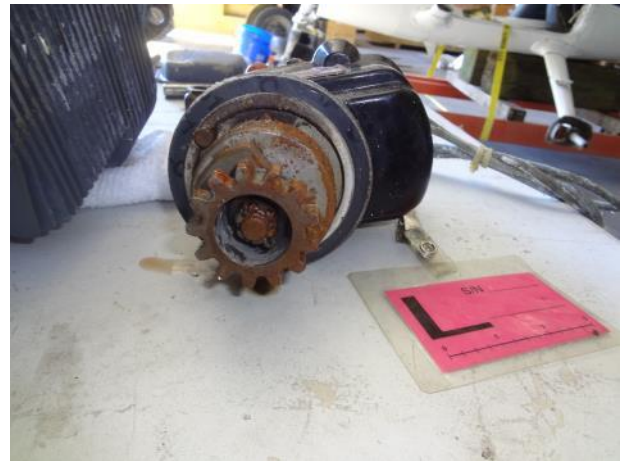
The left magneto remained attached to the mounting pad. The left magneto was a Slick Magneto, Model Number 4371; Serial Number 14051518. The unit was rotated by hand; however, due to corrosion no spark was noted, otherwise the unit was unremarkable.

Photo 45: Left Magneto Gear with Corrosion

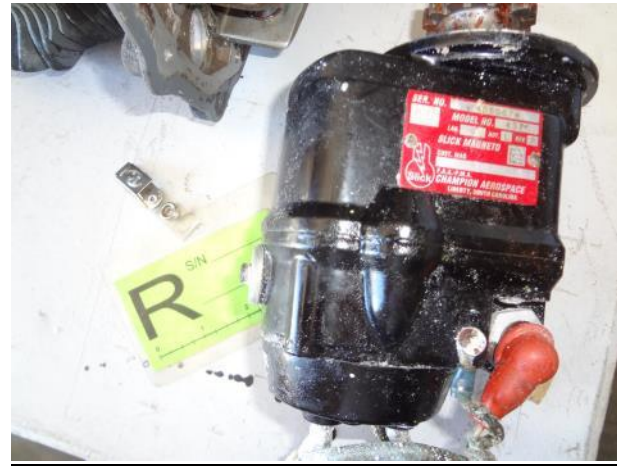
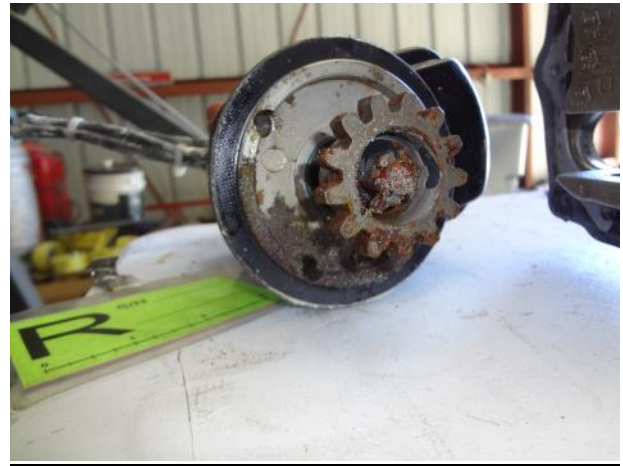
The right magneto remained attached to the mounting pad. The right magneto was a Slick Magneto, Model Number 4370; Serial Number 14050574. The unit was rotated by hand; however, due to corrosion no spark was noted, otherwise the unit was unremarkable.

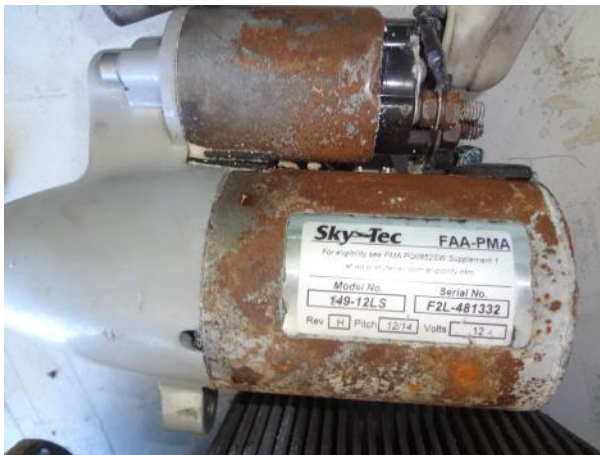
The starter remained attached to the engine. The manufacturer was SkyTec and the Model Number was 149-12LS and a Serial Number was F2L-481332. The unit exhibited corrosion but was otherwise unremarkable.

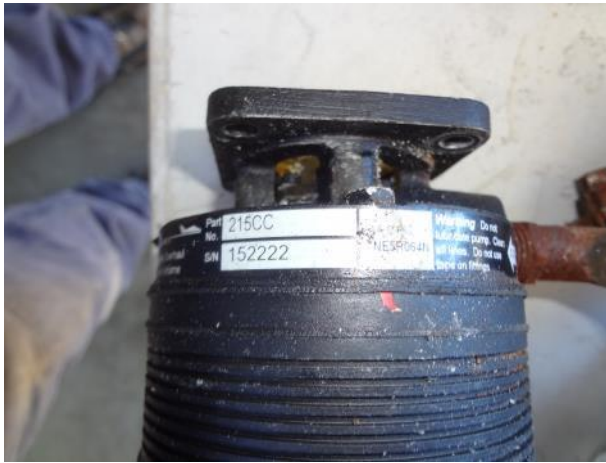
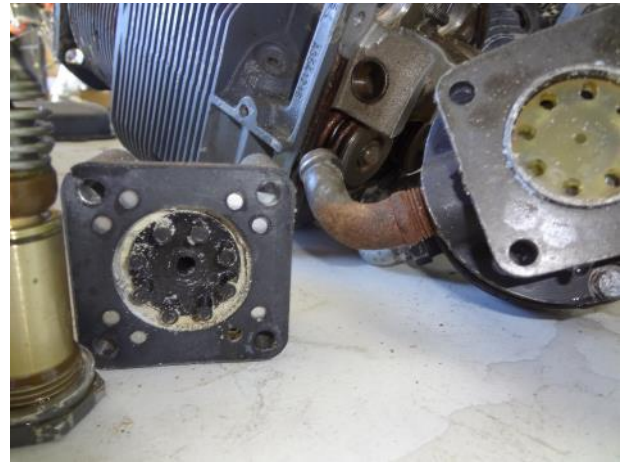
The vacuum pump was manufactured by Rapco Part number 215CC; Serial Number 152222. The unit rotated smoothly by hand; however, water was observed exiting from the exhaust port, and the unit was unremarkable.
