# Continental Motors

## ENGINE FIELD INSPECTION REPORT

| ENGINE MODEL | IO-520-BA10B |
| FILE NUMBER | 14-374 |

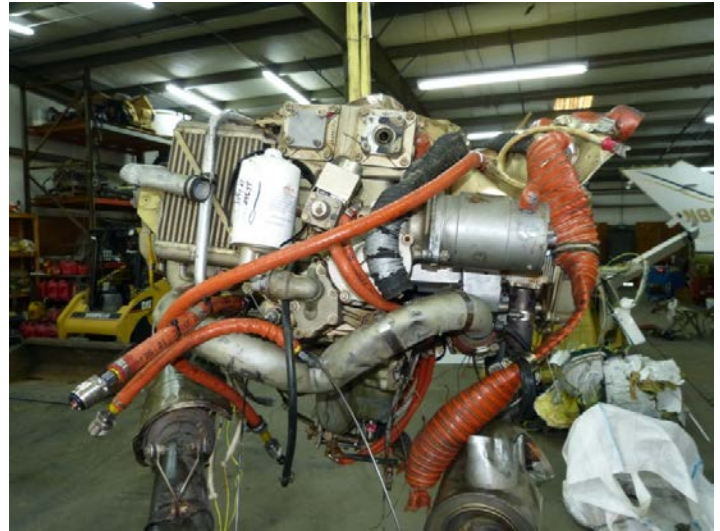
The engine was intact with all of the accessories attached, except the left magneto which was separated and hanging by the ignition leads, and the standby alternator. The intake and exhaust pipes had impact damage. The number one rocker cover was crushed inward. The oil cap and dipstick were missing. The oil filter was dented, and a small hole was observed in the left crankcase half, over the number two cylinder attachment point. The throttle, mixture, and propeller governor controls were hooked up and were free to move.

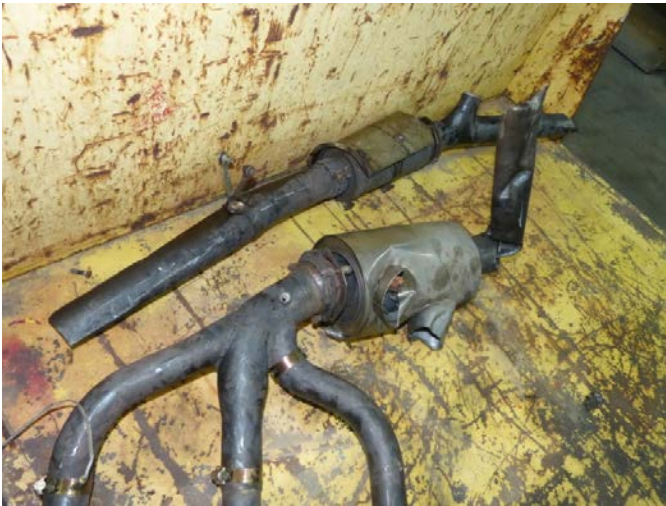
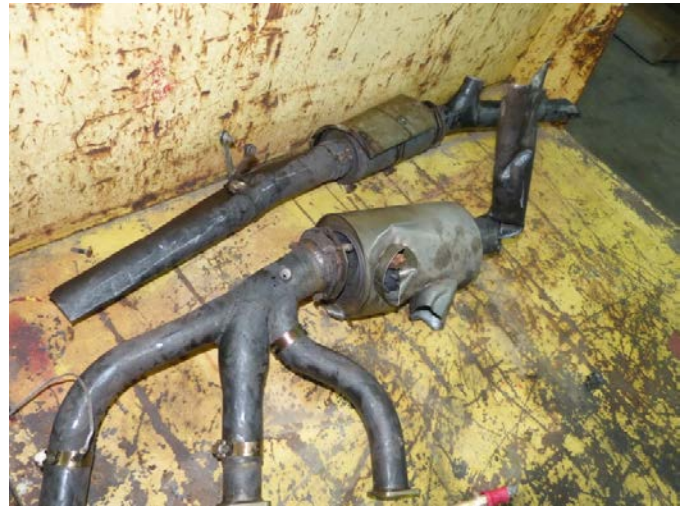
#### EXHAUST SYSTEM

The exhaust system was in place and had impact damage.

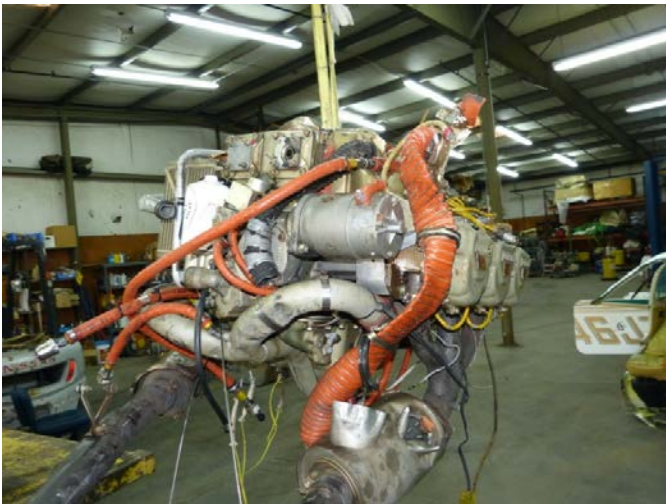
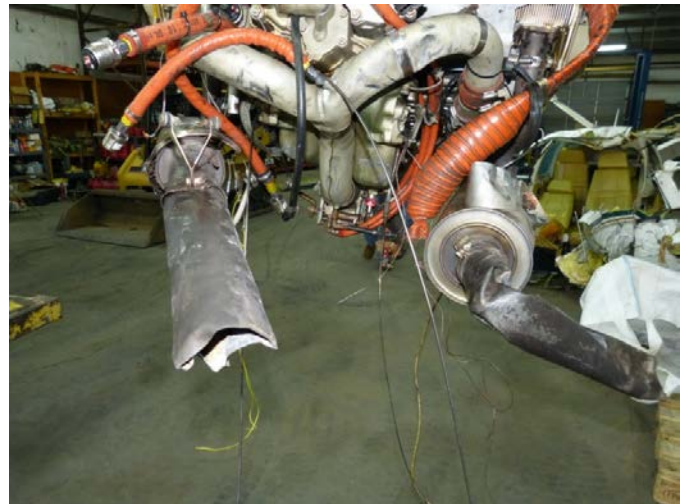
#### INDUCTION SYSTEM

The induction system was in place and had impact damage.

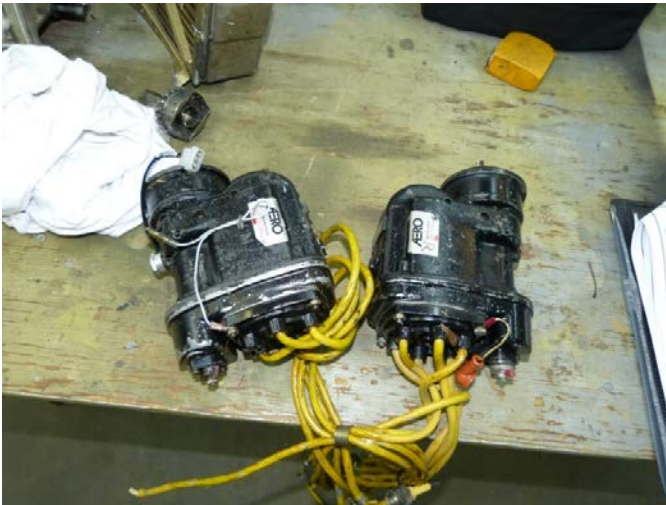
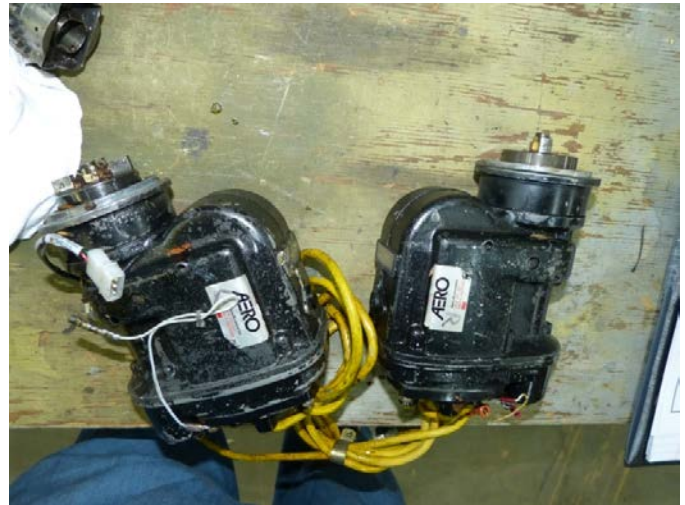
**PAGE 7 of 25****IGNITION SYSTEM****LEFT  
MAGNETO**

**Condition:** The magneto was separated from the engine and was hanging by the ignition harness. It had an Aero Accessories tag. The magneto drive shaft was rotated using an electric drill and a spark was observed at all terminals.

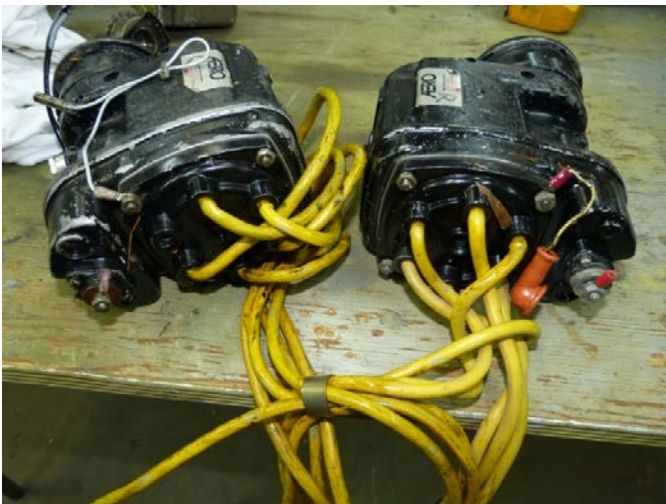
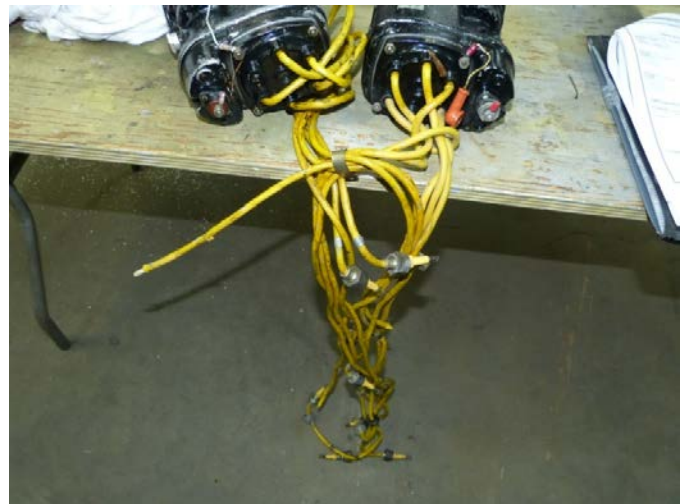
**RIGHT  
MAGNETO**

**Condition:** The magneto was in place and not damaged. It had an Aero Accessories tag. The magneto drive shaft was rotated using an electric drill and a spark was observed at all terminals.

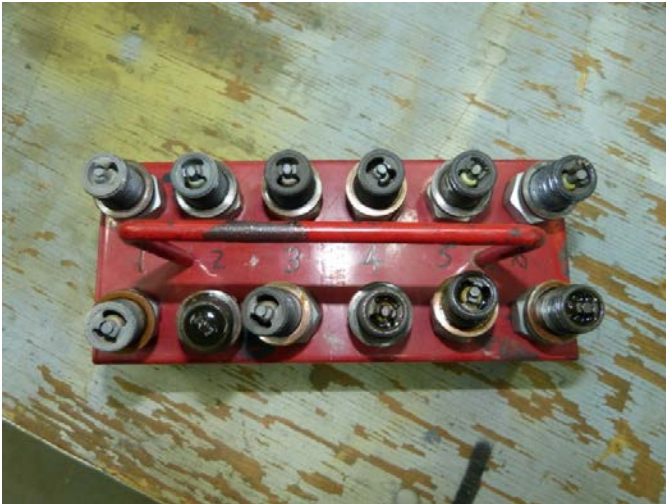
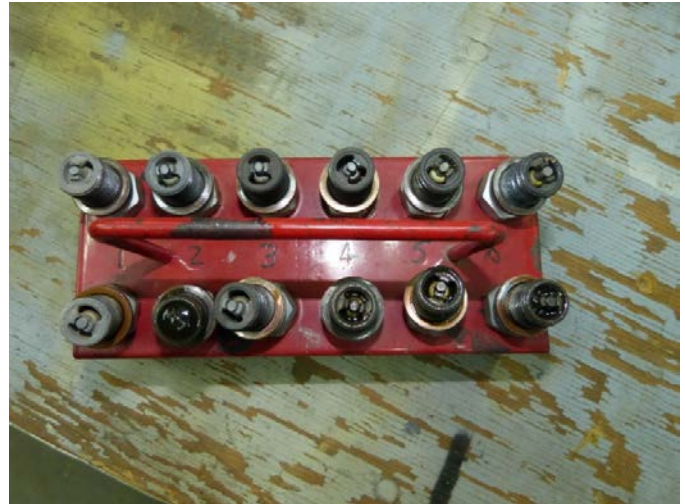
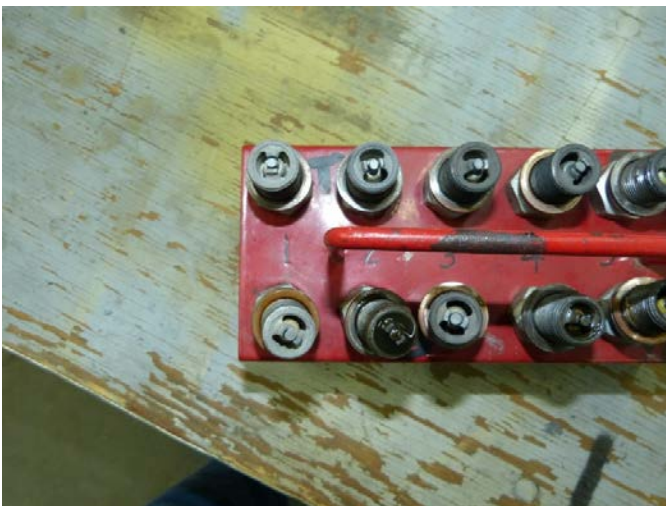
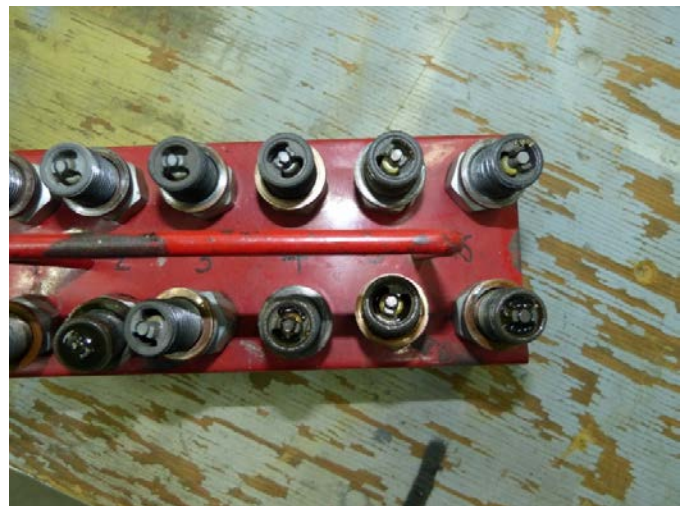
### SPARK PLUGS

All of the spark plugs were removed and examined. They had normal wear in the electrode areas when compared with the Champion Check-A-Plug comparison card. Bottom spark plugs two, four, five, and six had oil in the electrodes. The remainder of the spark plugs had light gray deposits in the electrode areas.

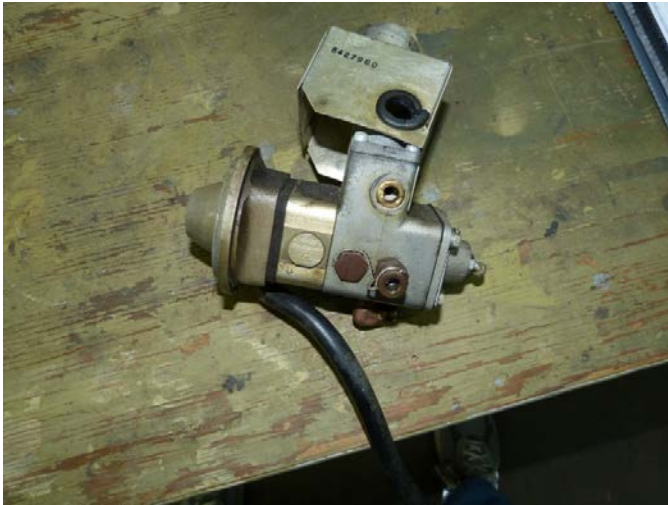
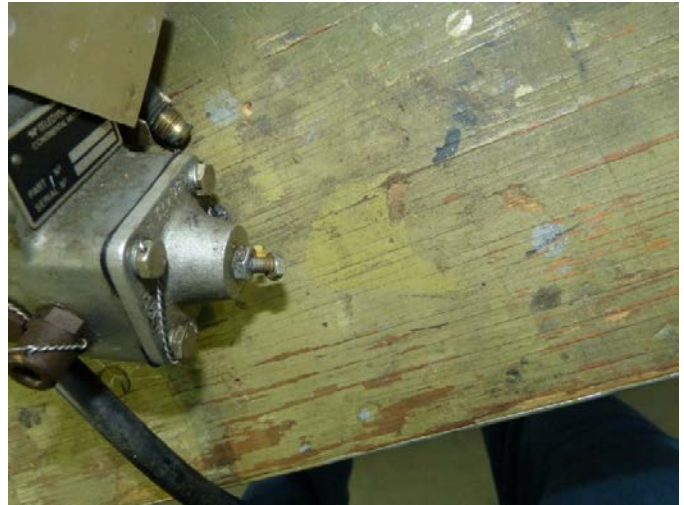
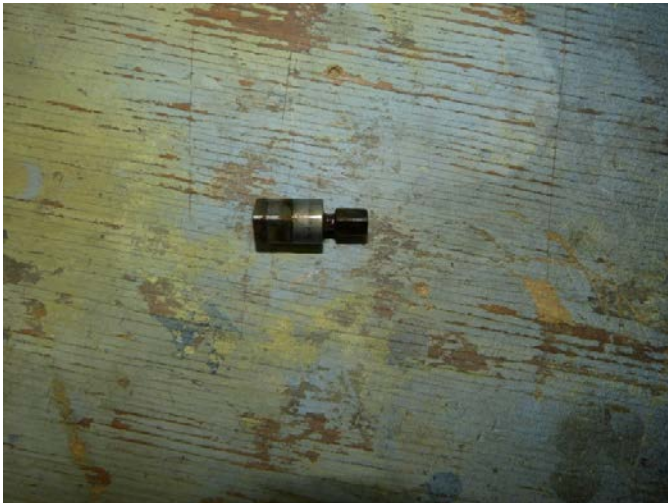
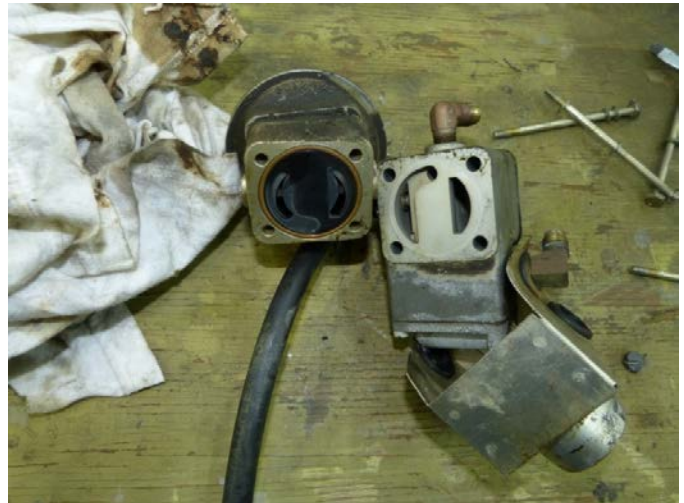
**FUEL PUMP**

The fuel pump was in place on the rear of the engine. The fuel inlet and vapor return lines were separated. The low pressure set screw on the rear of the pump was impact damaged. The drive coupling (653359B) was intact and not damaged. The safety wire and lead seal were in place. The drive shaft was free to rotate. The unit was disassembled and no internal damage was observed.

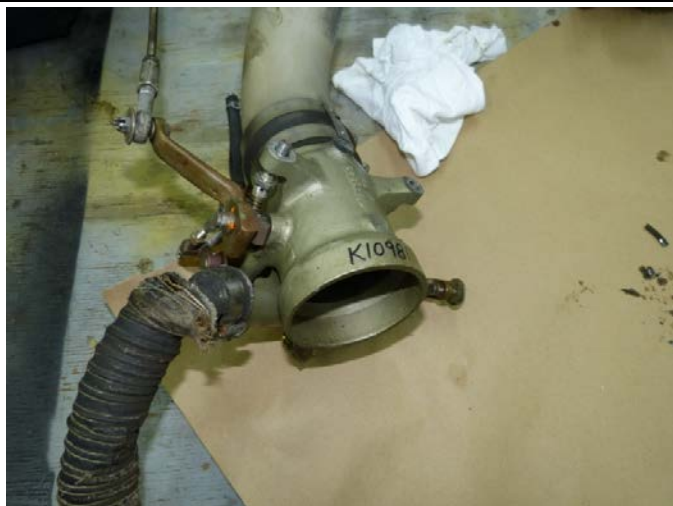
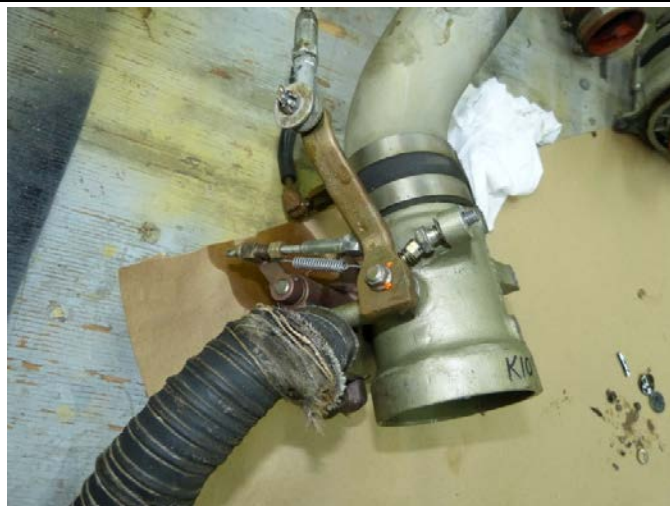
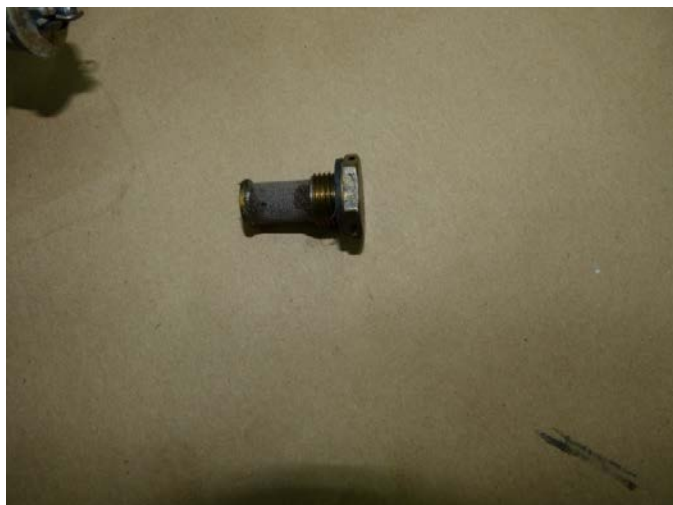
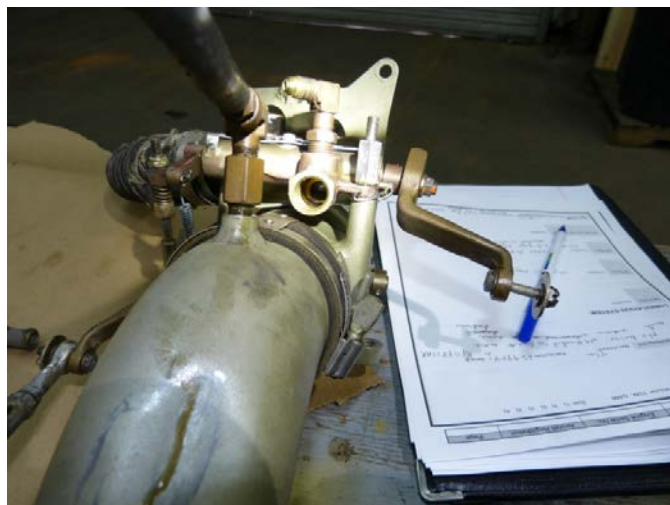
## THROTTLE BODY METERING UNIT

The metering unit was not damaged. The throttle and mixture controls were hooked up and were free to move. Some debris was observed on the fuel screen.

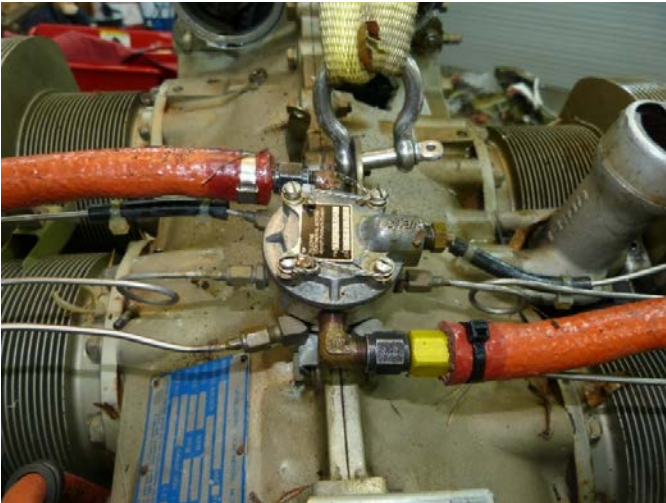
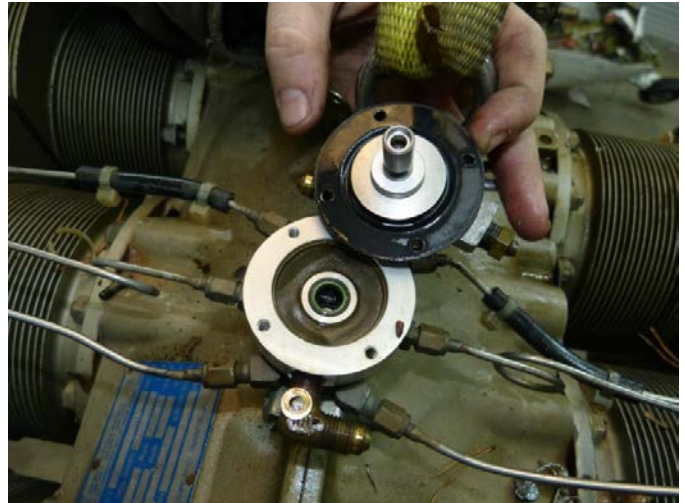
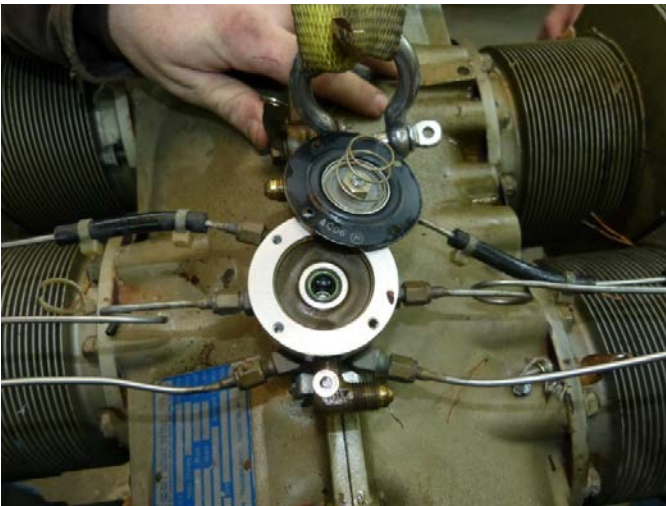
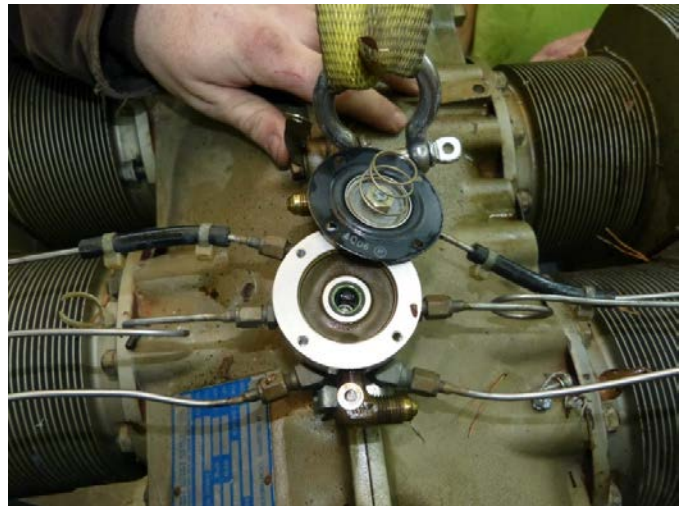
| Condition: | The safety wire and lead seal were in place. The unit was opened and the diaphragm and spring were not damaged. The screen was clean and clear. The nut was tight on the plunger. Fuel was observed in the unit. | | |

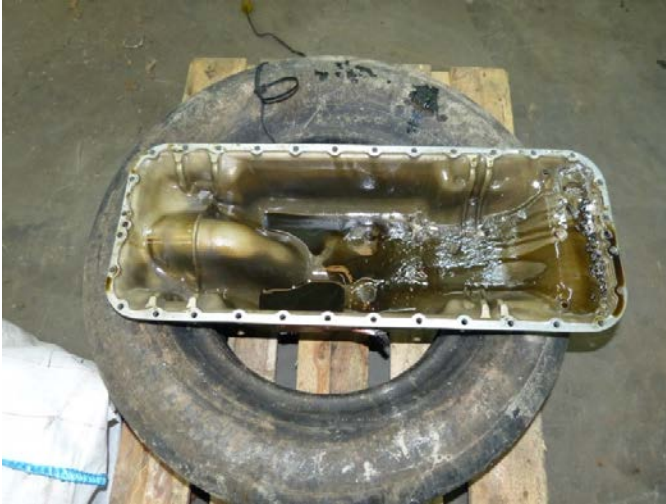
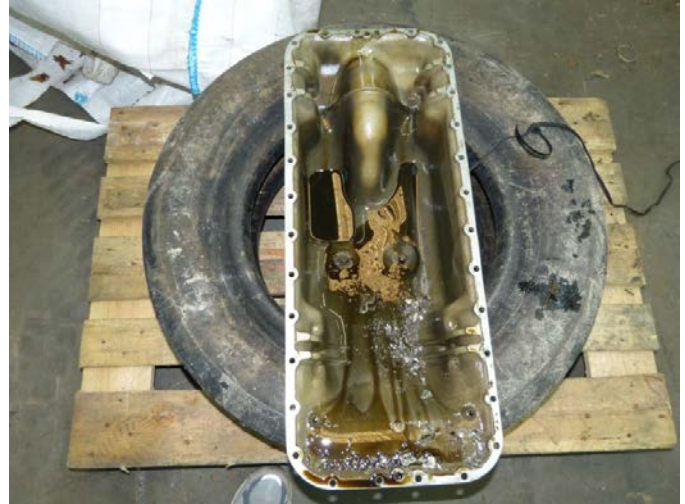
#### OIL SUMP

**Condition:** The oil sump was in place and not damaged.

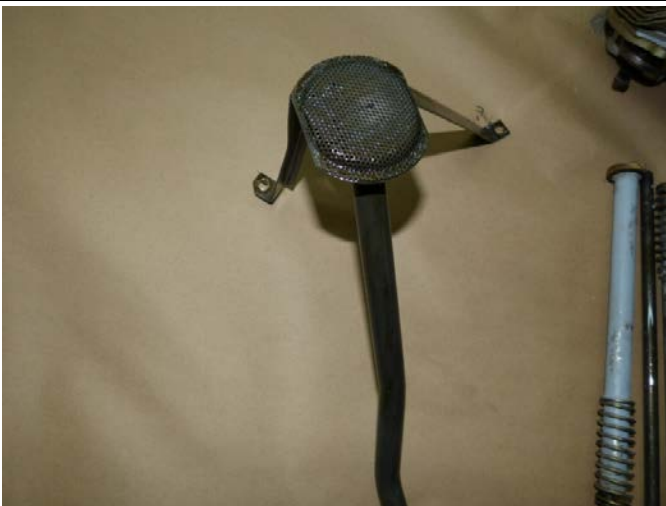
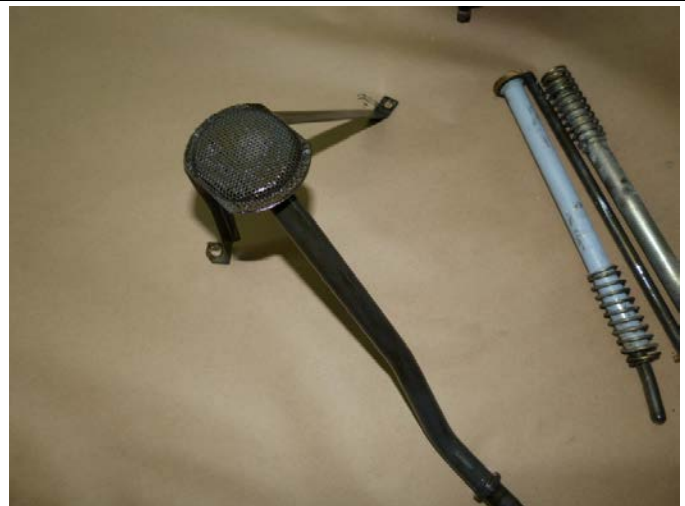
#### OIL PICK-UP TUBE & SCREEN

**Condition:** The oil pick-up screen and tube were not damaged. Some metal was observed on the screen.

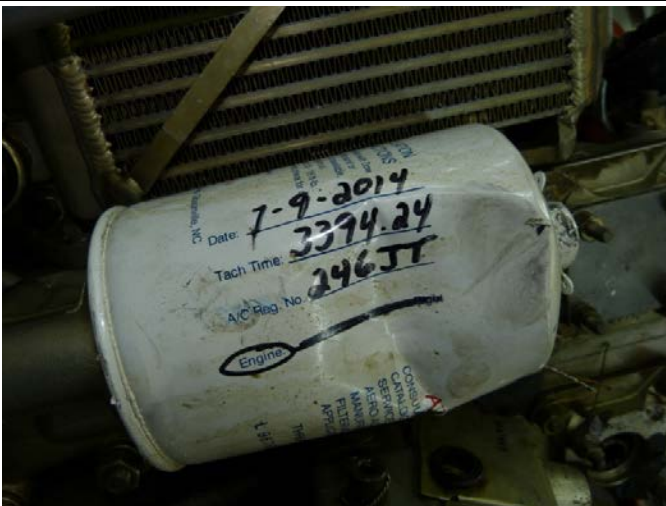
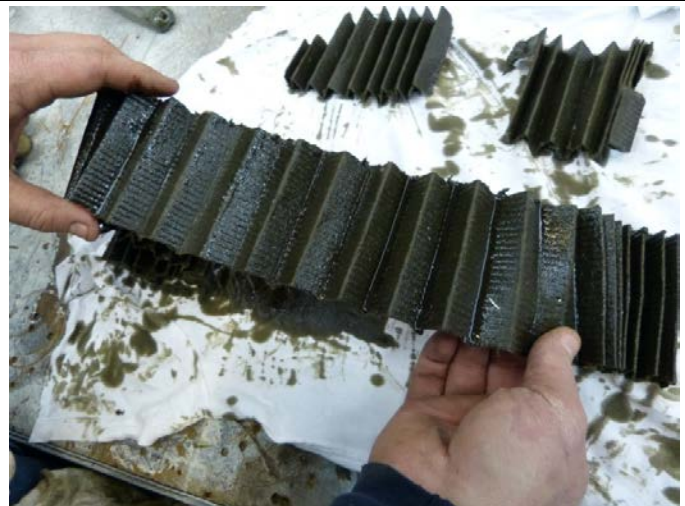
## OIL FILTER

The oil filter was in place and dented. The filter was cut open and small amounts of metal were observed in the element.

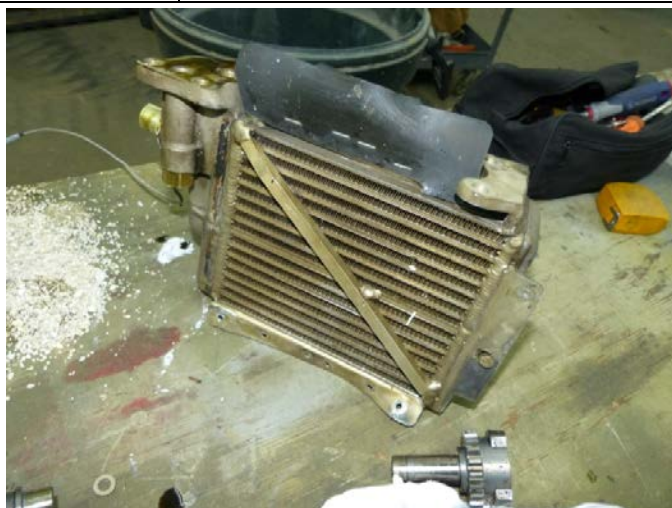
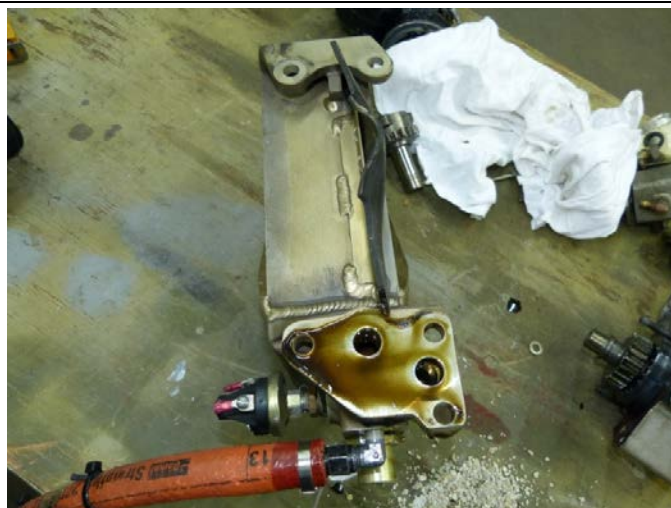
**OIL COOLER**

The oil cooler was in place and not damaged.

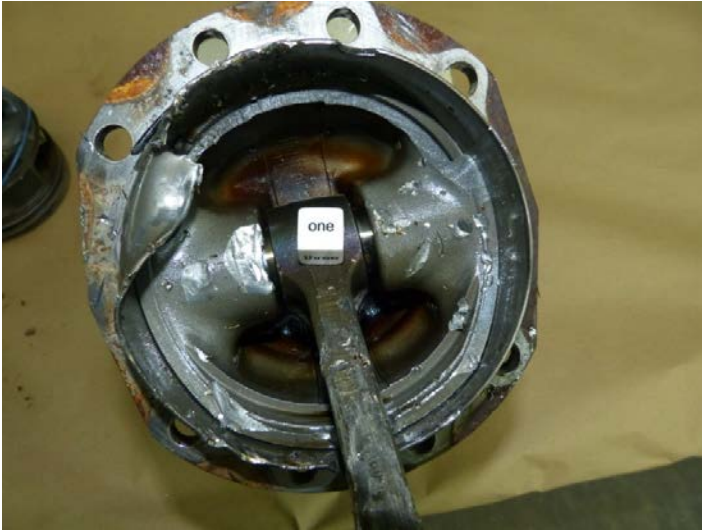
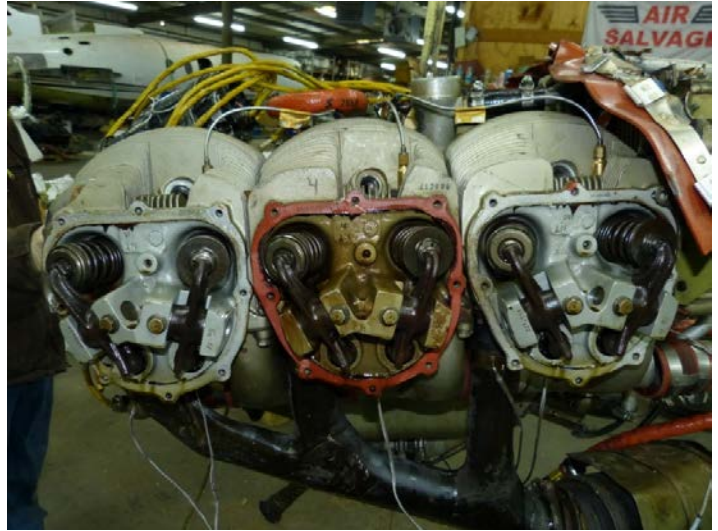
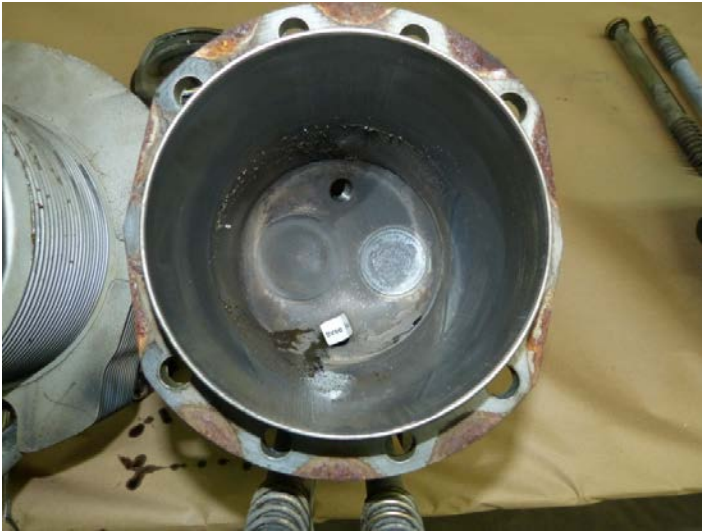
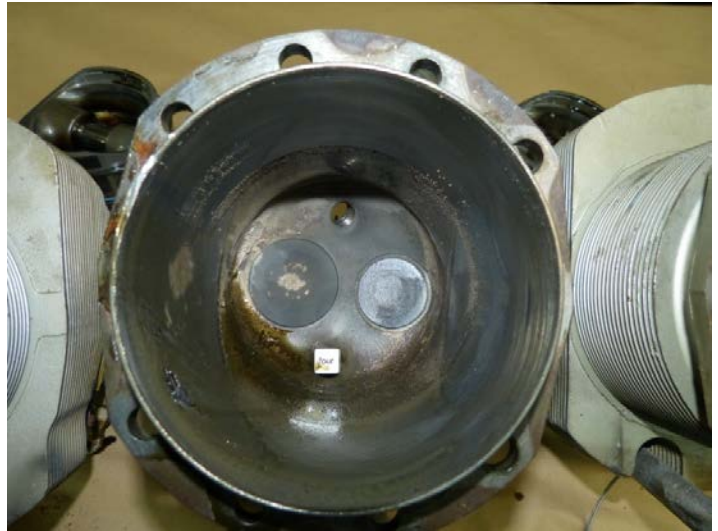
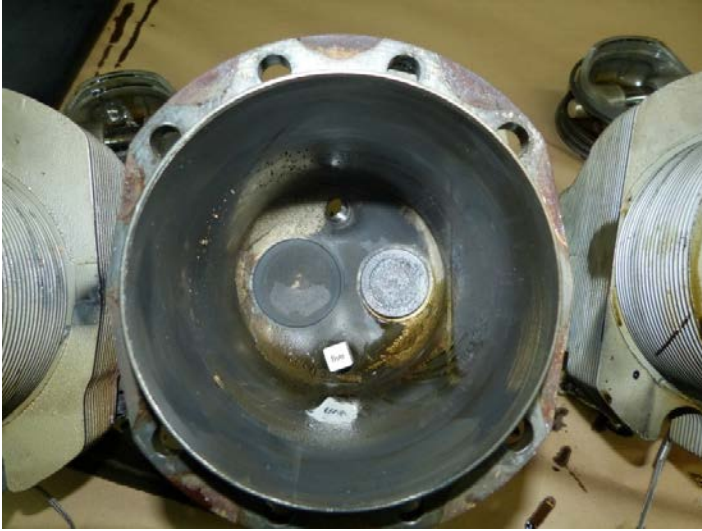
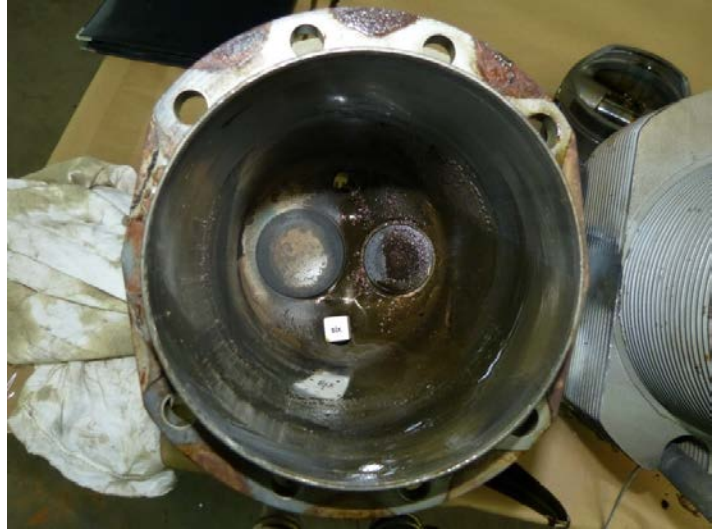
Cylinders: NT, 654961

All of the cylinders were removed, except the number two cylinder, which could not be removed because of impact damage. They had normal wear and normal combustion deposits in the domes. All of the valves were in place.

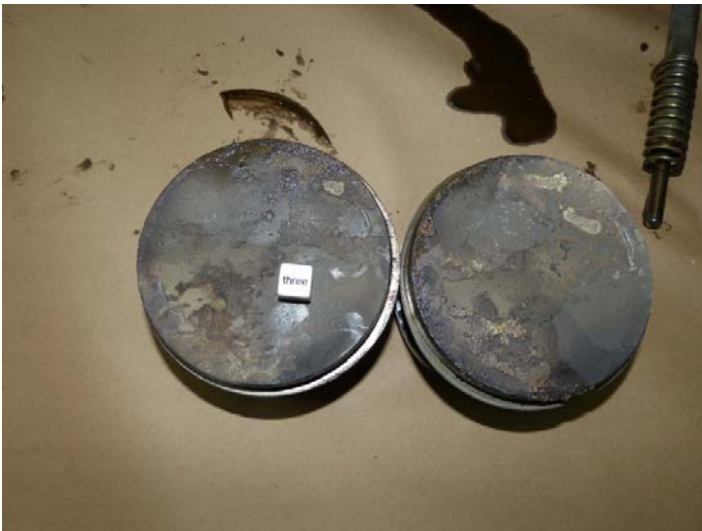
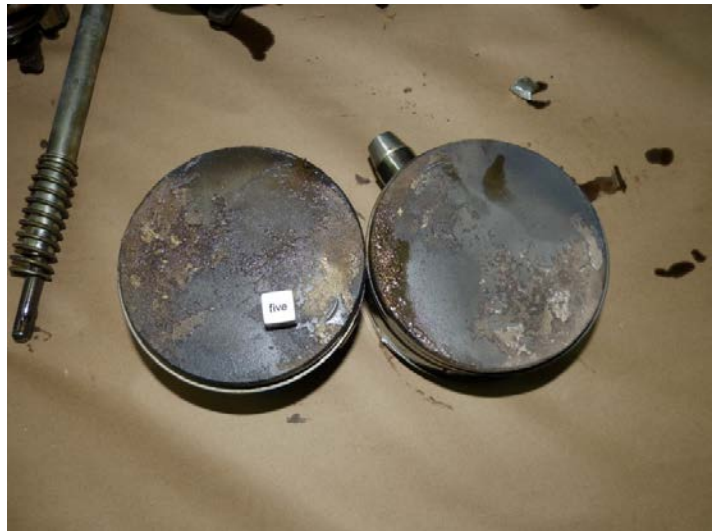
Pistons: 654850B P010

Pistons one and two could not be removed from their cylinders. The remainder of the pistons had impact damage marks from the valves on their faces. Otherwise they had normal combustion deposits and all of the rings were in place.

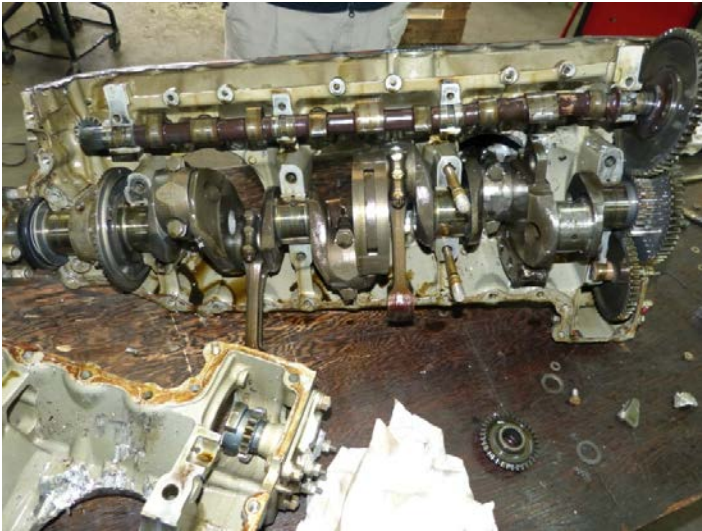
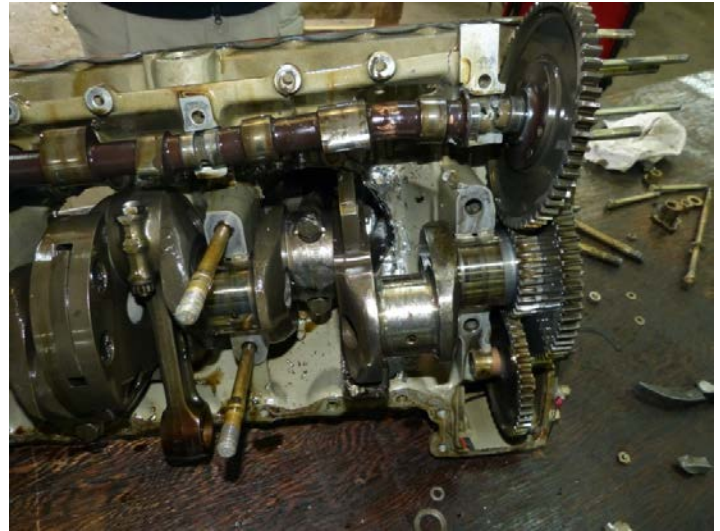
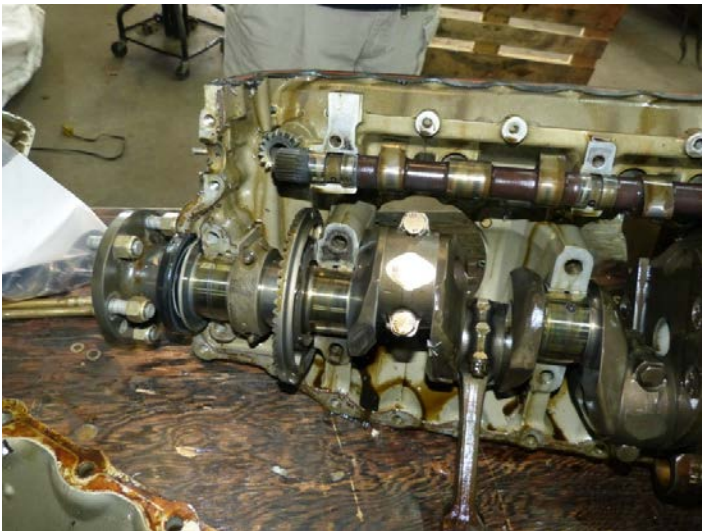
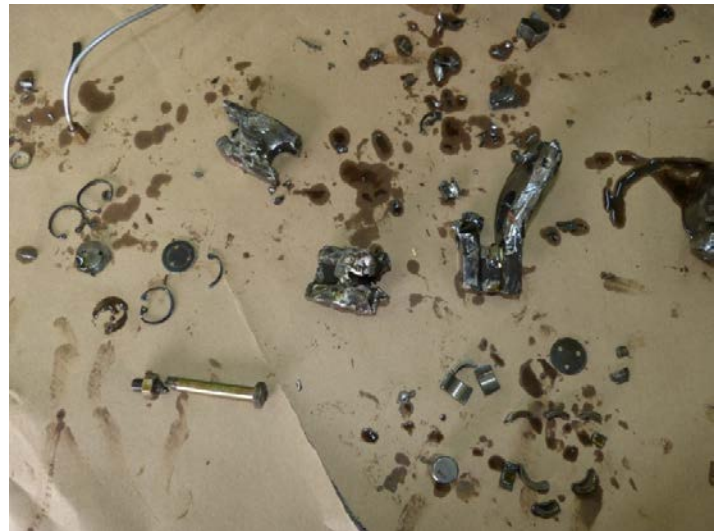
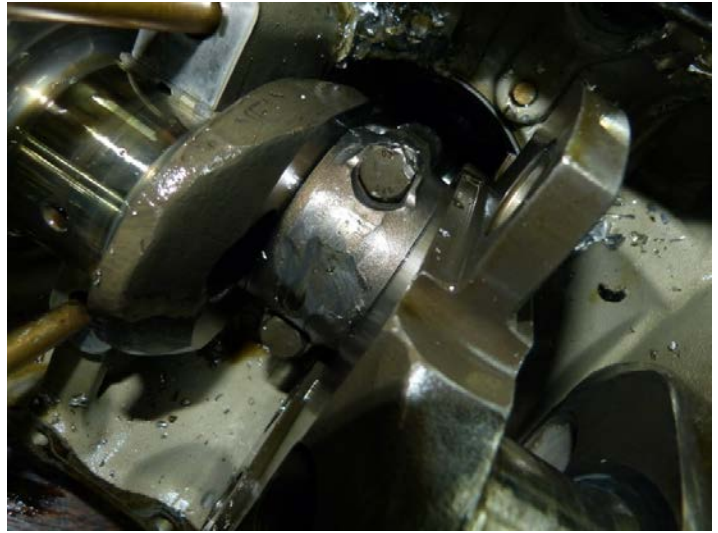
Crankshaft: SN-G309204N

One of the aft counterweights was separated from the crankshaft, and the number one connecting rod was separated from the crankshaft. The engine oil sump contained oil, and all of the crankshaft journals were coated with oil.

The crankshaft was intact, except that one of the aft counterweights was separated, and the counterweight hanger was damaged. All of the journals were coated with oil and no heat damaged was observed on the crankshaft. Parts of the counterweight were recovered, including three and one half retainer clips, three retainer plates, and one counterweight pin, with the number A101. All of the other counterweights were in place and free to move.

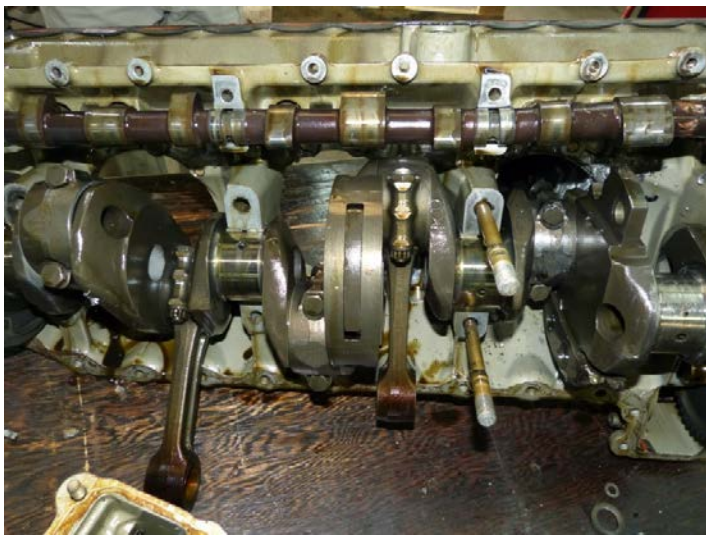
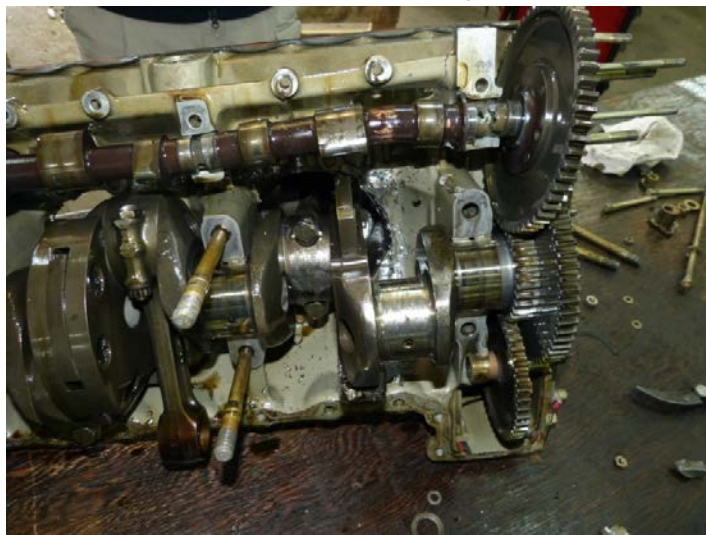
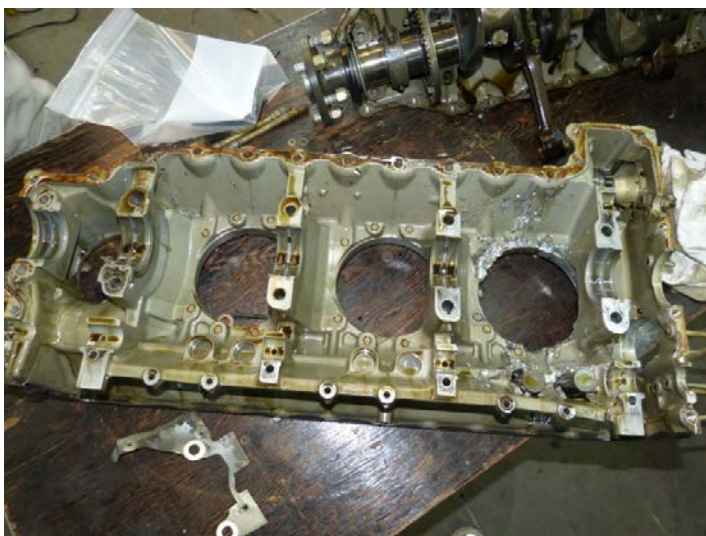
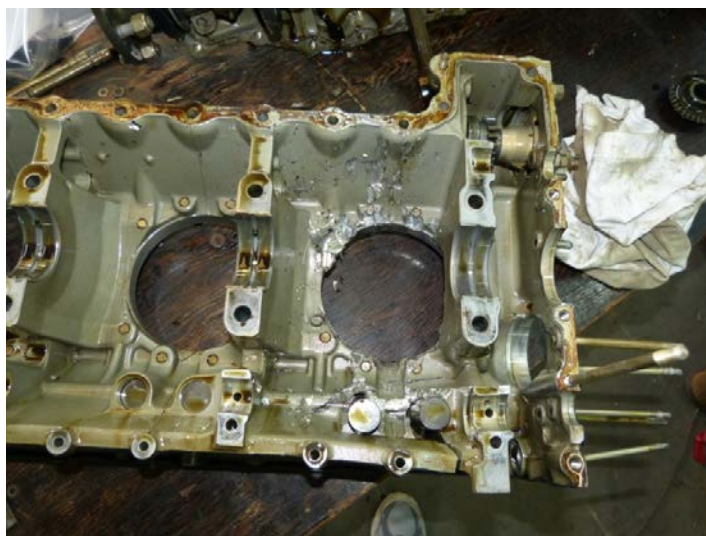
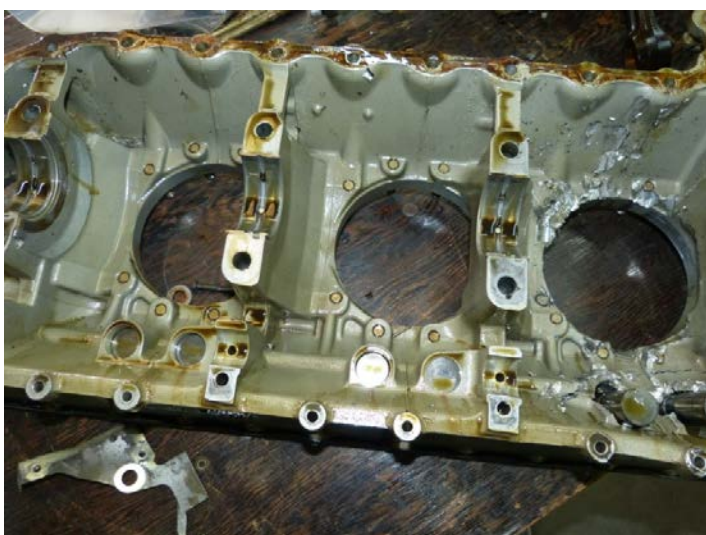
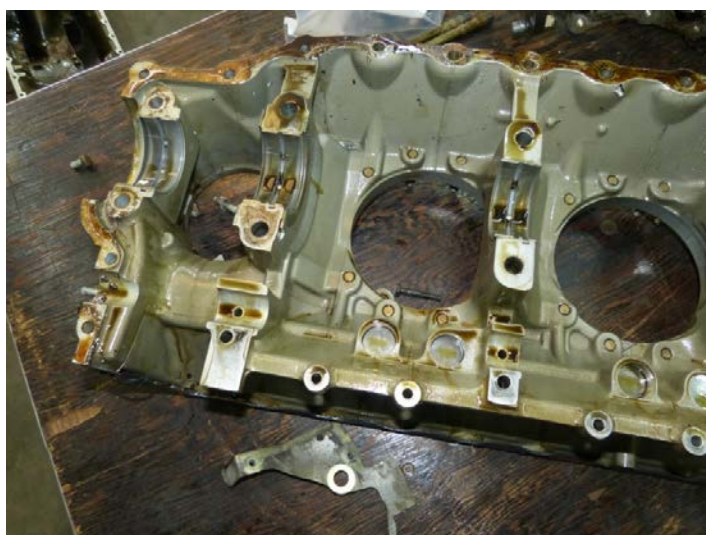
Camshaft and valve lifters:

The camshaft and valve lifters remained in the crankcase halves and were impact damaged.

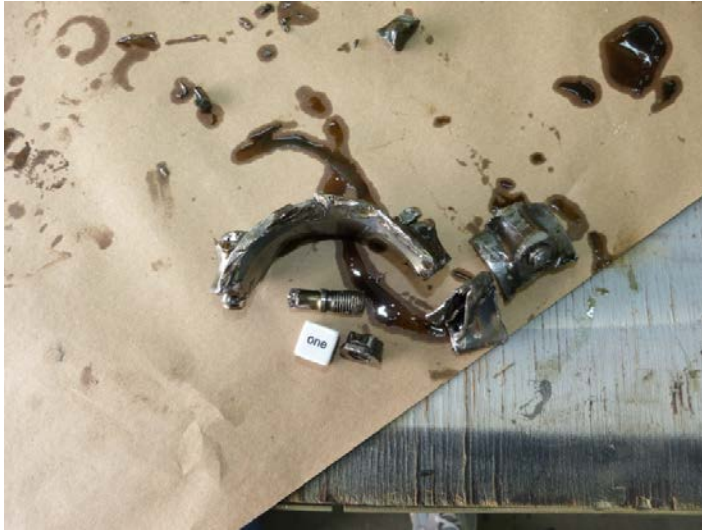
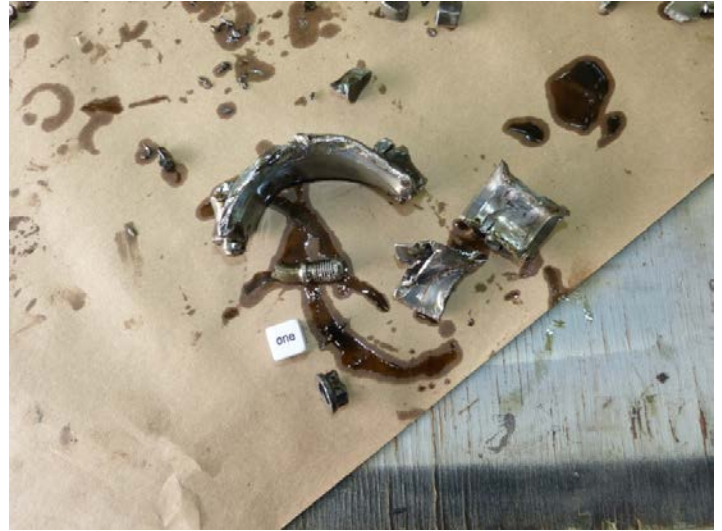
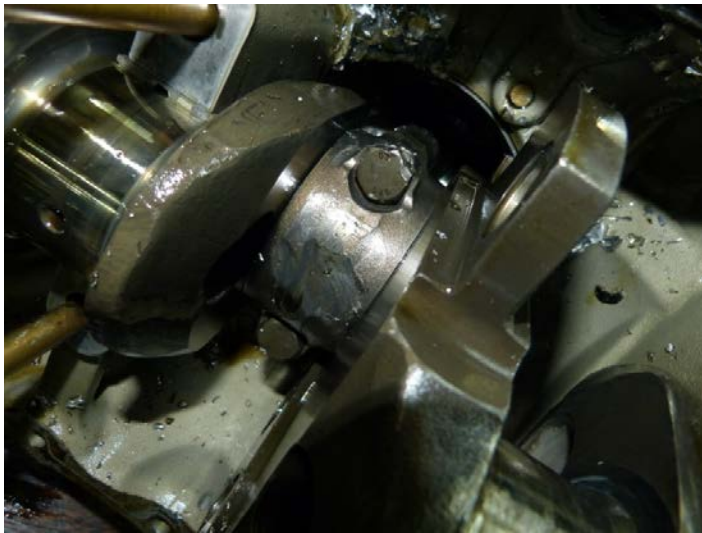
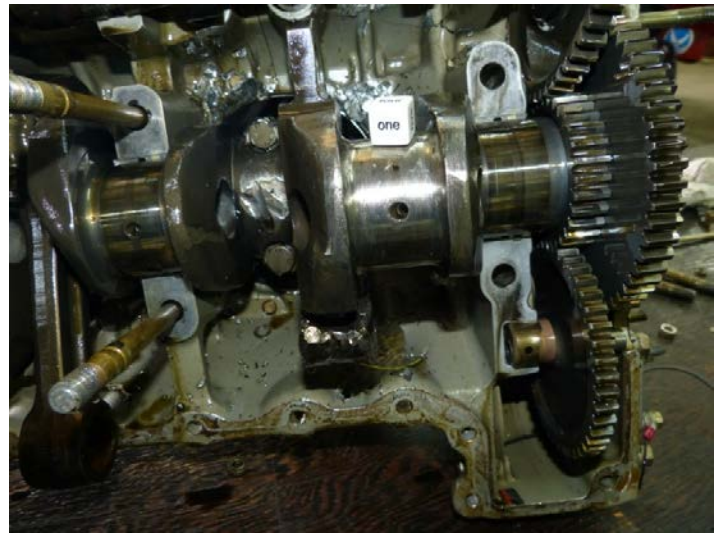
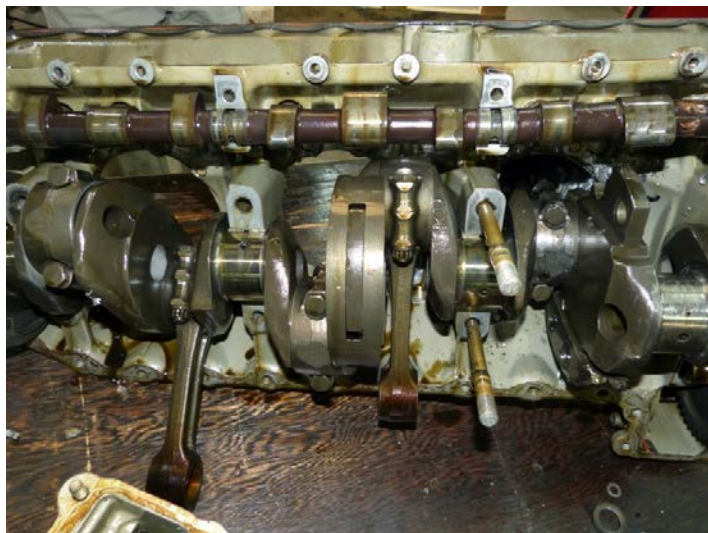
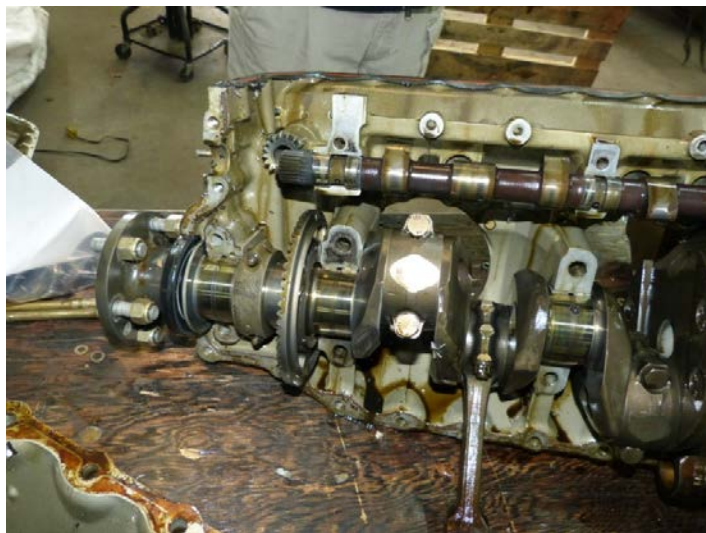
Connecting Rods: The connecting rods remained attached to the crankshaft and were free to move, except the number one connecting rod, which was separated by impact damage, and partly destroyed. The number two connecting rod remained attached to the crankshaft, but could not be moved because the cylinder remained attached.

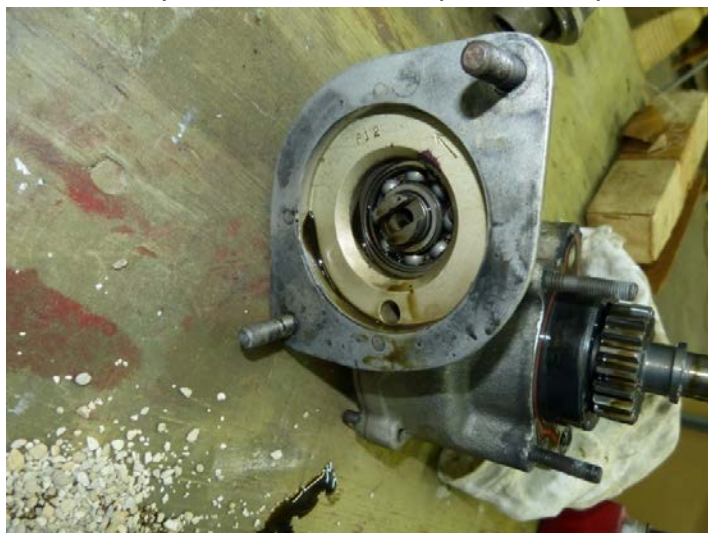
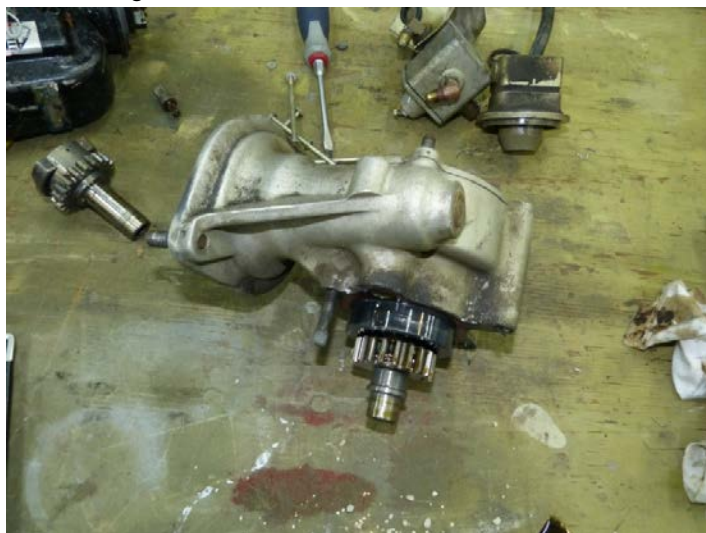
The starter was in place and not damaged. The drive shaft was free to rotate.

Starter Adapter: The starter adapter was in place and not damaged. The drive shaft was free to rotate.
