# Continental Motors

## ENGINE FIELD INSPECTION REPORT

| ENGINE MODEL | IO-520-BA10B |
| FILE NUMBER | 14-374 |

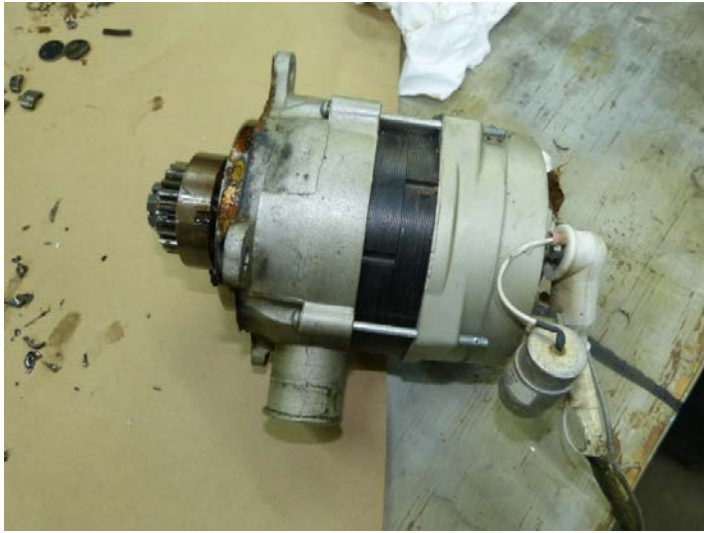
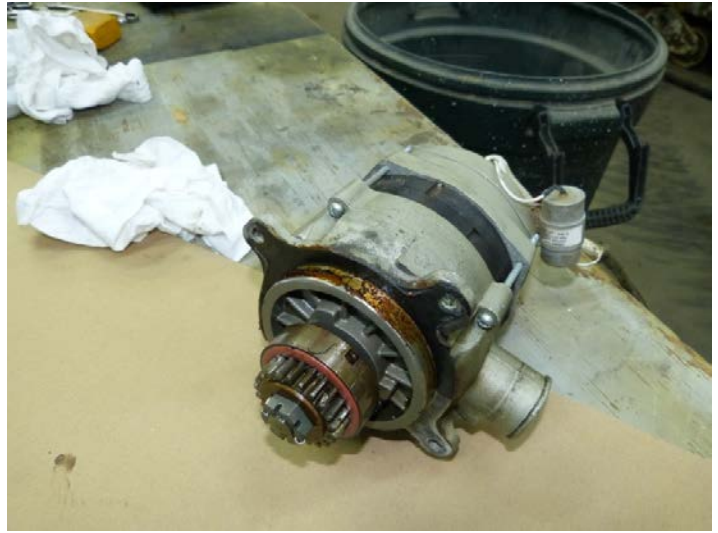
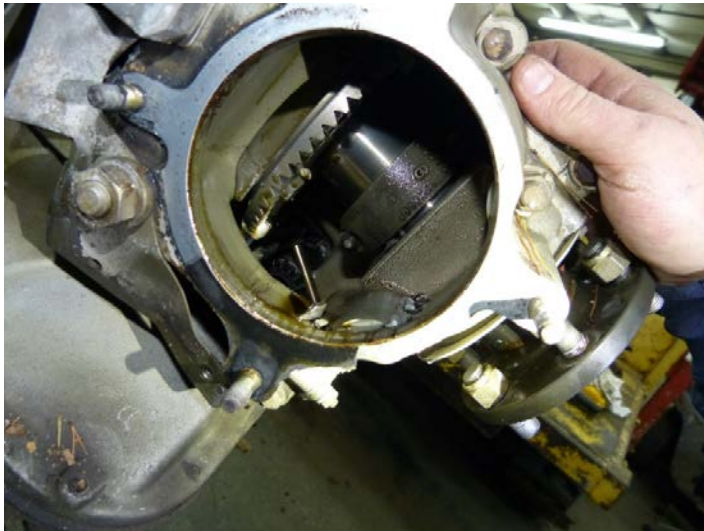
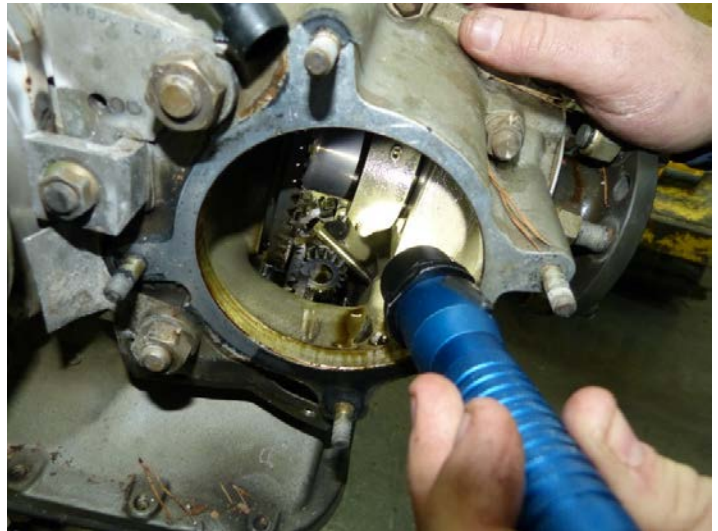
Alternator: Kelly Aerospace, ALX-9524R, SN-H100808

The alternator was in place and had light impact damage. The drive shaft was free to rotate.
