**MANDATORY SERVICE BULLETIN**

**MSB 99-3C**

**SUBJECT: CRANKSHAFT INSPECTION**

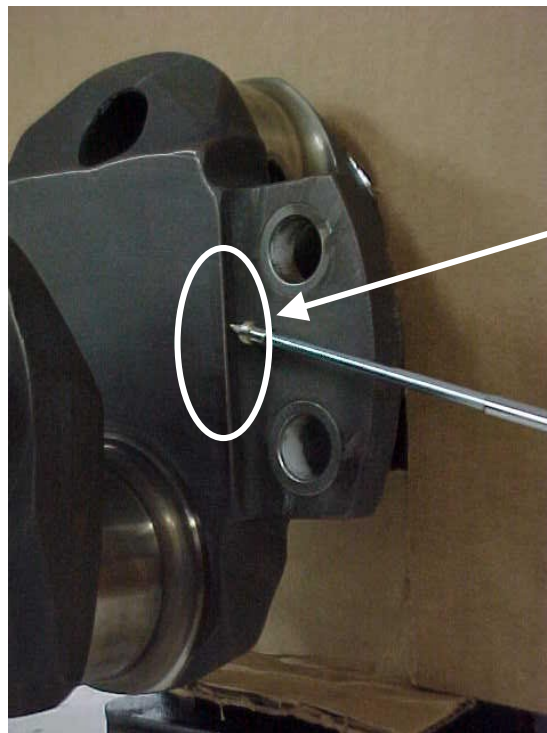
**FIGURE 9. FOCUS INSPECTION IN THIS AREA**

Chamfered edge of the aft side of number two and five crankshaft cheek centered between counterweight blade bushing holes on both sides

3. If the visual inspection does not clearly reveal a crack, perform an ultrasonic inspection of the aft side of number two and five crankshaft cheek in accordance with Section "B" ULTRASONIC INSPECTION.
4. If visual inspection reveals a crack the engine must be removed from service until repaired or replaced.

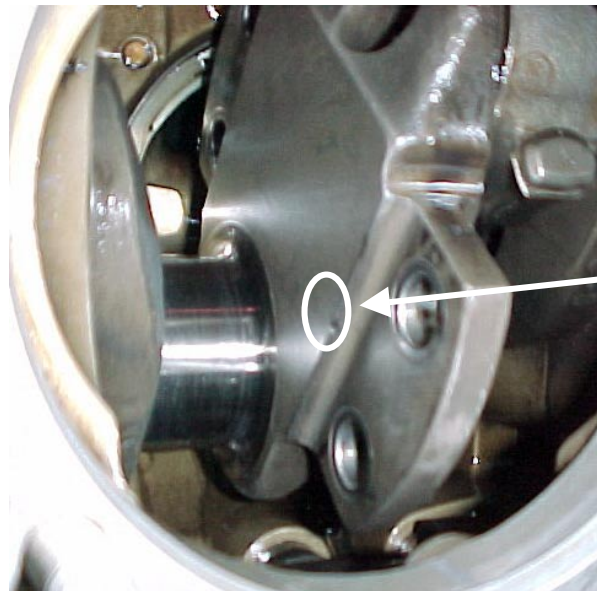
**FIGURE 10. CRANKSHAFT IN INSPECTION POSITION #2 CRANKCHEEK CONNECTING ROD REMOVED**

Inspect area of aft side of cheek between counterweight bushing holes at chamfered edge of blade shoulder on both sides

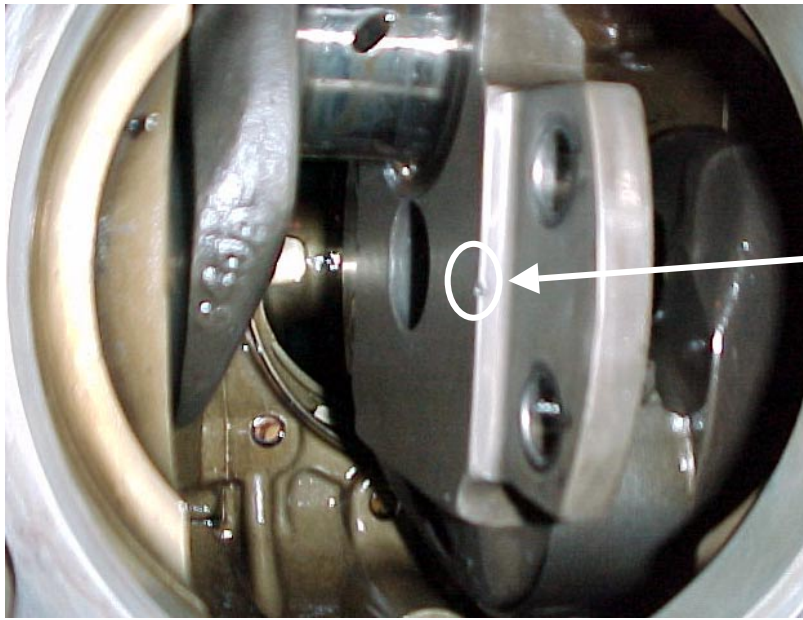
**FIGURE 11. CRANKSHAFT IN INSPECTION POSITION #5 CRANKCHEEK CONNECTING ROD REMOVED**

Inspect area of aft side of cheek between counterweight bushing holes at edge of blade shoulder on both sides
