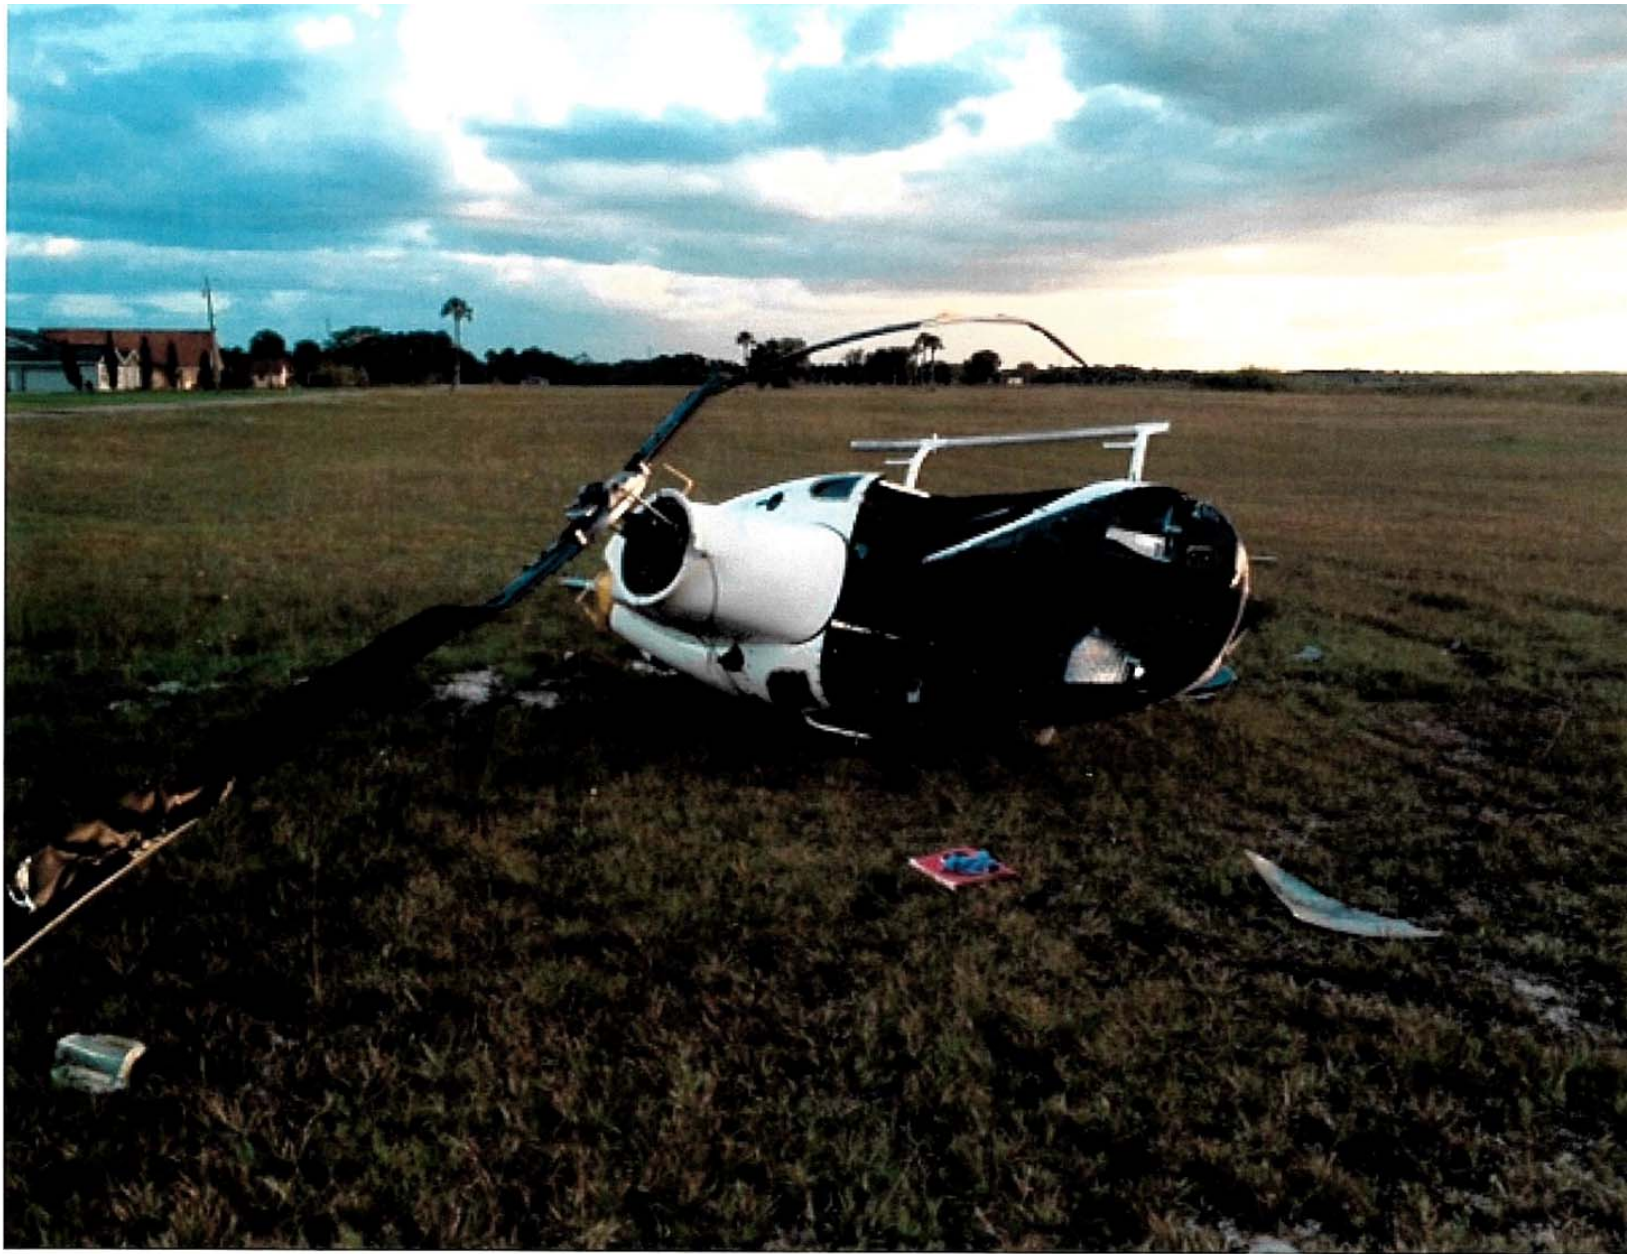
**Photo 1 – Forward View of Helicopter at Accident Site (Courtesy of FAA)**

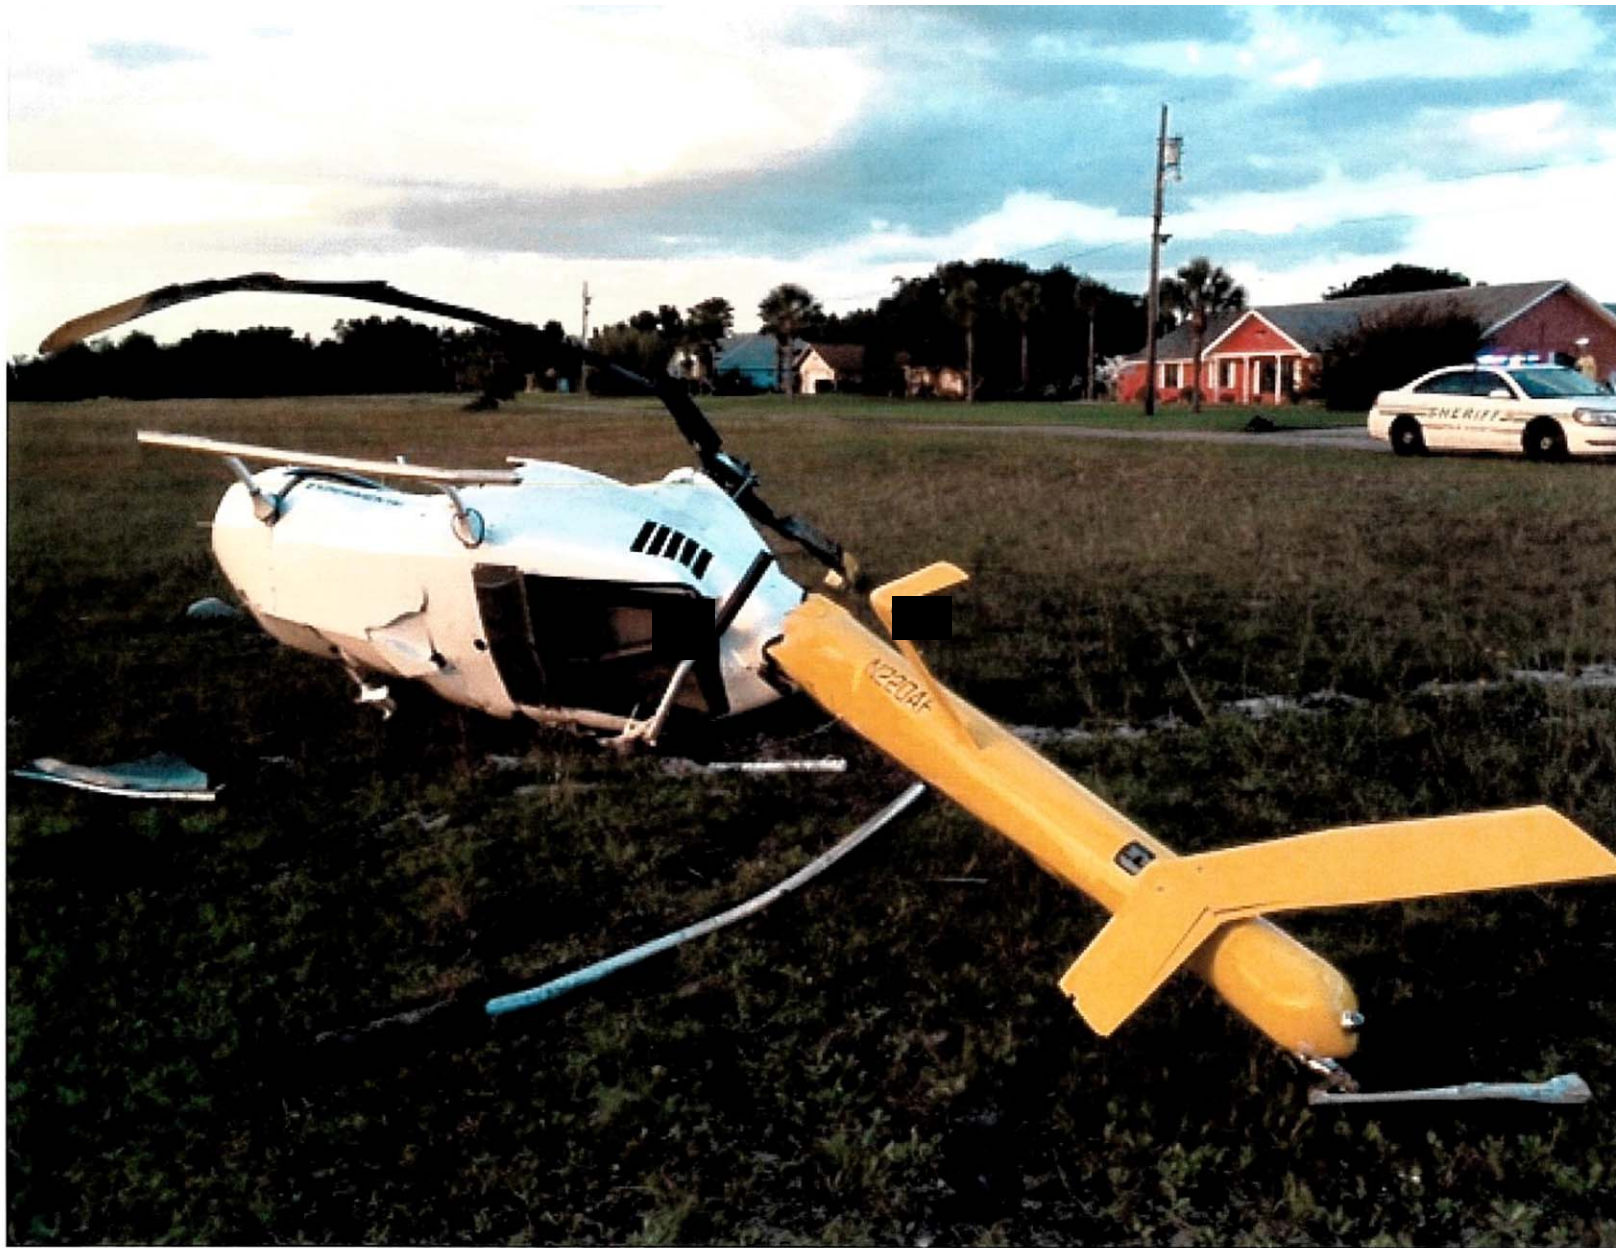
**Photo 2 – Aft View of Main Wreckage at Accident Site (Courtesy of FAA)**

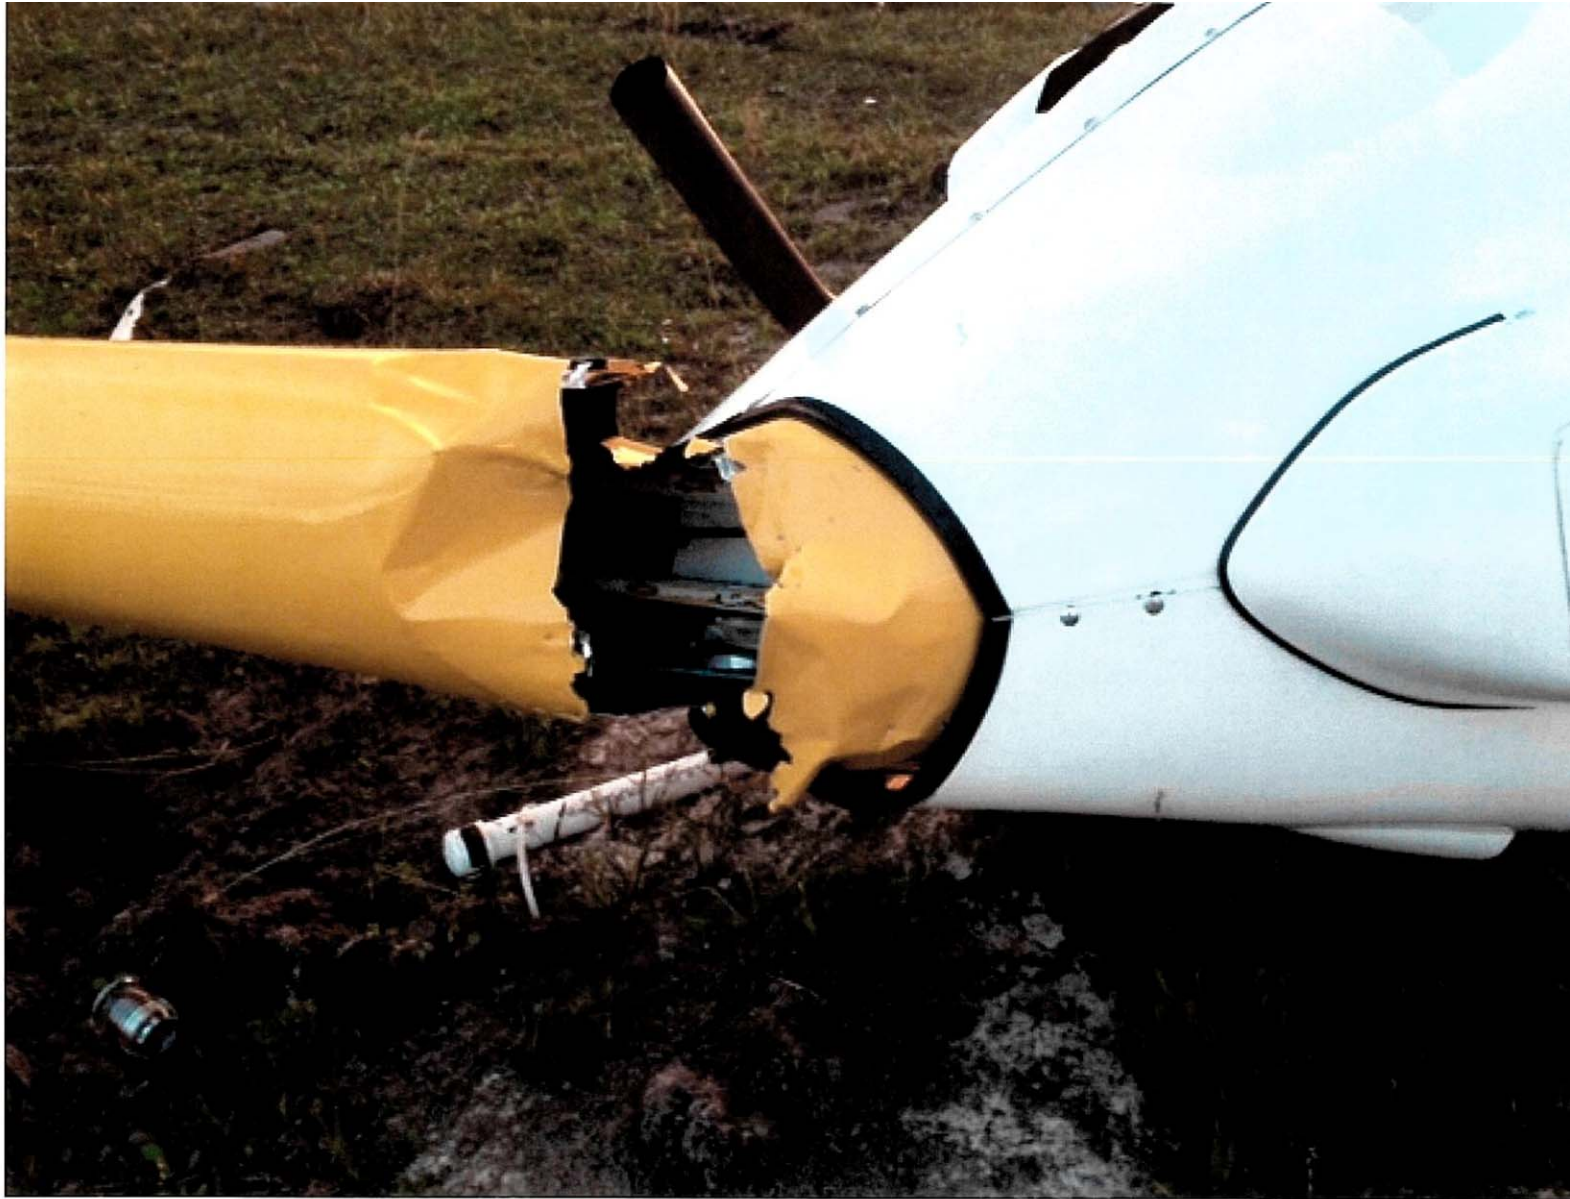
**Photo 3 – View of Tailboom (Courtesy of FAA)**

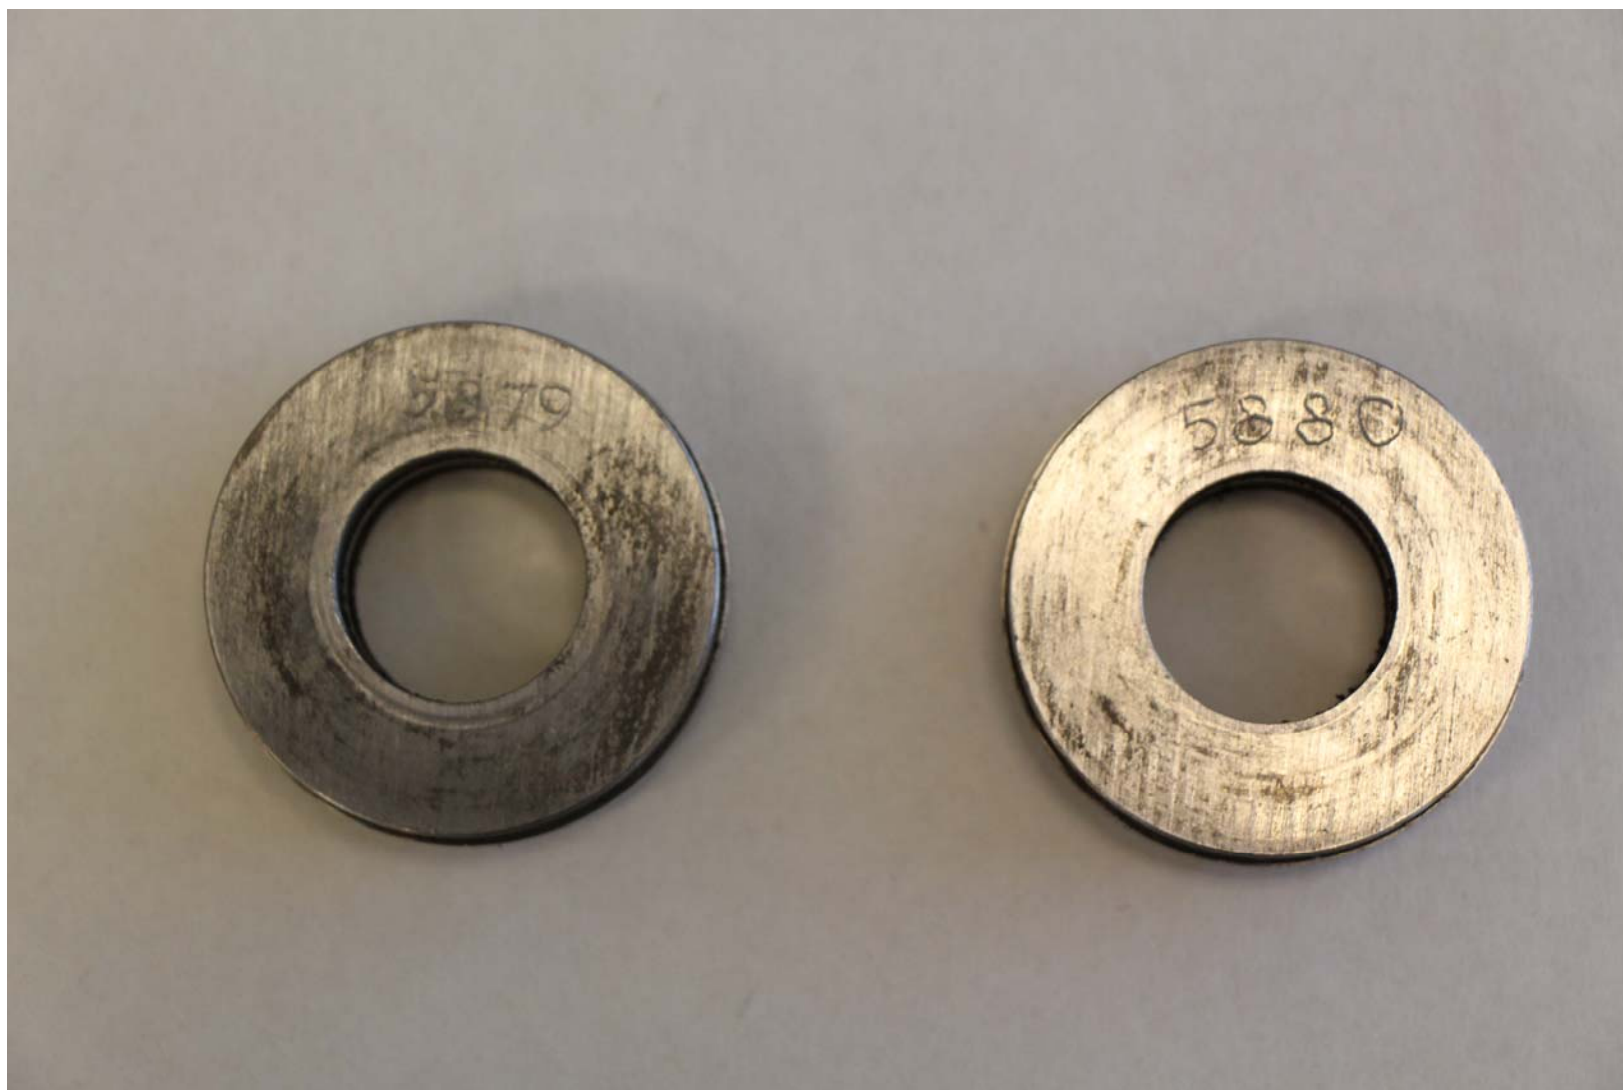
**Photo 4 – Elastomeric Bearings Recovered from Accident Airplane**

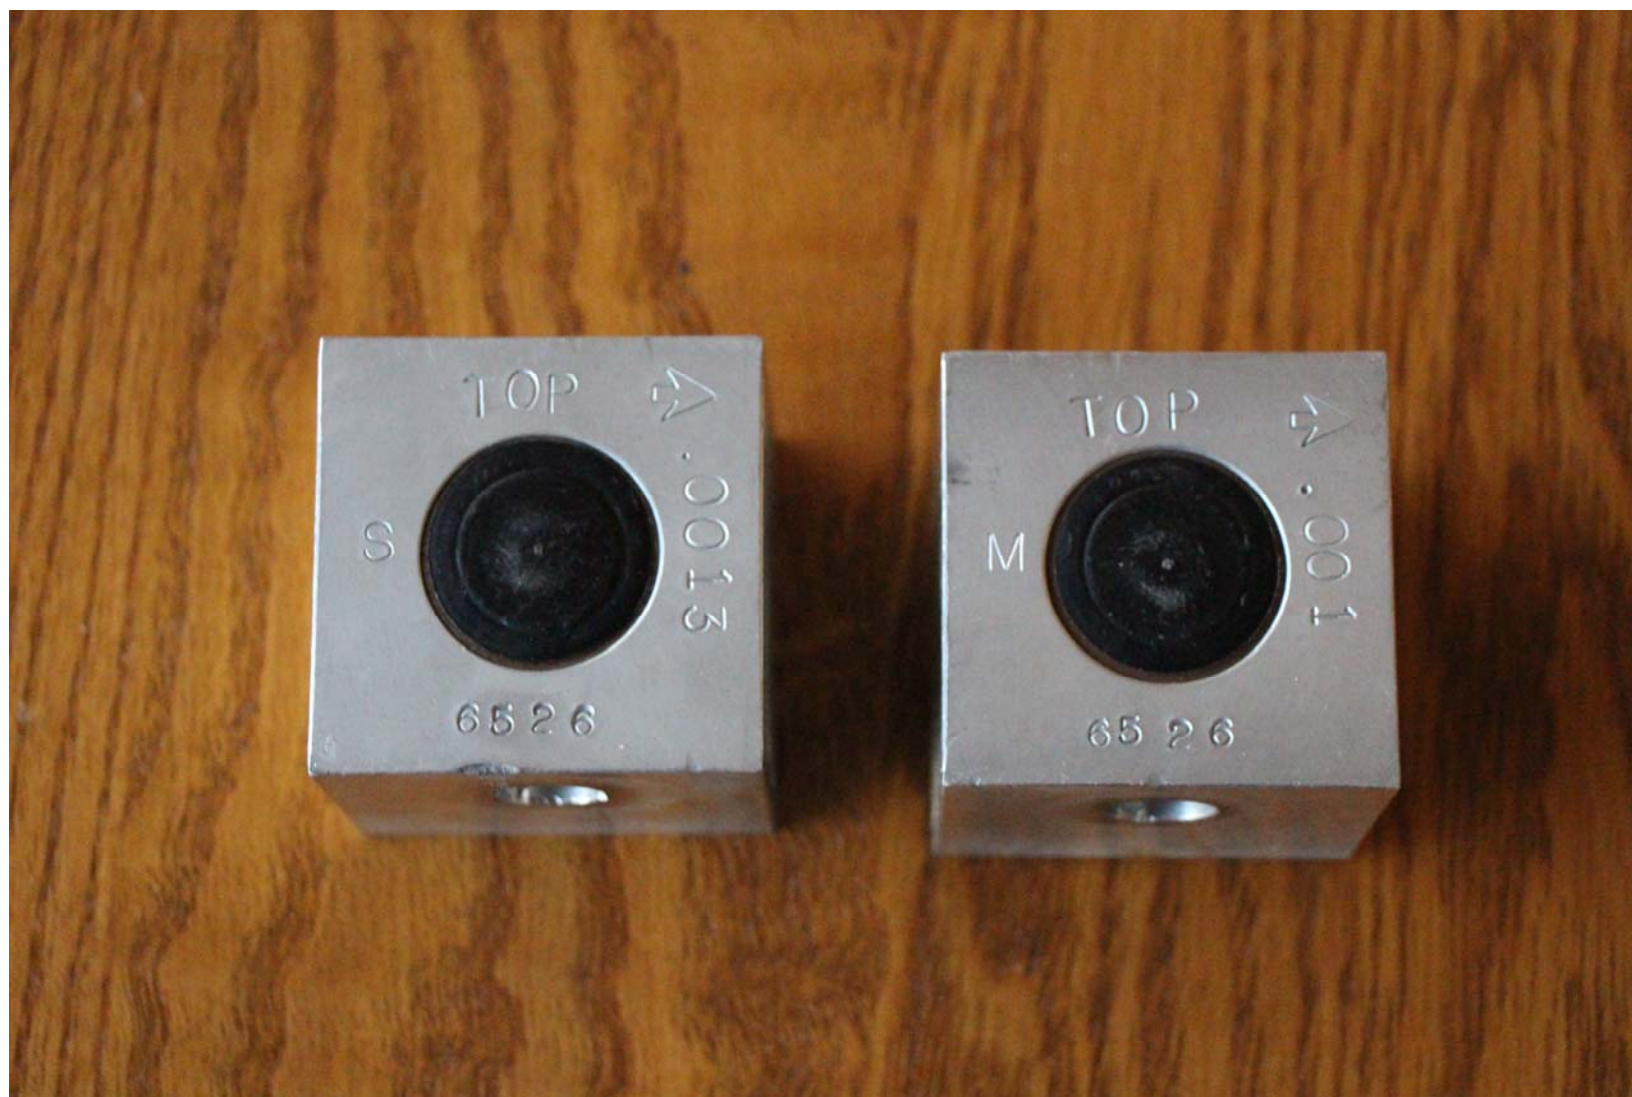
**Photo 5 – Elastomeric Bearing Thrust Blocks Recovered from Accident Airplane**

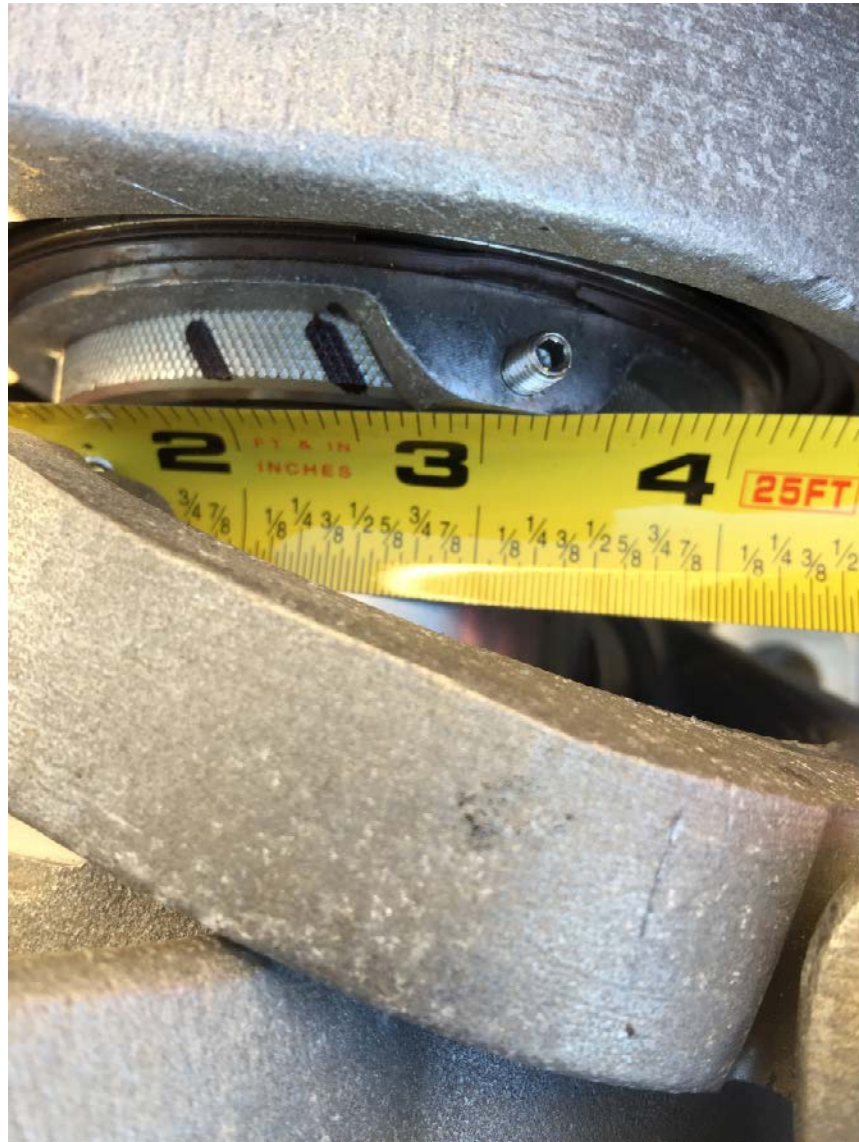
**Photo 6 – Slider Ball Adjustment Collar and Set Screws (Courtesy of Accident Pilot)**
