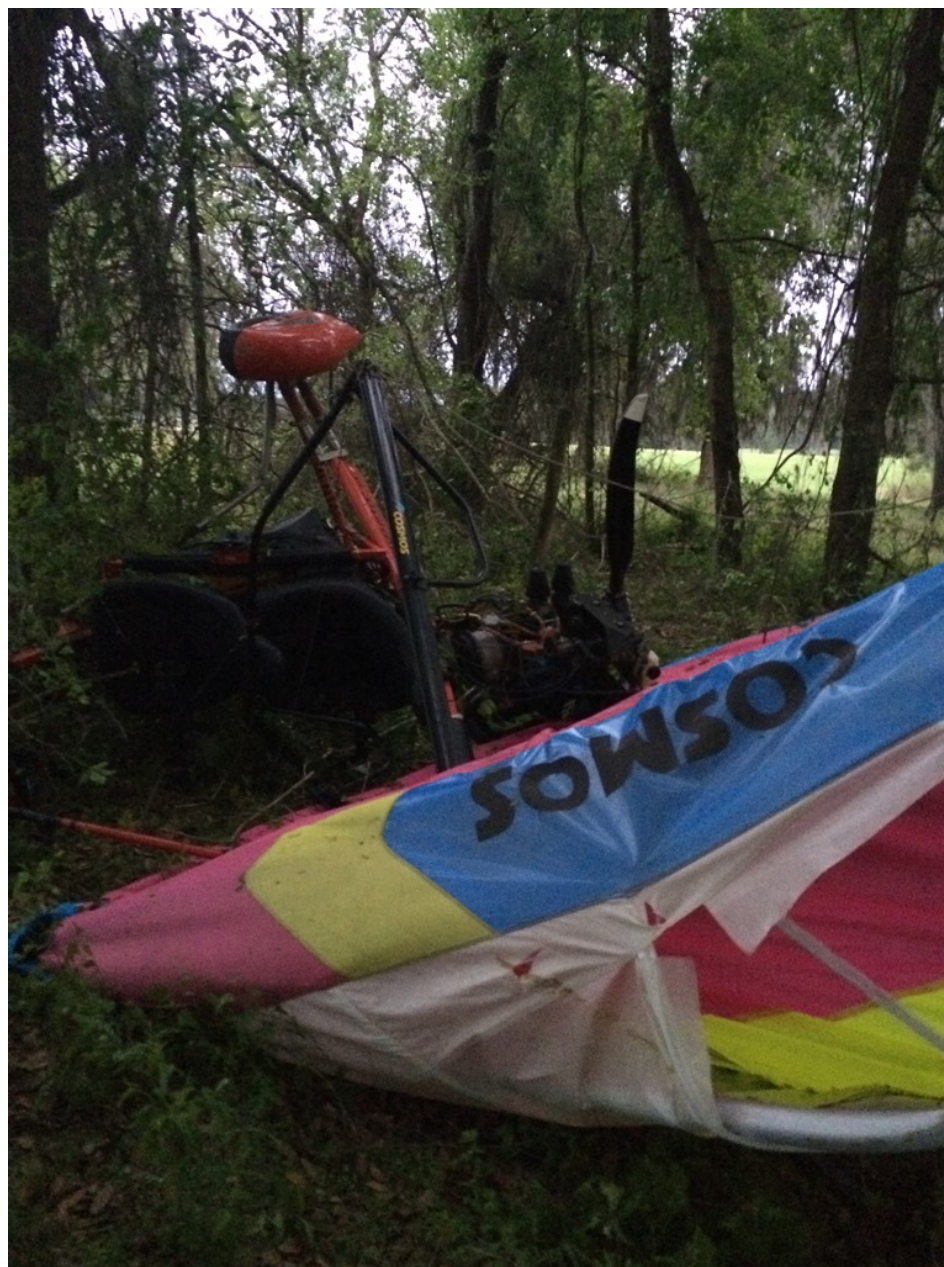
**Photo 1 – Digital Photograph Provided by Owner. View of the Aircraft at the Accident Site.**

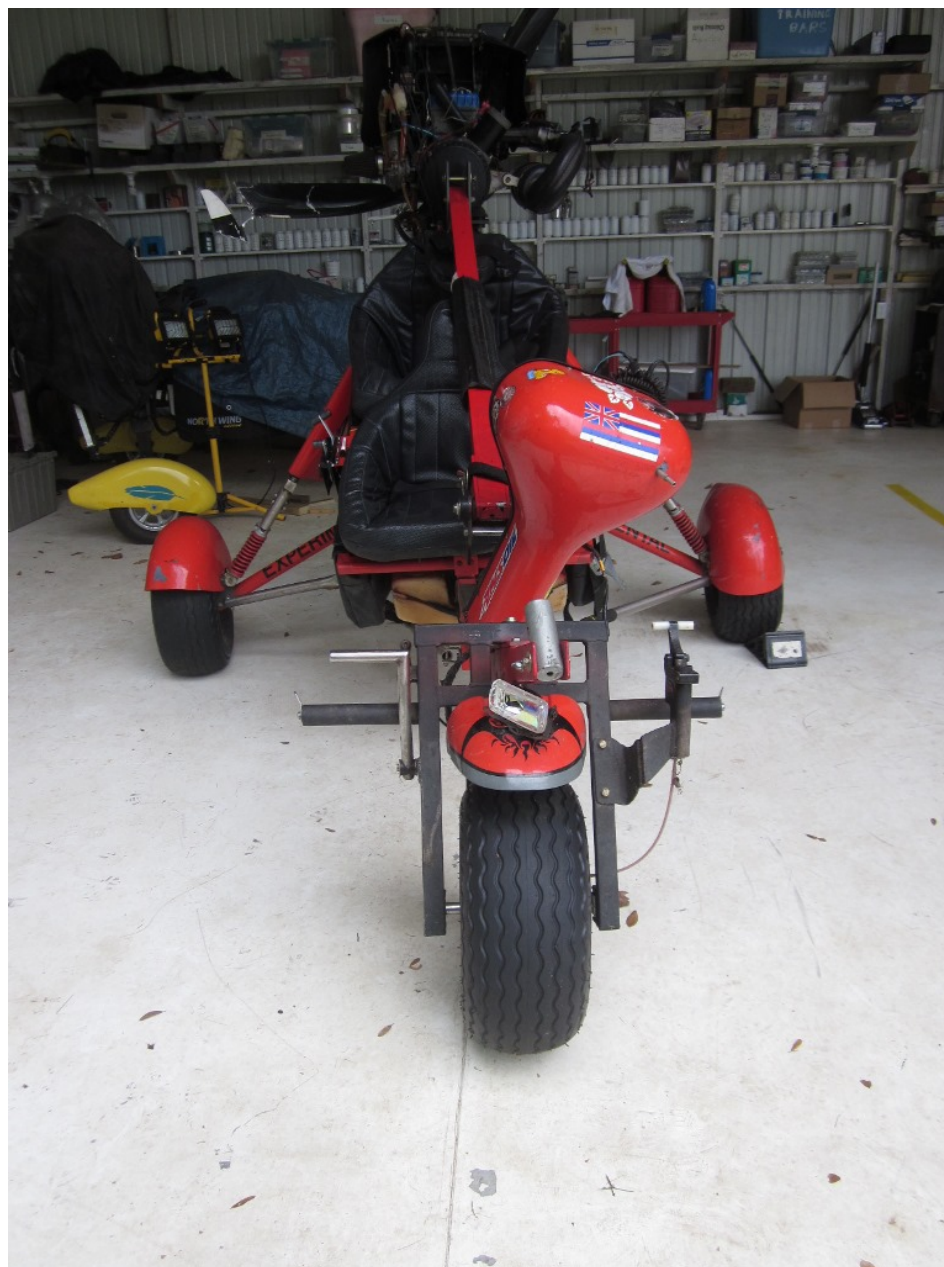
**Photo 2 - Digital Photograph Provided by Owner. Forward View of the Aircraft Following Recovery**

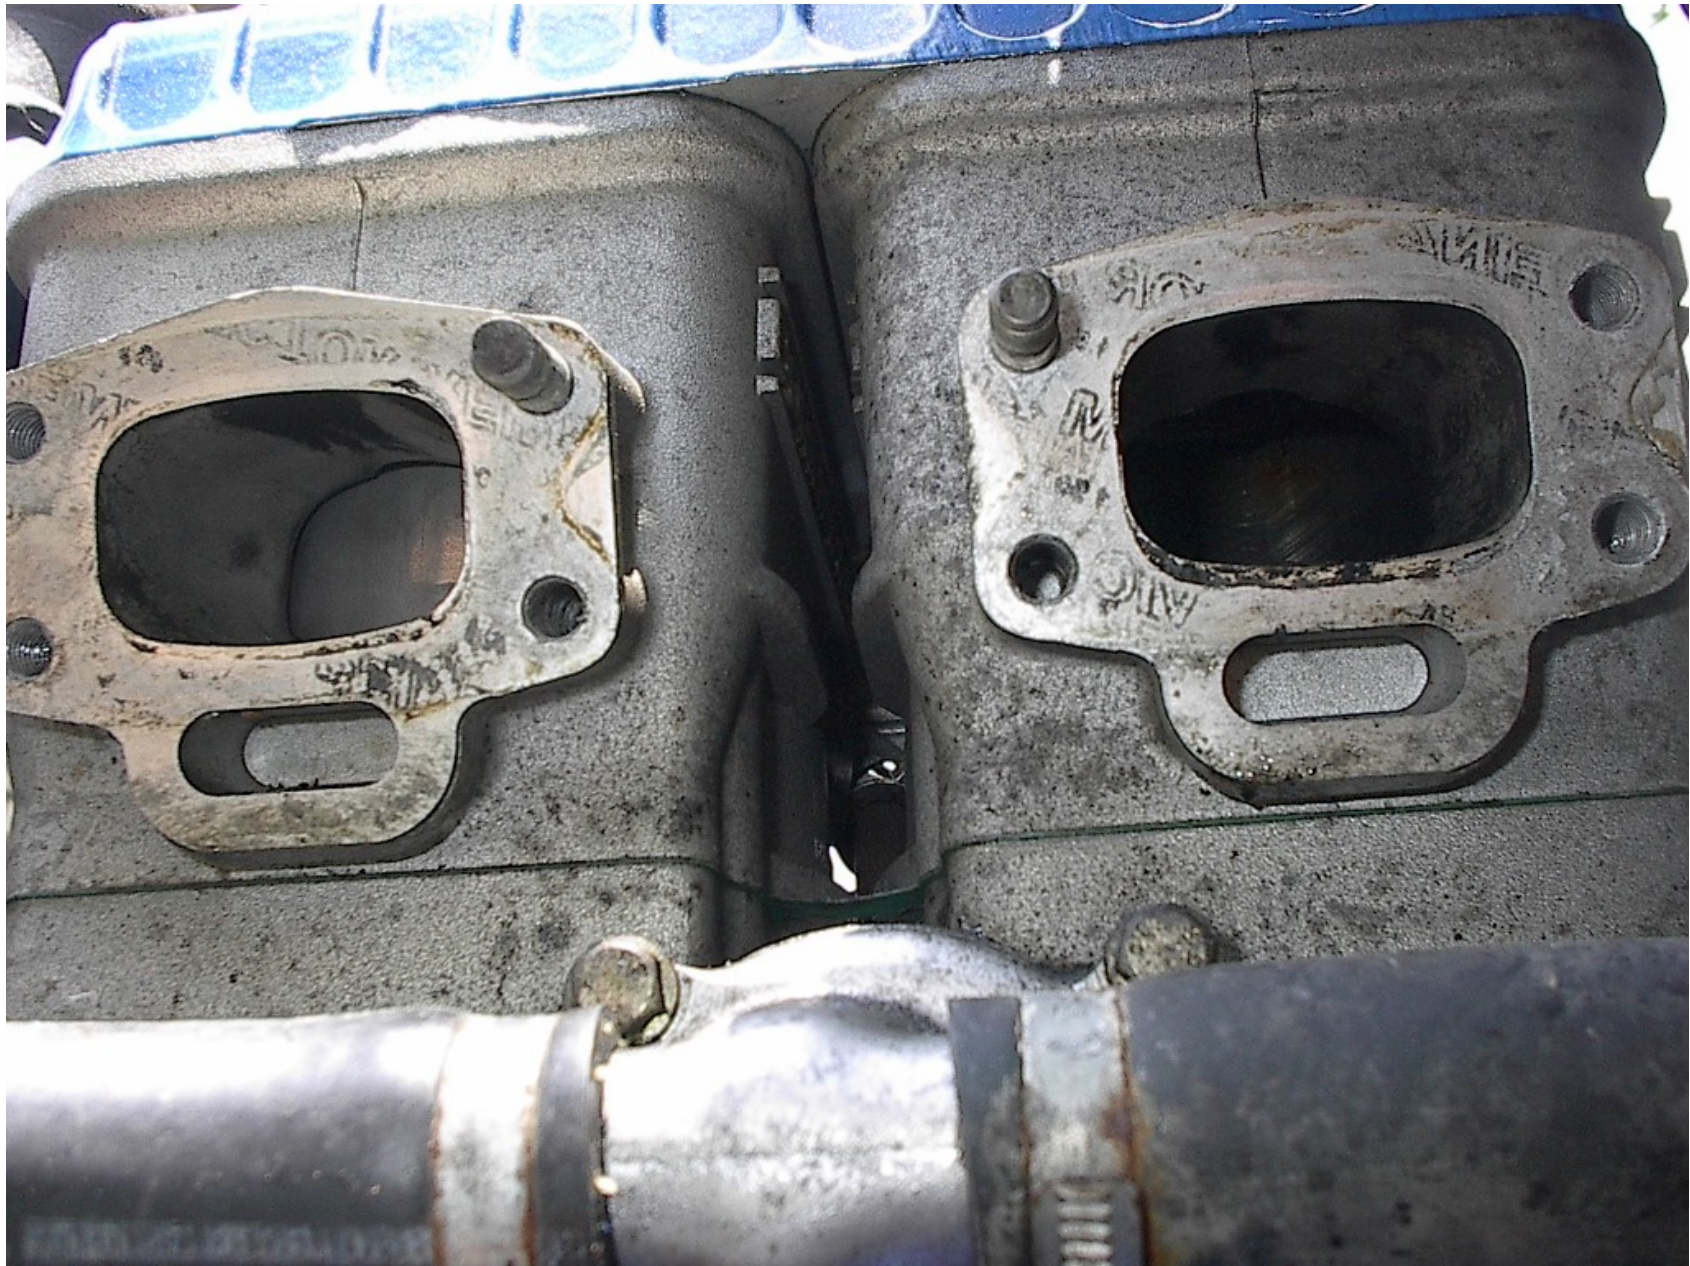
**Photo 3 - Digital Photograph Provided by Owner. View Depicting the Piston Sides of the Forward Cylinder. No Scuffing or Scoring was Noted on the Piston. Hone marks are Visible on the Rear Cylinder Walls**

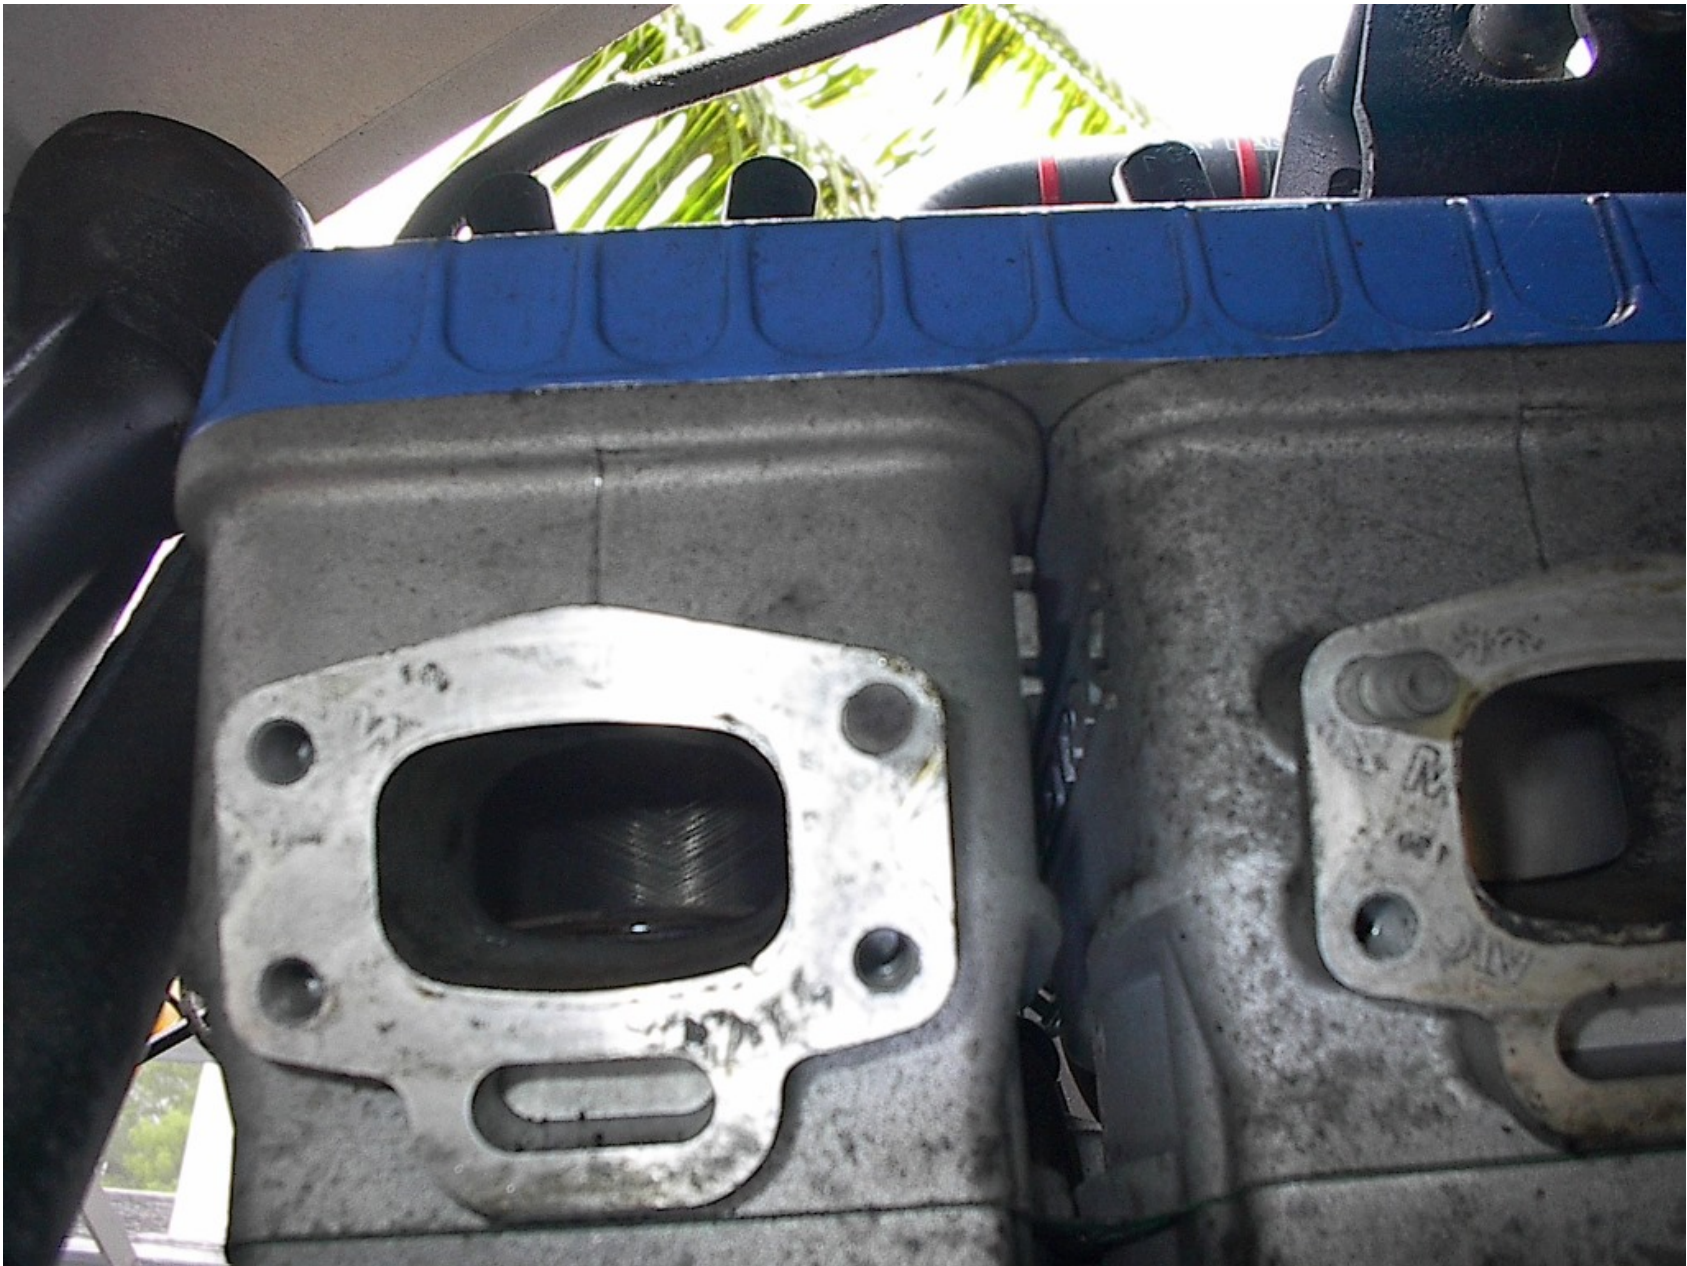
**Photo 4 - Photo 3 - Digital Photograph Provided by Owner. View Depicting the Piston Sides of the Rear Cylinder. No Scuffing or Scoring was Noted on the Piston. Hone marks are Visible on the Forward Cylinder Walls**
