## MEMORANDUM OF RECORD

**Subject:** ERA15LA184 – Airframe Exam

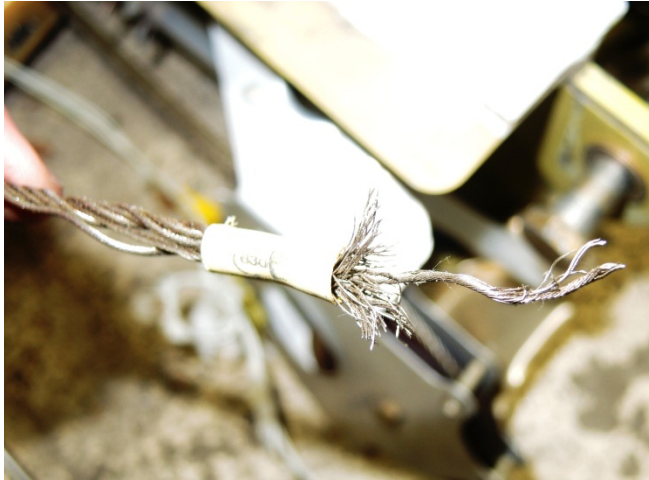
- All primary flight control cable continuities were confirmed from the cockpit to their respective flight control surface via cables disconnected at turn buckles during recovery initiatives and the right aileron control cable separated at the co-pilots control stick assembly.

**Photo 1: Right Aileron Cable as Found (Courtesy of Textron)**

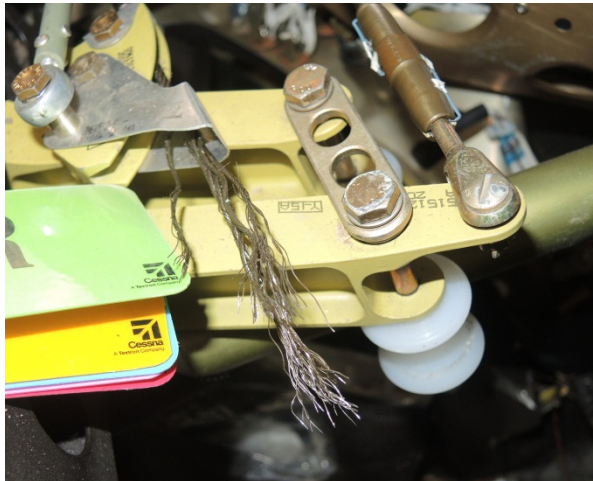
**Photo 2: Right Aileron cable as found at Control Stick Connection (Courtesy of Textron)**
