**ERA15LA184**

**Shelter Island, New York**

**Cessna 162 (Skycatcher)**

**NTSB ENGINE EXAMINATION REPORT**

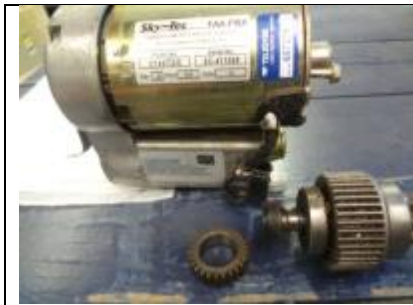
**Photo 10: Starter as Removed from Cardboard Box**

Skytec, Model No. C12ST2/S, Serial Number 2C-411028. The unit was impact separated from the engine and placed in a cardboard box and shipped with the engine crate.

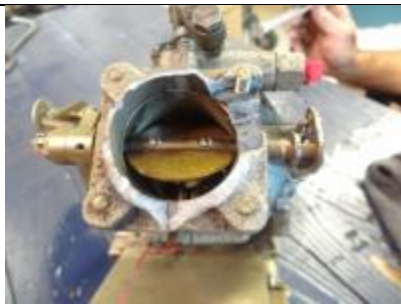
**Photo 11: Carburetor as Viewed after Removal from Cardboard Box**

The carburetor was manufactured by Volare, Model No. MA-3SPA, and Serial No. VN300802, Part No. 10-4894-1. The unit was impact separated and was located in a cardboard box shipped with the engine.

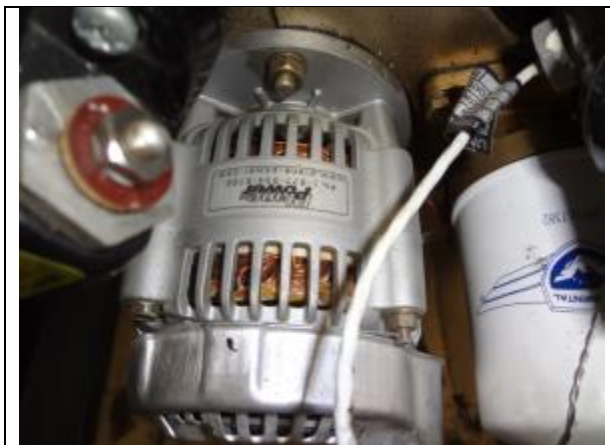
**Photo 13: Generator as Viewed Mounted on Engine**

Was manufactured by Plane Power, Part No. C14-50, Serial Number C14-101406. The unit remained attached to the rear section of the engine.

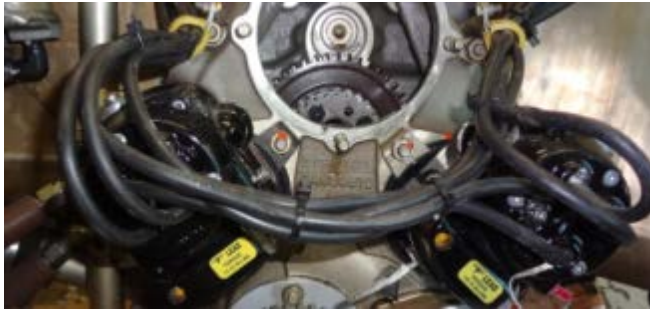
Photo 16: Both Magnetos as Received

The magnetos remained in place on the engine and securely mounted to the rear accessory pad.

The left magneto was a Champion Aerospace, Model No. 4301, Serial No. 09070230. The magneto was found timed at 24°. Optimal timing was 24°.

The right magneto was a Champion Aerospace, Model No. 4301, Serial No. 10101200. The magneto was found timed at 24°. Optimal timing was 24°.

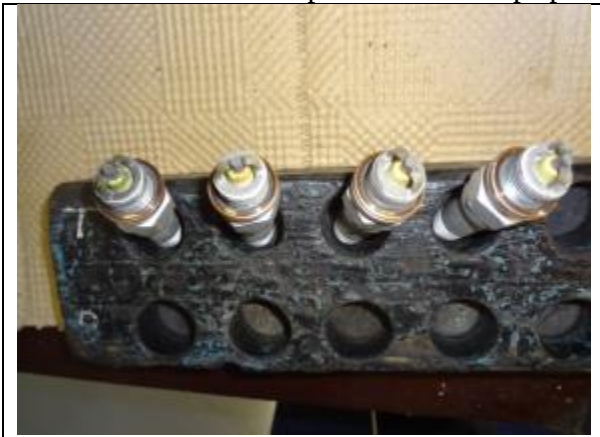
Photo 17: Top Spark Plugs

The sparkplugs were Champion Sparkplugs, Part No. REM37BY. The top sparkplugs were removed to check compression. The top sparkplugs appeared normal in color and like new.

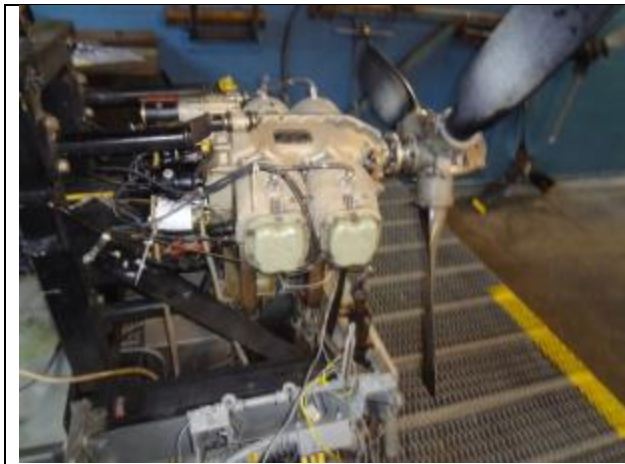
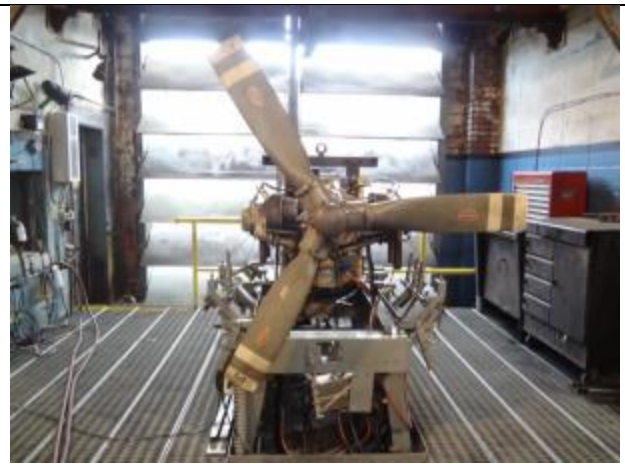
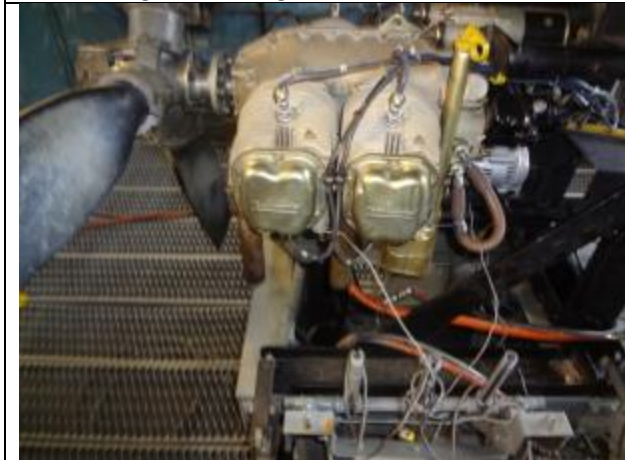
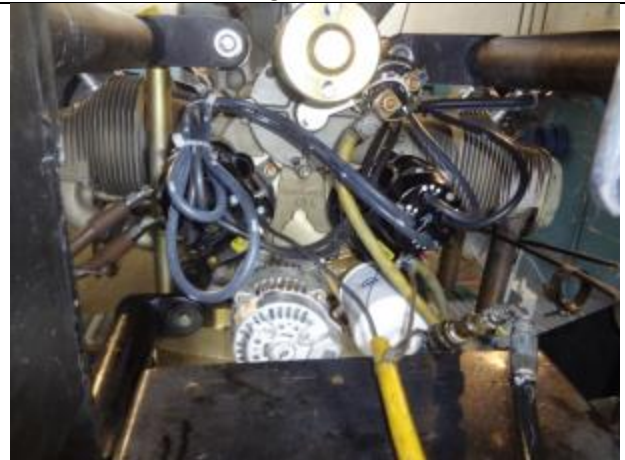
The engine was idled and no hesitations were noted. The magneto drop was within the normal range. The engine was accelerated and decelerated three (3) times with no hesitation noted. The engine was shutdown, propeller and test cell equipment was removed from the test cell to perform the hot compression checks. The engine operated at various power settings, as indicated in the engine run report in Appendix A, and no abnormalities, hesitations, or malfunctions were noted.
