# NATIONAL TRANSPORTATION SAFETY BOARD

## MATERIALS LABORATORY FACTUAL REPORT

Report No. 15-130

Place : Sylacauga, AL  
Date : April 27, 2015  
Vehicle : Diamond DA20-C1 Katana, N248ME  
NTSB No. : ERA15LA200  
Investigator : Dennis Diaz, AS-ERA

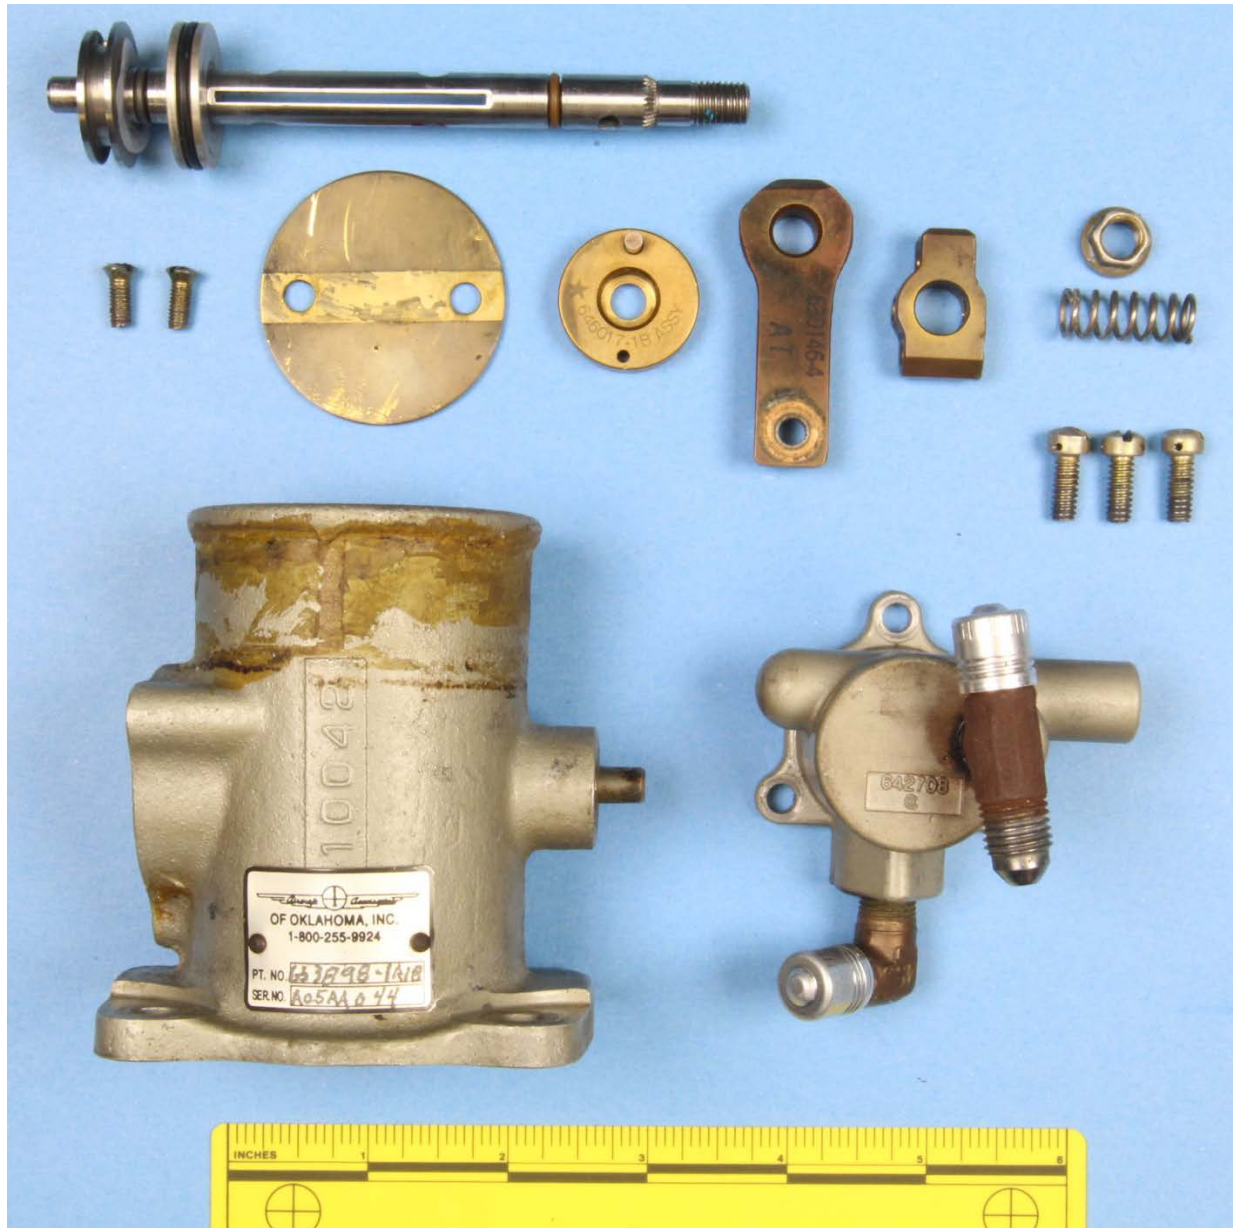
The as-received pieces from a fuel control unit are shown in Figure 1. The following inspections were conducted:

Figure 1 As-received pieces from the fuel control unit.

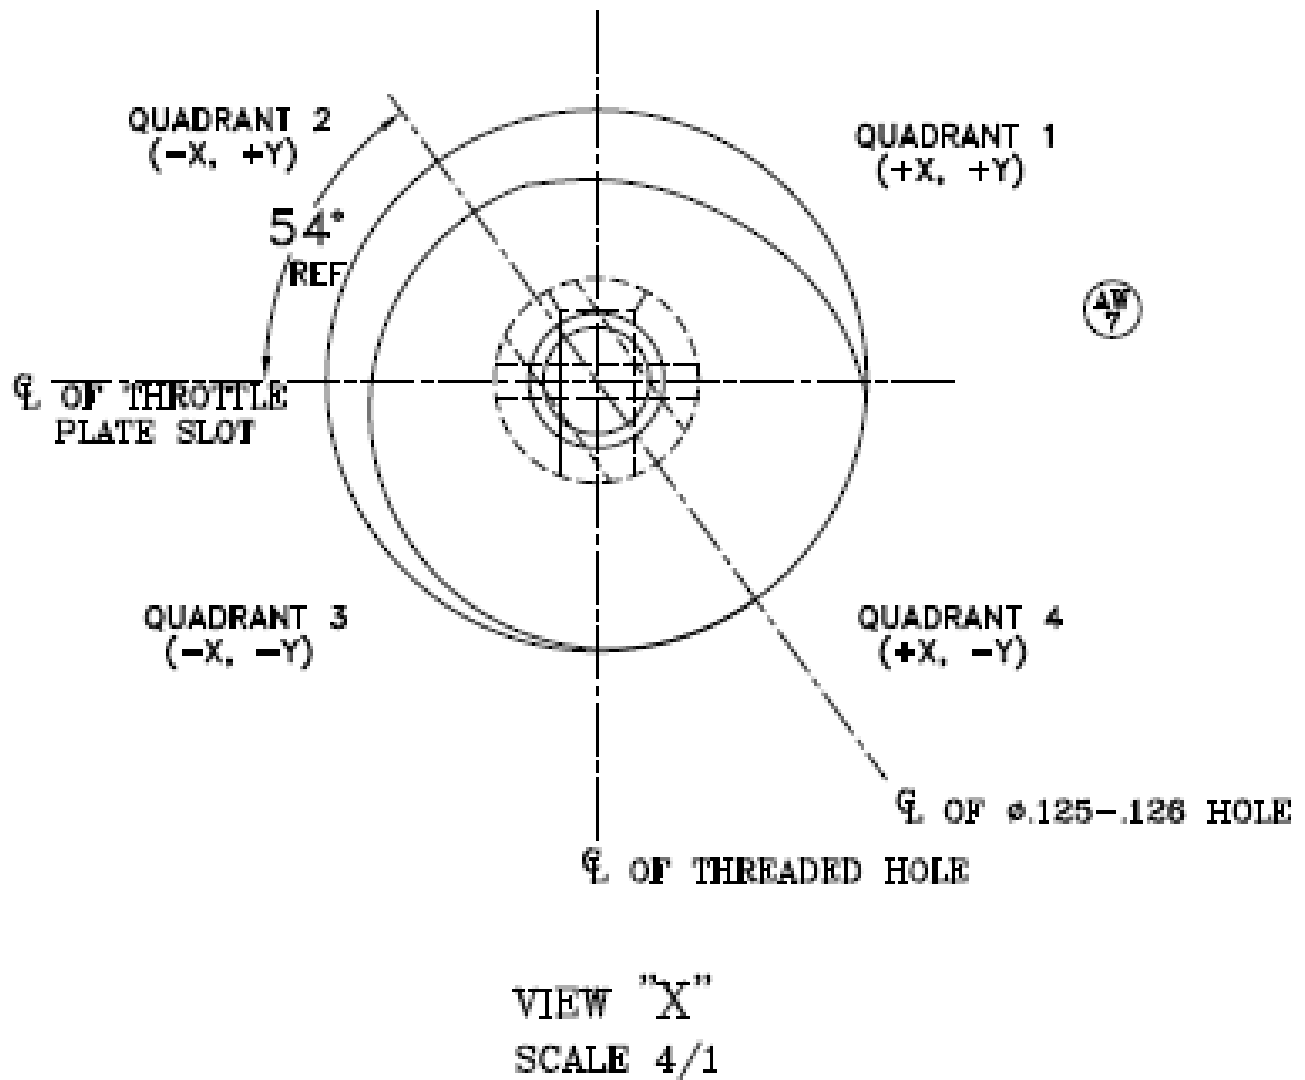
Figure 3 Portion of the manufacturer's engineering drawing show the cam orientation relative to key shaft features.

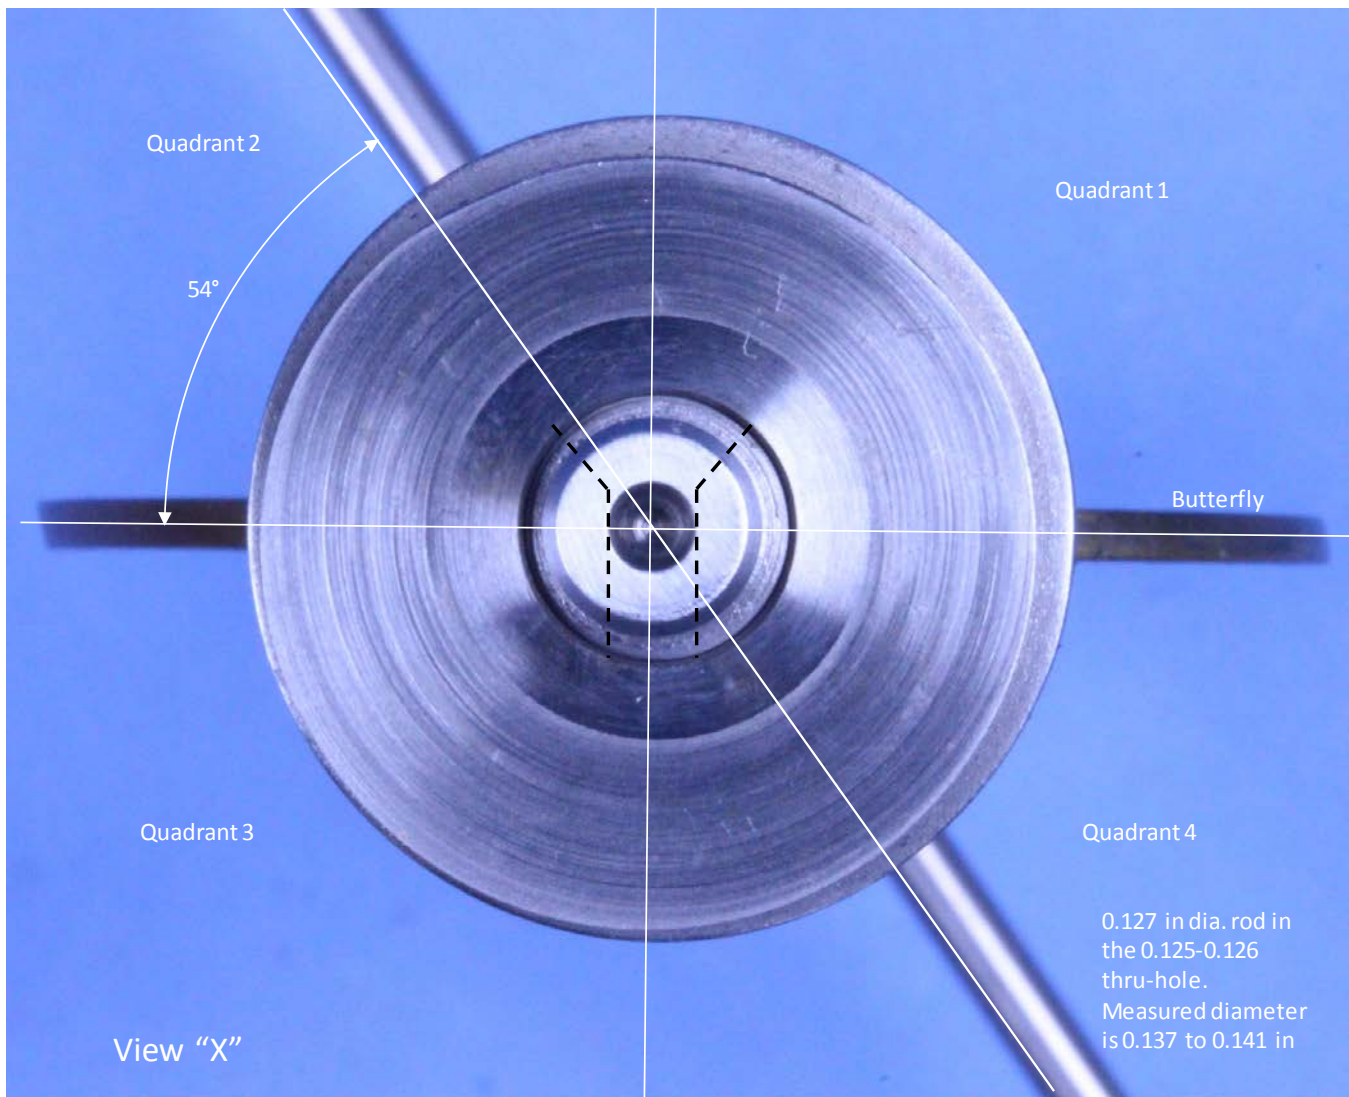
Figure 4 A photograph of the cam portion of the fuel metering disk shown in an orientation similar to Figure 3.

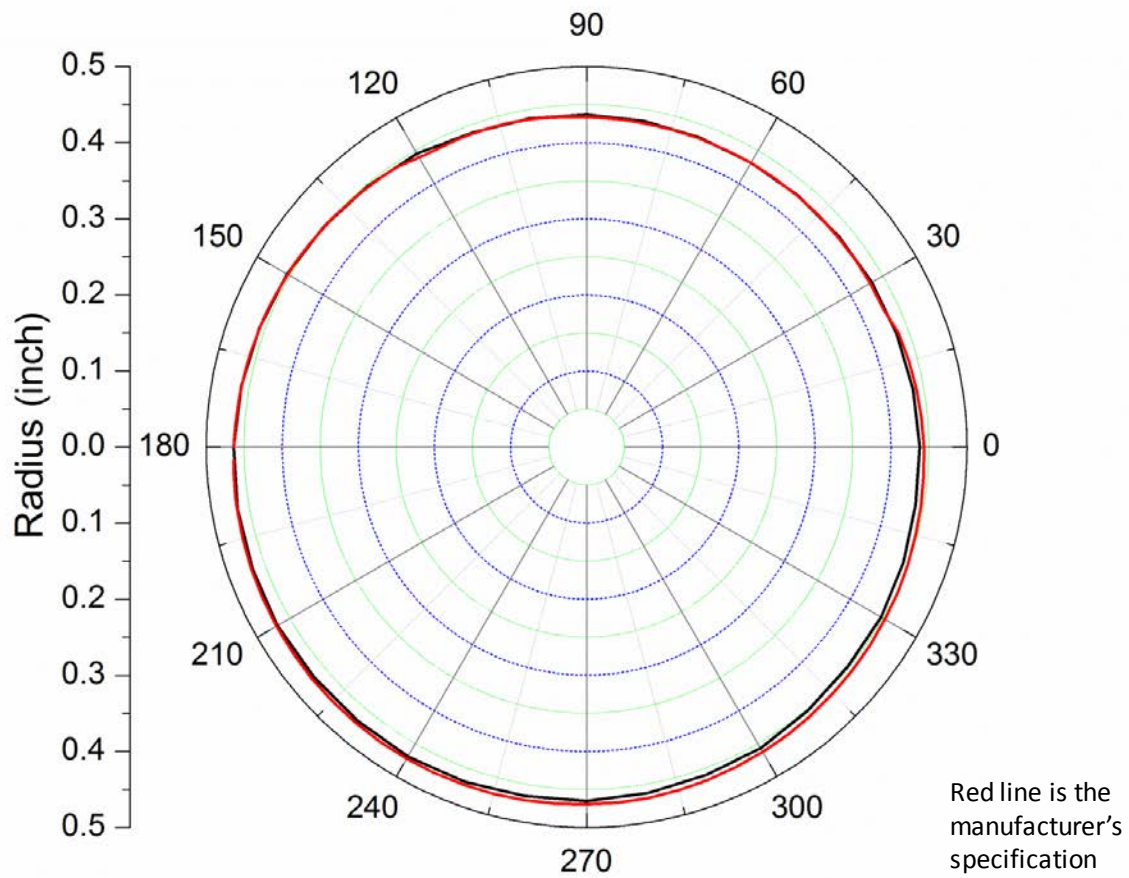
Figure 5 Graph showing the cam profile of the accident cam relative to the manufacturer's data.

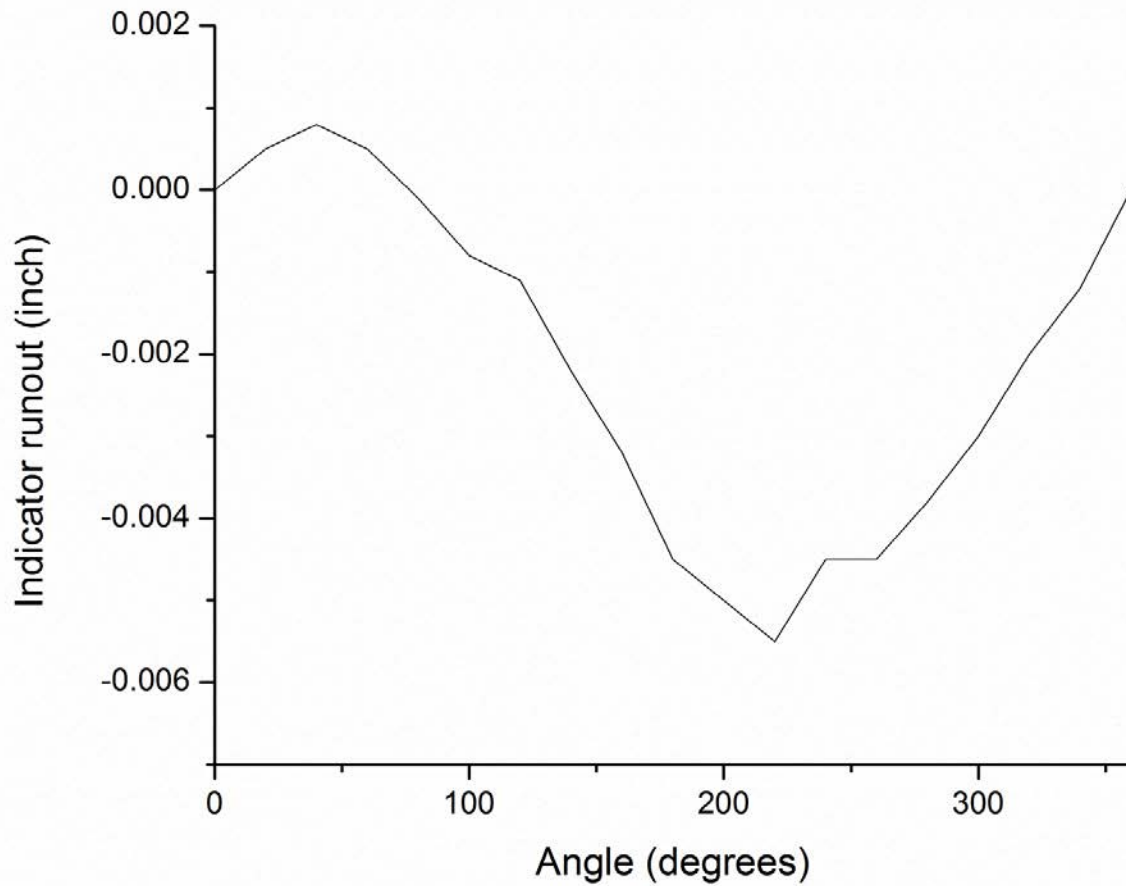
Figure 6 Total indicator runout of the 0.9902 inch diameter portion of the fuel metering cam (see figure 2).

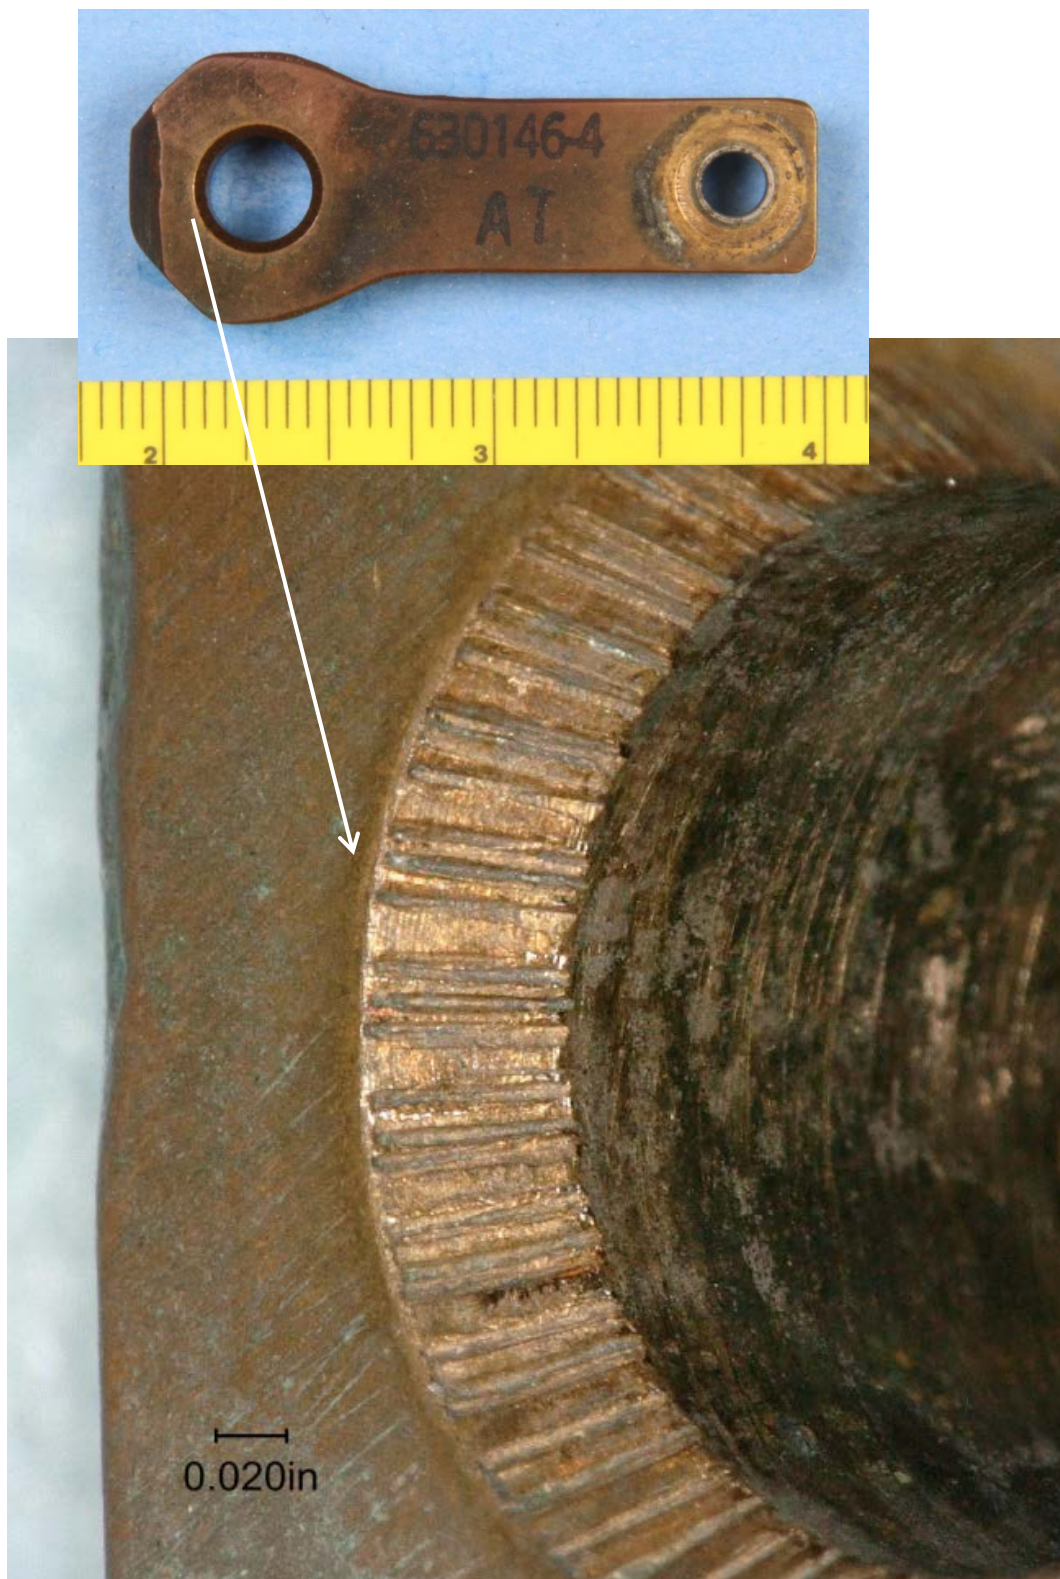
Examination of the tapered knurls on the mixture control lever revealed several “sets” of knurl impression marks (see Figure 7), consistent with the lever being repositioned on the shaft several times. The surface finish of the tapered area is patinated brown, with no indication of the metering lever sliding relative to the shaft. The tapered knurls on the shaft exhibited deformed crowns consistent with compressive deformation (see Figure 8).

Figure 7 Image of the mixture control lever and a higher magnification image of the tapered knurls.

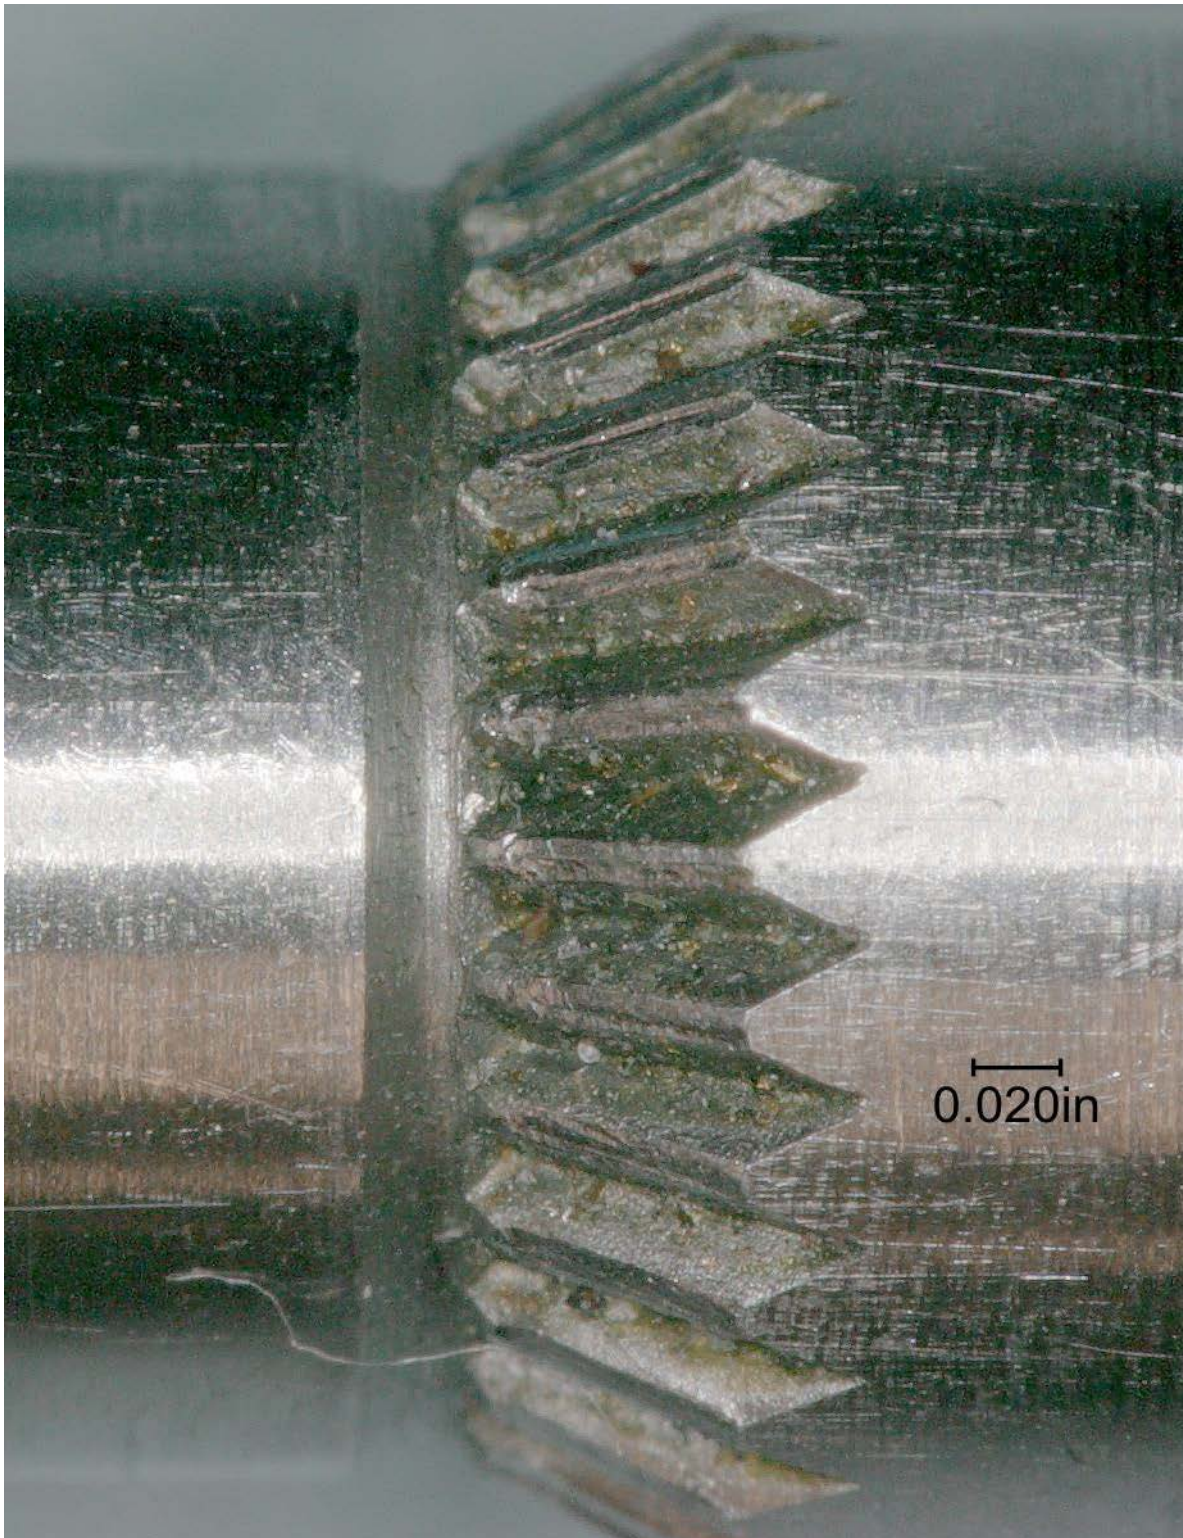
Figure 8 Image showing the tapered knurls on the shaft.

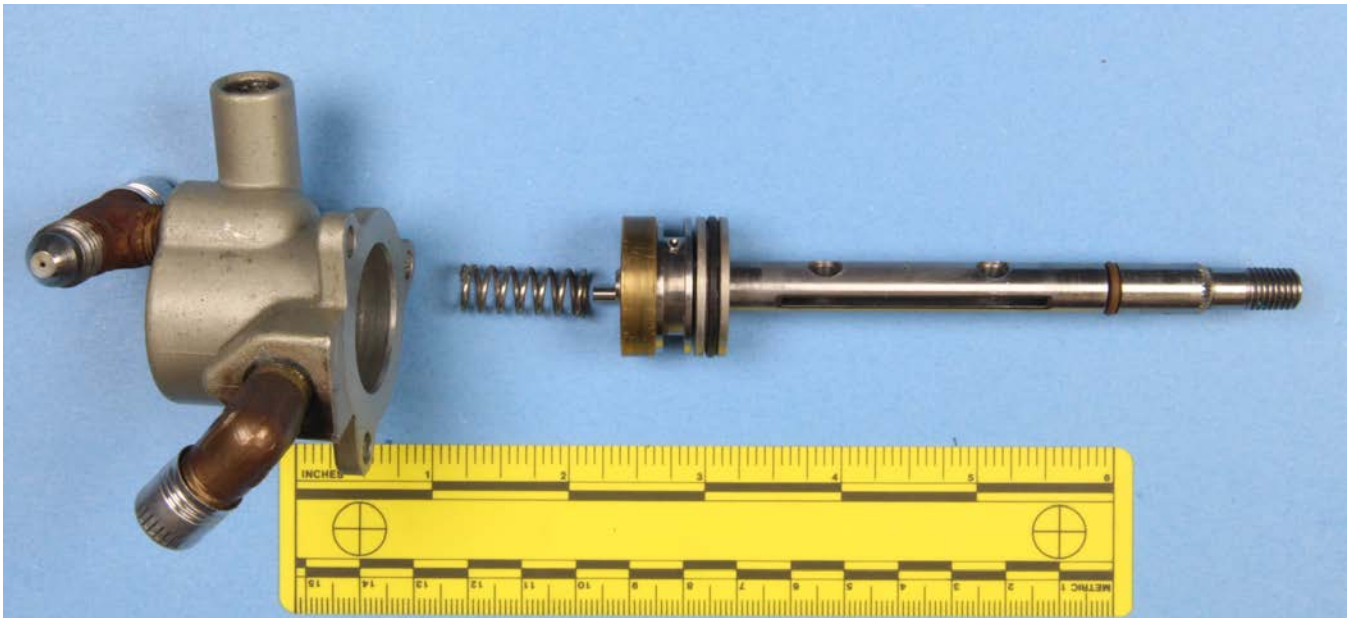
The fuel metering subassembly (see Figures 9 and 10) was examined for any issues and none were observed. The diameter and radial location of the fuel orifice was measured for the fuel metering plug assembly (part number 646017-1B ASSY) as shown in Figure 11.

Figure 9 Fuel metering subassembly.

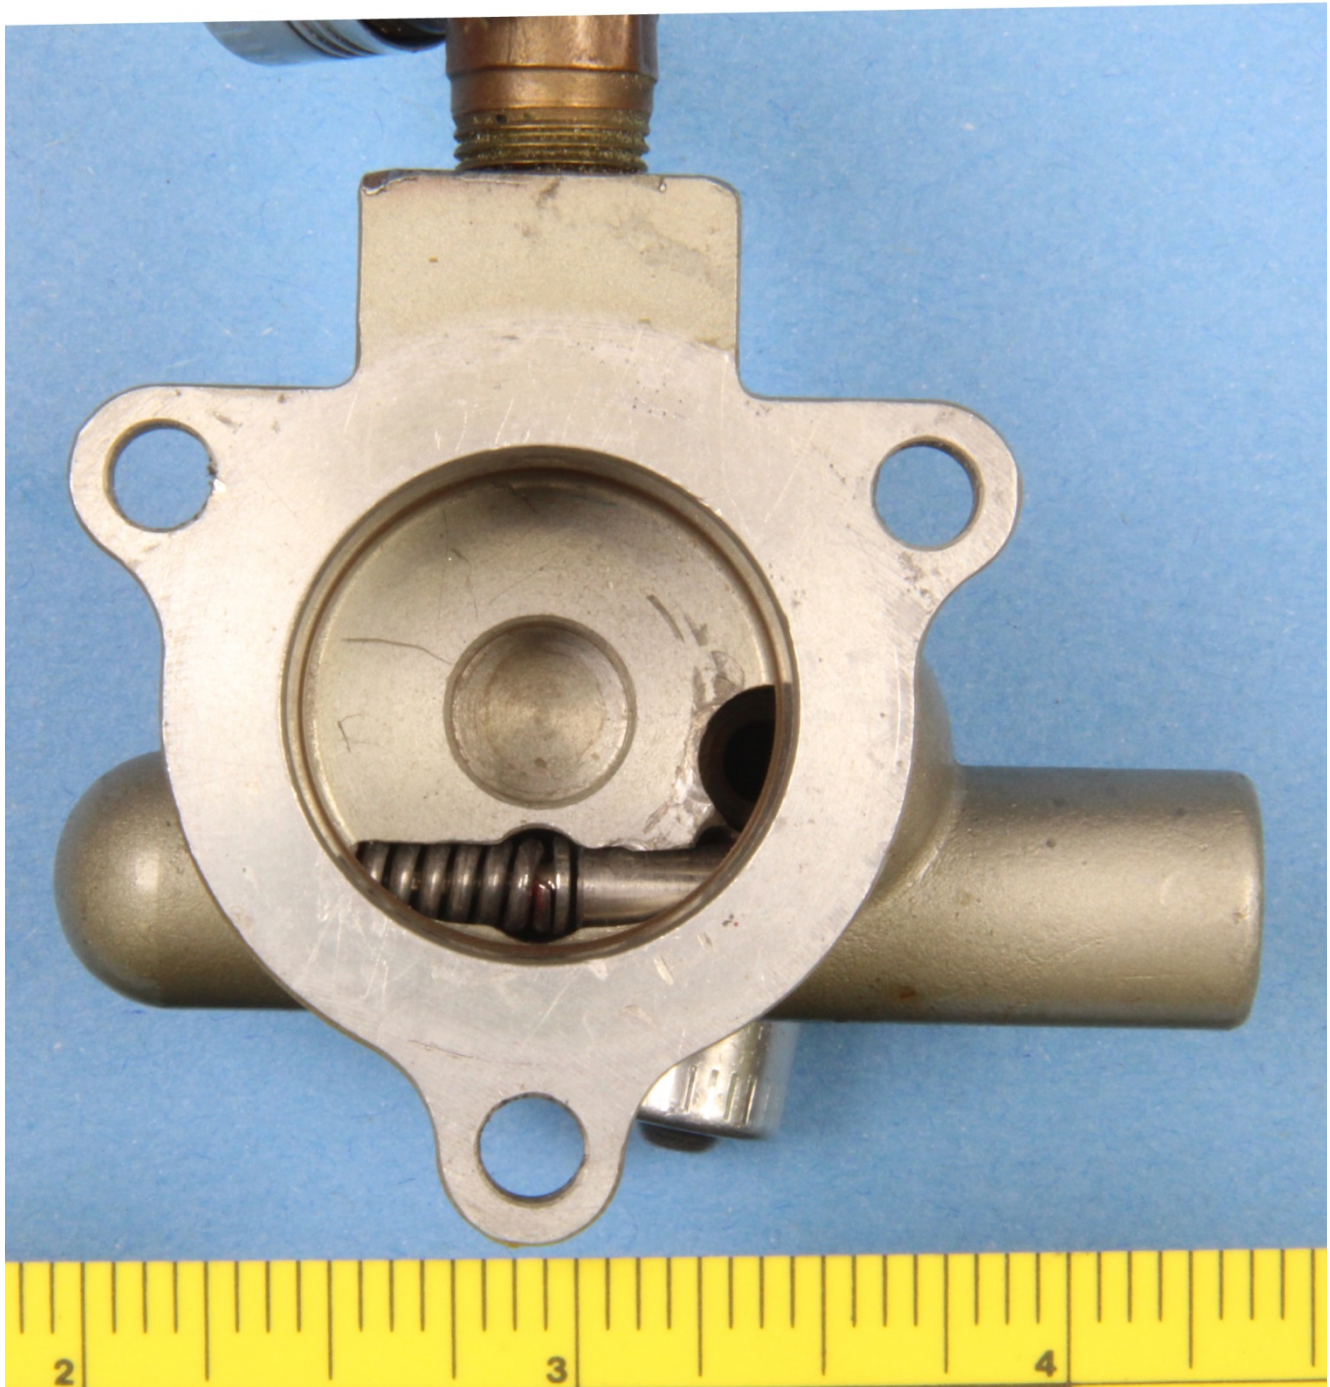
Figure 10 View inside of the fuel metering housing.

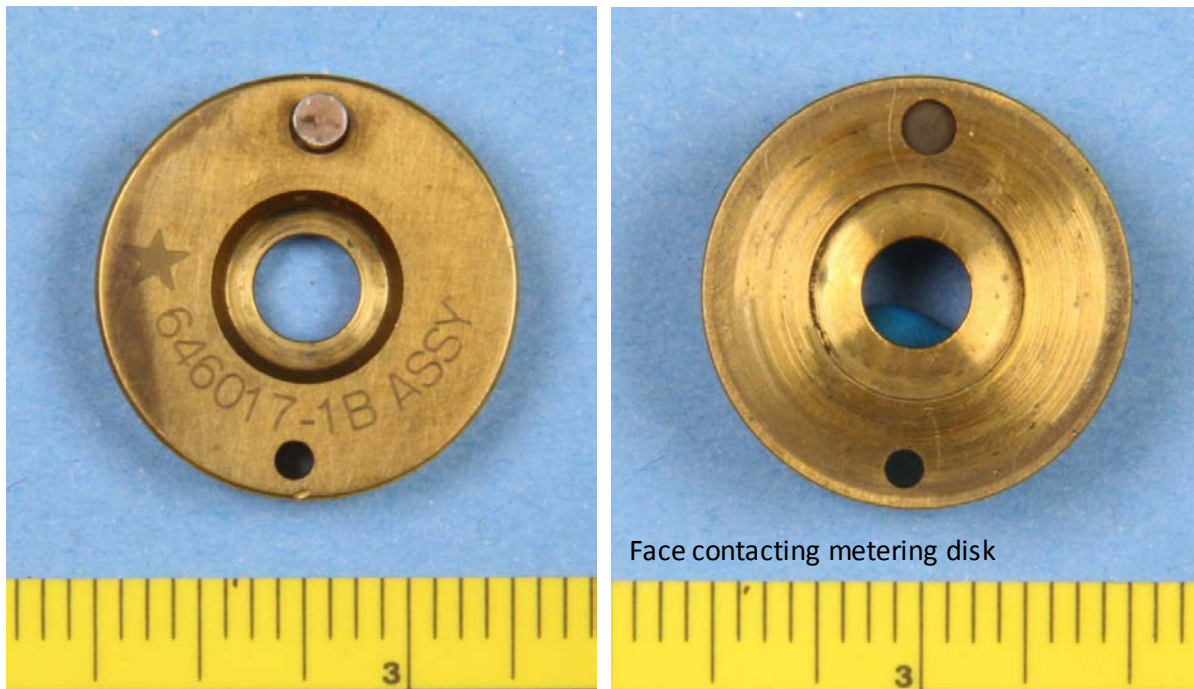
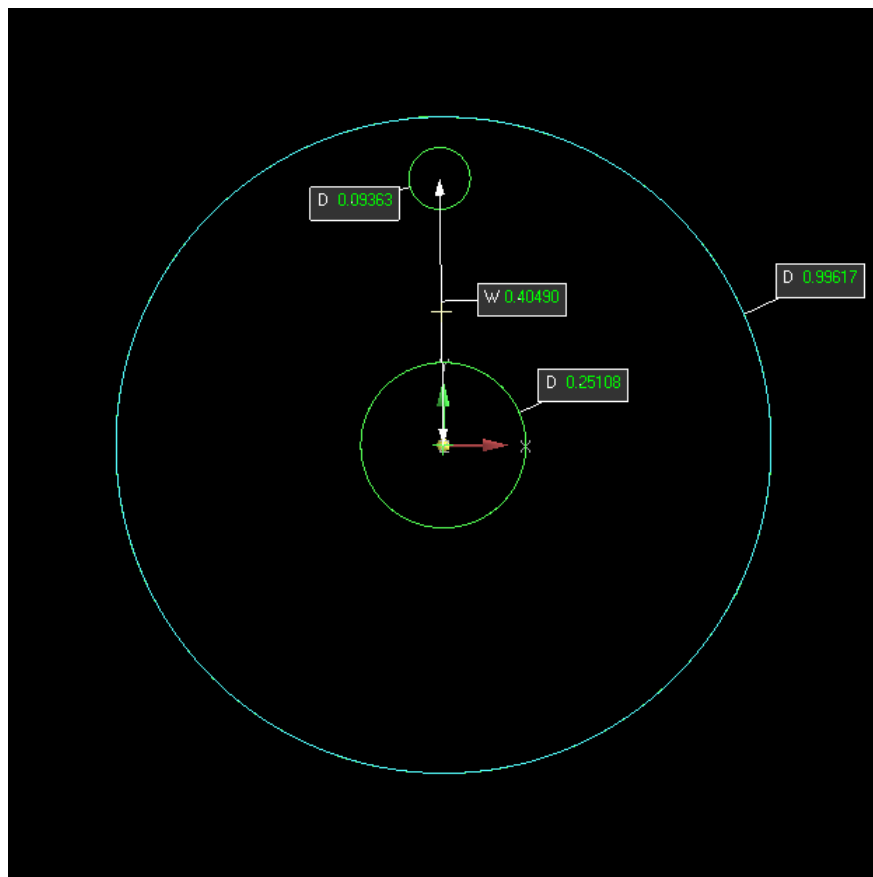
Figure 11 Images of the fuel metering plug assembly and key dimensions.
