# **National Transportation Safety Board**

## **Performance Study**

### **Specialist Report**

| Airplane: | Piper PA-28-151, N43503 |

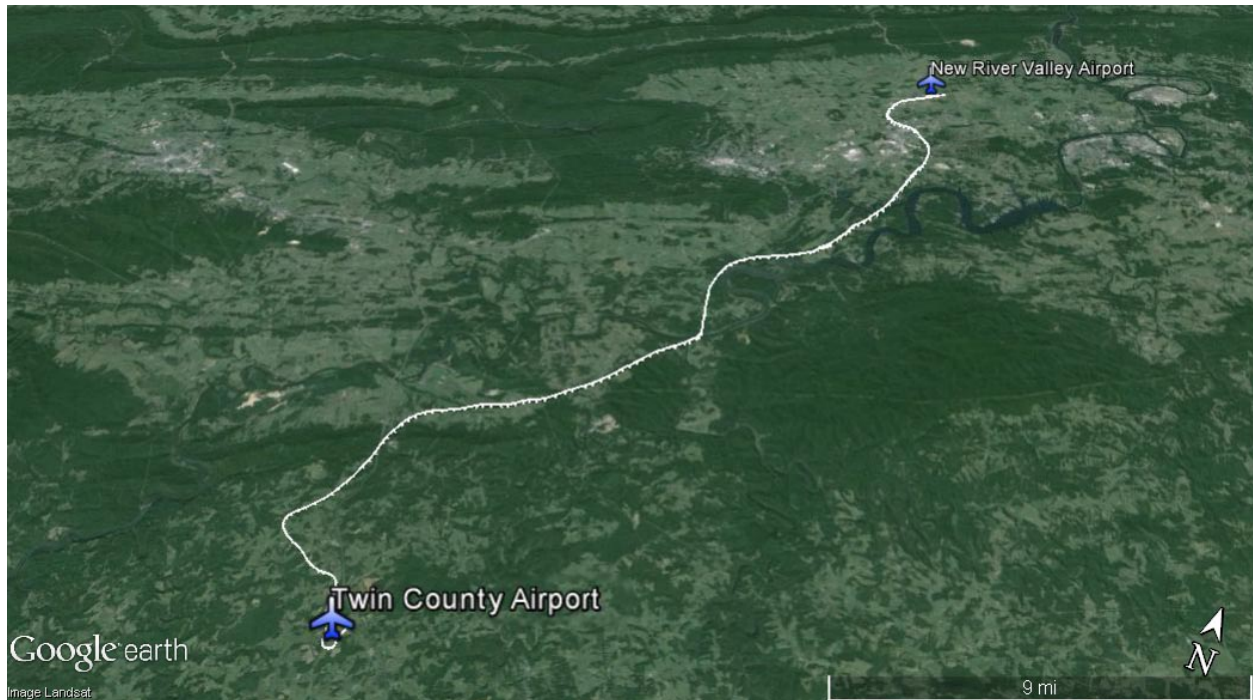
Data for the flight was available from an on-board Garmin GPSMAP 396. The 31 NM flight took 26 minutes and is shown in Figure 1.

Figure 1. Aircraft flight path from New River Valley Airport in Dublin, Virginia to Twin County Airport in Galax Hillsville, Virginia.

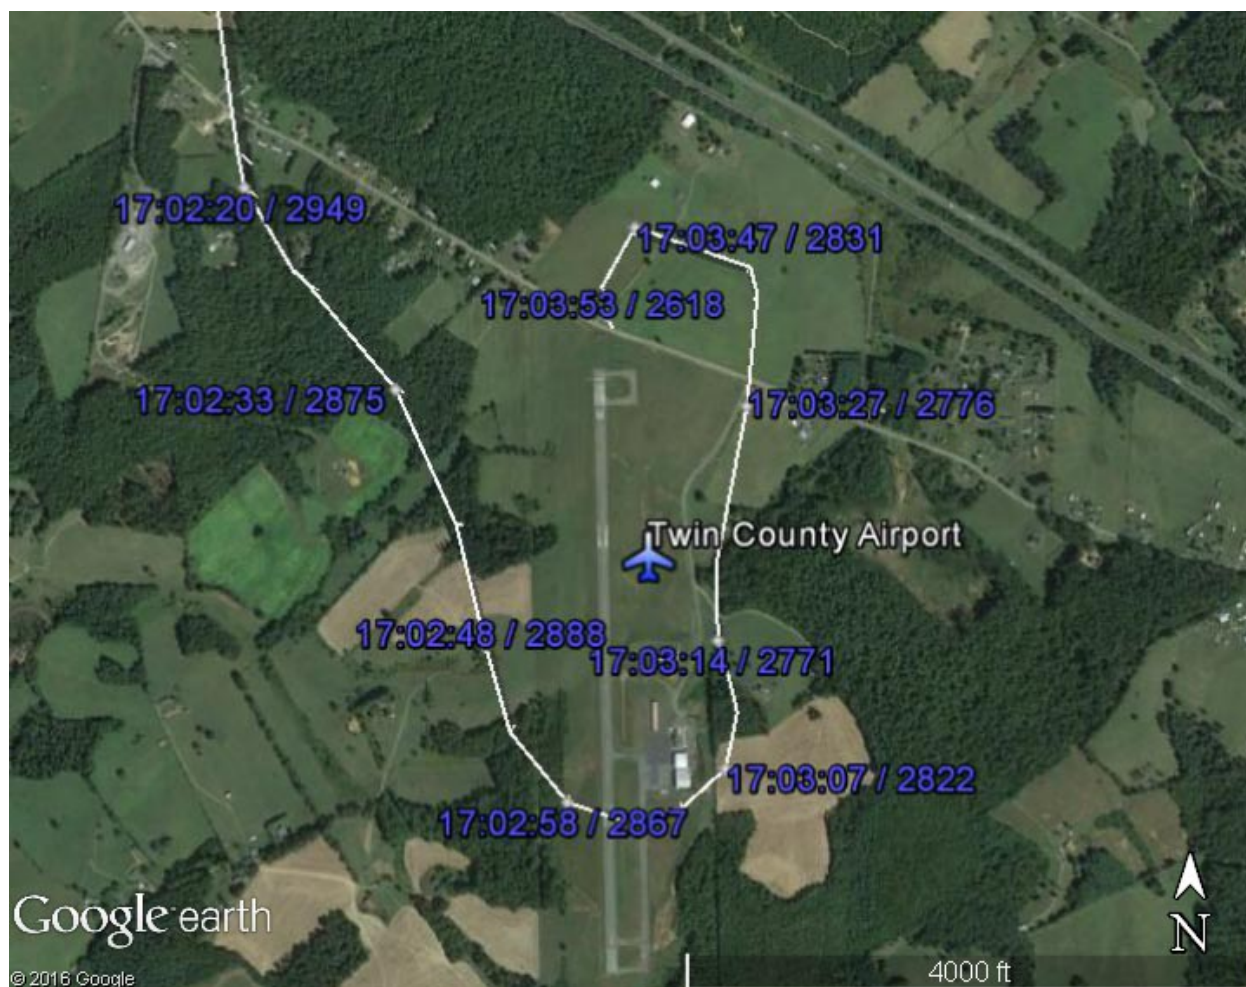
The aircraft's approach into Twin County Airport is shown in Figure 2. The aircraft's final position was about 300 ft short of runway 19.

**Figure 2.** Aircraft flight path into Twin County Airport in Galax Hillsville, Virginia.

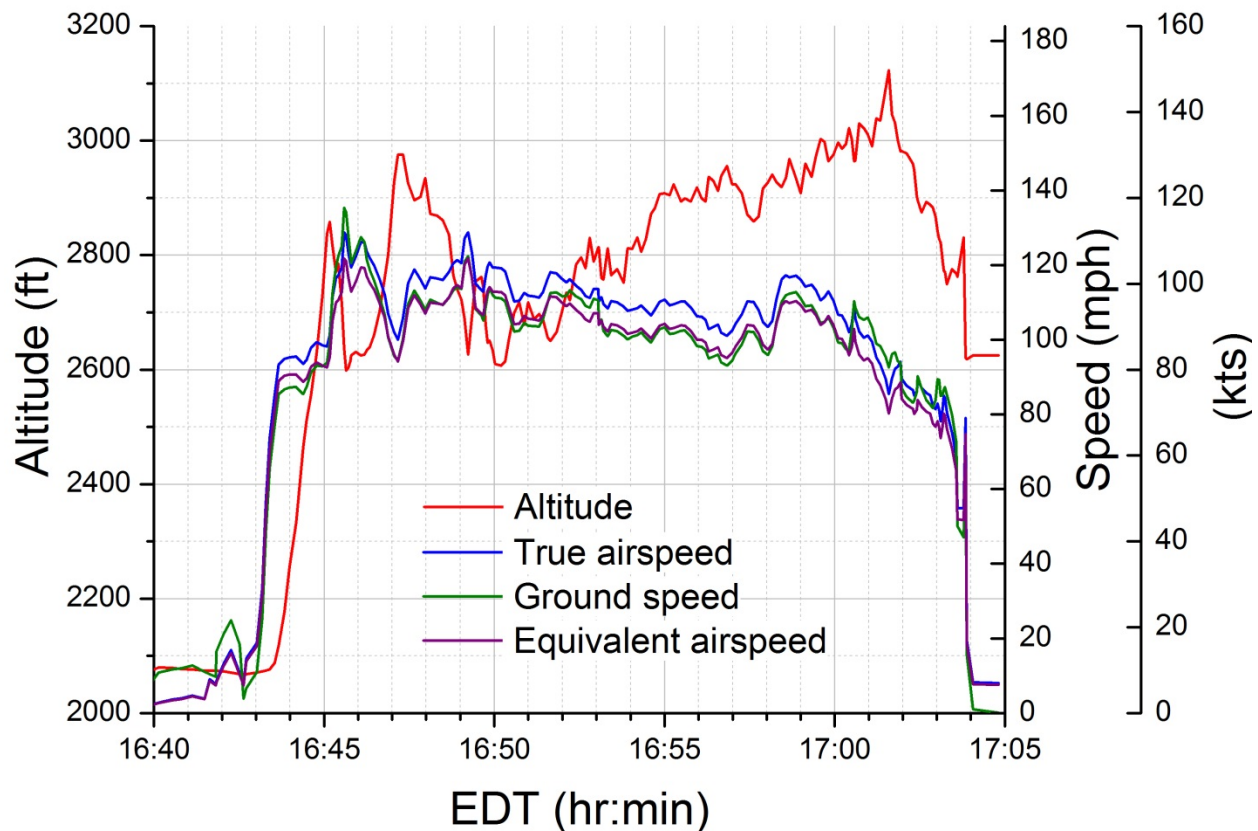
The true airspeed, equivalent airspeed, and groundspeed for the flight were calculated using the above winds and are shown in Figure 3. The aircraft averaged a speed of about 90 kts (103 mph) throughout the cruise portion of the flight.

**Figure 3.** Altitude and true airspeed, groundspeed, and equivalent airspeed for whole flight.

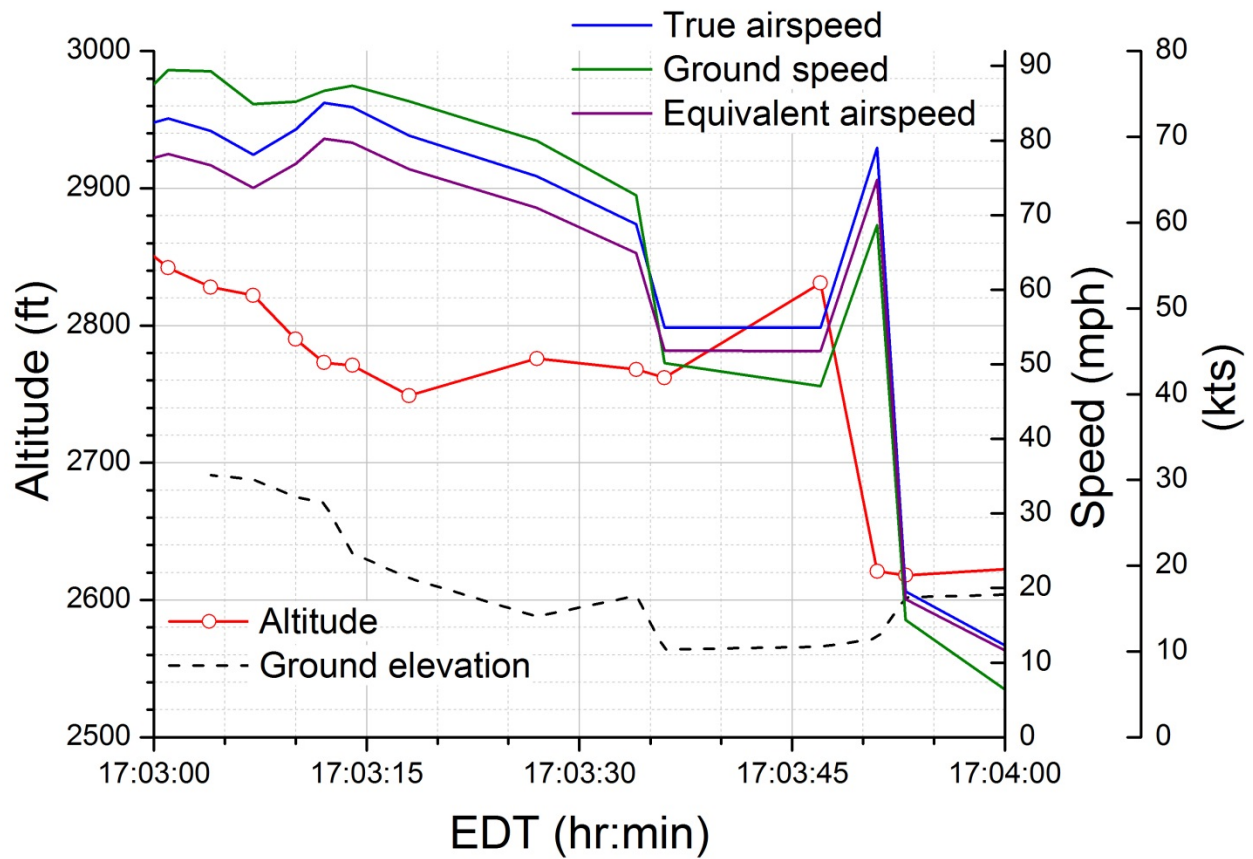
The aircraft's last minute of flight is shown in Figure 4. The aircraft was slowing on the downwind leg of its approach. Figure 5 shows the aircraft's ground track with equivalent airspeed and groundspeed noted for each recorded location.

**Figure 4.** Altitude and true airspeed, groundspeed, and equivalent airspeed for last minute of flight.

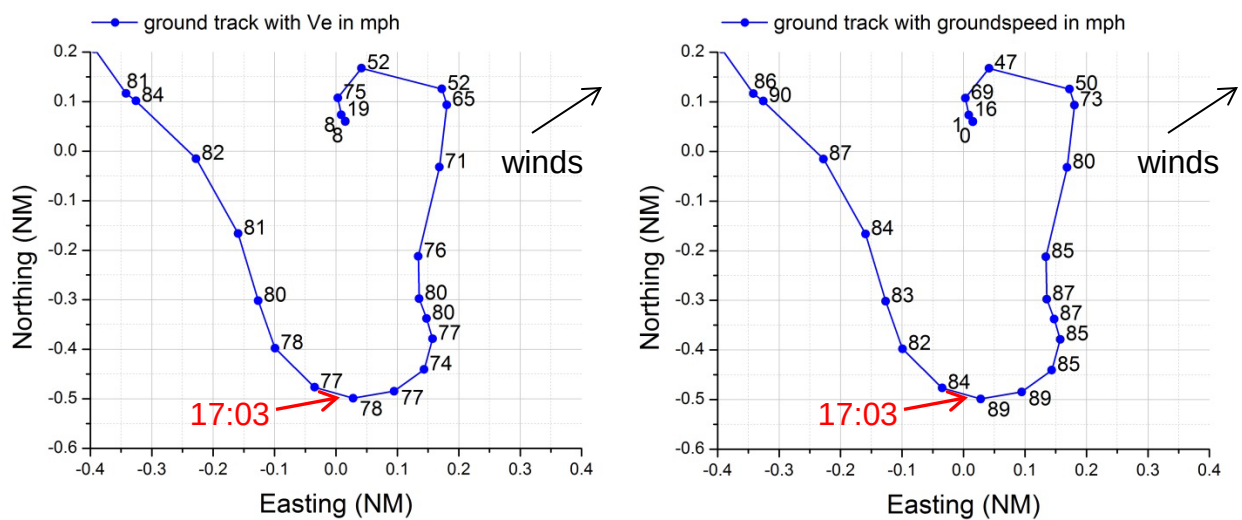
**Figure 5.** Ground track with equivalent airspeed (Ve) on the left and groundspeed on the right. The time 17:03 is noted by a red arrow on both plots.

At the last point before the aircraft's turn onto final, its equivalent airspeed with the winds recorded at KHLX ten minutes prior was 65 mph. The aircraft's groundspeed for the same point was 73 mph. The next two calculated speeds show the aircraft continuing to slow through the turn. At 17:03:47, the aircraft gains altitude and speed briefly before impacting the ground.

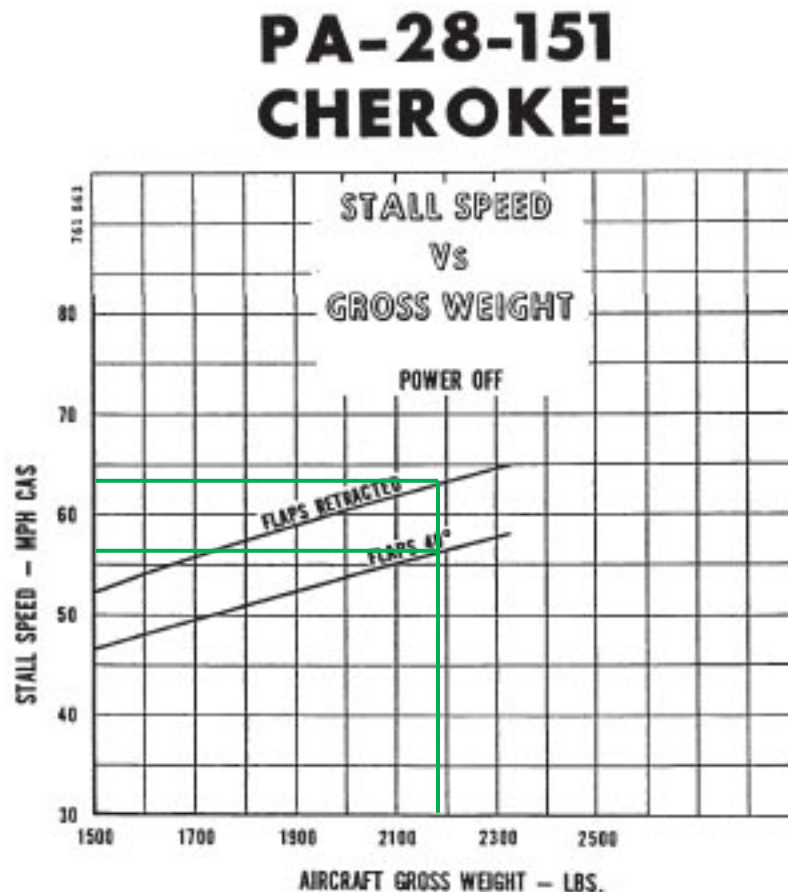
Figure 6 shows stall speed versus gross weight from the aircraft's Pilot's Operating Manual [1]. Power off stall speeds for 2,350 lbs were reported as 58 mph for flaps 40° and 64.5 mph for flaps retracted. For the aircraft's calculated weight of 2,184 lbs, the stall speeds would be about two to three mph slower (56 mph and 62 mph respectively).

**Figure 6.** Stall speeds versus aircraft gross weight from Pilot's Operating Manual.

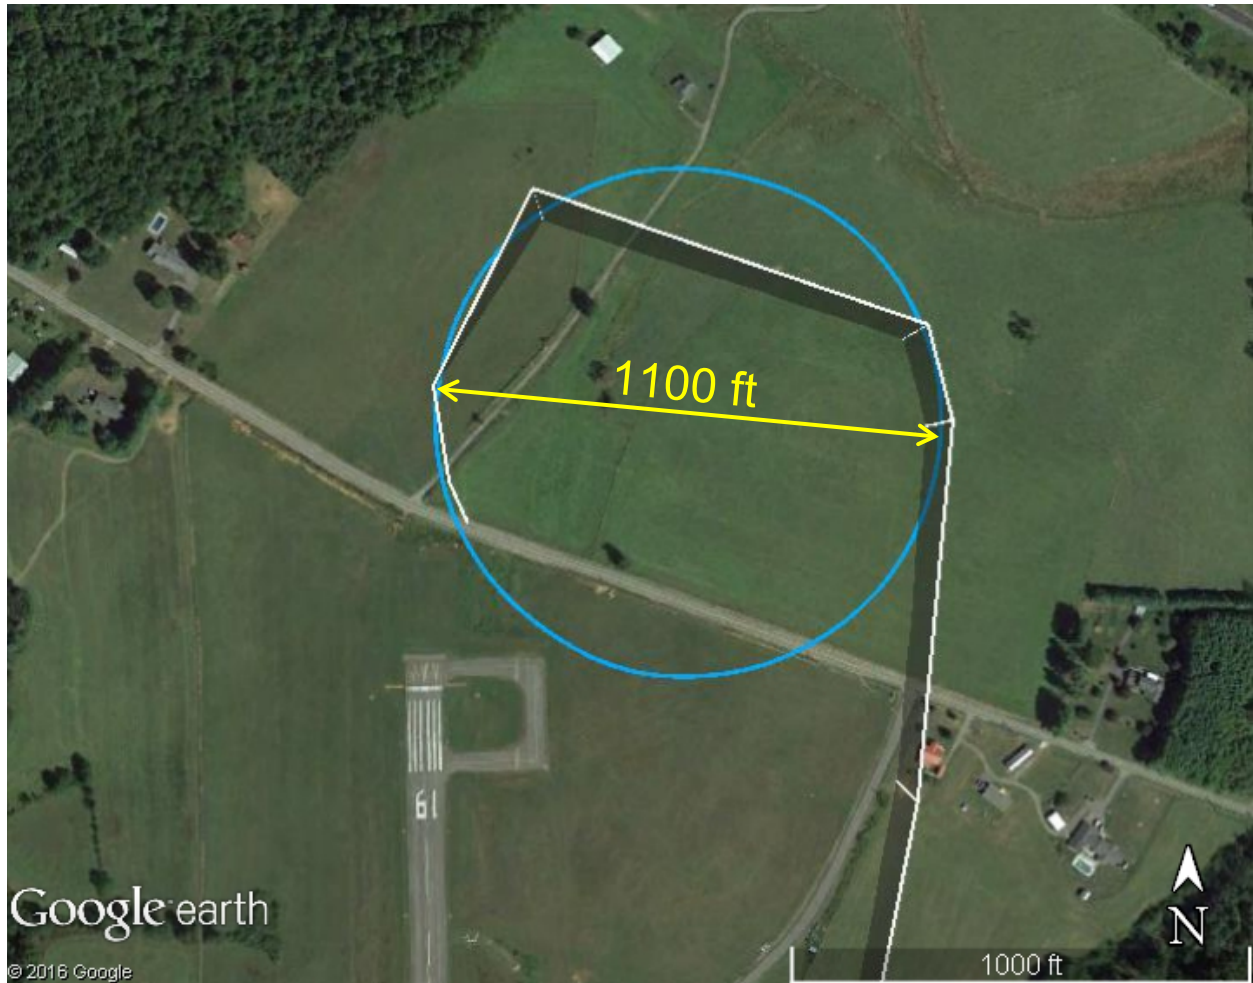
Fitting a smoothed curve through the final points of flight yields a 1,100 ft diameter circle.

**Figure 7.** Smoothed curve through final points of flight.

Applying a speed of 65 mph (equivalent airspeed referenced earlier) and a radius of 550 ft, the necessary bank was calculated to be about  $27^\circ$  for the lift to balance the centripetal force of the turn and keep the aircraft aloft. However, this is a kinematic equation and does not guarantee that a particular aircraft would be able to generate the necessary lift at that speed. Referring back to Table 1, increasing the bank to  $27^\circ$  (and extrapolating between  $20^\circ$  and  $40^\circ$ ) would raise the stall speed to 69 mph for flaps up and 62 mph for flaps down. As with Figure 6, the accident aircraft was lighter than the exemplar from the POM and its stall speed would be 2 to 3 mph

slower (67 mph and 60 mph respectively). The 65 mph speed the aircraft entered the turn at was below the flaps up stall speed and slowing by 5 mph through the turn would have dropped the airspeed below the flaps down airspeed. The winds used for the airspeed calculation were from the accident airport and were reported nine minutes prior to the accident.
