## Accident / Incident Summary Report

Report No.: 15-078

Lewis Ag Aviation Inc.  
Ayres S2R T34 Reg. N524SL  
Climax, Georgia  
9 July 2015  
PT6A-34 Engine  
S/N 56452

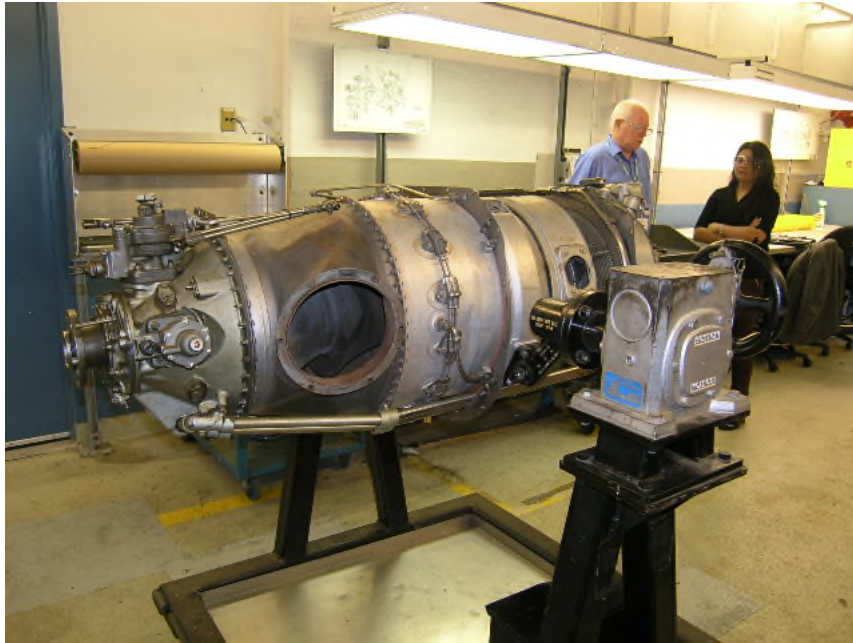
**Exhaust Duct:** Displayed moderate compressional and torsional deformation.

Photo No. 1  
Engine left hand forward view.

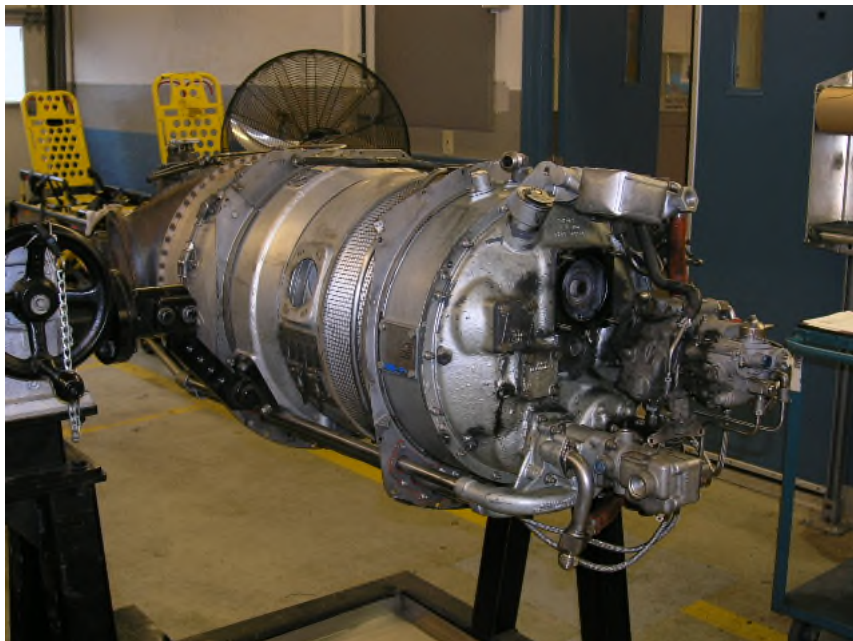
Photo No. 2  
Engine left hand aft view.

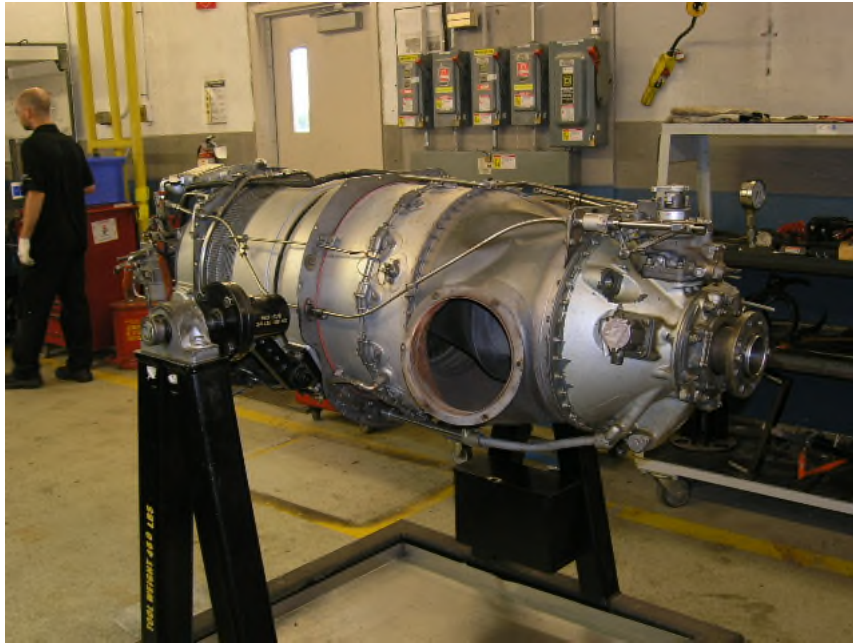
Photo No. 3  
Engine right hand forward view.

Displayed no distress. All connections and locking devices were intact. Please refer to photos No. 3, 4, and 5.

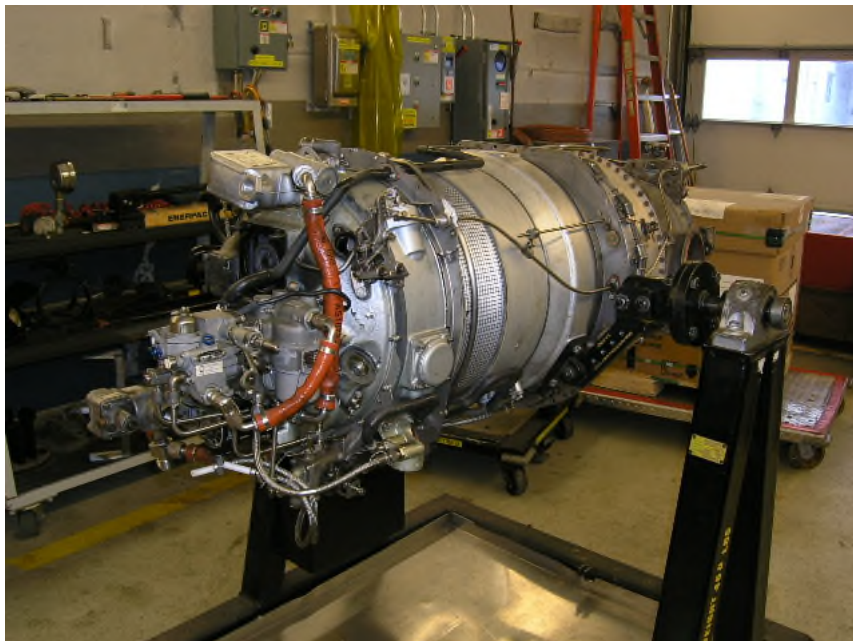
Photo No. 4  
Engine right hand aft view.

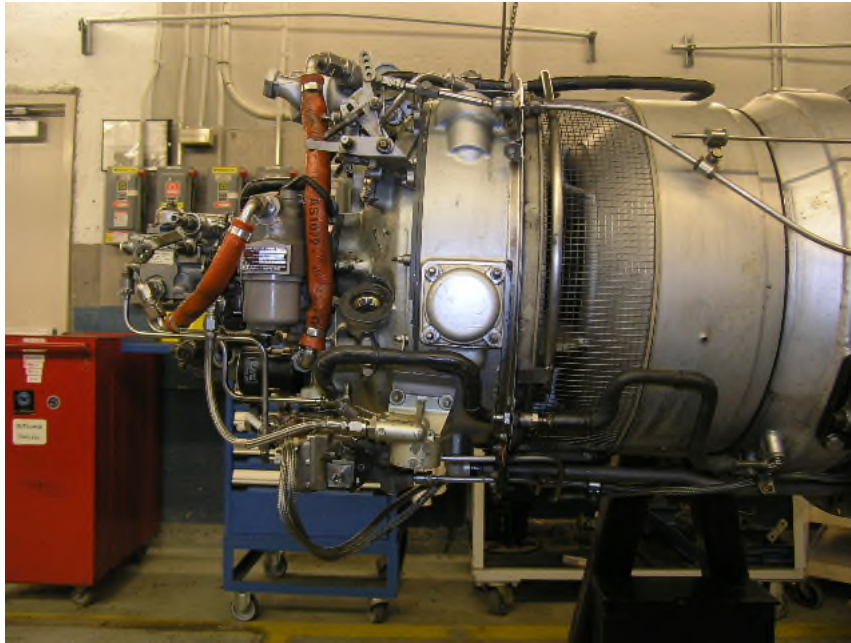
Photo No. 5

Engine accessory section, right hand view.

**Compressor Discharge Air (P3):** The P3 filter housing was not received. The P3 filter housing “B” nut fittings’ lock wire was separated. The connections were secure. Please refer to photos No. 5, 6.

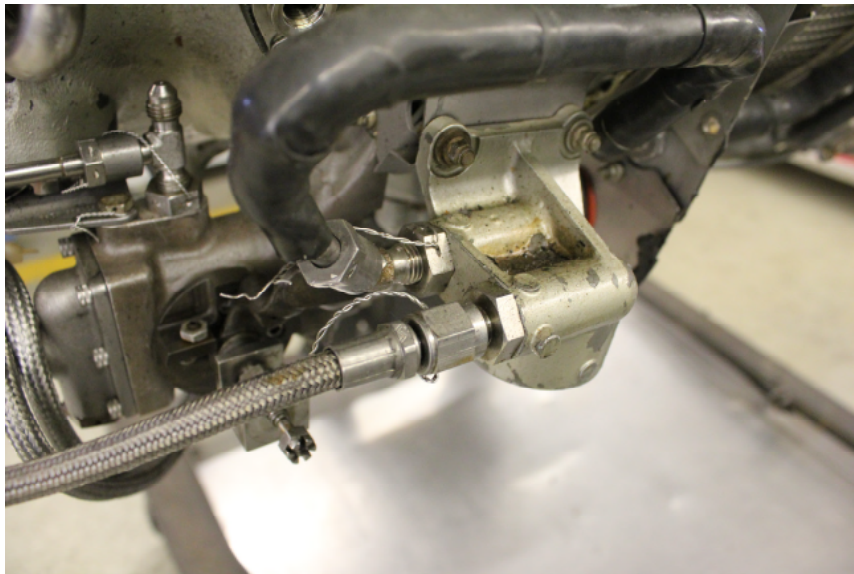
Photo No. 6  
P3 filter housing mounting boss.

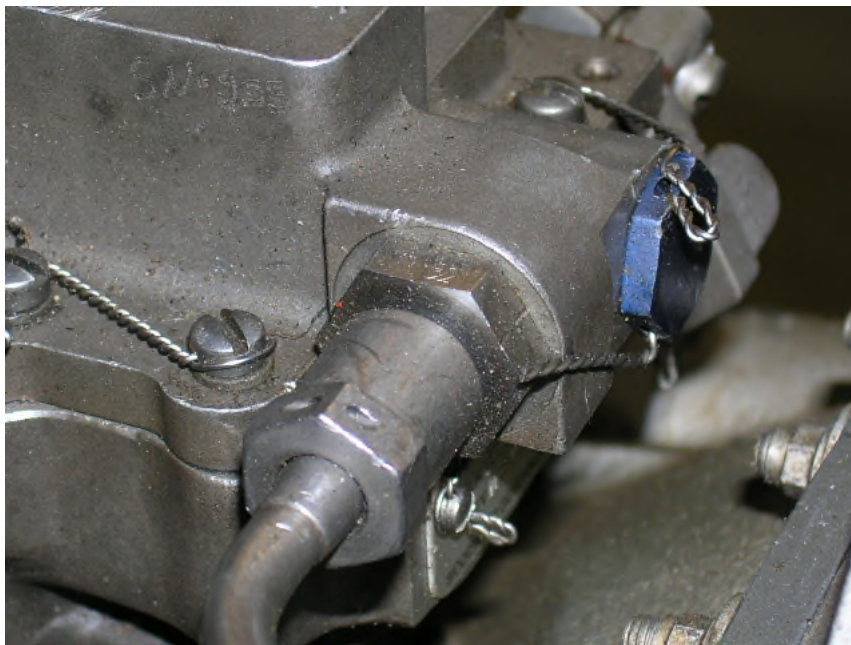
**Power Turbine Control (Py):** Displayed no distress. All connections and locking devices were intact. Please refer to photos No. 1, 3, 4, 7 and 8.

Photo No. 7  
Propeller governor Py fitting, detail.

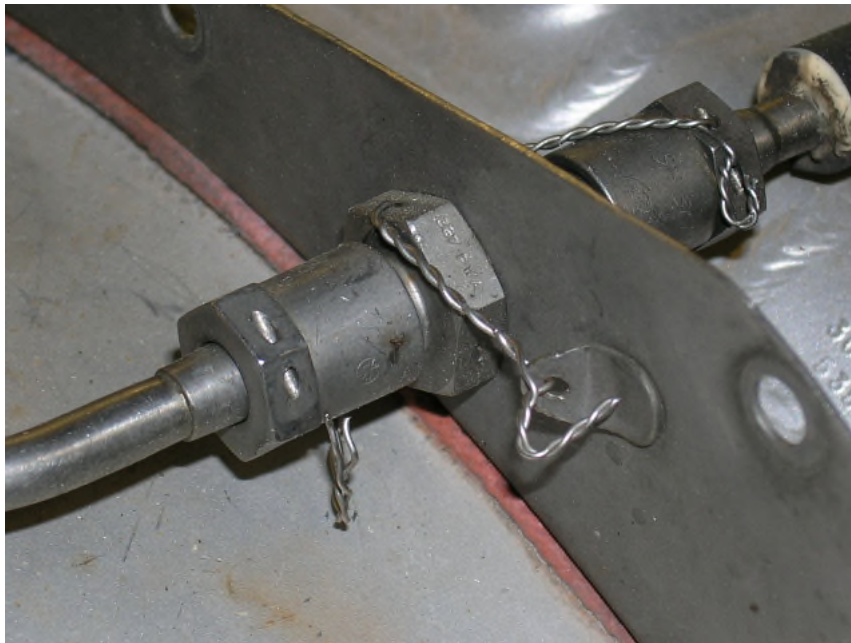
Photo No. 8  
Py firewall seal fitting.

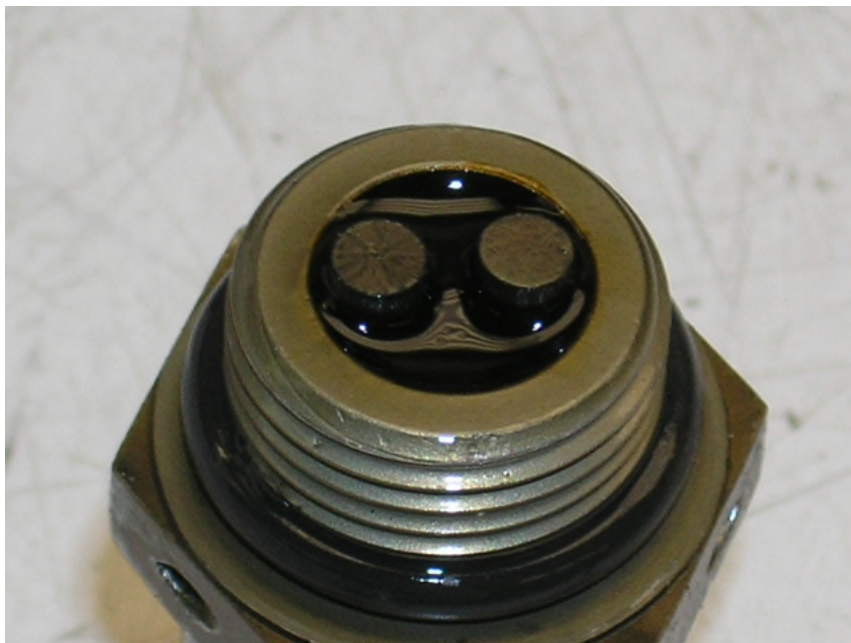
**Reduction Gearbox Chip Detector:** Clean. Please refer to photo No. 9.

Photo No. 9  
Reduction gearbox chip detector.

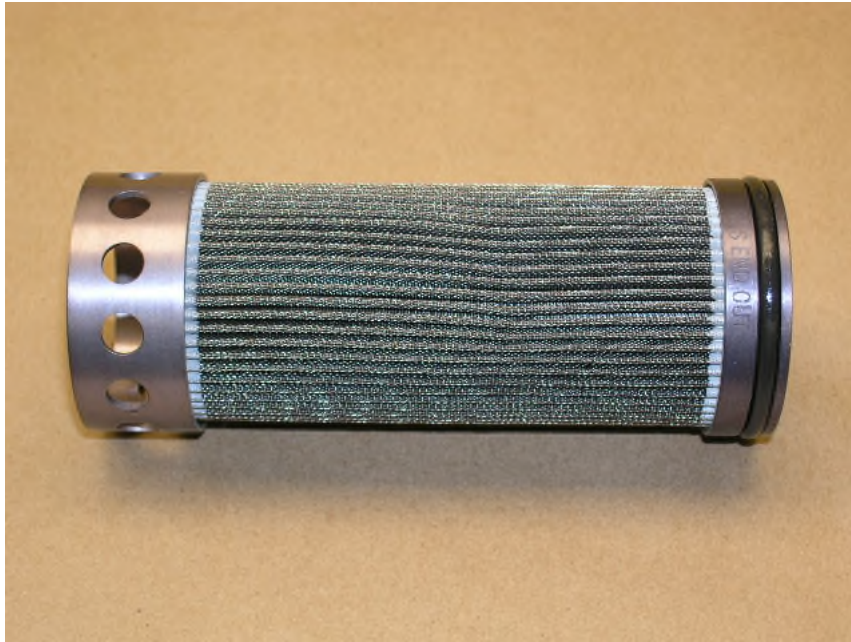
**Oil Filter:** Clean. Please refer to photo No. 10.

Photo No. 10  
Oil filter.

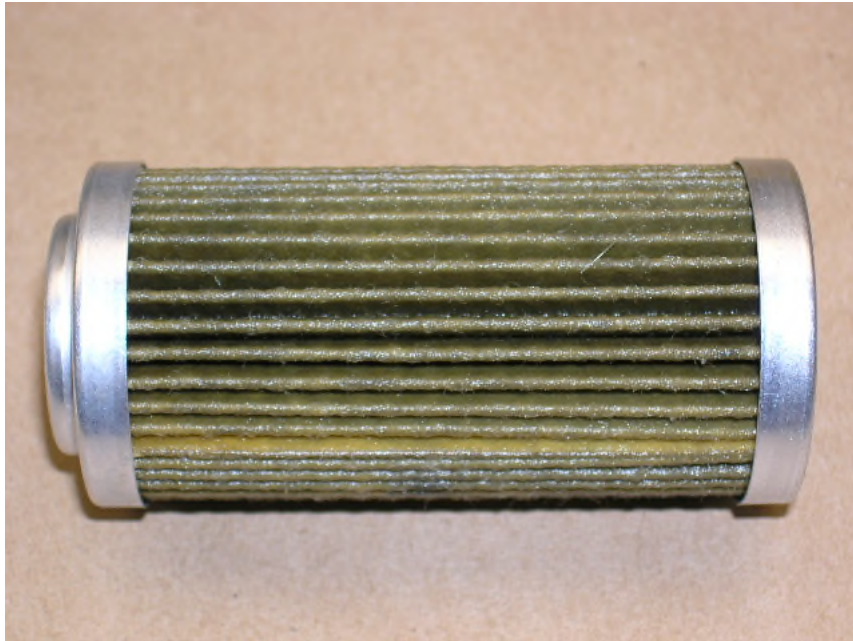
**Fuel Filter:** Clean. The residual fuel contained in the filter housing was clean. Please refer to photos No. 11 and 12.

Photo No. 11  
Fuel filter.

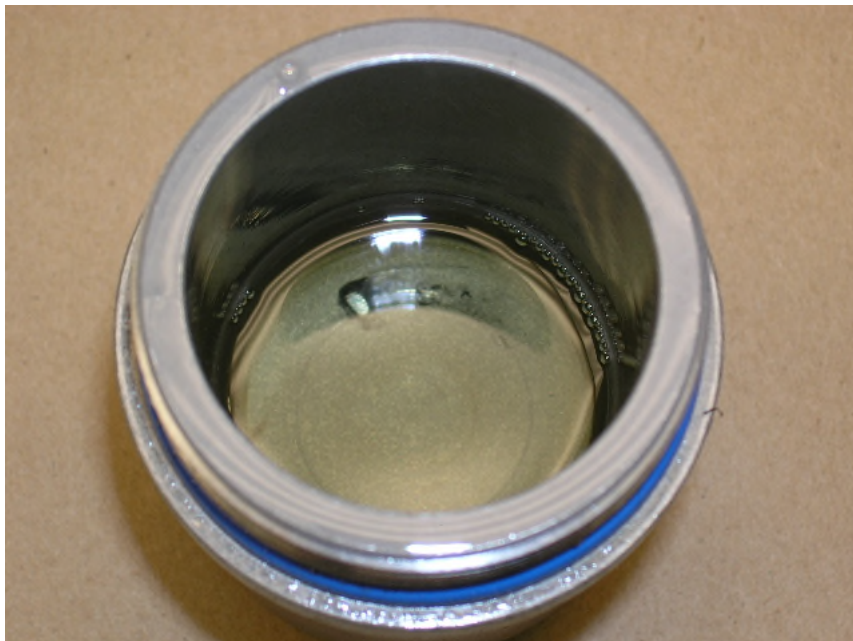
Photo No. 12  
Fuel filter housing and residual fuel.

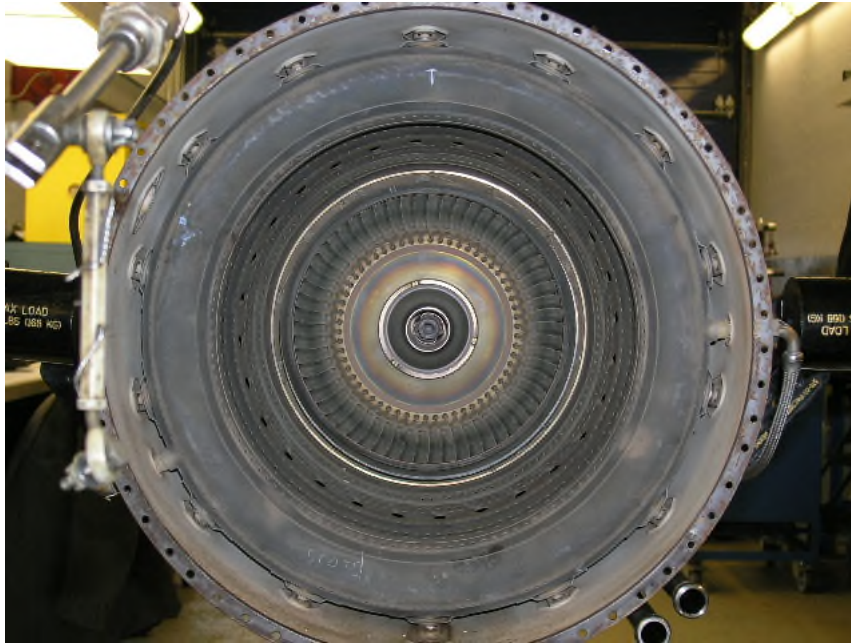
Photo No. 13

**Combustion Chamber Liner:** Observed in-situ. Displayed no distress. Please refer to photo No. 13.

Gas generator case interior, combustion chamber liner and compressor turbine, in-situ.

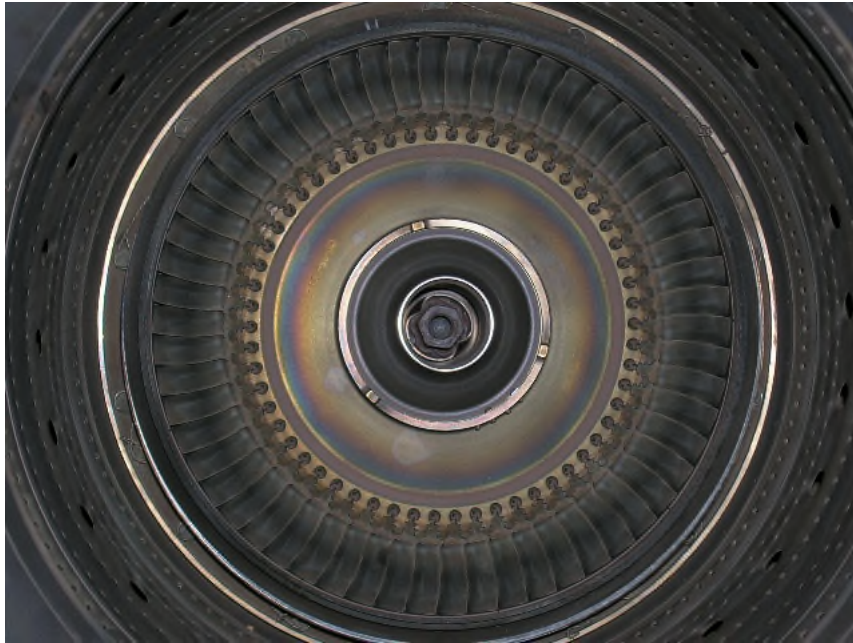
**Compressor Turbine Shroud:** Observed in-situ, displayed no distress. Please refer to photo No. 14.

**Compressor Turbine:** Observed in-situ. The disc and blade airfoils displayed no indications of distress. Please refer to photo No. 14.

Photo No. 14  
Compressor turbine, in-situ.

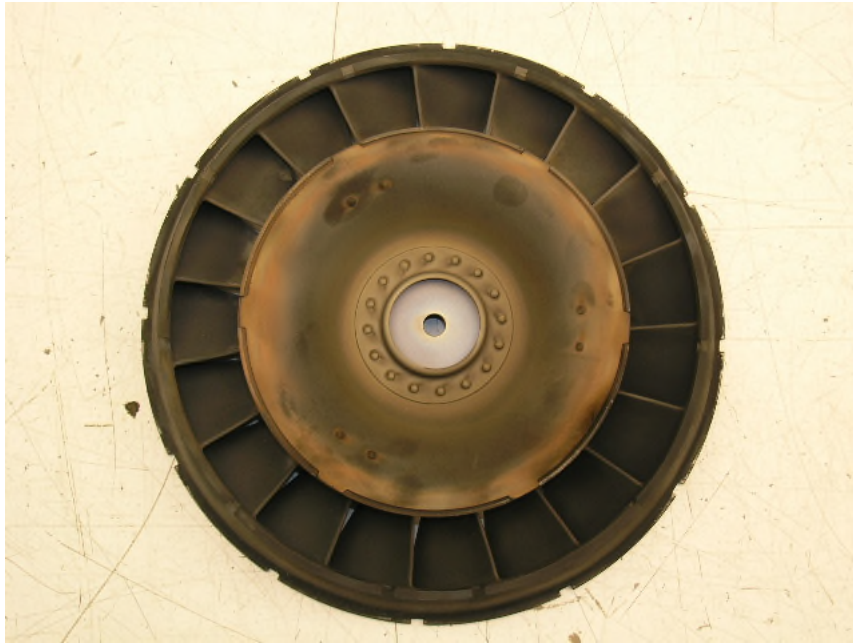
Photo No. 15

**Power Turbine Guide Vane Ring and Interstage Baffle:** The vane airfoils were intact. The upstream side vane ring inner drum and interstage baffle face displayed no distress. The downstream side outer drum, inner drum, and baffle displayed circumferential rubbing, with frictional heat discoloration and material smearing, due to contact with the power turbine. Please refer to photos No. 15 through 17.

Power turbine guide vane ring and interstage baffle, upstream side.

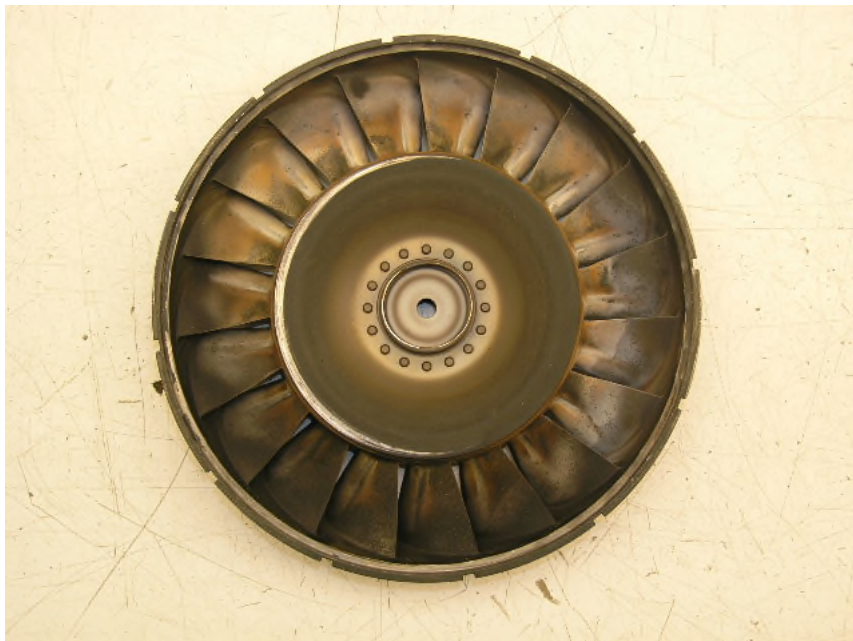
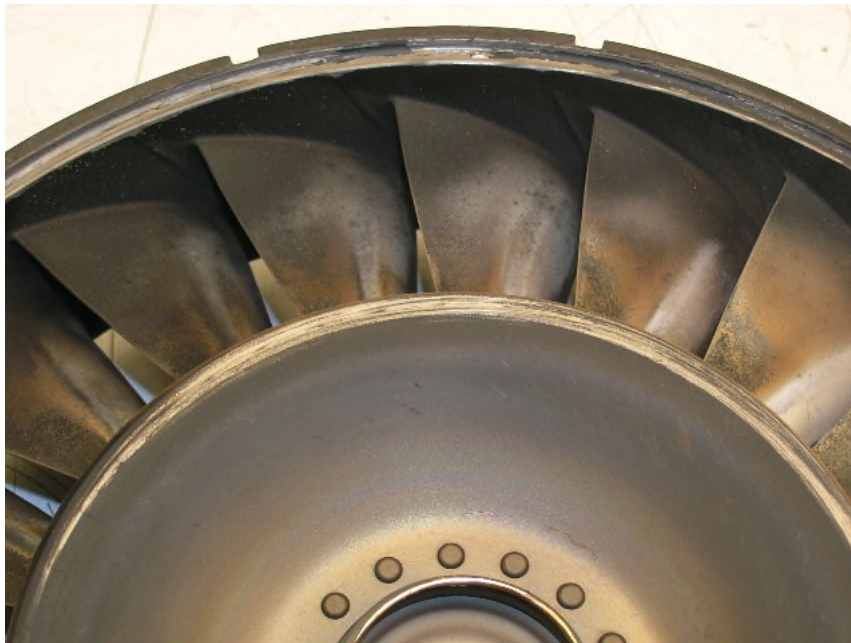
Disassembly of the power section showed strong circumferential rubbing, with frictional heat discoloration and material smearing, displayed by the power turbine guide vane ring, the power turbine, and the power turbine shroud due to their making contact under impact loads and engine housing distortion.

Power turbine guide vane ring and interstage baffle, downstream side.

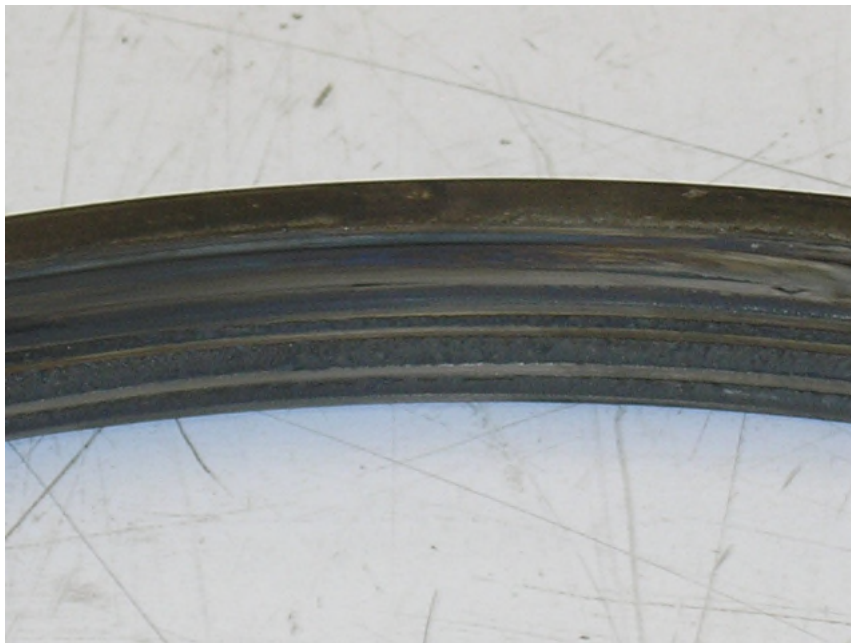
Photo No. 18

**Power Turbine Shroud:** Displayed heavy circumferential rubbing, with strong frictional heat discoloration and material smearing, due to contact with the power turbine blade tips. Please refer to photo No. 18.

Power turbine shroud, detail.

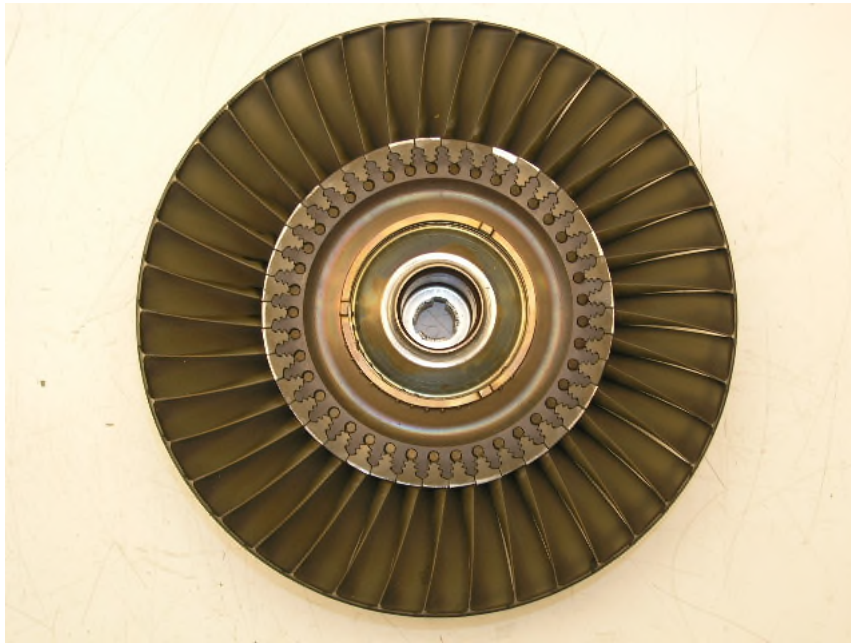
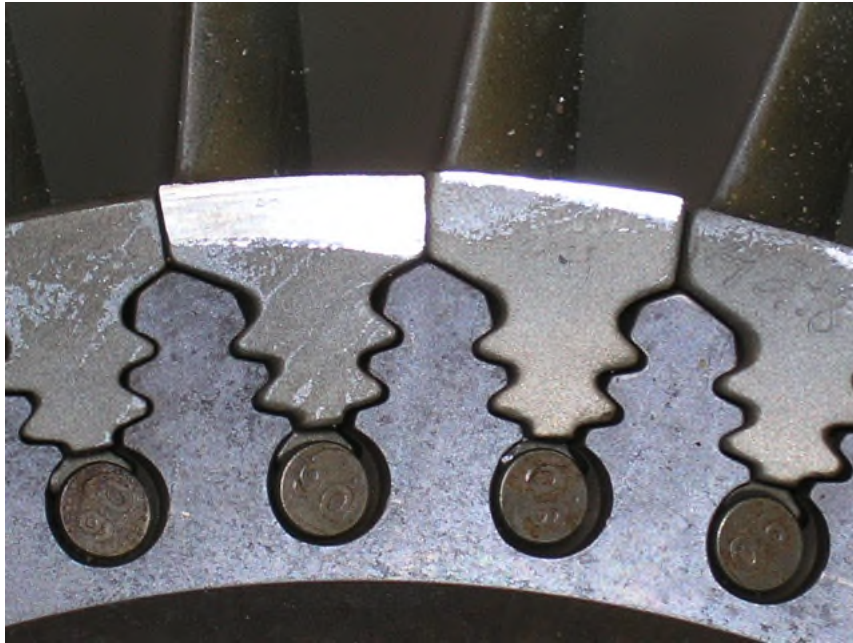
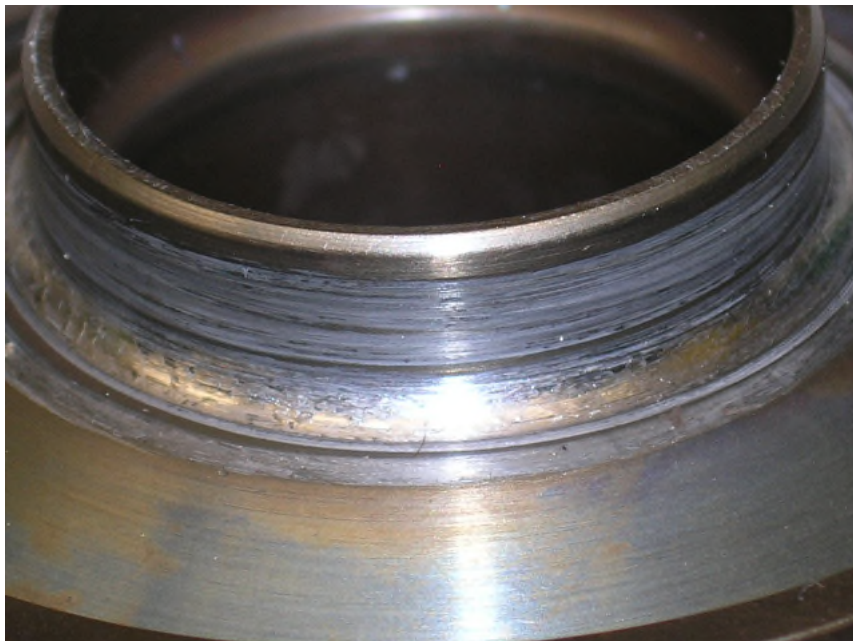
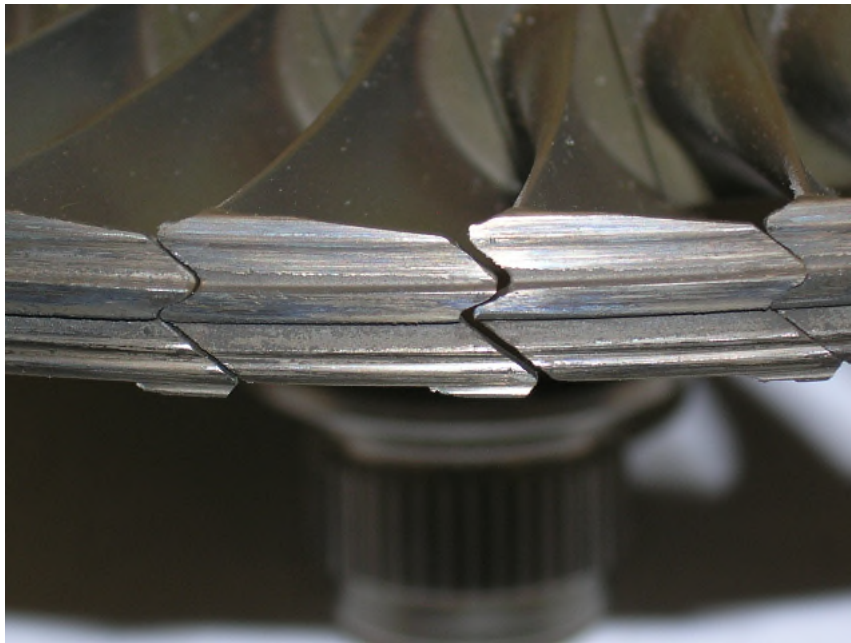
The engine displayed contact signatures to its internal components characteristic of the engine producing power in a high power range at the time of impact.

**Power Turbine:** The upstream side blade platforms, blade tip leading edges, and the disc hub displayed circumferential rubbing due to contact with the power turbine guide vane ring. The blade tips displayed circumferential rubbing, with frictional heat discoloration and material smearing, due to contact with the power turbine shroud. Please refer to photos No. 19 through 22.

Photo No. 19  
Power turbine, upstream side.

Photo No. 20  
Power turbine upstream side, detail.

Photo No. 21  
Power turbine upstream side hub, detail.

Photo No. 22  
Power turbine blade tips.

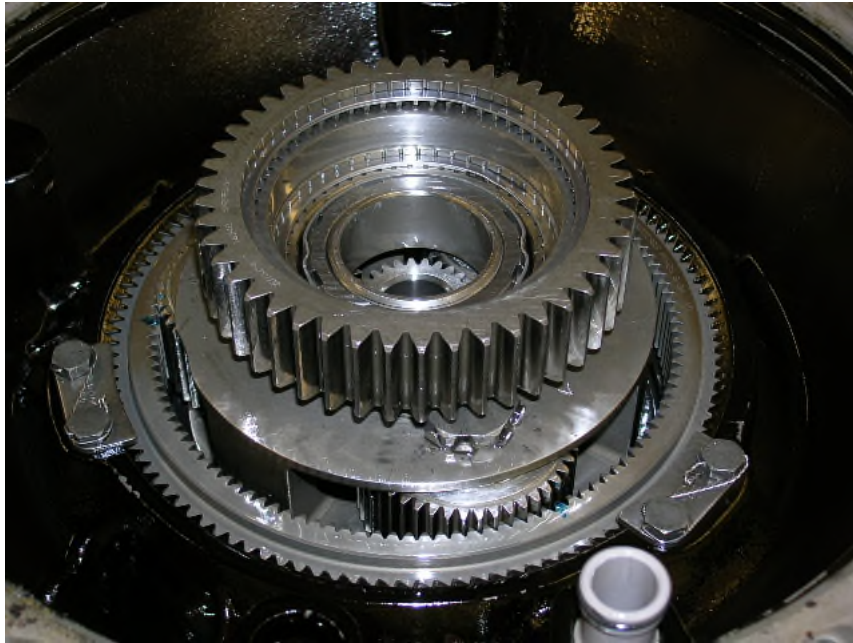
The reduction gearbox 1<sup>st</sup> and 2<sup>nd</sup> stage gearing displayed no indications of operational distress. Please refer to photos No. 23 and 24.

Photo No. 23  
Reduction gearbox 1<sup>st</sup> stage gearing.

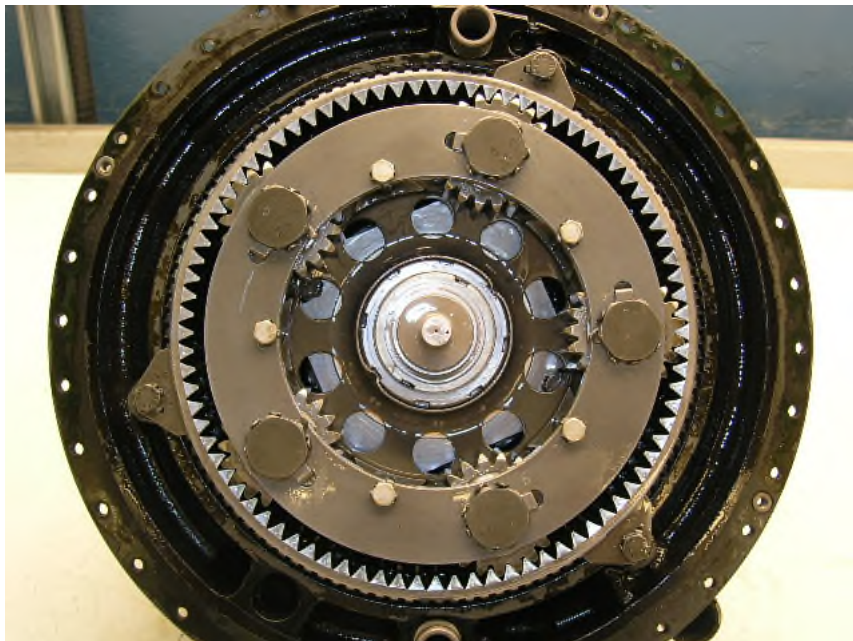
Photo No. 24  
Reduction gearbox 2<sup>nd</sup> stage gearing.

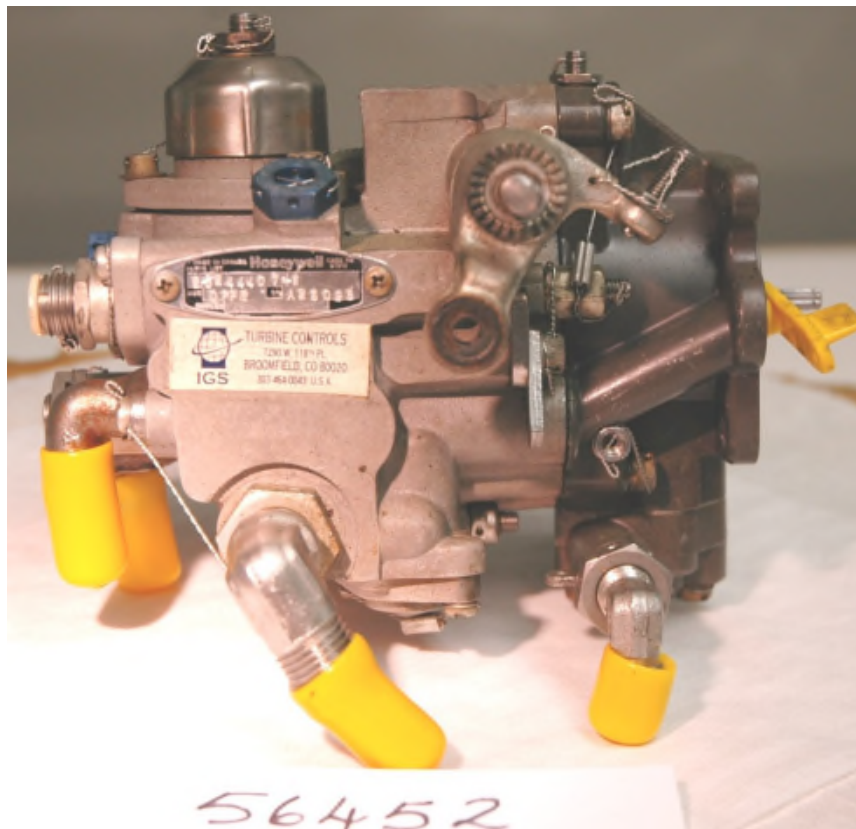
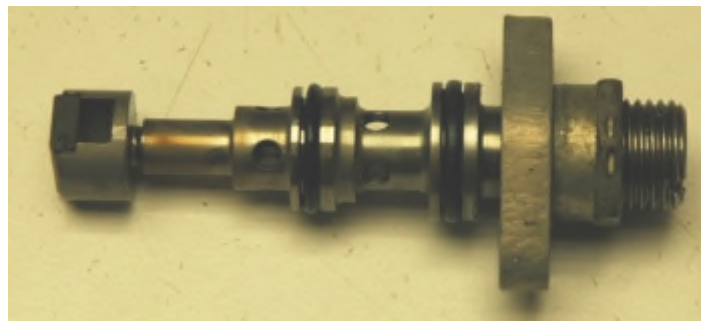
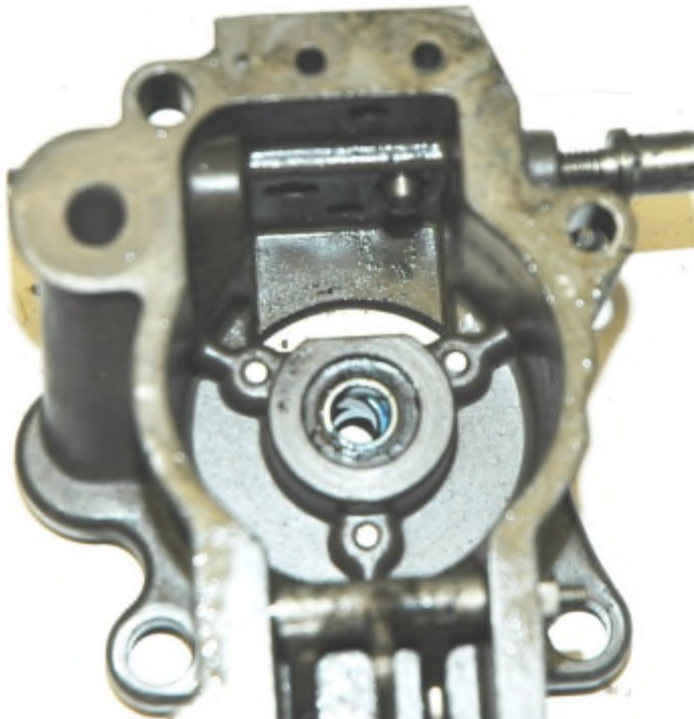
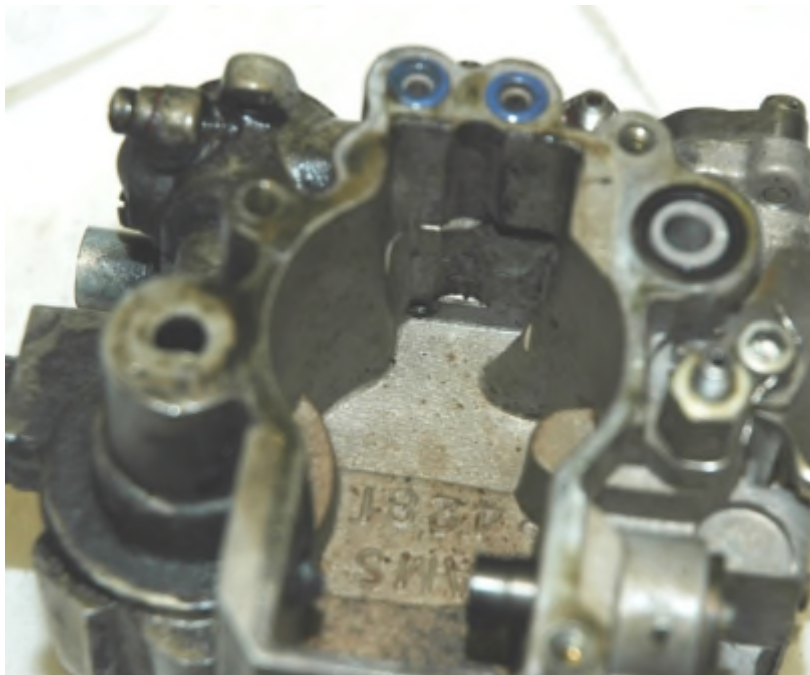
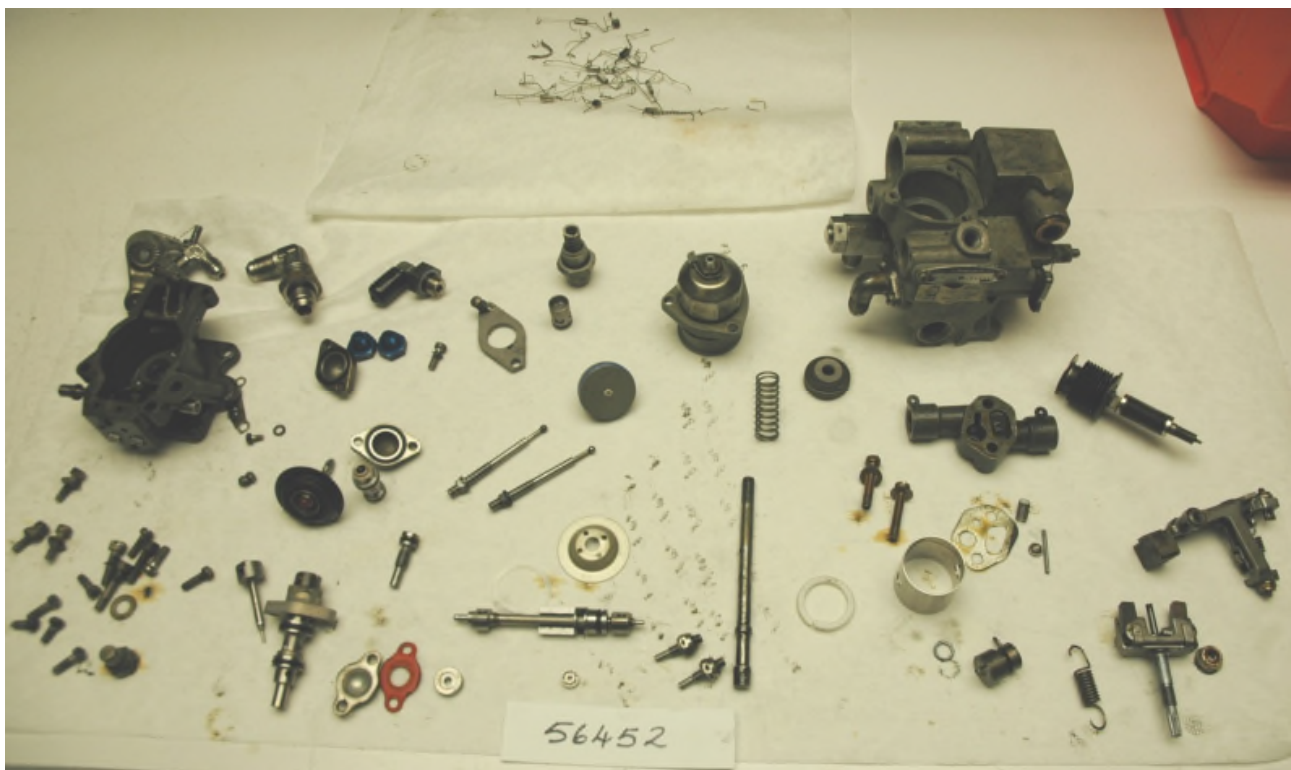
**Fuel Control Unit:** P/N 2524440-7-6 S/N 2524440-7-6. Prior to functional testing the air adapter was removed to permit inspection of the Py orifice and Py bleed, and the P3 inlet elbow was removed to inspect the Px orifice. Oil contamination was evident at the air adapter gasket, but there was no contamination in the orifices or bleed. With the unit installed on the test stand, air was applied to the pneumatic system and a leak-test solution was applied to the flanges and joints to check for leaks. Slow bubbling, within inspection limits, was observed at the air adapter gasket. No other leaks were observed. The unit was tested in accordance with normal functional test protocol with no anomalies noted that would preclude normal unit operation and full fuel flow availability. The functional test included operation at a fixed speed, fixed throttle lever position and fixed P3 air steady state condition for 10 minutes while the fuel outlet flow was monitored for any variations which would indicate deterioration of the pneumatic bellows. No fuel flow variation was observed during the monitoring period. Following functional test the unit was disassembled and detailed inspected. The components displayed normal running wear, with no anomalies that would preclude normal operation. Please refer to photos No. 25 through 29.

Photo No. 25  
Fuel control unit as removed.

Photo No. 26  
Fuel control unit metering valve.

Photo No. 27  
Fuel control unit drive body interior.

Photo No.28  
Fuel control unit flow body.

Fuel control unit as disassembled.

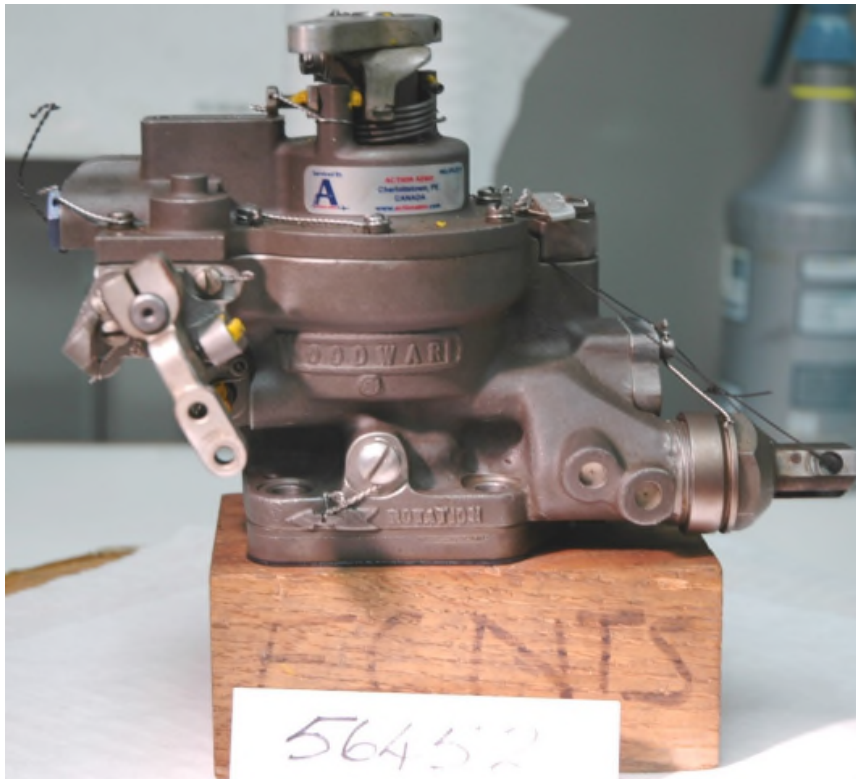
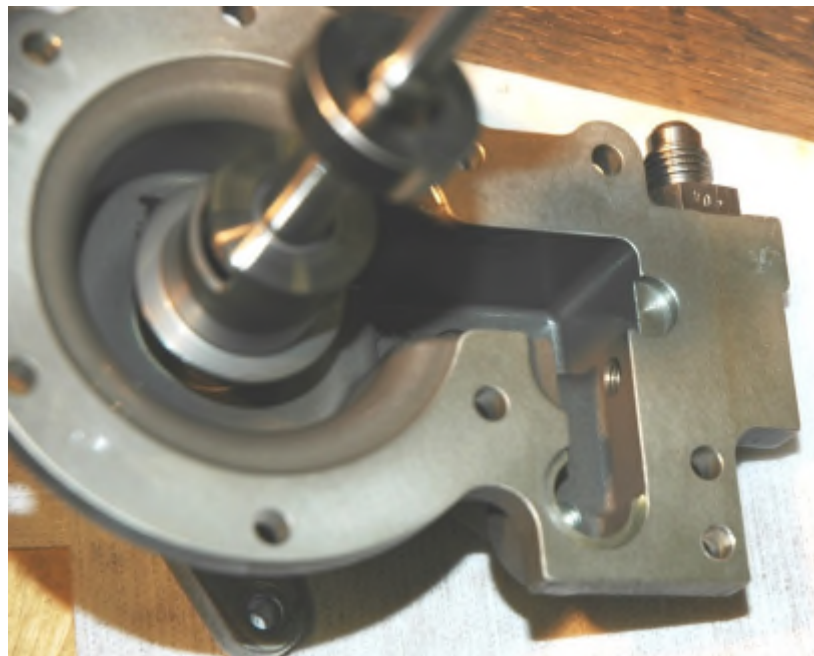
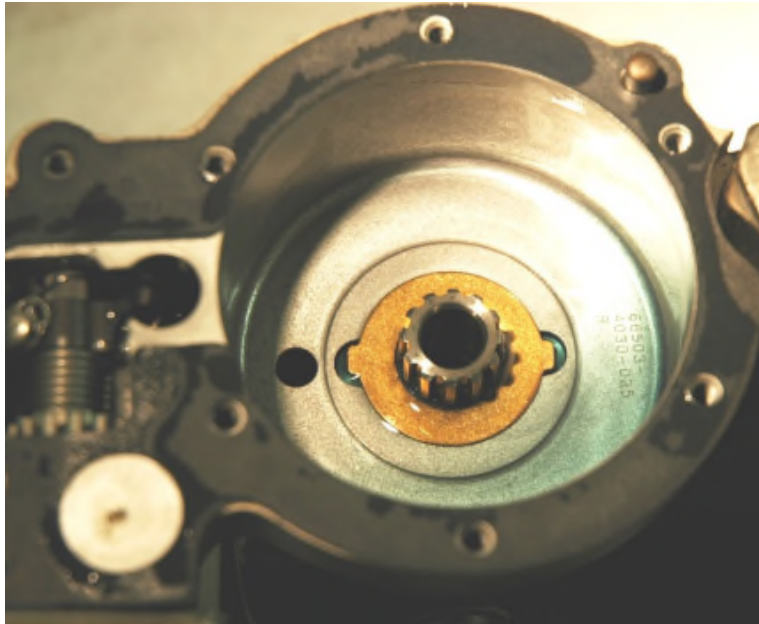
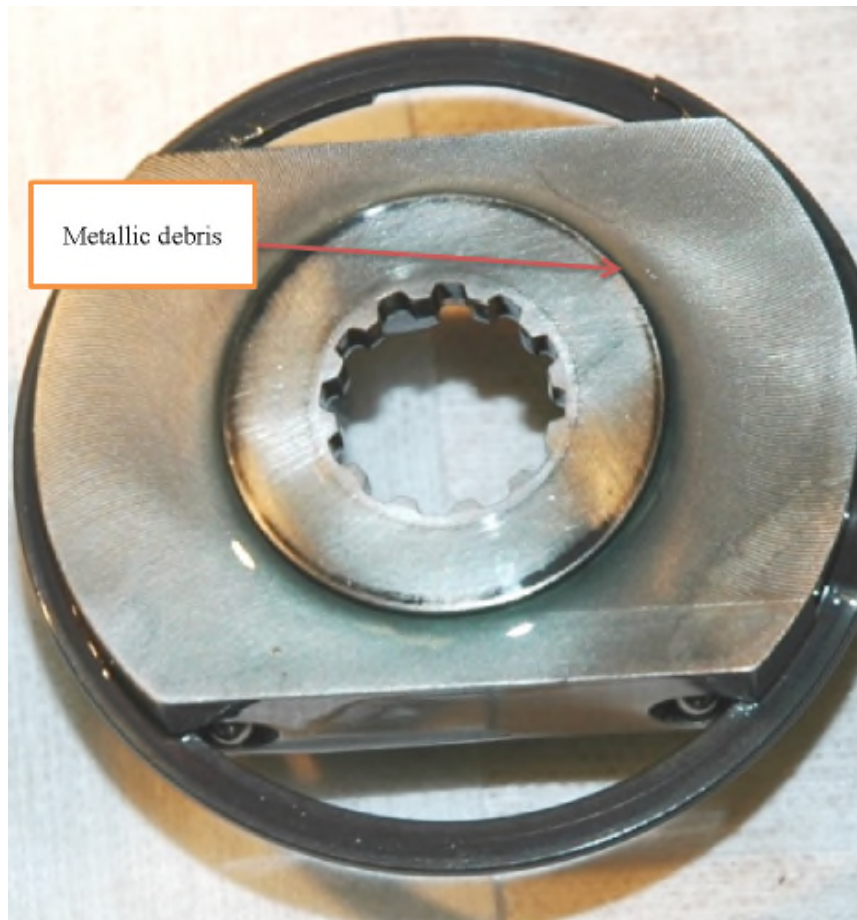
**Propeller Governor:** P/N 8210-002-01, S/N 11933427. The engine test cell run confirmed satisfactory operation. The unit was partially disassembled in order to check for contamination in the pneumatic section or obstruction of the Py flapper. There was no debris in the pneumatic section, the Py bleed, or in the ball-head cavity. A small piece of metallic debris was present on the underside of the flyweight table. There was no obstruction at the Py flapper. There were no scars on the ball-head cavity. The ball-head was complete and the weights fell evenly and freely. Please refer to photos No. 30 through 33.

Photo No. 30  
Propeller governor as removed.

Photo No. 31  
Propeller governor cover interior

Photo No. 32  
Propeller governor ball-head cavity.

Propeller governor flyweight table.

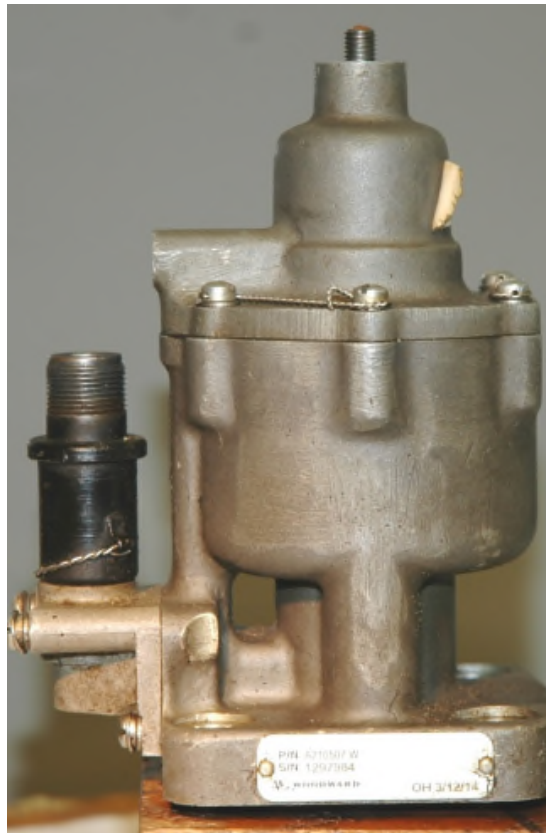
**Overspeed Governor:** P/N A210507W S/N 1297984. Functional testing in accordance with normal test protocol was satisfactory, with minor variations not affecting normal operation. Please refer to photo No. 34.

Photo No. 34  
Propeller overspeed governor, as received.
