# HARTZELL PROPELLER INC.

Aircraft Accident/Incident Report No.: 150709

## PROPELLER TEARDOWN REPORT

**Propeller Model:** HC-B3TN-3D with T10282N+4 blades

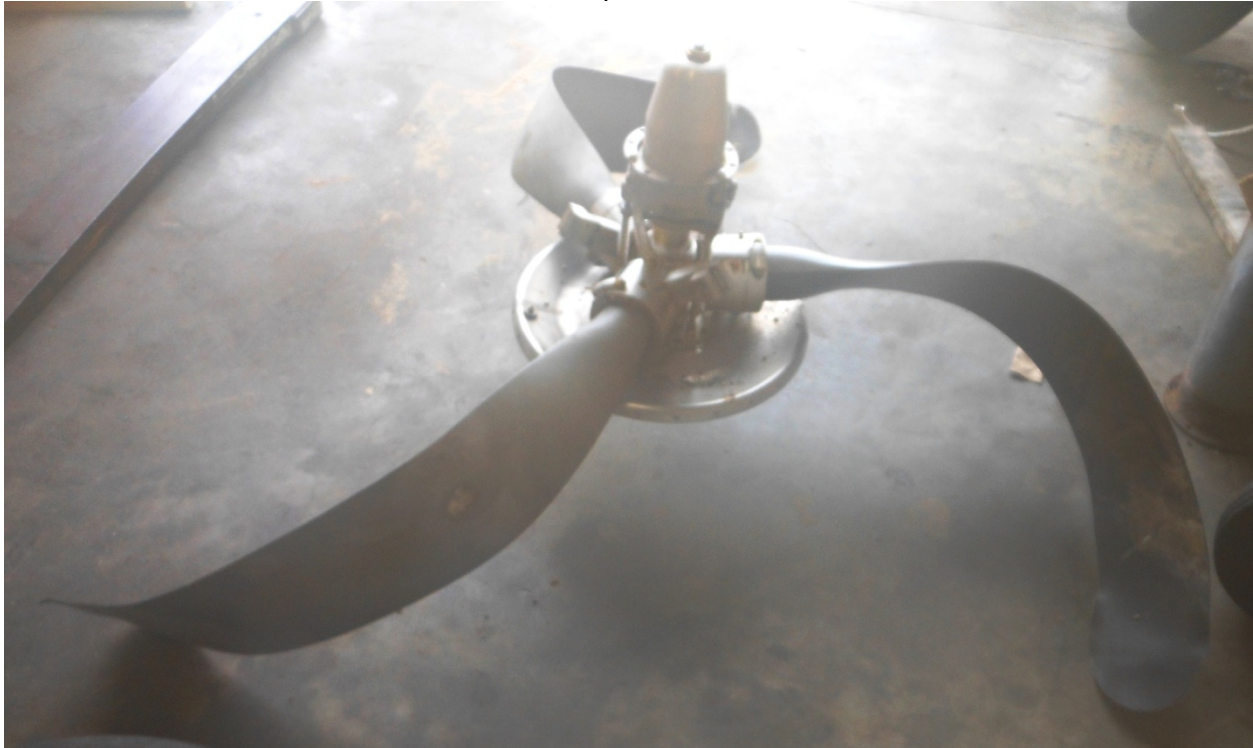
Photo #1 – Propeller As-Received

The propeller remained attached to the engine and was removed after recovering the wreckage and prior to my arrival at Souther Field Aviation. Photo #1 shows the condition when I arrived. All three blades showed similar bending in the aft direction and twisting leading edge down (toward flat pitch). Photo #2 shows how the cylinder, piston, feathering spring assembly and guide collar had separated from the hub unit. With the cylinder separated, all three blades had rotated beyond (more negative) the normal reverse position.

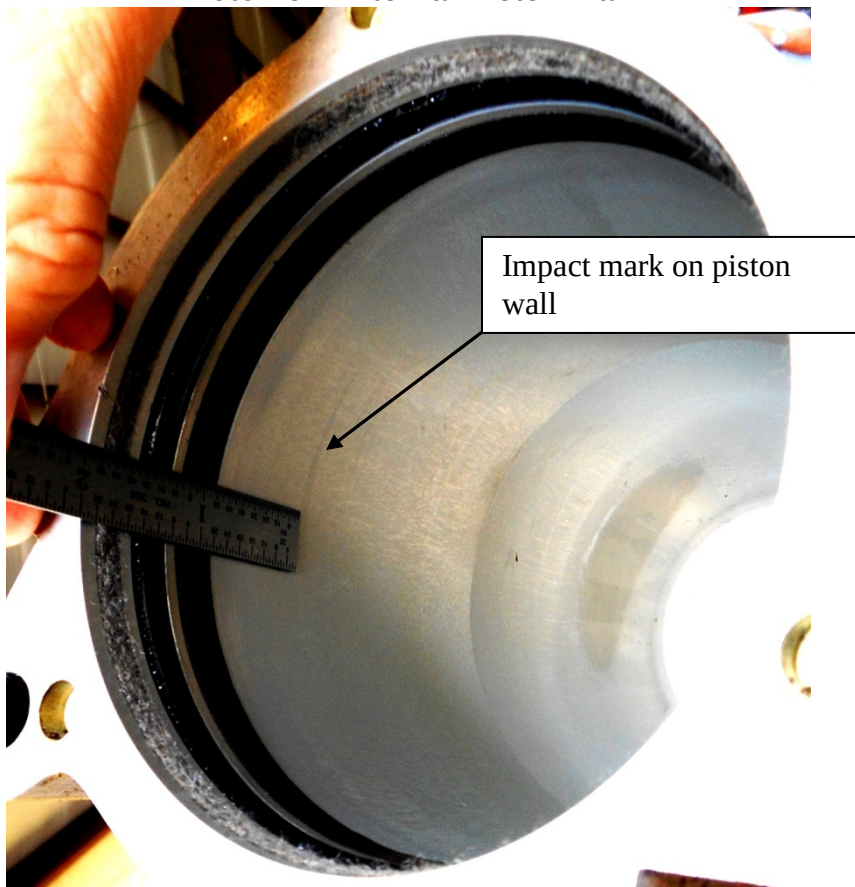
Photo #3 – Internal Piston Mark

**Piston and Beta Guide Collar:** The piston was still attached to the cylinder/pitch change rod and feathering spring assembly. The cylinder assembly separated at the hub attachment threads. The piston showed an internal impact mark (made by top corner of cylinder) adjacent to the #2 blade providing some blade angle information (see Photo #3). This mark was approximately 2" from the bottom edge of the piston which equates to a blade angle of approximately 12°. 12° is the approximate running flight idle blade angle (18° low pitch stop setting - ~6° beta valve null out travel = 12°). This mark implies the piston was extended at the low pitch position during the impact sequence and prior to the cylinder separation. The feathering spring assembly remained intact and under compression with the spring keepers in place. No attempt was made to remove the compressed feathering spring on-site.

The piston also had impact marks made by the counterweight arms/slugs adjacent to each blade arm. These impact marks were made during the initial series of blade strikes but prior to cylinder separation.

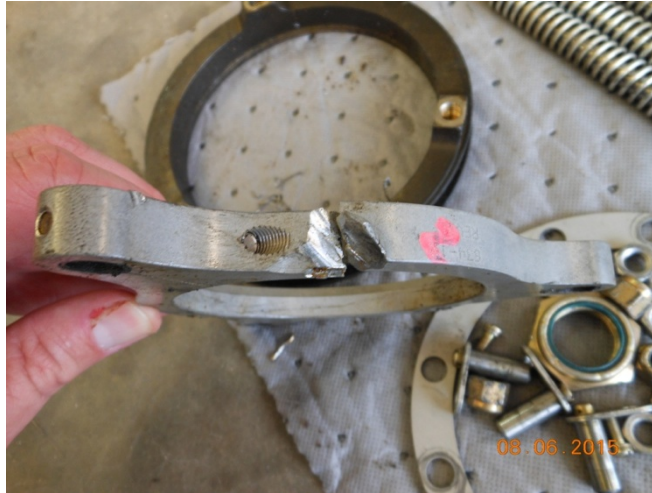
Photo #4 – Beta Rod Collar

The guide collar was fractured near an impact mark made by the #2 link arm. The guide collar clamps around the cylinder attaching threads, retains the beta ring return springs and guides the

beta rods. There were impact marks on the guide collar made by the link arms at all three blade locations but only one fracture adjacent to the #2 link arm (see Photo #4).

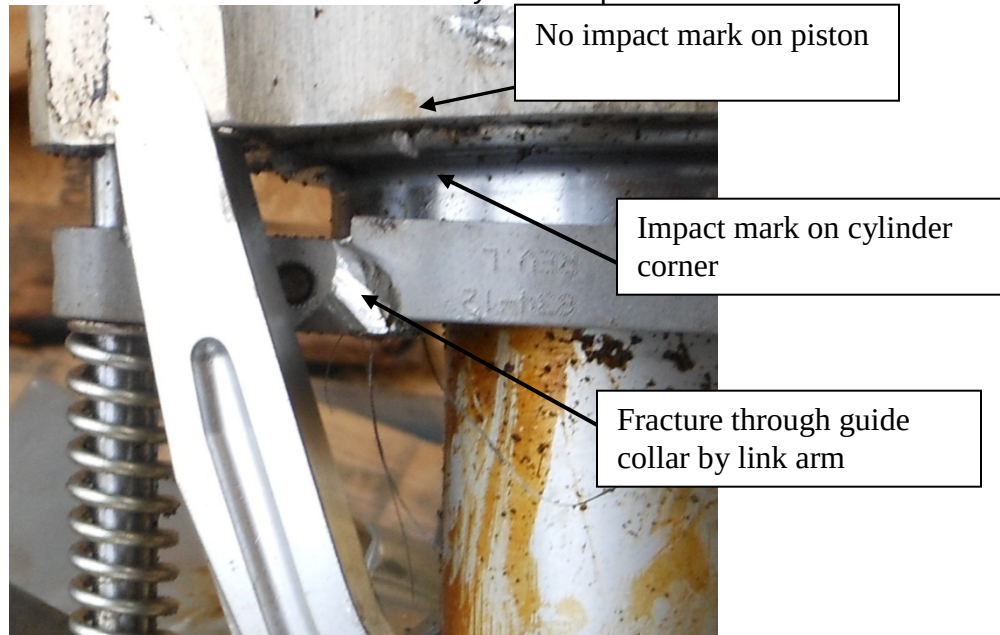
Photo #5 – Beta Rod Fracture and Cylinder Impact Mark

There was an impact mark in the bottom corner of the cylinder adjacent to the #2 blade and corresponding to the location of the guide collar fracture but no corresponding impact mark on the piston. This impact mark on the cylinder could only have been made prior to cylinder separation (with the piston extended in a low blade angle position) without marking the piston in the same location (see Photos #5 and #6). This damage is consistent with the counterweight impact marks on the side of the piston made prior to cylinder separation.

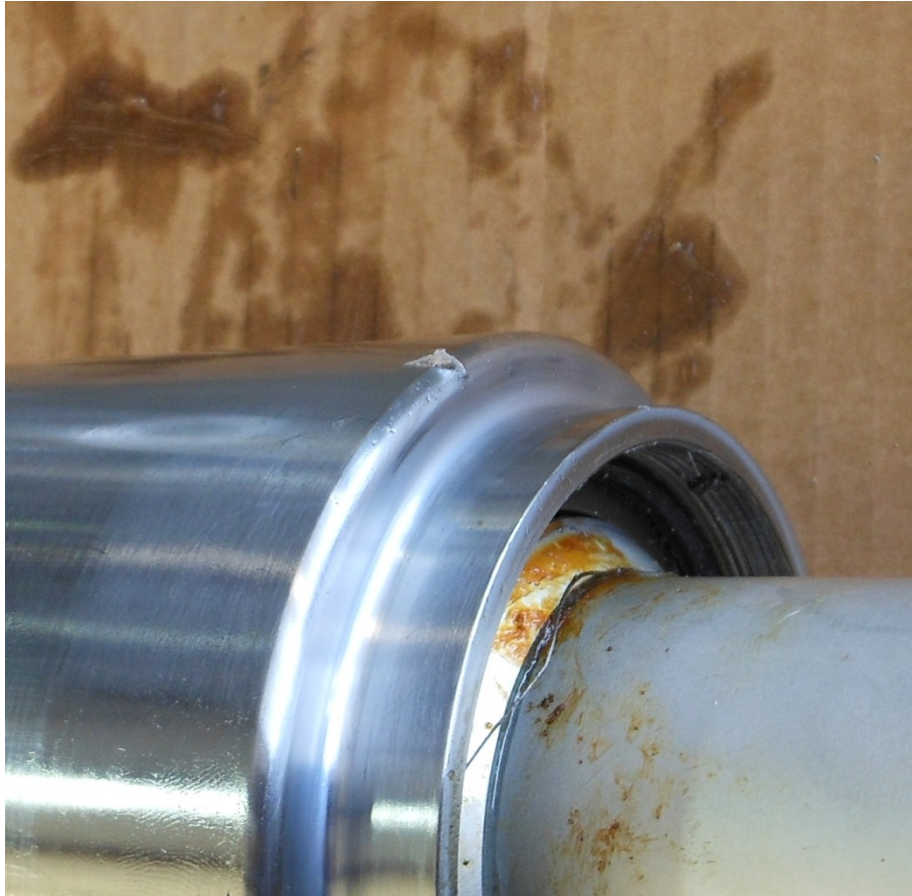
Photo #6 – Cylinder As-Removed

**Cylinder:** The cylinder was forced off the hub mounting threads during repeated blade ground strikes. The threads on the cylinder were damaged with some thread whiskers visible on the cylinder and hub (visible in Photo #6 and Photo #9).

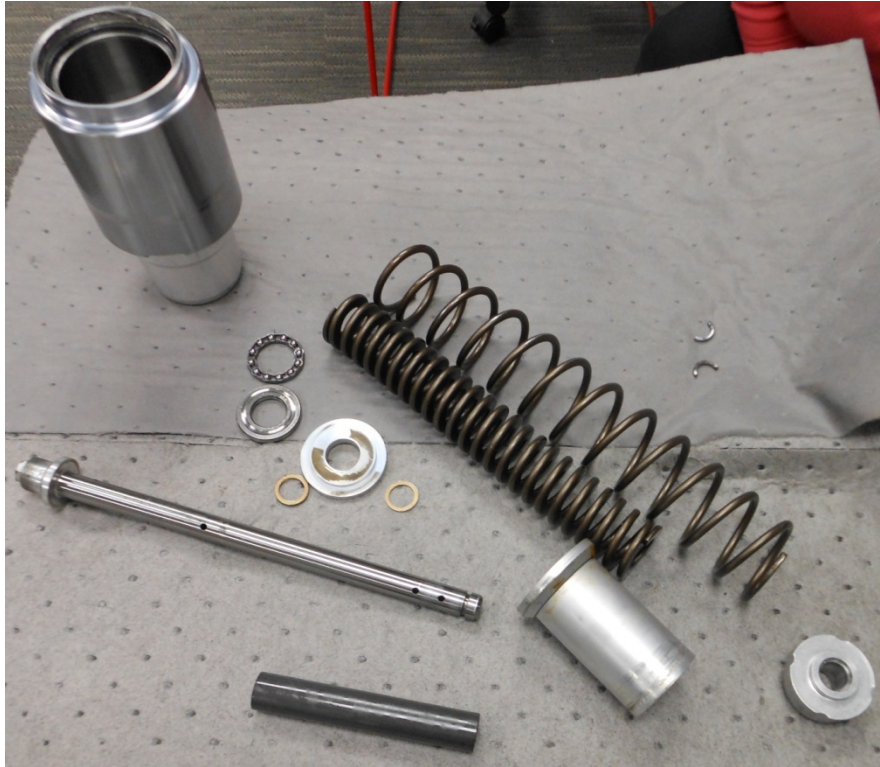
**Photo #7 – Cylinder Assembly Components**

**Feathering Spring Assembly:** The feathering spring assembly was intact and captive on the pitch change rod in the as-received condition. The outer spring support sleeve had annular impact marks where it contacted the hub center bore after the cylinder assembly separated. The feathering spring was removed during the cylinder inspection at Hartzell Propeller on October 5, 2015 (see Photo #7). The aft spring seat had visible indentations from the split keeper gaps indicating a high axial load in the forward direction (see Photo #8)

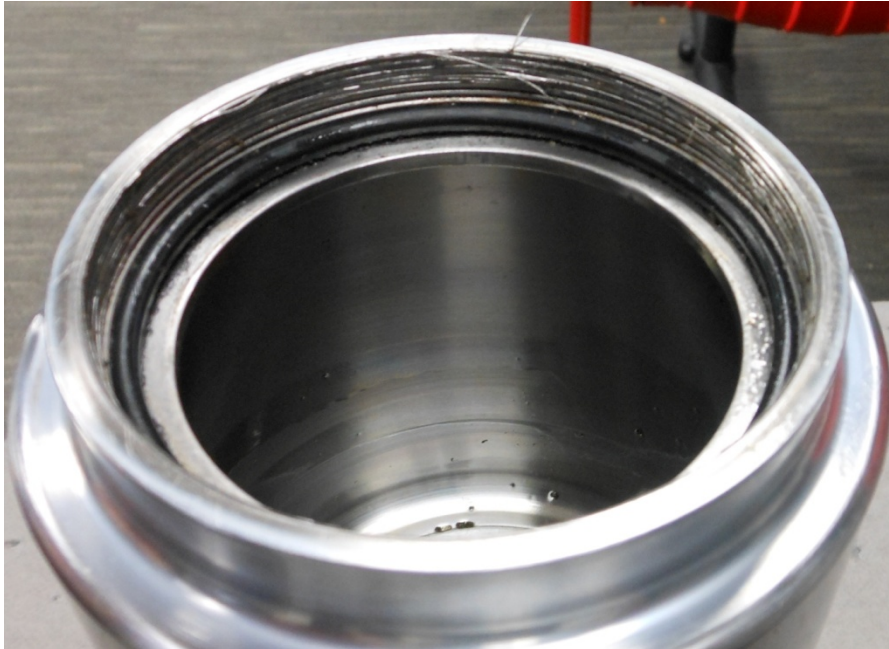
Photo #9 – Cylinder Attachment Threads

**Cylinder attachment:** The cylinder was forced off its hub mounting threads but the hub-side threads appeared undamaged (hub is heat treated, cylinder is not heat treated).

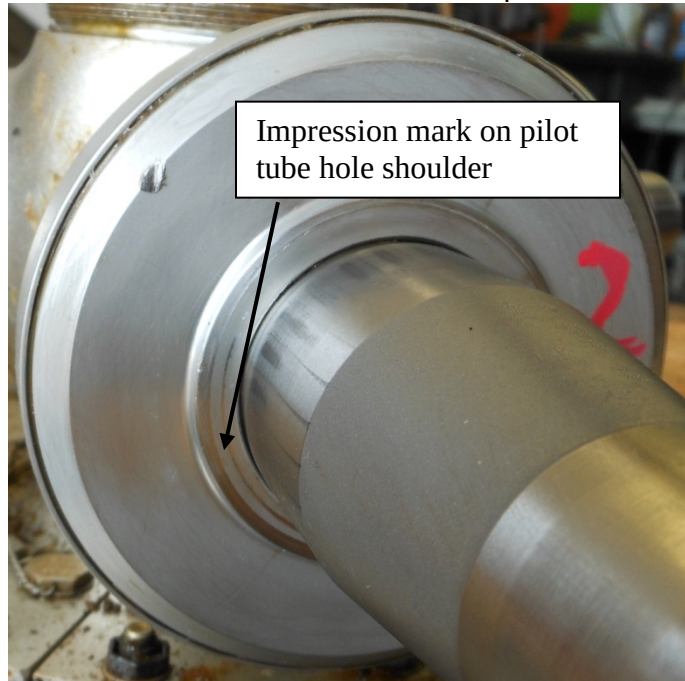
**Photo #10 – Blade Arm/Blade Butt Impression Mark**

**Impression marks from blade butts:** There were discernible blade butt impression marks on all three blade arm/pilot tube shoulders made by the blade material surrounding the pilot bore bearing. These marks were consistent with the deformation on the individual blade butts. These impression marks were in the

aft/trailing edge quadrant indicating both rotation and forward aircraft speed (see Photo #10). There were also visible pilot tube bearing marks on the pilot tube.

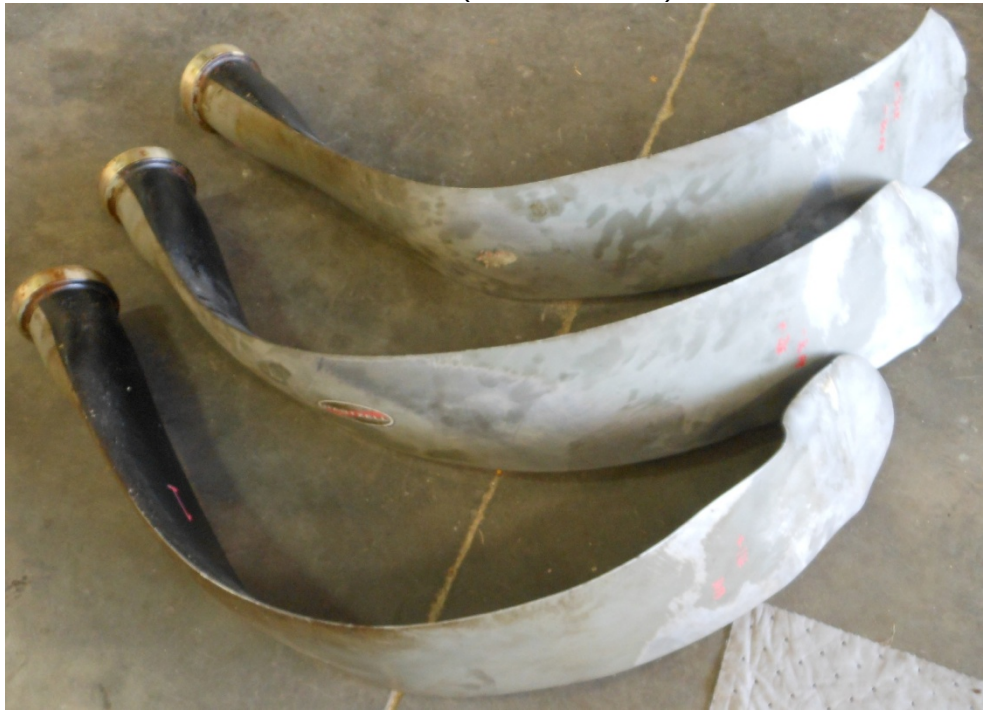
**Photo #9 (Camber Side)**

- Paint, camber side - Chordwise and spanwise scoring from 30" radius to tip.
- Paint, flat side - Normal wear and abrasion.
- Bend - Bending aft starting at approximately 12" from butt.
- Twist - Leading edge towards low pitch.
- Lead edge damage - Local leading edge deformation curled down ~8-12" from tip.
- Trail edge damage - Local deformation/waviness ~8-12" from tip.
- Butt impression - Pilot tube shoulder impression centered ~aft/trail quadrant.

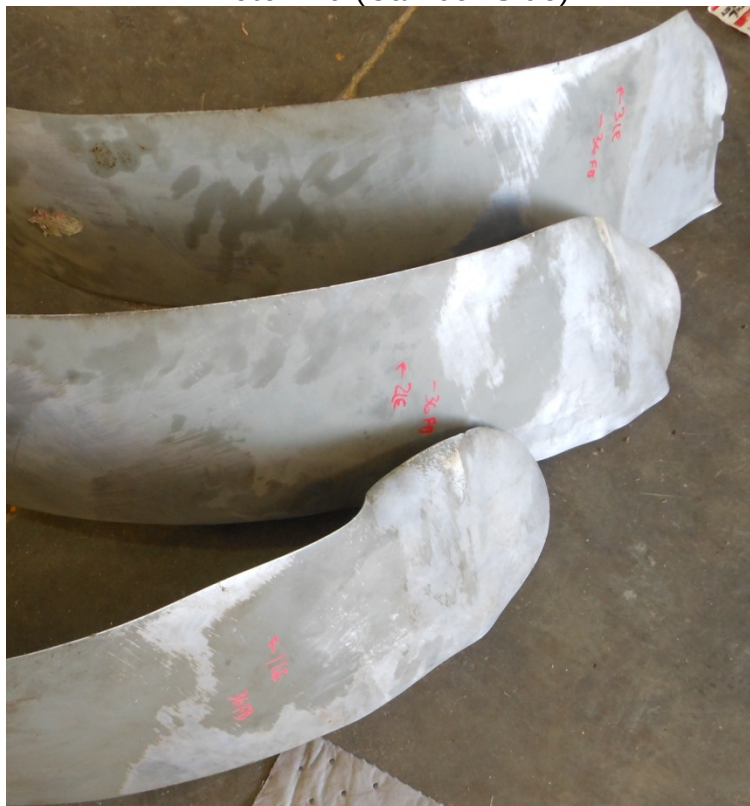
**Photo #10 (Camber Side)**

- Paint, camber side - Chordwise and spanwise scoring from 18" radius to tip.
- Paint, flat side - Some chordwise paint scuffs otherwise normal wear and abrasion.
- Bend - Bending aft starting at approximately 12" from butt.
- Twist - Leading edge towards low pitch.
- Lead edge damage - Local leading edge waviness last 6" to tip.
- Trail edge damage - Local trailing edge waviness last 6" to tip.
- Butt impression - Pilot tube shoulder impression centered ~aft/trail quadrant

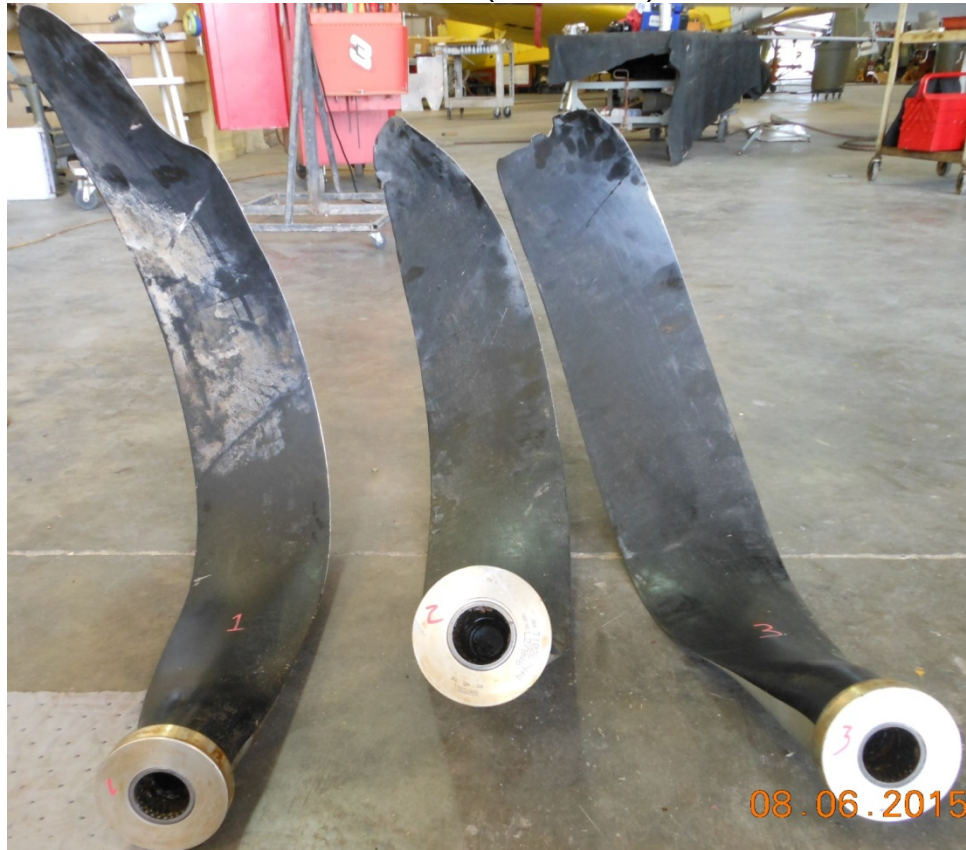
**Photo #11 (Face Side)**

- Paint, camber side - Chordwise and spanwise scoring from 18" radius to tip.
- Paint, flat side - Some chordwise paint scuffs otherwise normal wear and abrasion.
- Bend - Bending aft starting at approximately 12" from butt.
- Twist - Leading edge towards low pitch.
- Lead edge damage - Last 4-6" of tip fractured.
- Trail edge damage - Local deformation/waviness ~8-12" from tip.
- Butt impression - Pilot tube shoulder impression centered ~aft/trail quadrant
