# OPERATIONS REPORT

# Aircraft Alert Form

Wilmington  
International Airport

| Aircraft Type (Make & Model): | Beech Craft 35-C33 | Tail #: N829T |

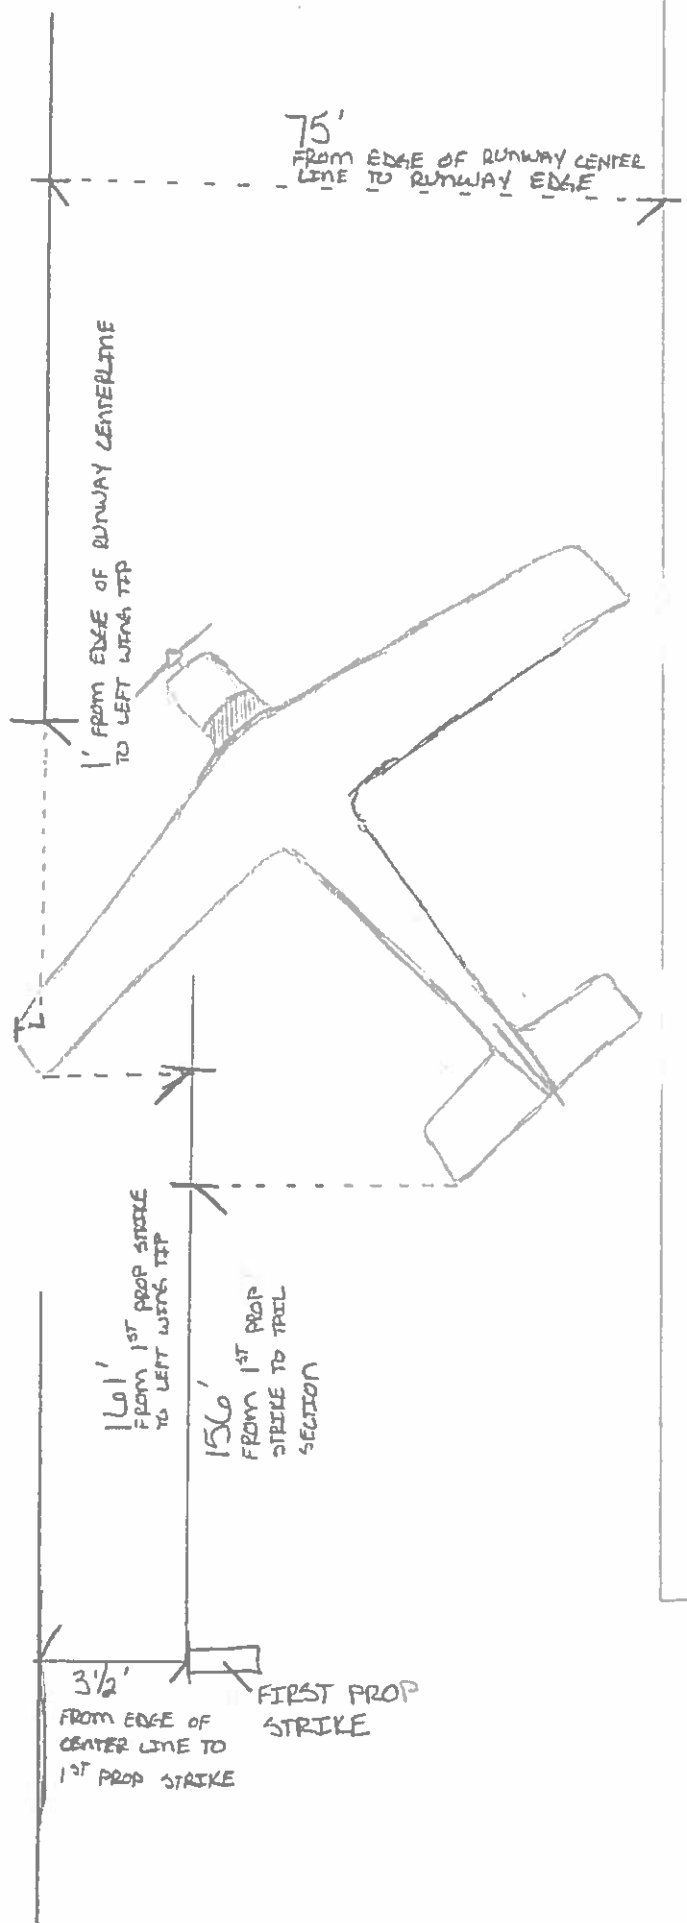
Diagram is  
NOT TO SCALE

Upon R-18's arrival at 10:33, found the Beechcraft 35-C33 nose gear up and lying on the nose of the aircraft. The main landing gear was approximately 50% down (pictures attached). The pilot was out of the aircraft and did not appear to be injured at this time. No fluids were leaking from the aircraft and no other hazards were noted. R-18 assumed Incident Command. ILM PSO Dispatch notified New Hanover County 911 Center at approximately 10:32 of the Alert 3. After Engineer/Paramedic DiMauro made contact with the pilot and confirmed that he was not injured and did not need medical attention, Engineer/Paramedic DiMauro notified New Hanover County 911 Center by radio to cancel all mutual aid units enroute to the airport. At 10:39, PSO Chief Taylor was notified by PSO Dispatcher Keel of the situation and advised that he will be enroute to the airport shortly. After speaking with Chief Taylor by phone, Specialist Smith notified PSO Dispatch to contact ACE Wrecker Service, located at 2012 Castle Hayne Road, Wilmington, NC 28401 of the situation and will be in need of their assistance. ACE Wrecker Service's phone number is 1-800-835-4245.

Diagram attached. Diagram is not to scale.
