**NATIONAL TRANSPORTATION SAFETY BOARD**

Office of Aviation Safety  
Eastern Region

**Wreckage Photo Array**

**ERA15LA273**

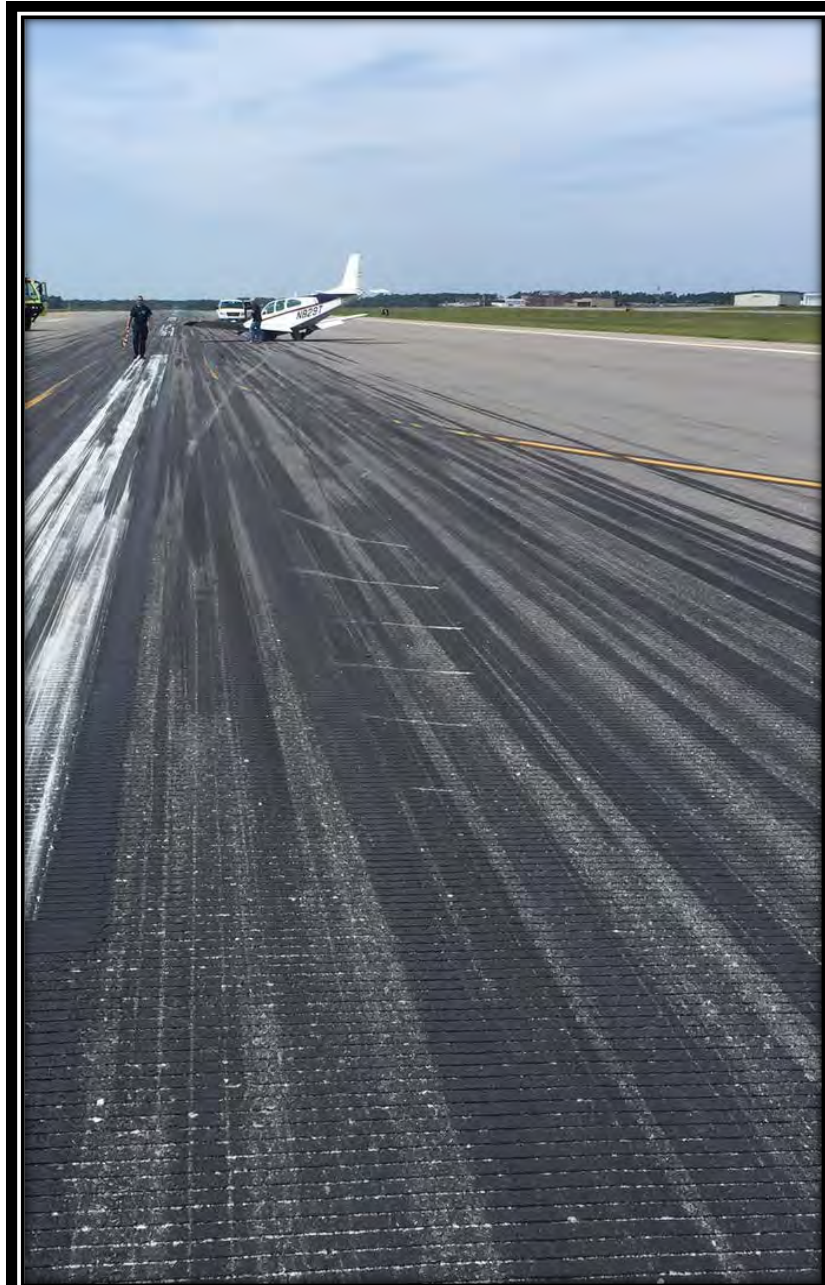
**Photo 1 – Runway Scars and Airplane (Photo Courtesy of FAA)**

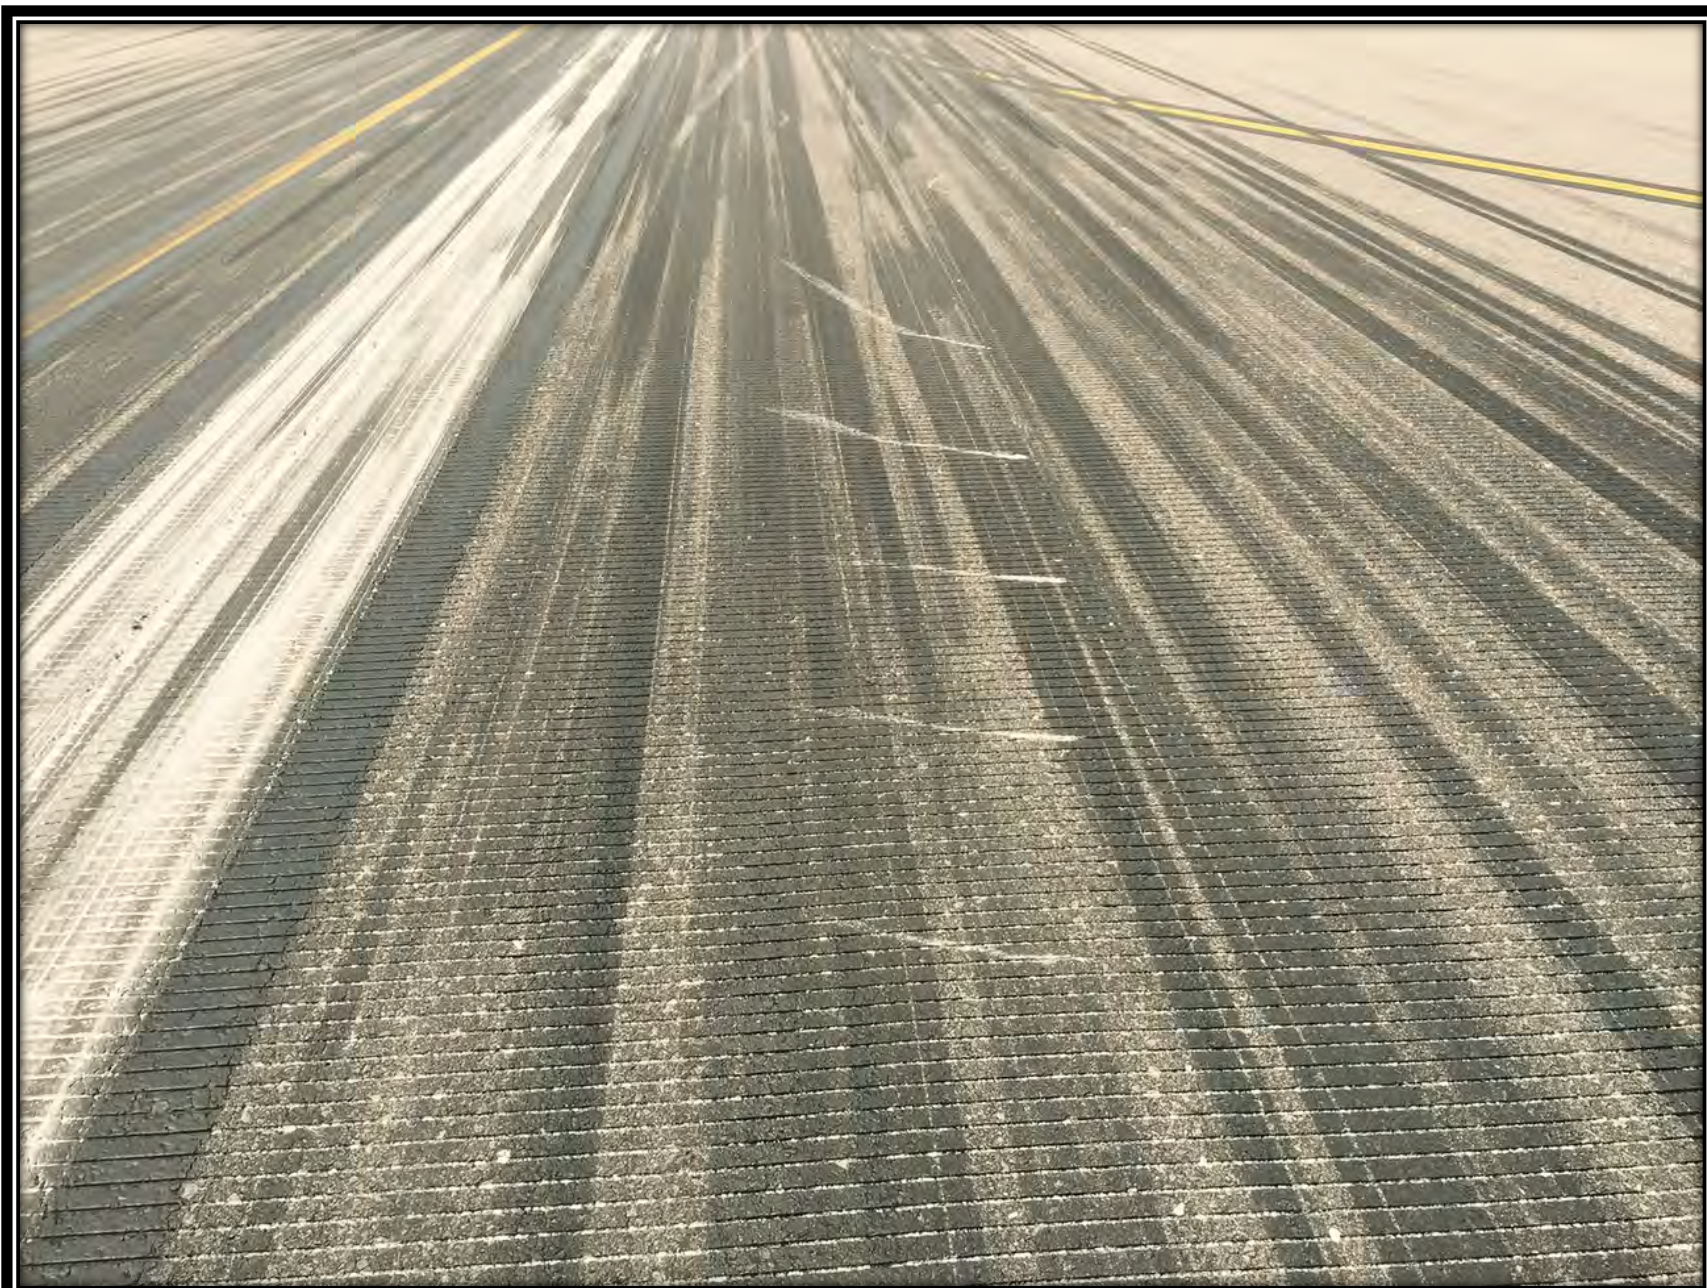
**Photo 2 – Close Up View of Runway Scars (Photo Courtesy of FAA)**

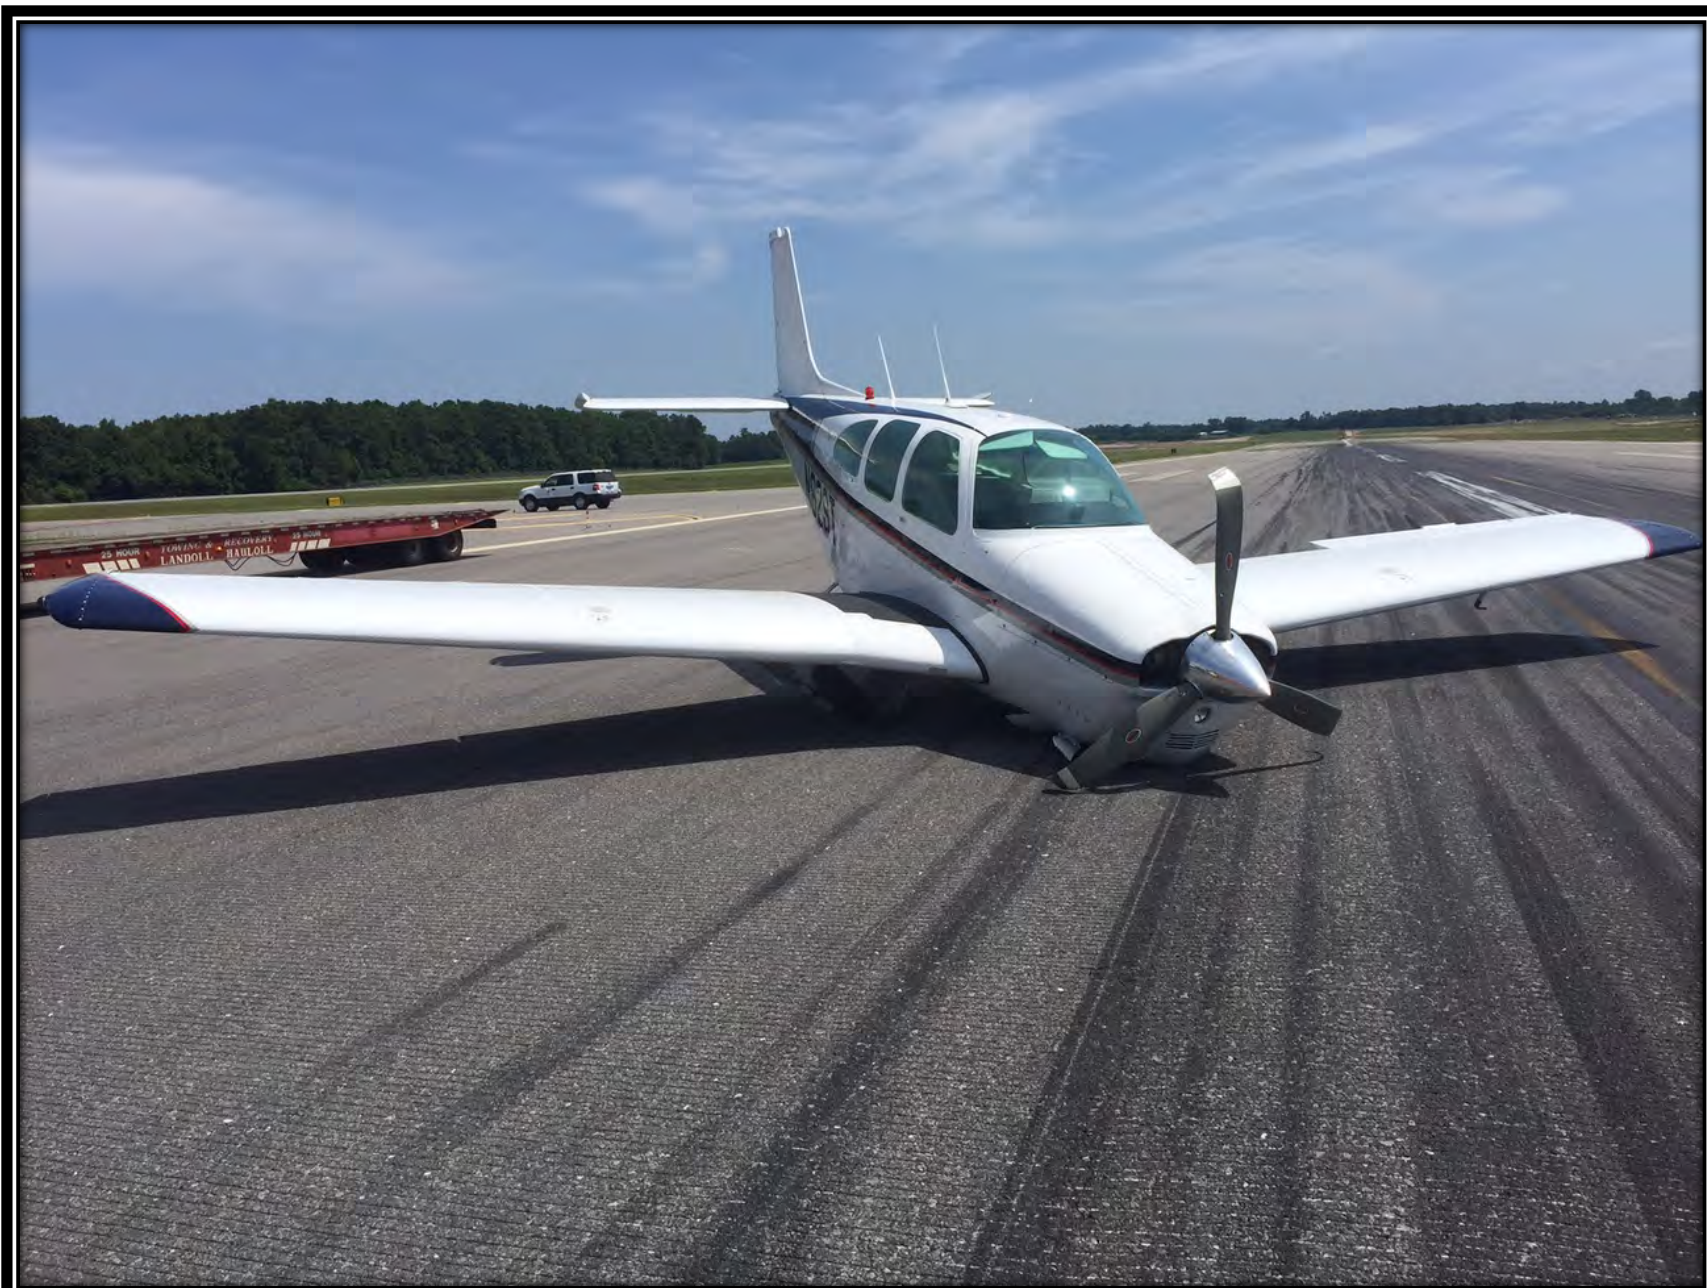
**Photo 3 – Airplane – View from Front (Photo Courtesy of FAA)**

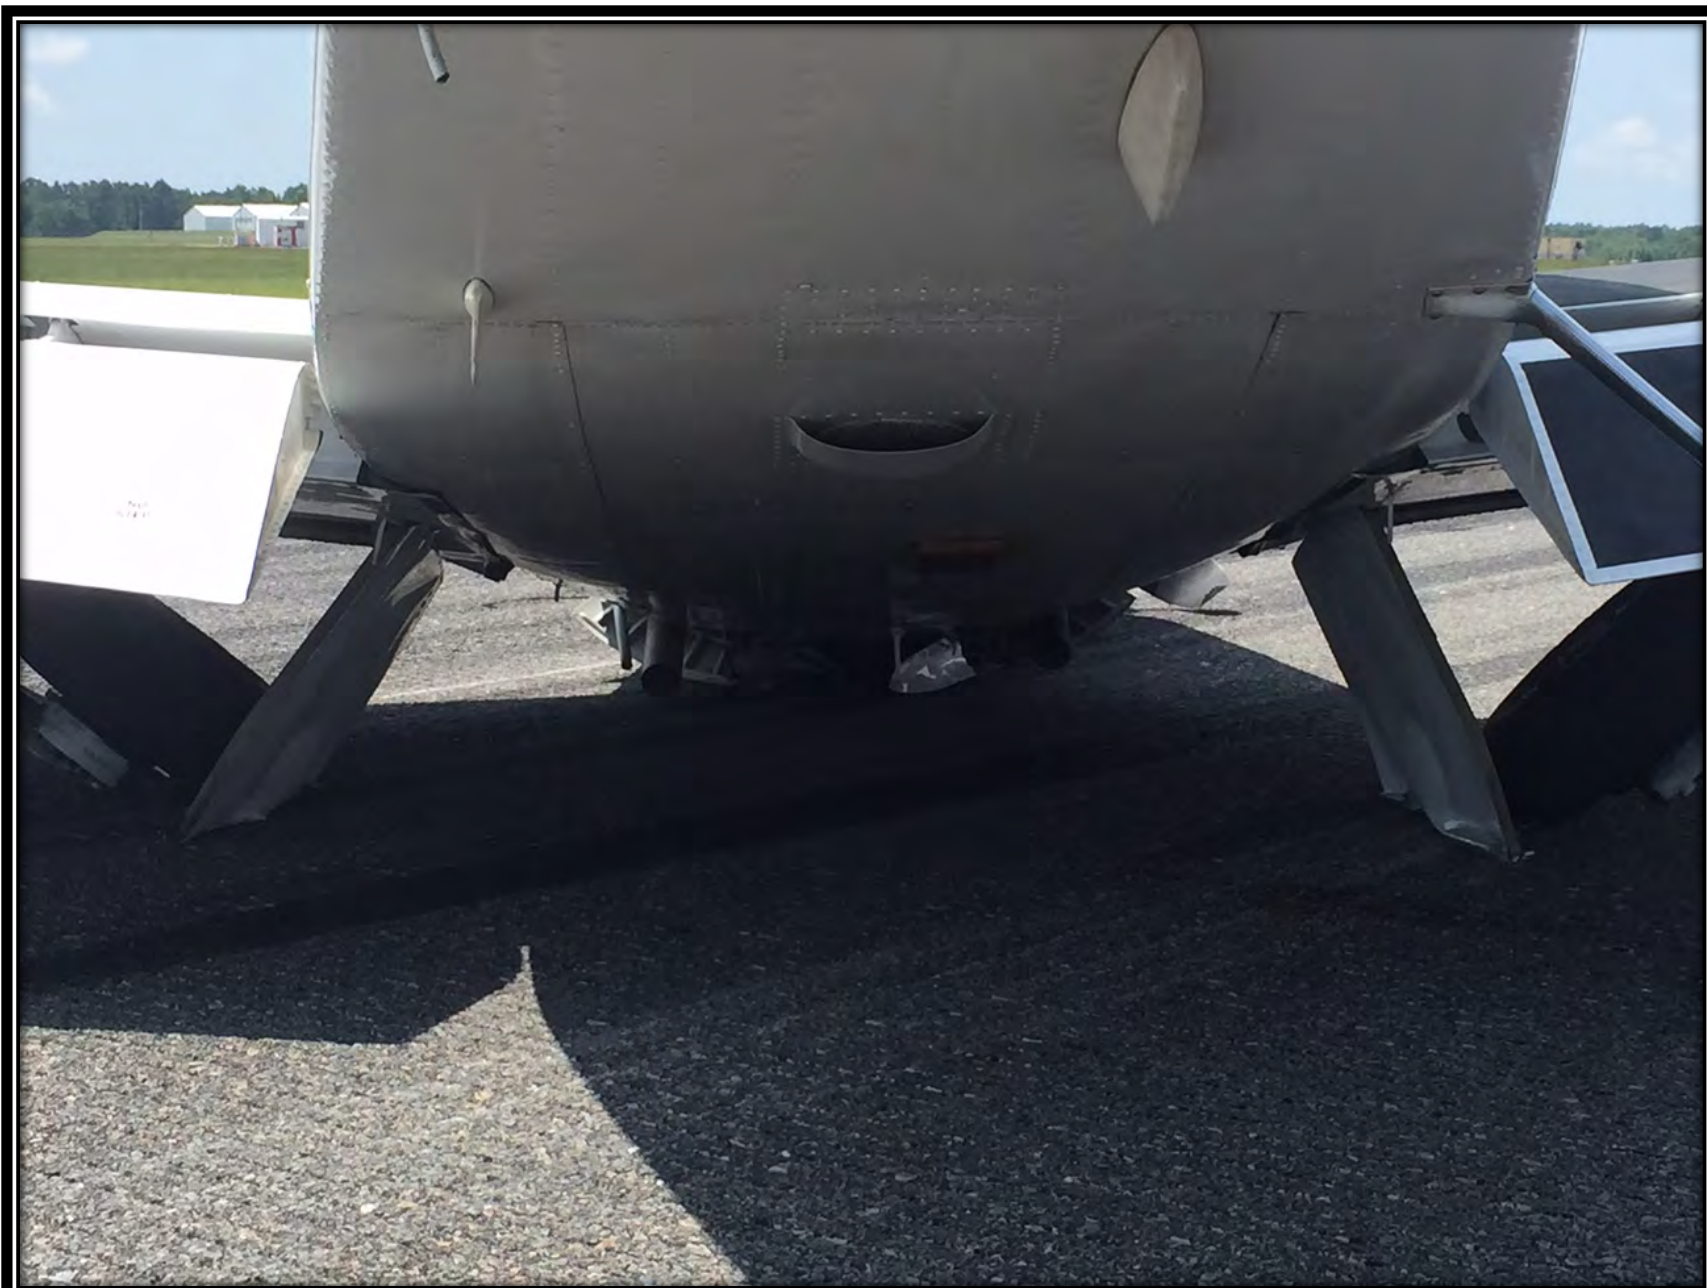
**Photo 4 – Airplane Belly and Main Landing Gear (Photo Courtesy of FAA)**

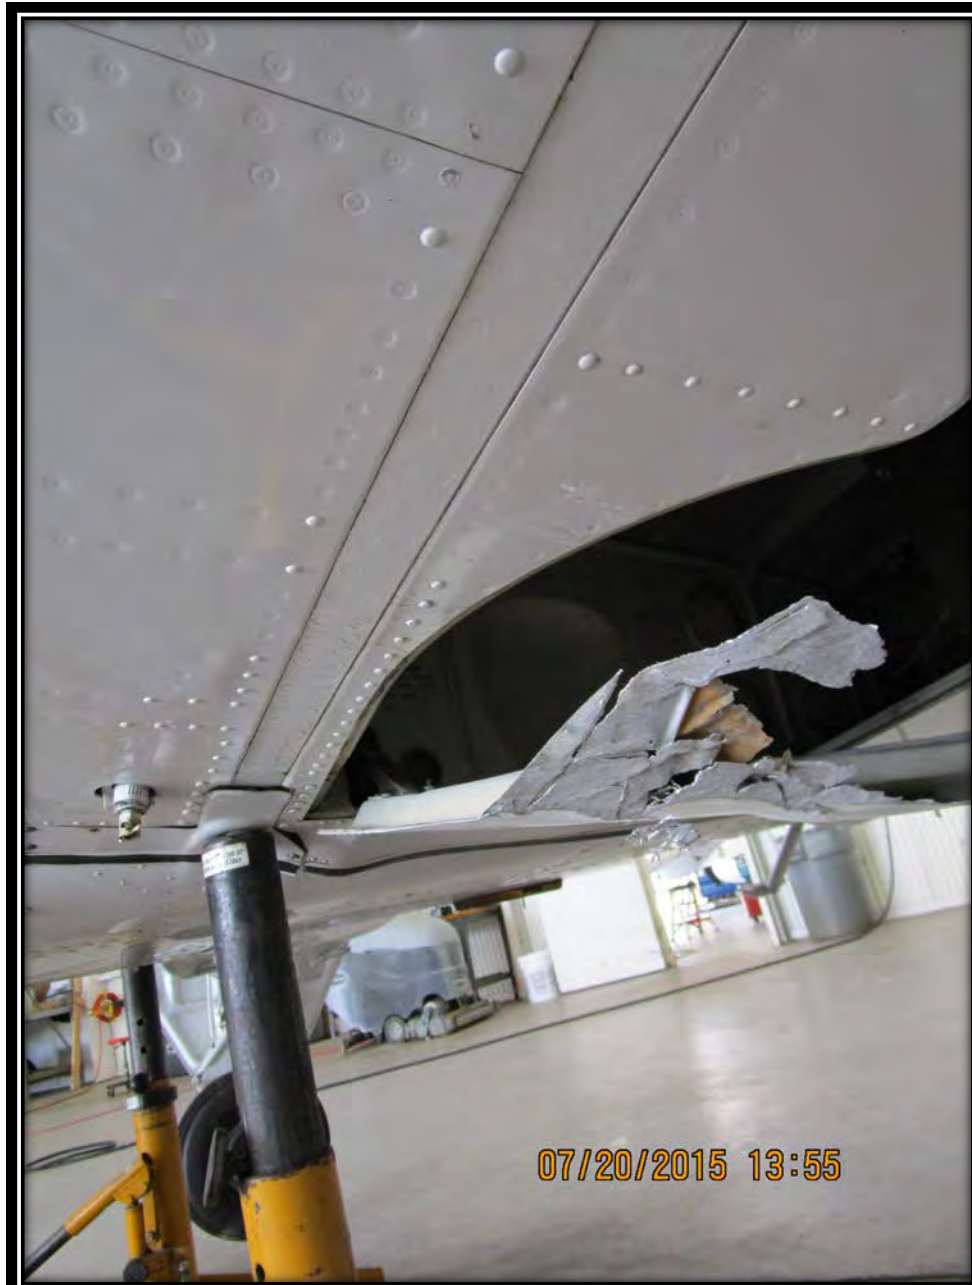
**Photo 5 – Left Inner Main Landing Gear Door (Photo Courtesy of FAA)**

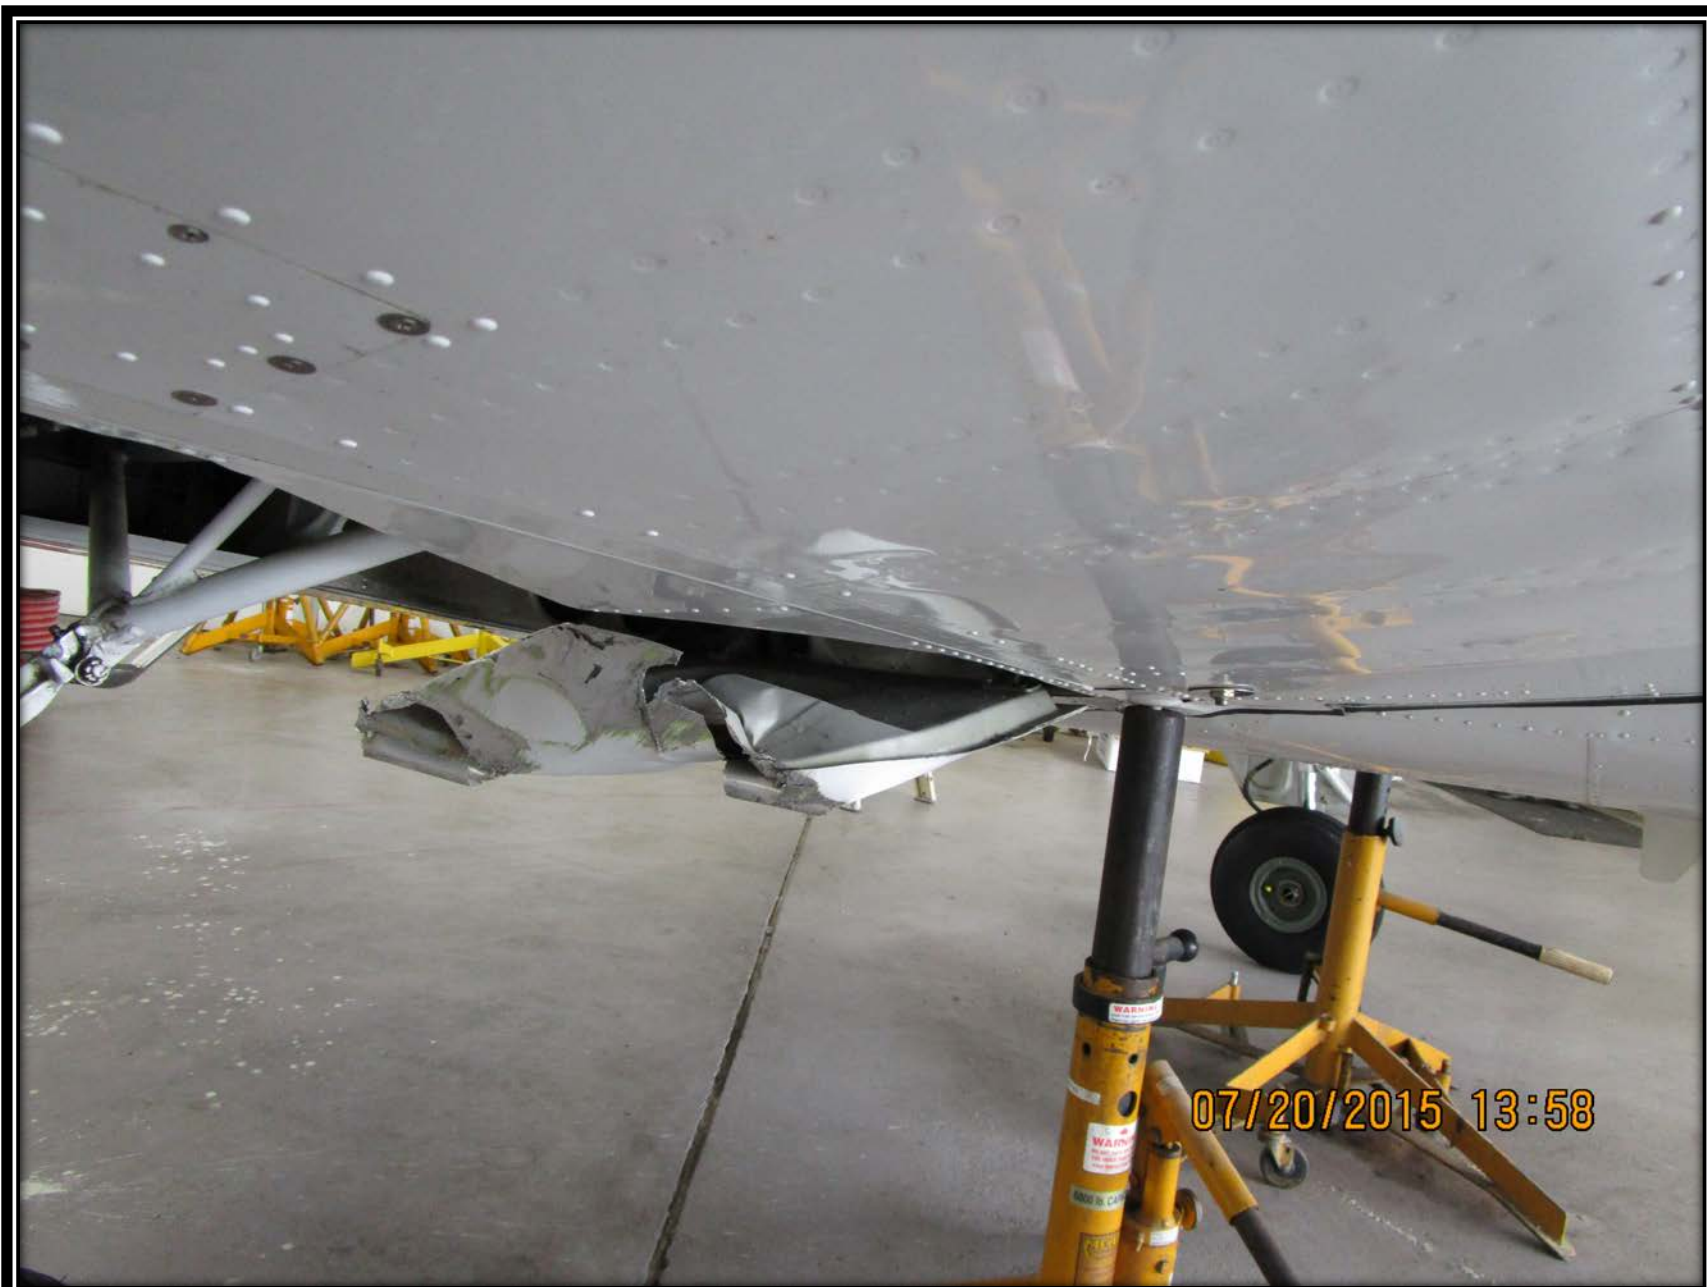
**Photo 6 – Right Inner Main Landing Gear Door (Photo Courtesy of FAA)**

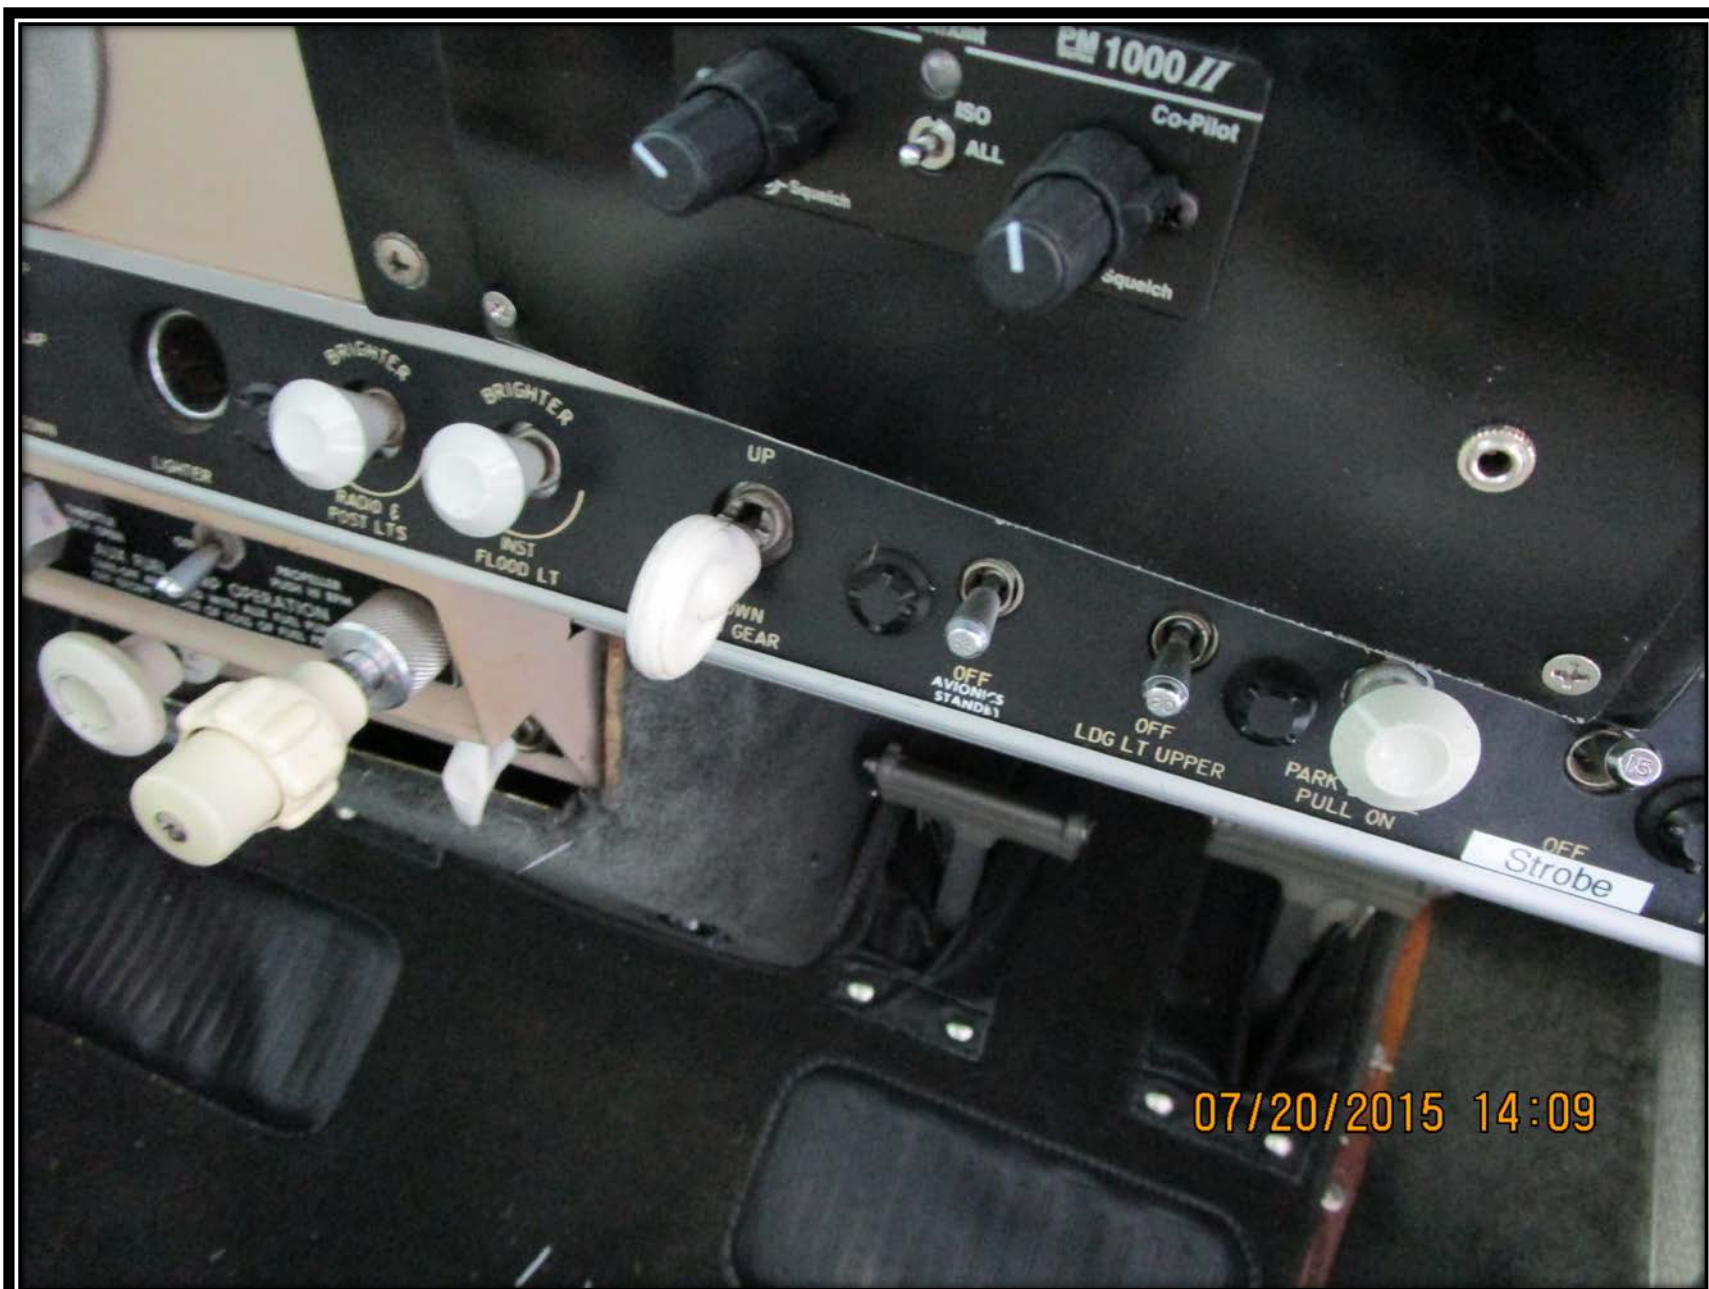
Photo 7 – Cockpit Gear Lever (Photo Courtesy of FAA)

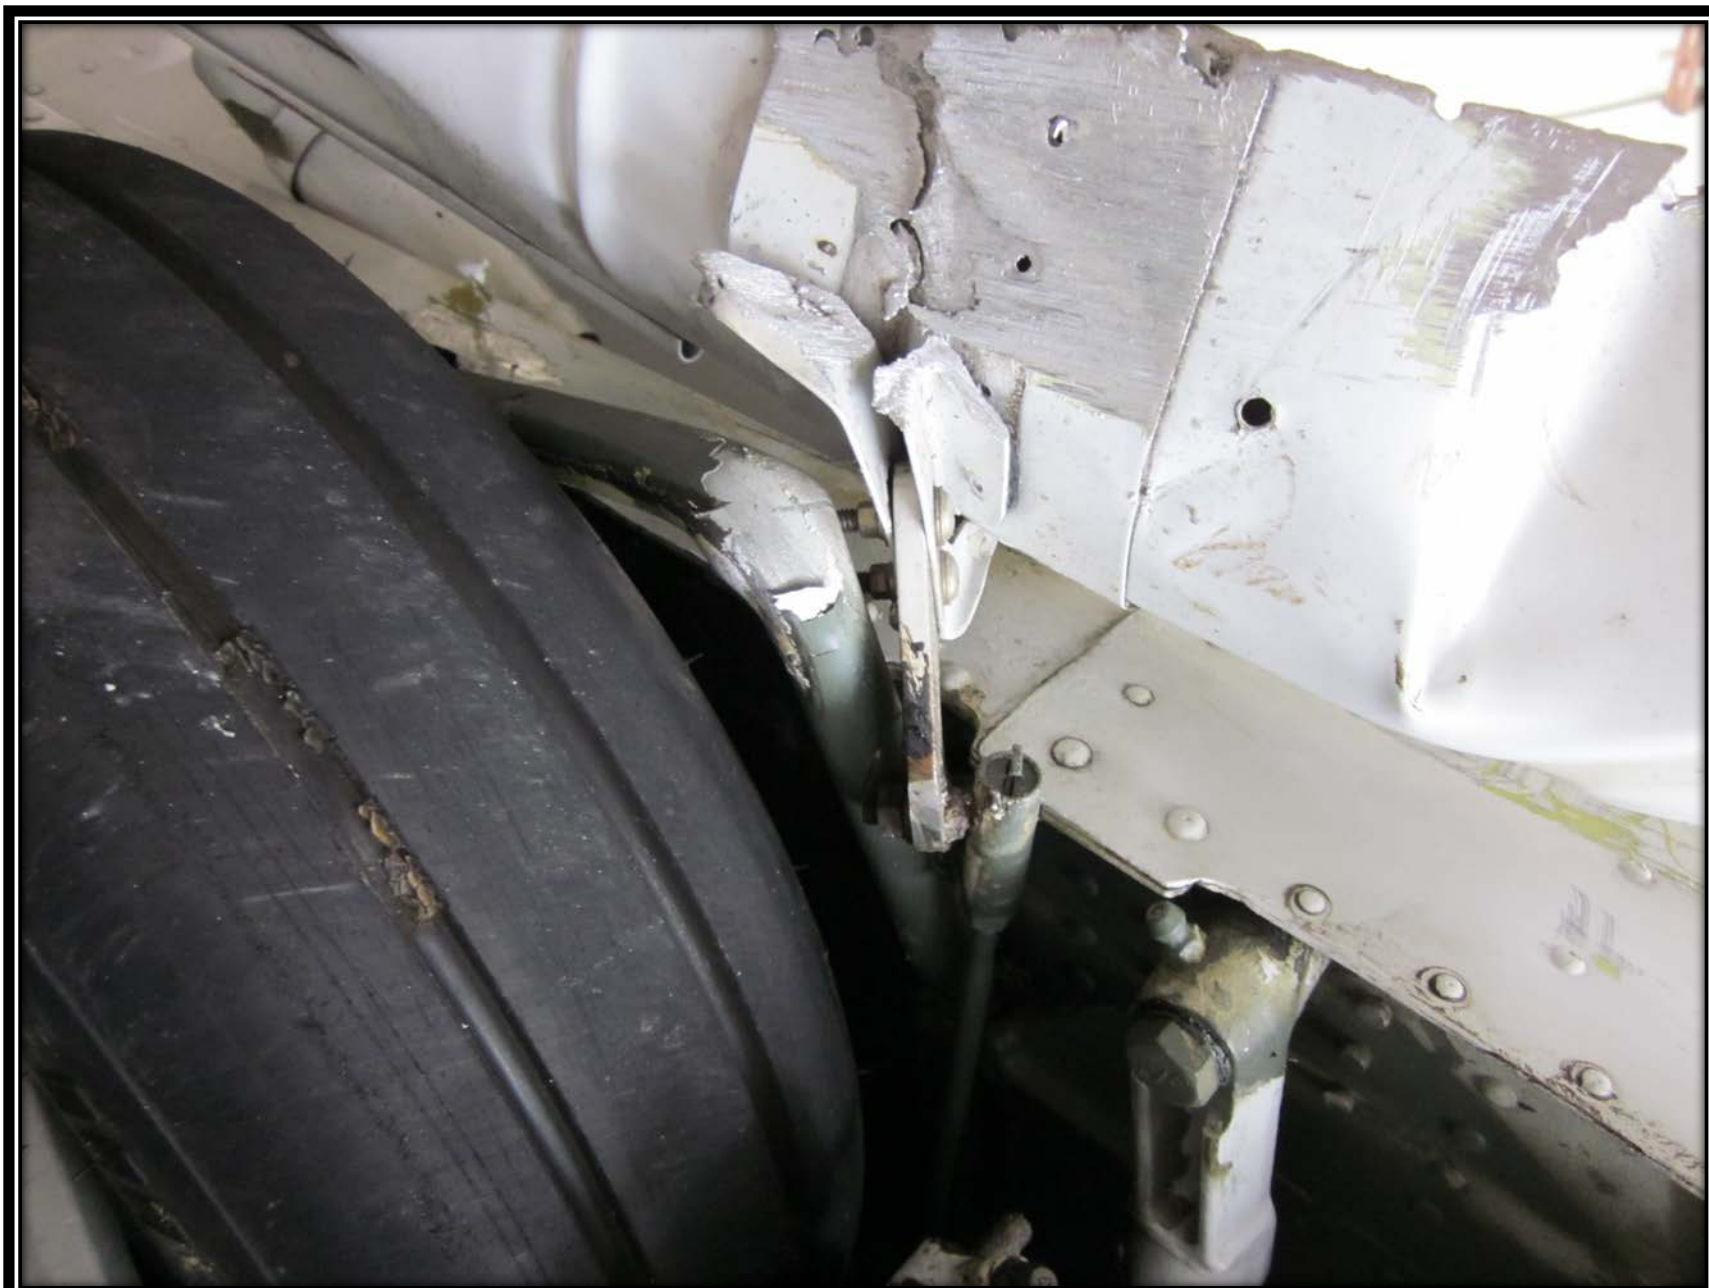
**Photo 8 – Nose Gear Damage (Photo Courtesy of FAA)**
