# NATIONAL TRANSPORTATION SAFETY BOARD

## MATERIALS LABORATORY FACTUAL REPORT

Report No. 16-028

Place : Fort Lauderdale, Florida  
Date : July 23, 2015  
Vehicle : Piper PA-28R-180, N4631J  
NTSB No. : ERA15LA289  
Investigator : Timothy W. Monville, AS-ERA

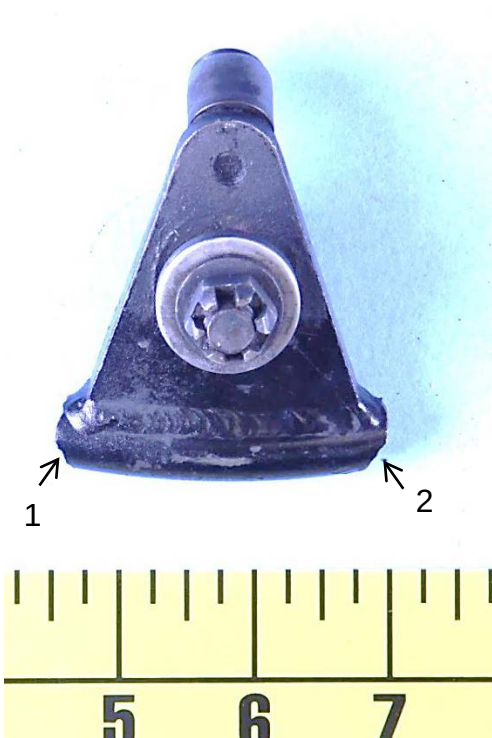
Figure 1 shows a photograph of the as-received left main landing gear assembly. The assembly fractured at the two locations indicated by arrows "1" and "2". Bench binocular microscope examination of the engine mount revealed fracture face arrowed "1" contained a fatigue crack indicated by bracket "01" in figure 2 that emanated from the outer surface and fracture face arrowed "2" contained two fatigue cracks indicated by brackets "02" and "03" in figure 3 that emanated from the outer surface. Each fatigue crack emanated from multiple origins on the outer face of the tube portion in areas indicated by brackets "01", "02" and "03" in figures 2 and 3. Each fatigue crack exhibited crack arrest marks and propagated through the wall of the tube portion. The fatigue cracks terminated in the areas indicated by dashed lines in figures 2 and 3. The areas outside of the fatigue crack regions were on a slant plane and contained rough texture features consistent with overstress separation.

Figure 1. Photograph of the as-received engine mount that fractured at two areas indicated by arrows "1" and "2".

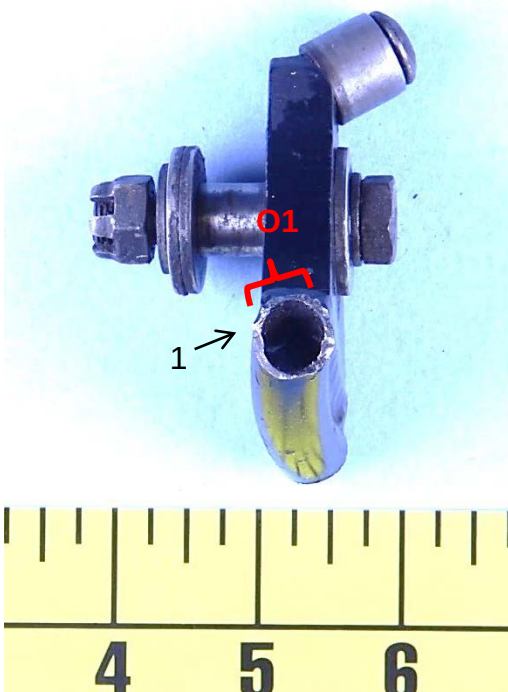
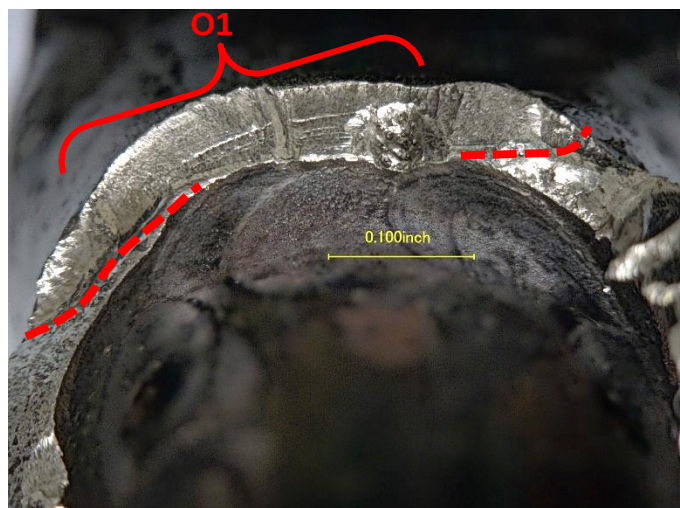
Figure 2. Photograph of fracture face arrowed "1" in figure 1 (left) and close-up photograph of the fatigue crack origin area indicated by bracket "O1" (right).

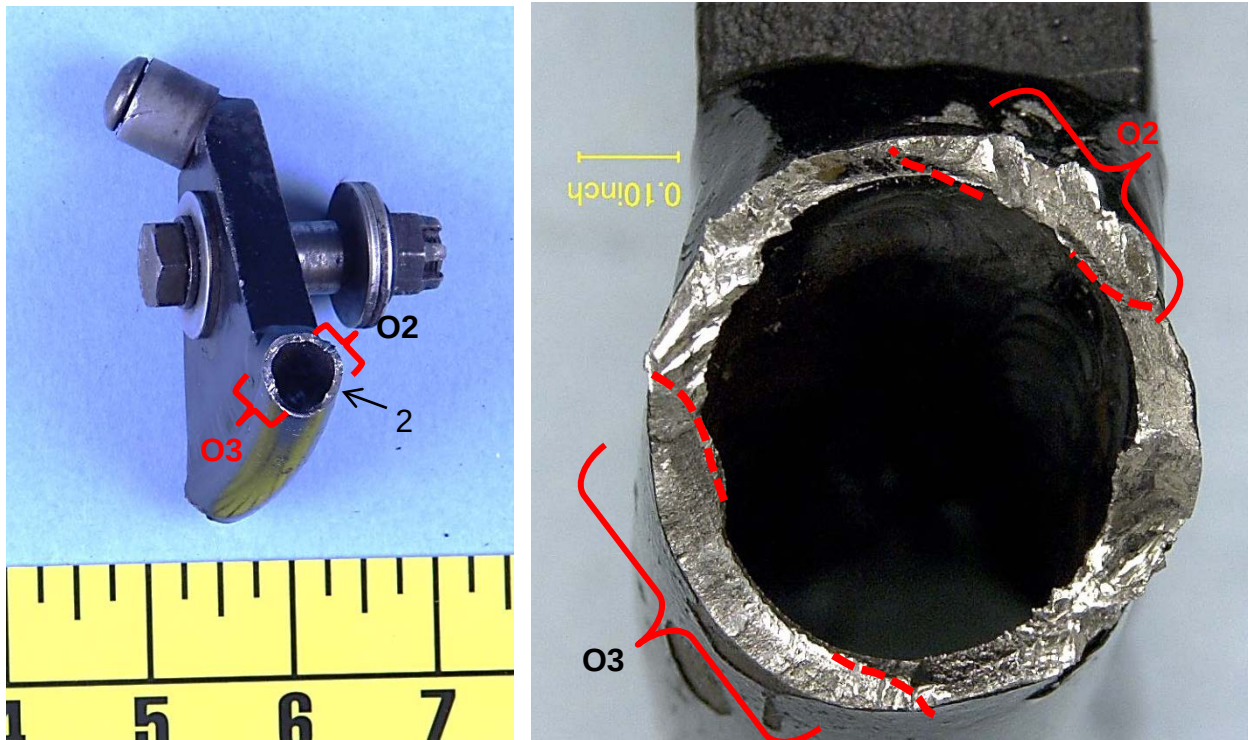
Figure 3. Photograph of fracture face arrowed "2" in figure 1 (left) and close-up photograph of the fatigue crack origin areas indicated by bracket "O2" and O3" (right).

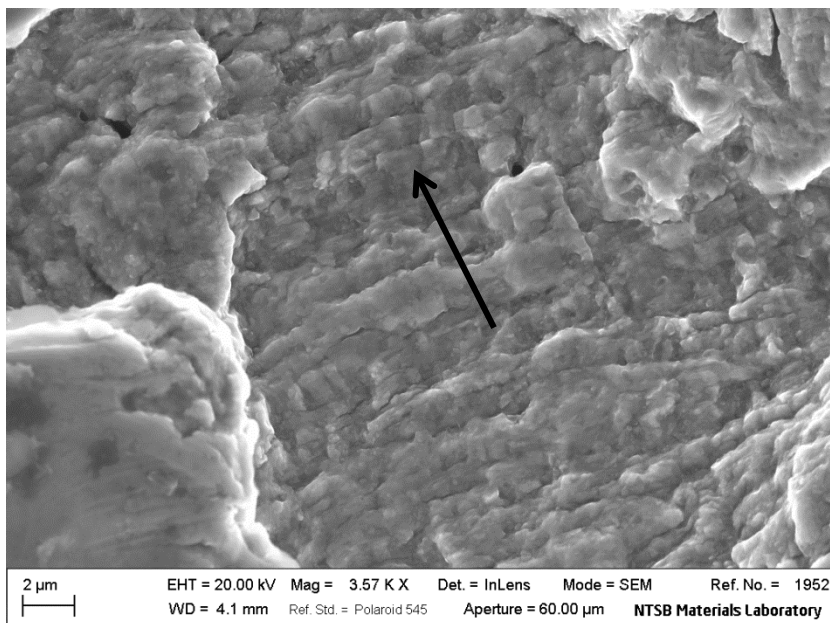
Scanning electron microscope examination of fracture faces "01" and "02" revealed a large portion of the fine fracture features in the fatigue regions were obliterated by mechanical damage as a result of relative movement between mating fracture faces. Figure 4 shows an isolated area in fatigue region "01" that contained fatigue striations. The areas located outside of the fatigue regions contained dimple features consistent with overstress separation.

Figure 4. Scanning electron microscope image of fracture face "1" in the area of fatigue origin "O1" in figure 2 showing fatigue striations. Fatigue propagation was in the general direction indicated by an arrow.
