**ERA15LA293**  
**Georgetown, Kentucky**  
**August 1, 2015**  
**~ 2100 EDT**  
**Beech King Air C90B, N257CQ**  
**NTSB EXAMINATION REPORT**  
**47 Embedded Photographs**

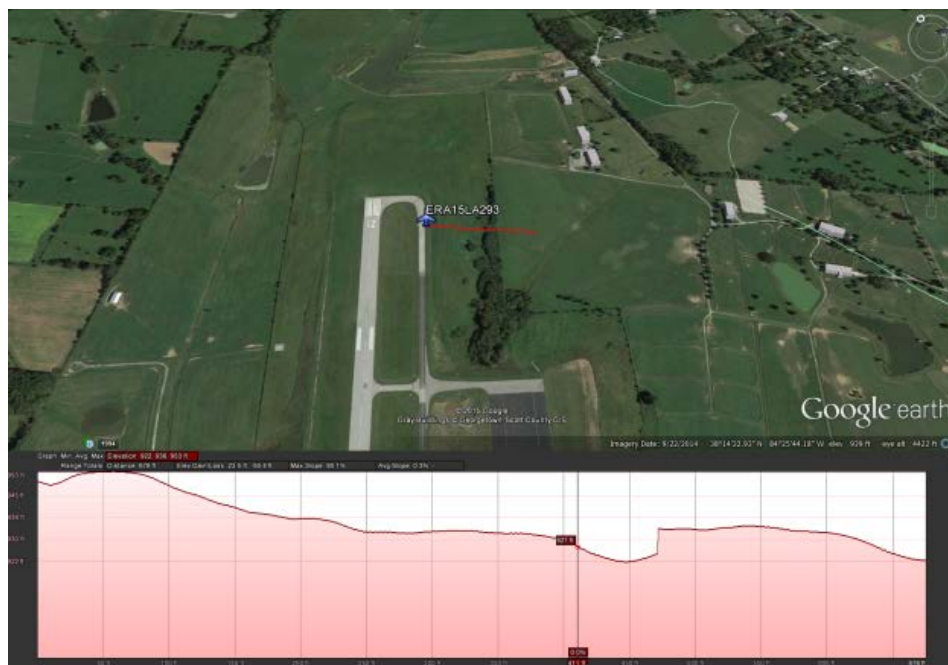
Photo 1: Google Earth with Approximate flight Path Overlay and Terrain Feature

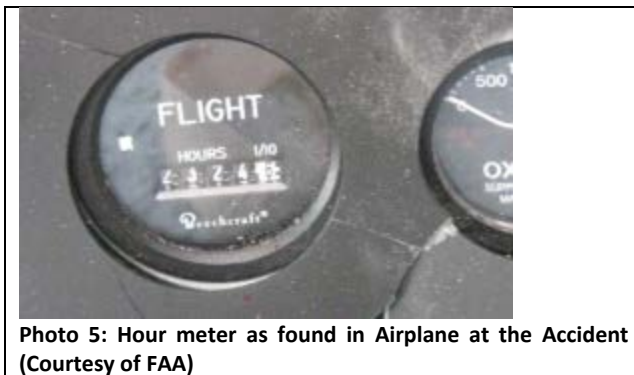
Photo 5: Hour meter as found in Airplane at the Accident  
(Courtesy of FAA)

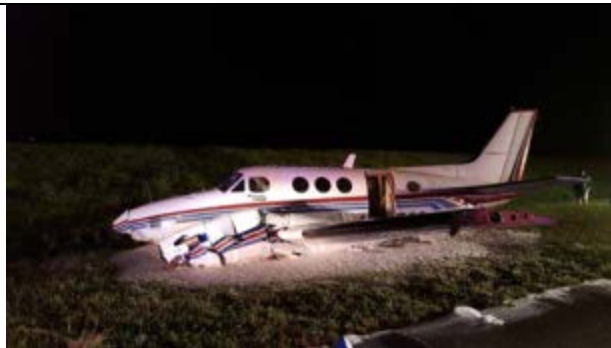
Photo 6: Airplane at Rest - Night of Accident (Courtesy of Local Authorities)

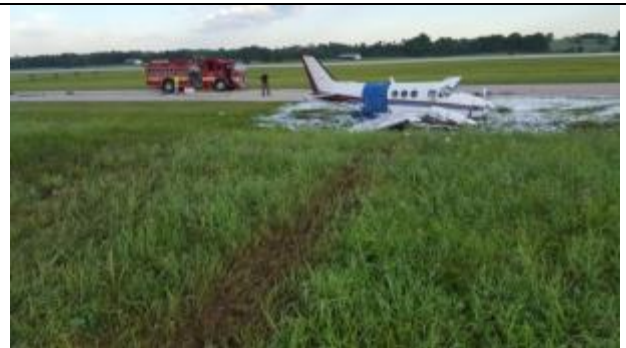
Photo 7: Right Side of Airplane at Rest - Morning after Accident (Courtesy of Local Authorities)

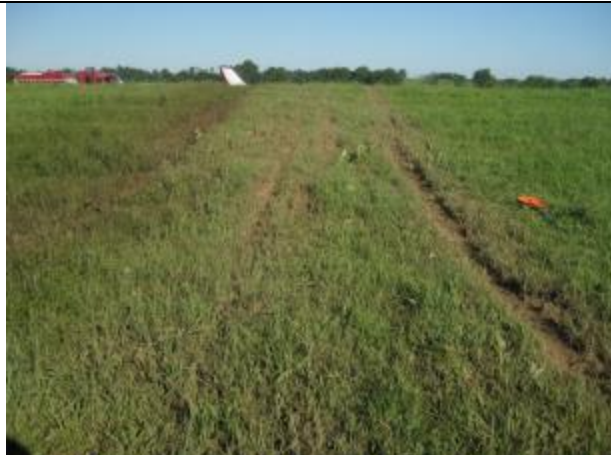
According to a FAA inspector, the airplane impacted the ground in a right-wing low attitude. The airplane slid about 174 feet, impacted an embankment, became airborne, and then came to rest on airport property, about 238 feet from the initial impact location. According to FAA and local police photographs, the airplane came to rest upright, on the belly of the aircraft, parallel to an airport taxiway. The left engine propeller was found in the feathered position, separated from the engine flange, and was in the vicinity of the wreckage. All four propeller blades exhibited S-bending and chordwise scratching along the propeller face. The right engine propeller blade was in flat pitch; however, only one propeller blade was bent aft and no other damage was observed on the other three right engine propeller blades.

Photo 8: Ground Scars Up a Berm - Airplane Vertical Tail section in Background (Courtesy of FAA)

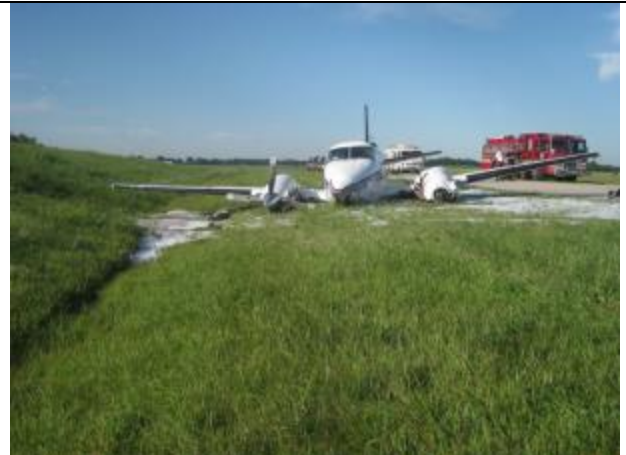
Photo 9: Front View of Airplane at Rest (Courtesy of FAA)

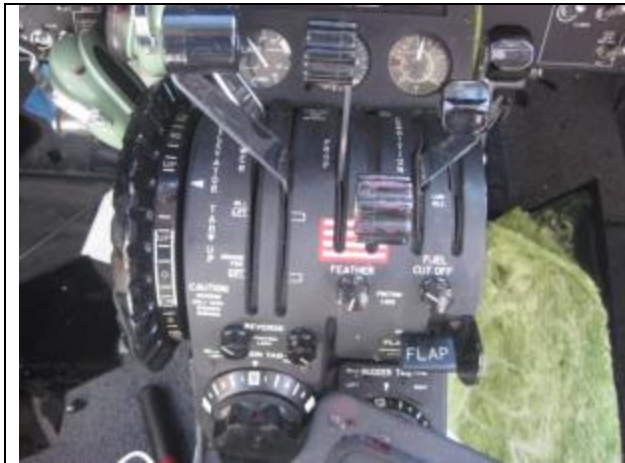
On-scene examination of the cockpit by an FAA inspector revealed that the left engine power lever was in the full forward position and the right engine power lever was approximately

mid-range. The left engine propeller lever was full forward and the right engine propeller lever was in the feather position. The condition lever for the left engine was near "low idle" and the right condition lever was in the forward position. Although the airplane was equipped with a cockpit voice recorder (CVR) the unit was deactivated and circuit breaker pulled and collard on April 5, 2007<sup>3</sup>. Both cockpit seats exhibited deformation towards the forward and left. The forward-facing left side seat in the cabin exhibited seat deformation to the forward and left direction. The aft facing seat on the right side exhibited deformation on the back-right side of the seat pan. Minimal webstretching was observed on the cockpit seatbelts and no webstretching was observed on the cabin seatbelts, also the shoulder harnesses for the cabin were stowed and exhibited no deformation and webstretching. The seats remained attached to the floor.

Photo 10: Power Lever Quadrant as Viewed on Scene (Courtesy of FAA)

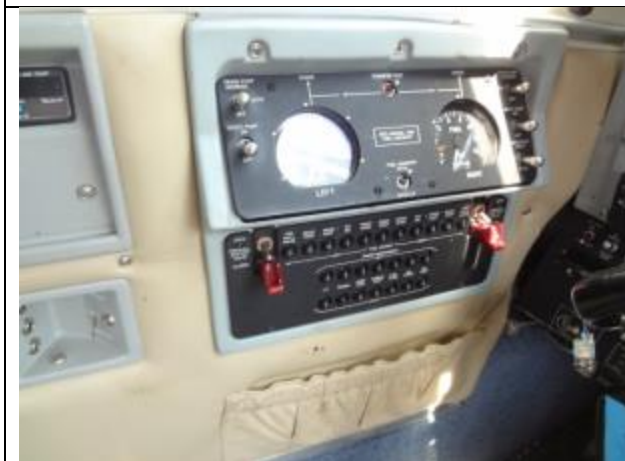
The left and right firewall shutoff valves were in an "OPEN" position. The fuel cross feed valve position was not determined.

Photo 12: Fuel Panel - Post Recovery

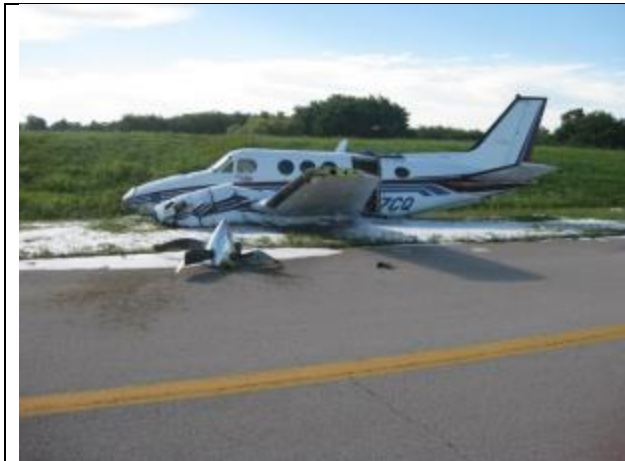
Photo 14: Left side of Airplane at Accident Location (Courtesy of FAA)

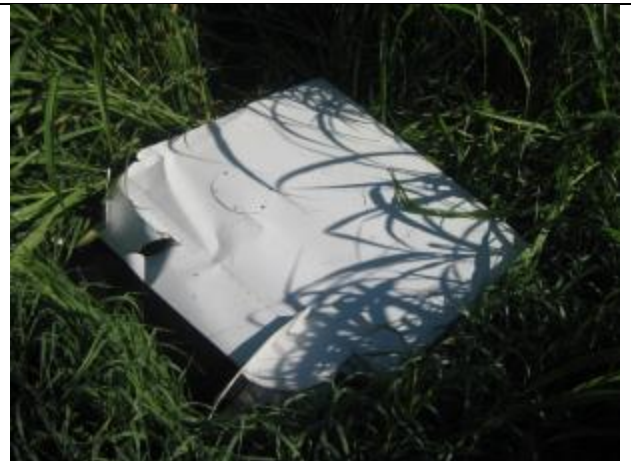
The outboard approximate 11 inches of the wing was impact separated and not recovered; however, the separation point exhibited impact damage. The fuel cap was secured and in place. The outboard flap actuator measurement was not able to be obtained; however, when the

Photo 15: Wingtip as Found along Debris Path (Courtesy of FAA)

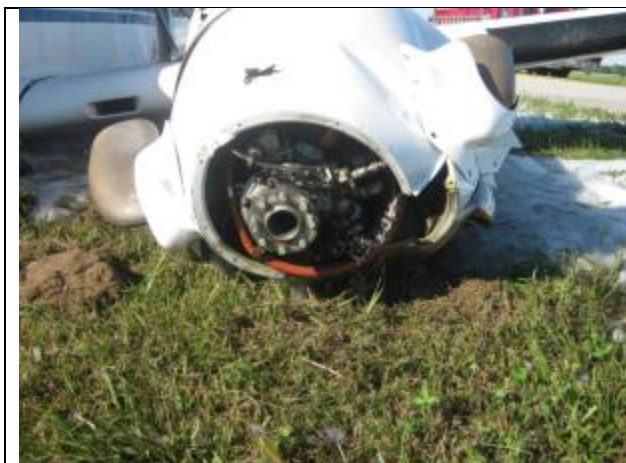
The 550 shaft hp (shp) turboprop engine remained attached to the left wing at the accident location. However, was canted in the negative or downward direction approximately 15 degrees, forward of the wing. The propeller was impact separated from the propeller hub and according to photographic evidence was co-located with the main wreckage. According to the maintenance manual, the compressor rotor was comprised of three (3) axial stages, three (3) interstage spacers, and a single-stage centrifugal impeller.

Photo 16: Left Engine as Viewed (Courtesy of FAA)

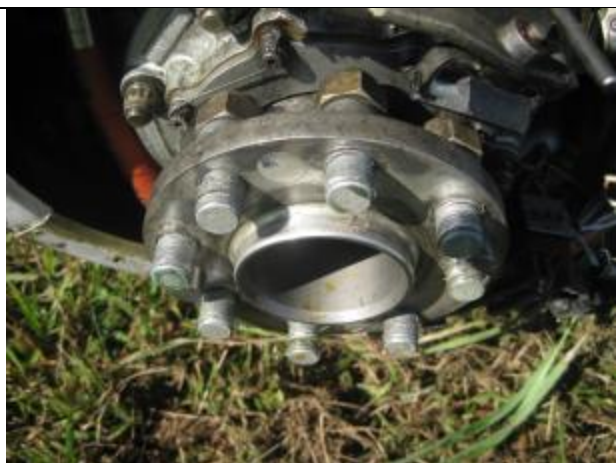
Photo 17: Left Engine Propeller Hub as Viewed (Courtesy of FAA)

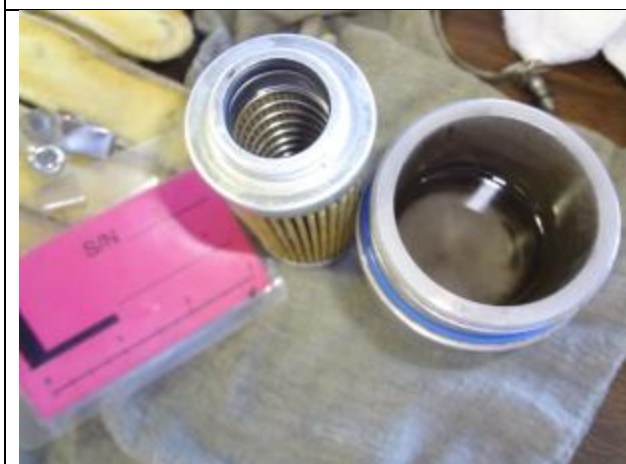
The fuel control unit was removed and a liquid, similar in smell as Jet A aviation fuel was present in the fuel bowl and no debris was noted. The fuel filter was removed and was free of debris. The quantity with the fuel filter removed was about one-half (1/2) full. The left side nacelle tank was examined and opened up at the top of tank. The fuel sensing unit was removed and exhibited a bend, and the unit attach fitting was cracked. Examination of the tank revealed a breach of the bladder tank in the lower portion of the fuel tank. Further examination indicated that the fuel pump was displaced aft and exhibited impact damage in the surrounding area. Trace amounts of fuel was located in the bottom of the bladder tank. The hydro-mechanical fuel shutoff valve was accessed through an outboard access point. The fuel shutoff valve was in the "OPEN" position.

Photo 18: Fuel Bowl Approximately 1/2 Full

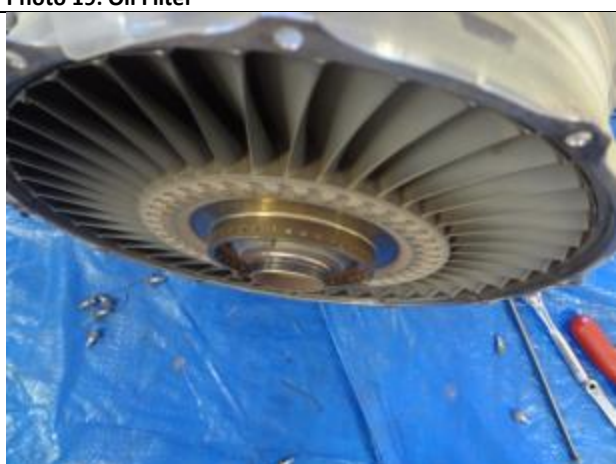
could not be rotated. Determination was made to begin disassembly of the engine to determine the binding. Power turbine disc revealed evidence of rotation scoring on the power turbine disc face, adjacent to the center bore, and blade tips. Removal of the PT did not free up the power section, and compressional deformation was noted on the exhaust case. The chip detector was removed, examined, and was free of debris. The oil filter was removed and free of debris and oil was noted. The Py system was intact and secured. The igniters were removed and were normal in appearance.

Photo 21: Power Turbine Disc with Rotational Score Marks

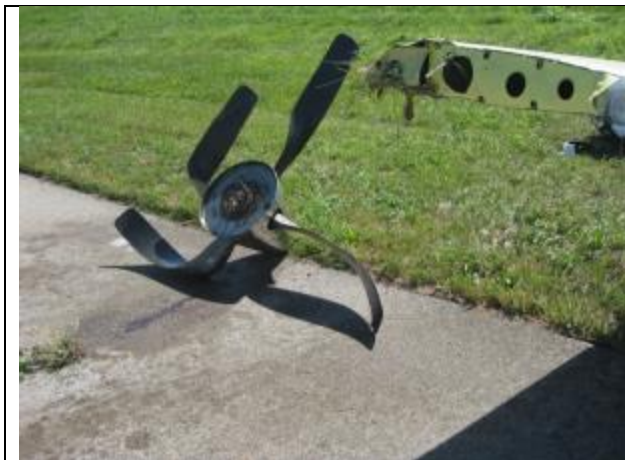
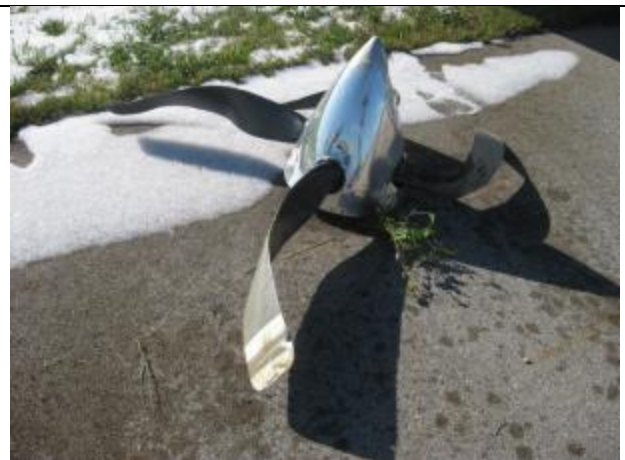
The left propeller was a McCauley model 4HFR34C768C, Serial No. 952488, 4-bladed, controllable pitch propeller. According to the most recent Phase inspection<sup>4</sup> the propeller's most recent overhaul was December 17, 2012. At the time of the Phase inspection the propeller had accrued 2,312.0 hours total time in service (TTIS) and 114.8 hours' time since overhaul (TSO). Post recovery examination of the propeller revealed various degrees of S-bending and tip curling on all four (4) of the blades. The blade angles also appeared to be in or near the feathered position and exhibited signature marks consist with as being under power at the time of impact. The propeller spinner exhibited impact compression damage. The blades were labeled "A," "B," "C," and "D" by investigative personnel. Blade "A" exhibited leading edge damage and tip damage with a blade tip twist. Blade "B" exhibited leading edge and trailing edge damage. Blade "C" exhibited minimal chordwise scratches. Blade "D" exhibited leading edge tip damage with a nick in the leading edge. The blades labeled "A" "B" and "C" exhibited impact damage at the mating surface with the propeller spinner damage was in-line with the "C" blade. Blades "C" and "D" are bent in the opposite direction. Blades "A" and "B" are twisted in a spanwise direction.

Photo 22: Left Propeller (Courtesy of FAA)

Photo 23: Left Propeller as Found (Courtesy of FAA)

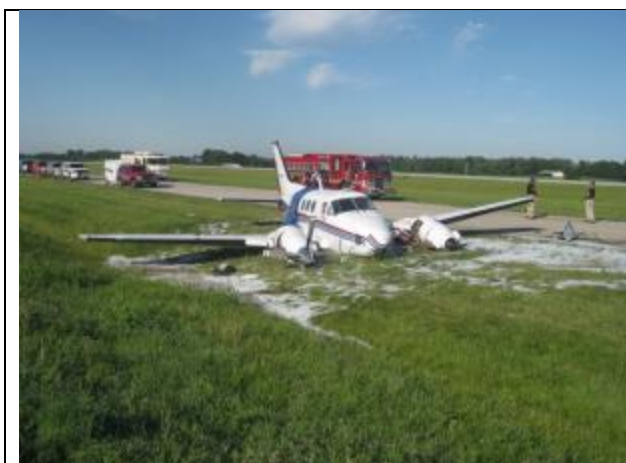
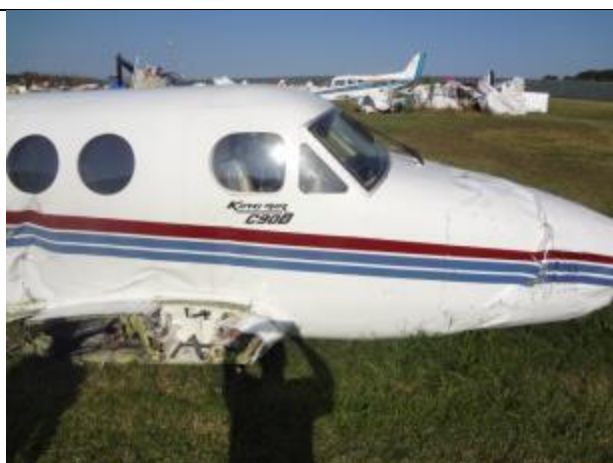
The nose section exhibited buckling at, and forward of, the aft bulkhead of the avionics. The nose gear was impact separated.

Photo 24: Nose Section as Viewed (Courtesy of FAA)

Photo 25: Nose Section - Post Recovery

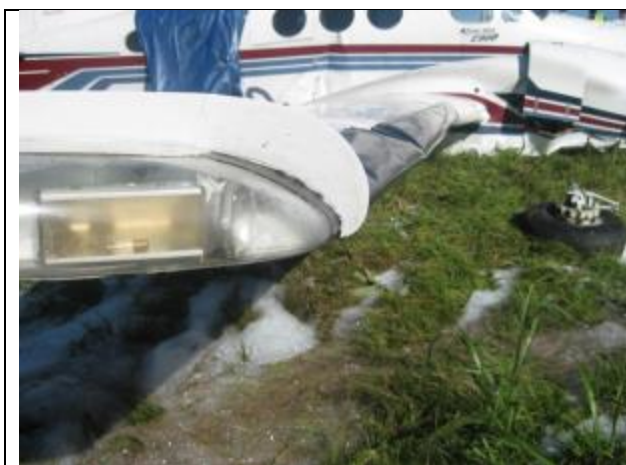
The right wing exhibited impact damage and crushing on the leading edge beginning at the engine nacelle and going outward. The outboard 35 inches was removed to facilitate recovery. The right main landing gear was impact separated and according to photographic evidence was co-located with the wreckage forward of the right wing between the engine nacelle and wingtip. The right inboard flap measurement was noted as 2 7/8 inches which correlated to an approximate 5- to 10-degree flap position. The landing gear was extended at the time of impact; however, the lower gear strut was separated, and the landing gear braces were buckled.

Photo 26: Right Wing as Found (Courtesy of FAA)

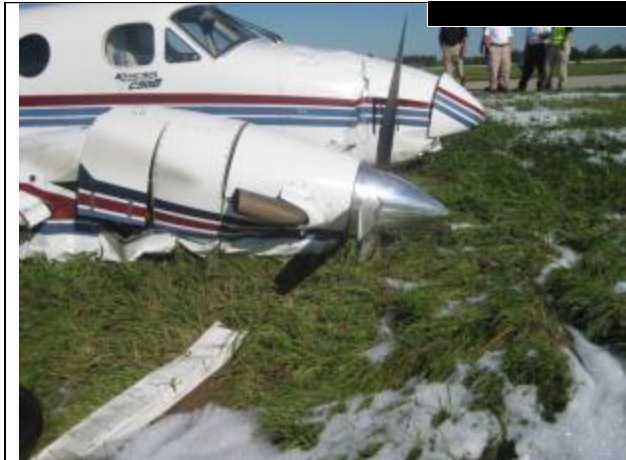
The 550 shp turboprop engine remained attached to the right wing at the accident location and the propeller remained attached to the engine. According to the maintenance manual, the compressor rotor was comprised of three (3) axial stages, three (3) interstage spacers, and a single-stage centrifugal impeller. The engine was examined as it was received, and it remained attached to all attach mounts. The propeller blades were in the latch position or near flat pitch. The right-wing nacelle tank fuel cap remained attached but had been unsecured during the recovery. The cowlings were removed to facilitate further examination. Removal of the right inboard exhaust allowed examination of the power turbine stage. The vanes appeared normal; however, no rotation was able to be accomplished by hand. Determination was made to begin disassembly of the engine to determine the binding. The chip detector was removed, examined, and was free of debris.

Photo 28: Right Engine as Viewed (Courtesy of FAA)

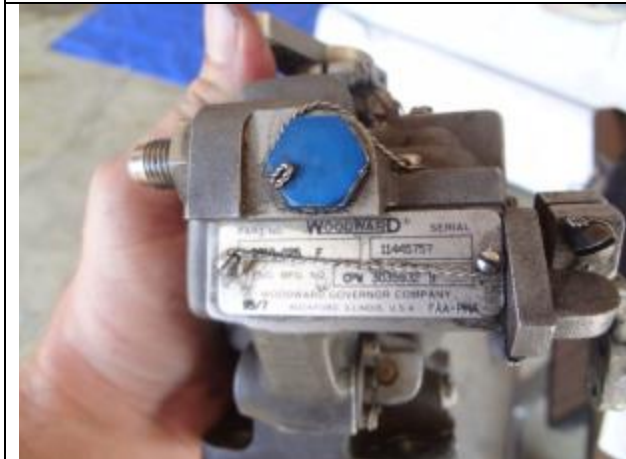
The propeller beta arm (propeller reversing lever) was noted attached to the respective attach points; however, it had to be removed to facilitate disassembly. The propeller governor was a Woodward Governor Company Model No. 8210-025 F; Serial No. 11445757. The unit was examined and was noted in or near the feather position. However, upon removal of the unit the spring arm realigned and was in the low pitch position.

Photo 36: Propeller Governor

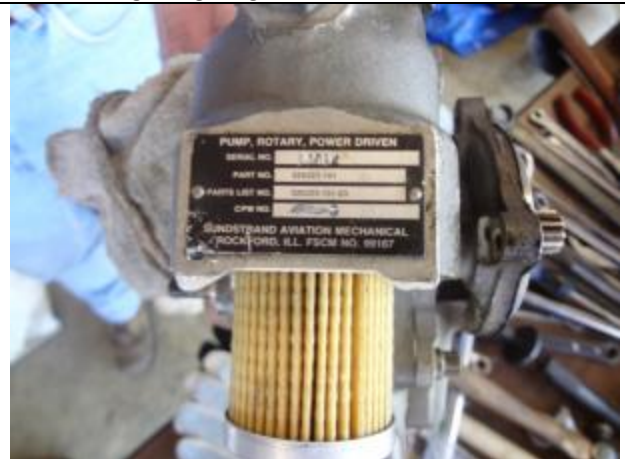
The fuel pump was a Sundstrand Aviation Mechanical unit; Part No. 025323-101; Serial No. 14612. The spline gear remained attached and was unremarkable. The unit was removed and a liquid, similar in smell as Jet A aviation fuel was present in the fuel bowl and no debris was noted. The quantity was approximately 1/5 of a fuel bowl full. The fuel filter was removed and was free of debris. A small crack was noted in the oil/heat exchanger fuel out line; however, no evidence of prior leaking was noted. The right-side nacelle tank was examined and opened up at the top of tank. The fuel sensing unit was removed and exhibited a slight bend, and the unit attach fitting was cracked. Examination of the tank revealed trace amounts of fluid in the bottom of the bladder tank. The nacelle tank was filled with approximately four (4) gallons of water. A minor amount of fluid was observed leaking from the base of the nacelle tank. The hydro-mechanical fuel shutoff valve was accessed through an outboard access point. The fuel shutoff valve was in the "OPEN" position. The fuel control unit was an Allied Signal; Model No. DP-F2; Serial No. A33331 was removed and the phenolic coupling remained attached and unremarkable. A sticker was attached to the unit and stated, "Rubber Assembly Date 11/2007."

Photo 37: Fuel Pump

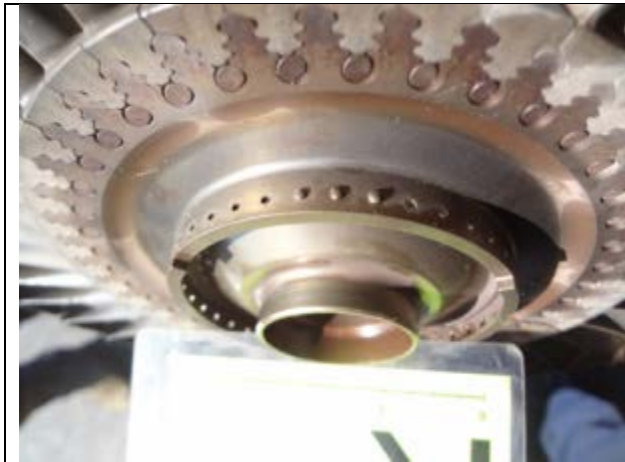
gouging along the shroud. However, close examination revealed two (2) score marks along the inner section of the power turbine disc, which mated up to the power turbine vane baffle.

Photo 40: Two Parallel Minor Score Marks on Inner Section

There were no mechanical malfunctions or abnormalities that would have precluded normal operation. However, examination of the engines revealed that the left engine was developing power at the time of the accident, but no power setting could be ascertained. The right engine was examined and revealed no compressor rotation or power at the time of the accident; however, two (2) light score marks, noted on the power turbine, was likely due to the propeller windmilling at the time of the accident.

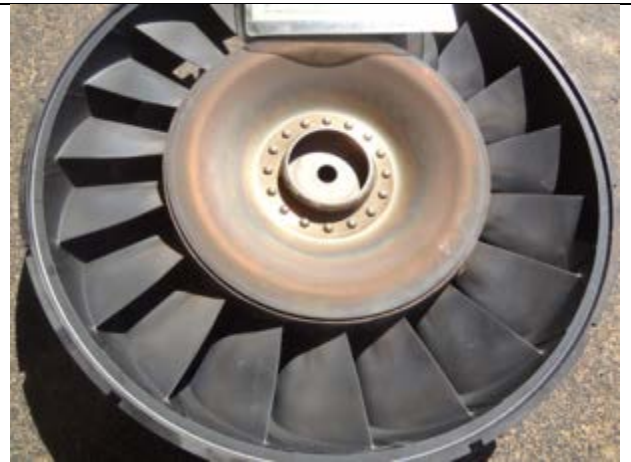
Photo 41: Power Turbine Vane Baffle

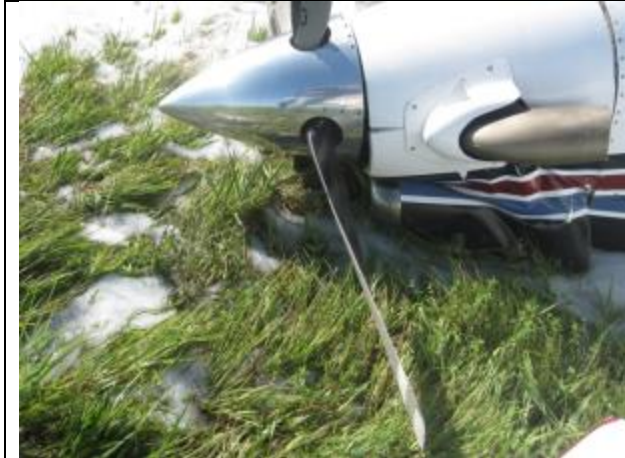
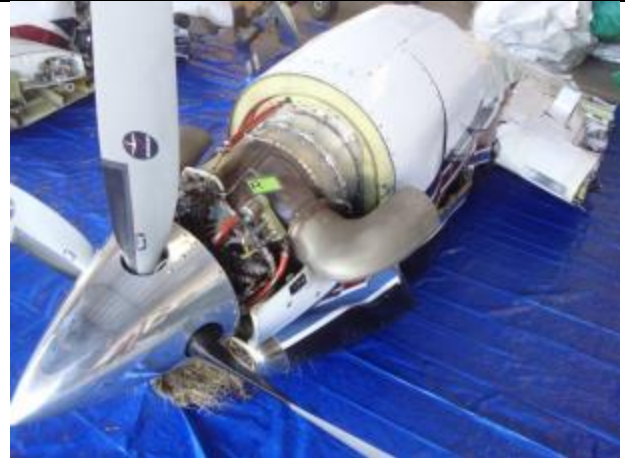
Sometime following the removal of the lower cowlings the propeller blades were found to have moved to a feather or near feather position. It was unable to be determined at what point following the removal of the lower cowlings the blades went into feather.

The right propeller was a McCauley model 4HFR34C768C, Serial No. 950298, 4-bladed, controllable pitch propeller. According to the most recent Phase inspection<sup>5</sup> the propeller's most recent overhaul was December 17, 2012. At the time of the Phase inspection the propeller had accrued 2,312.0 hours TTIS and 114.8 hours TSO. The blade angles also appeared to be in the latch position, and devoid of any signature marks or spanwise gouging, consist with developing power at the time of impact. Following the removal of the lower cowling the propeller blades moved to a feather or near feather position. The propeller blade angle is controlled by oil pressure and therefore it is likely that the absence of oil pressure allowed the blade angles to move to a feather position.

Photo 42: Right Propeller as Viewed (Courtesy of FAA)

Photo 43: Right Engine Propeller as First Viewed - Post Recovery

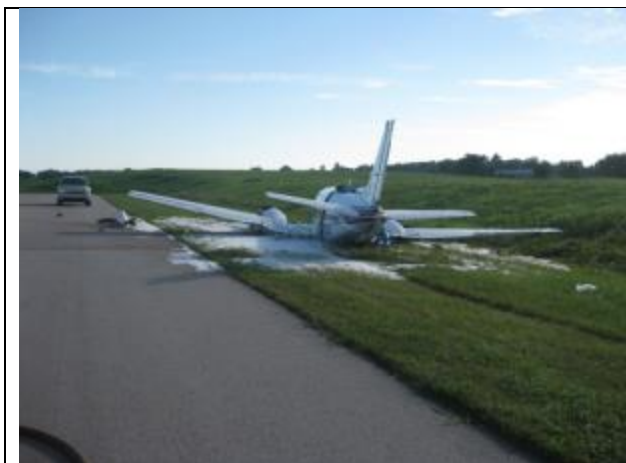
The Empennage, according to photographic evidence obtained at the accident location, remained attached to the fuselage. The horizontal section, which included the elevator, and vertical tail section, which included the rudder, remained intact and exhibited no impact crushing or damage. All flight controls and trim cables were manually manipulated at their respective recovery cut points and no anomalies were noted or detected. The elevator trim tab was measured at 0.75 inches, which correlated to a trim setting of 25 degrees trailing edge tab down. The rudder trim was measured at 8.25 inches, which correlated to a trim setting of 15 degrees trailing edge right. Examination of the cockpit trim indicator revealed about 7 degrees nose up elevator trim setting and a slight nose right rudder trim.

**Photo 44: Empennage Section as Viewed from Aft looking Forward (Courtesy of the FAA)**

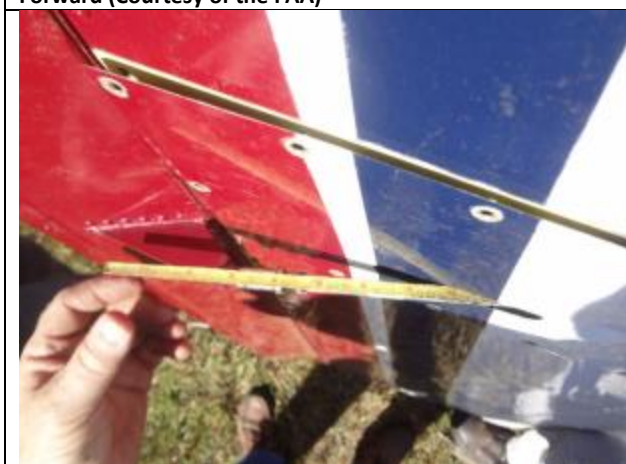
The primary and secondary flight control cables remained intact from the cockpit controls to their respective flight control. The left aileron trim tab was observed to be about neutral, the rudder trim tab was about 12 degrees tab trailing edge right, and the two elevator trim tabs were about 25 degrees tab trailing edge down. The inboard flap actuator extensions suggested the inboard flaps were extended about 8 degrees, but the outboard flap actuators were fully retracted. The landing gear was extended. The two main landing gear lower struts were separated, and the extend braces were buckled.

**Photo 46: Rudder Trim Measurement**
