## 1.0 Introduction

G-IV s/n 1225, N450KK is currently operated by La Venezolana de Seguros y Vida CA.

On April 24, 2015, G-IV s/n 1225 conducted a flight from Maiqueita Airport Carracas, Venezuela (CCS) to Fort Lauderdale, FL (FLL). The flight loading consisted of a pilot and co-pilot and no passengers. The flight crew and aircraft experienced an over pressurization incident enroute. The pilots followed the Aircraft Flight Manual (AFM) procedures and executed a successful landing at FLL. An initial visual inspection performed by the flight crew did not reveal any indications of damage. The plane was then flown to Reliable Jet Maintenance (RJM) at Boca Raton, FL (BCT) airport.

**G-IV S/N 1225 Structural Evaluation-Over Pressurization Event**

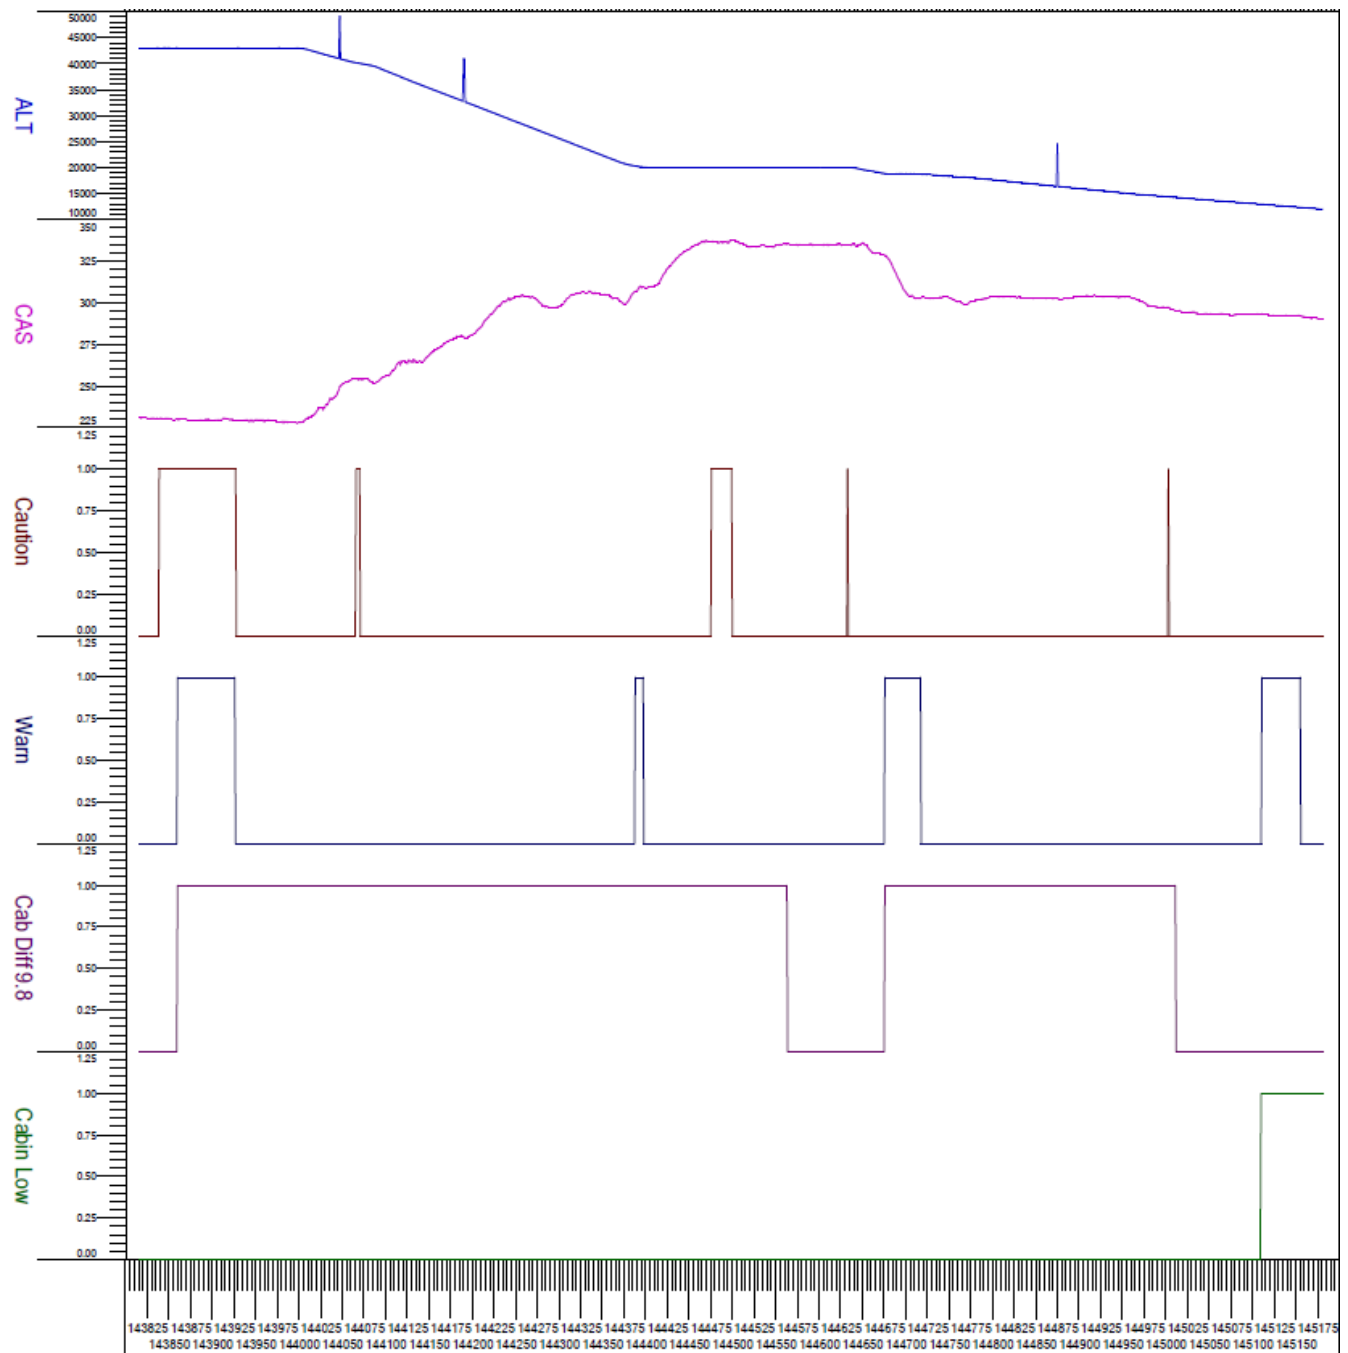
**Fig. 2-1**

- B. Comments on FDR download:
- i. Lateral acceleration is not recording properly
  - ii. Reviewed the FDR and did not see any exceedances with vertical G's or with pitch and roll rate. Maximum vertical G's was less than +/- 0.5 G's. Could not find any indication that the aircraft had high lateral or vertical G's or any high (roll or pitch) rate of change.

- iii. No FDR data to support if the safety valve operated correctly.
  - iv. The FDR does not record Cabin Pressure/Altitude.
  - v. The FDR shows that the first over pressure 9.8 message was on for 704 seconds and 336 seconds the second and final time with a 112 second gap.

- viii. The Crew did not follow the AFM recommend steps for an Amber "Cabin DFRN 9.6" or a Red "Cabin DFRN 9.8" CAS message.
  - ix. The over pressurization message does not appear to be an indication failure.

Download of FDR Data

- x. Recommend a Chapter 5 "Pressure Differential Exceedance – Inspection". It is unknown if the safety valve operated correctly.

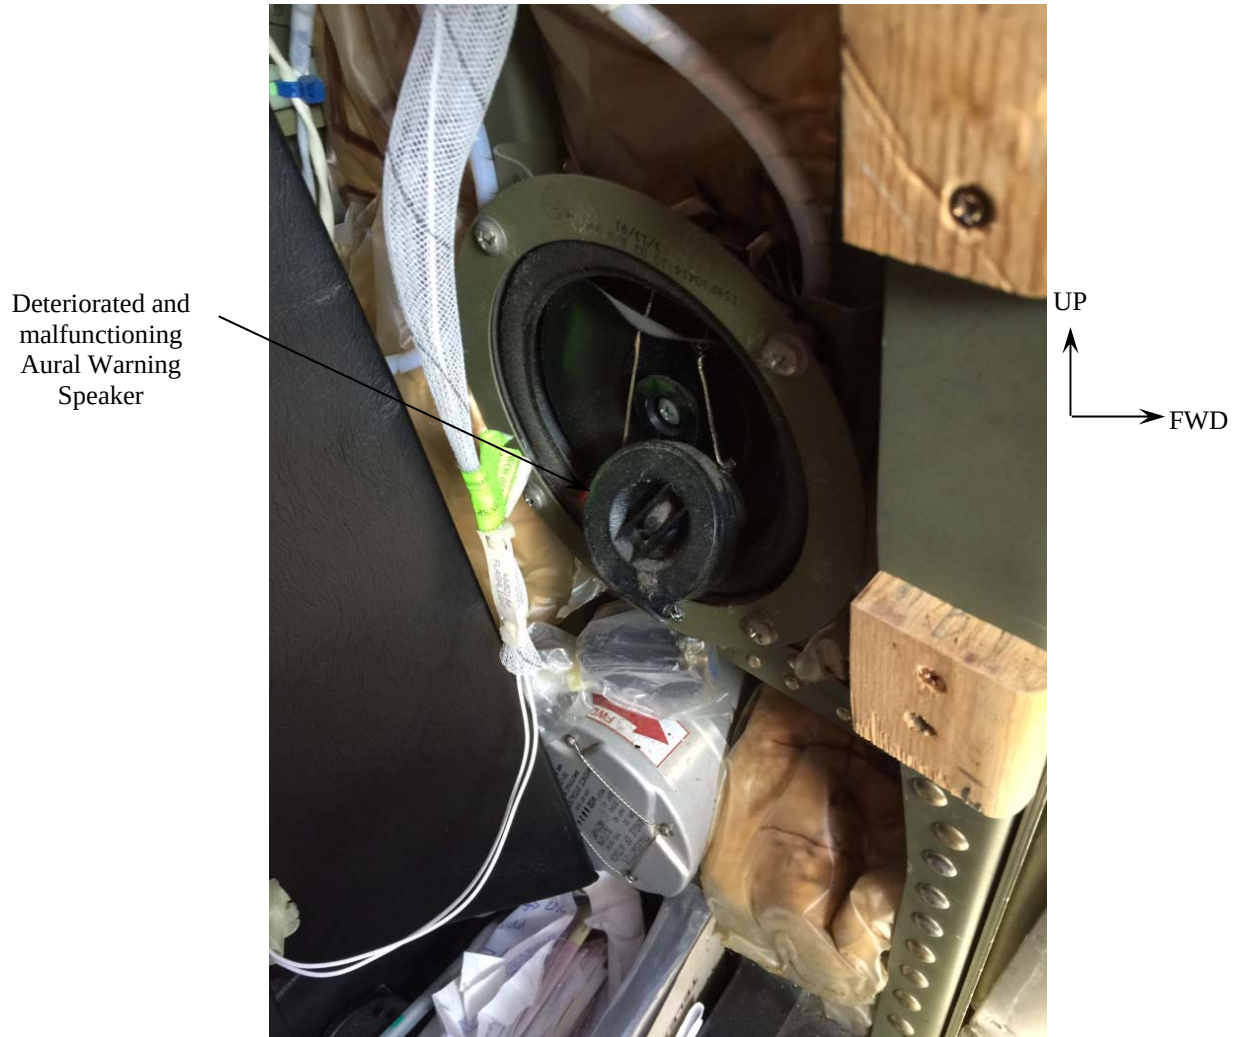
- C. An initial inspection of the aircraft by RJM personnel provided the following information:
- i. The Aural Warning Speaker showed evidence of deterioration.
  - ii. The Aural Warning Speaker volume was not functioning properly.

**Fig. 2-2**  
Aural Warning Speaker with covering removed.

- iii. Trouble shoot the Aural Warning Speaker system to determine the cause of the volume problem.
    - a. Replace parts and adjust the system as required to obtain proper function..
  - iv. Clean and remove the Foreign Object Debris (FOD) from the Outflow Valve Safety Port system in accordance with Chapter 21-02-05 of the G-IV MM and/or the applicable CMP Card.
    - a. After cleaning the Outflow Valve Safety Port system, perform a functional test of the system in accordance with Chapter 21-02-05 of the G-IV MM and/or the applicable CMP Card.
- Note: RJM Personnel initially tried to clear the Safety Port by using the air pressure procedure but were unsuccessful. The Safety Port was ultimately cleaned out by using flexible wire prior to GAC Representatives arrival. While on-site, it was observed that the Safety Port was again plugged with “Mud Dobber” debris

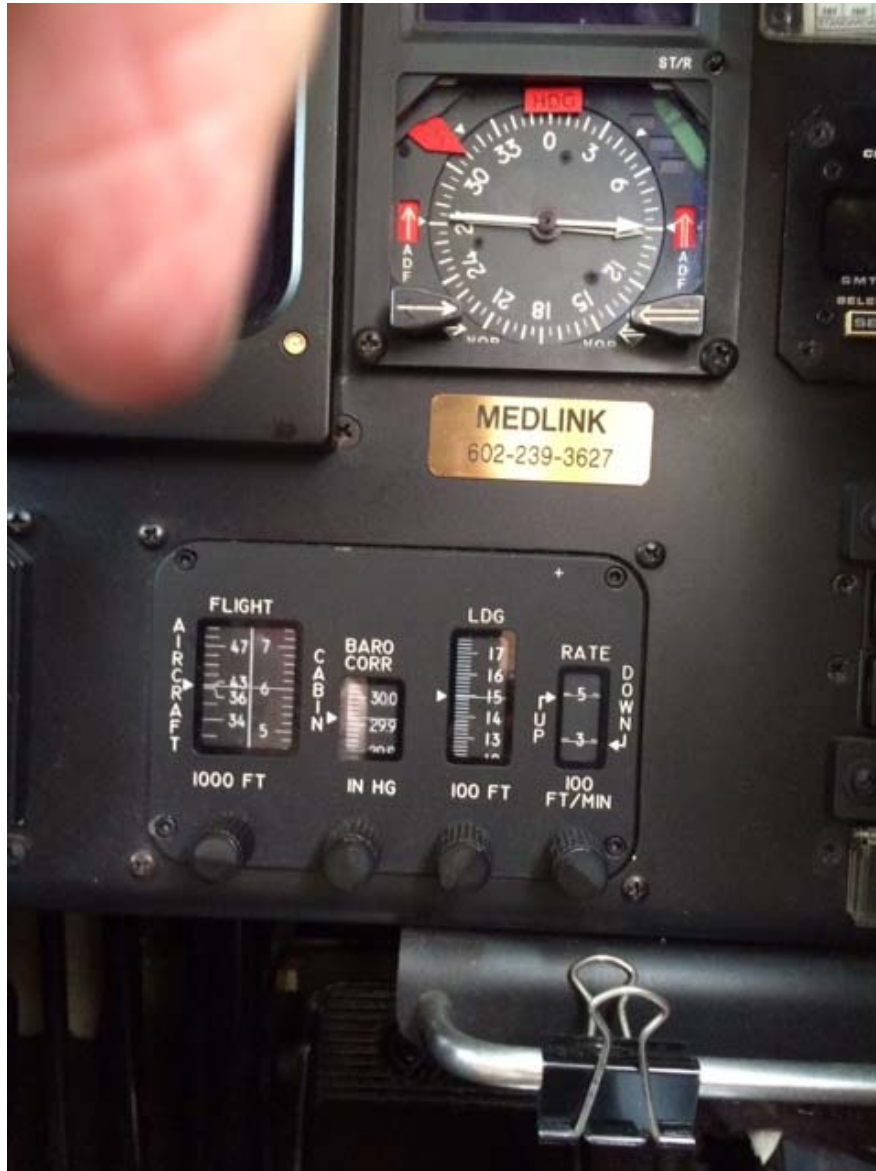
**Fig. 2-3**

- iii. A photo of the Cabin Pressure Altitude settings at the time of arrival at the RJM facility were provided.

Cabin Pressure Altitude settings at the time of arrival at RJM.

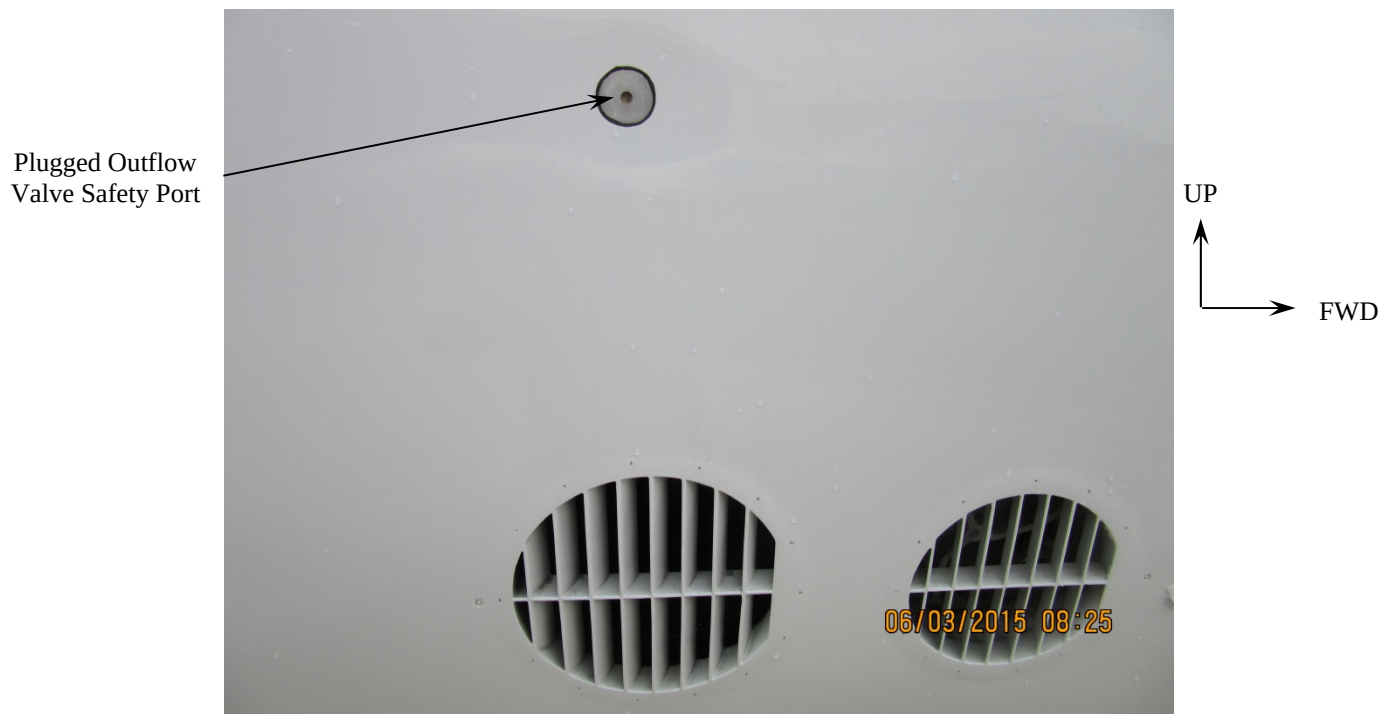
**Fig. 2-4**

- iv. The Outflow Valve Safety Port was plugged with mud and bug residue and was not functioning.

View looking inboard at the Outflow Valve and Safety Port

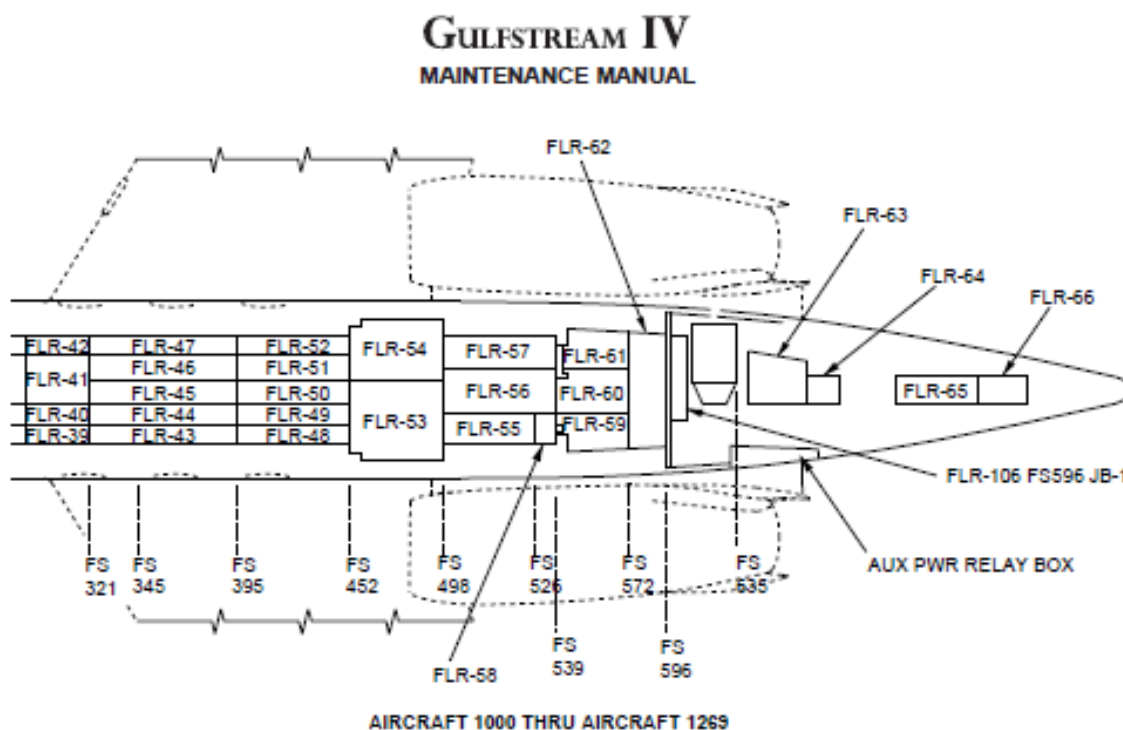
**Fig. 3-1**

- i. Floor panels FLR-44, FLR-46, FLR-50 and FLR-51 (Ref. Fig 3-1) were unfastened and removed from the aircraft to gain access to accomplish an under floor inspection of the fuselage floor structure.
- ii. Floor panel FLR-44 (1159BH21001-407) exhibited evidence of crushed core and insert damage around the fasteners attaching the panel to FS 379 Intercoastal Installation.
- iii. Floor panels FLR-46, FLR-50 and FLR-510 did not visually exhibit any evidence of crushed core or pulled/working inserts.
- iv. A visual evaluation of the floor boards between FS 345 thru 452 indicated mismatches and distortion at the fastener rows attaching the floor boards to the floor beams at LBL 6.0, LBL 18 and LBL 30.5. The floorboards located between RBL 6 to RBL 30.5 appeared to be flat.
- v. See Section 4.0 for the findings related to the floor beams and underlying structure.

- i. Replace the 1159BH21001-407 Floorboard and associated hardware with new parts in accordance with Chapter 53-30-00 of the G-IV MM and/or applicable CMP Cards.
- ii. Visually and NDT Inspect floor panels FLR-43, FLR-45, FLR-46, FLR-47, FLR-48, FLR-49, FLR-50, FLR-51, FLR-52, FLR-53, FLR-54 (ref. Fig. 3-1) for 10isbanding, crushed core, elongated holes, loose/working inserts and any other discrepant condition(s).
- iii. Visually inspect the adjacent and underlying structure as instructed in Sections 4, 5 and 6.
- iv. Document any discrepant conditions identified and submit to GAC Technical operations for further evaluation.
- v. If no discrepancies are found on a panel, it may be reused and installed in accordance with Chapter 53-30-00 of the G-IV MM and/or applicable CMP Cards.

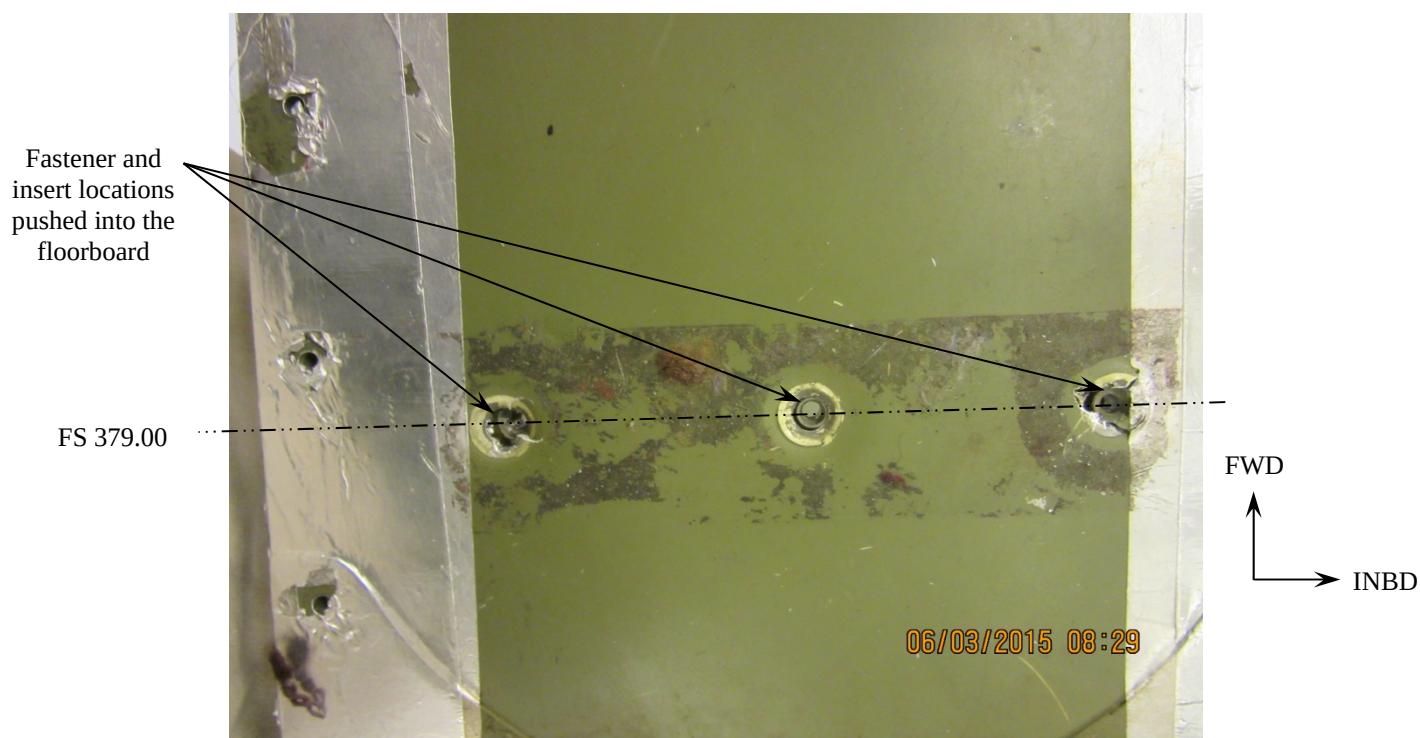
**Fig. 3-2**

View looking down on 1159BH21001-407 Floorboard

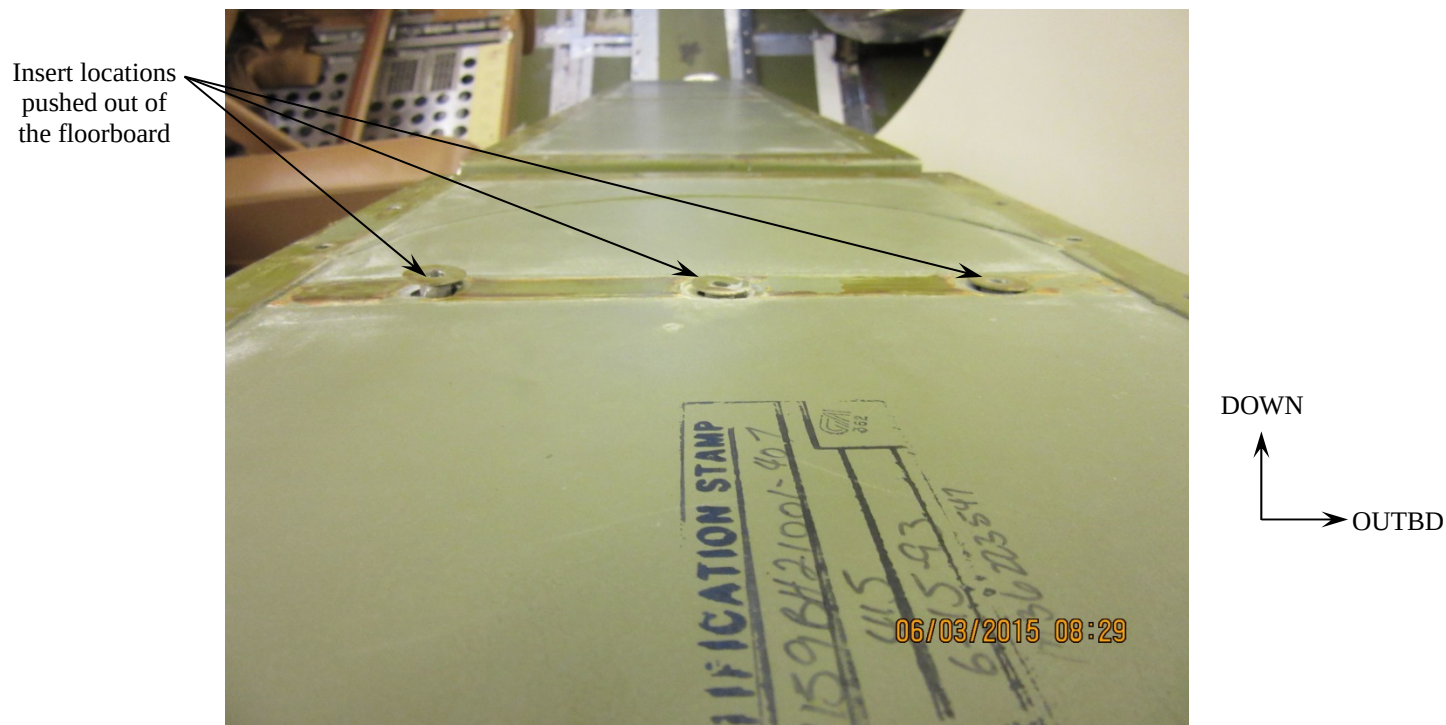
**Fig. 3-3**

View looking at the lower surface of the 1159BH21001-407 Floorboard

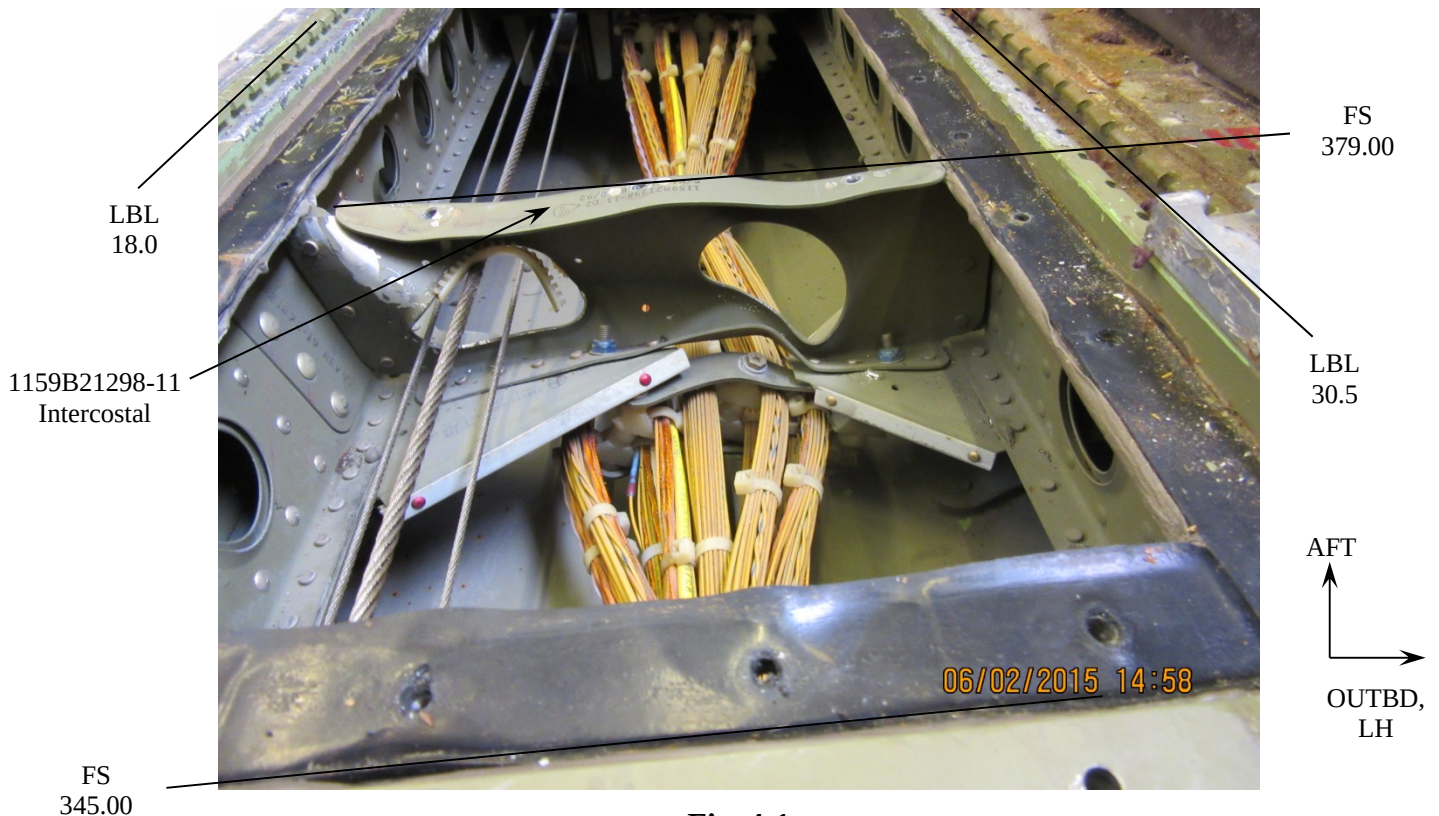
**Fig. 4-1**

- i. The 1159B21298-11 Intercostal between LBL 30.5 and LBL 18.0 was deformed and bent.
- ii. The 1159B21298-15/-16 Intercostals between LBL 6.0 and RBl 6.0 was deformed and bent. The 1159B21272-23/-24 brackets attaching the 1159B21298-15/-16 Intercostals to the LBL 6.0 Floor Beam were cracked.
- iii. Due to the interior and floor board installations, the remaining areas of the 1159B2198-3 Intercostal Instl were inaccessible to be viewed. A complete inspection will be required to determine the full extent of the damage to the 1159B21298-3 Intercostal Instl..
- iv. Numerous other small parts and components may be damaged but not identified in this report. They will need to be identified and documented during the detailed inspection and evaluation.

View looking aft at FS 379.00 between LBL 18.0-LBL 30.5

- i. Do a complete visual inspection of the 1159B21298-3 Intercostal Instl
  - a. Identify and replace any discrepant parts with new parts as required.  
**Note:** Section 5.0 of this report identifies the replacement of the Floor Beam(s) and associated components and should be worked in conjunction with the requirements of this section.
  - b. Document and submit to GAC Technical Operations any structural damage identified with a full description and digital photos for evaluation.

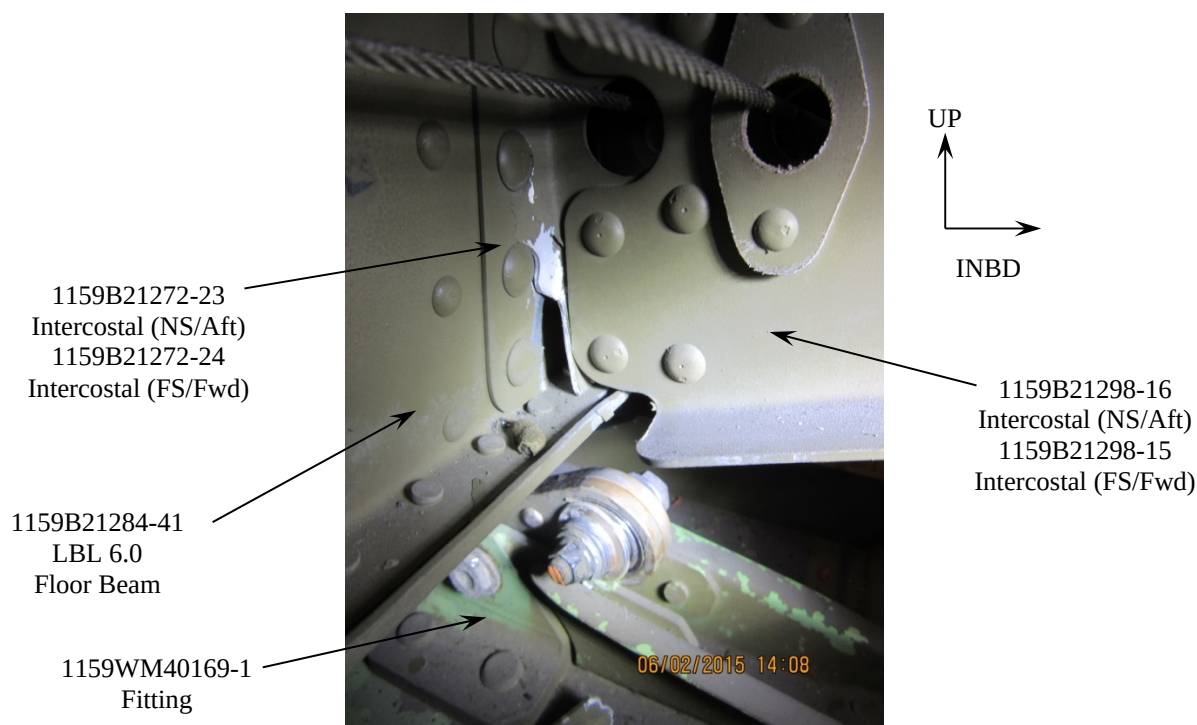
**Fig. 4-2**

View looking fwd at FS 379.00 at LBL 6.0

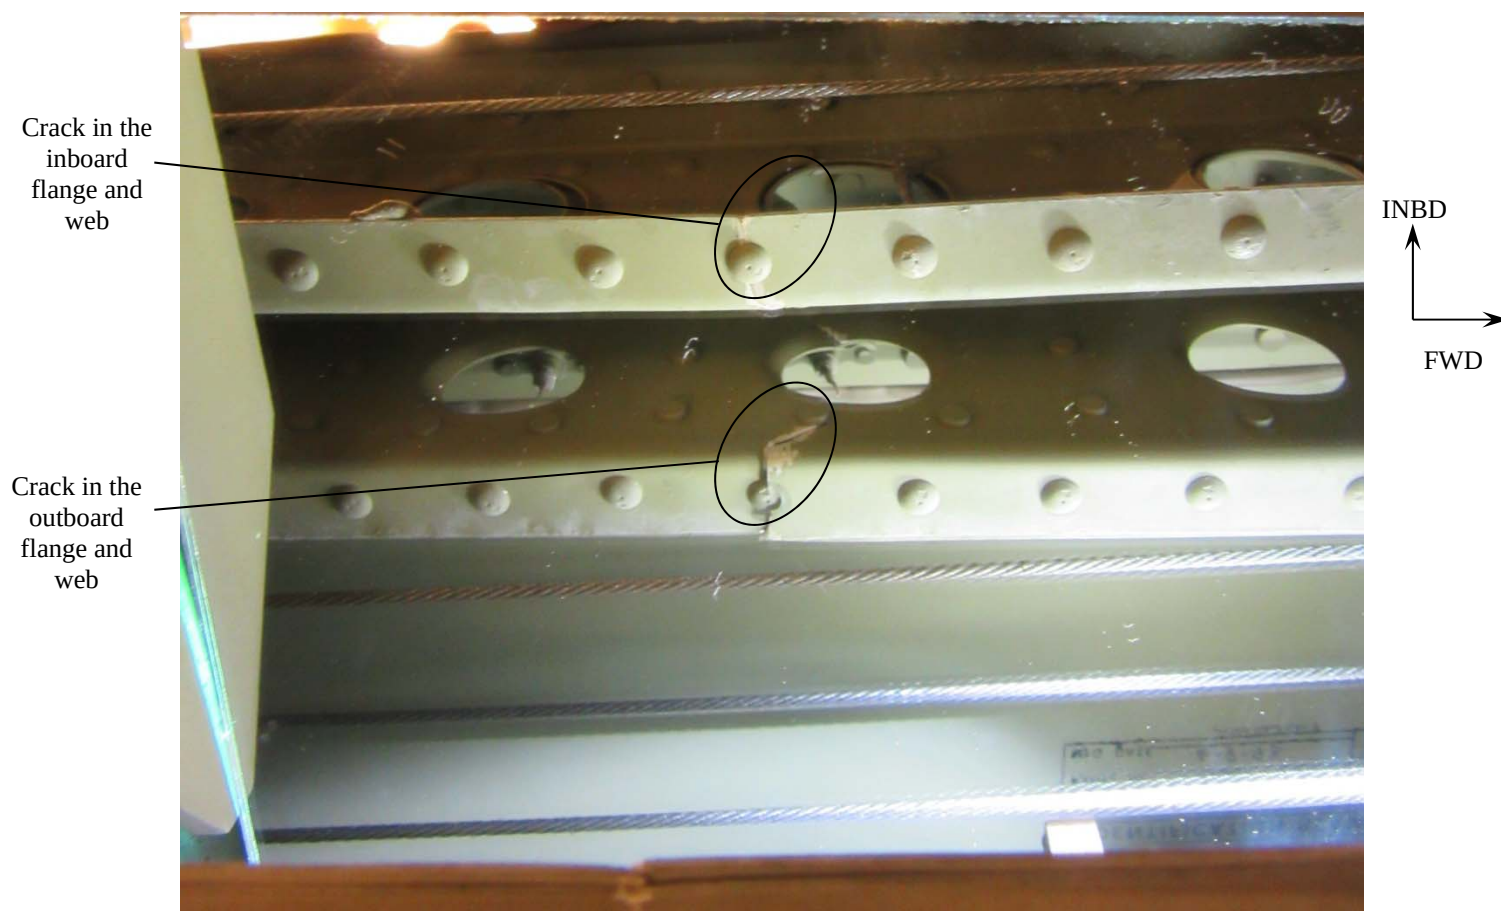
**Fig. 5-1**

- a. The 1159B21284-41 Beam Installation was cracked and distorted at the following locations:
  - (a) FS 360 - (Inboard and Outboard Sides) (Fig. 5-1).
  - (b) FS 388 - (Outboard Side) (Fig. 5-2).
  - (c) FS 391.5 - (Inboard Side) (Fig. 5-2).
  - (d) FS 452.50 - The attachment joint had indications of diagonal buckling on the aft 6" of the web on the inboard and outboard side of the beam (Fig. 5-3).
  - (e) The FS 379.00 Wing Link Attach Fittings were fractured (Fig. 5-4 to 5-6).

View looking up at the cracks at FS 360 in the 1159B21284-41 Floor Beam

- iii. Repair/Resolution:
  - a. Remove and replace the 1159B21284-41 Floor Beam to the requirements of the 1159B20005-7 Structure Assy and 1159B20005-5 Structure Instl.
  - b. Document and submit to GAC Technical Operations any structural damage identified with a full description and digital photos for evaluation

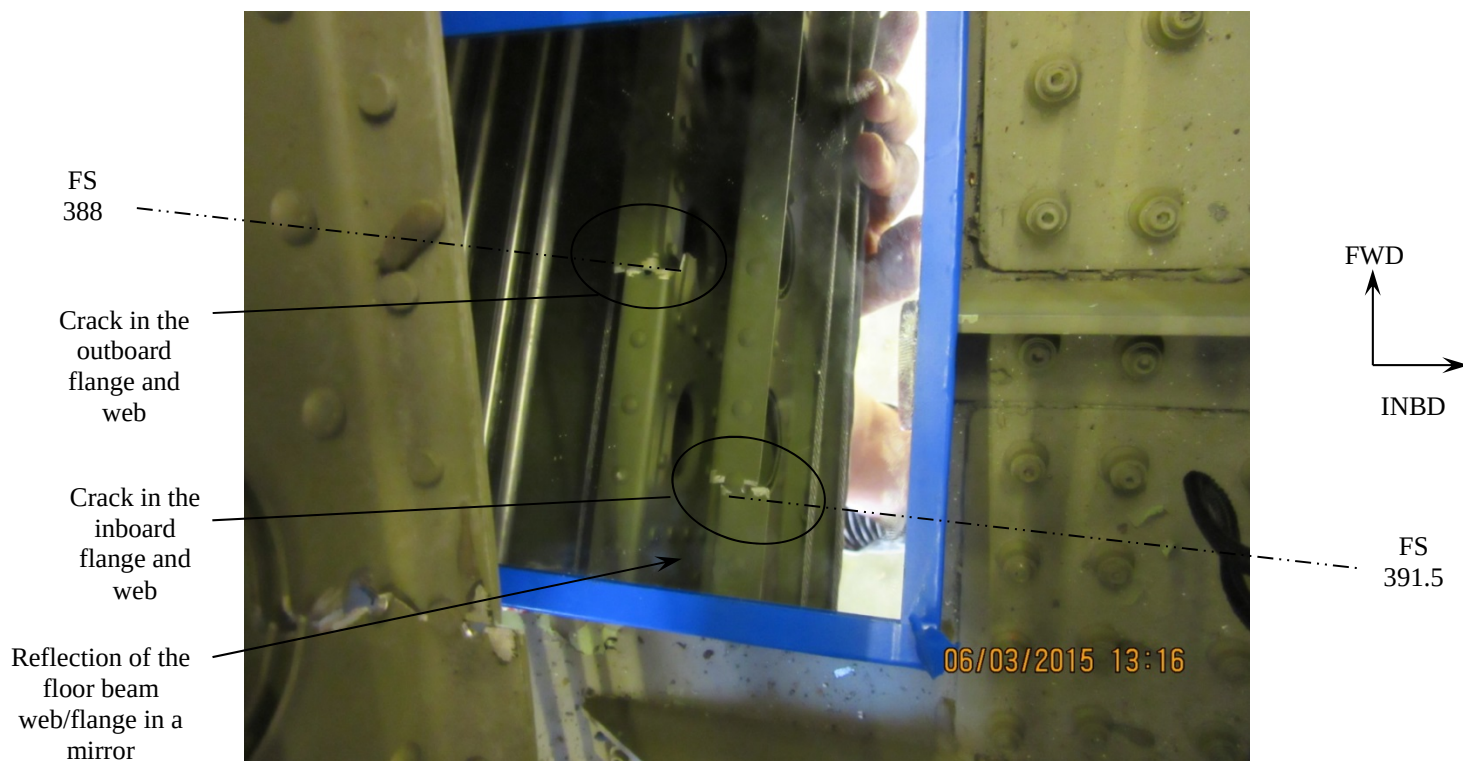
**Fig. 5-2**

View looking up at the cracks at FS 388/391.5 in the 1159B21284-41 Floor Beam

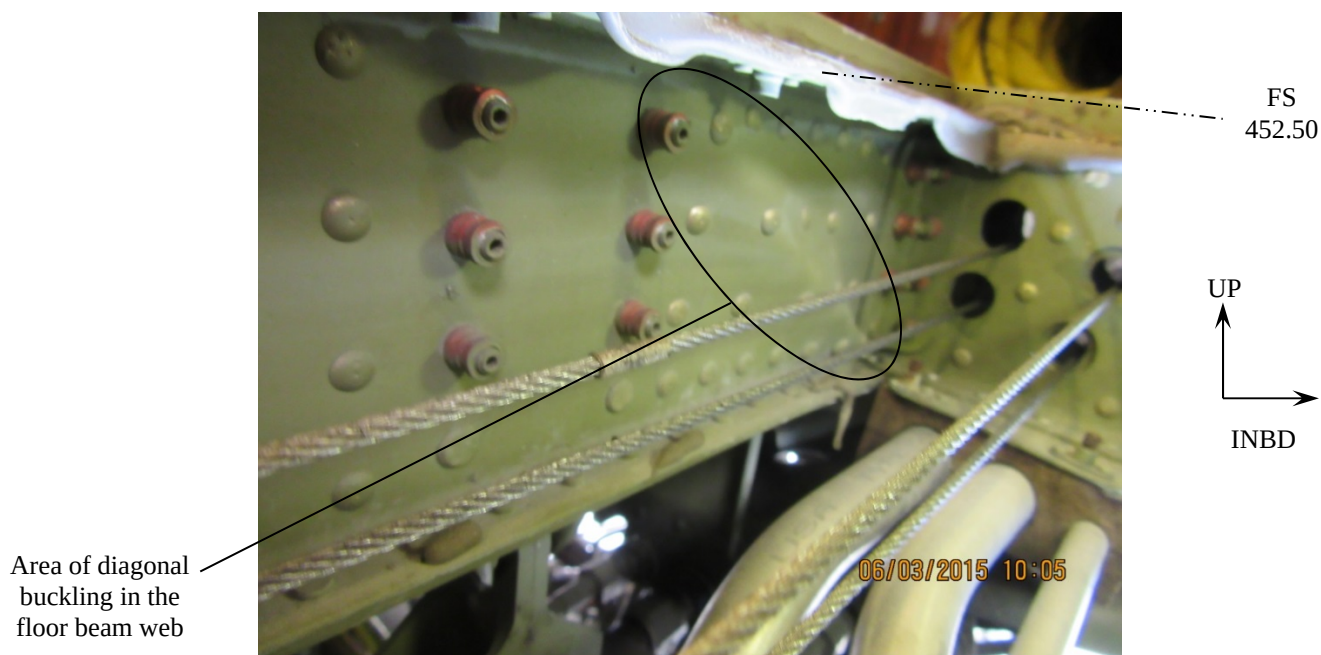
**Fig. 5-3**

View looking aft/inbd at the outboard face of the web of the LBL 6 Floor Beam at FS 452.50  
(The outboard web exhibited similar conditions)

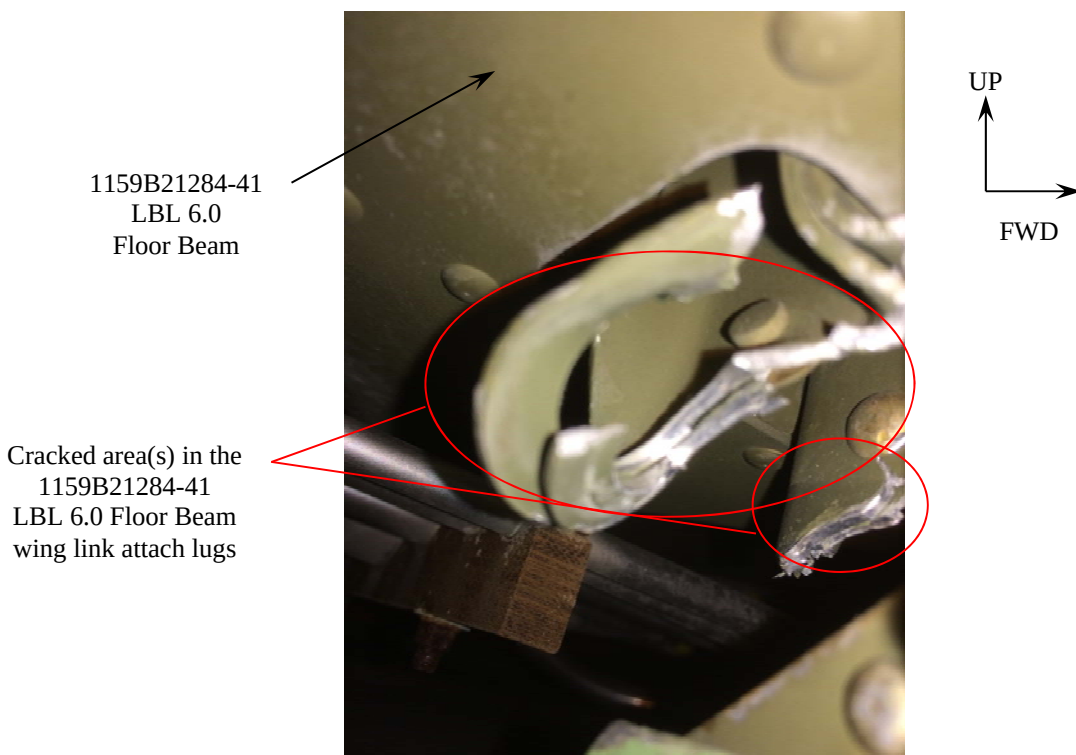
**Fig. 5-4**

View looking fwd at the FS 379.00/ LBL 6.0  
wing link attach point in the Floor Beam

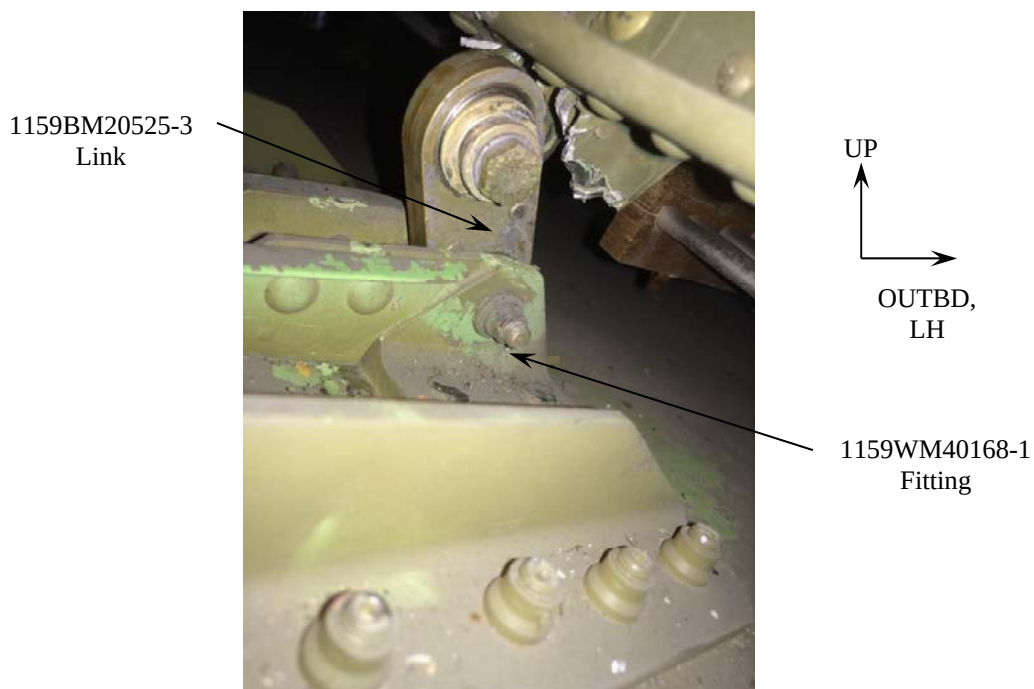
**Fig. 5-5**

View looking aft at the FS 379.00 /LBL 6.0 Link Instl

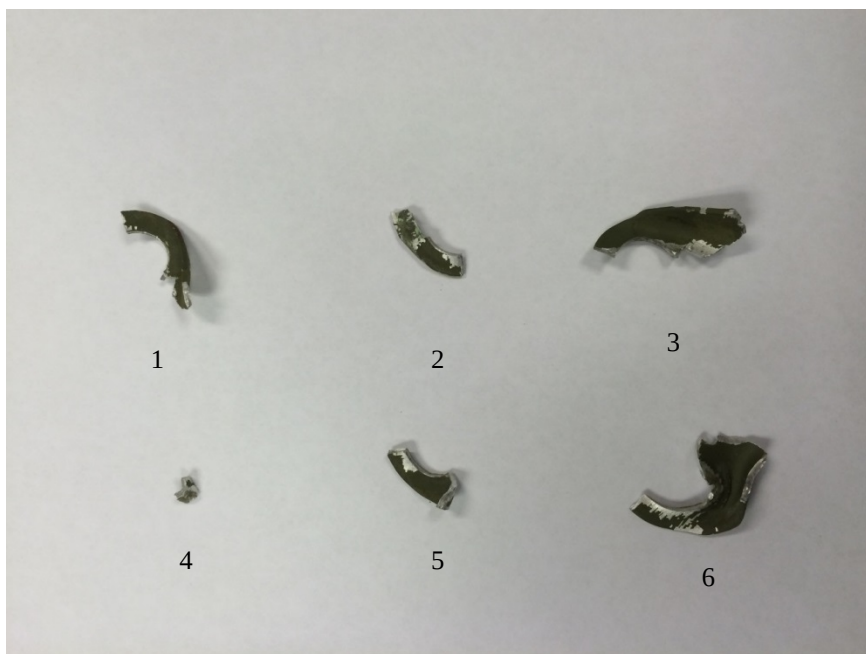
**Fig. 5-6**

Fractured material from the FS 379.00/LBL 6.0  
Floor Beam wing Link Attach Fitting

e. An initial evaluation of the fractured surface(s) of parts 1, 3 and 6 under a 50X Power microscope indicated a “Ductile Overload Failure” of the surface.

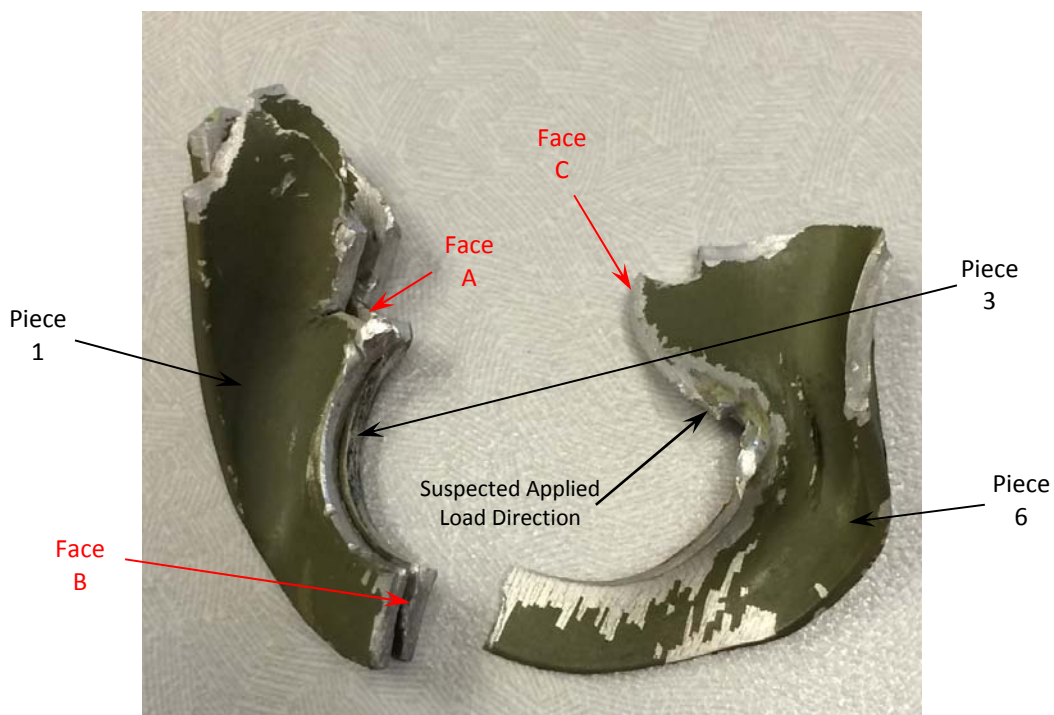
**Fig. 5-7**

Fractured material from the FS 379.00

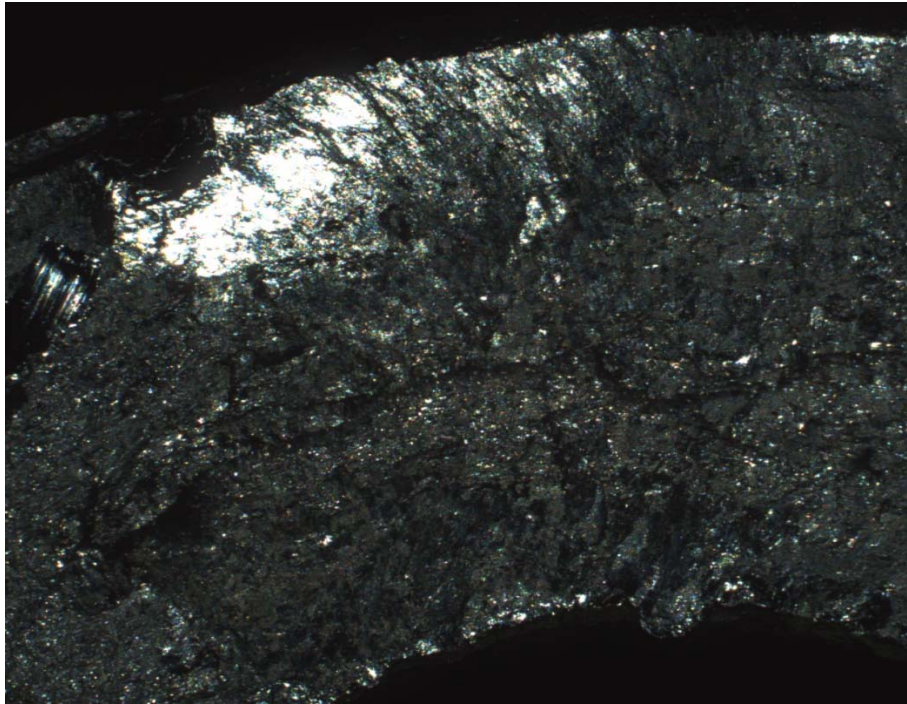
**Fig. 5-8**

Face A-Crack Opened Mechanically To Reveal Crack Face  
Tearing from Elongation. Failure Mode: Ductile Overload

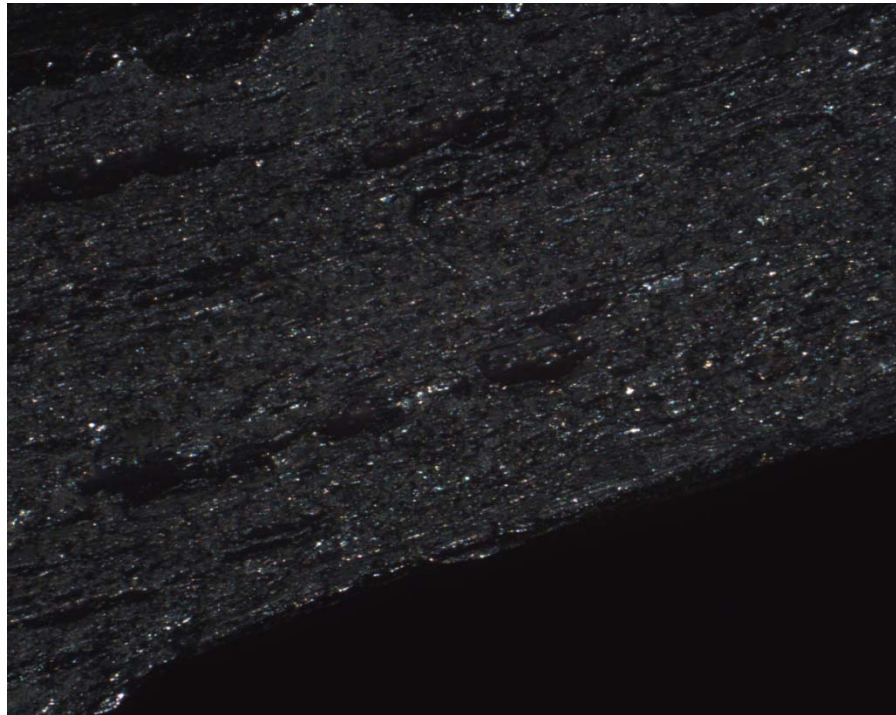
**Fig. 5-9**

Face B-Net Section Tension Failure  
Failure Mode: Ductile Overload

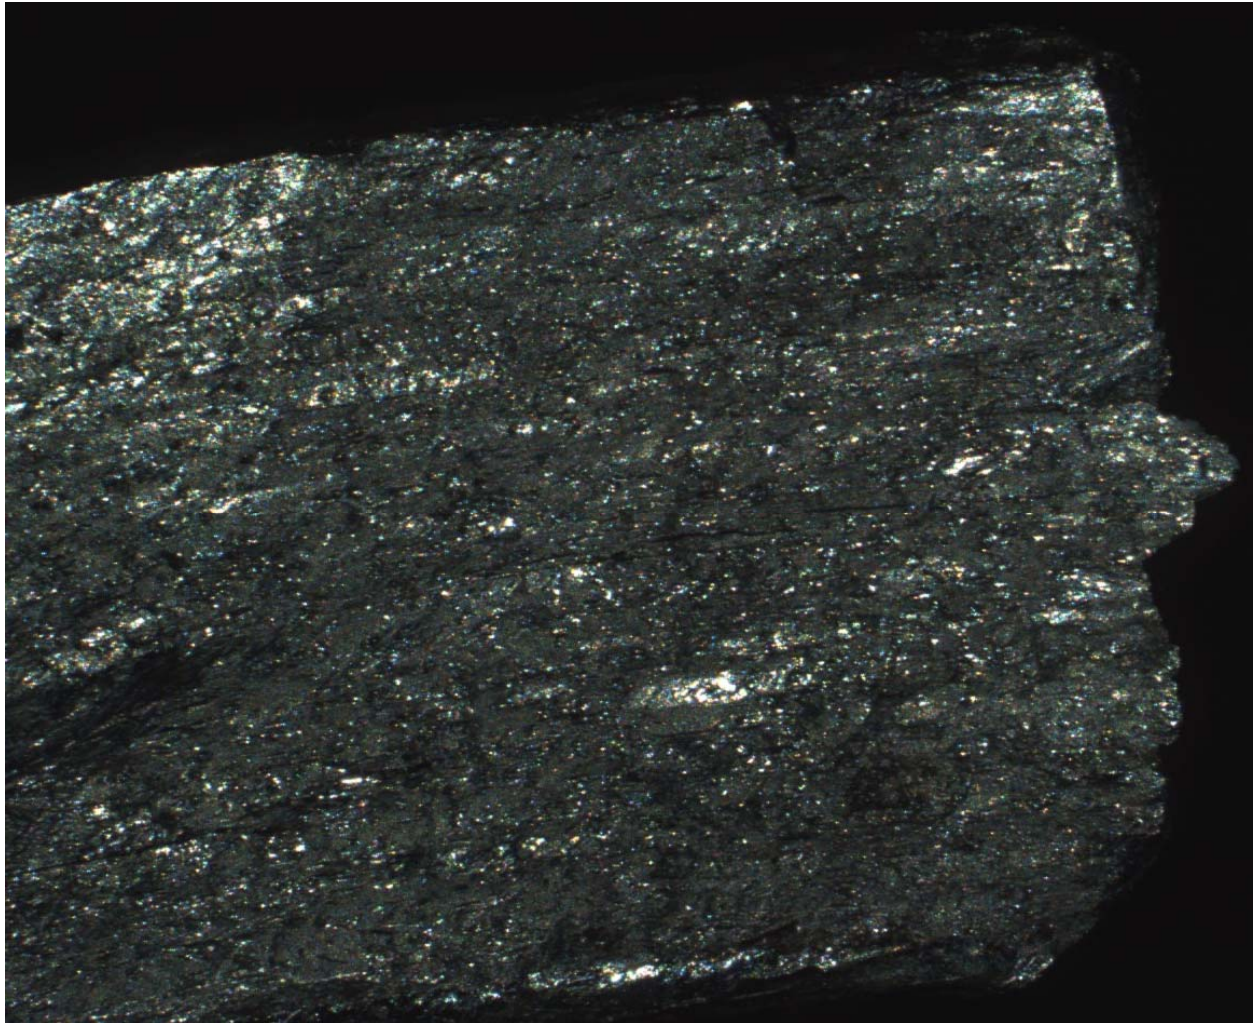
**Fig. 5-10**

Face C-Failure area adjacent to applied load  
Failure Mode: Ductile Overload

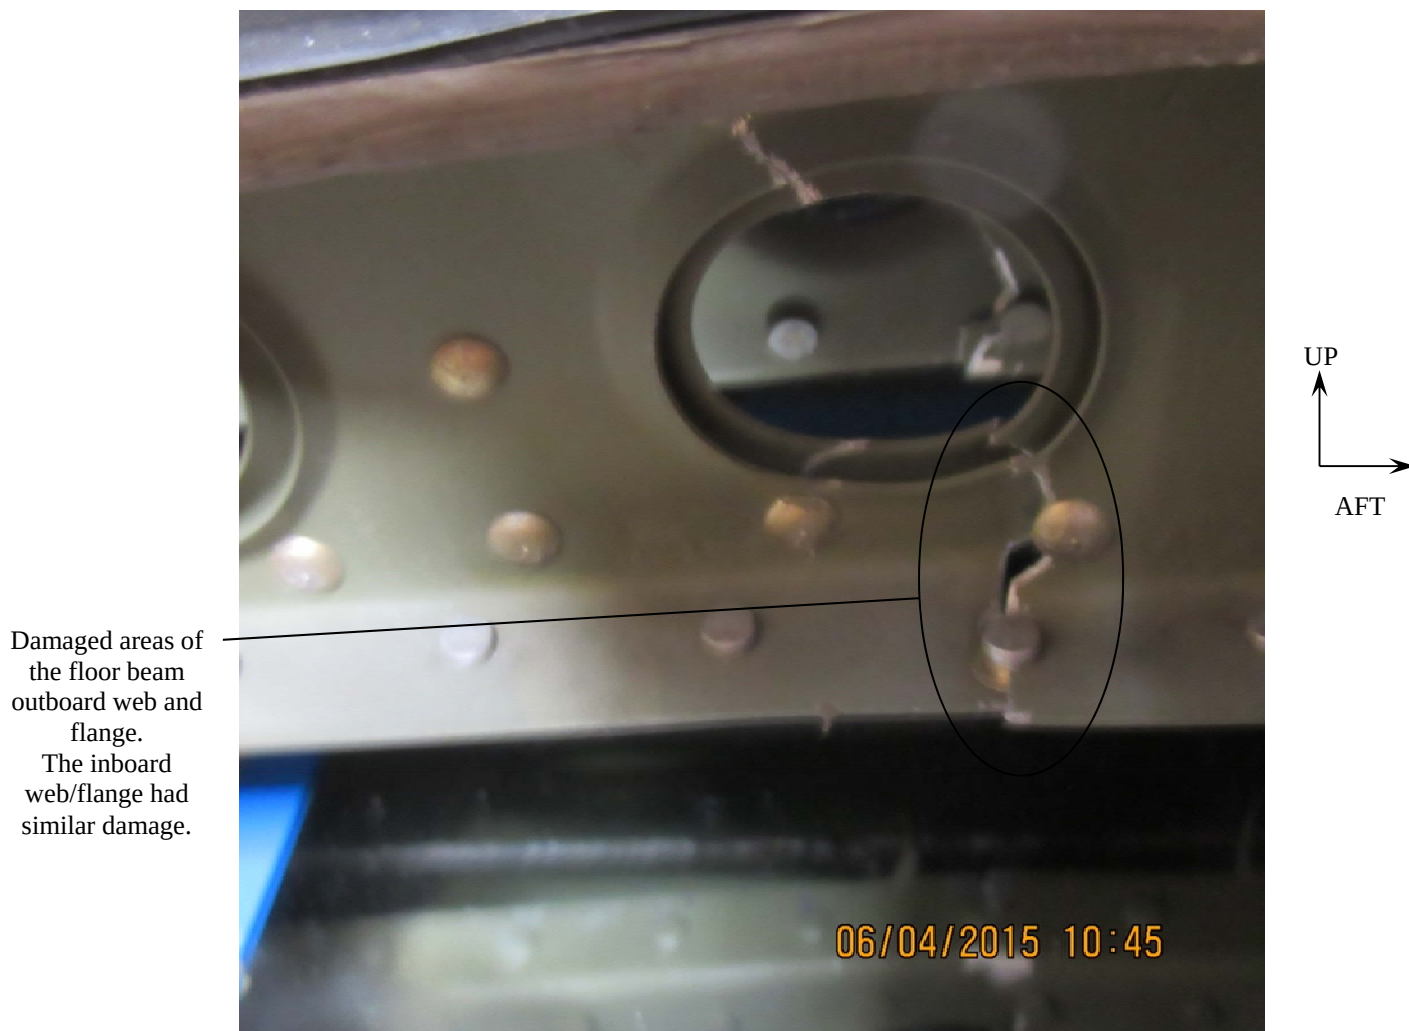
**Fig. 5-11**

- a. The 1159B21284-43 Beam Installation was cracked and distorted at the following locations:
  - (a) FS 360.00 - (Inboard and Outboard Sides) (Fig. 5-11 and 5-12).
  - (b) FS 373.00 - (Inboard Side) (Fig. 5-13).
  - (c) FS 384.00 - (Inboard and Outboard Side) (Fig. 5-14).
  - (d) FS 412.00 - (Inboard and Outboard Side) (Fig. 5-15).
  - (e) FS 452.50 - The attachment joint had indications of diagonal buckling on the aft 6" of the web on the inboard and outboard side of the beam. (Fig. 5-16).

View looking inboard at the outboard web/flange of the LBL 18 Floor Beam at FS 360

- iii. Repair/Resolution:
  - a. Remove and replace the 1159B21284-43 Floor Beam to the requirements of the 1159B20005-7 Structure Assy and 1159B20005-5 Structure Instl.
  - b. Document and submit to GAC Technical Operations any structural damage identified with a full description and digital photos for evaluation
