## 1.0 Introduction

G-IV s/n 1225, N450KK is currently operated by La Venezolana de Seguros y Vida CA.

On April 24, 2015, G-IV s/n 1225 conducted a flight from Maiqueita Airport Carracas, Venezuela (CCS) to Fort Lauderdale, FL (FLL). The flight loading consisted of a pilot and co-pilot and no passengers. The flight crew and aircraft experienced an over pressurization incident enroute. The pilots followed the Aircraft Flight Manual (AFM) procedures and executed a successful landing at FLL. An initial visual inspection performed by the flight crew did not reveal any indications of damage. The plane was then flown to Reliable Jet Maintenance (RJM) at Boca Raton, FL (BCT) airport.

**G-IV S/N 1225 Structural Evaluation-Over Pressurization Event**

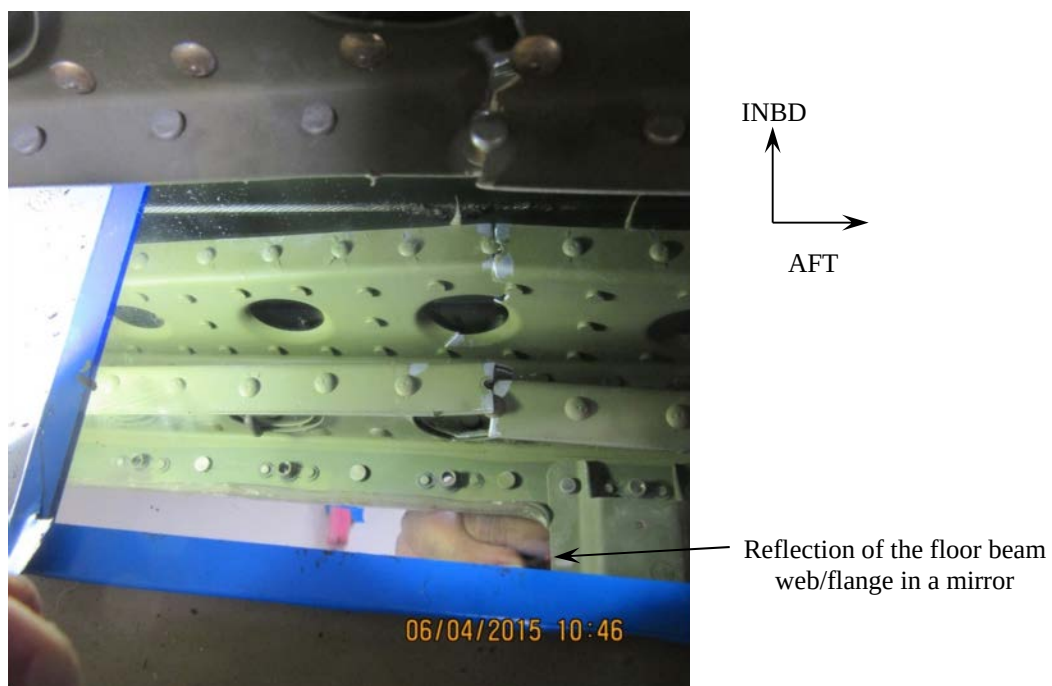
**Fig. 5-12**

- a. The 1159B21284-43 Beam Installation was cracked and distorted at the following locations:
  - (a) FS 360.00 - (Inboard and Outboard Sides) (Fig. 5-11 and 5-12).
  - (b) FS 373.00 - (Inboard Side) (Fig. 5-13).
  - (c) FS 384.00 - (Inboard and Outboard Side) (Fig. 5-14).
  - (d) FS 412.00 - (Inboard and Outboard Side) (Fig. 5-15).
  - (e) FS 452.50 - The attachment joint had indications of diagonal buckling on the aft 6" of the web on the inboard and outboard side of the beam. (Fig. 5-16).

View looking up at the lower web/flange of the LBL 18 Floor Beam at FS 360.00

- iii. Repair/Resolution:
  - a. Remove and replace the 1159B21284-43 Floor Beam to the requirements of the 1159B20005-7 Structure Assy and 1159B20005-5 Structure Instl.
  - b. Document and submit to GAC Technical Operations any structural damage identified with a full description and digital photos for evaluation

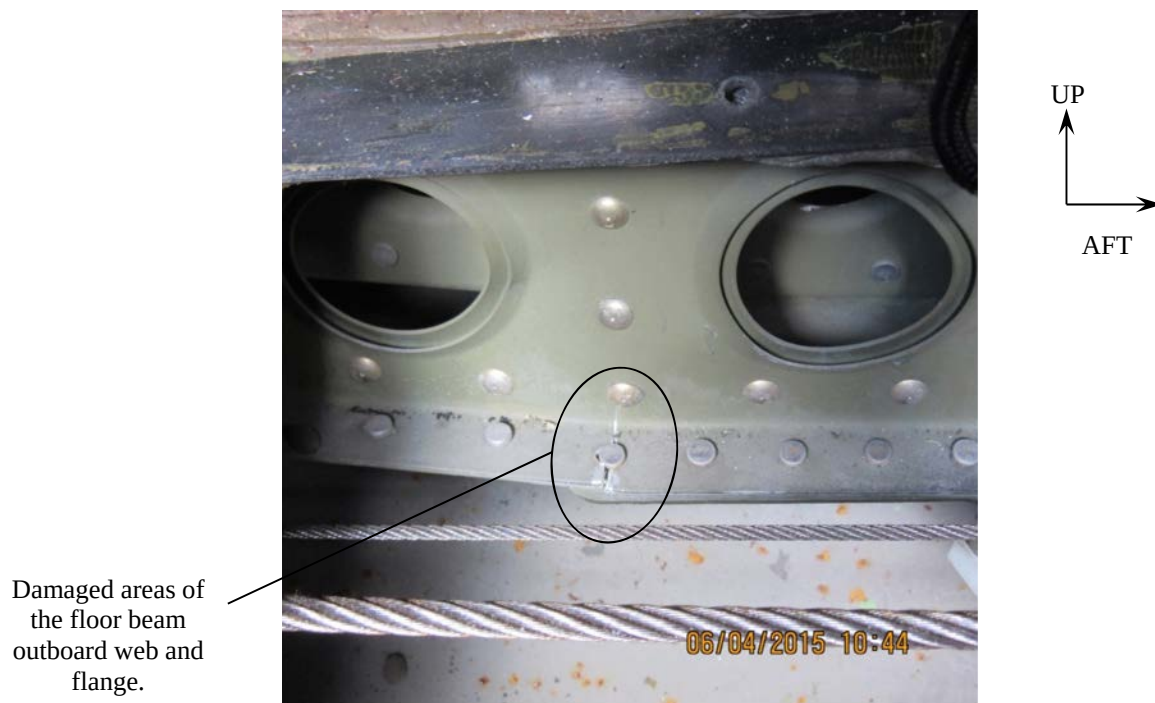
**Fig. 5-13**

View looking inboard at the outboard web/flange of the LBL 18 Floor Beam at FS 373.00

Damaged areas of the floor beam outboard web and flange. The inboard web/flange had similar damage.

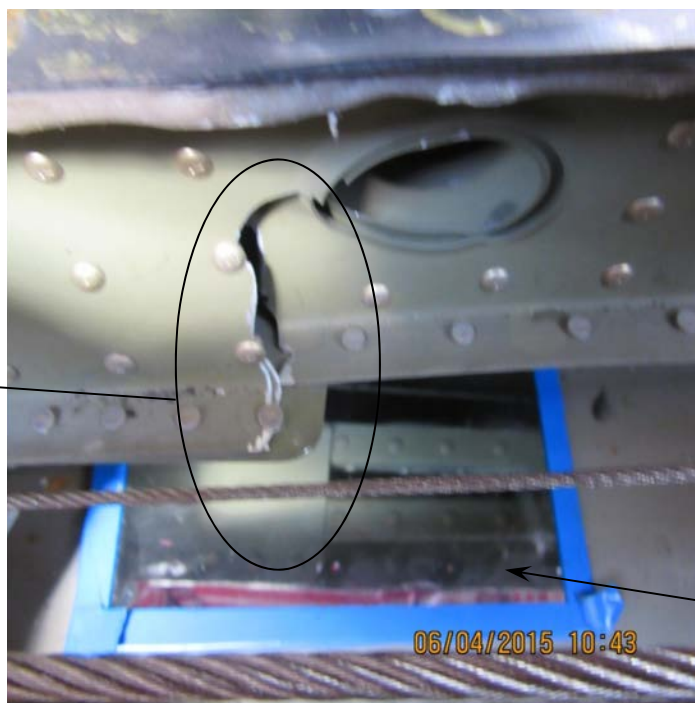
**Fig. 5-14**

View looking inboard at the lower web/flange of the LBL 18 Floor Beam at FS 384.00

Damaged areas of the floor beam inboard/outboard web and flanges.

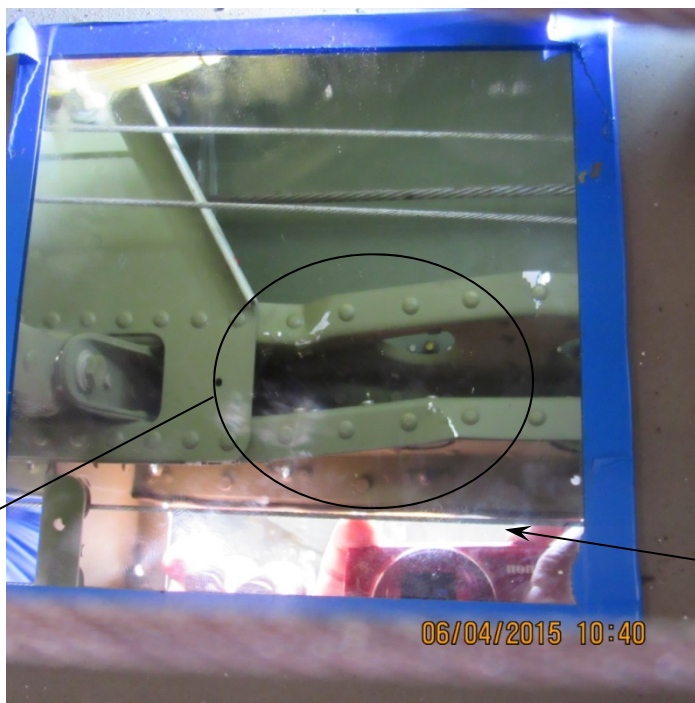
**Fig. 5-15**

View looking up at the lower web/flange of the LBL 18 Floor Beam at FS 412.00

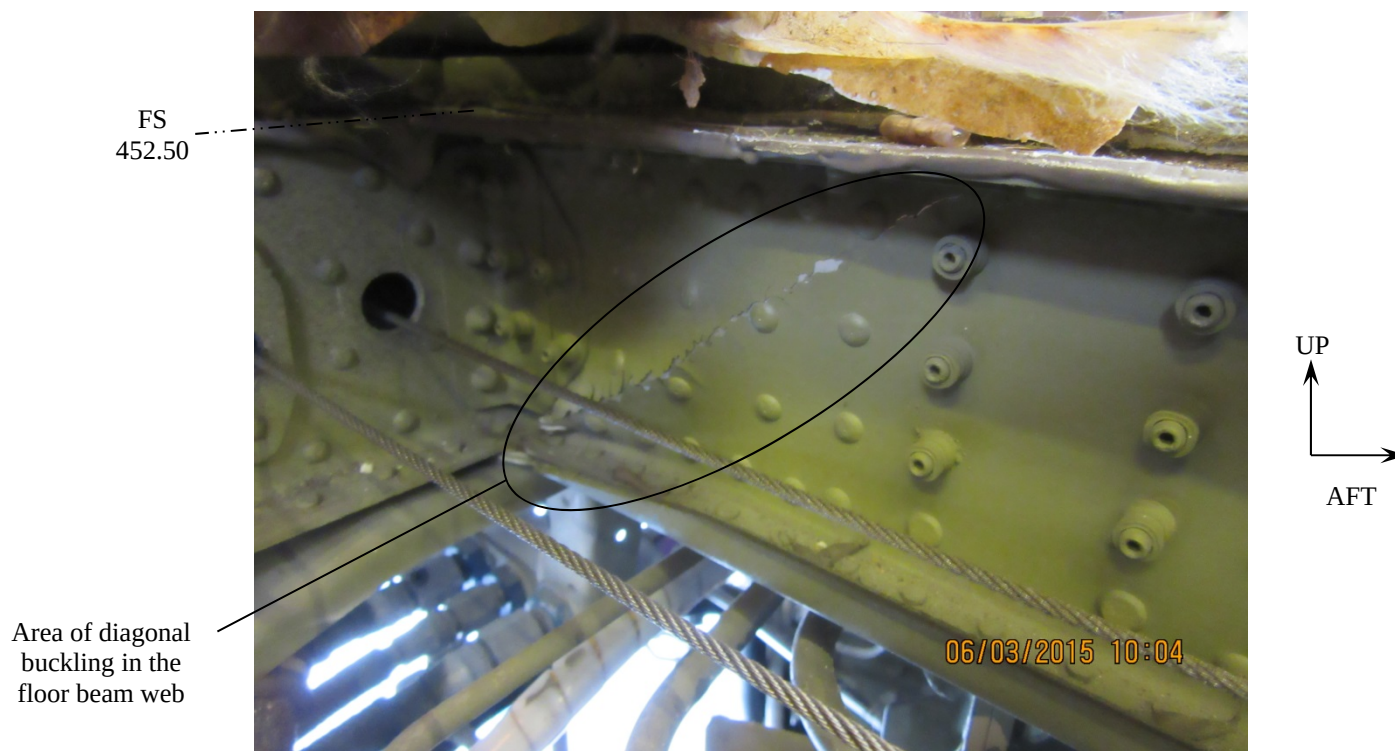
**Fig. 5-16**

View looking outboard at the inboard face of the  
LBL 18.0 Floor Beam Web at FS 452.50  
(The inboard web exhibited similar conditions)

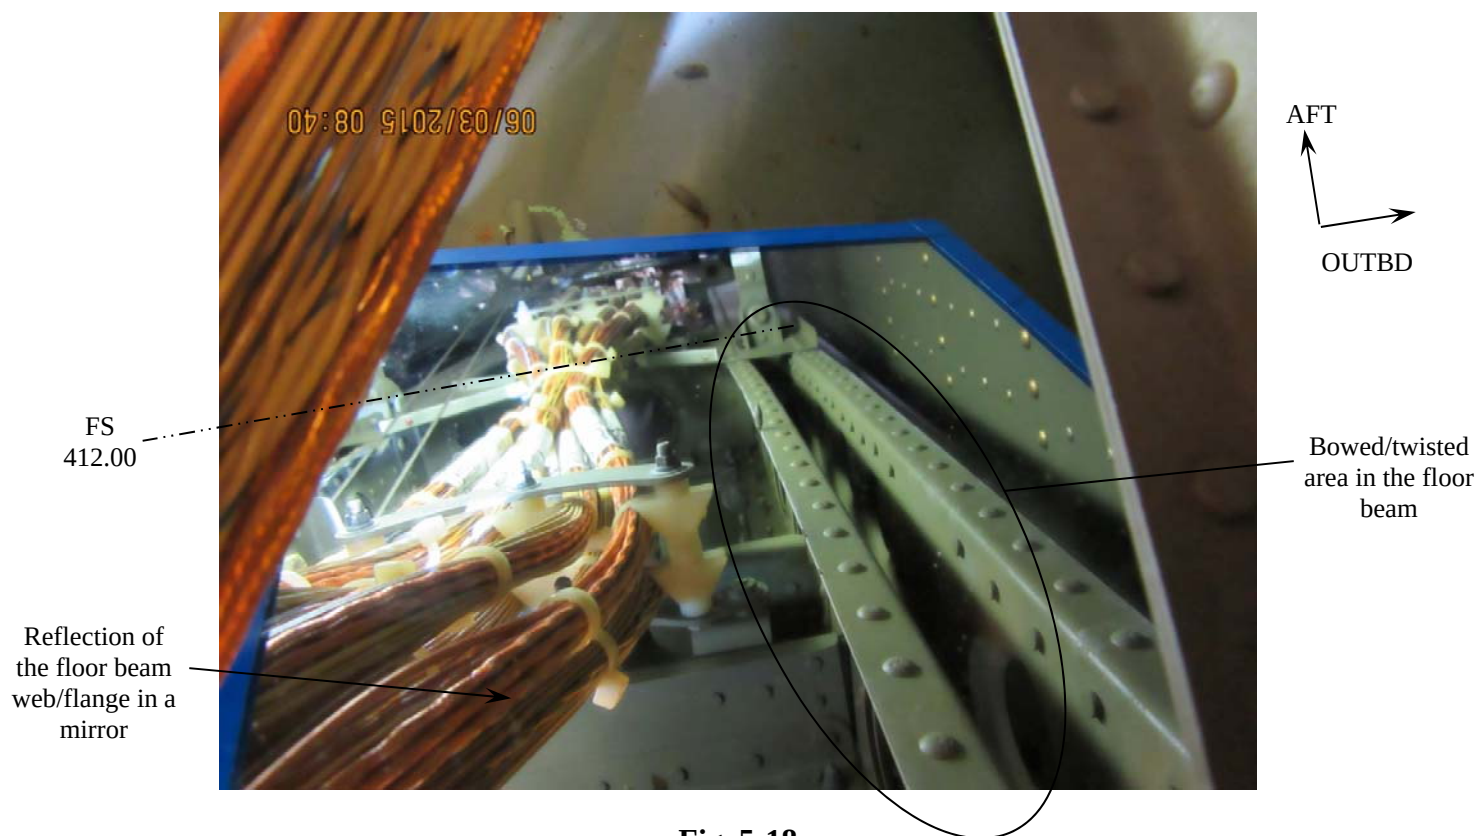
**Fig. 5-18**

- a. The beam was deflected (twisted) outboard of location between FS 359.00 to FS 384.00 (Fig. 5-18).
- b. The inboard flange of the web was buckled forward of the FS 412 wing link (Fig. 5-19).

View looking aft at FS 359.00 at LBL 30.5

- (a) Remove and replace the 1159B21284-45 Floor Beam to the requirements of the 1159B20005-7 Structure Assy and 1159B20005-5 Structure Instl.
- (b) Document and submit to GAC Technical Operations any structural damage identified with a full description and digital photos for evaluation

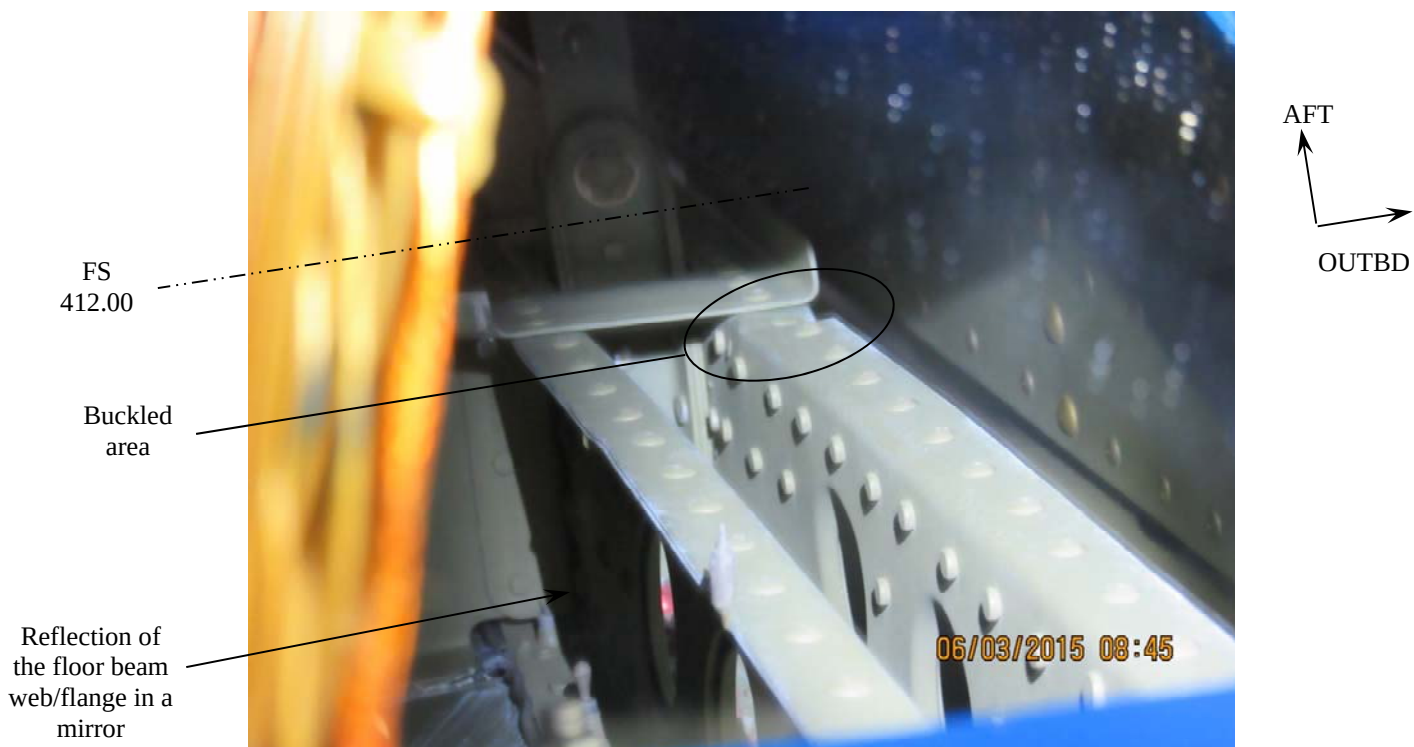
**Fig. 5-19**

View looking aft at FS 412.00 at LBL 30.5

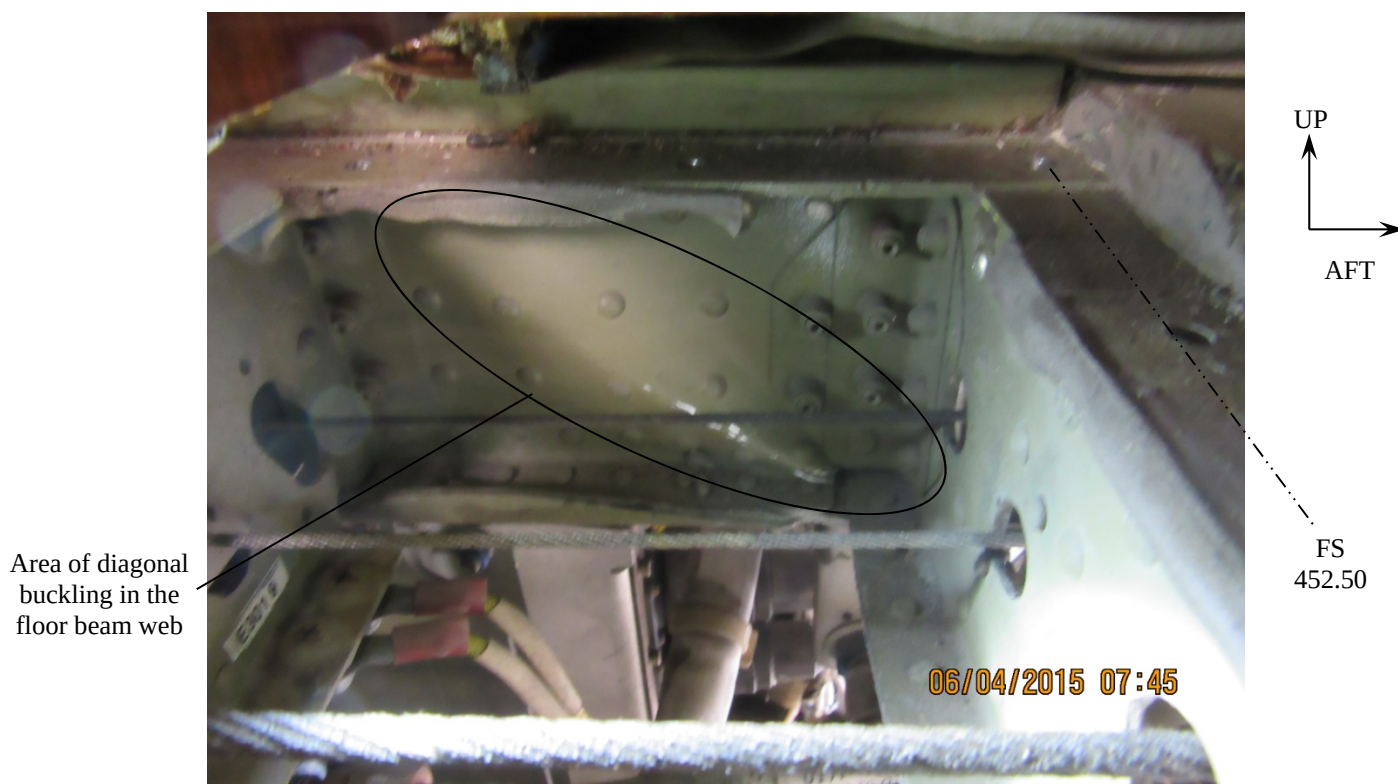
**Fig. 5-20**

- a. FS 452.50-- The attachment joint had indications of diagonal buckling on the aft 6" of the web on the inboard and outboard side of the beam.

View looking outboard at the inboard face of the RBL 18.0 Floor Beam Web at FS 452.50

- a. Remove and replace the 1159B21284-44 Floor Beam to the requirements of the 1159B20005-7 Structure Assy and 1159B20005-5 Structure Instl.
- b. Document and submit to GAC Technical Operations any structural damage identified with a full description and digital photos for evaluation

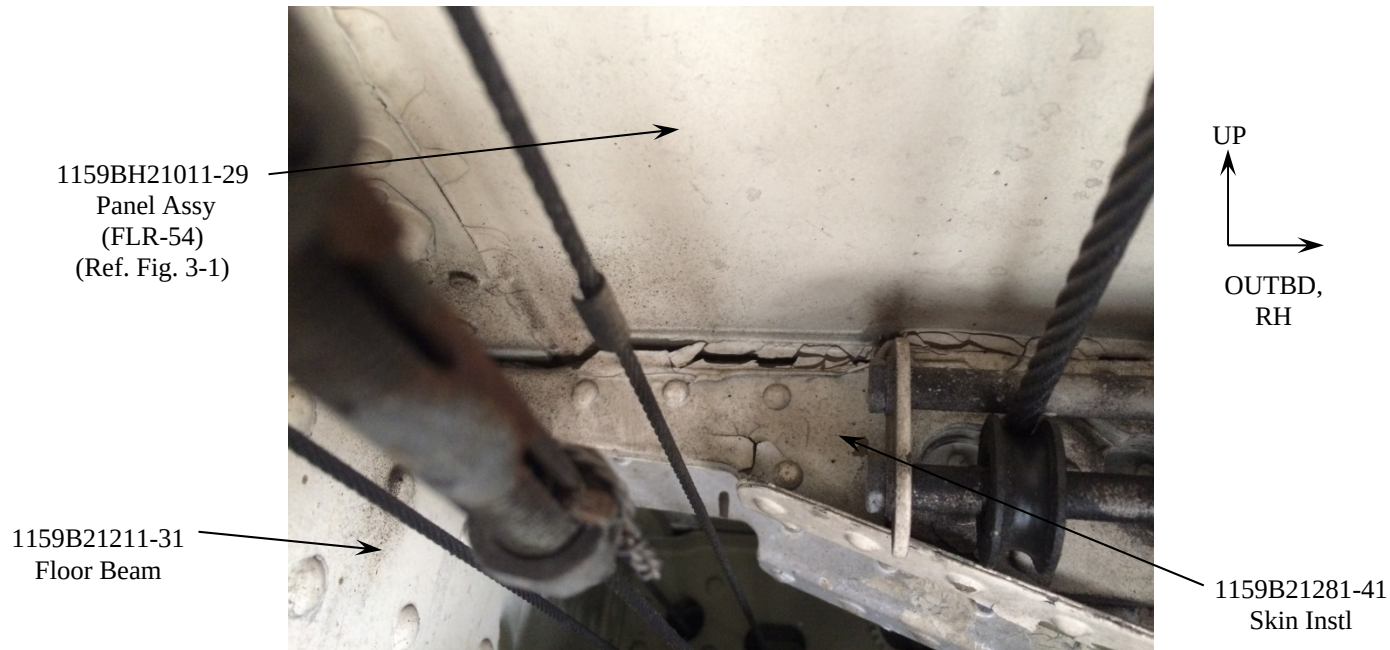
**Fig. 6-1**

- The interface between the 1159B21281-41 Beam Assy and the 1159BH21011-29 Panel Assy exhibited an area of separation between the matting surfaces.
- See Section 5.0 for the floor beam findings at FS 452.50
- On both the LH and RH side of the aircraft, between Stringer #9 and the top edge of the wing to body fairing, the forward row of rivets attaching the 1159B41311 Skin exhibited evidence of cracked/lifting paint on the rivet heads (See Fig.'s 6-2 to 6-5).

View looking up/forward at the interface of the Floorboard, Intercoastal and Floor Beam at FS 452.50 and RBL 6.0

- i. Perform a complete visual inspection of the 1159B21281-1 Beam Instl. At FS 452.50.
- ii. Perform the Pressure Differential Exceedance Inspection in Accordance with the G\_IV MSG-3 MM, Section 05-50-00, Section 13.
- iii. Document and submit to GAC Technical Operations any structural damage identified with a full description and digital photos for evaluation

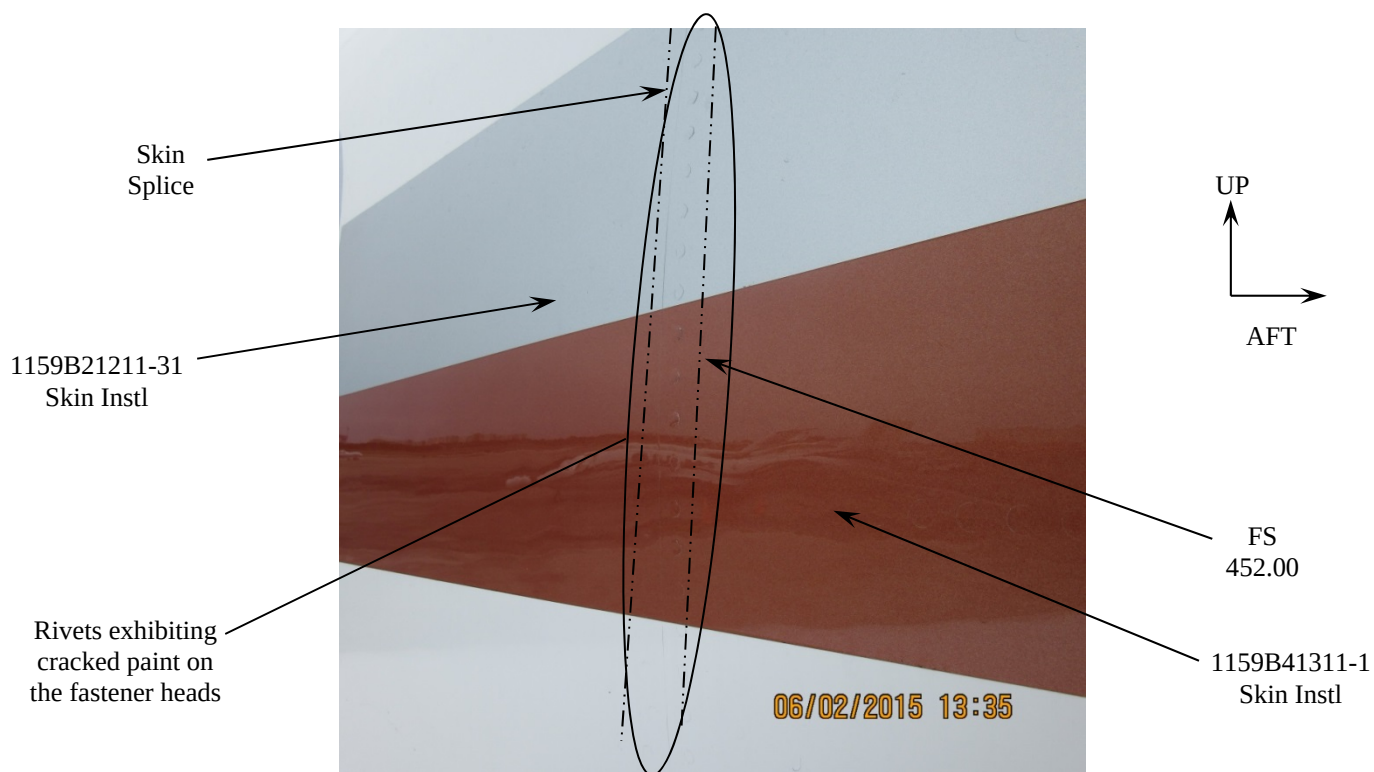
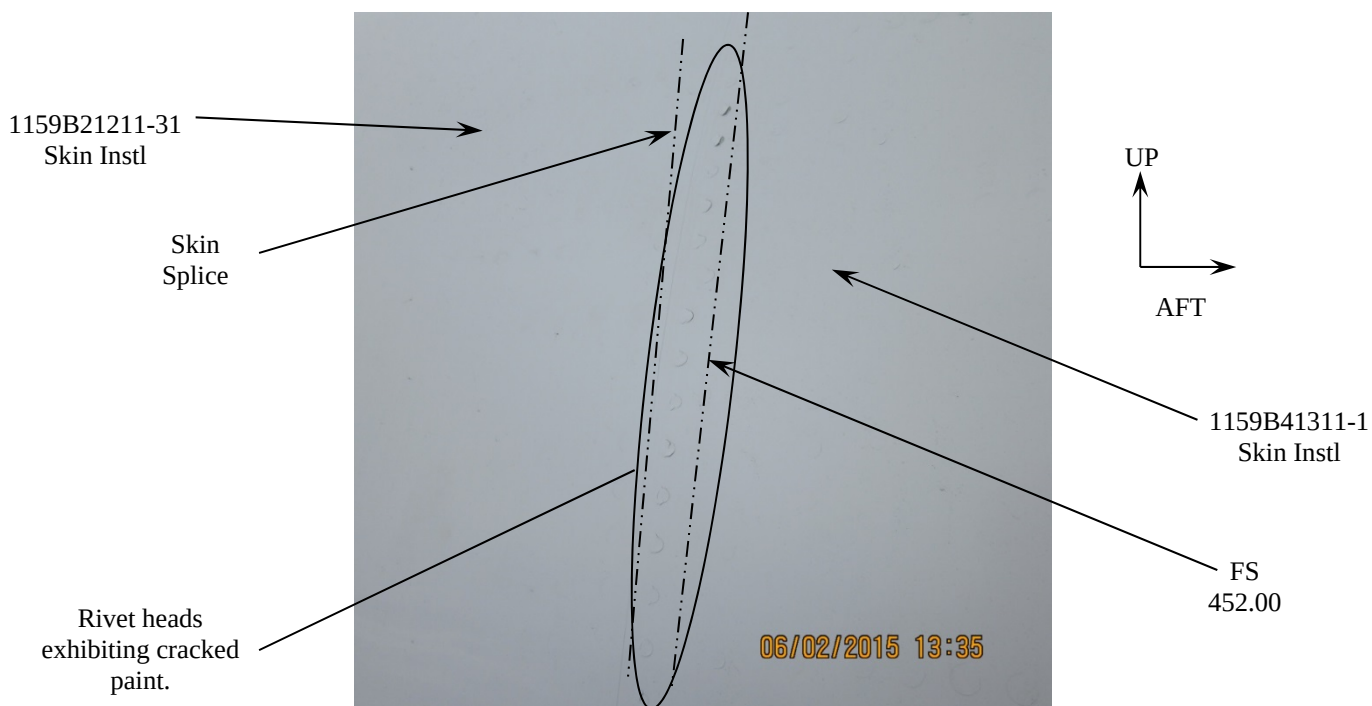
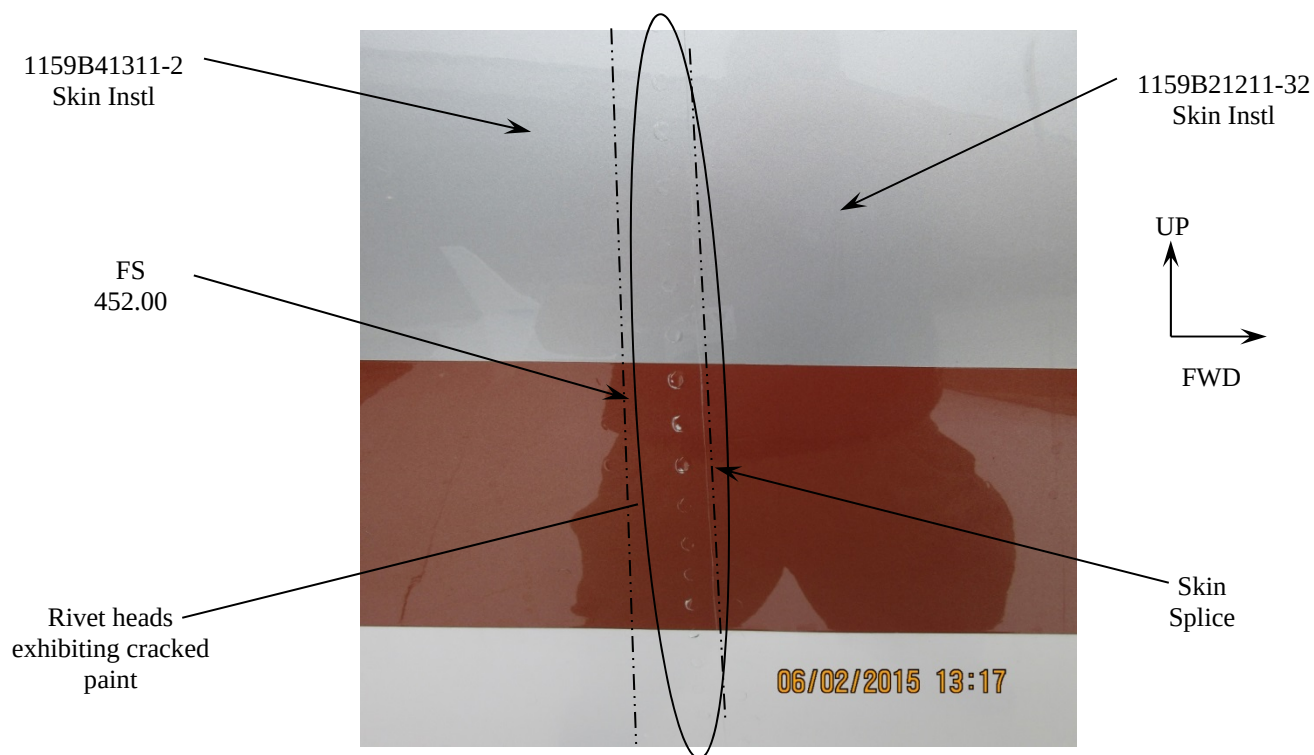
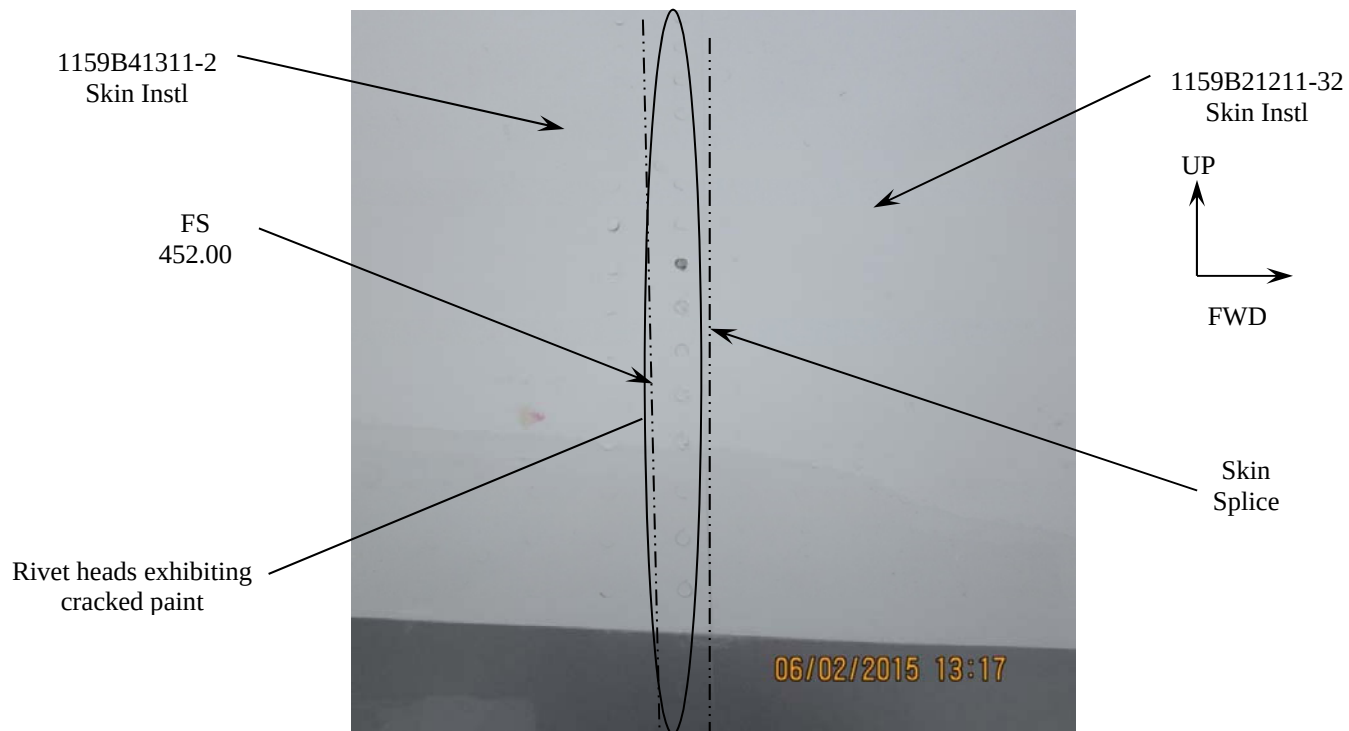
**Fig. 6-2**  
View looking inboard at the LH Skin

**Fig. 6-3**  
View looking inboard at the LH Skin

**Fig. 6-4**  
View looking inboard at the RH Skin

**Fig. 6-5**  
View looking inboard at the RH Skin

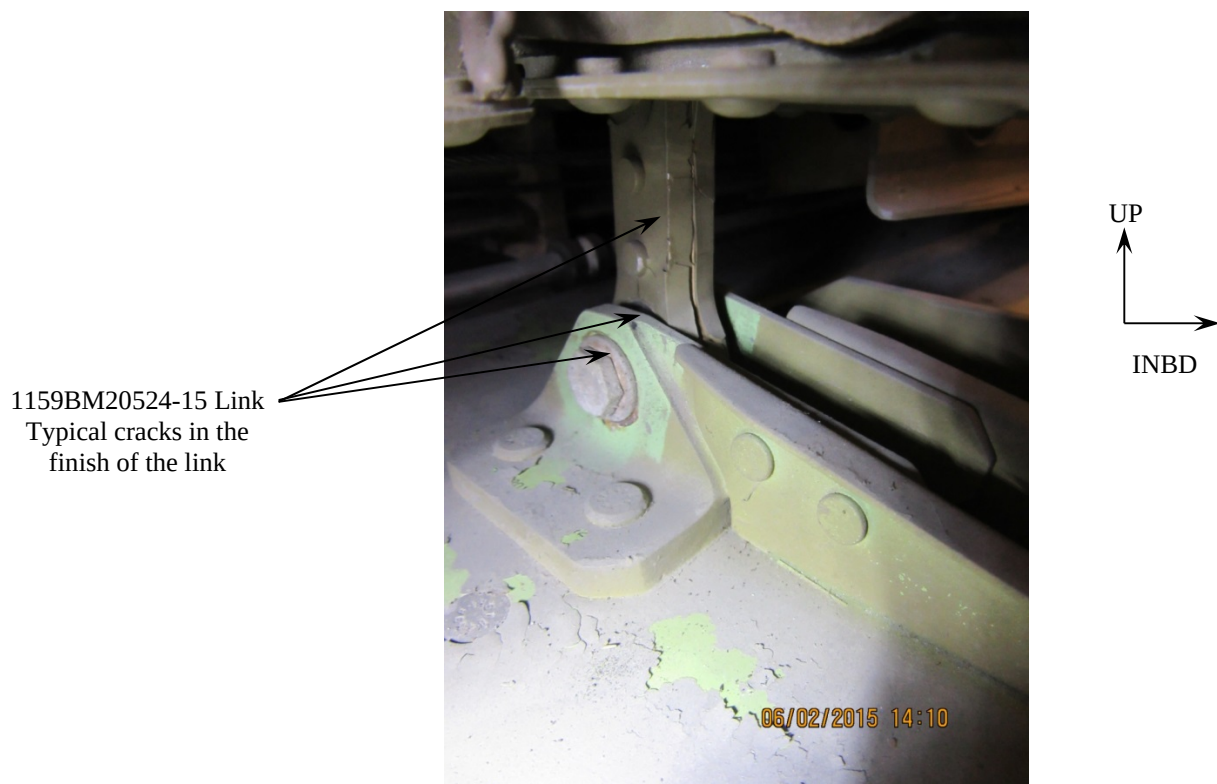
**Fig. 7-1**

- i. FS 345.875:
  - a. LBL 30.5 No link at this location.
  - b. LBL 18 The link appeared to be vertical and installed properly.
  - c. LBL 6 The link exhibited cracked finish on multiple faces (Fig. 7-1).

FS 345/LBL 6.0 Wing link exhibiting cracked finish on multiple surfaces

- i. At each identified link location, remove and replace the noted link(s) and install with new hardware in accordance with Chapter 53-30-00 of the G-IV Illustrated Parts Catalog (IPC):
- ii. Prior to installation of the new links, High frequency Eddy Current (HFEC) Inspect the associated attach fittings on the wings for cracks in accordance with the G-IV Non-Destructive Testing (NDT) Manual. Pay particular attention to the lugs, holes and the fillet radii of the vertical legs.
- iii. Inspect the hole diameters of the associated attach fittings on the wings (Ref. Fig. 7-10):

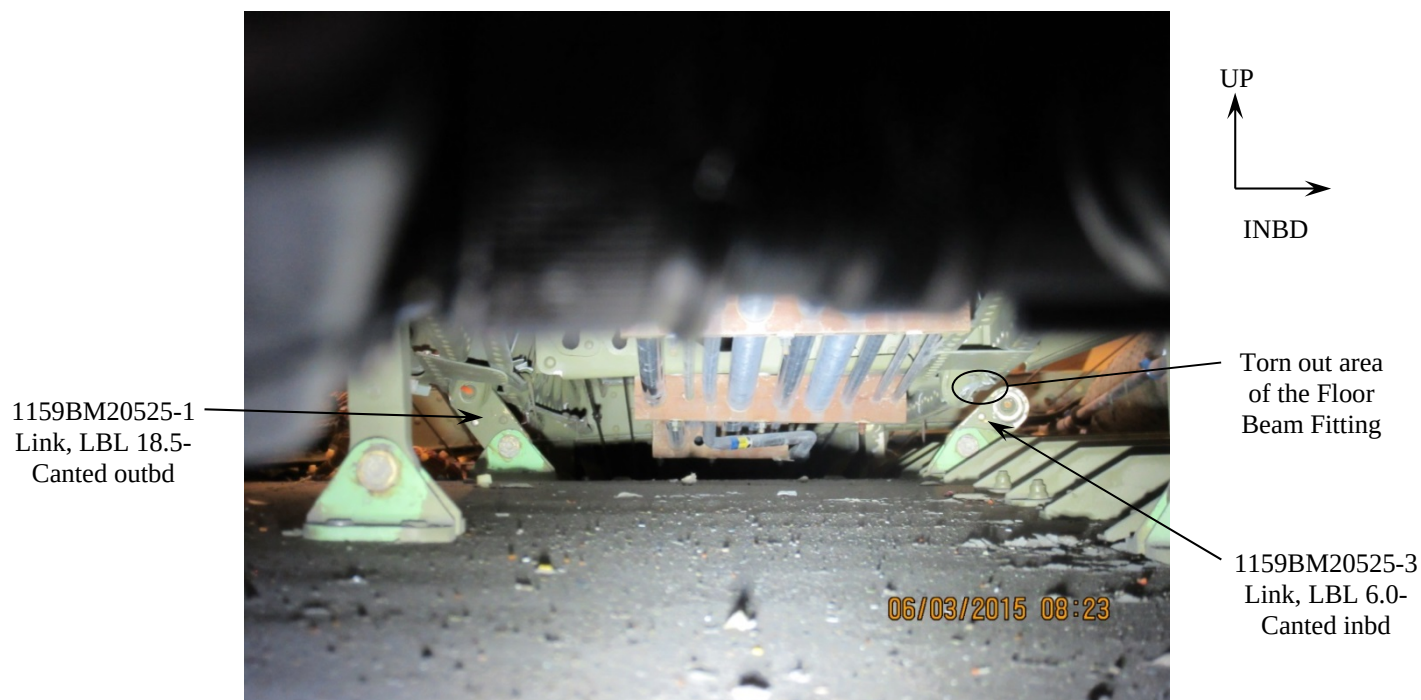
**Fig. 7-2**

- ii. FS 379.00:
  - a. LBL 30.5 The link was attached at the upper and lower points. The upper attachment was leaning outboard (Fig. 7-3).
  - b. LBL 18 The link was attached at the upper and lower points. The upper attachment was leaning outboard (Fig. 7-2).

- c. LBL 6 The link was attached at the lower point. The upper attach point was broken off from the beam attachment. The link was leaning inboard (Fig. 7-2).

View looking forward at FS 379/LBL 18 and LBL 6 Wing Links

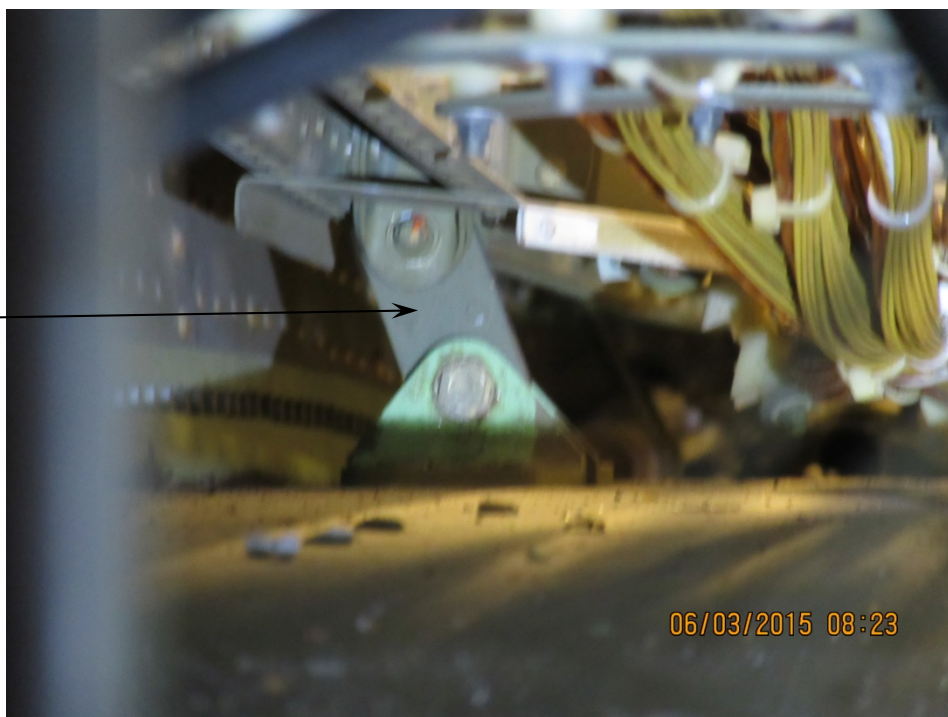
**Fig. 7-3**

1159BM20525-3  
Link, LBL 30,0-  
Canted outbd

View looking forward at FS 379/LBL 30.5 Wing Link

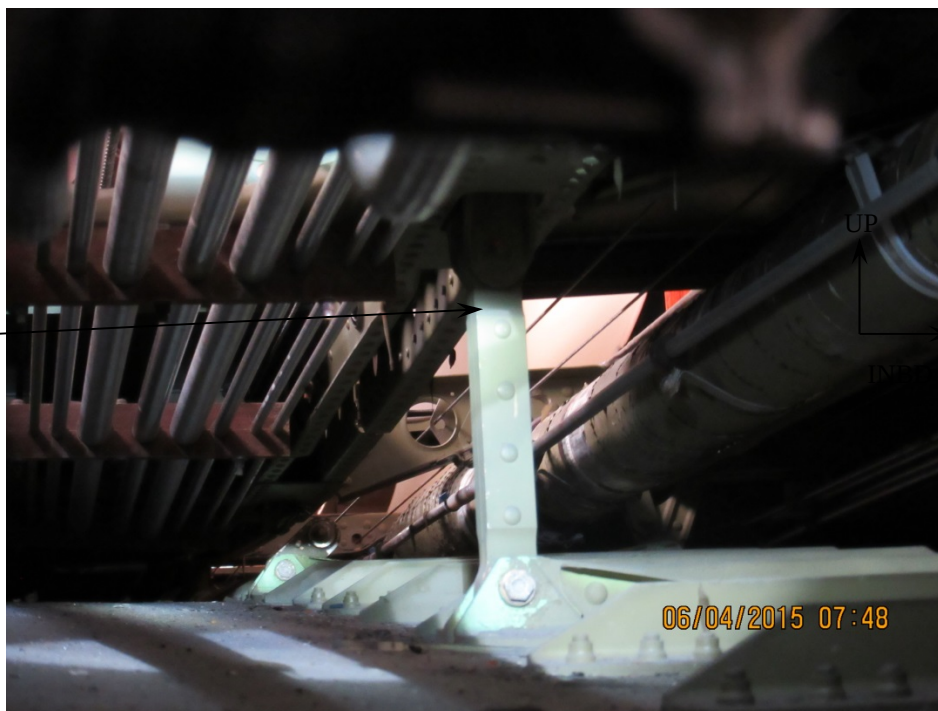
**Fig. 7-4**

- c. LBL 6 The link was attached at the upper and lower points. The upper attachment was leaning outboard (Fig. 7-4).
  - d. RBL 6 The link appeared to be vertical and installed properly.

1159BM20526-19  
Link, LBL 6.0-  
Canted outbd

View looking forward at FS 412/LBL 6.0 Wing Link

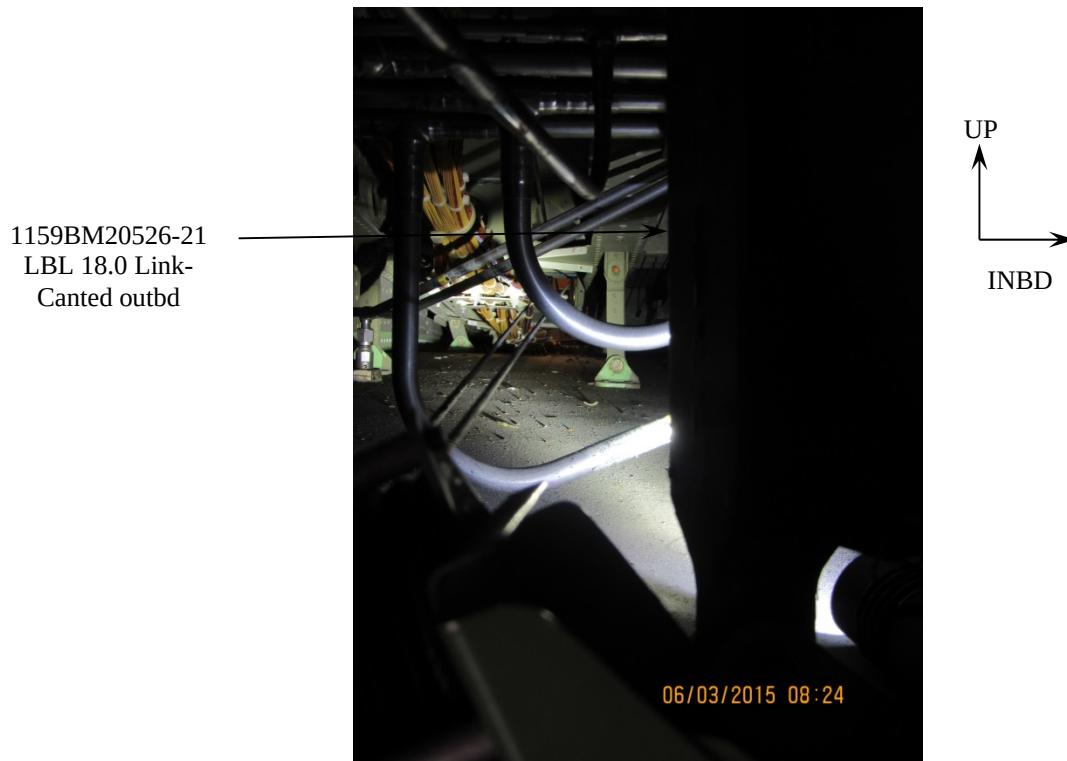
**Fig. 7-5**

- iii. FS 412.00:
  - a. LBL 30.5 The link was attached at the upper and lower points. The upper attachment was leaning outboard (Fig. 7.6).
  - b. LBL 18 The link was attached at the upper and lower points. The upper attachment was leaning outboard (Fig. 7-5).

View looking forward at FS 412/LBL 18.0 Wing Link

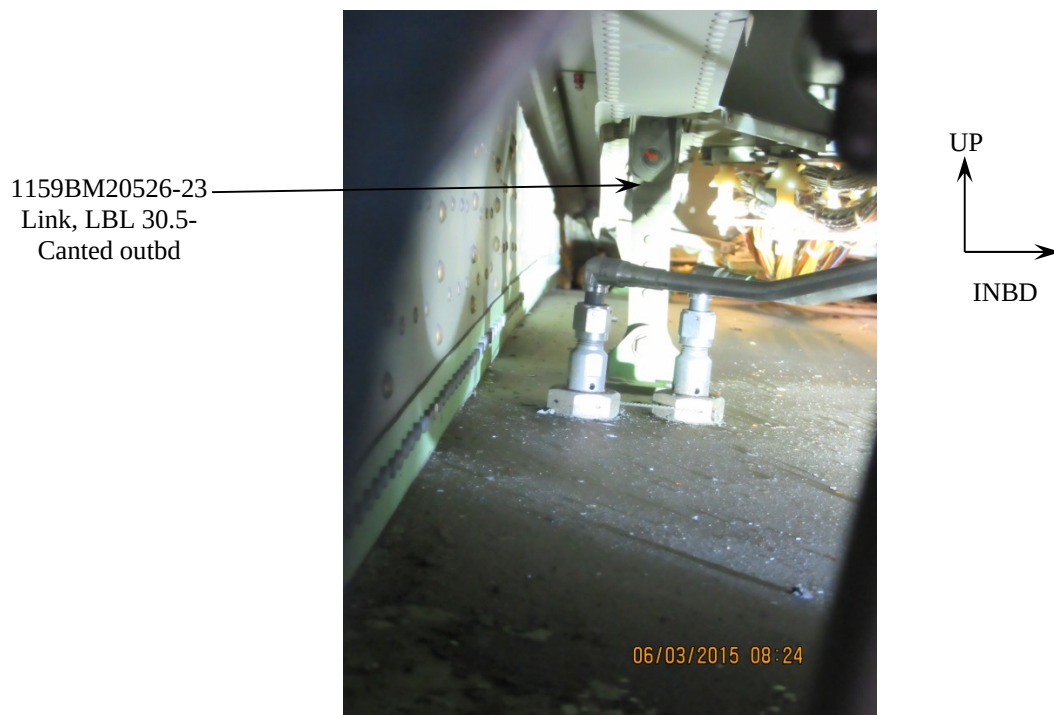
**Fig. 7-6**

View looking forward at FS 412/LBL 30.5 Wing Link

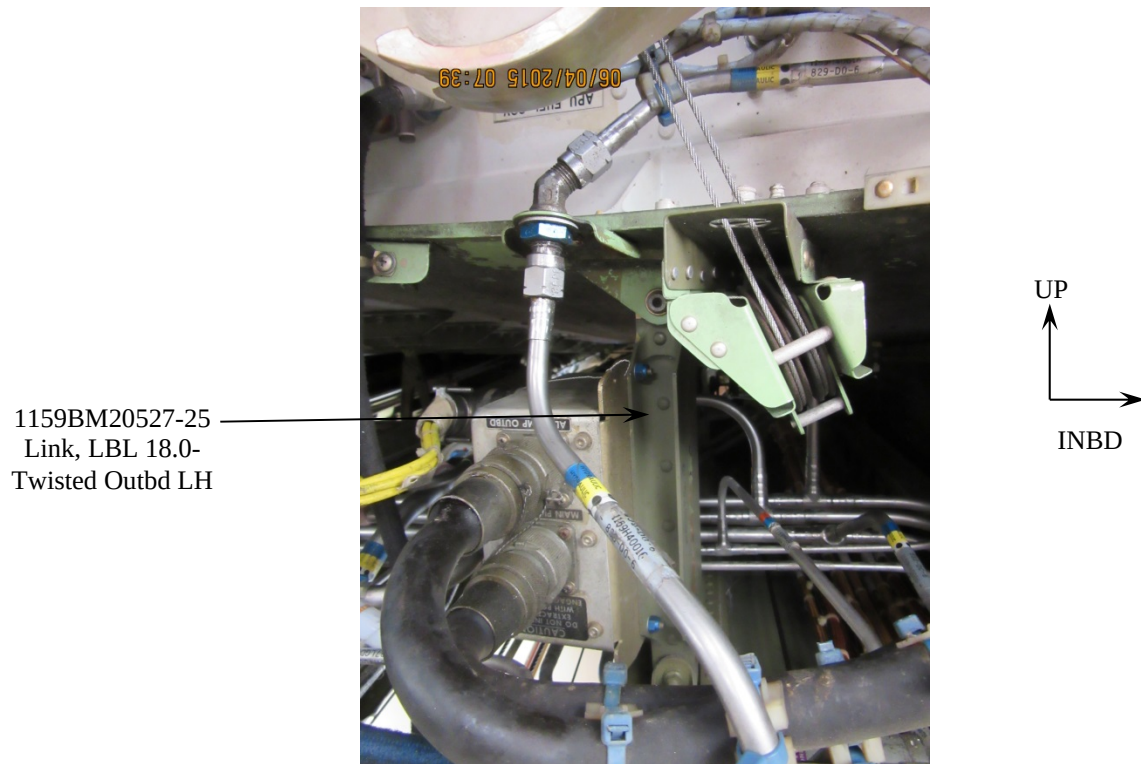
**Fig. 7-7**

- a. LBL 30.5 No link at this location.
  - b. LBL 18 The link was vertical, but visibly twisted to the left when looking forward (Fig. 7-7).
  - c. LBL 6 The link was vertical, but visibly twisted to the left when looking forward (Fig. 7-8).

View looking forward at FS 445/LBL 18.0 Wing Link

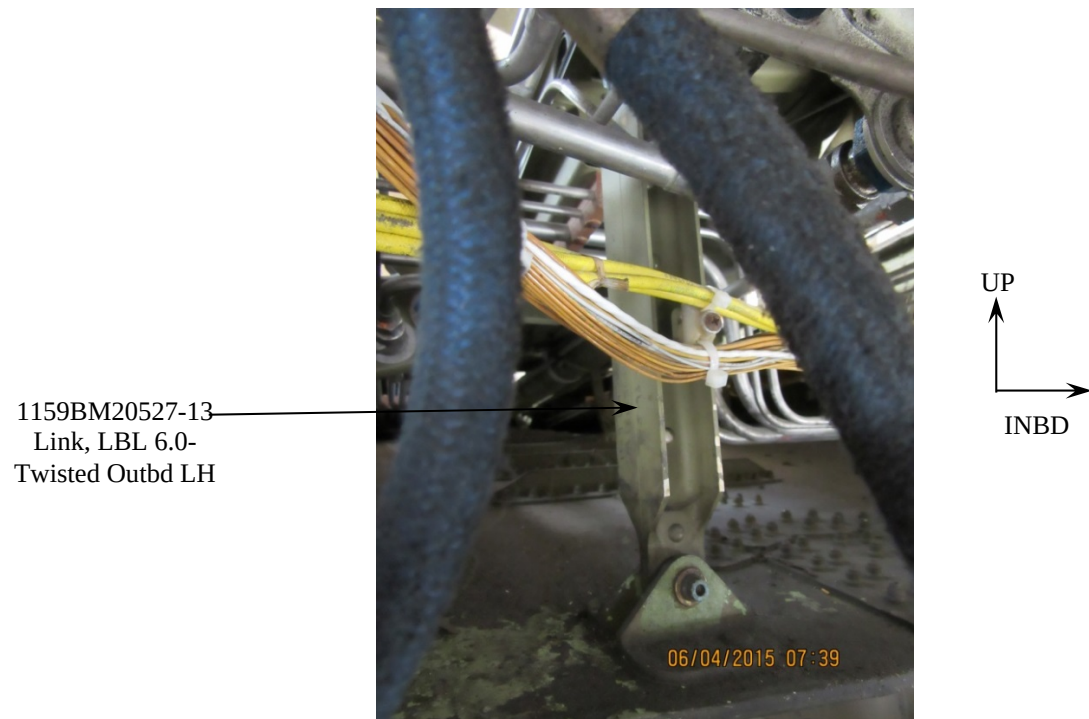
**Fig. 7-8**

View looking forward at FS 445/LBL 6.0 Wing Link

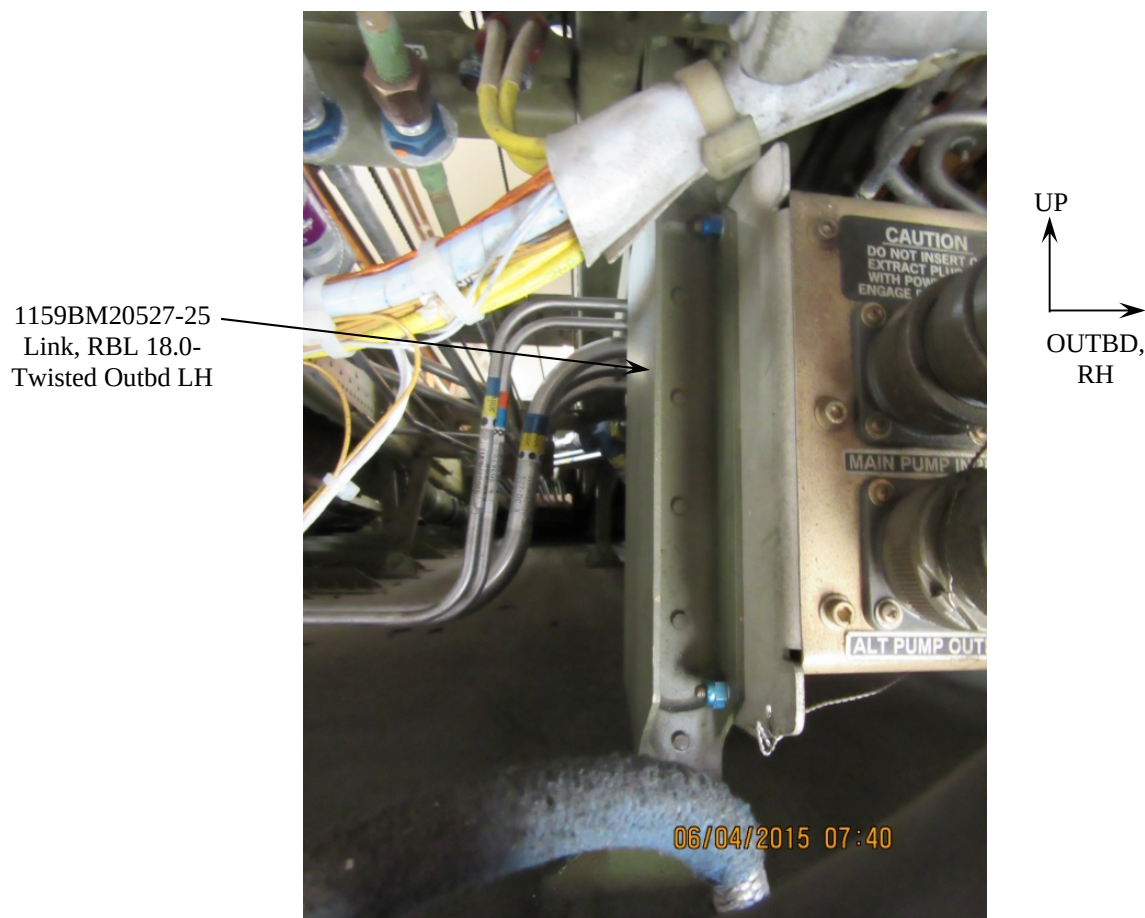
**Fig. 7-9**

- d. RBL 6 The link appeared to be vertical and installed properly.
  - e. RBL 18 The link was vertical, but visibly twisted to the left when looking forward (Fig. 7-9).

View looking forward at FS 445/RBL 18.0 Wing Link
