## 1.0 Introduction

G-IV s/n 1225, N450KK is currently operated by La Venezolana de Seguros y Vida CA.

On April 24, 2015, G-IV s/n 1225 conducted a flight from Maiqueita Airport Carracas, Venezuela (CCS) to Fort Lauderdale, FL (FLL). The flight loading consisted of a pilot and co-pilot and no passengers. The flight crew and aircraft experienced an over pressurization incident enroute. The pilots followed the Aircraft Flight Manual (AFM) procedures and executed a successful landing at FLL. An initial visual inspection performed by the flight crew did not reveal any indications of damage. The plane was then flown to Reliable Jet Maintenance (RJM) at Boca Raton, FL (BCT) airport.

**G-IV S/N 1225 Structural Evaluation-Over Pressurization Event**

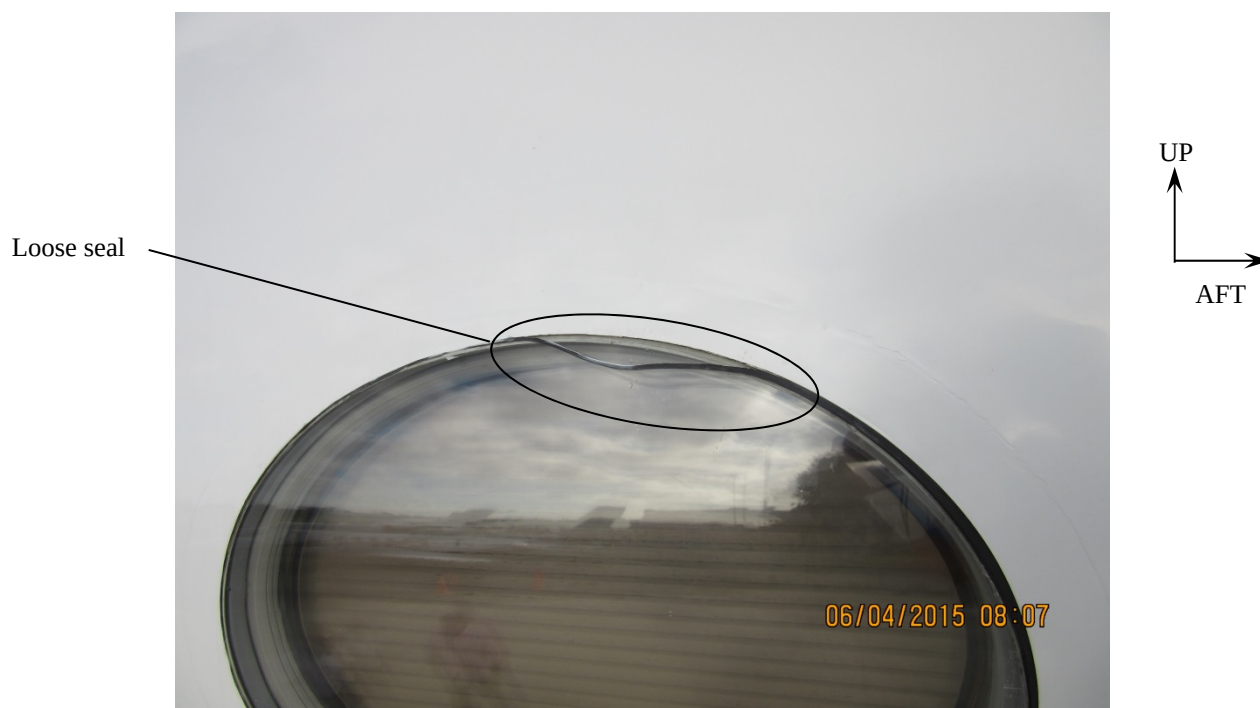
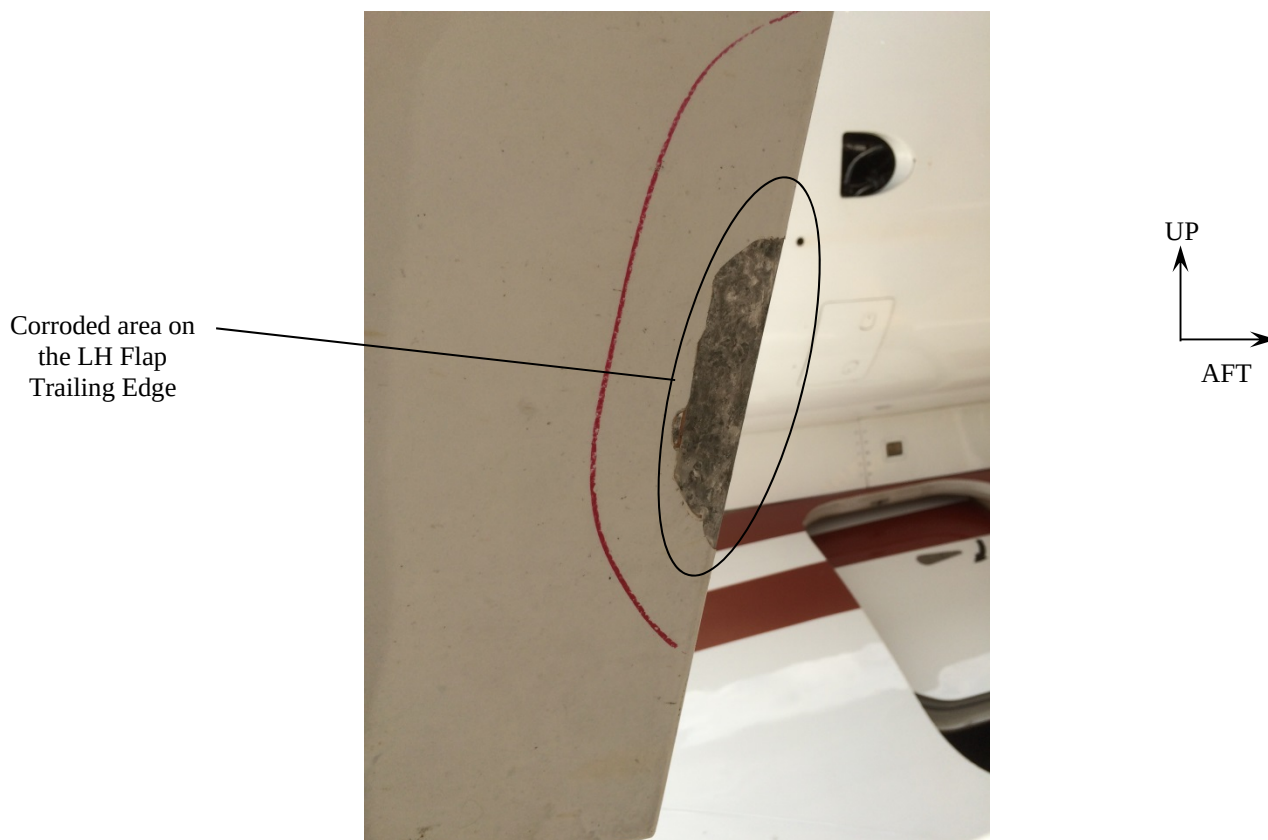
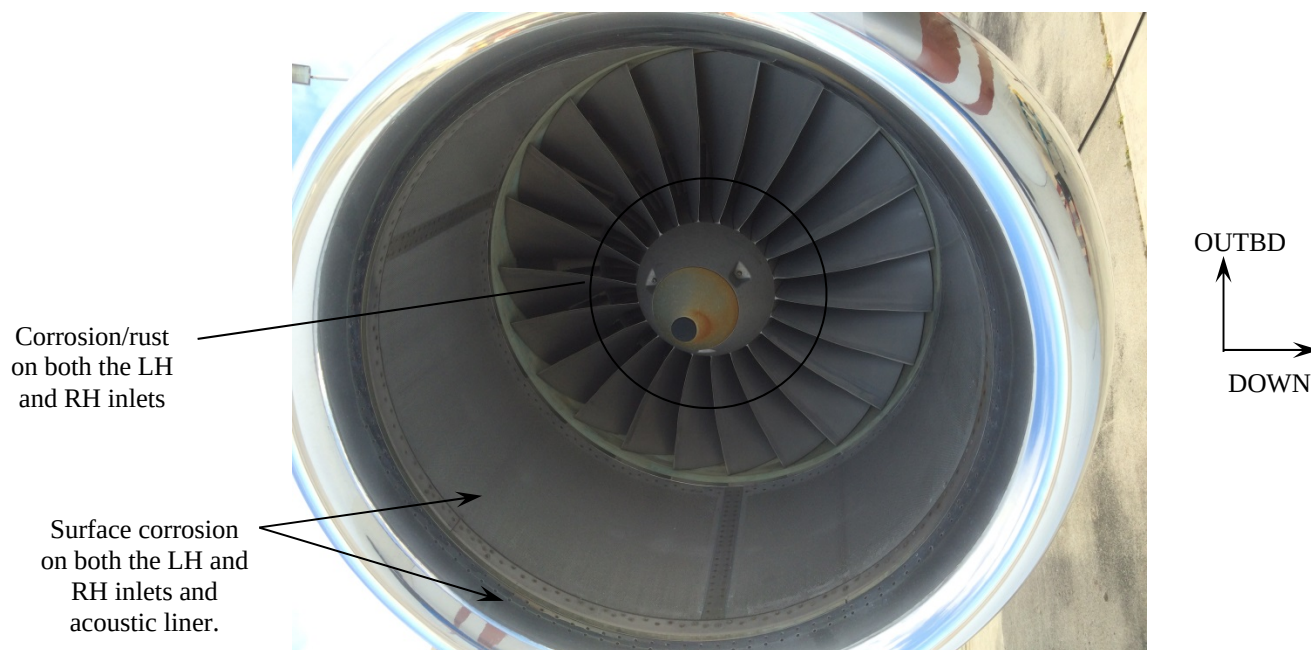
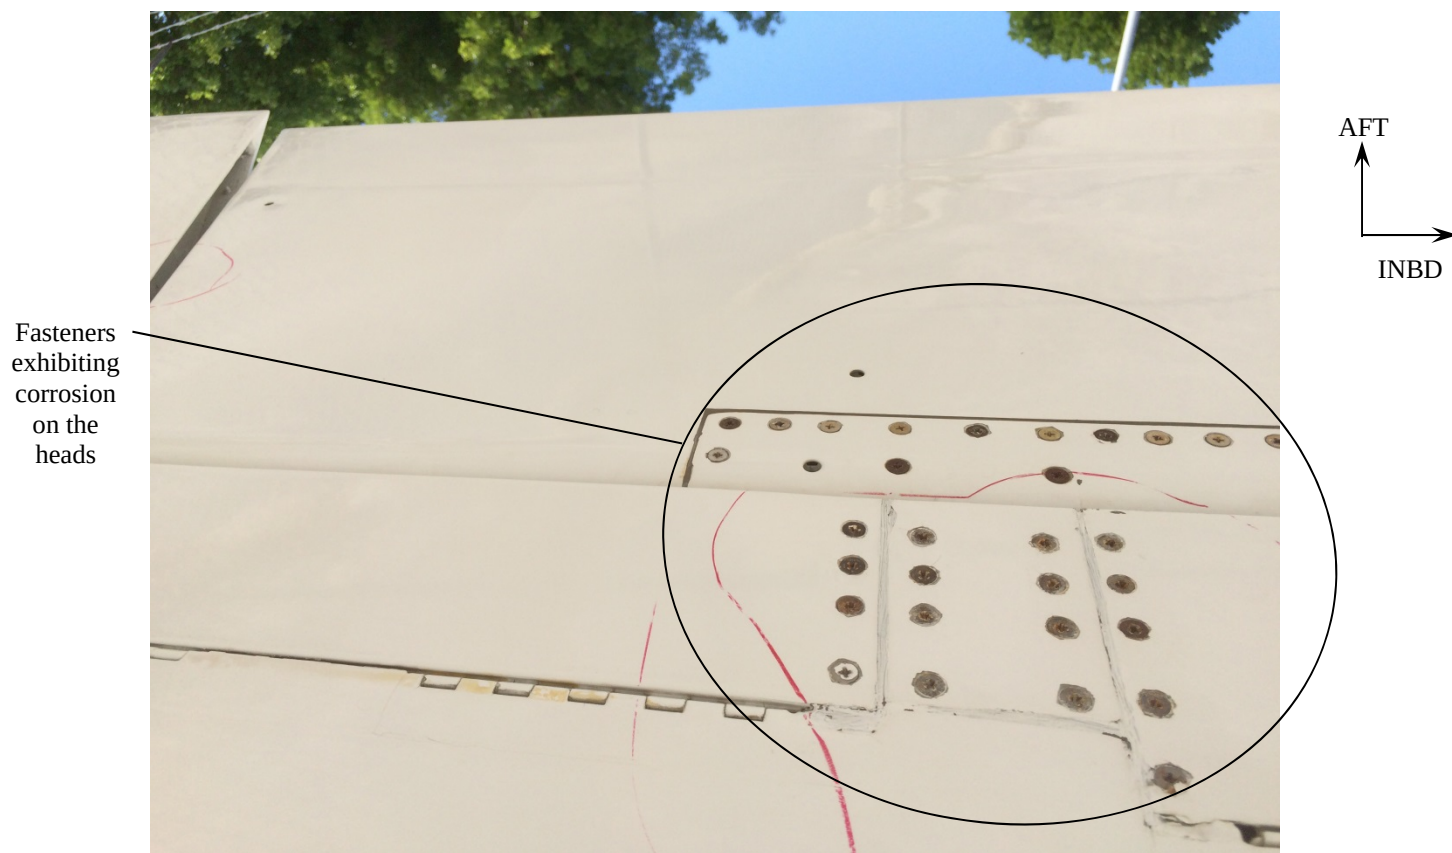
- i. Except as noted in the previous sections of this report, a visual inspection of the aircraft did not exhibit or reveal any of the traditional indications of an over pressurization, hard landing or over loading of the structure. The following items were not found:
  - a. Pulled, working or sheared fasteners.
  - b. Wrinkled, buckled or bulging skins.
  - c. Mis-aligned/binding doors, escape windows, interiors.
  - d.
- ii. The seal around LH Cabin Window #4 was hanging loose along the top edge of the window.
- iii. Multiple areas of corrosion were observed on the aircraft. Some of the locations exhibiting corrosion were:
  - a. The fasteners on the LH lower wing common to the aileron hinges.
  - b. The LH and RH engine inlets.
  - c. The flap trailing edge.
  - d. Light surface corrosion on multiple locations on the fuselage.

**Fig. 8-1**  
View looking inbd at LH window #4

View looking up at the lower surface of the LH Flap Trailing Edge

View looking into the engine inlet

View looking up at the lower surface of the LH Aileron

- B. Repair/Resolution:
- i. None required for the over Pressurization Incident. Document and rework discrepancies in accordance with RJM and the owners requirements.
  - ii. Document and submit to GAC Technical Operations any structural damage identified with a full description and digital photos for evaluation as necessary.
