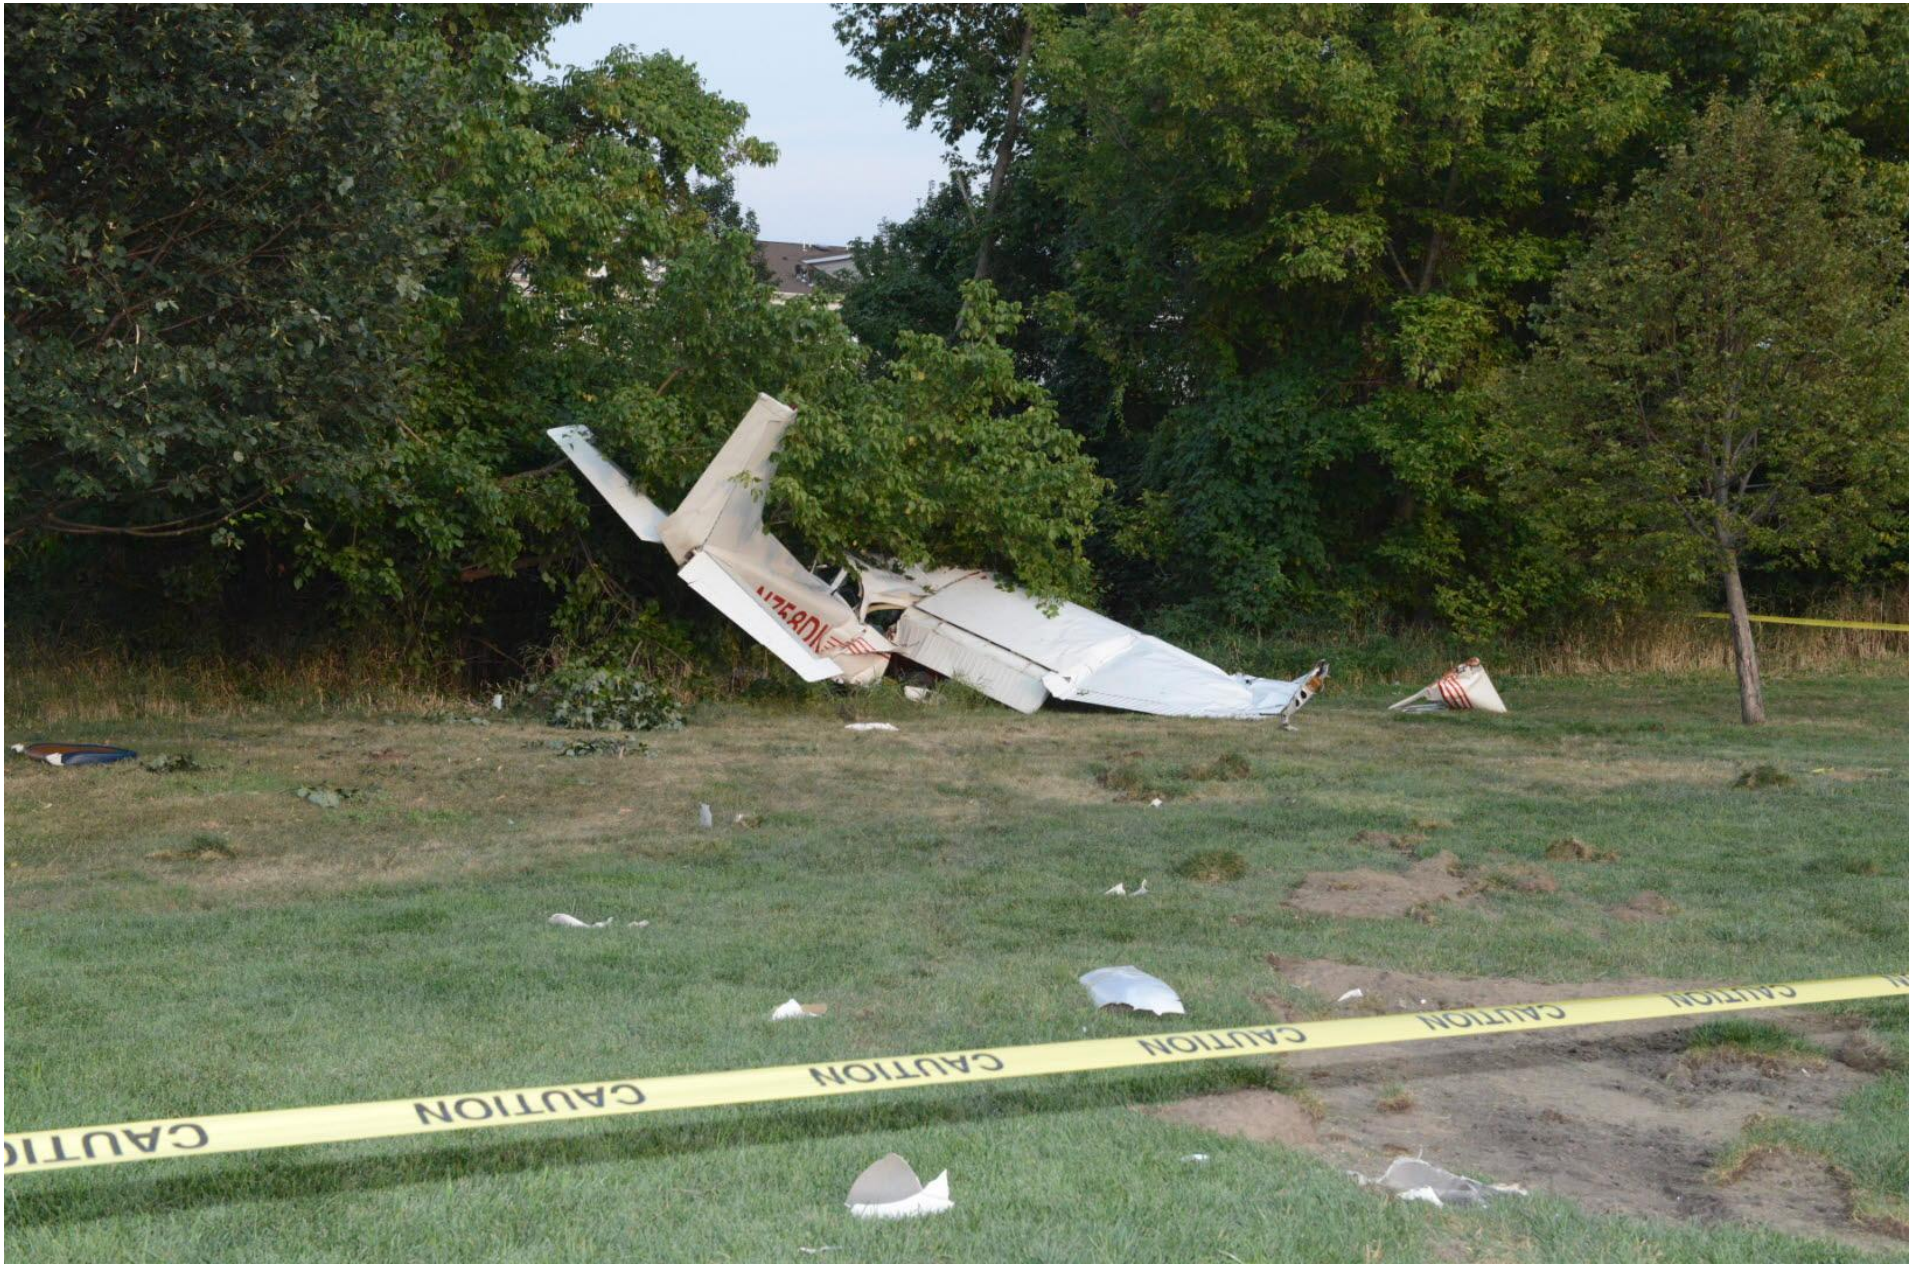
**Photo 1 –Wreckage as Found (FAA)**

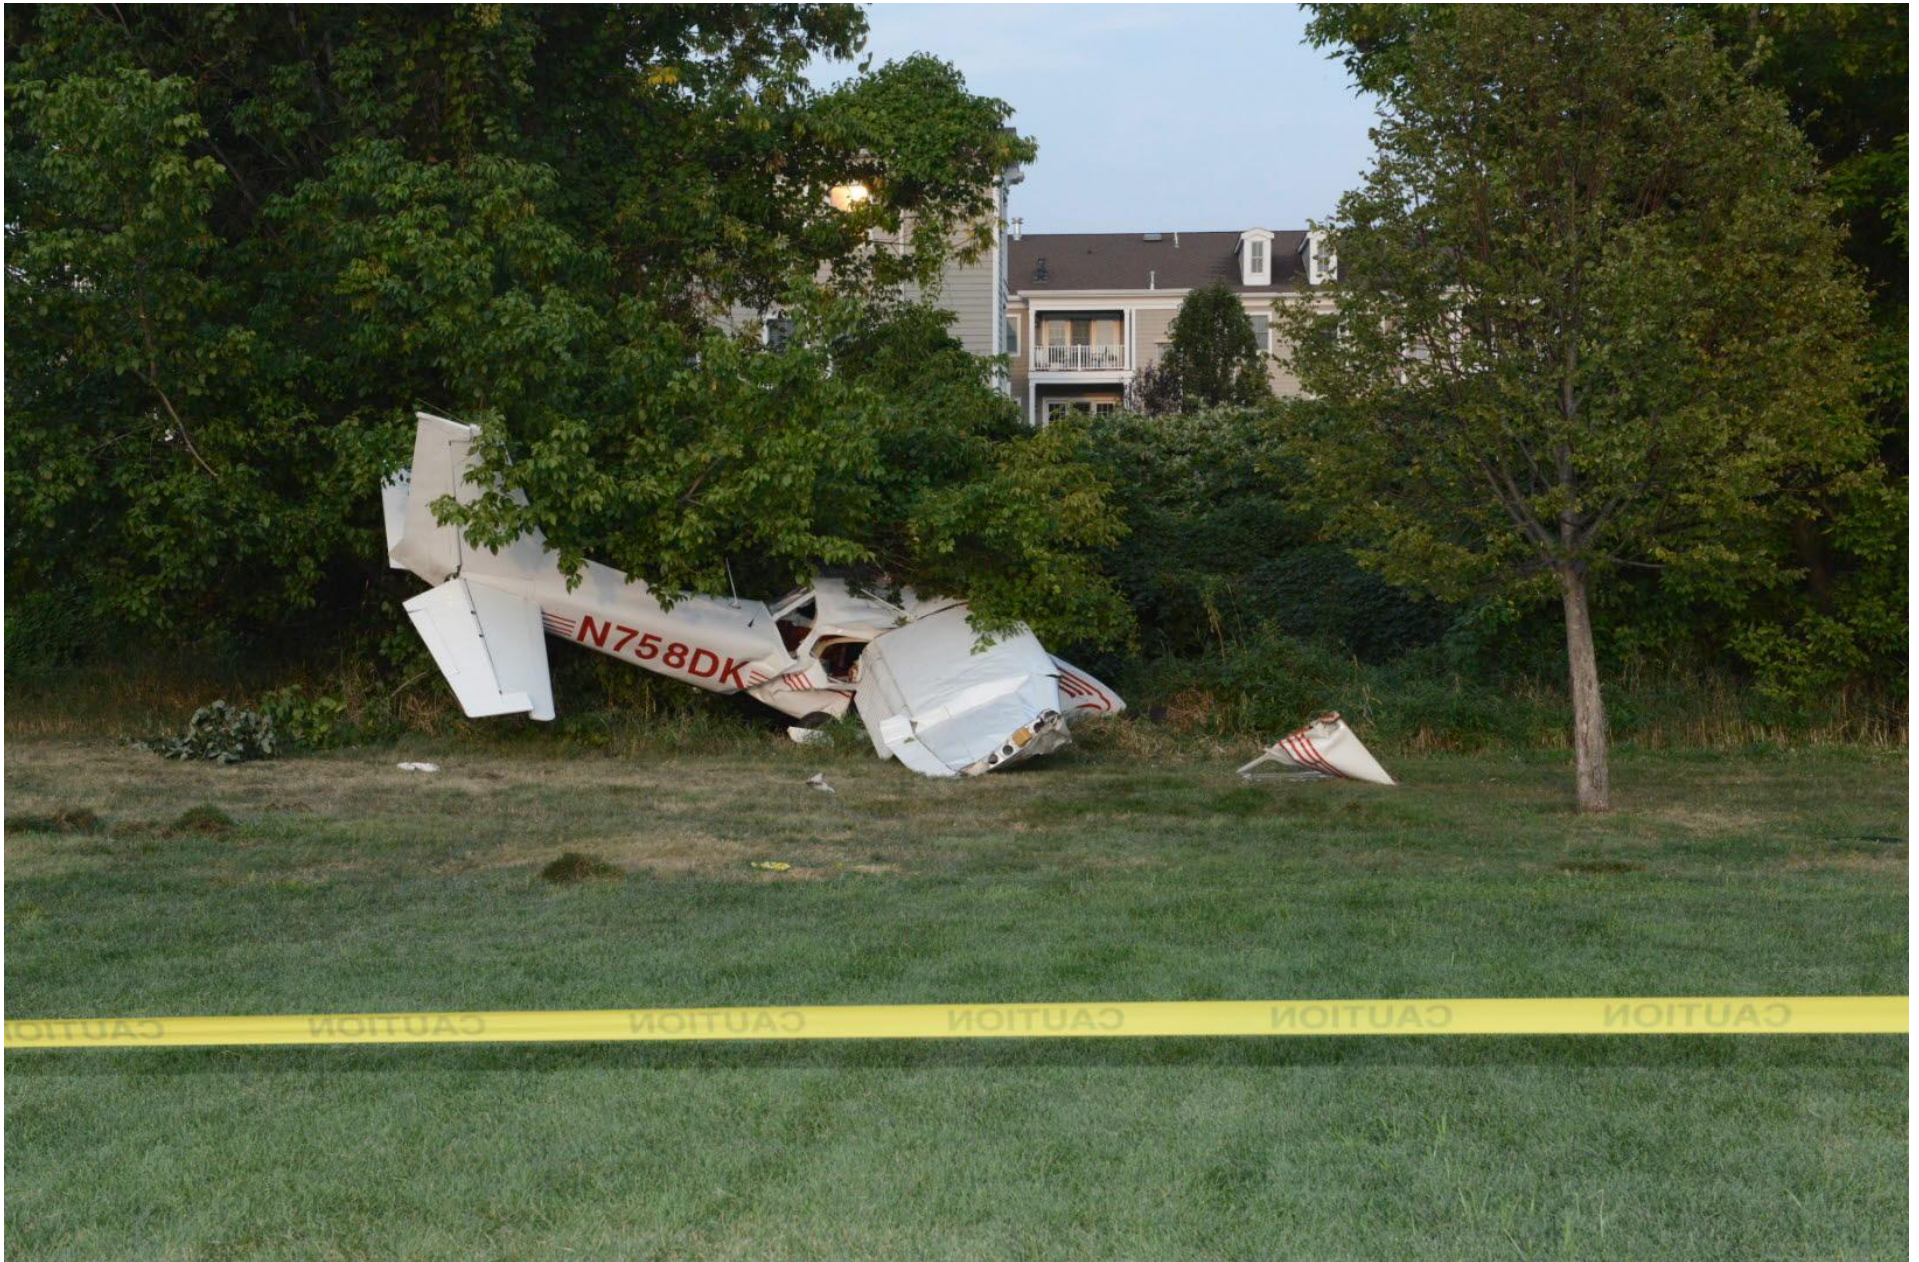
**Photo 2 – Side View of Wreckage as Found (FAA)**

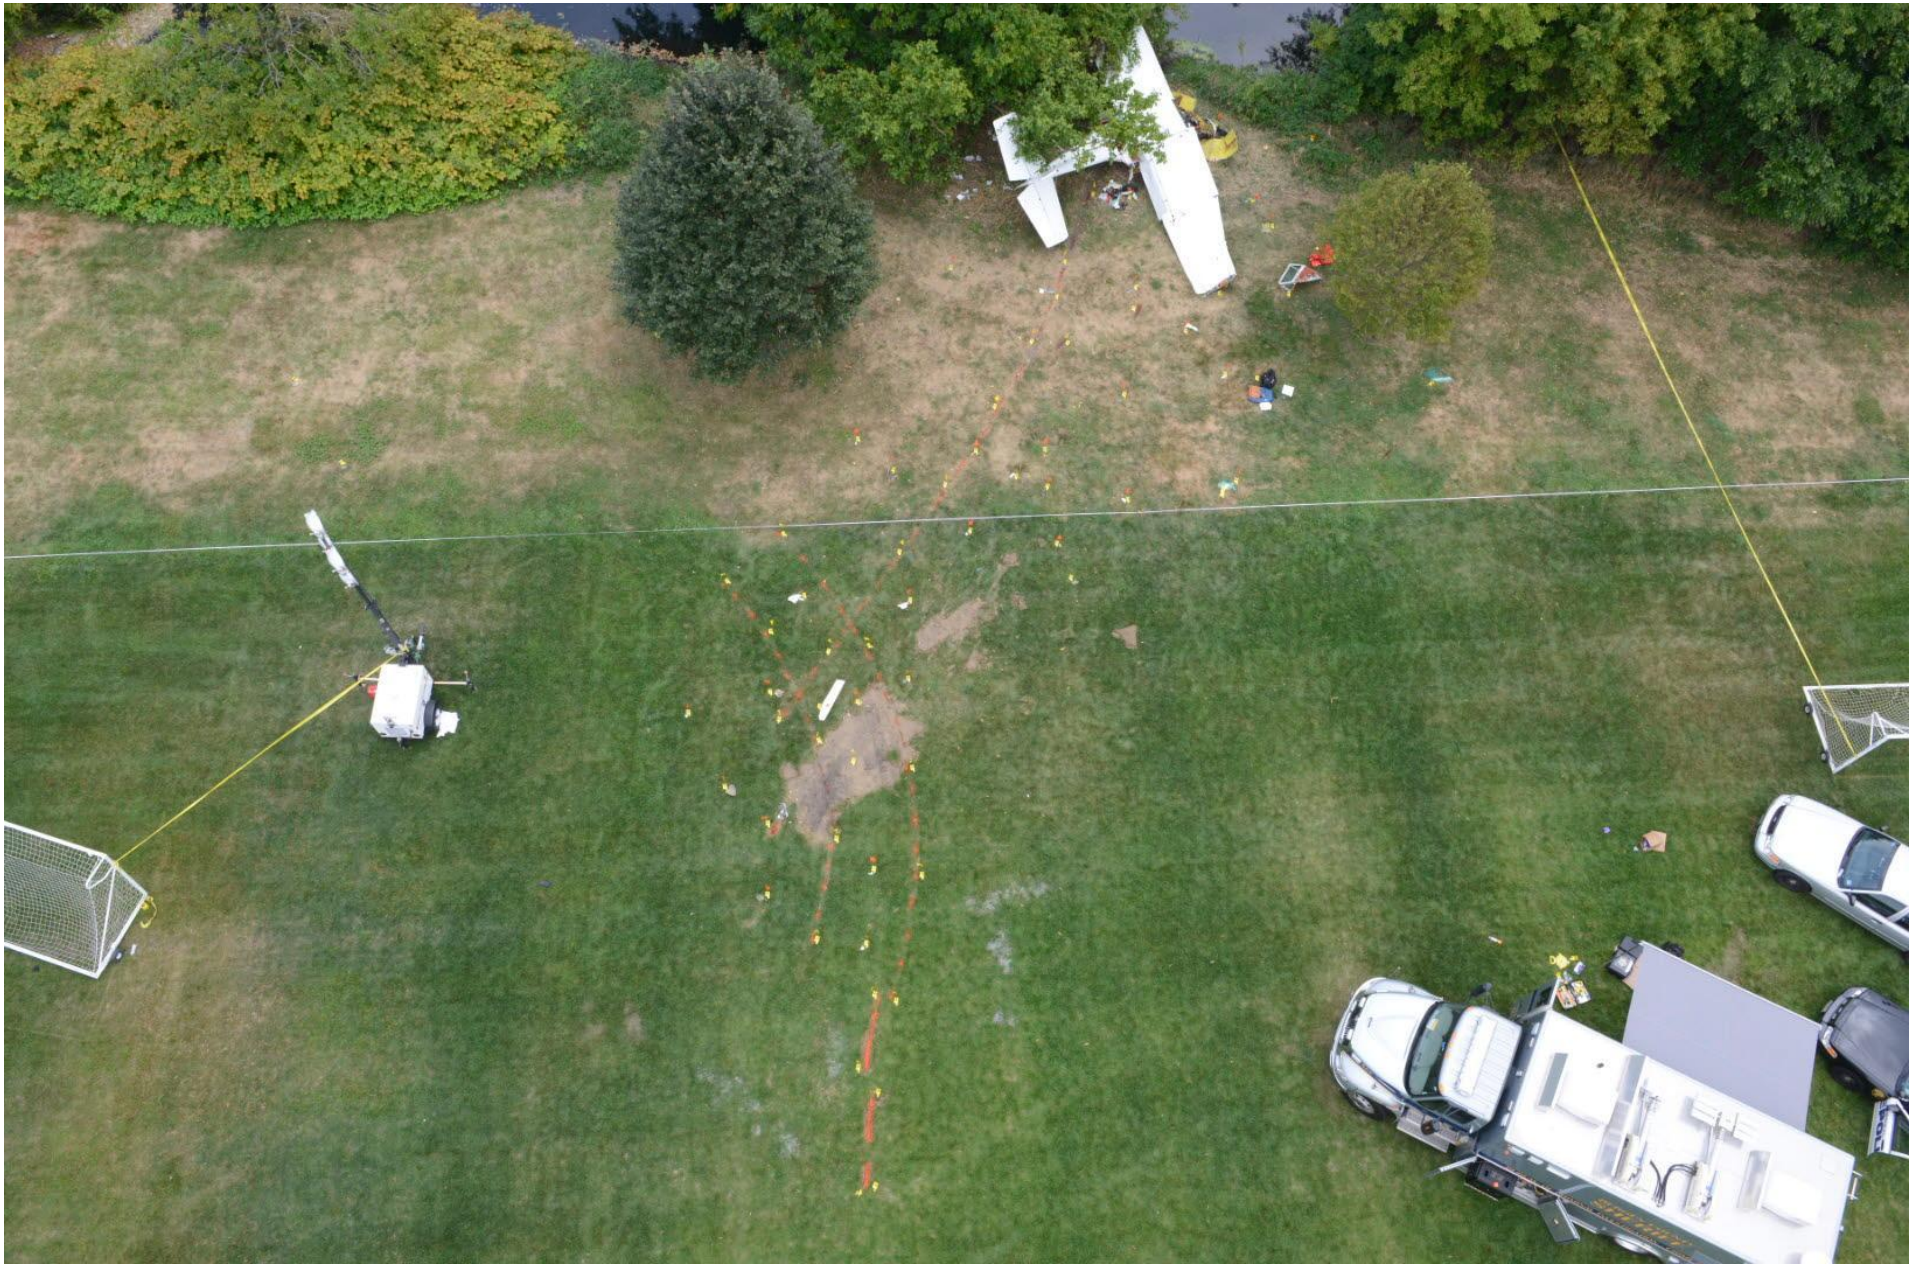
**Photo 3 – Aerial View of Initial Ground Scar and Wreckage as Found (FAA)**

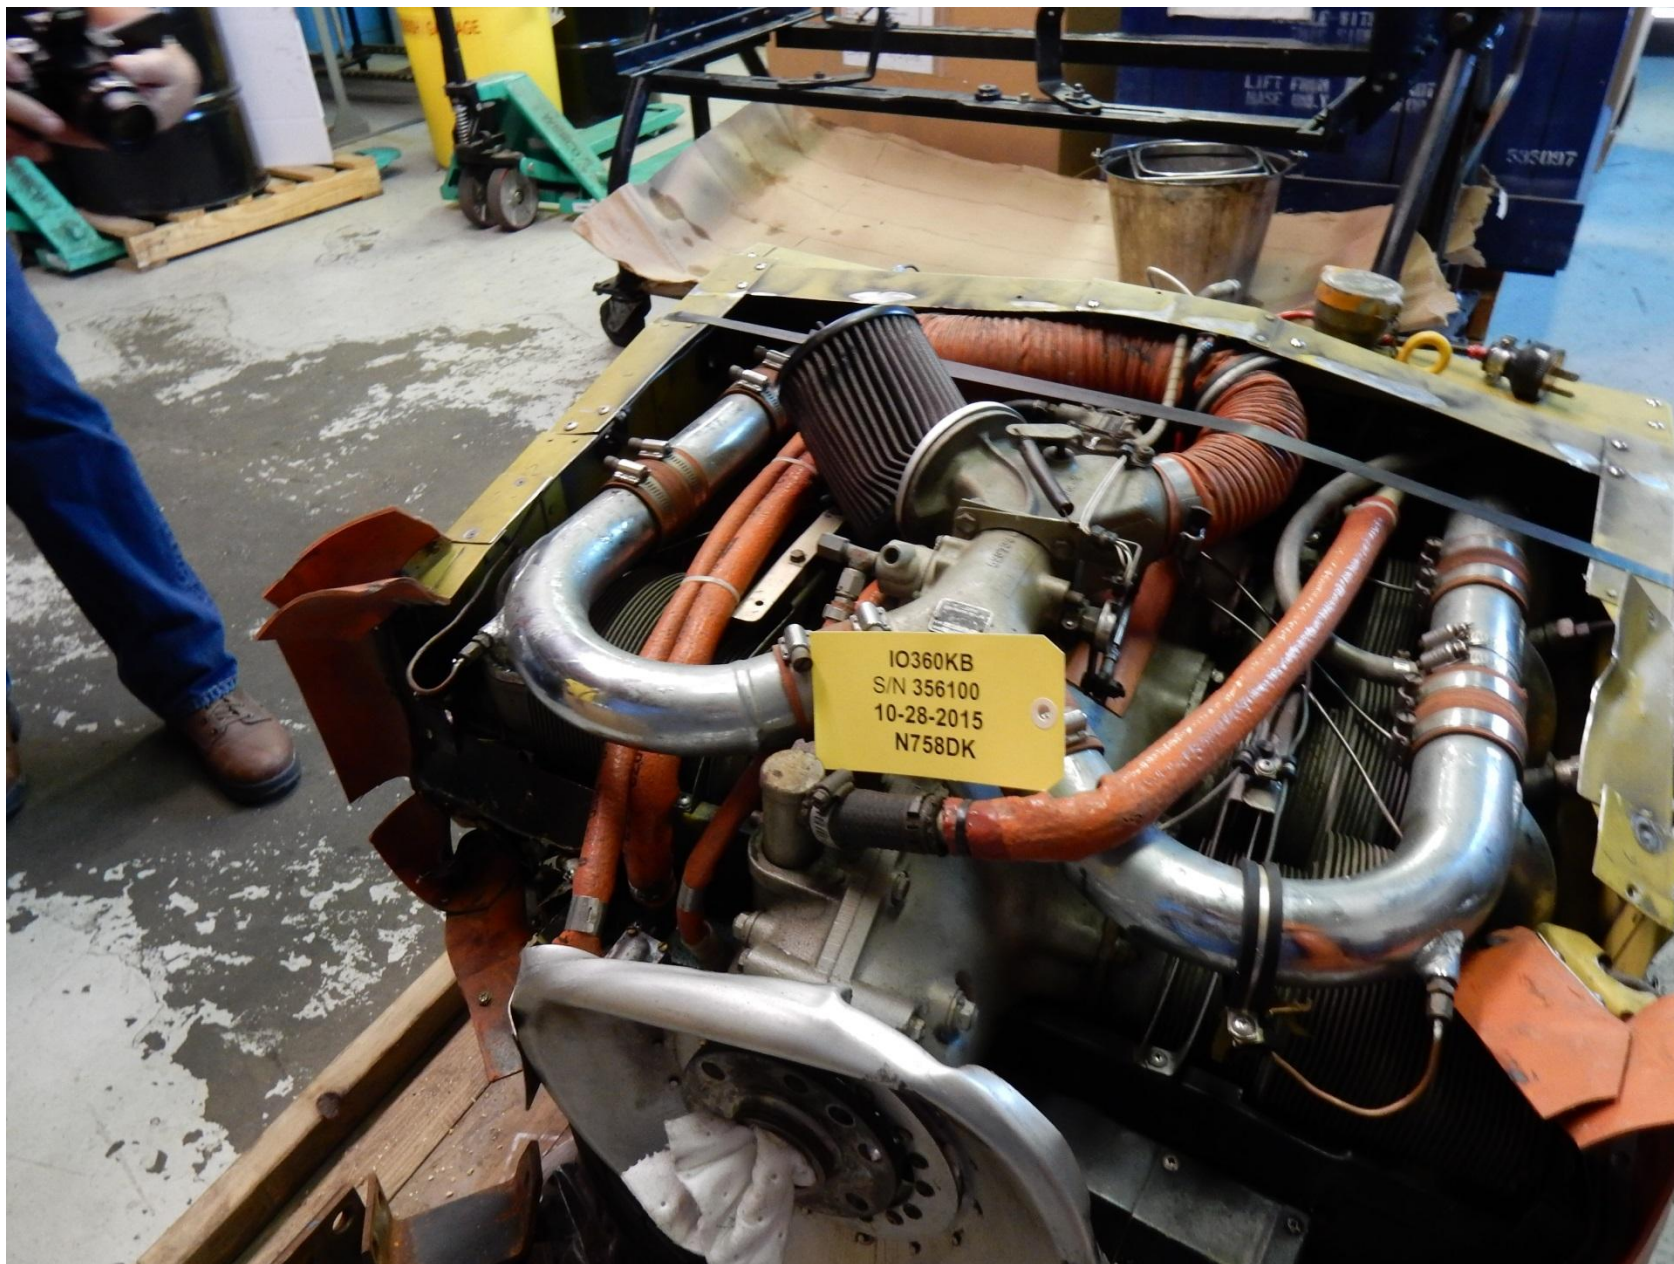
**Photo 4 – Engine as Delivered from Quarantine for Exam (FAA)**

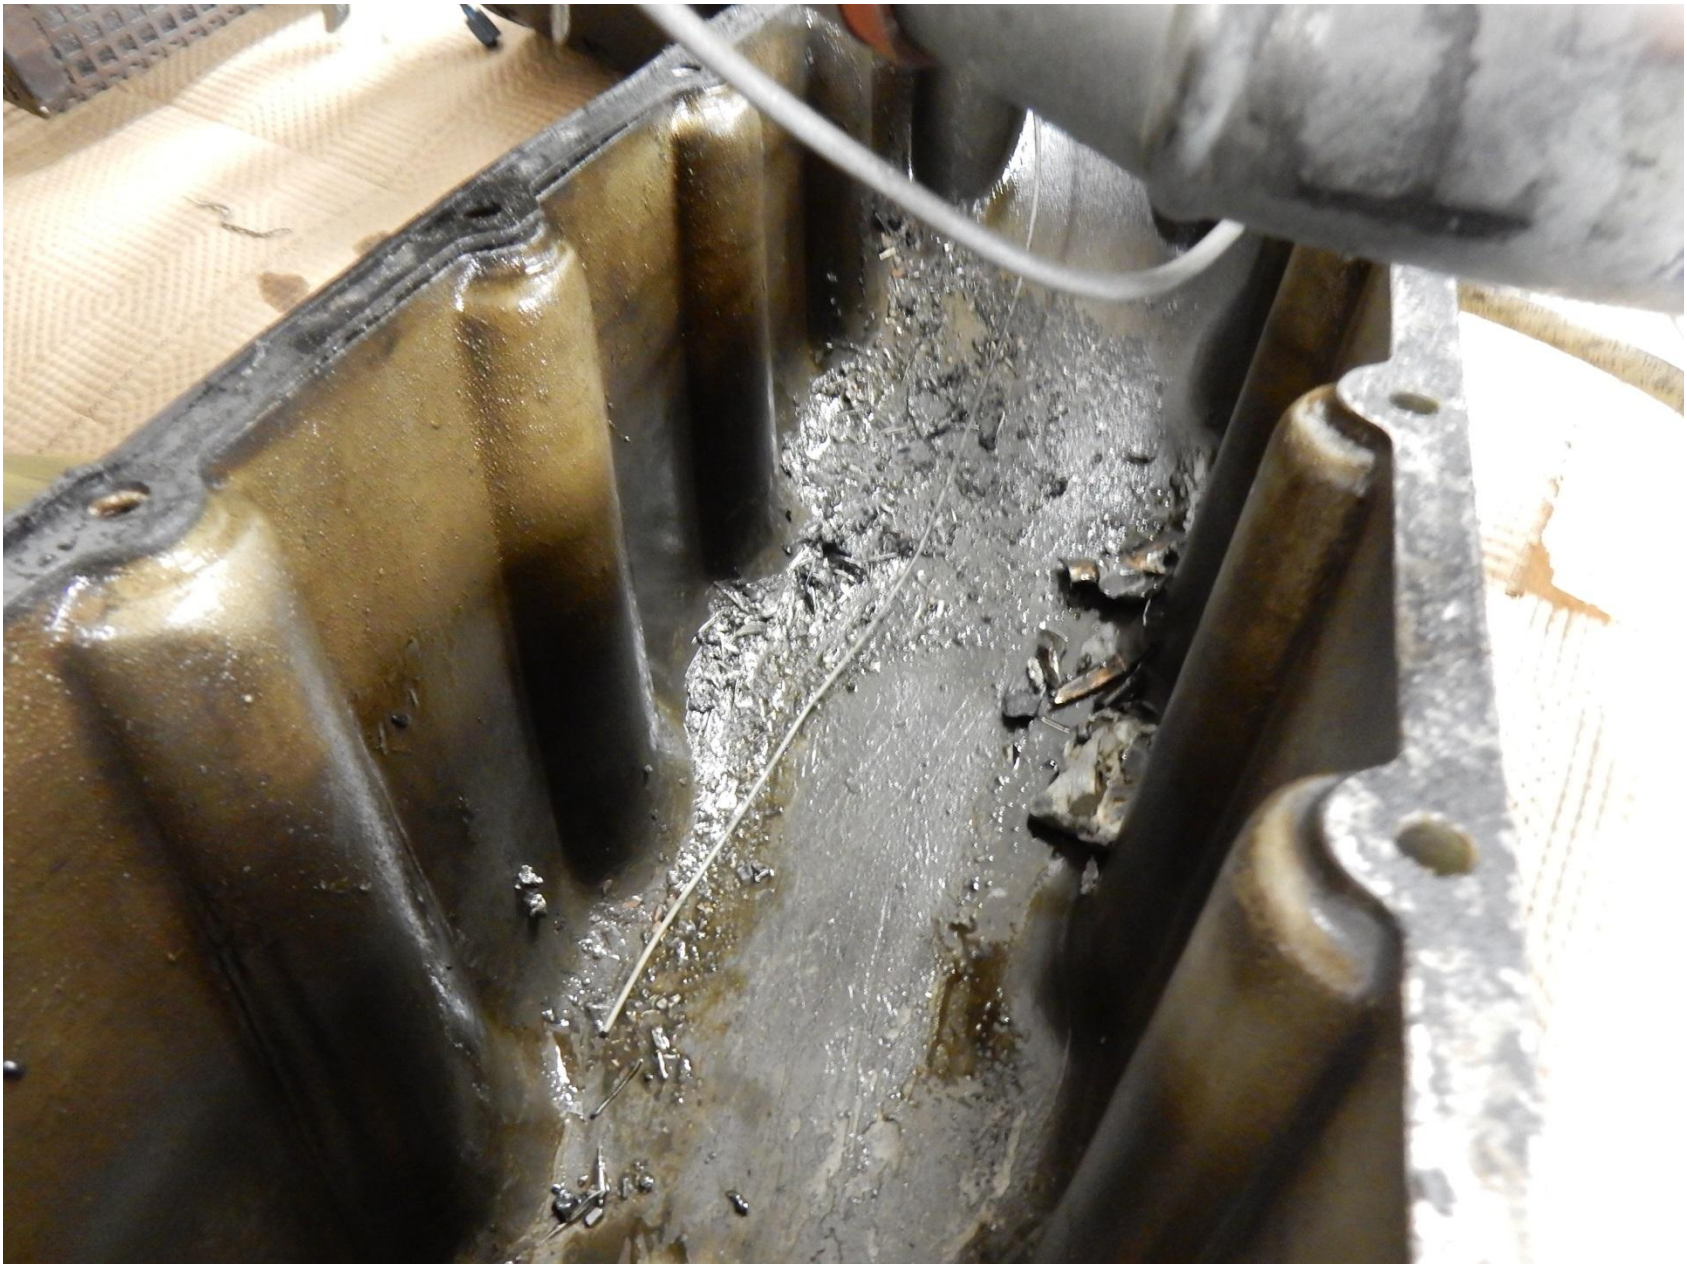
**Photo 5 – View of Metal Fragments and Bearing Material in Oil Sump as Found (FAA)**

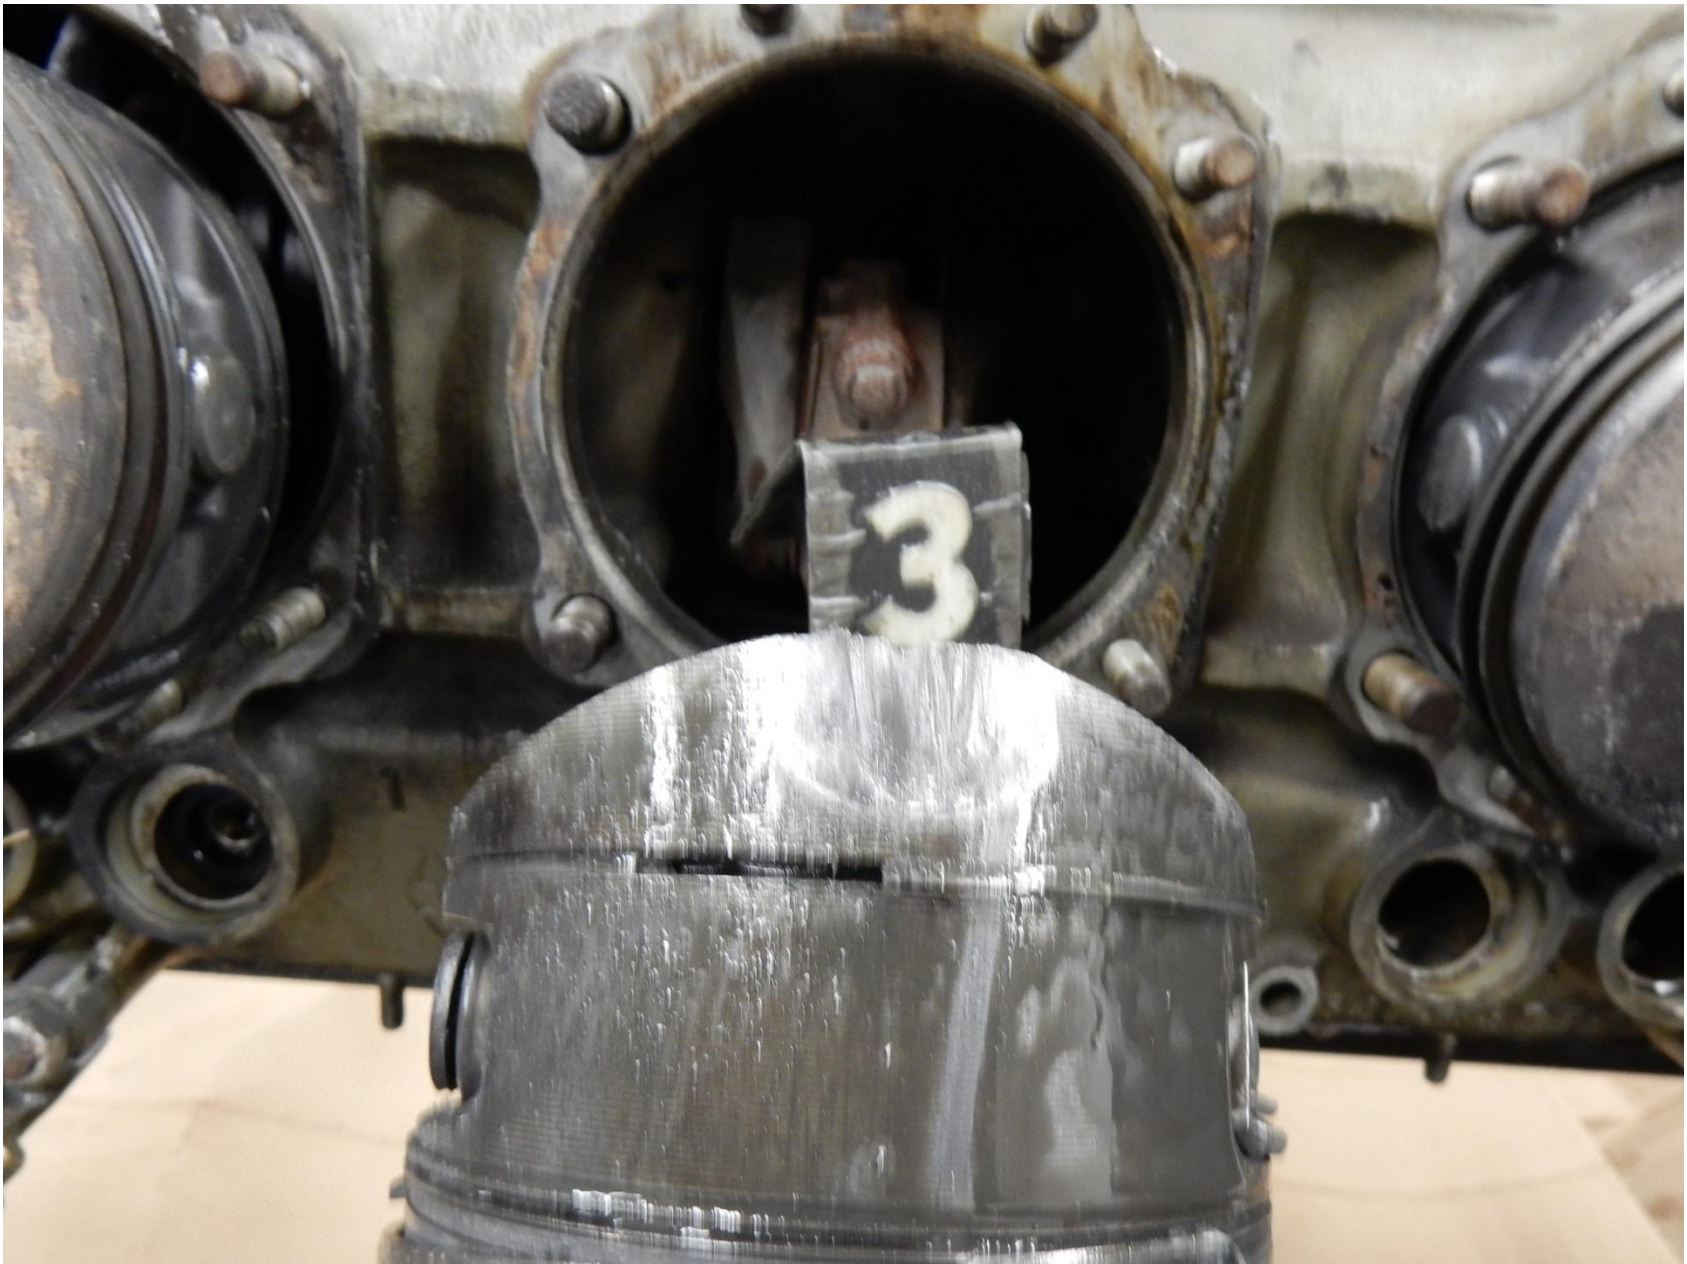
**Photo 6 – View of Impact Damage to #3 Piston Skirt (FAA)**

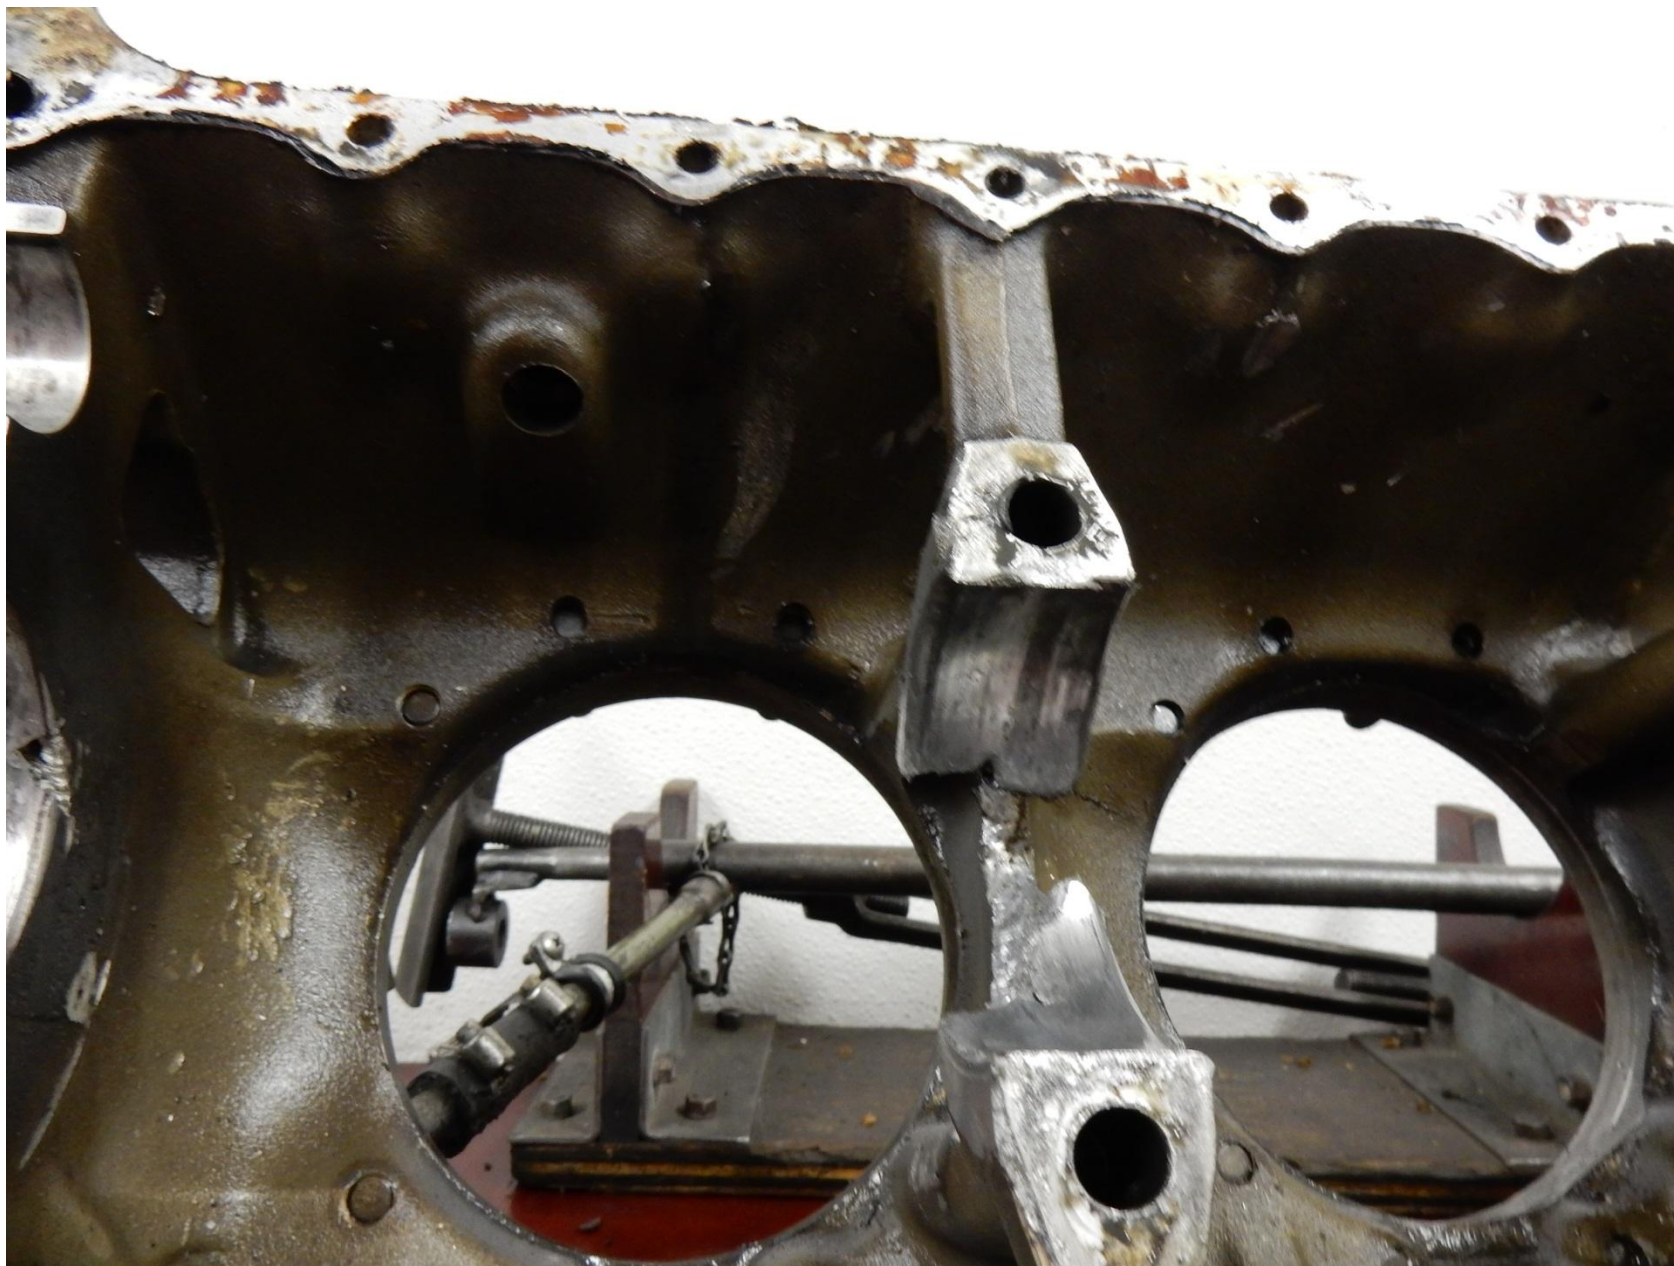
**Photo 7 – View of Distressed and Fractured Main Bearing Journal (FAA)**
