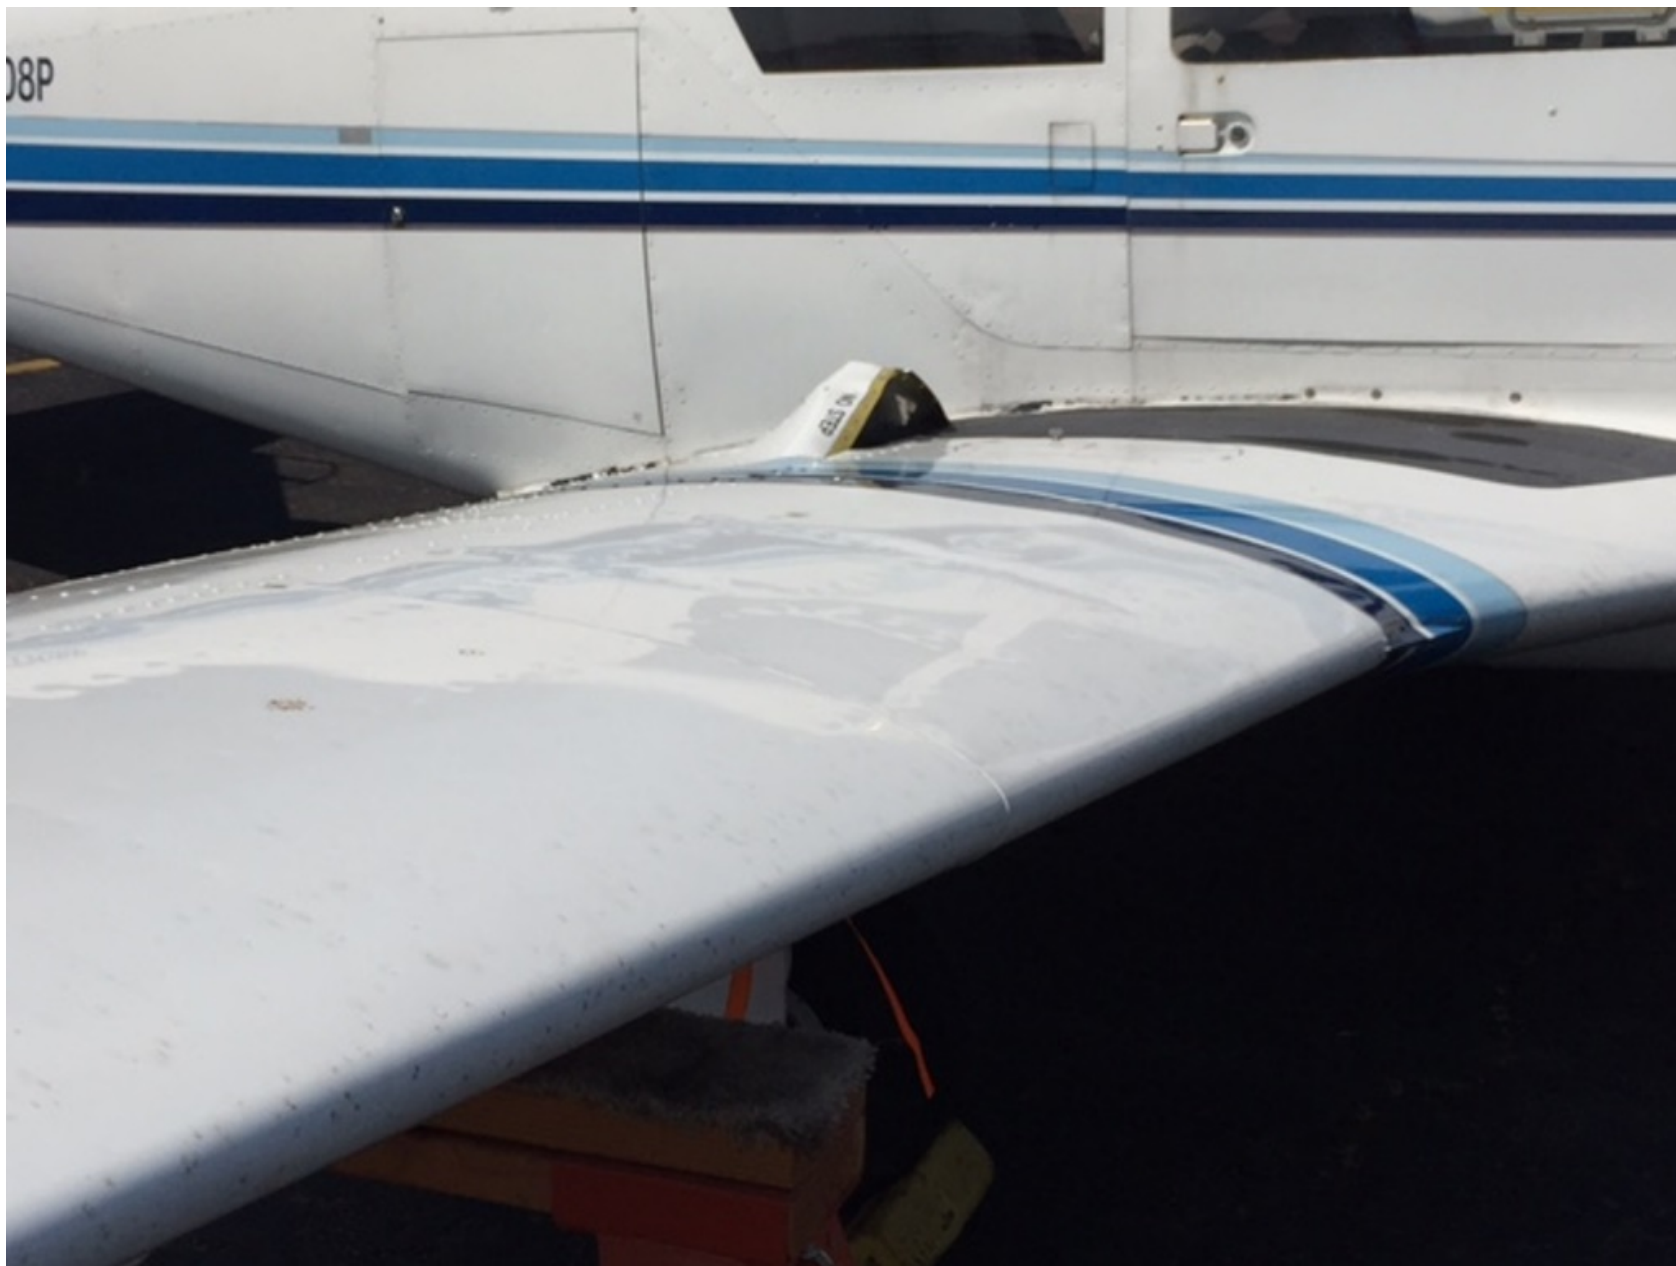
**Photo 1 – Right Wing Damage (FAA Photo)**

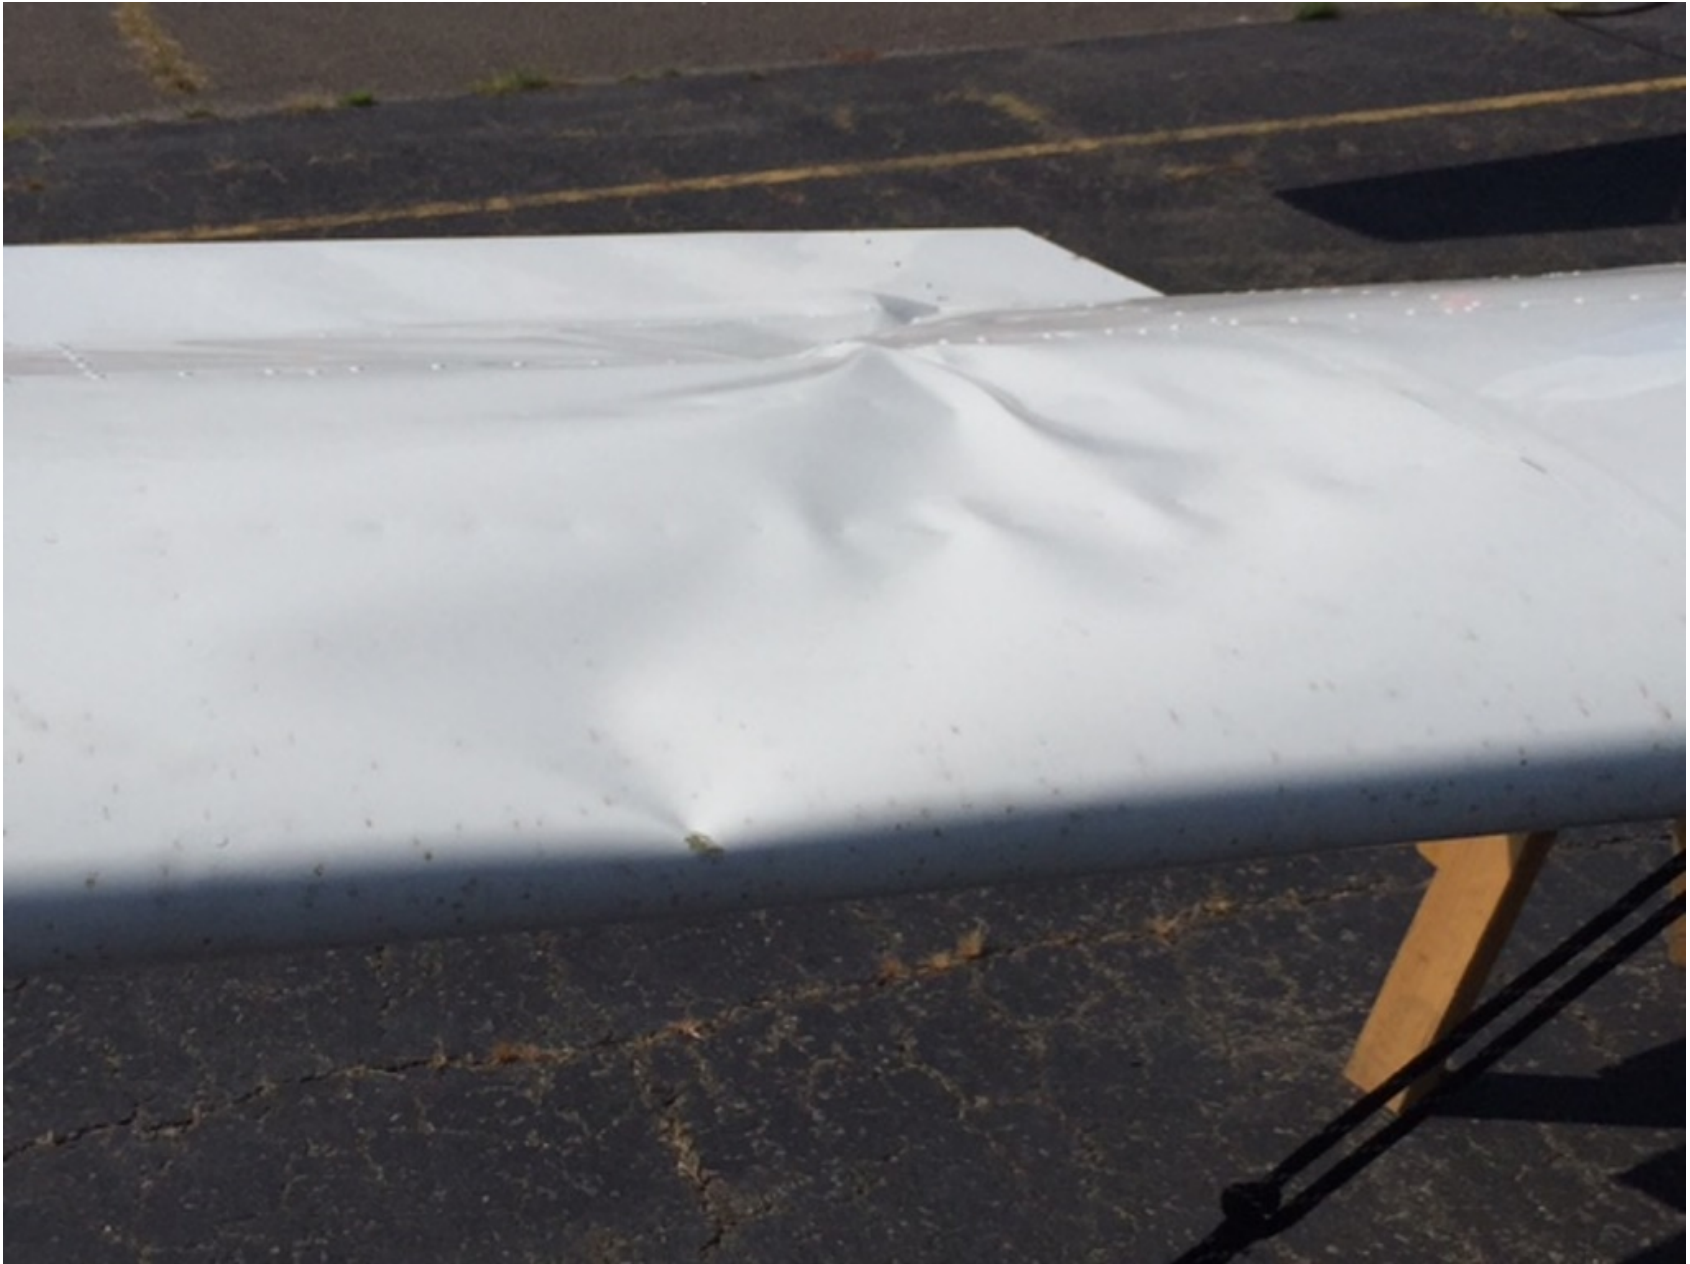
**Photo 2 – Right Wing Damage (FAA Photo)**

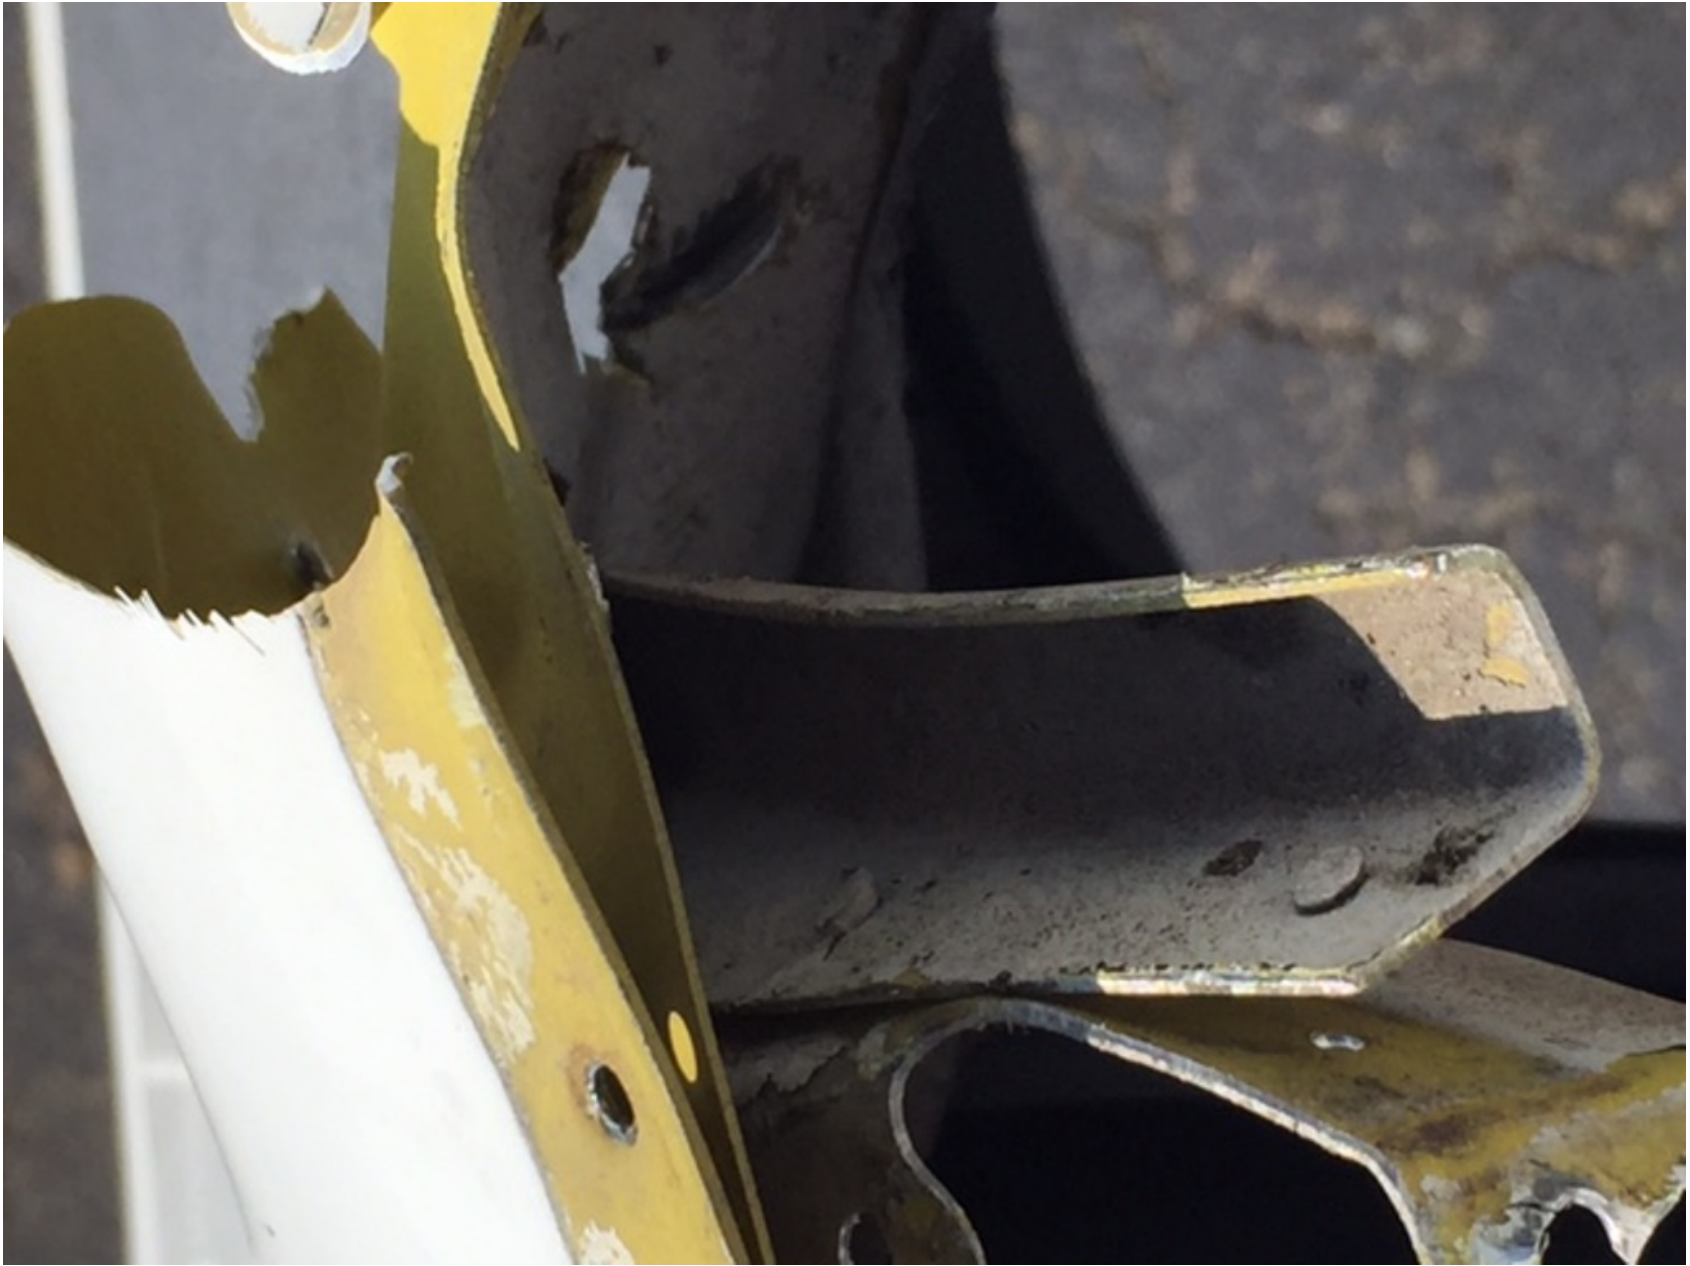
**Photo 3 – Empennage Damage (FAA Photo)**
