Re: Petition For Reconsideration or Modification  
Accident Number ERA15LA366  
September 21, 2015 Bally, PA  
Joshua Zimmer, Petitioner

## National Transportation Safety Board Aviation Accident Final Report

| Location: | Bally, PA | Accident Number: | ERA15LA366 |
| Date & Time: | 09/21/2015, 1830 EDT | Registration: | N347SP |

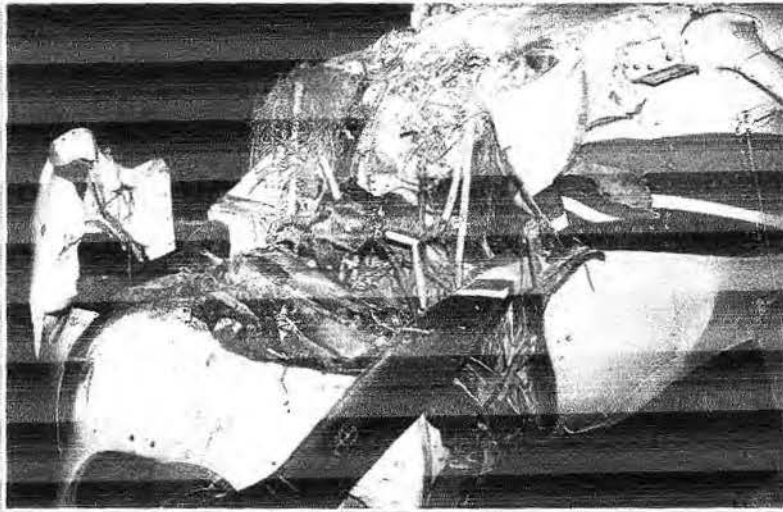
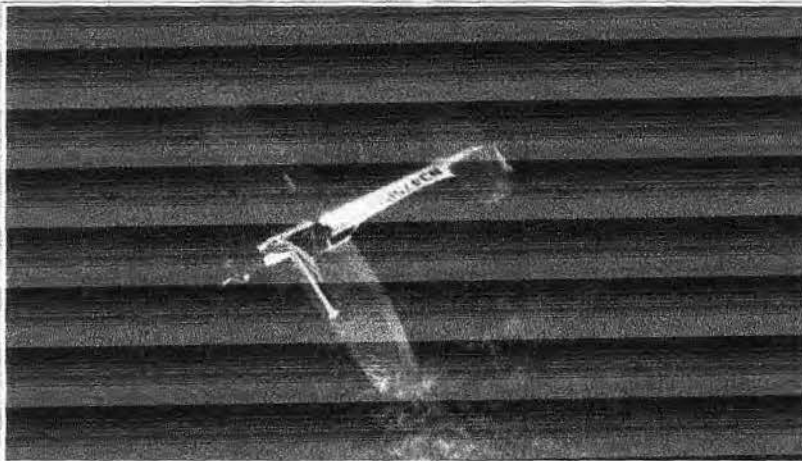
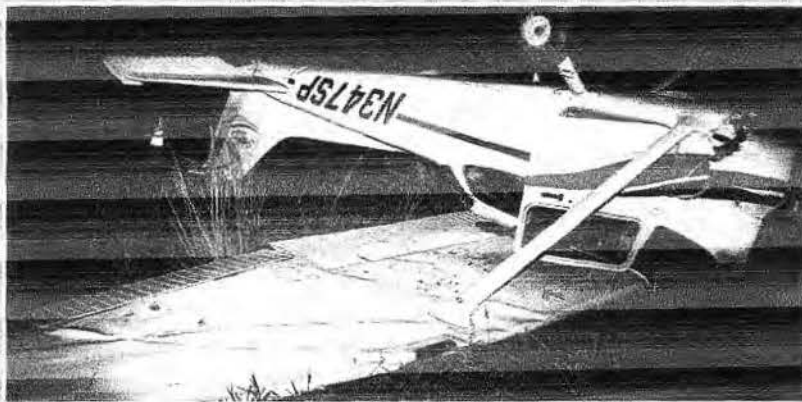
Mr. Strauss was incorrect when he reported that the right main gear collapsed on touchdown because a series of photographs of the accident aircraft show that the right main gear was in the design position. Thus, the aircraft landed in a wings level configuration.
