# NATIONAL TRANSPORTATION SAFETY BOARD

## MATERIALS LABORATORY FACTUAL REPORT

Report No. 16-070

Place : Mount Airy, Maryland  
Date : September 19, 2015  
Vehicle : Cessna 150M, N714CW  
NTSB No. : ERA15LA368  
Investigator : Aaron McCarter, AS-ERA

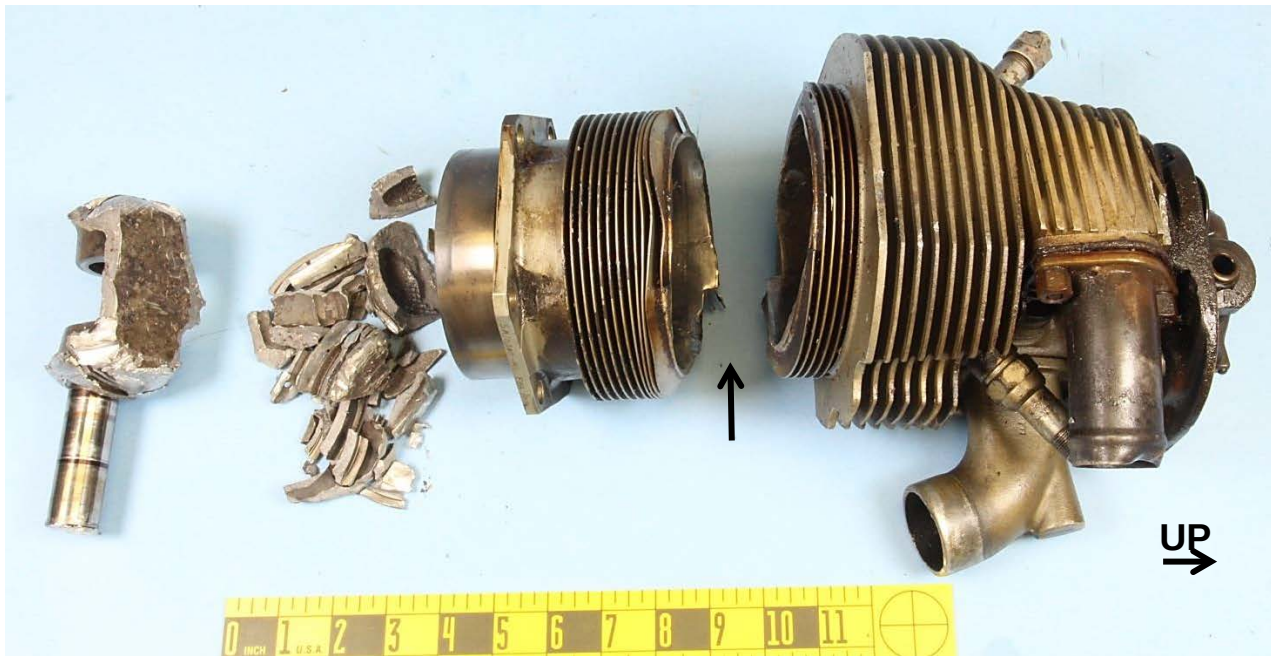
Figure 1 shows a photograph of the as-received pieces of the #4 cylinder, fractured piston, and wrist pin. The #4 cylinder fractured at the barrel portion, and the piston fractured into many pieces. The wrist pin was intact, showed no evidence of a crack, and was partially inserted into the piston pin.

Figure 1. As-received pieces of the #4 cylinder (right side of page), fragments of the piston and piston pin that was partially inserted into the fractured piston (left side of page). The cylinder fractured in the barrel portion in the area indicated by an arrow.

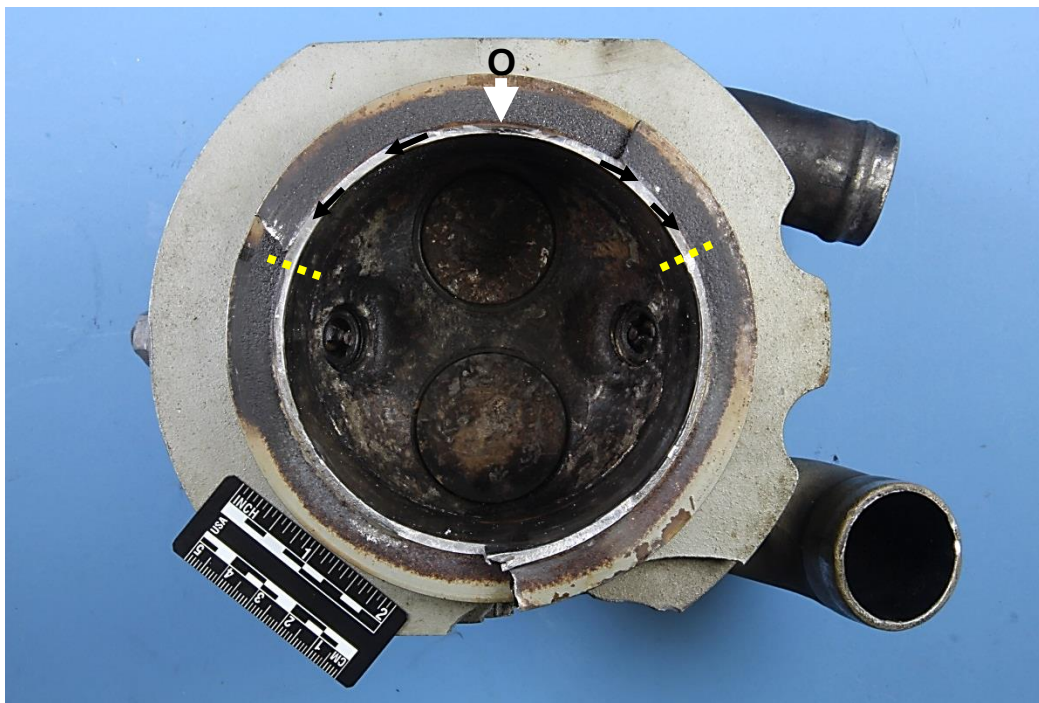
The outer surface of the barrel in the general area of the fracture contained cooling fins. The cooling fins and relief radii between the fins in the area of the fracture exhibited evidence of minor corrosion. The upper fracture face of the cylinder was brush cleaned with Alconox, a commercial detergent. Bench binocular microscope examination of the upper fracture face revealed a dark thumbnail mark typical of a fatigue crack emanated from the outer surface of the barrel, in the area indicated by arrow "O" in figures 2 through 3, on the side of the head that contained the exhaust valve (side containing the smaller diameter valve). The fatigue crack originated from a corrosion pit on the outer surface in the areas indicated by arrow "O" in figure 4. Fatigue crack propagation was through the thickness of the barrel and extended laterally approximately 2.5 inches to each side of the fatigue origin area. Fatigue propagation was in the general direction indicated by unmarked arrows in figure 2 and terminated in the areas indicated by dashed lines in figure 2. The fracture features outside of the fatigue region, and those in the piston exhibited a rough texture on a slant plane typical of overstress separation.

Figure 2. View looking at the upper fracture face of the barrel. The barrel contained a fatigue crack that emanated from the outer surface in the are indicated by arrow "O". The fatigue crack propagated in the general direction indicated by arrows and terminated in the areas indicated by dashed lines.

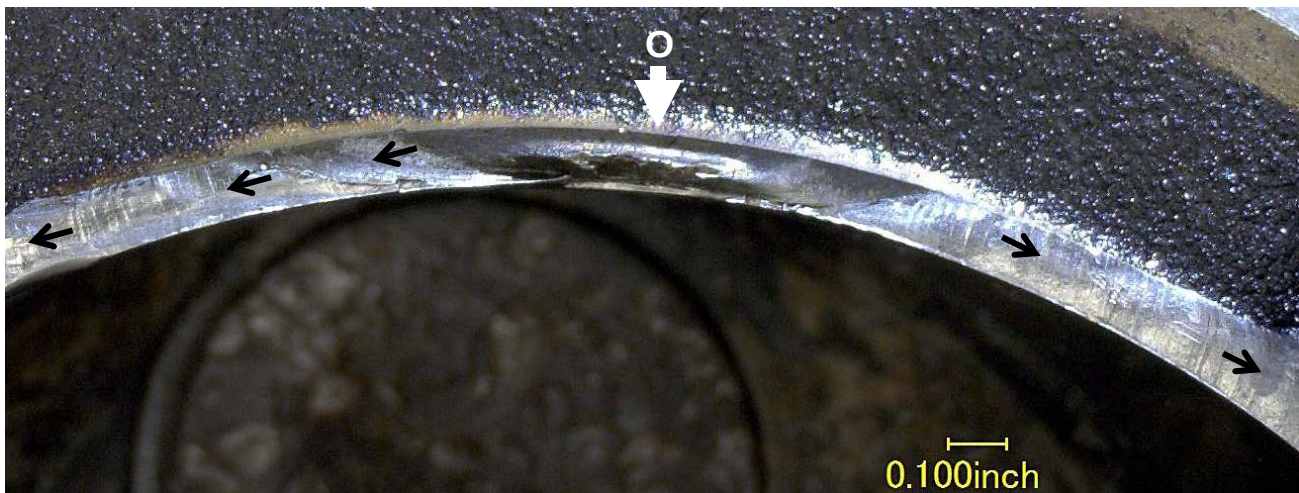
Figure 3. Close-up photograph of the fatigue origin area indicated by arrow "O" in figure 2.

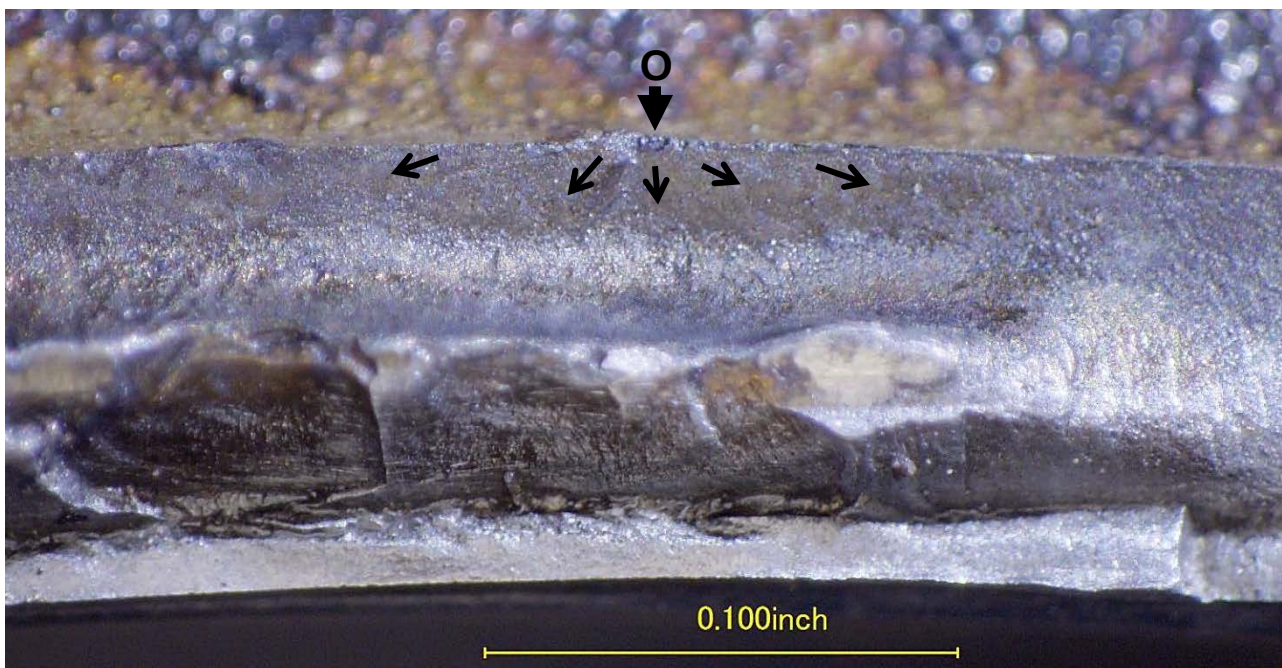
Figure 4. The fatigue crack emanated from a corrosion pit on the outer surface of the barrel in the area indicated by arrow "O" in figures 3 and 4.
