| Report number: <b>ML305914</b> | |
| <p><b>Continental Motors, Inc.</b><br/> <i>Powering Aircraft Since 1929</i></p> <p><b>CONTINENTAL MOTORS<br/>METALLURGICAL REPORT</b></p> | <p><u>Distribution</u></p> <p>1] Phillip Grice</p> |
| Subject: Engine Serial 305914 | |

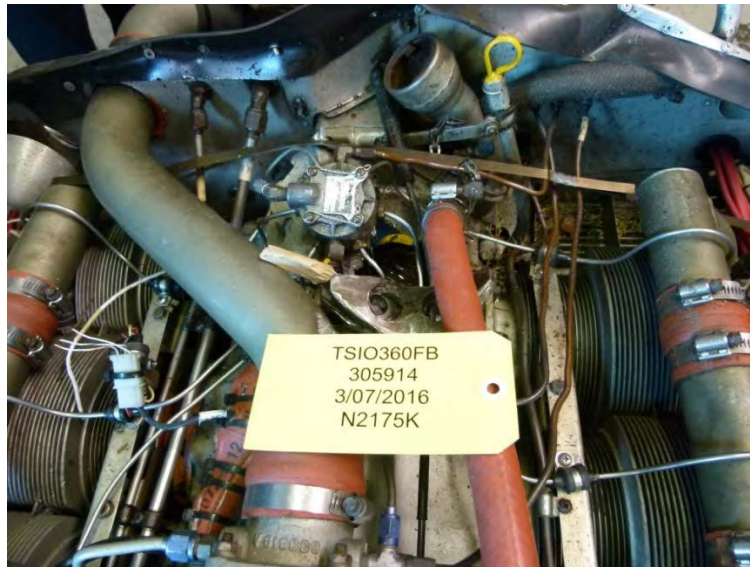
The TSIO360FB engine serial 305914 had severe damage from an internal failure. The engine as received is shown in figure 1. A counterweight was located on the exterior of the engine as also seen in figure 1. This is one of the aft counterweights and is shown again in figure 2. The counterweight pins did not show any unusual wear, as shown in figure 3. The pin retainer plates and snap rings were damaged, but did not appear to have any manufacture anomalies, as shown in figure 4.

Figure 1 Engine as received

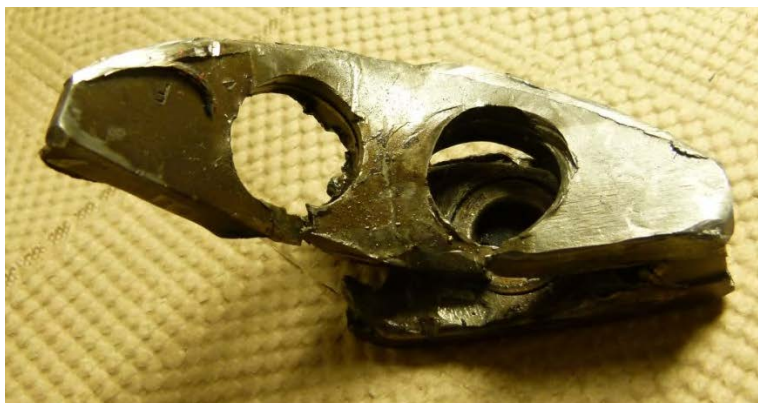
Figure 2 Fractured counterweight

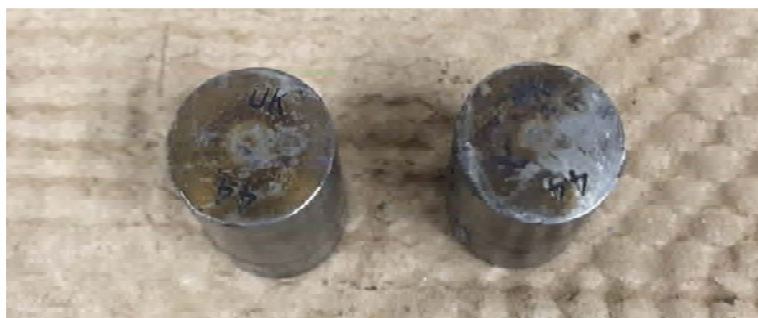
Figure 3 Counterweight retainer pins

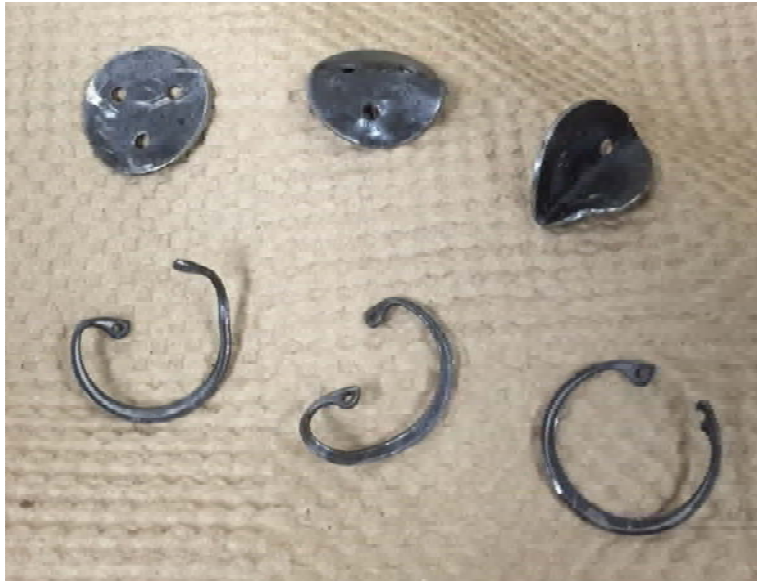
Figure 4 Liberated counterweight pin retainer plates and snap rings

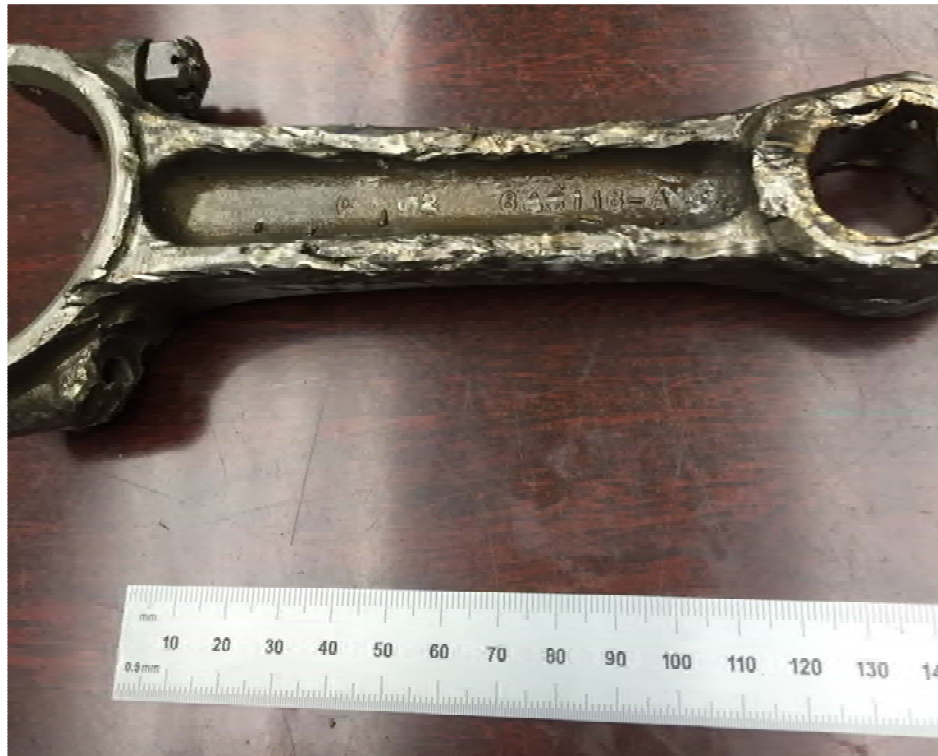
The adjacent connecting rods, cylinders, and pistons also showed significant damage. The connecting rod came apart at the bolts. The rod is shown in figures 5 and 6. Figures 7-11 show the fracture surfaces of the bolts.

Figure 5 Connecting rod

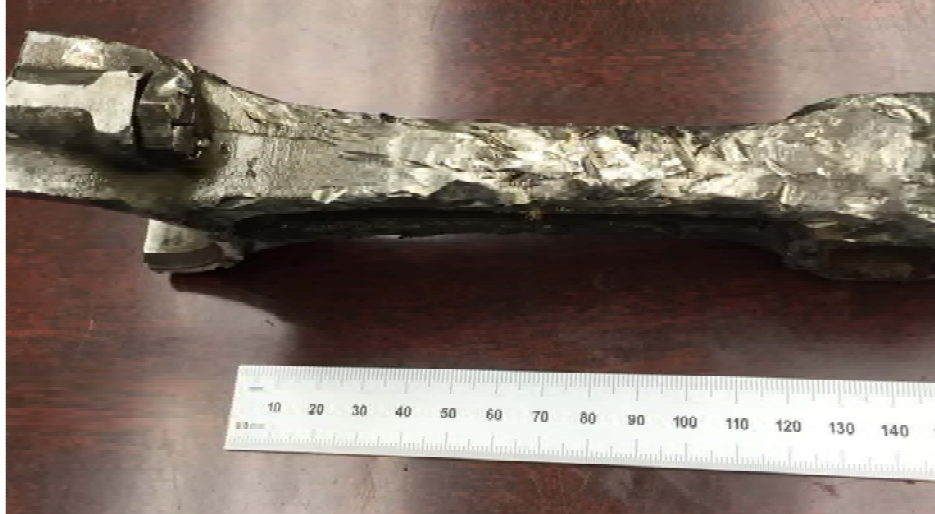
Figure 6 Connecting rod

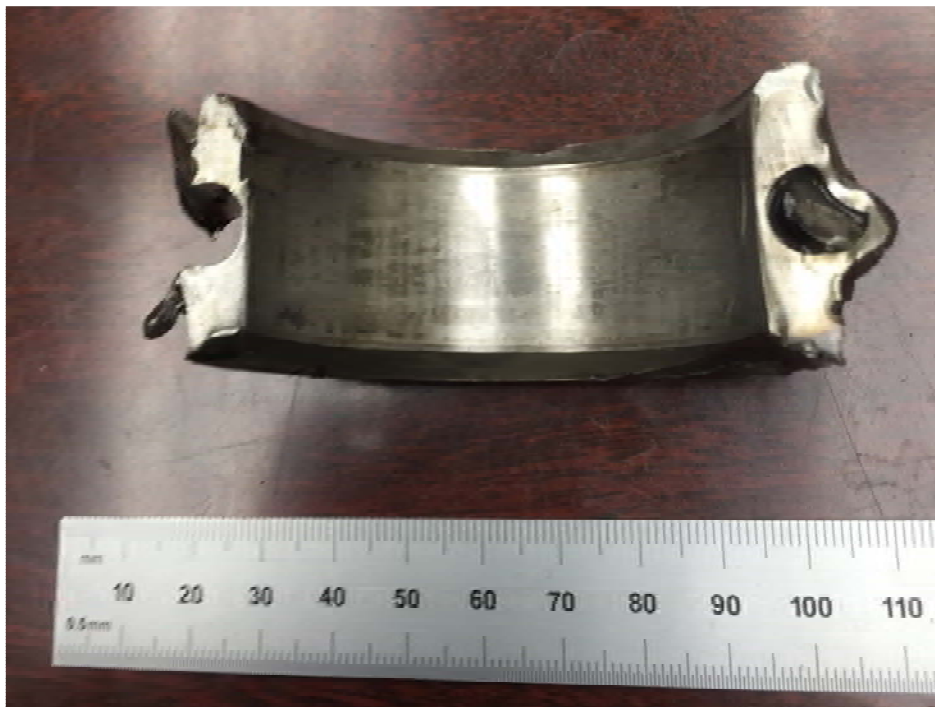
Figure 7 Rod cap

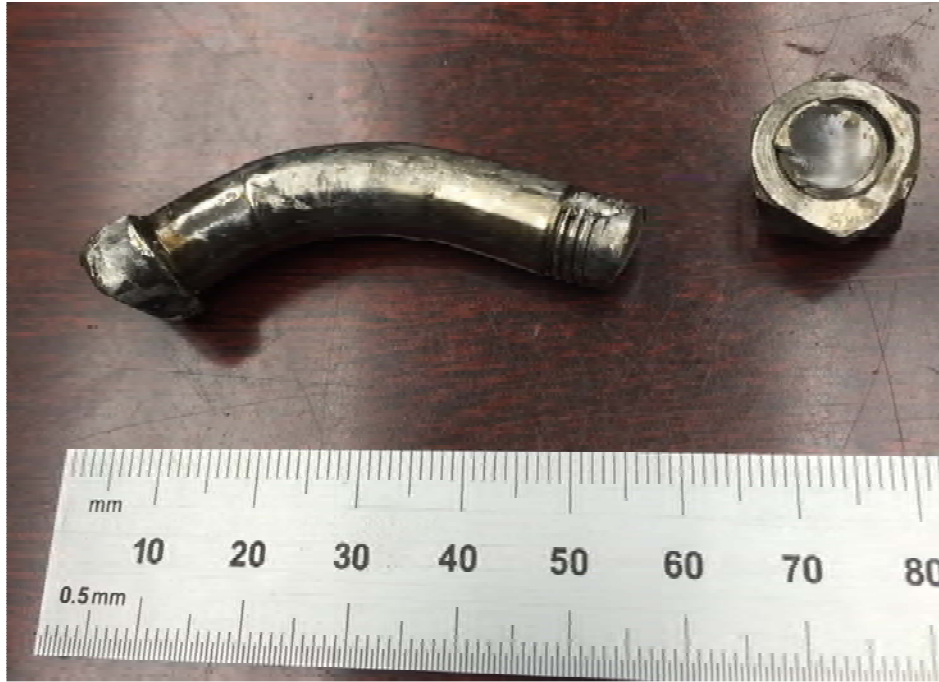
Figure 8 Rod bolt and nut

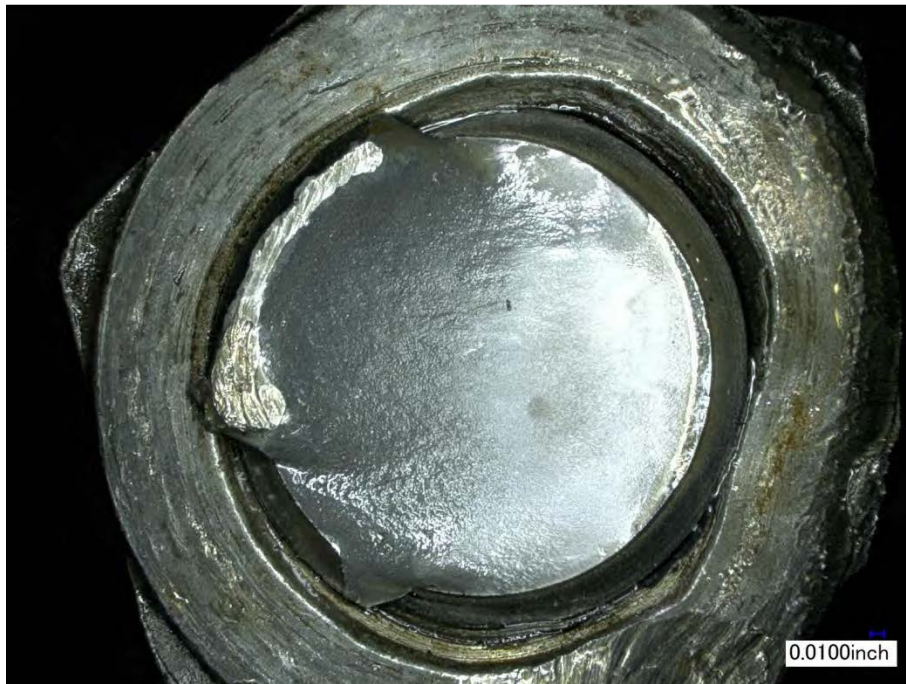
Figure 9 Bolt fracture surface

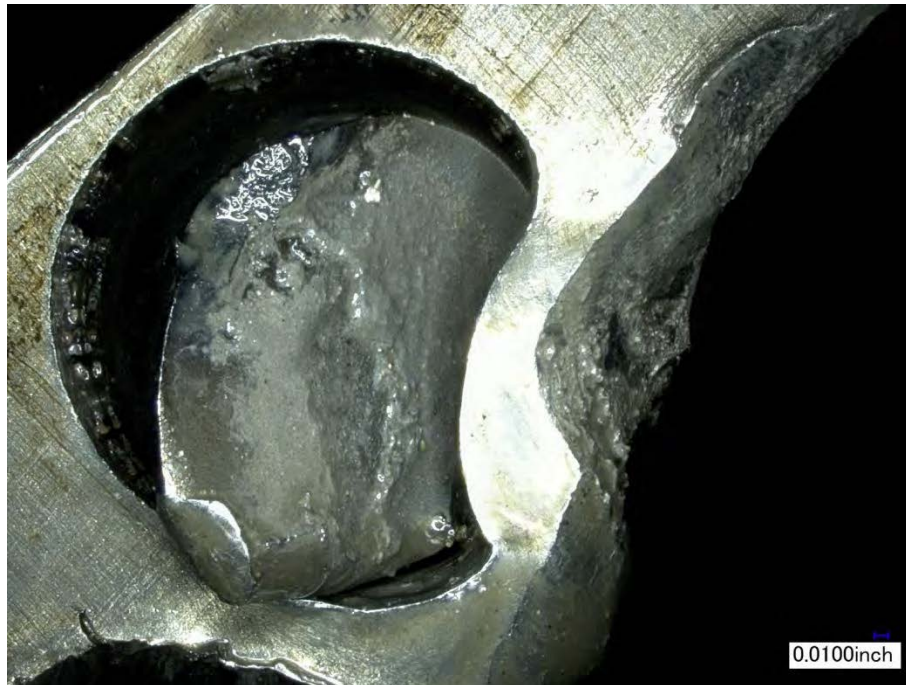
Figure 10 Bolt fracture surface

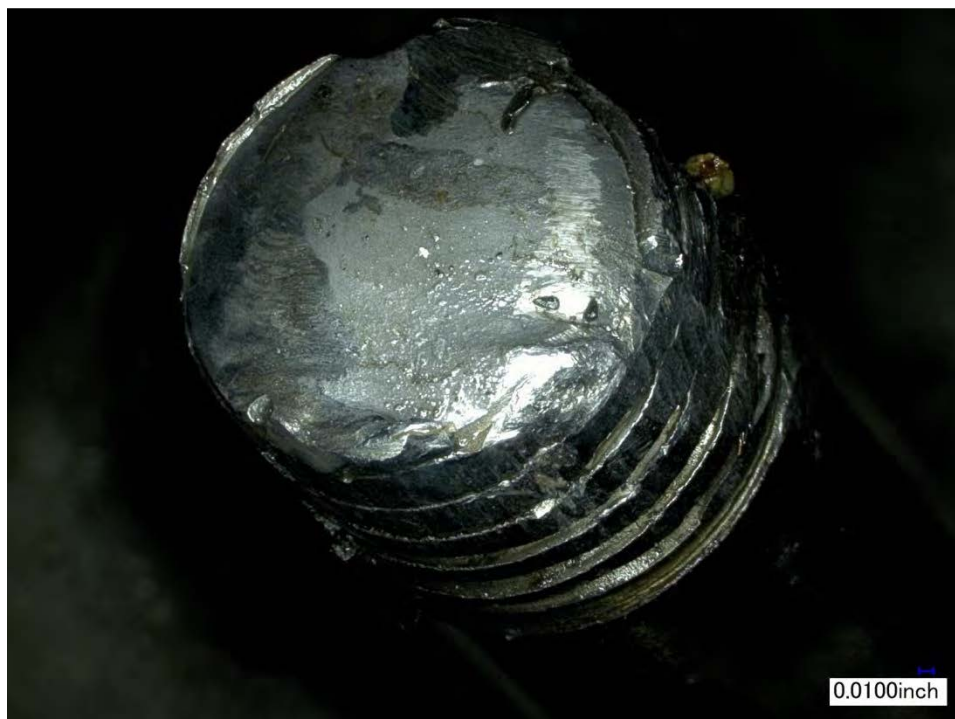
Figure 11 Rod bolt fracture surface

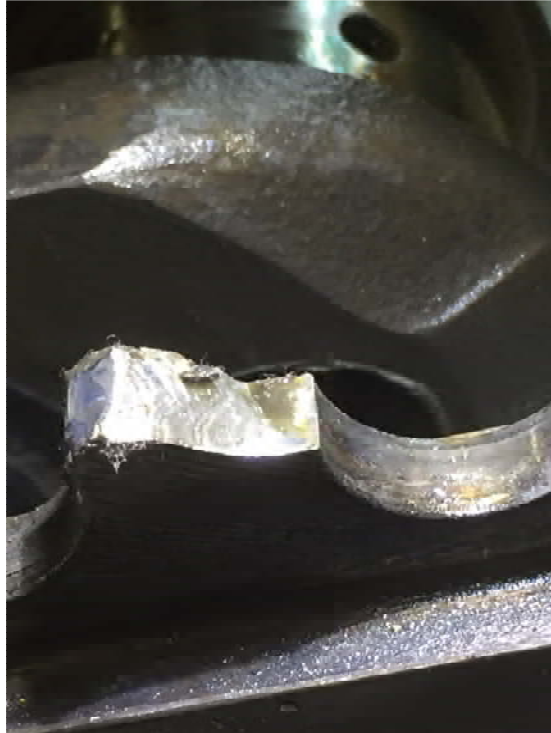
The liberated counterweight came from the aft counterweight blade of the crankshaft shown in figures 12 and 13. The fracture surfaces indicate crack grown in fatigue, with an origin at the aft blade surface, as shown in figure 14. This is consistent with a crack on the blade on the surface of bushing installation. There is significant damage on the fracture surfaces, however, that masks additional crack features.

Figure 12 Fractured crankshaft aft hanger blade

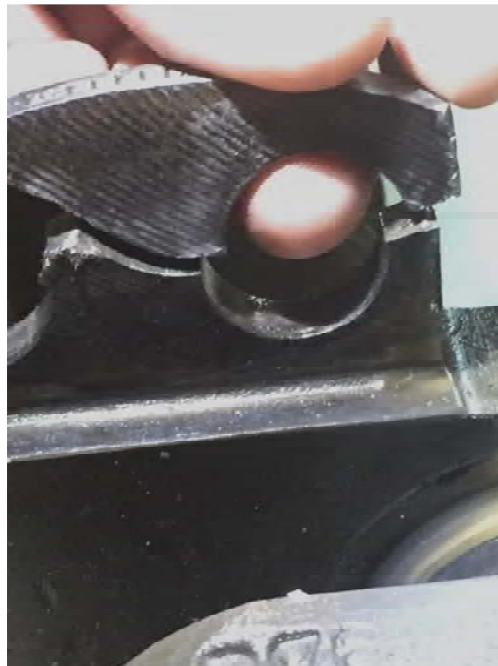
Figure 13 Aft blade with liberated piece

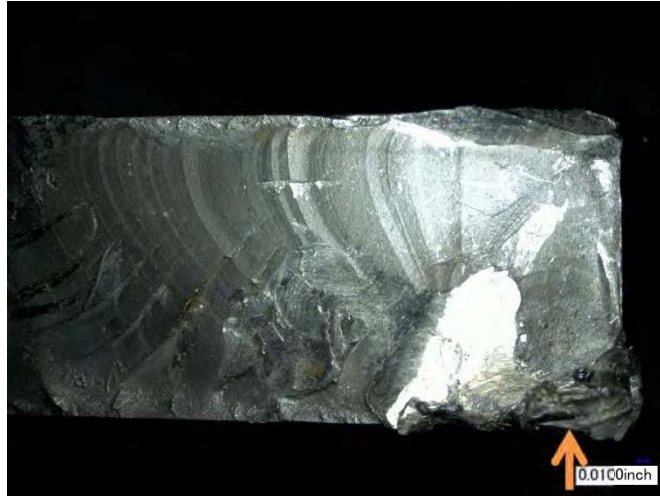
Figure 14 Liberated piece from counterweight blade shows crack growth in fatigue. Initiation area is shown by the arrow.

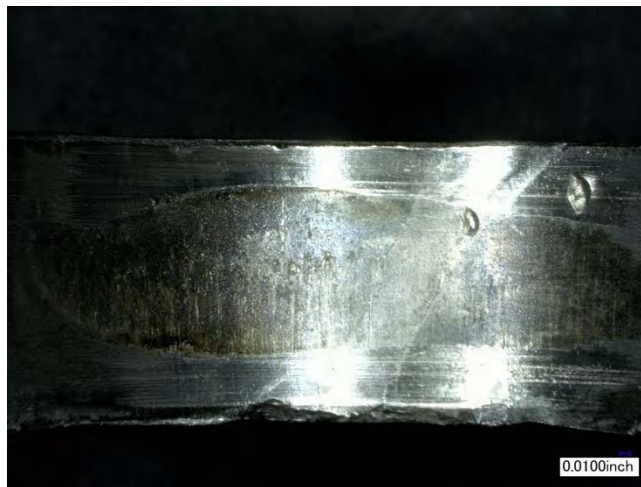
The bushing hole adjacent to the fracture in figure 12 shows marks consistent with movement for a period of time, as shown in figure 15. Figure 16 shows the opposite bushing hole without these marks. Figure 18 shows a sketch of the location of the initial cracks.

Figure 15 Bushing hole adjacent to liberated piece of hanger blade

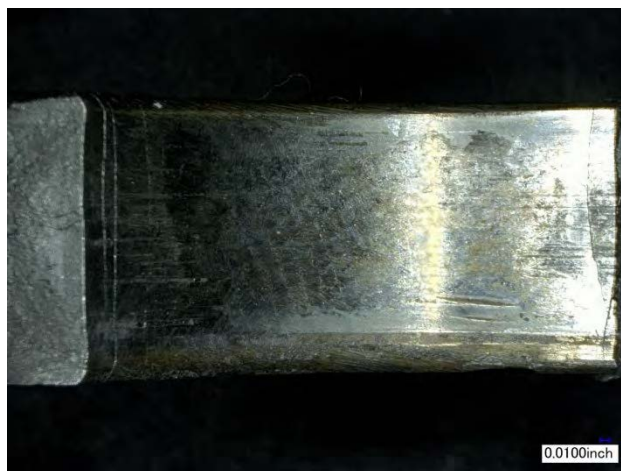
Figure 16 second fractured bushing hole

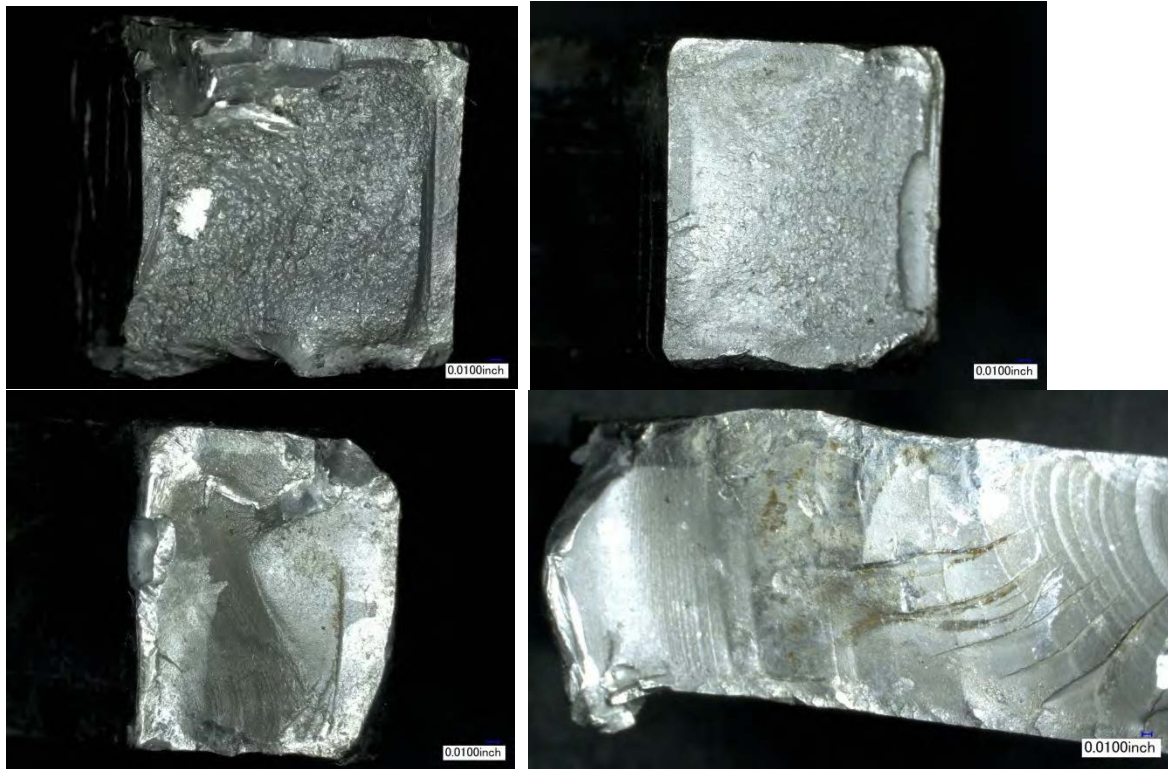
Figure 17 Fractured hanger blade sections. Top two show failure in overload from outer wall of the counterweight hanger blade. The lower two show crack growth in fatigue from the initial cracks depicted in figure 18.
