SARASOTA MANATEE AIRPORT AUTHORITY  
6000 Airport Circle, Sarasota, FL 34243-2105 Tel: (941) 359-6200

## AIRCRAFT INCIDENT/ACCIDENT REPORT

Registration: N622PG

Make: Cessna Model : Citation 550

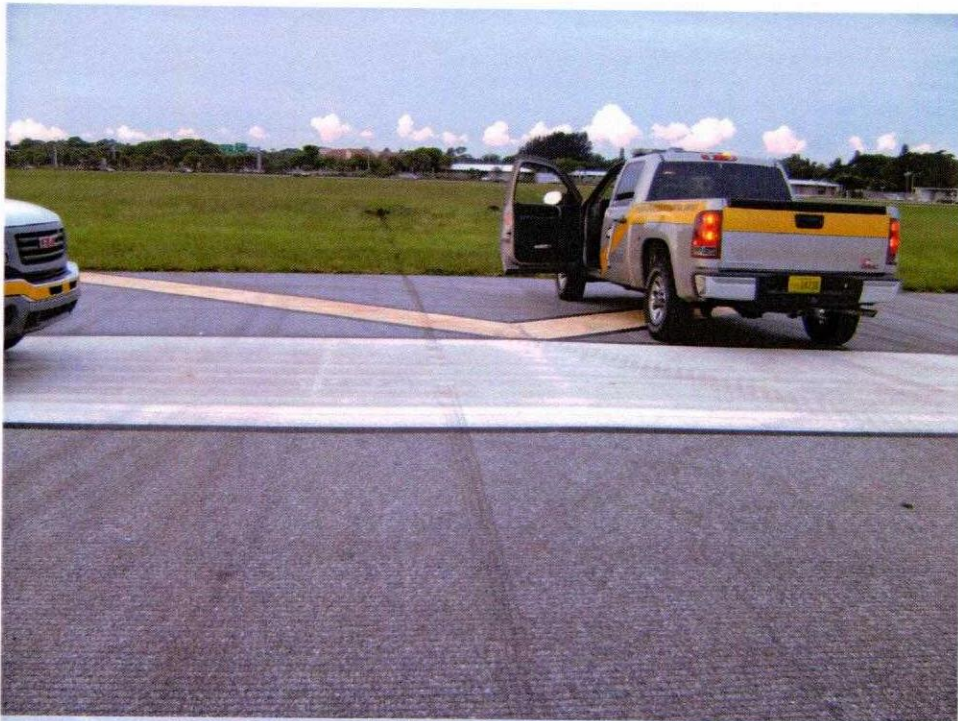
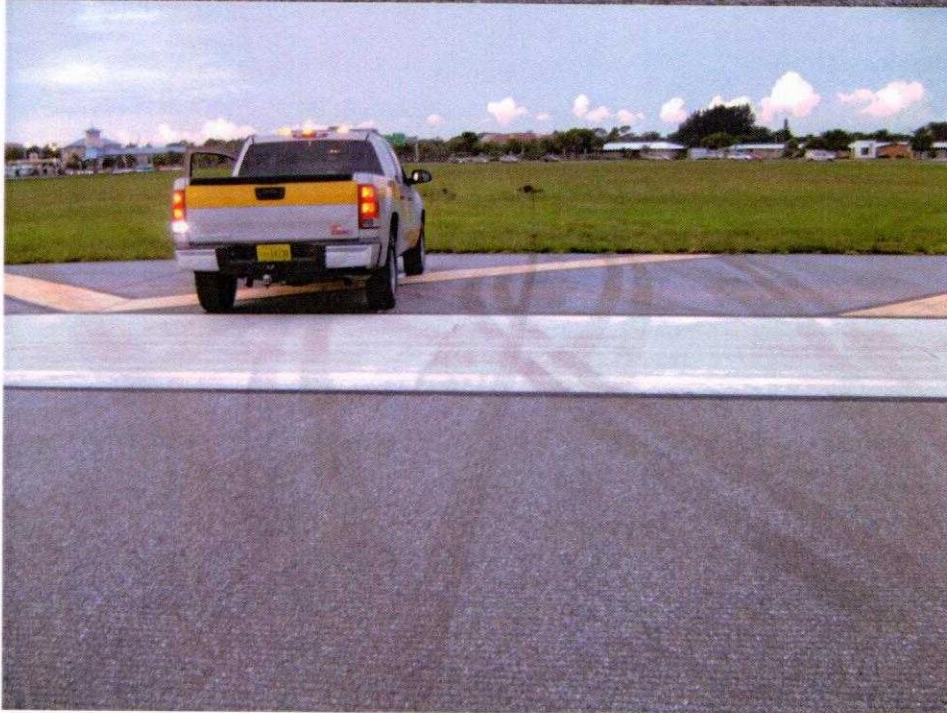
Path of travel of aircraft  
from runway 22 touch-  
down markings.

Right main tire mark  
visible on runway for  
about 1,130 ft.

Left main tire mark  
visible for about 100 ft.

Testing point of  
aircraft: 120 ft from  
CY threshold line
