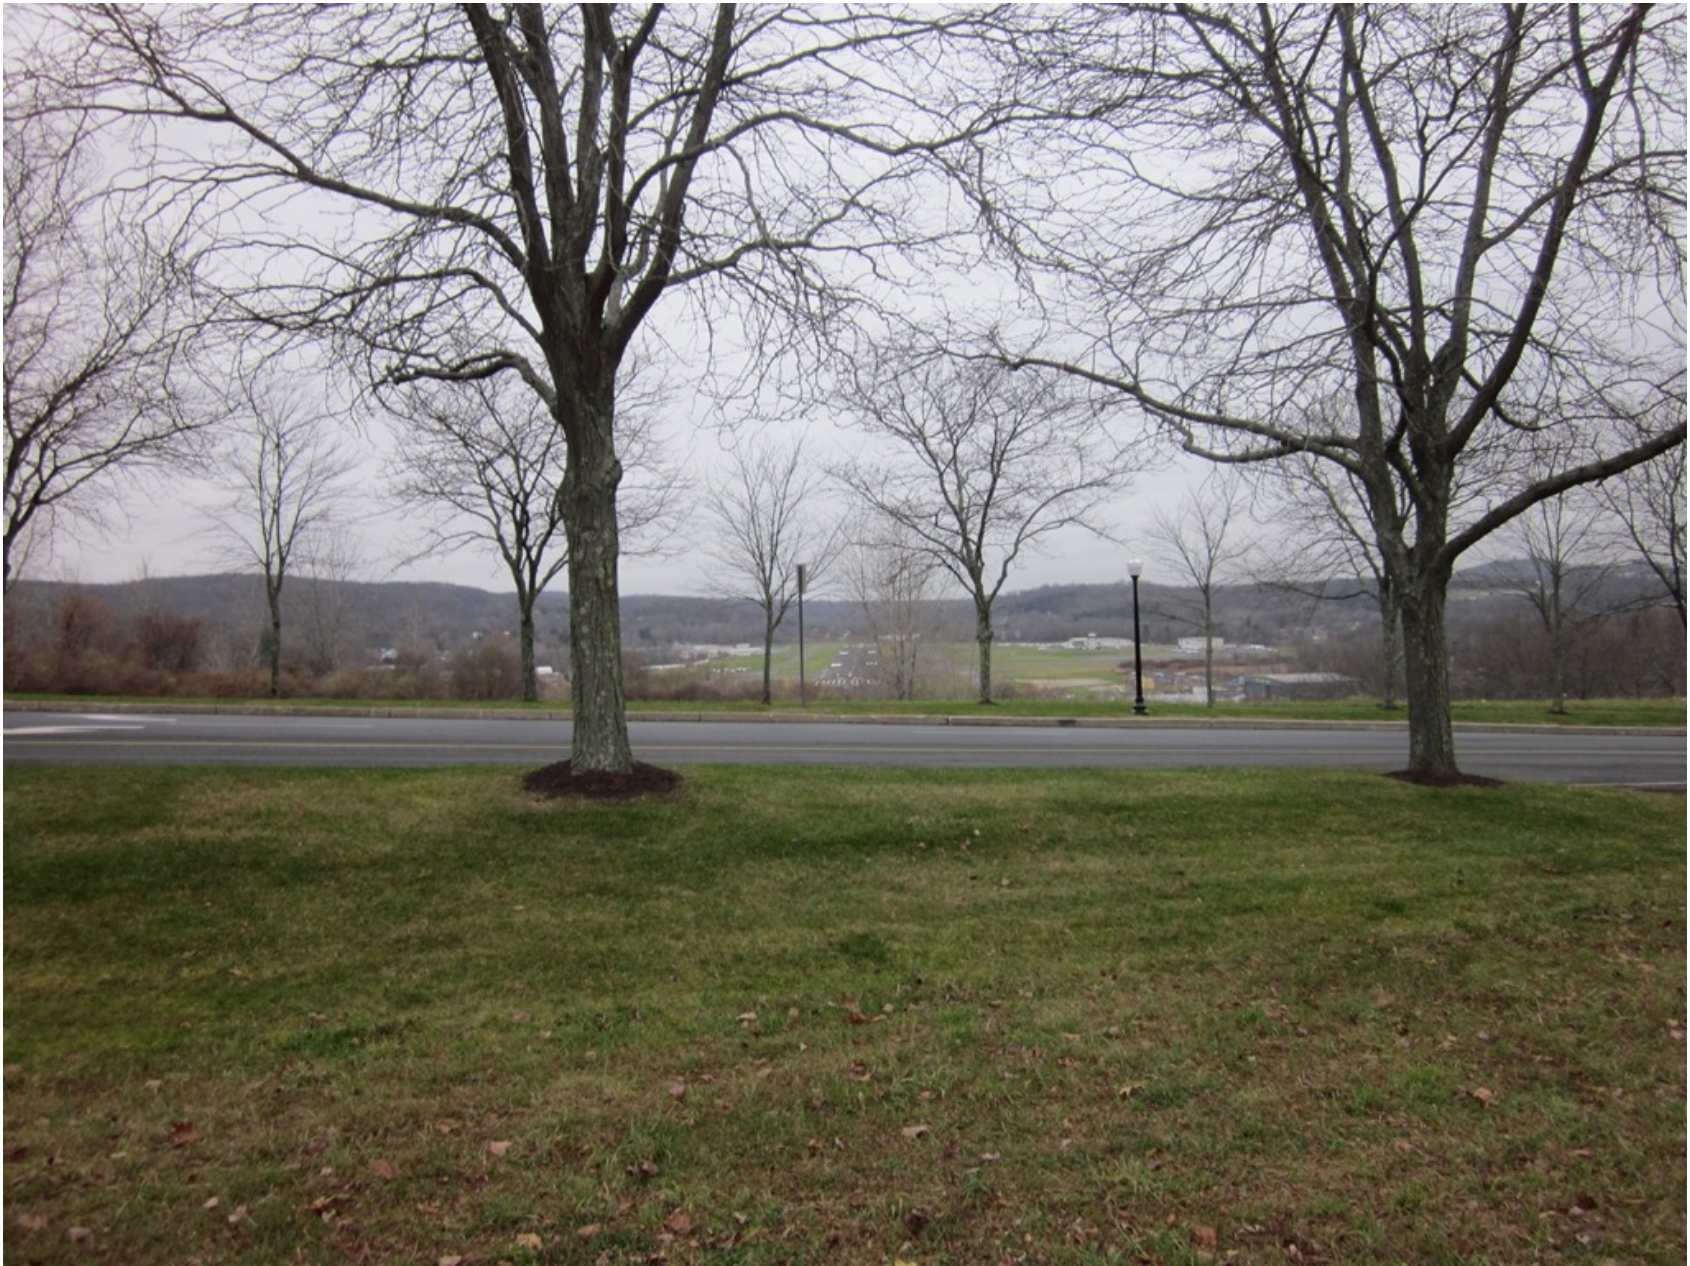
**Photo 1 – Approach End Runway 26 – Courtesy of FAA**

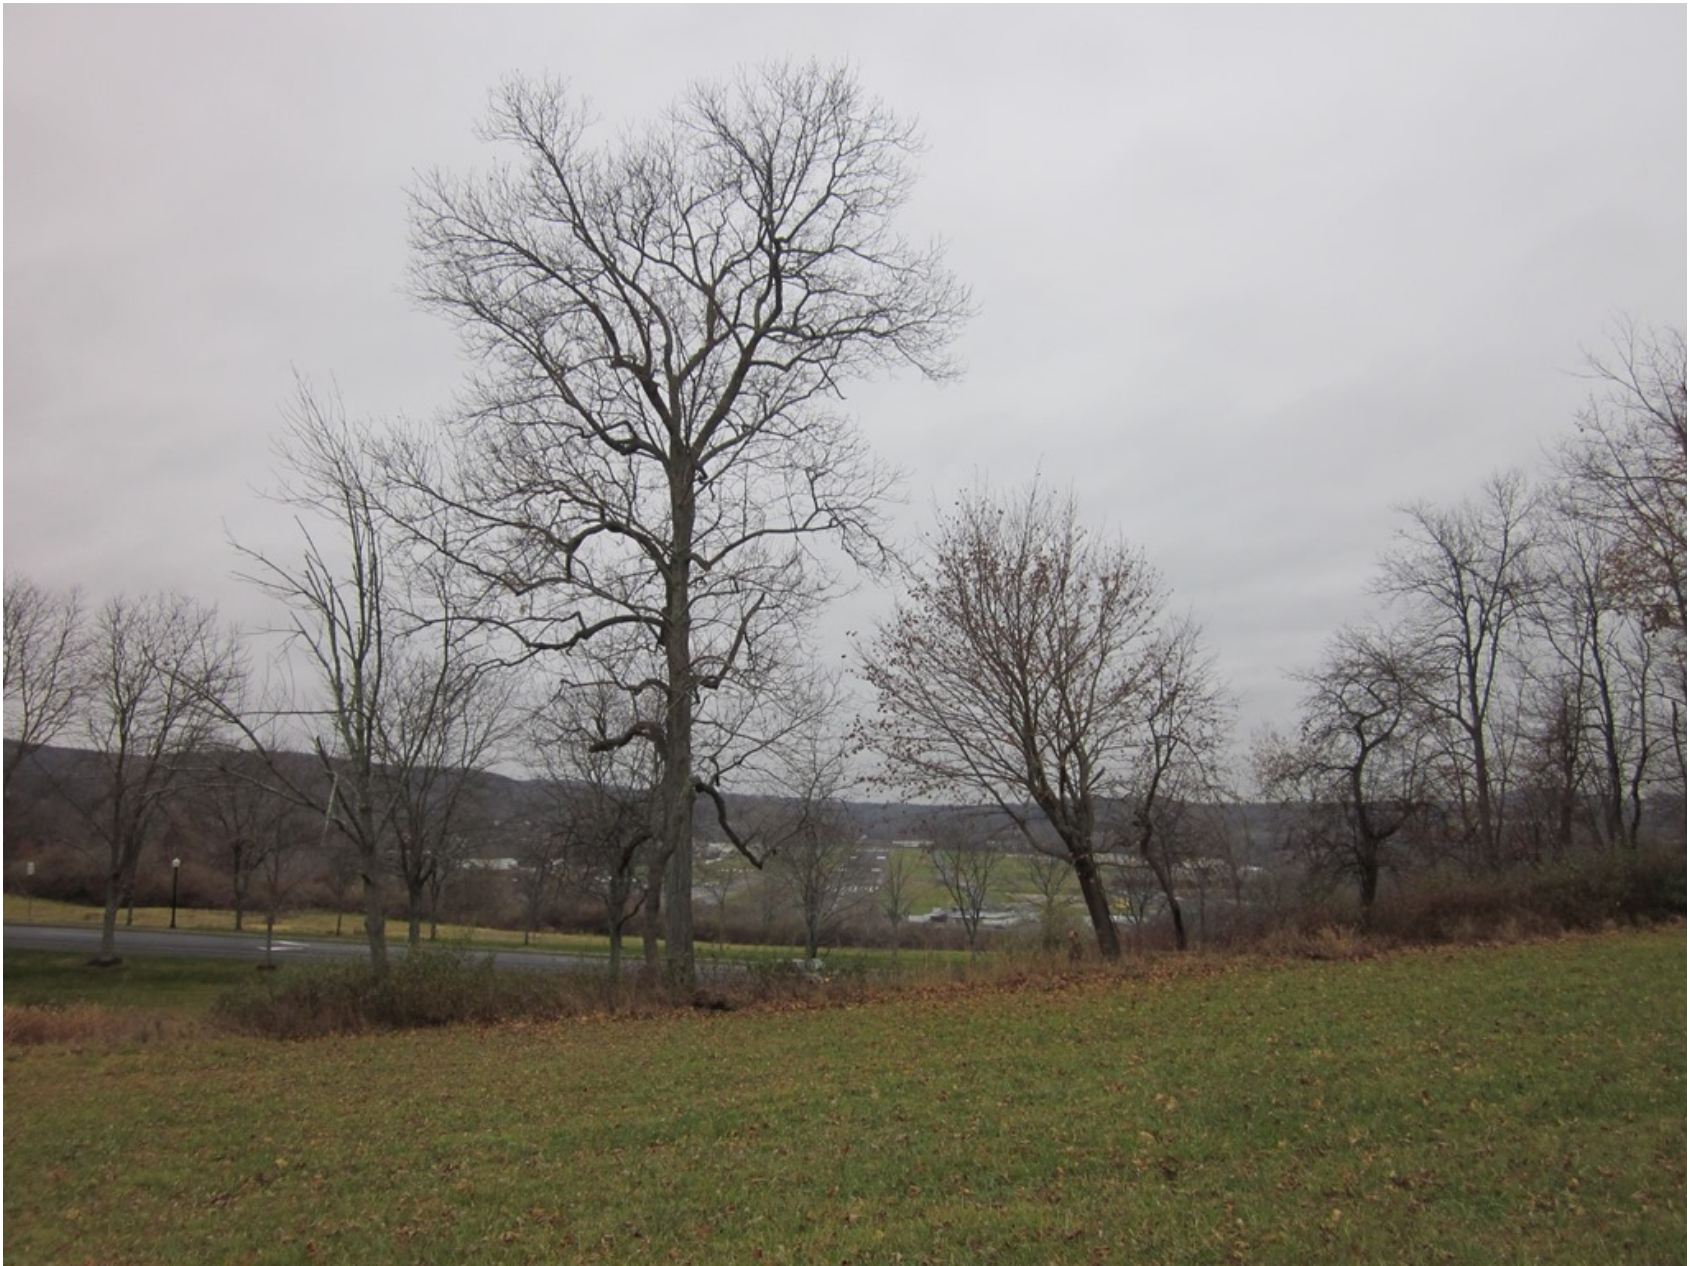
**Photo 2 – Tree on Approach Runway 26 – Courtesy of FAA**

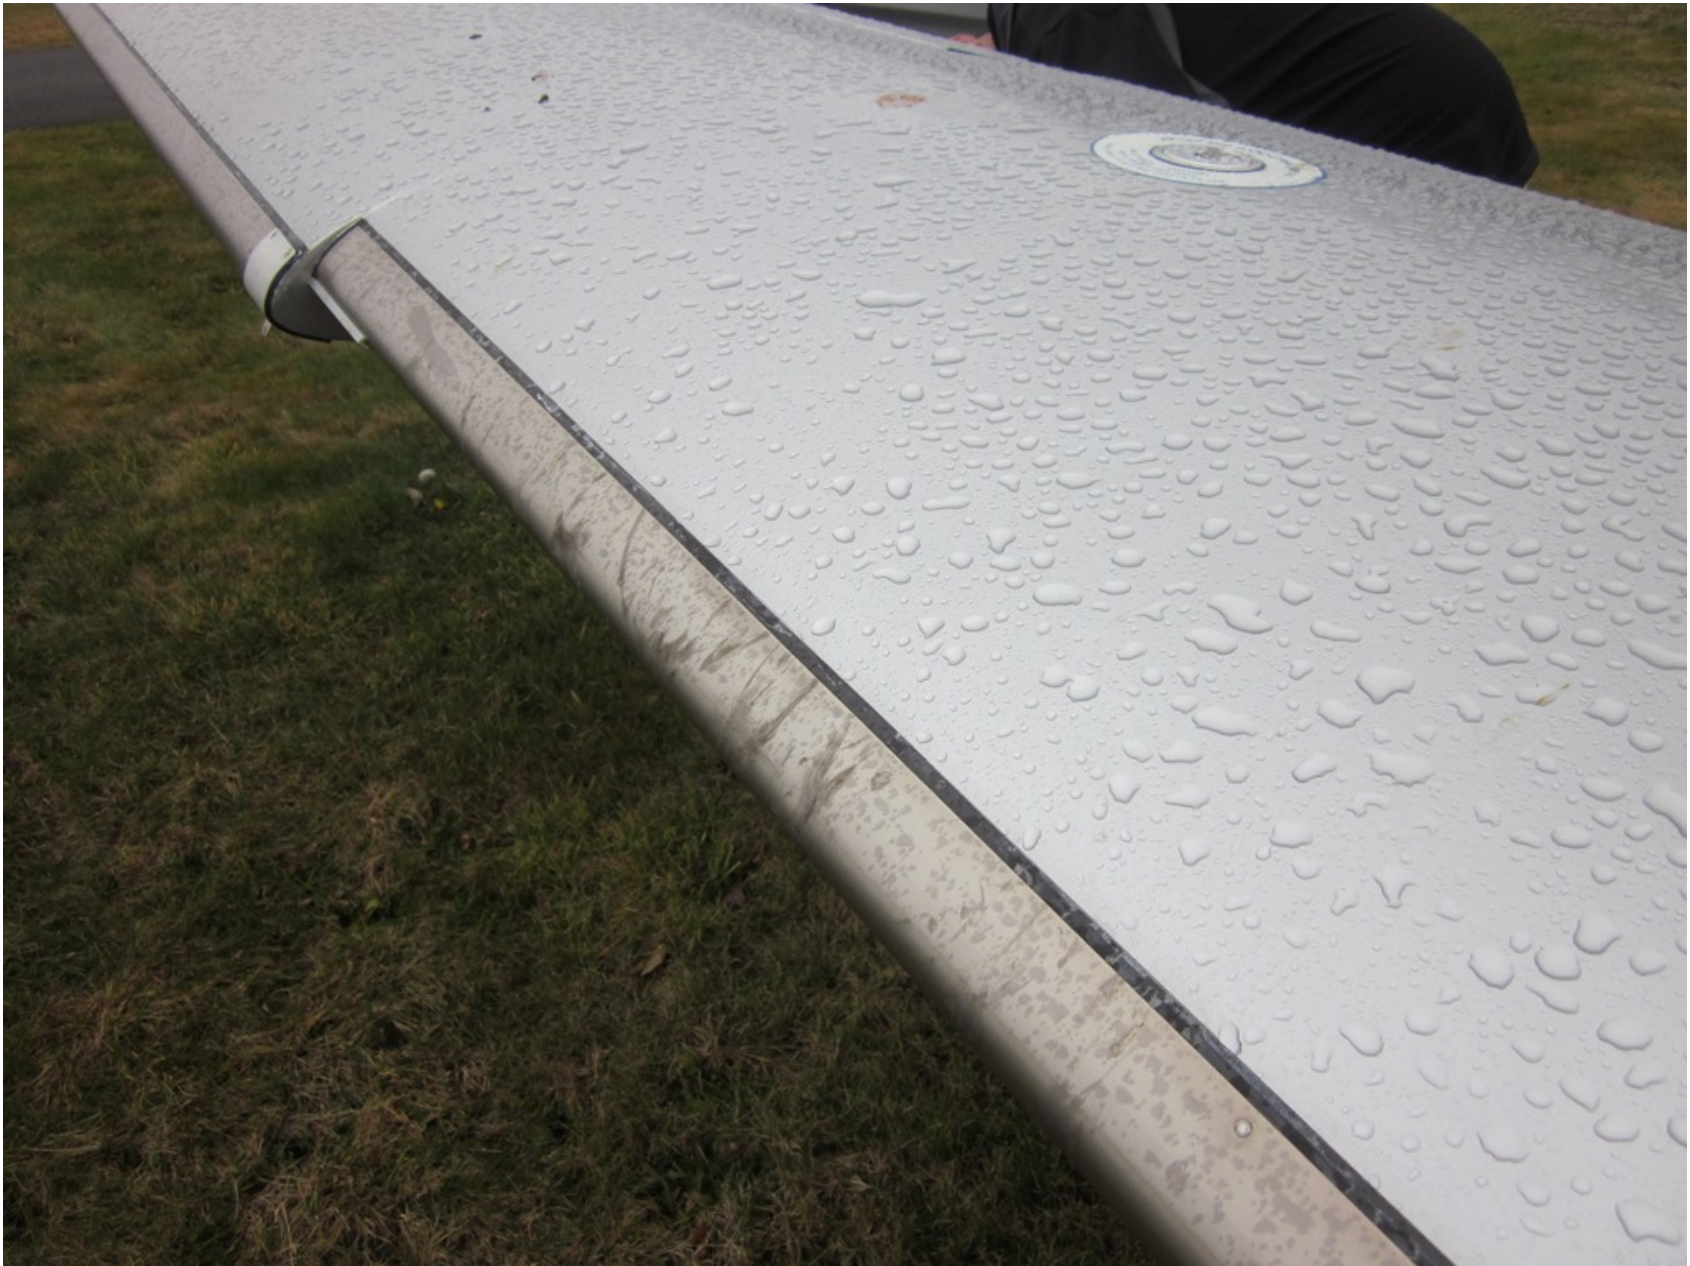
**Photo 3 – Right Wing – Courtesy of FAA**

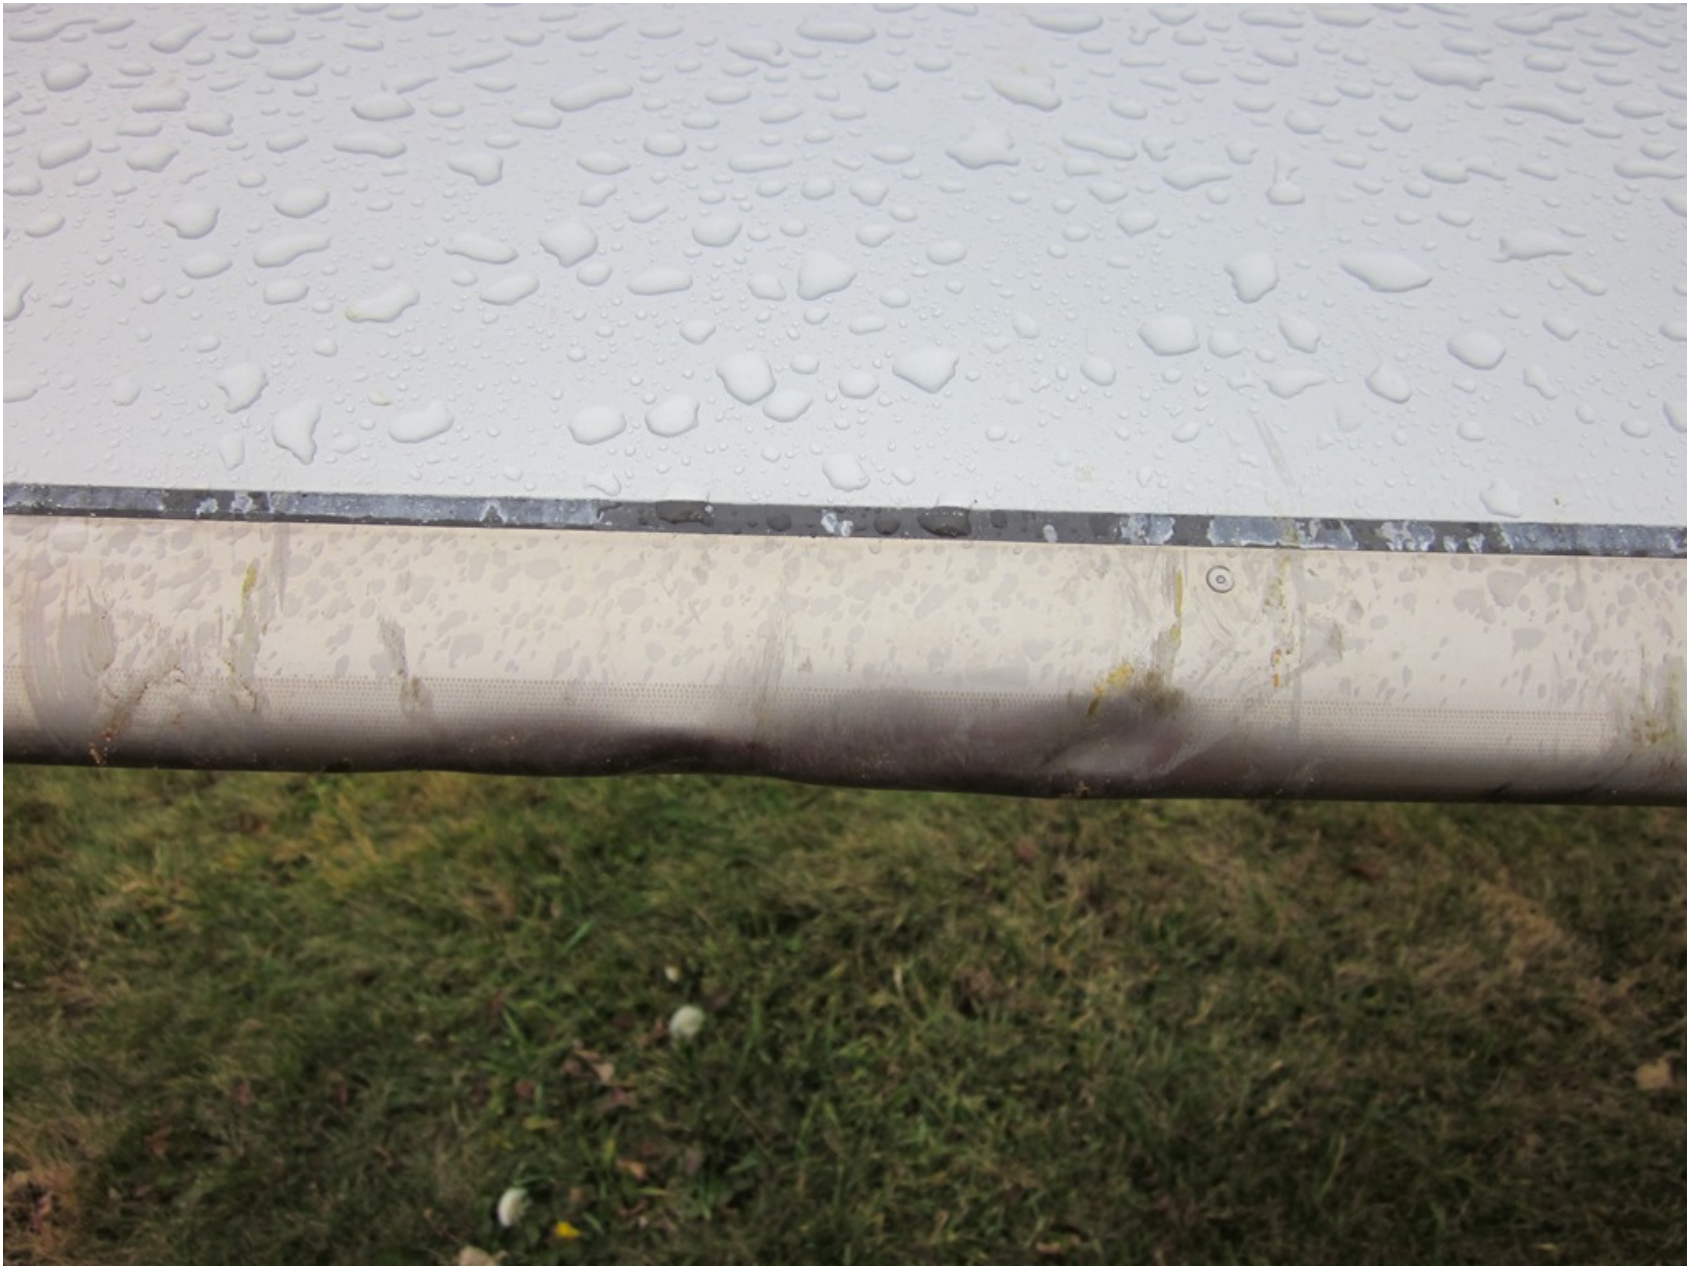
**Photo 4 – Moderate Sized Dents – Courtesy of FAA**

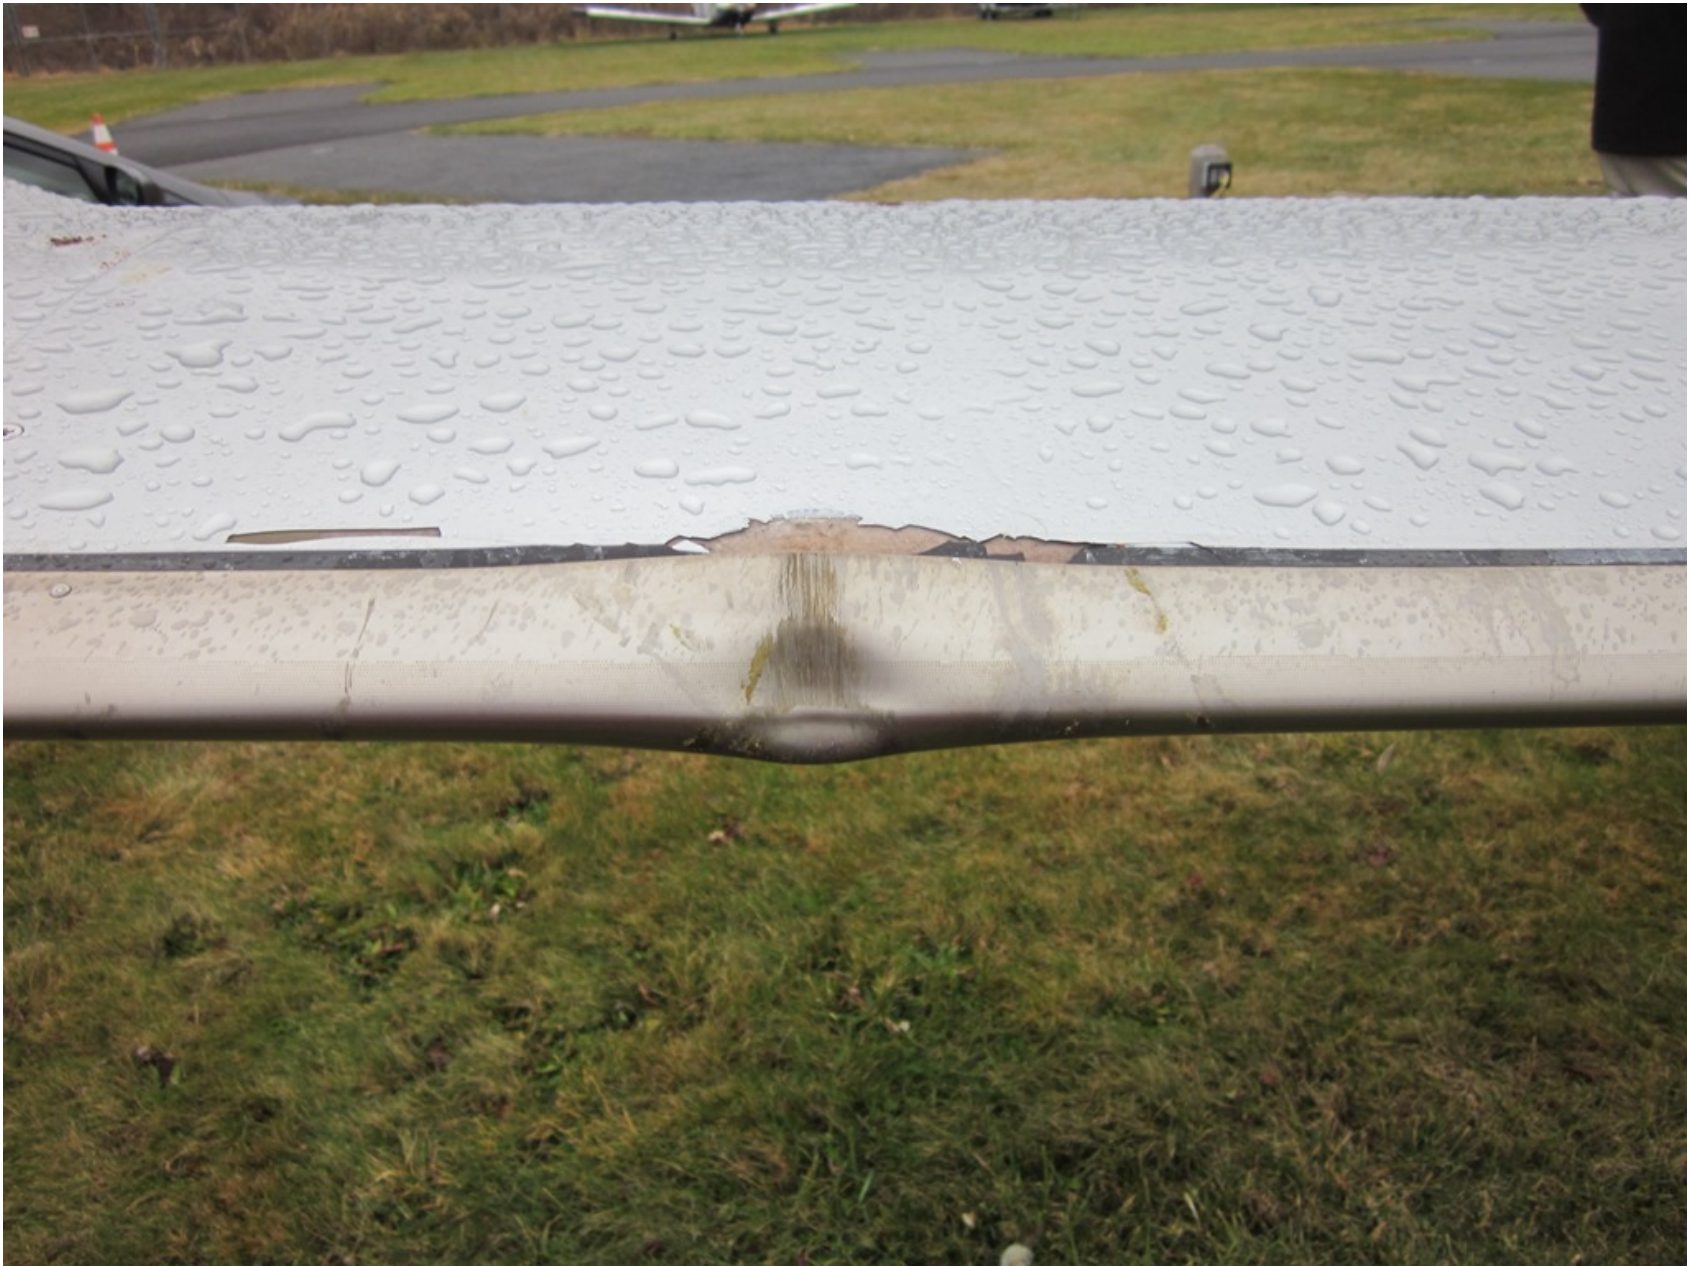
**Photo 5 – Large Dent – Courtesy of FAA**

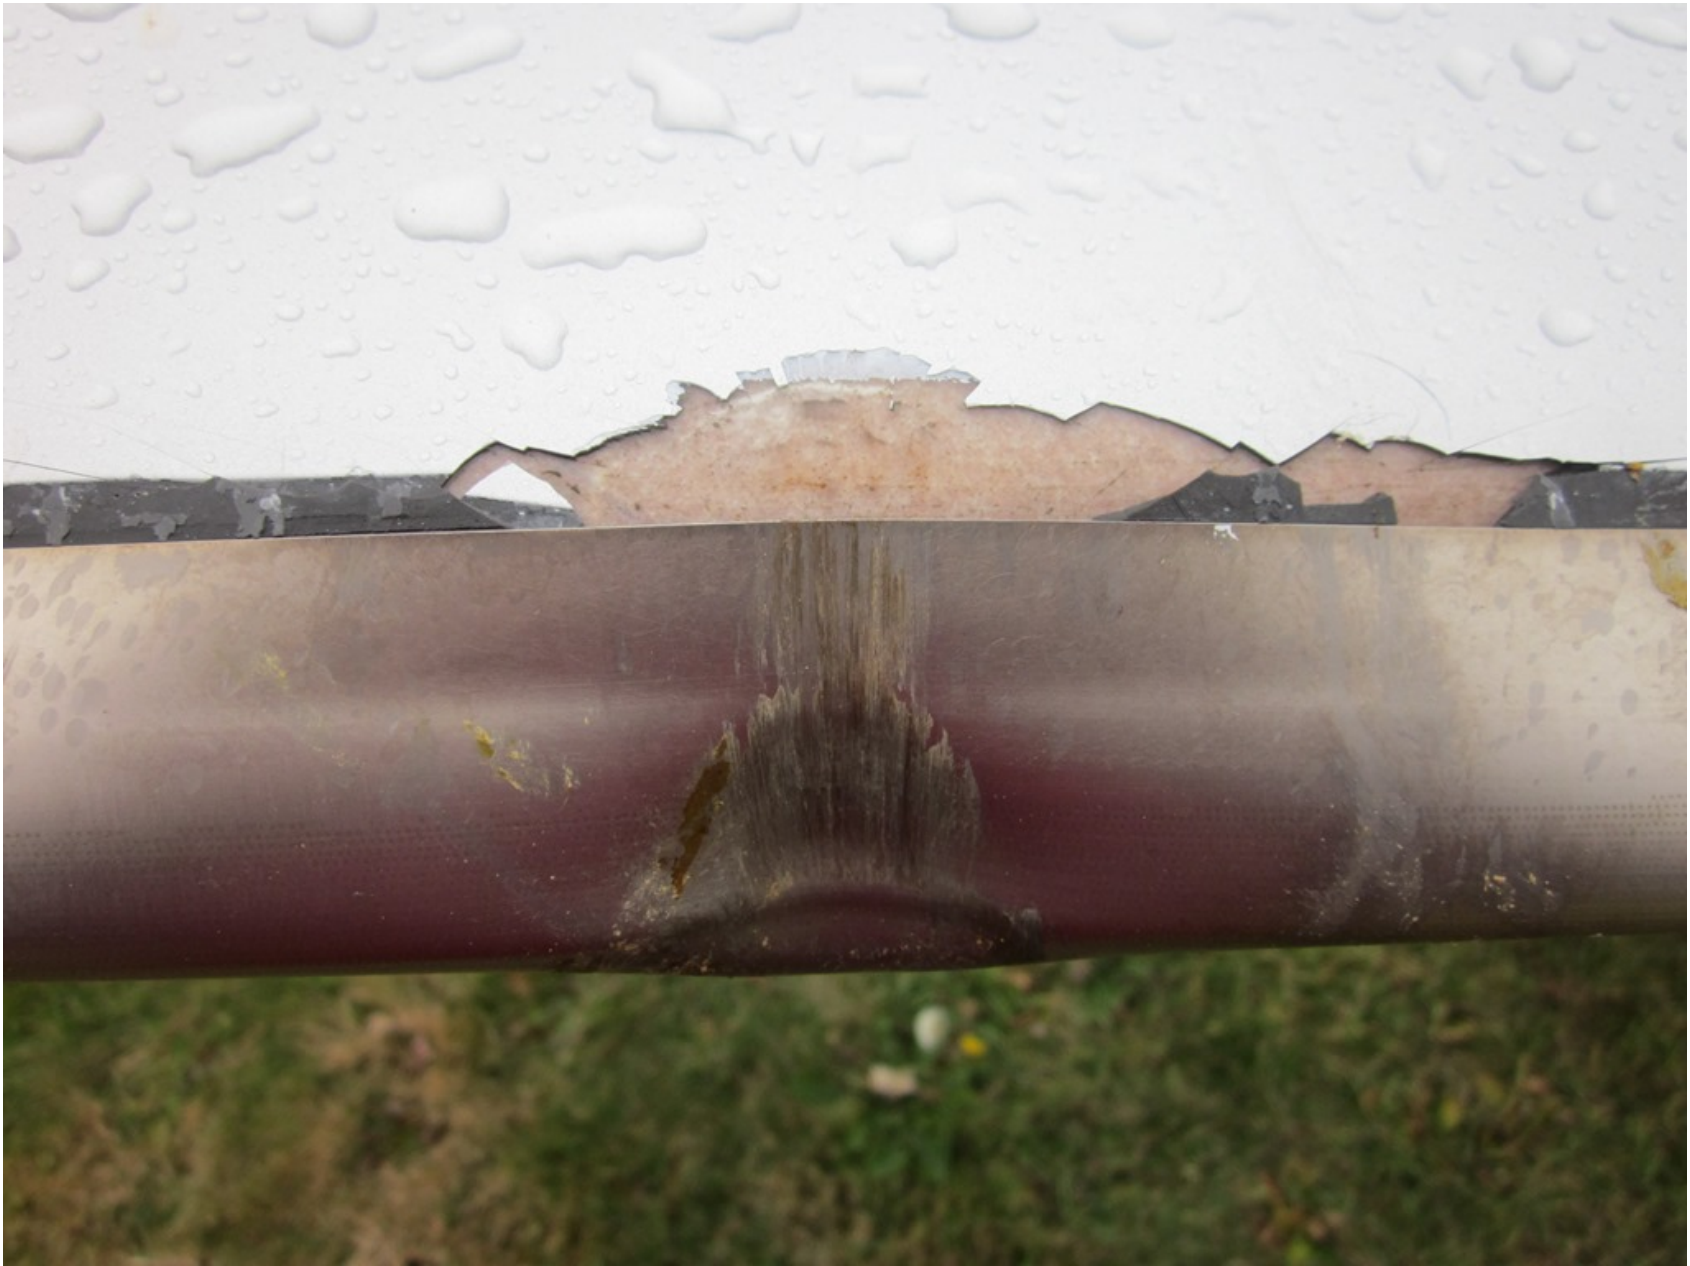
**Photo 6 – Close Up of Large Dent – Courtesy of FAA**

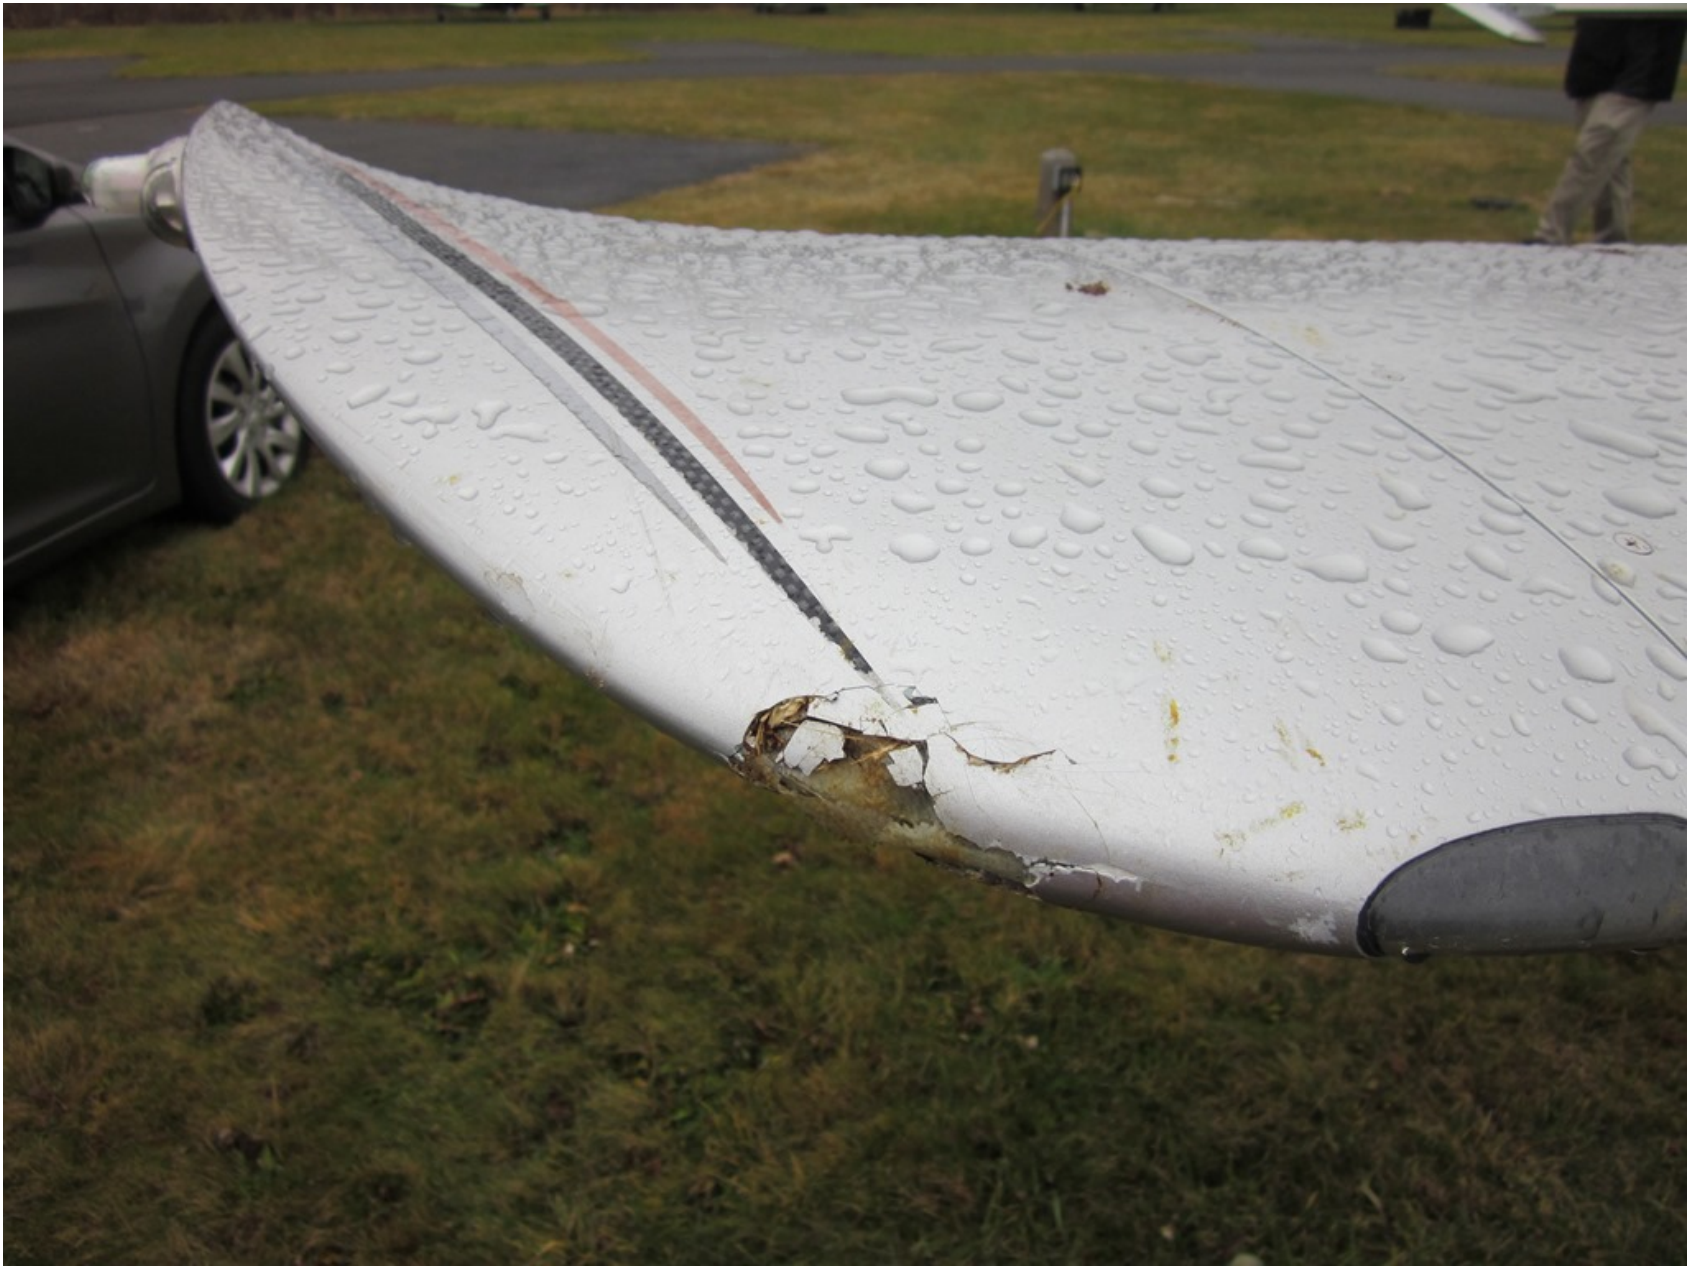
**Photo 7 – Right Wing Tip Cap – Courtesy of FAA**

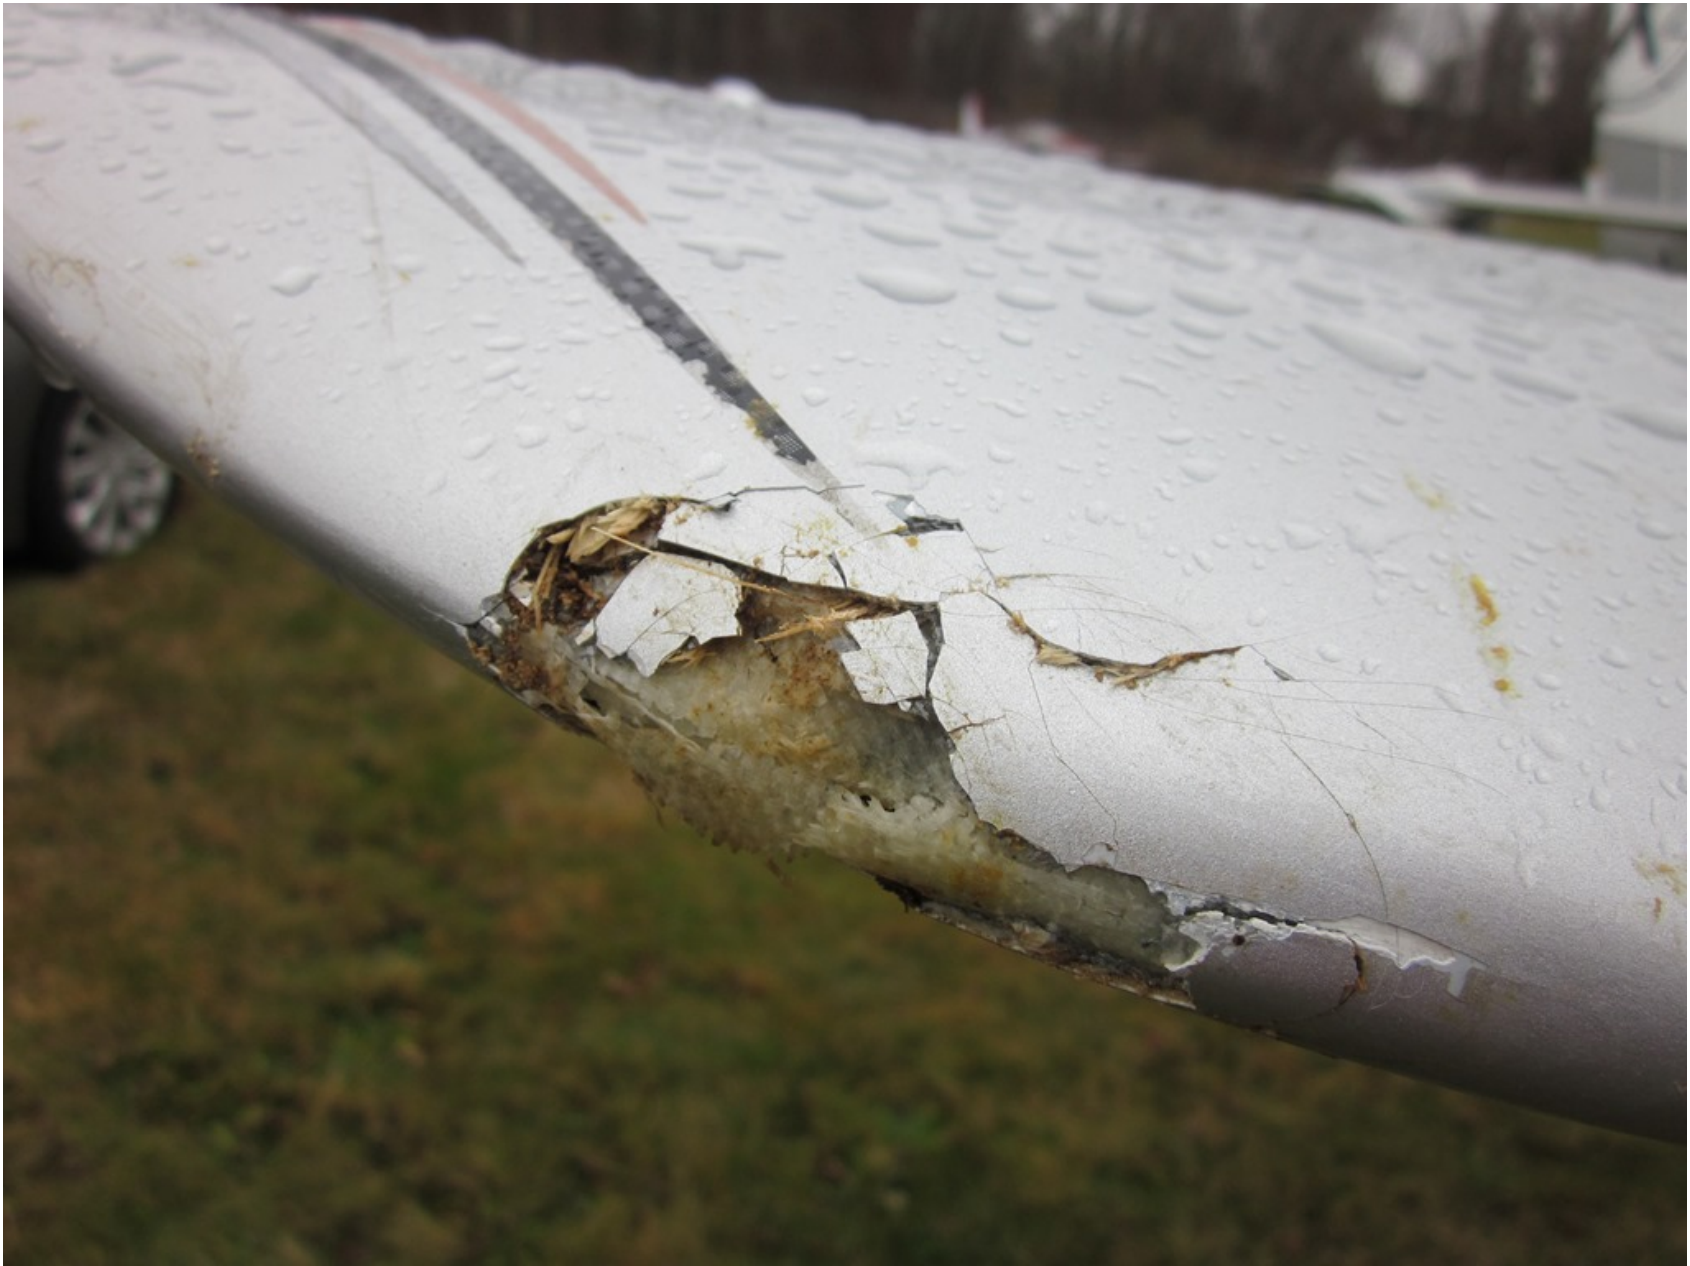
**Photo 8 – Close Up of Right Wing Tip Cap – Courtesy of FAA**

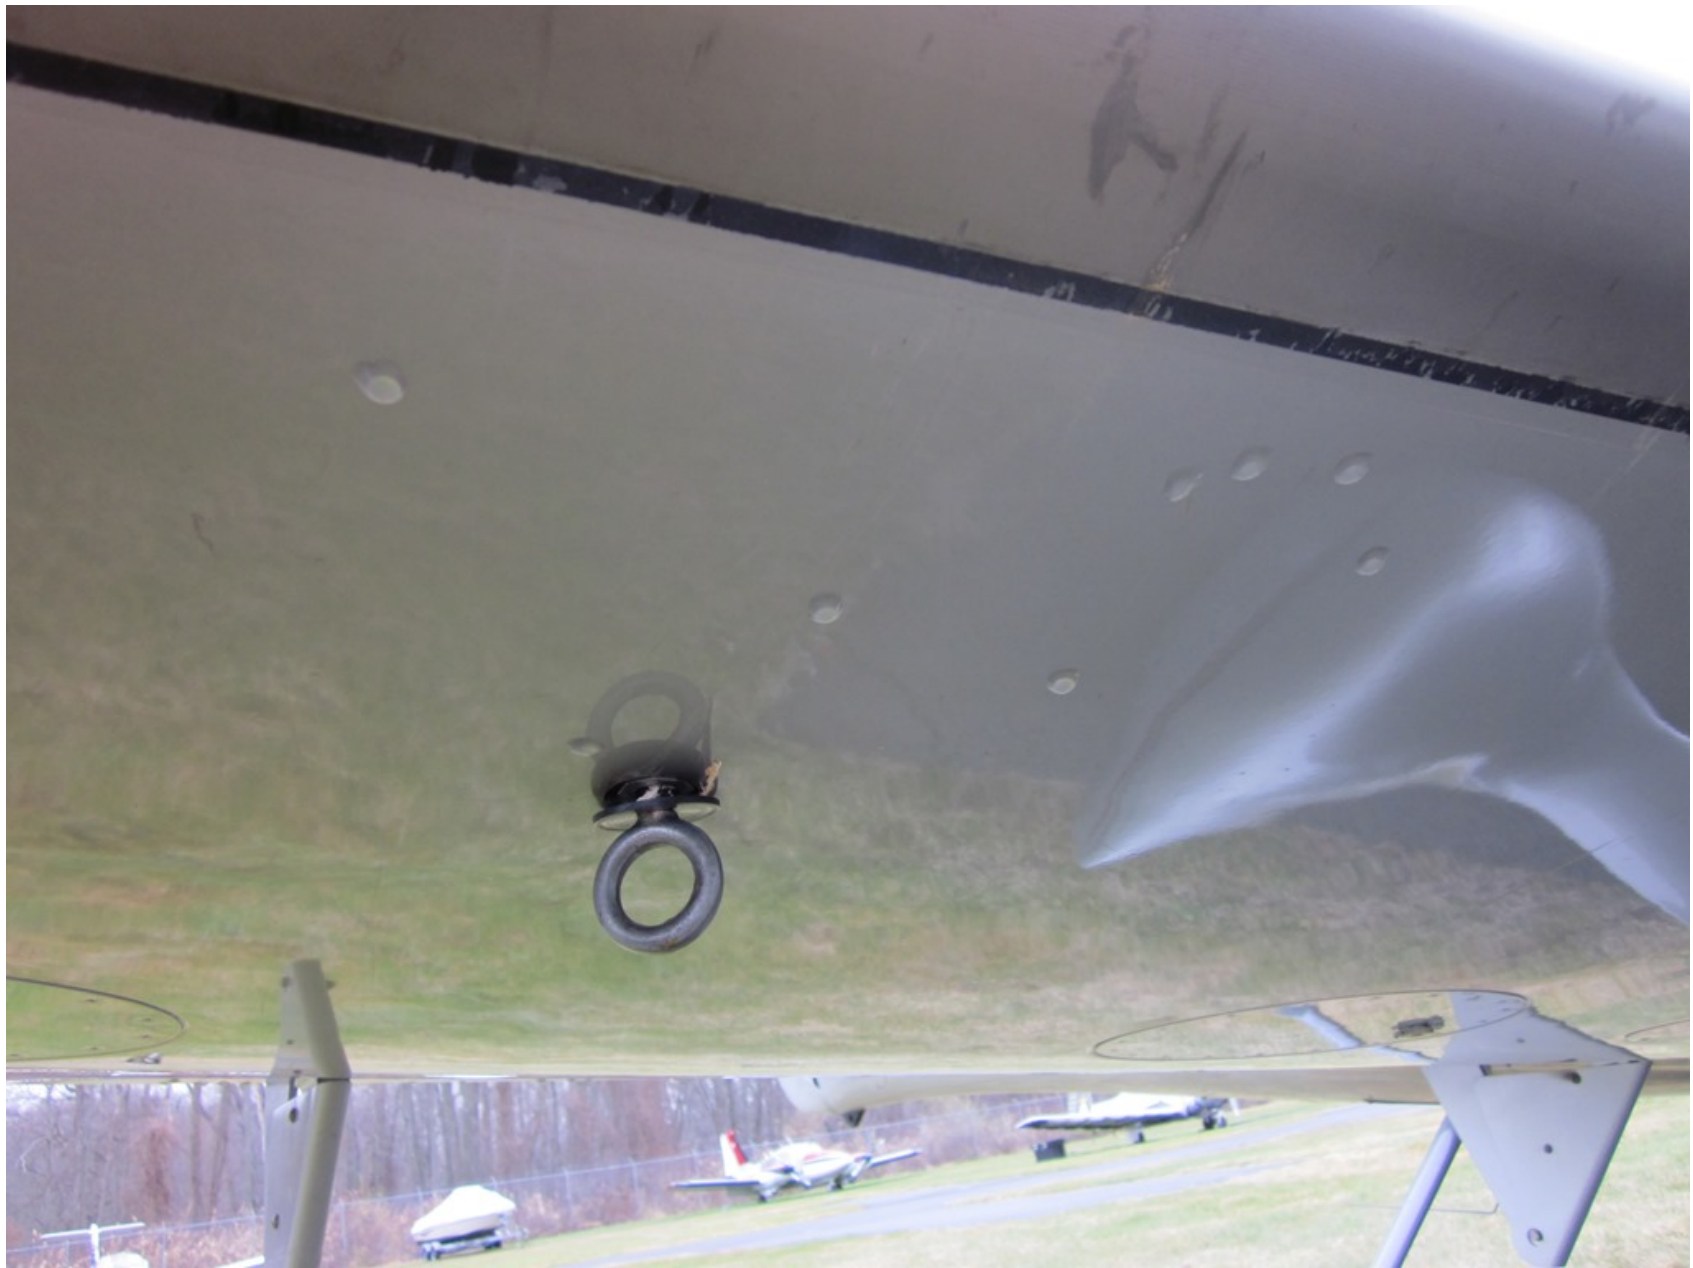
**Photo 9 – Right Wing Tie Down – Courtesy of FAA**

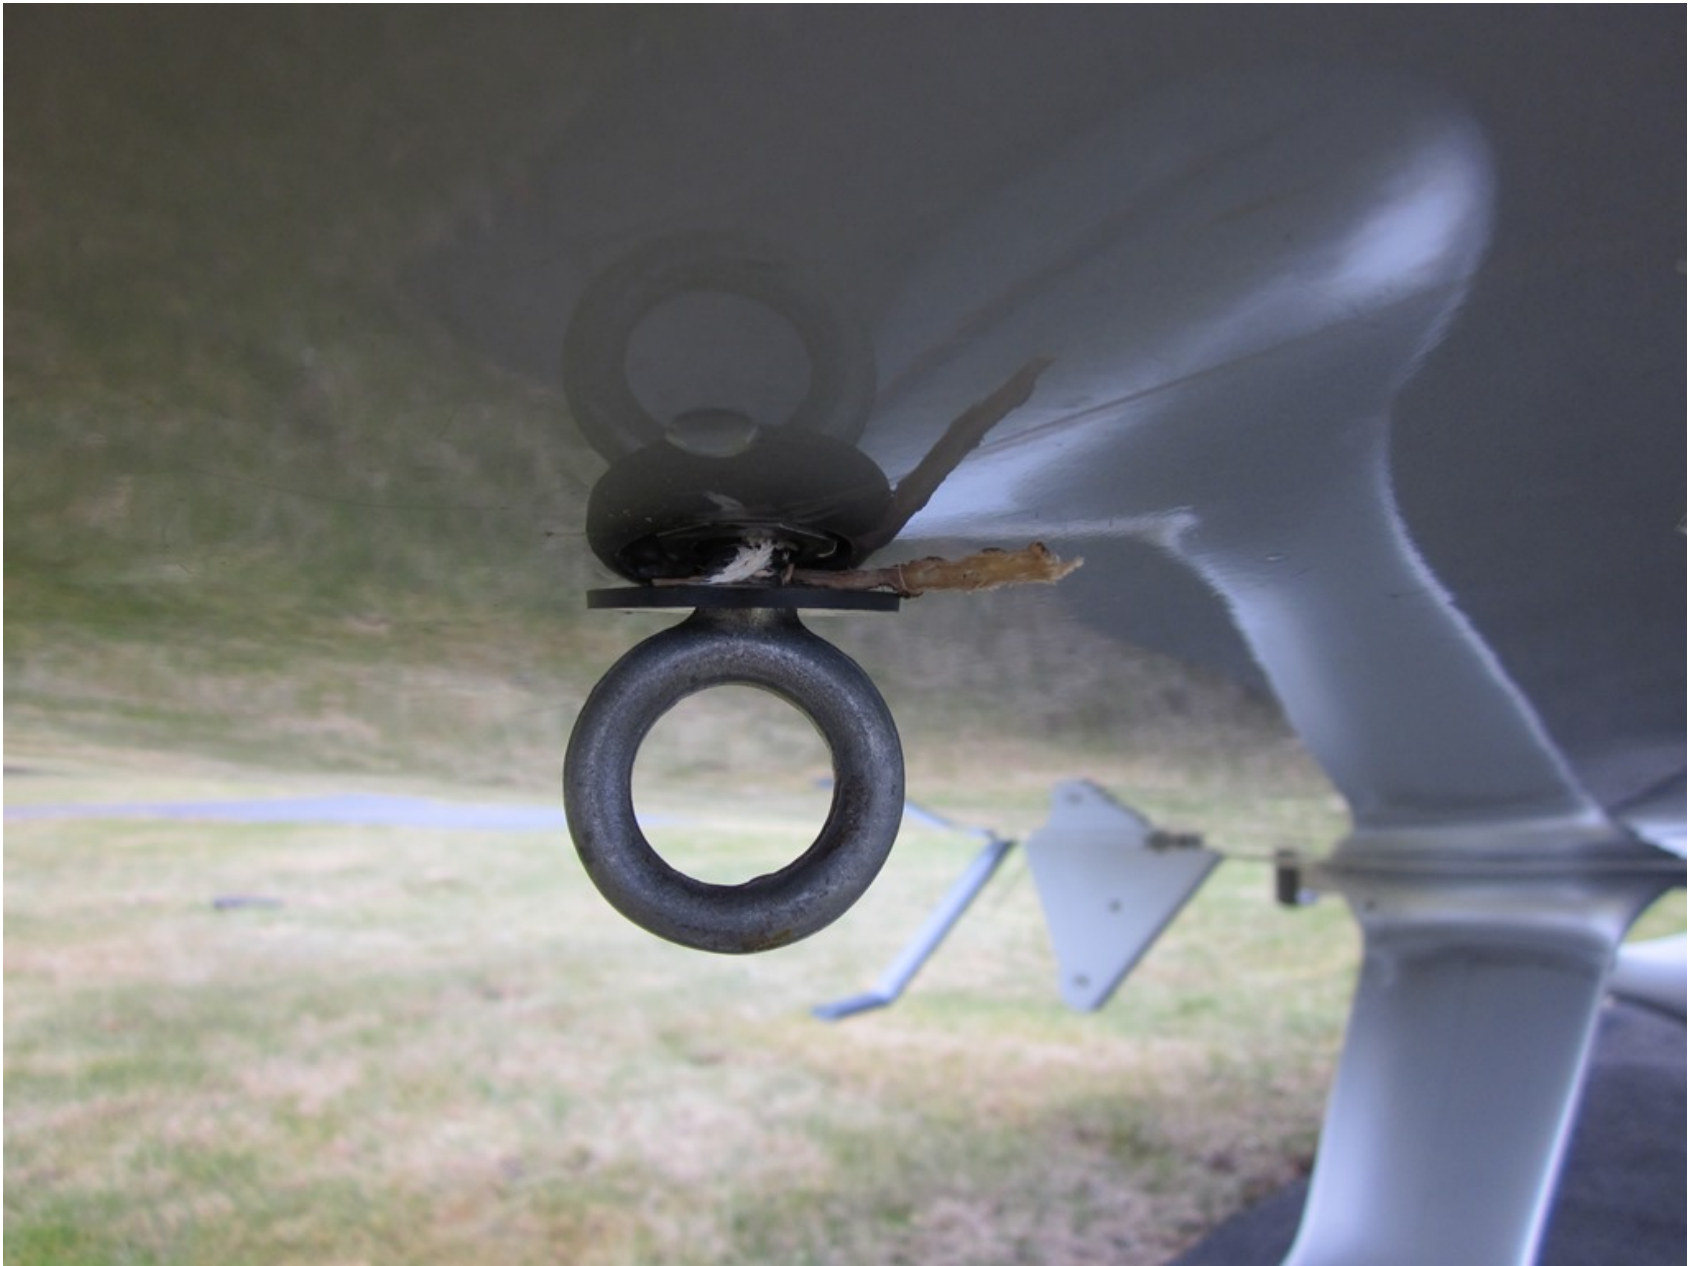
**Photo 10 – Close Up of Right Wing Tie Down – Courtesy of FAA**
