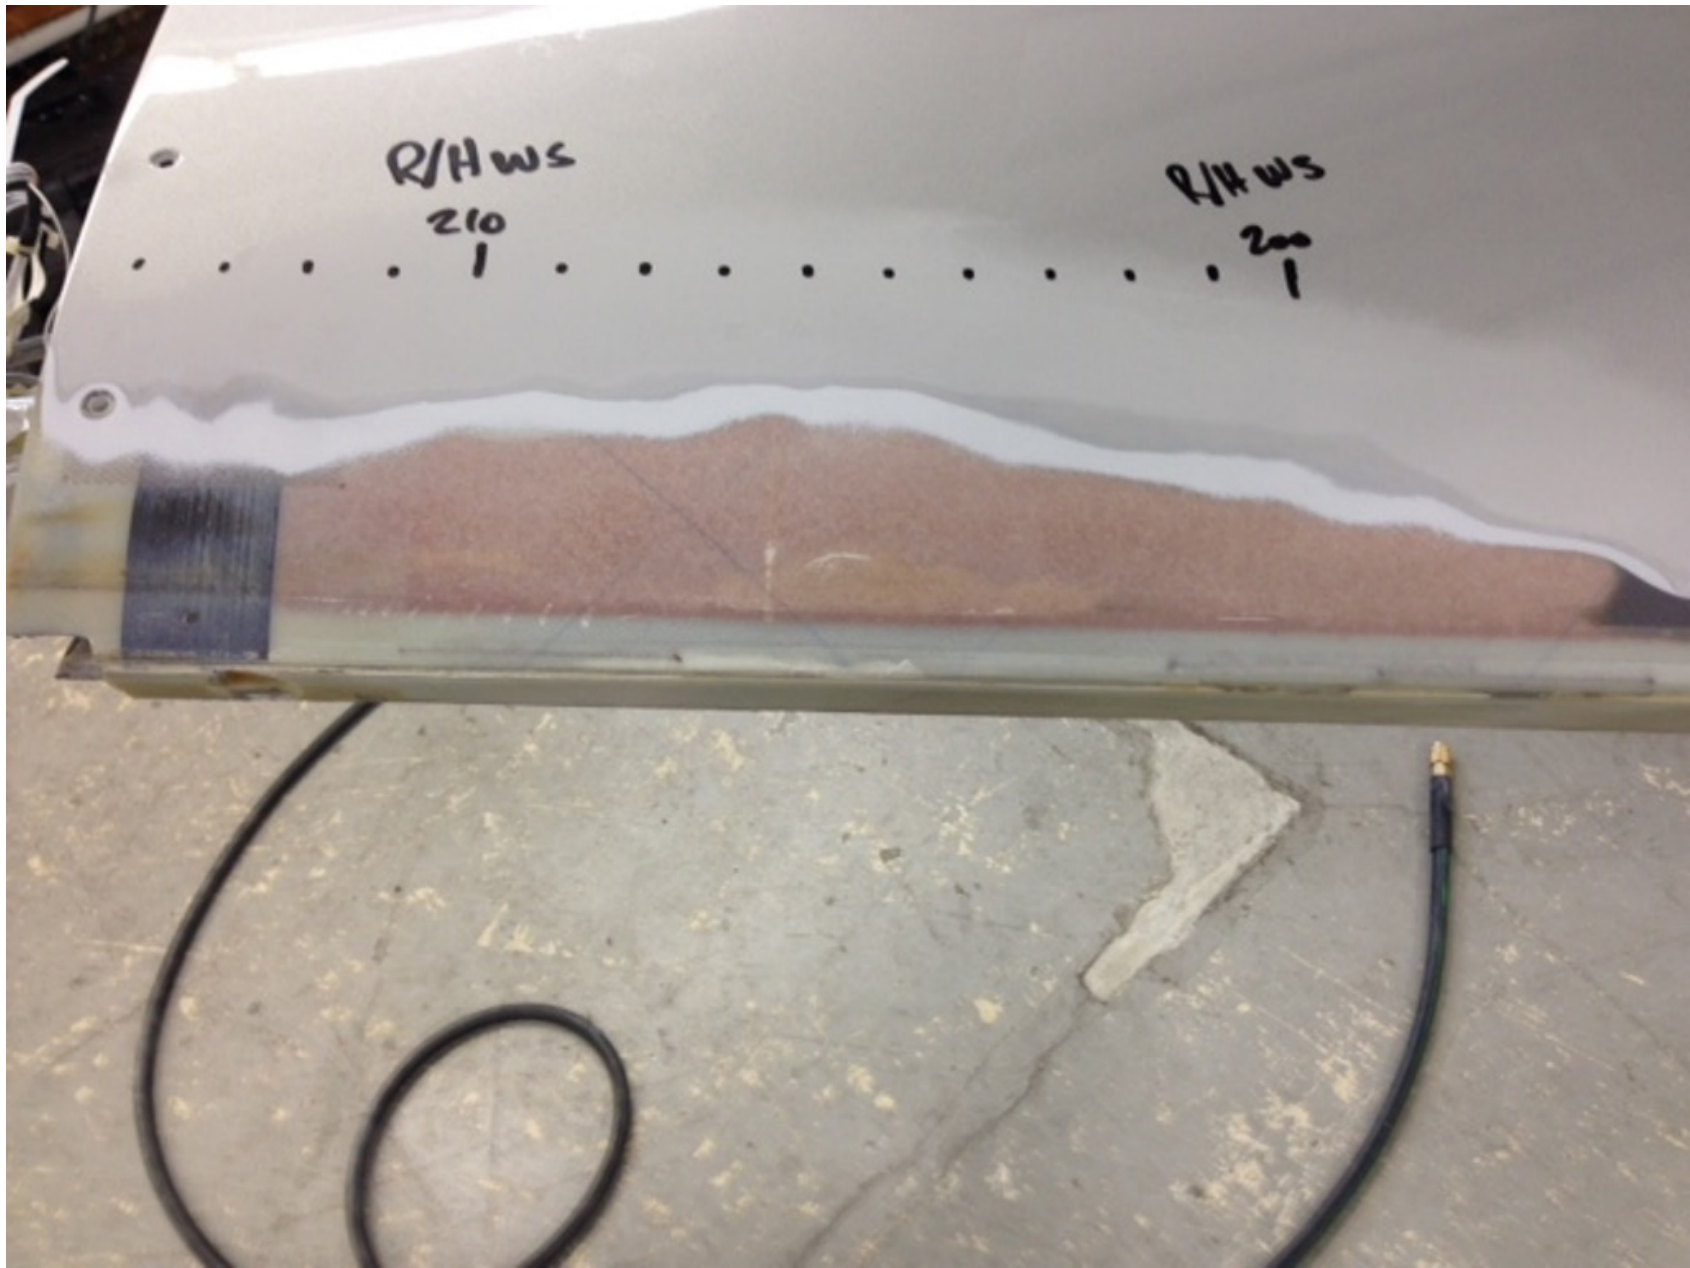
**Photo 11 – Area of Damage to Solid Laminate and Sandwich Structure – Courtesy of Cirrus Aircraft**

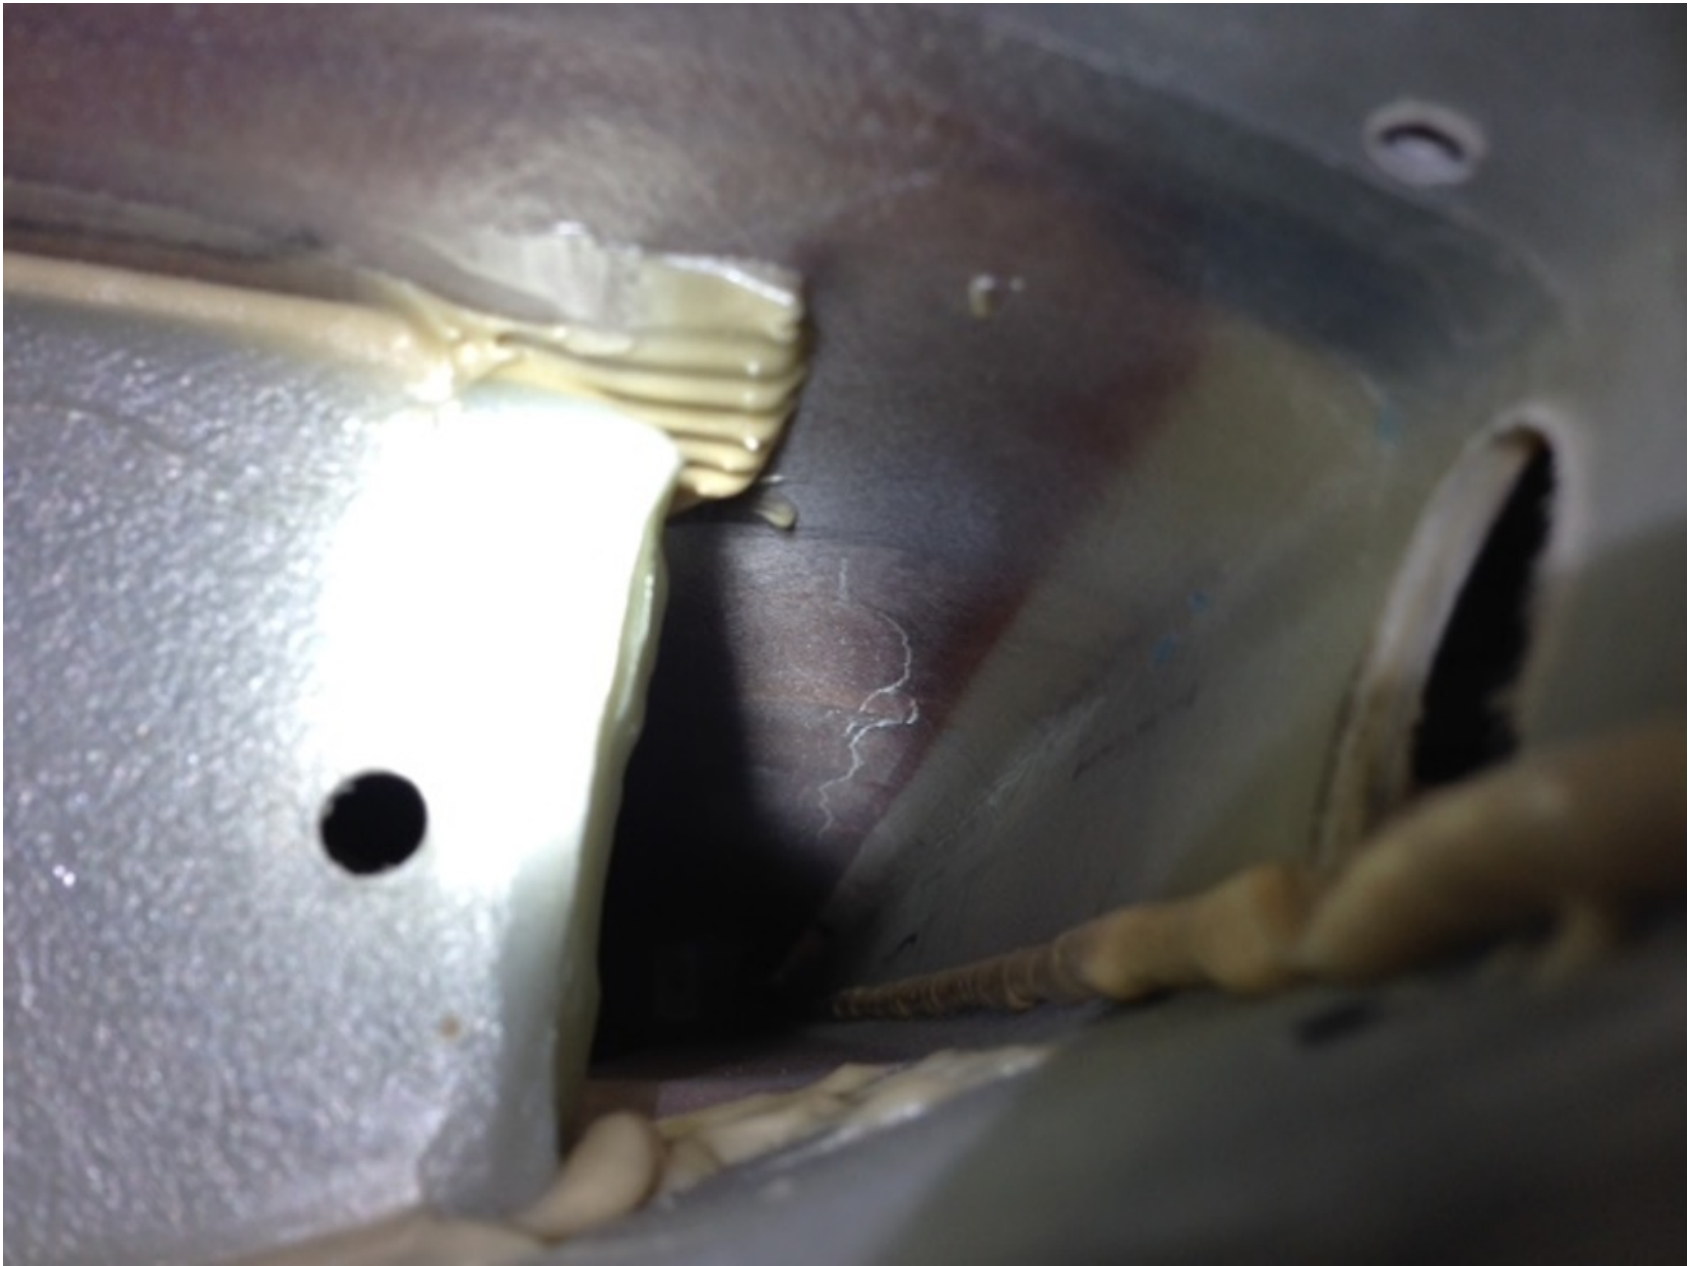
**Photo 12 –Image of Interior of Damaged Wing – Courtesy of Cirrus Aircraft**

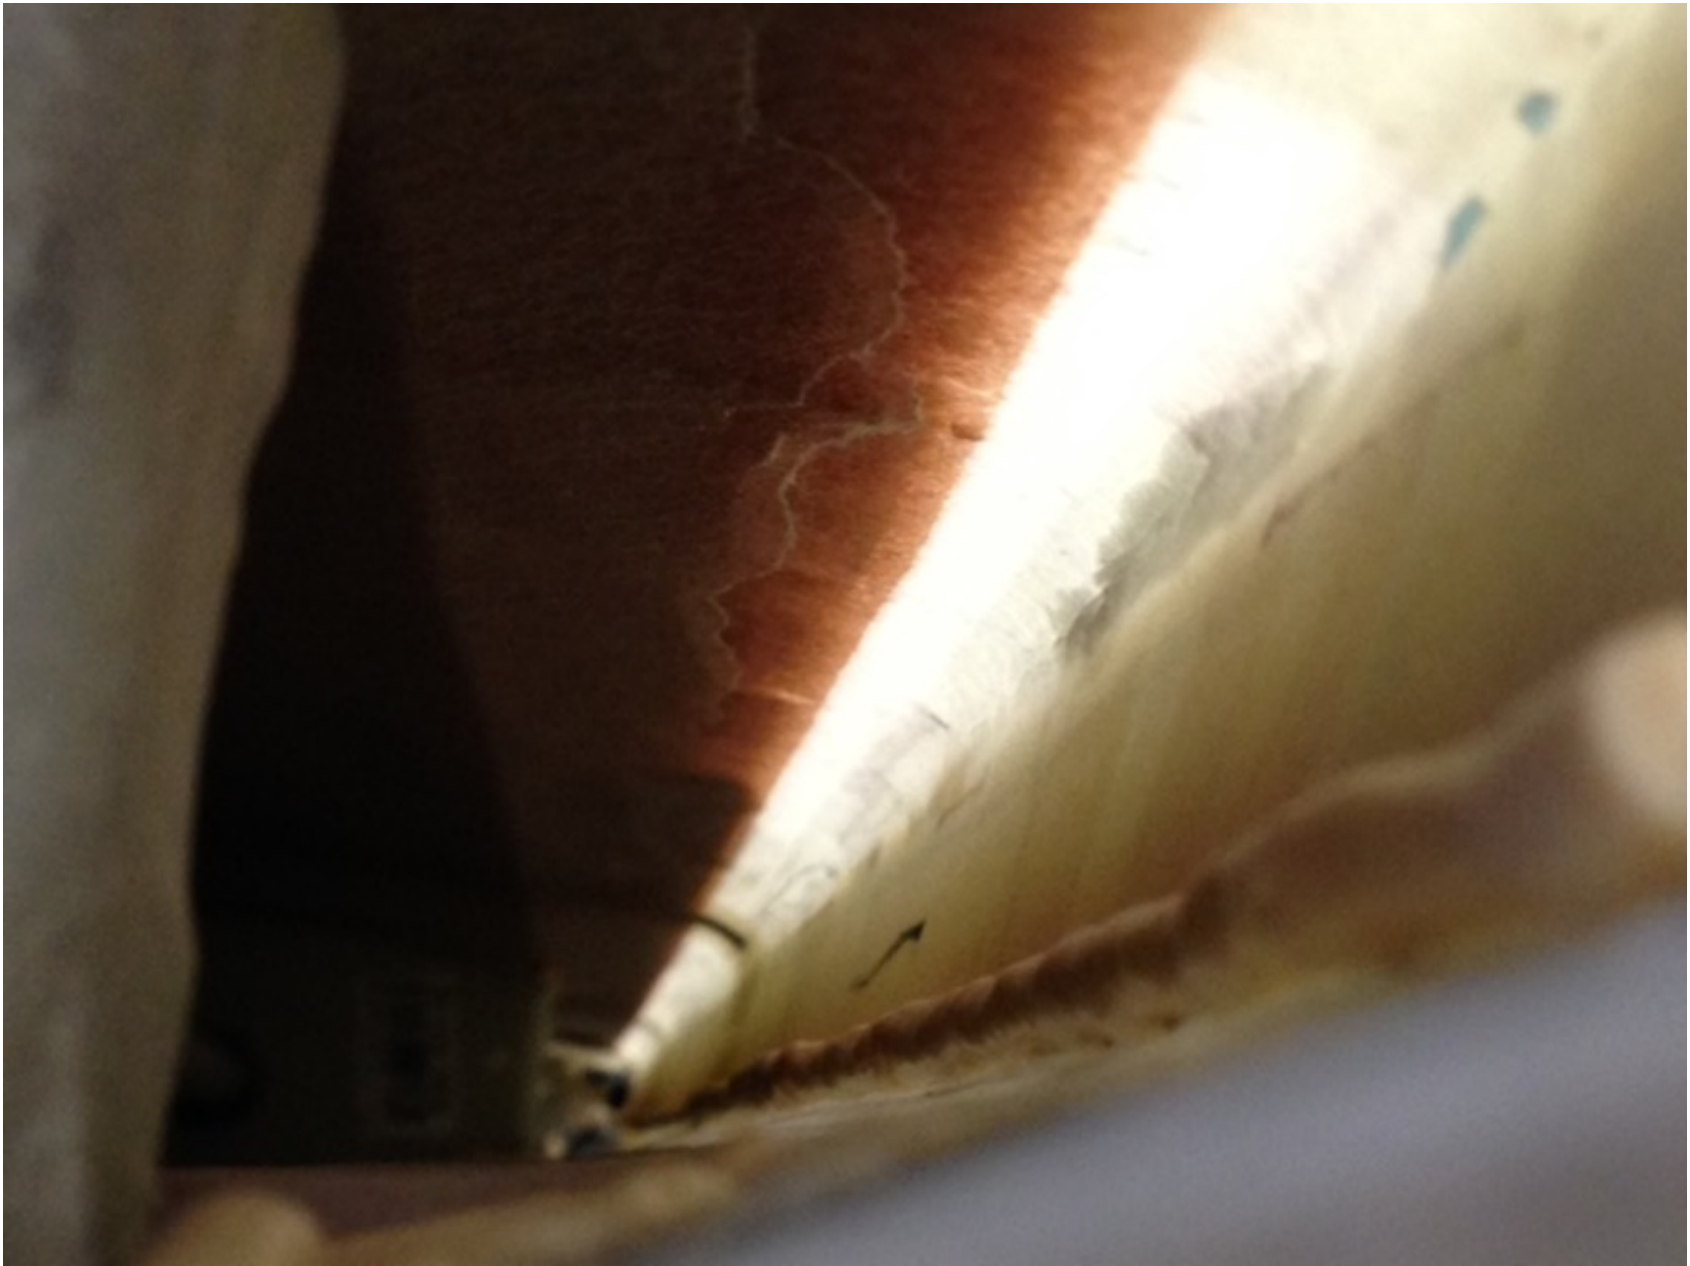
**Photo 13 – Enhanced Image of interior of Damaged Wing – Courtesy of Cirrus Aircraft**

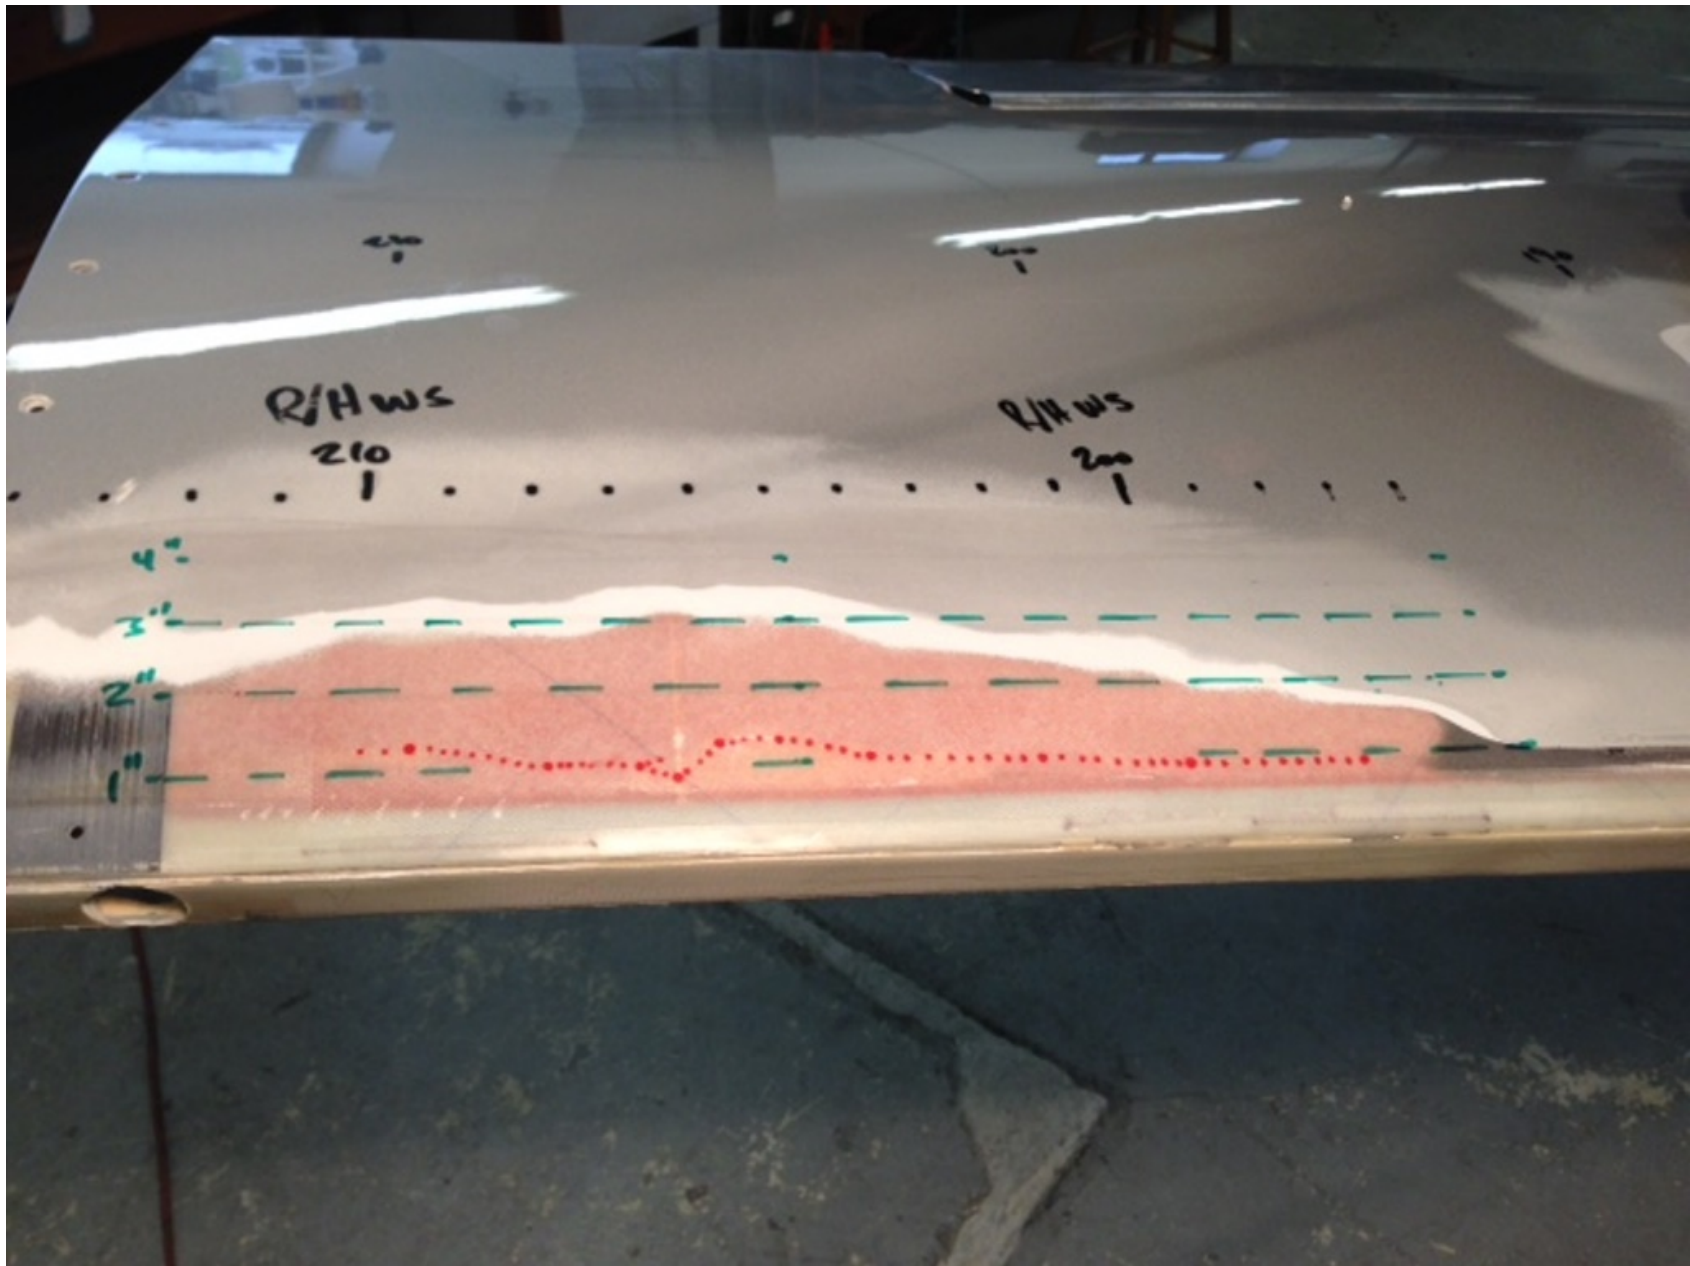
Photo 14 – Image of Dotted Line Indicating Location of Internal Crack – Courtesy of Cirrus Aircraft

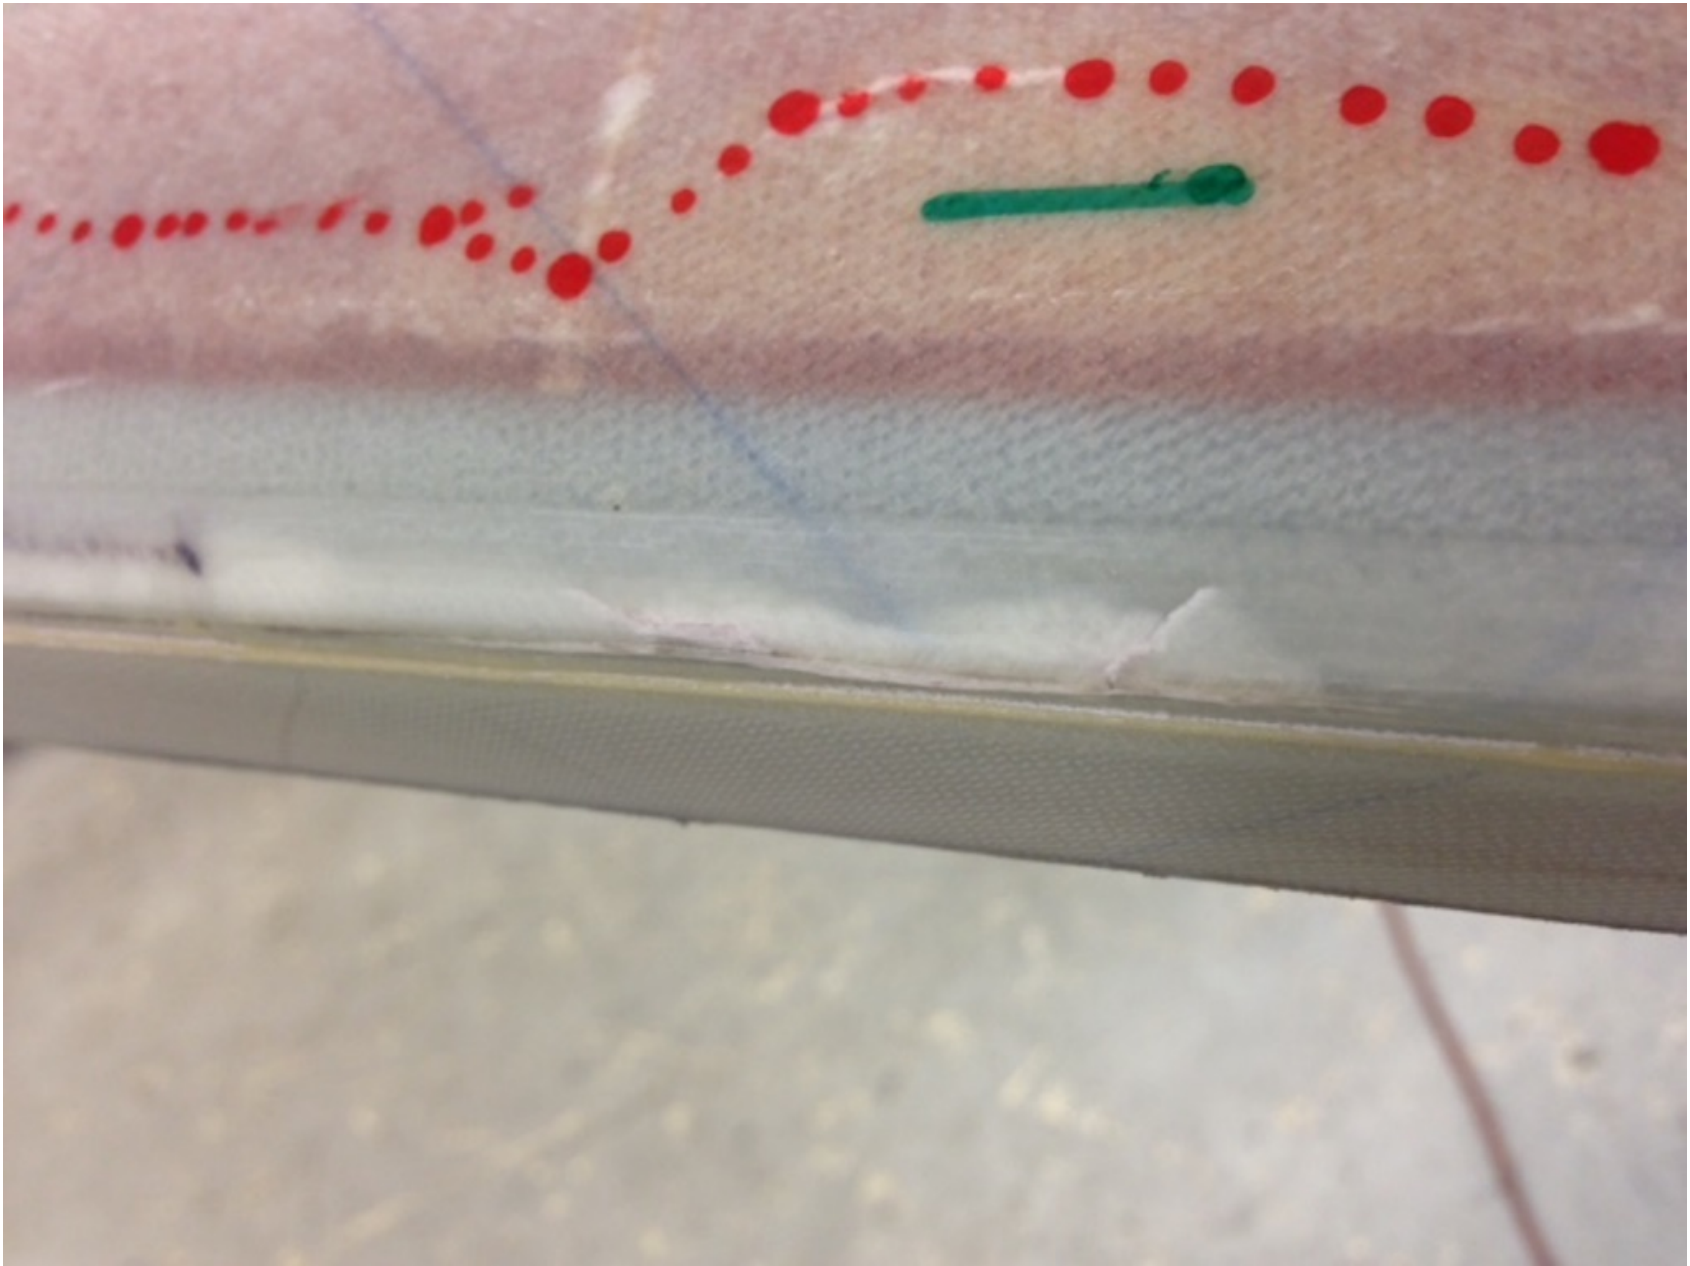
**Photo 15 – Close Up of Dotted Line and Leading Edge Damage – Courtesy of Cirrus Aircraft**
