## MEMORANDUM FOR RECORD

**Date: April 28, 2016**  
**Reference: Email Excerpt**  
**Witness: Mark Stuntzner (Bell Helicopter)**  
**NTSB Accident Number: ERA16LA160 Baltimore, MD**

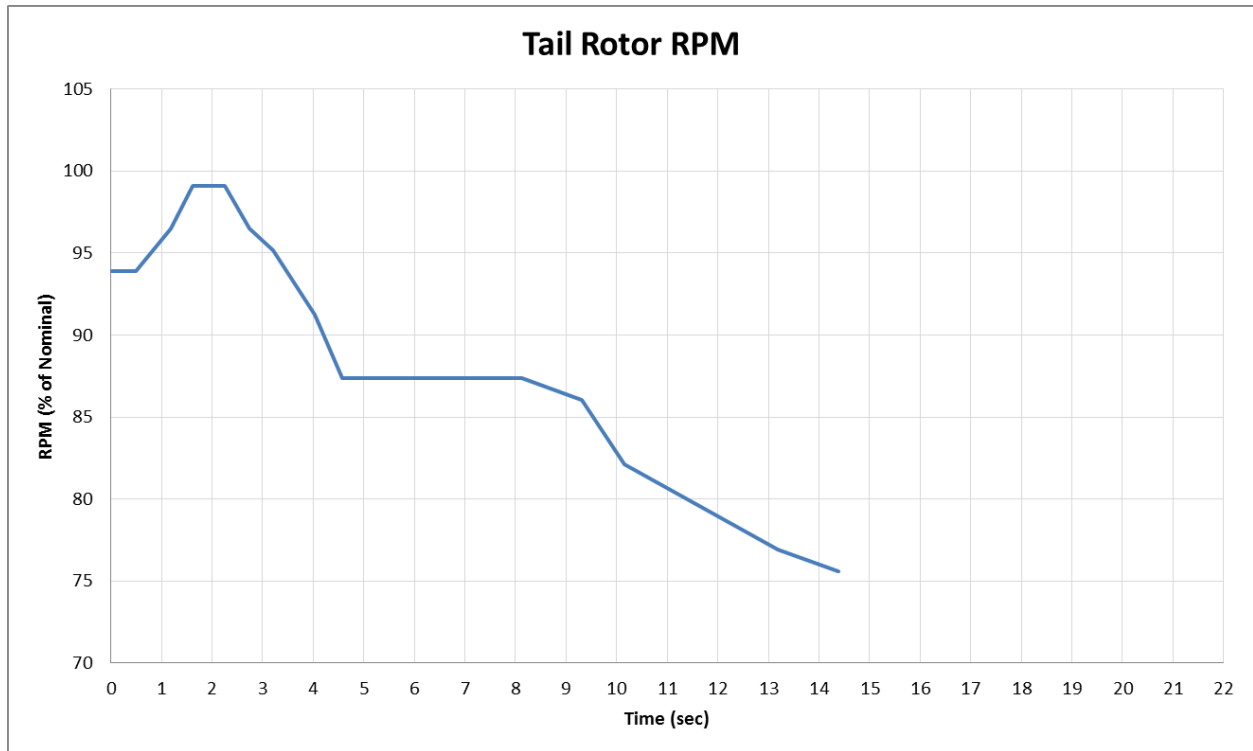
Tail Rotor RPM Time History Graph

"Attached is a plot of T/R rpm for the flight up to about 14 seconds into the video. You will note from the spectrograms that the T/R harmonic frequencies were relatively strong, but the sound signatures for Nr, N1, and N2 were too faint to analyze. As you know the Nr and T/R rpm are mechanically linked in-flight, so the T/R rpm should correspond to the Nr. You also may note that the first rpm data points are about 93% rpm and then go up to 99%. The helicopter was spinning right at the beginning of the video and then the pilot statement states that he lowered collective after initial onset of the right yaw/spin. Lowering of the collective would allow a drooping Nr to recover somewhat. I agree with the pilot that he suffered Loss of Tail Rotor Effectiveness (he mentions ETL instead of LTE, just a slight mistake)."
