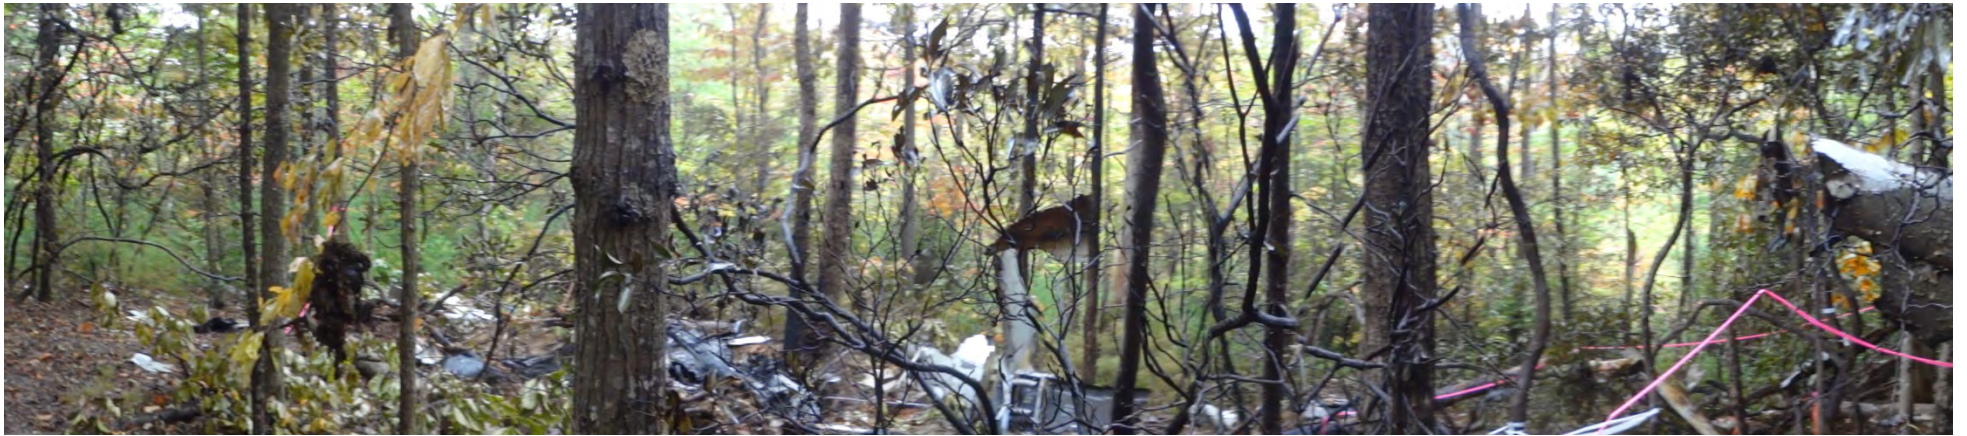
**Photo 1 – Panoramic View of Accident Scene looking down to valley**

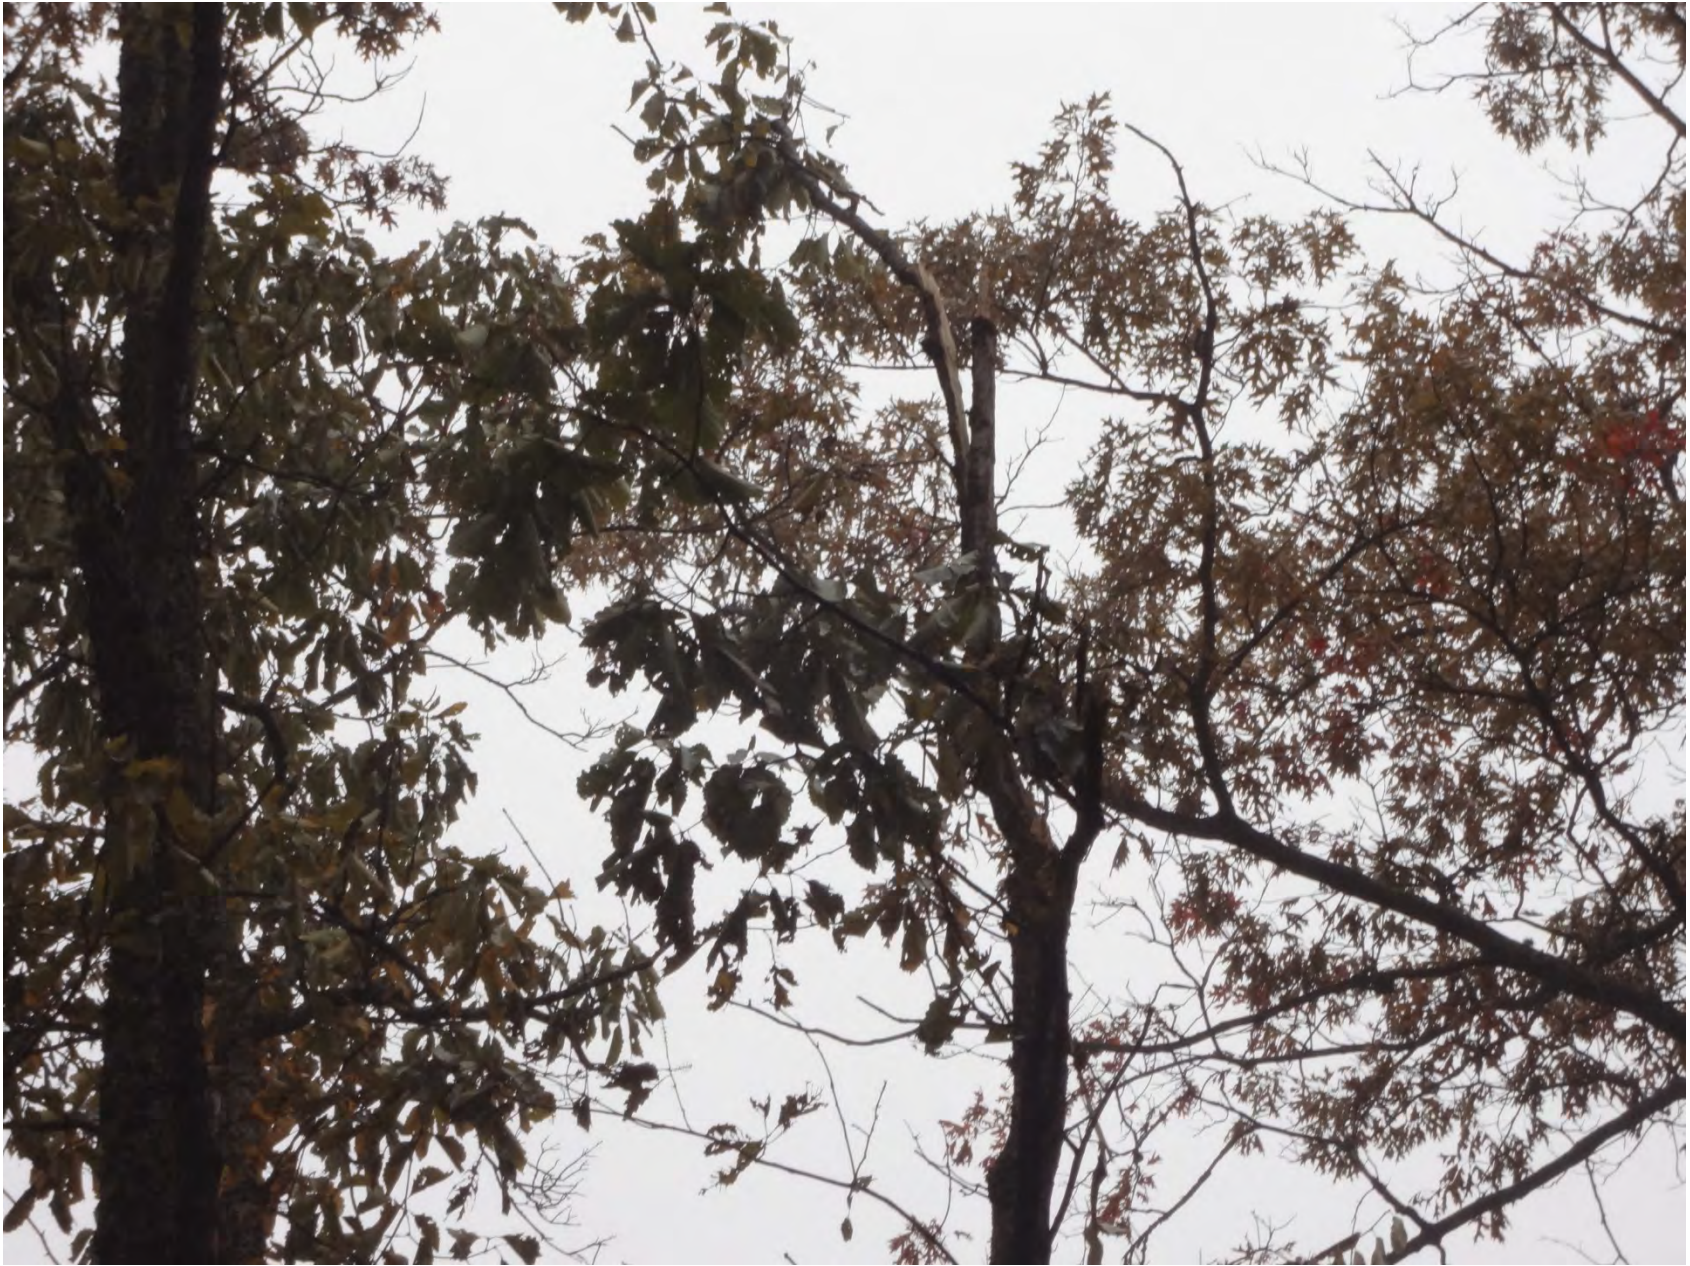
**Photo 2 - Initial Tree Strike**

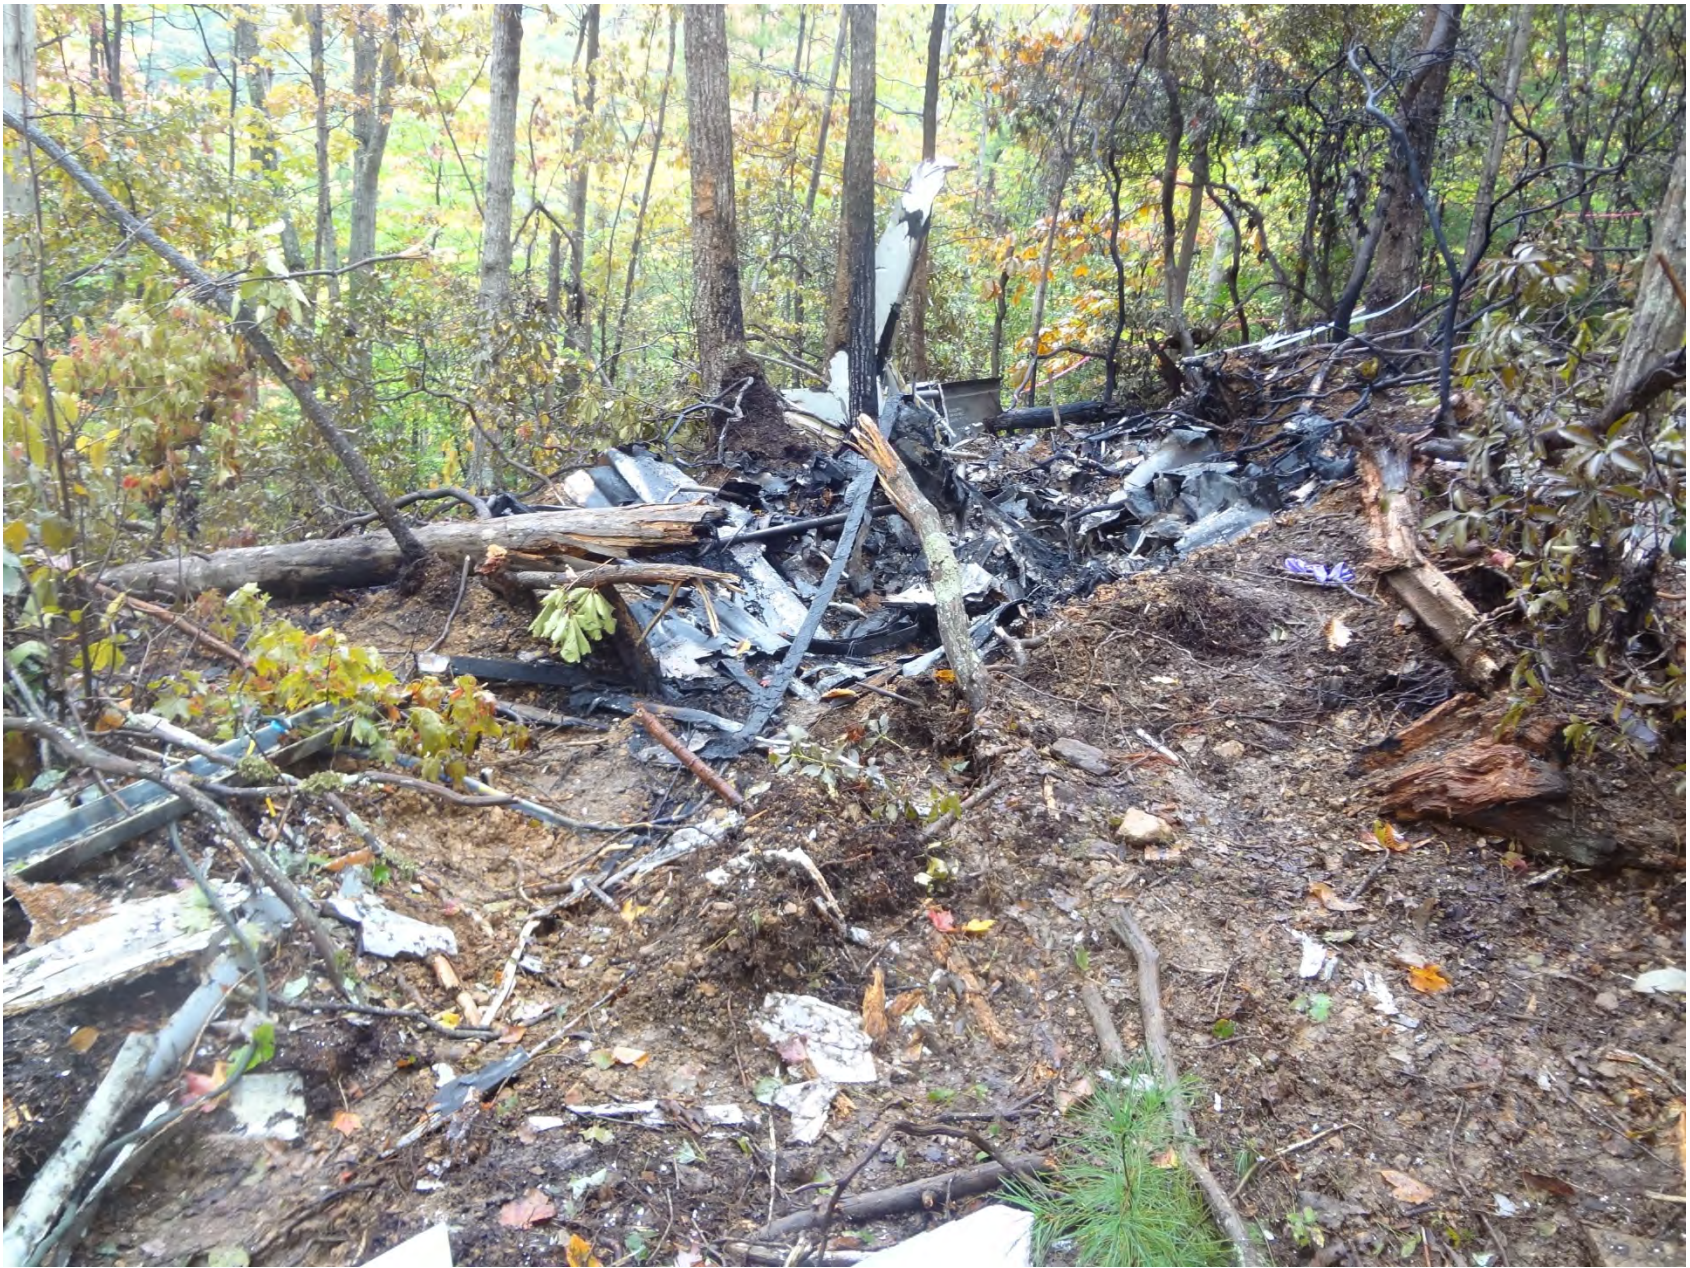
**Photo 3 - View of Airplane at Rest Viewed from uphill**

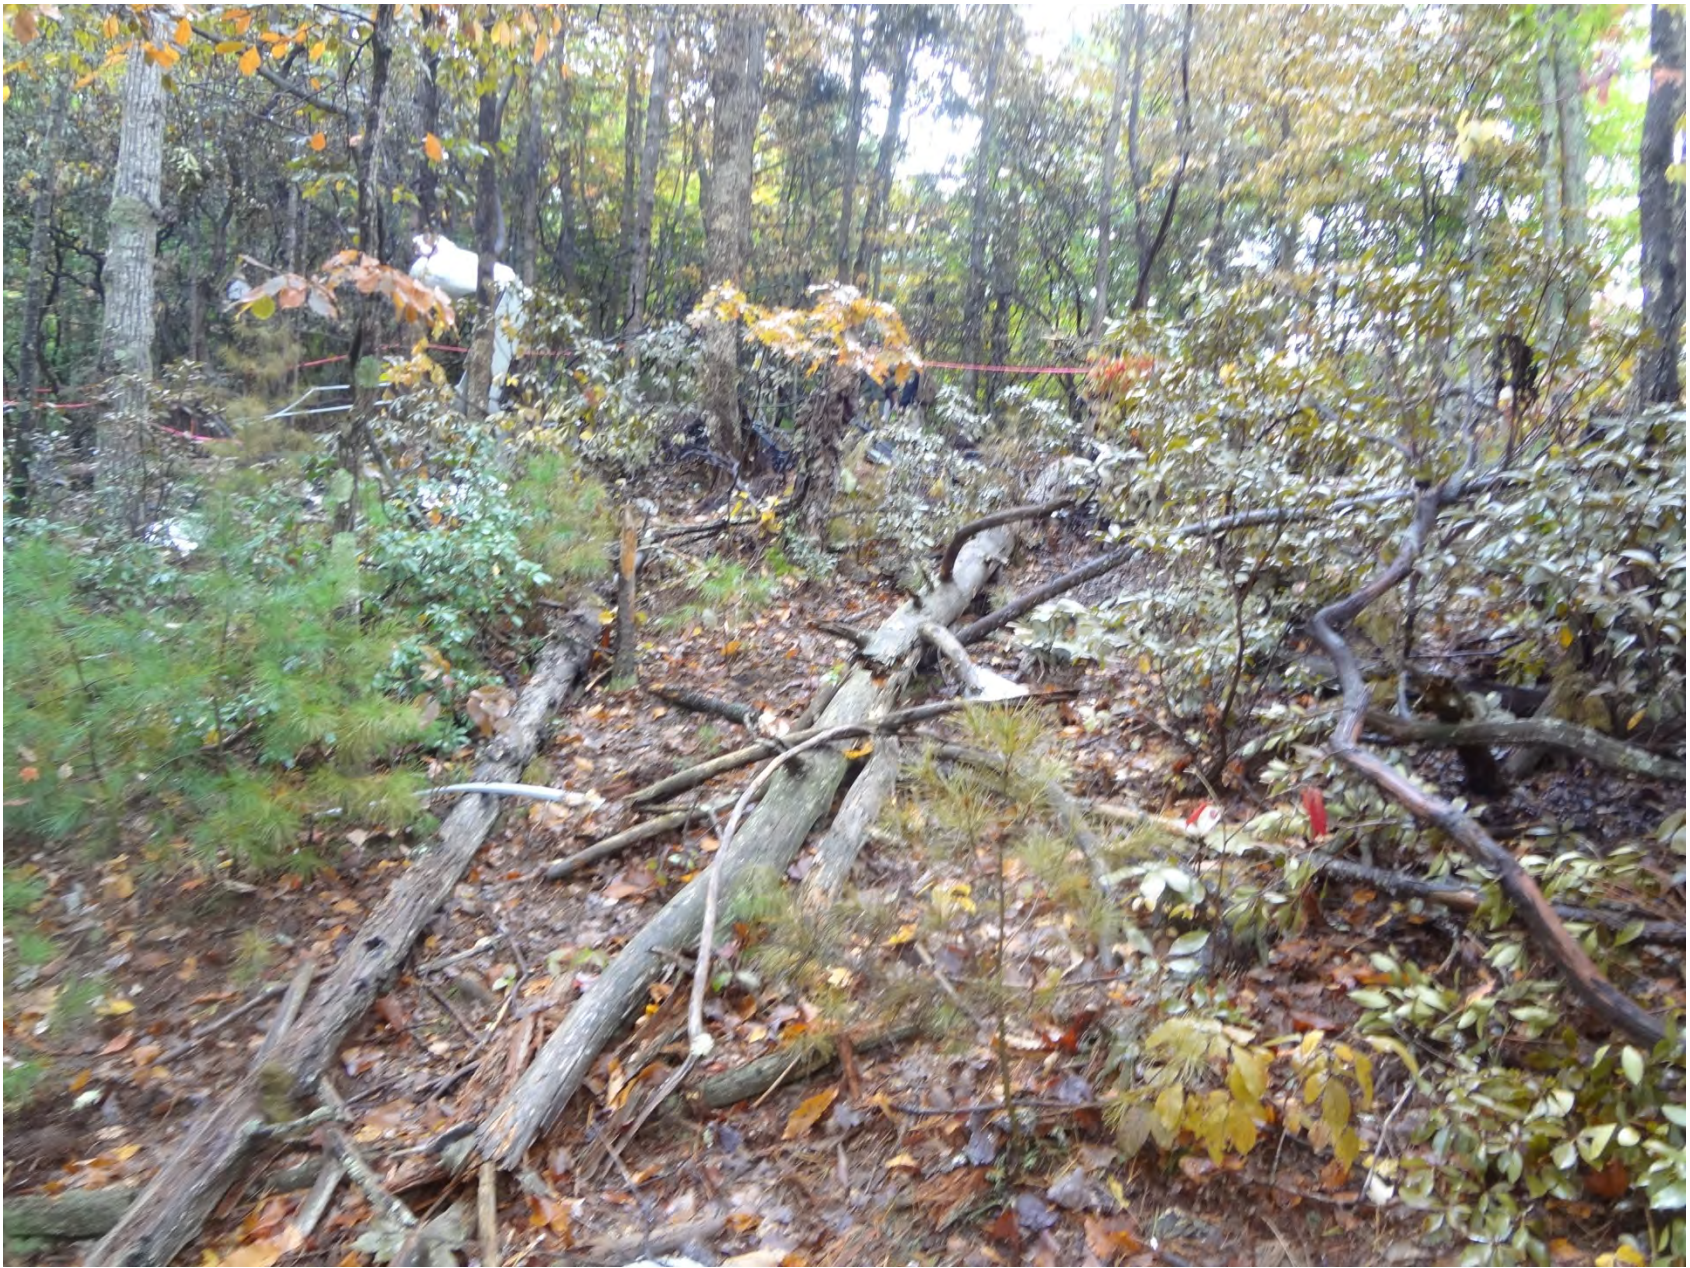
**Photo 4 - View of Airplane at Rest from Below the Wreckage**

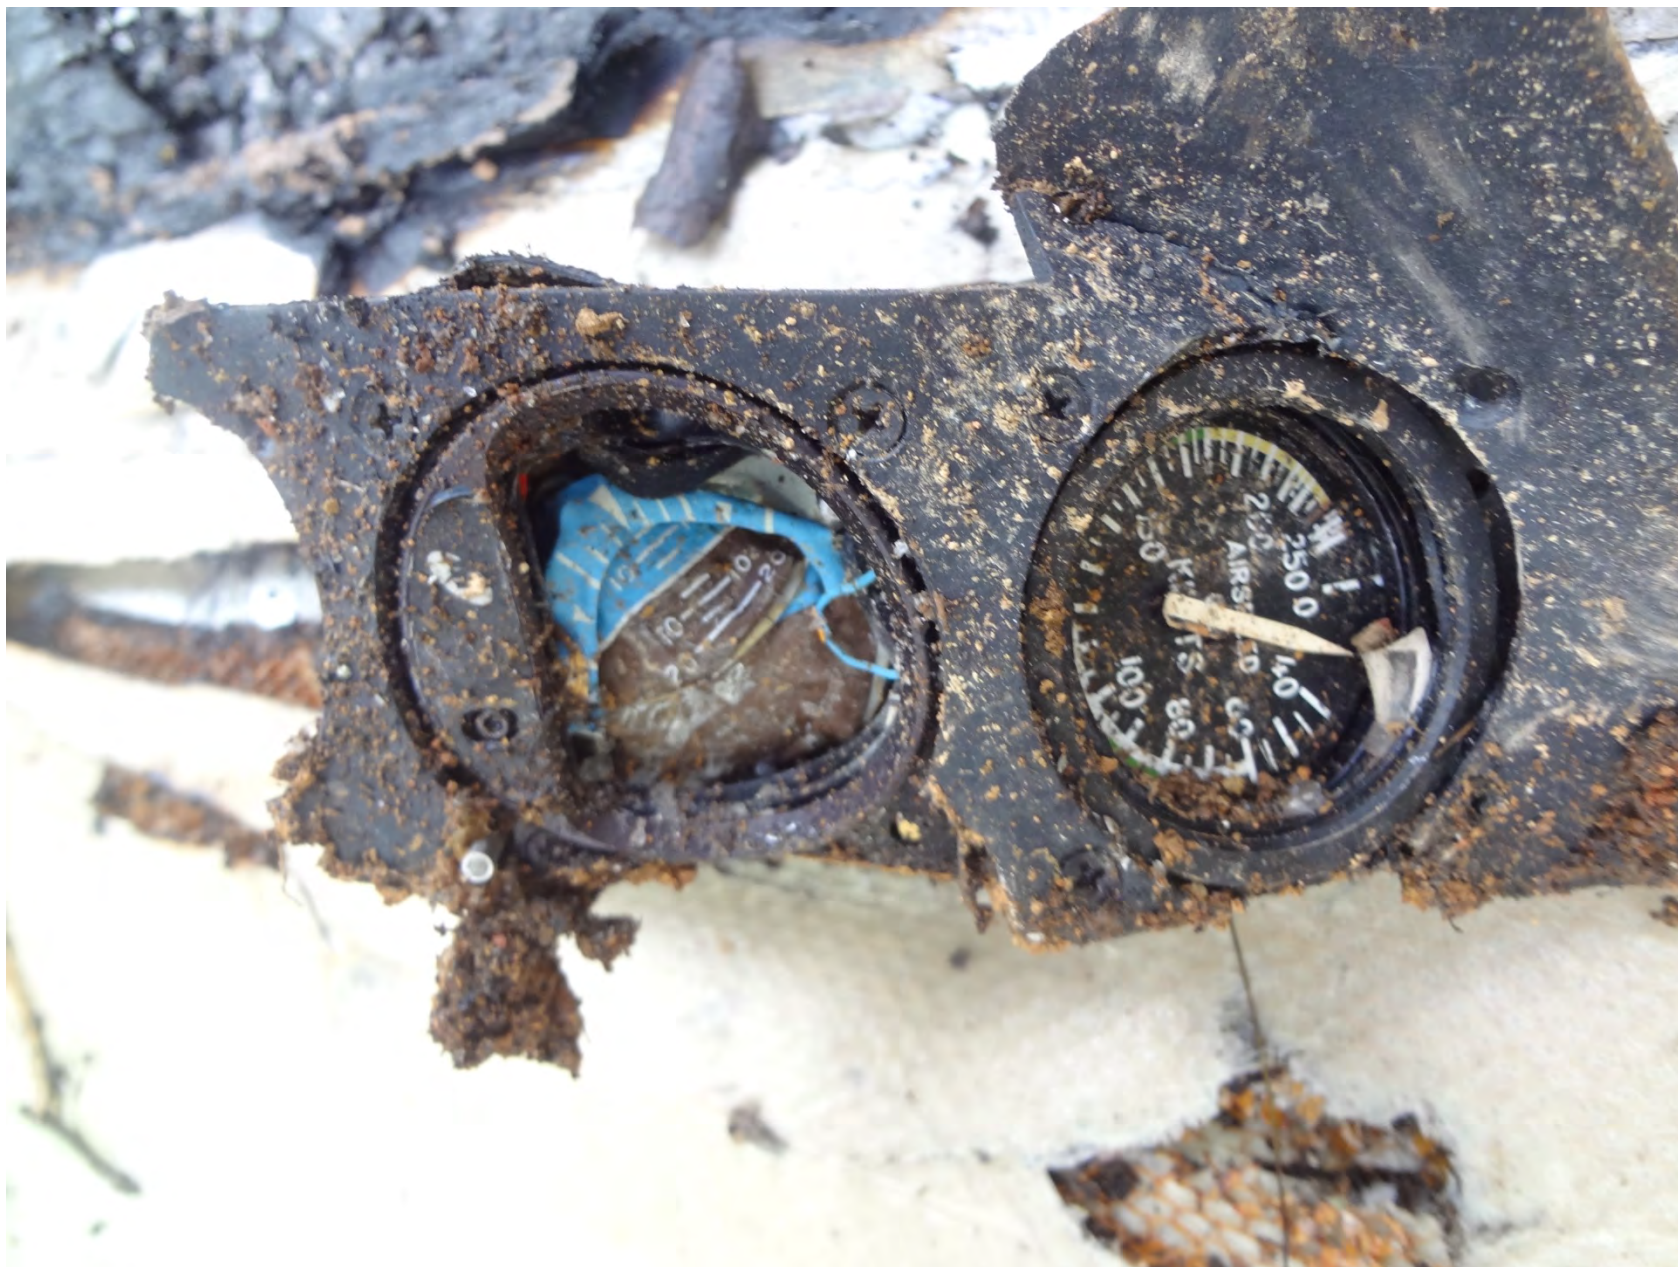
**Photo 5 - Backup Attitude Indicator and Airspeed indicator as found**

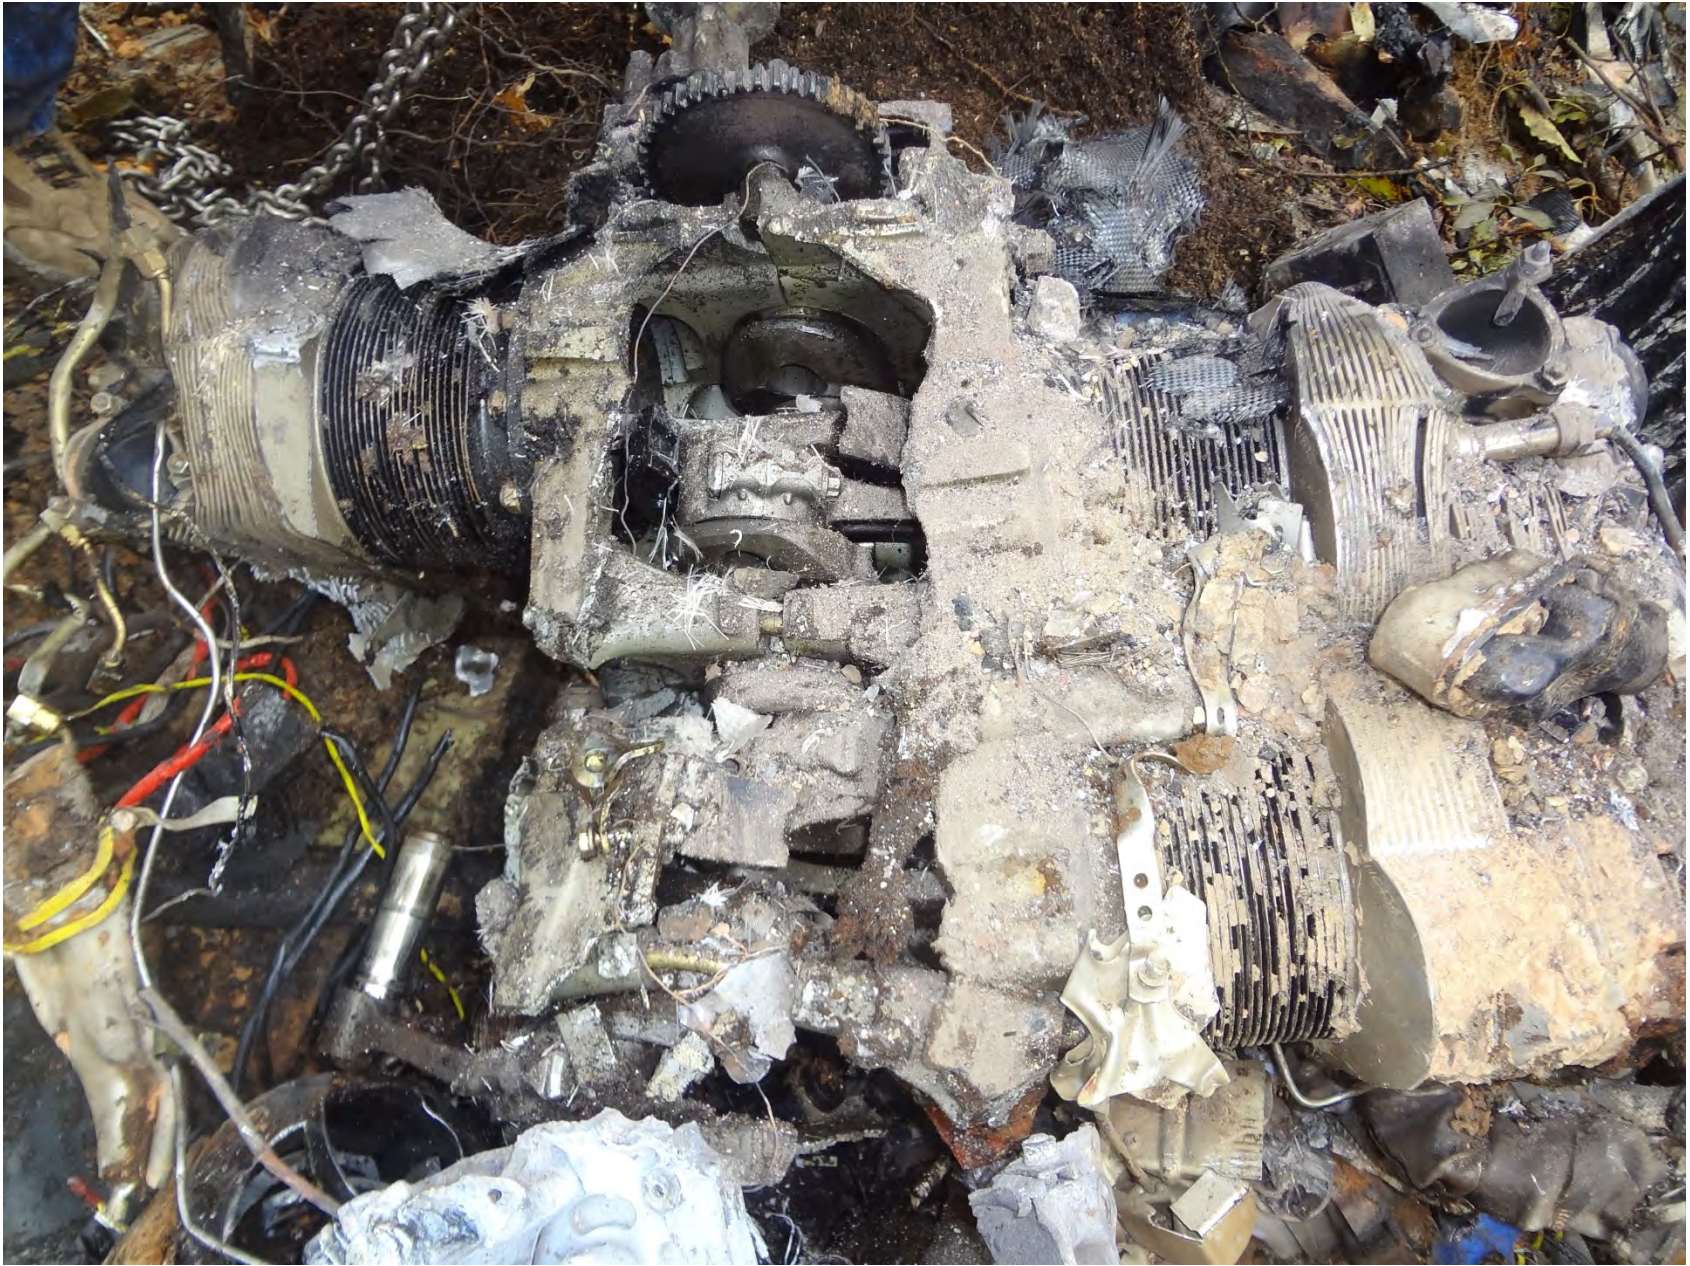
**Photo 6 - Engine after Extraction from the Ground**

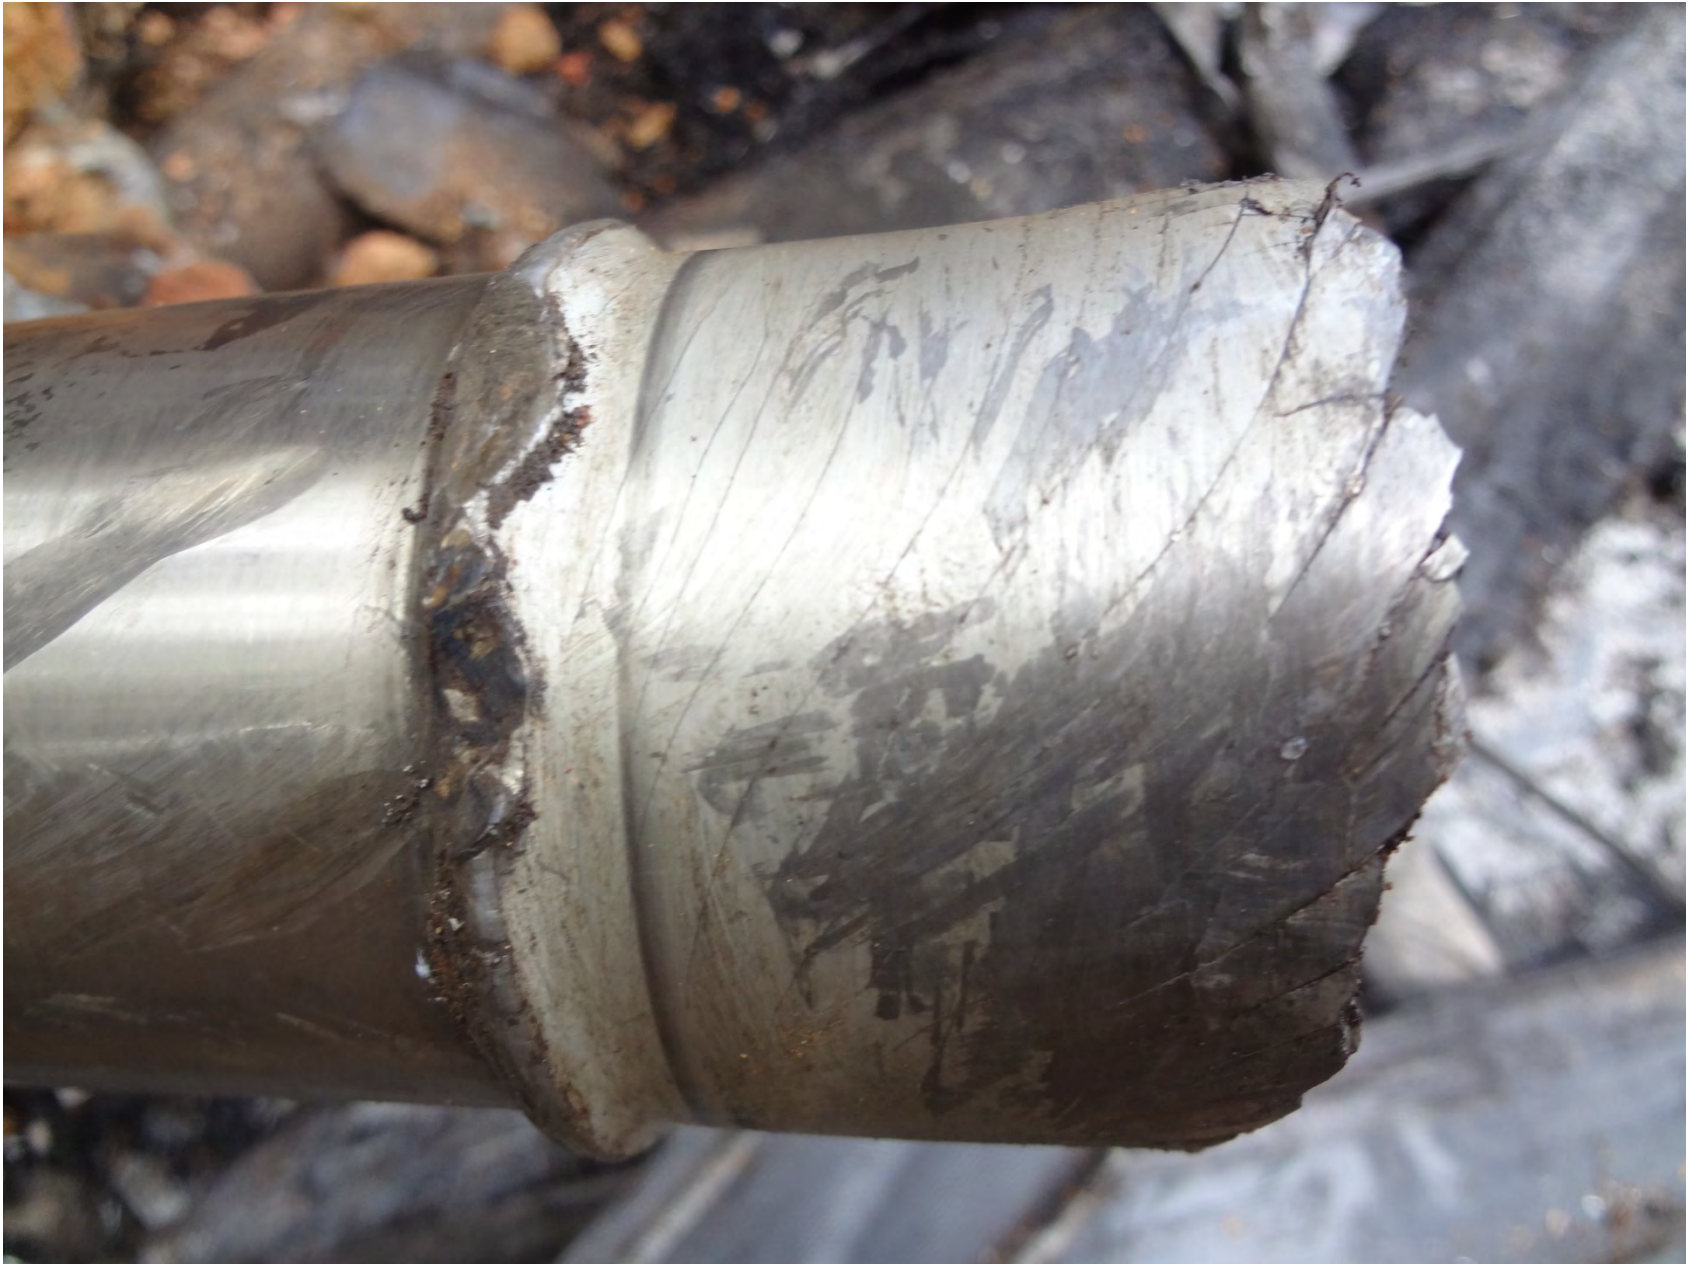
**Photo 7 - Crankshaft Striation as found**

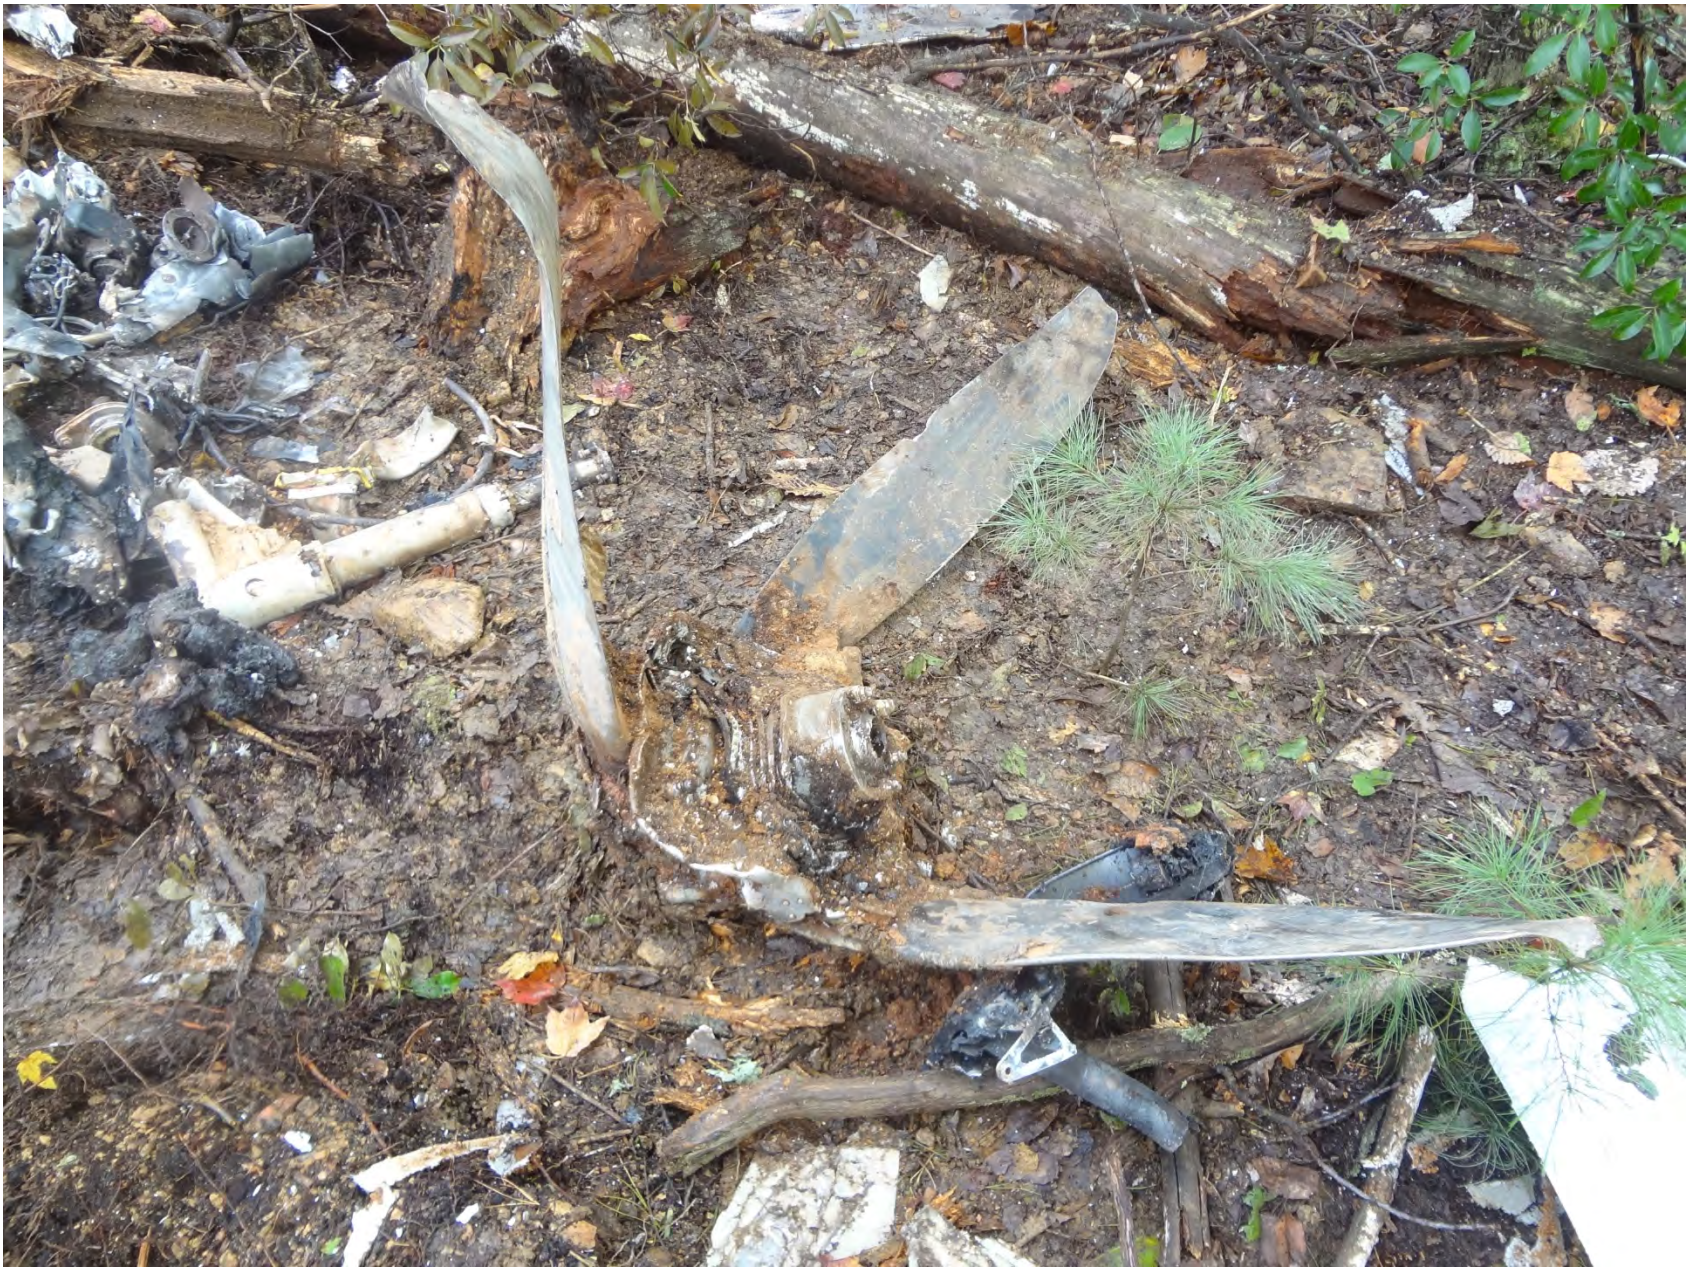
**Photo 8 - Propeller Blades after Removal from the Impact Crater**
